STRUCTURAL INVESTIGATION WORKS,
ALL SAINTS CHURCH,
WISTOW, NORTH YORKSHIRE

ARCHAEOLOGICAL WATCHING BRIEF

Report no: 2015/498.R01
Version: Final
Date: May 2015
Author: Ed Dennison & Shaun Richardson

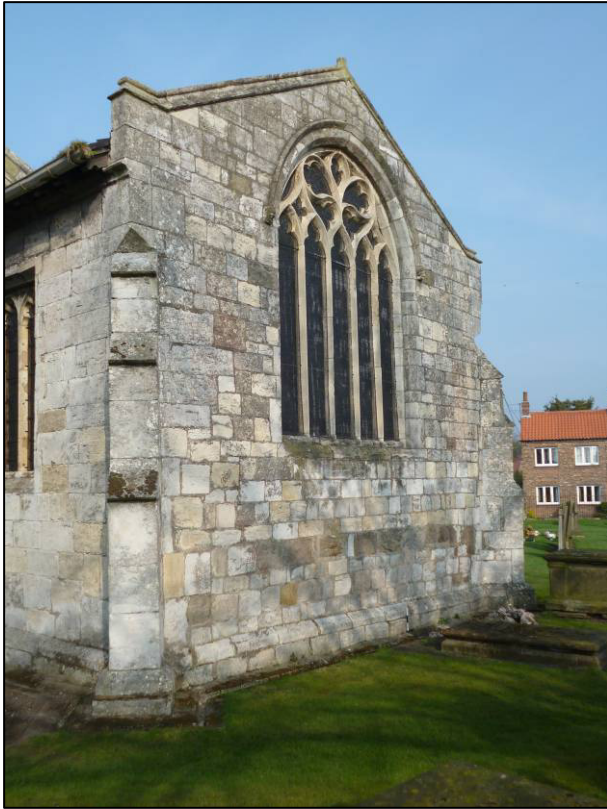
- 4.1 The single trench was excavated in the churchyard, at the base of the approximate centre of the chancel's east wall (see plates 1 and 2). The trench was aligned parallel to the wall (i.e. north-south). As previously noted, the trench averaged 0.45m wide throughout, and had a maximum length of 2.90m. Prior to excavation, the ground surface was formed by a decayed concrete surface drain running along the base of the chancel wall. At the south end of the trench, the ground surface was set at 7.66m AOD, and at the north end it was at 7.58m AOD. The trench was excavated to a maximum depth of 1.02m below ground level (BGL), so that the base of the trench lay at 6.56m-6.66m AOD. Two 19th century grave slabs lay close to the east side of the trench.

Plate 1: View of east end of chancel prior to excavation of trench, looking NW.

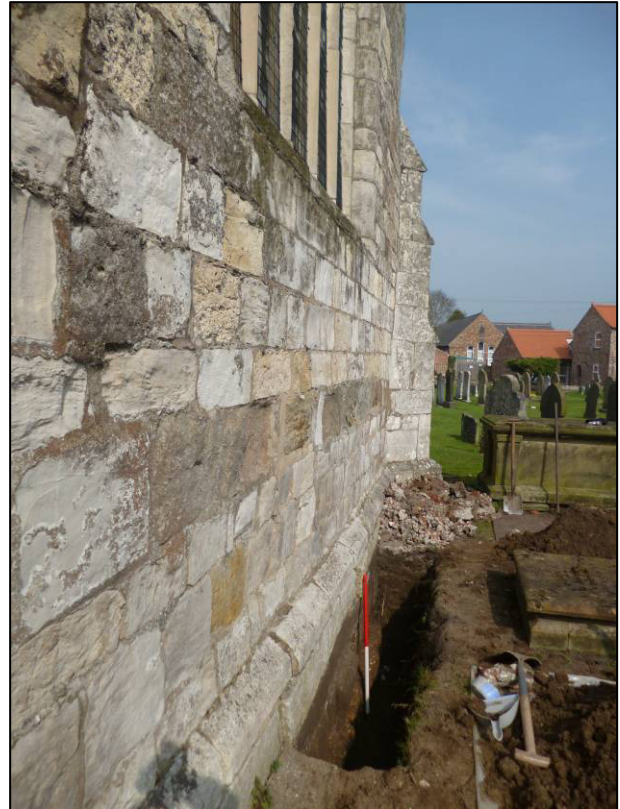
Plate 2: Trench after excavation, looking N.

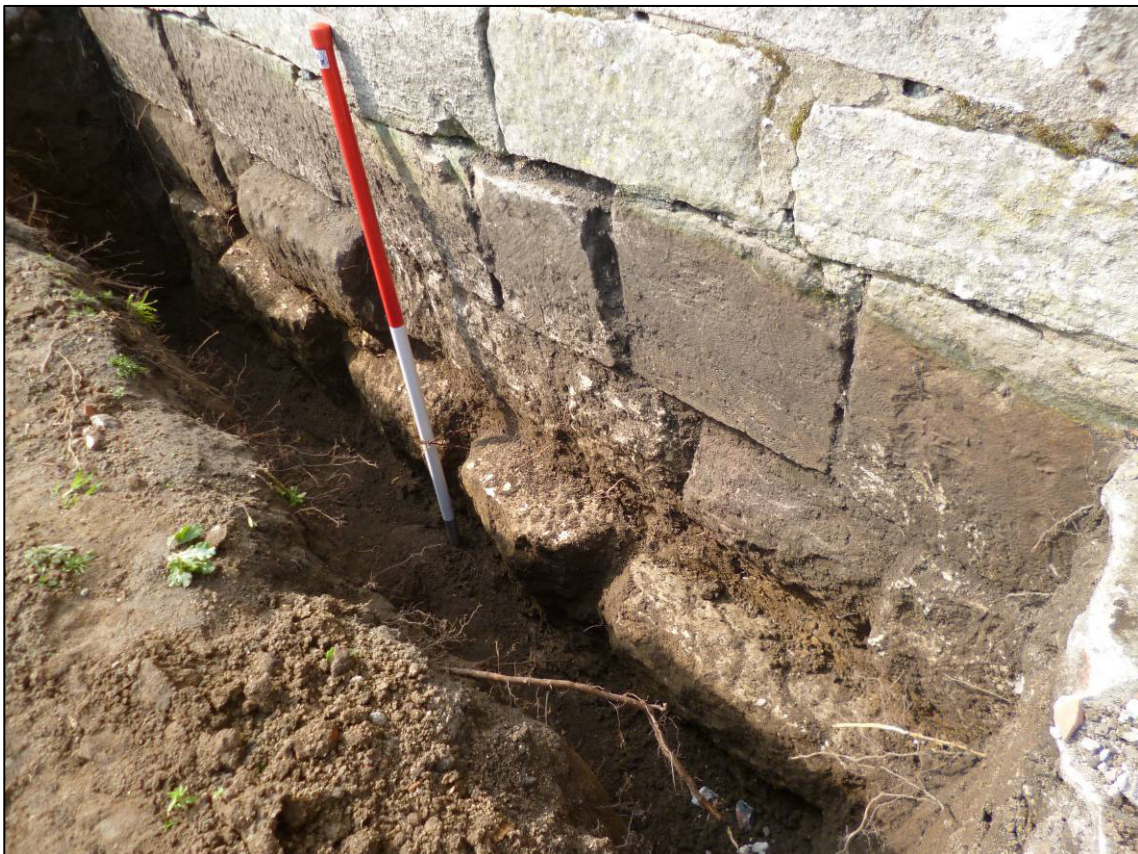
- 4.2 The chancel wall footings were exposed in the north side of the trench (see plate 3). A chamfered plinth extends across the whole of the chancel's east wall. The course forming the plinth is of Magnesian limestone, like much of the rest of the church; the individual stones are square and coursed, with neatly tooled faces. At its south end, above the trench, the top of the chamfered plinth was set at 8.06m AOD, whereas the north end was slightly lower at 7.97m AOD. Below the plinth course, the wall face dropped vertically for three courses. The upper two courses were of a similar stone to the plinth, but the stones of the third course were less well dressed; one stone projected from the wall face above, but this was a result of

movement, rather than being an earlier or decayed structural feature. Below the third course, the footings of the chancel wall were exposed. These were formed by a single course of large, crudely squared and dressed stones, projecting up to 0.12m from the wall face above. At both ends of the trench, the base of the footings was set at the same level as the limit of excavation (6.66m AOD at the south end, and 6.56m AOD at the north end).

Plate 3: Trench after excavation, showing foundations of chancel wall, looking SW.
