ALTERATIONS AND ERECTION OF EXTENSIONS,  
WILLOW COTTAGE, 2 PASTURE LANE,  
BEVERLEY, EAST YORKSHIRE

ARCHAEOLOGICAL OBSERVATION,  
INVESTIGATION AND RECORDING

Report no: 2014/480.R01  
Version: Final  
Date: May 2015  
Author: Ed Dennison & Jim Fraser

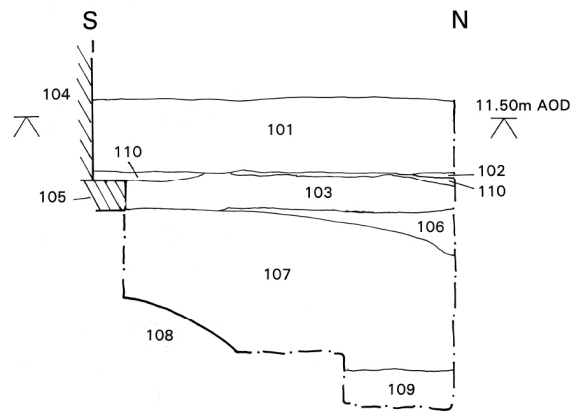
Section 1: West end of Trench 1

- 5.4 The earliest deposit exposed in the bottom of the west end of the trench was a friable grey-brown clay silt (109), similar to deposit 119 seen to the east, and at least 0.2m thick (see Section 3). This material also probably represented a fill of the presumed town ditch (124) and was encountered at 1.5m BGL (10.05m AOD). A small assemblage of late 18th-early 19th century pottery was recovered from the fill (109), together with one sherd dating to the 14th-16th century (see Appendix 2).

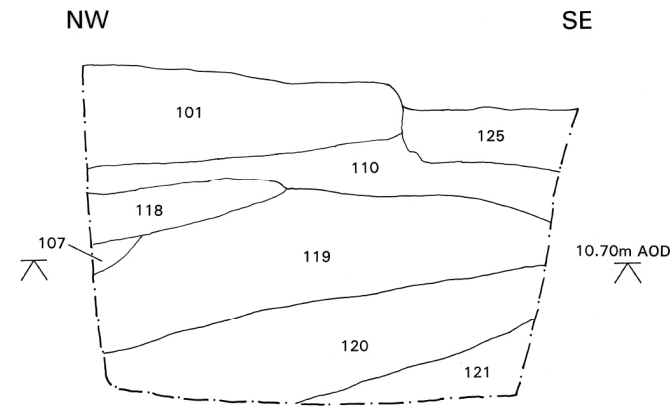
Section 2: East end of Trench 1

- 5.3 The earliest deposit exposed in the bottom of the east end of the trench was a firm grey-brown silt (121) at least 0.4m thick (see Section 2). This was overlaid by a hard dark brown-grey silt (120) over 0.58m thick, which contained fragmented ceramic building materials (hereafter CBM) and chalk. This, in turn, was overlaid by a friable grey-brown silt (119) up to 0.6m thick. These three deposits (119, 120 and 121) probably represented fills of the presumed town ditch (124) which passes through this part of the site and which was also encountered to the south in the stripped area (see below). The latest fill of the ditch (119), was encountered between 0.5m-0.6m below ground level (hereafter BGL) (11.10m AOD) at the east end of the trench, falling to 1.0m BGL (10.40m AOD) towards the centre.

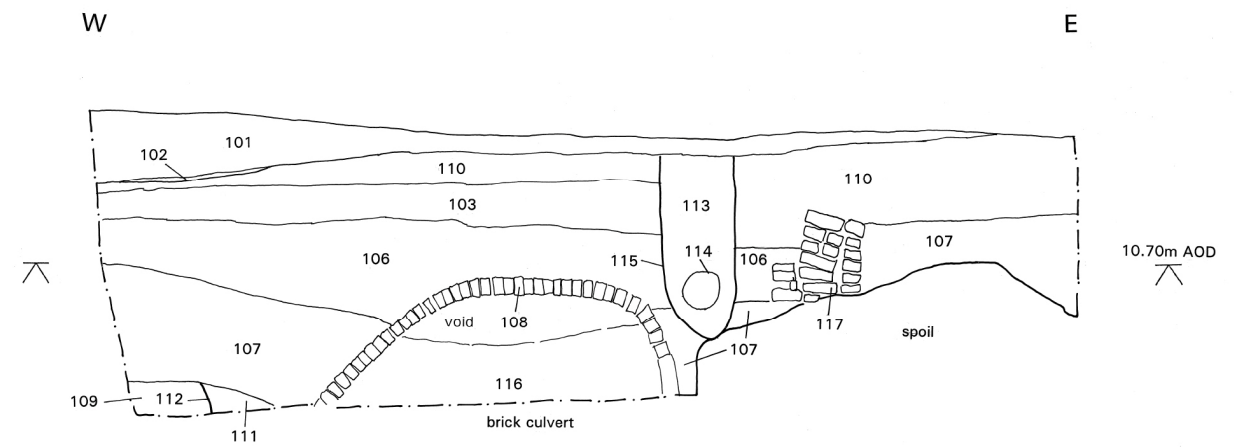
Section 3: North side of Trench 1

- 5.7 A ground-raising/consolidation deposit (107) of crushed mortar and fragmented CBM up to 0.64m thick had been deposited either side of the culvert (108) and the brick foundation (117) (see Section 3); a small assemblage of late 19th-early 20th century pottery was recovered from this consolidation deposit (107) (see below). A layer of very hard mortar (106) up to 0.6m thick and containing fragmented chalk and CBM, overlay the top of the culvert and the ground-raising/consolidation deposit (107), and was defined at its east end by the brick foundation (117). A further deposit of very hard mortar (118) up to 0.3m thick, again containing fragmented chalk and CBM, partially overlay the eastern extent of the consolidation deposit (107) (see Sections 2 and 4). These three deposits (106, 107 and 118) levelled the ground and were encountered at 0.55m BGL (11.15m AOD) in the east end of the trench, falling slightly to 0.61m BGL (10.94m AOD) to the west.

- 5.8 A light brown clay silt (103), up to 0.3m thick, overlay all but the east end of the hard mortar layer (106) (see Section 3). Above this, a layer of grey-brown silt (110) up to 0.6m thick, containing crushed mortar and fragmented CBM, overlay the earlier deposits and structures apart from the western extent of the light brown silt (103). This layer (110) was probably associated with the landscaping of the area after the installation of the brick-built culvert (108) and was encountered 0.3m BGL (11.40m AOD) at the east end of the trench, falling to 0.4m BGL (11.15m AOD) to the west.

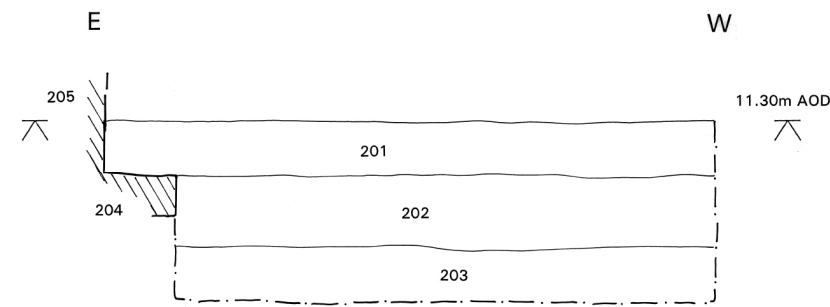
Section 5: South side of Trench 2

- 5.17 The earliest deposit exposed in the trench was a dark grey silt (203) over 0.3m thick, encountered at 0.97m BGL (10.59m AOD) (Section 5). This possibly represented a late fill of the presumed town ditch (124), or a deliberate backfill of the town ditch after the construction of the brick culvert (108) seen in Trench 1.
- 5.18 A layer of crushed mortar and fragmented CBM (202) up to 0.4m thick, overlay the dark grey silt (203) (see Section 5). This deposit (202), encountered at 0.57m BGL

- 5.19 A layer of turf and topsoil (201) up to 0.57m thick overlay deposit 202 and formed the current ground surface, at 11.56m AOD (see Section 5). The concrete foundation (204) for the house was also exposed in the east end of the trench.

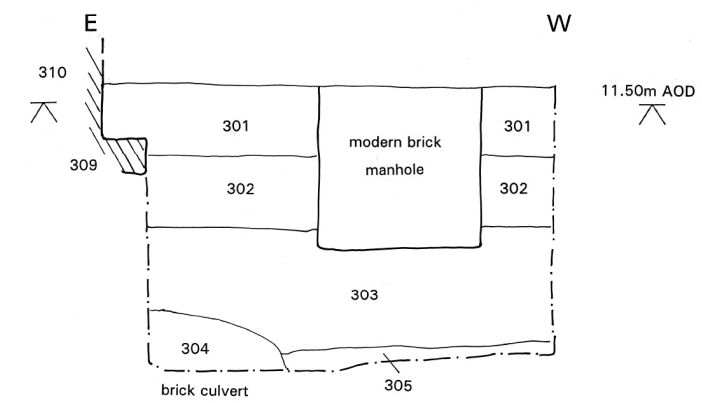
Section 6: South side of Trench 3

- 5.22 The earliest deposit exposed in the bottom of the trench was a layer of brown silt clay (305) over 0.1m thick, which possibly represented material which had formed a bank but had been levelled and then dumped into the presumed town ditch (124) (see Section 6). This deposit was encountered at 1.44m BGL (10.14m AOD).

- 5.23 During excavation of Trench 3, the west side of a north-west/south-east aligned brick-built arched culvert (304) was noted, cut into the brown silt clay (305) in the very bottom of the trench (see Section 6 and plate 5). Health and Safety concerns prohibited safe access into the trench, and so only rough dimensions could be recorded. The culvert was over 0.34m high and at least 0.74m wide and was built using hand-made bricks of a similar form and size as those used to construct the culvert (108) seen in Trench 1. The top of the culvert was encountered at 1.26m BGL (10.32m AOD), and it may well have connected with the Trench 1 culvert although this could not be confirmed. The fill (312) of the culvert could not be investigated properly due to the depth of the trench, but it appeared to be a dark grey silt similar to deposit 116 seen in Trench 1.

- 5.25 A modern drain and associated brick-built manhole truncated the earlier deposits, prior to the deposition of a layer of turf and topsoil (301) up to 0.4m thick (see Section 6). The concrete foundation for the existing building (309) was also seen

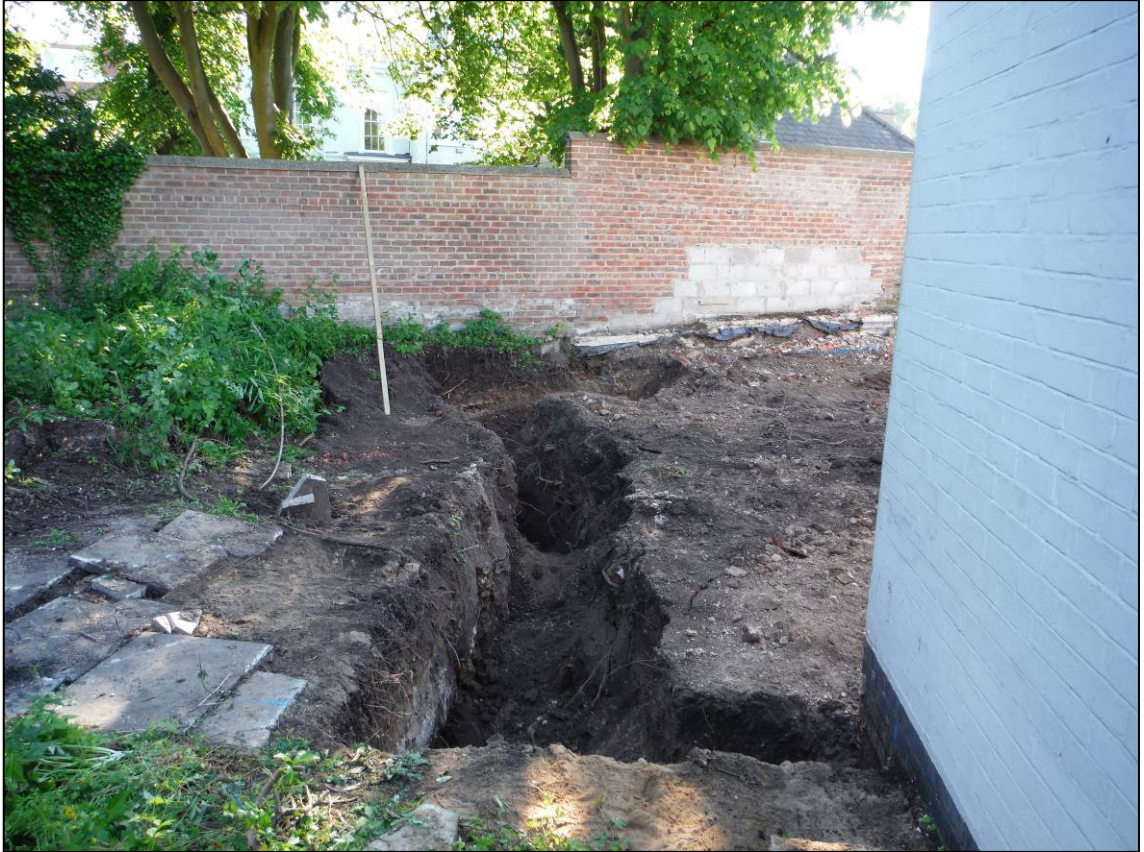
- 5.2 Trench 1, the northern extent of the foundation trench for the proposed extension, was sited running off the north-east corner of the existing building in an easterly direction. The trench was dog-legged in plan, measuring c.11.5m long overall, between 1.4m-1.8m deep and 0.6m wide, and was subject to frequent collapse (see plate 1).

Plate 1: General view of Trench 1 for eastern extension, looking E.

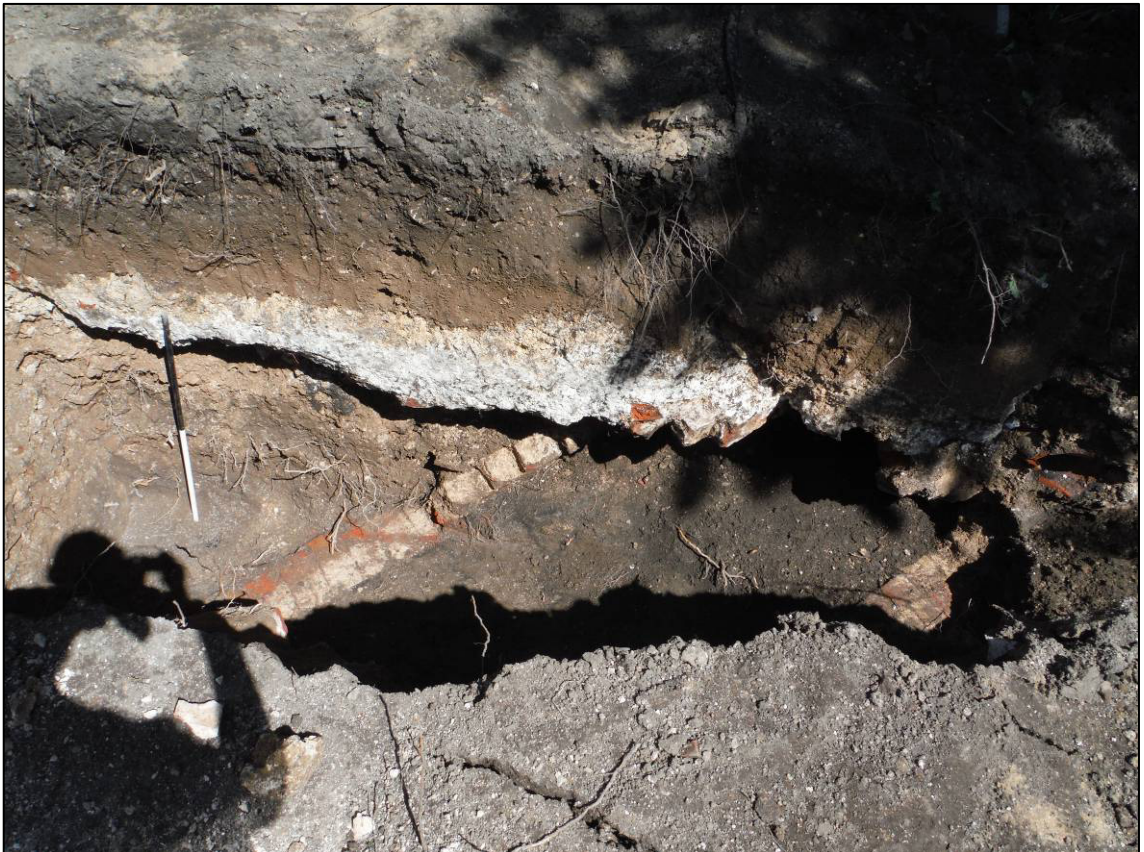
construction of a mortar-bonded brick-built arched culvert (108) which was visible in the base of the trench. This cut was only seen on the west side of the culvert, as to the east the bottom of the trench was obscured by fallen spoil. The culvert (108) was running at an angle of c.45° to the trench, but extrapolation showed it to be c.1.5m wide (1.0m wide internally), and it was over 0.70m high and built of late 18th-early 19th century hand-made bricks measuring 240mm by 120mm by 60mm (see Section 3) (see plate 2). The top of the culvert was encountered at 0.8m BGL (10.60m AOD) and the arch was made of bricks laid as stretchers, while the bricks of the walls were laid on end; the opening was partially filled or blocked with a dark grey silt fill (116). The construction cut (112) on the west side of the culvert had been backfilled with a deposit of crushed mortar with inclusions of fragmented CBM (111).

Plate 2: Culvert (108) exposed in base of Trench 1, looking N.

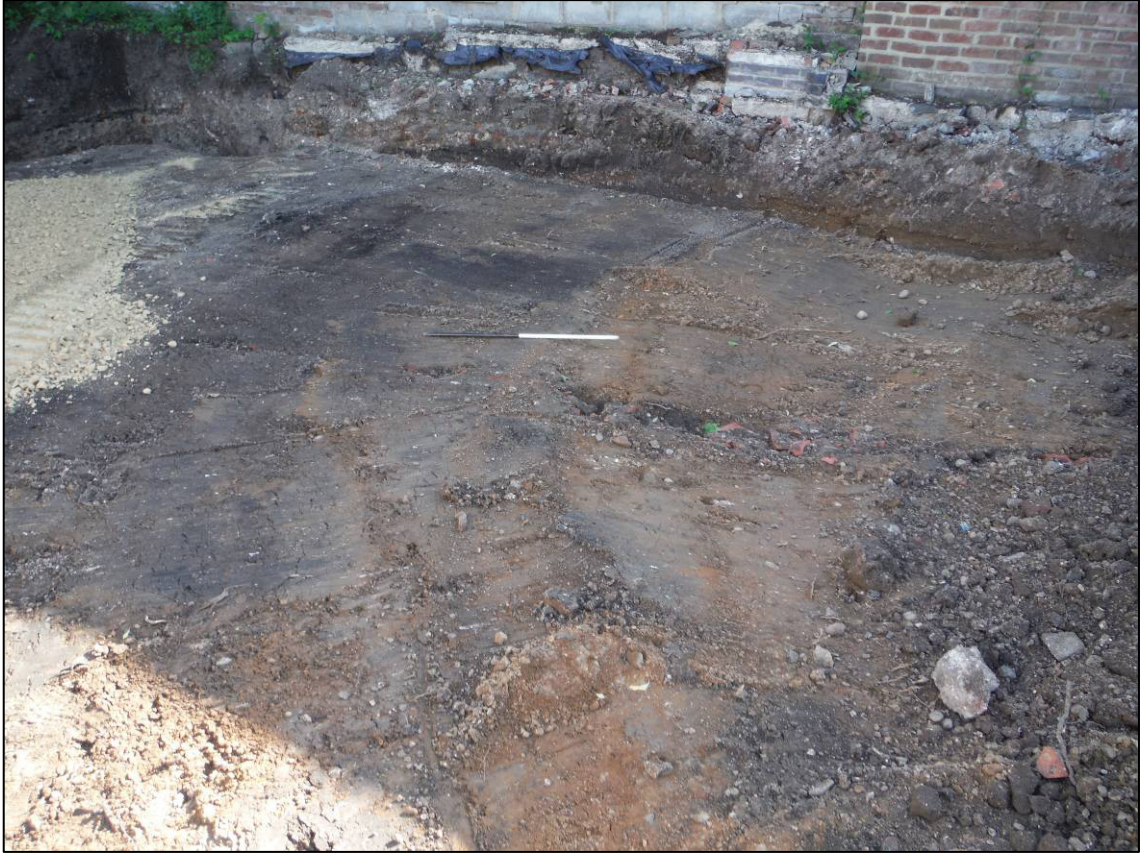
- 5.12 The stripped area for the proposed extension on the east side of the current building measured up to 10.75m wide (north-south) by up to 12.0m long (east-west). A garage for the existing property had previously occupied part of this area and had been recently demolished, leaving a 0.3m thick layer of concrete and modern rubble (125) (see Sections 2 and 7). As a result of the site strip, the ground level was reduced by roughly 0.3m-0.4m (to 10.90m-10.97m AOD) (see plate 3).

Plate 3: General view of stripped area for eastern extension, looking NE.

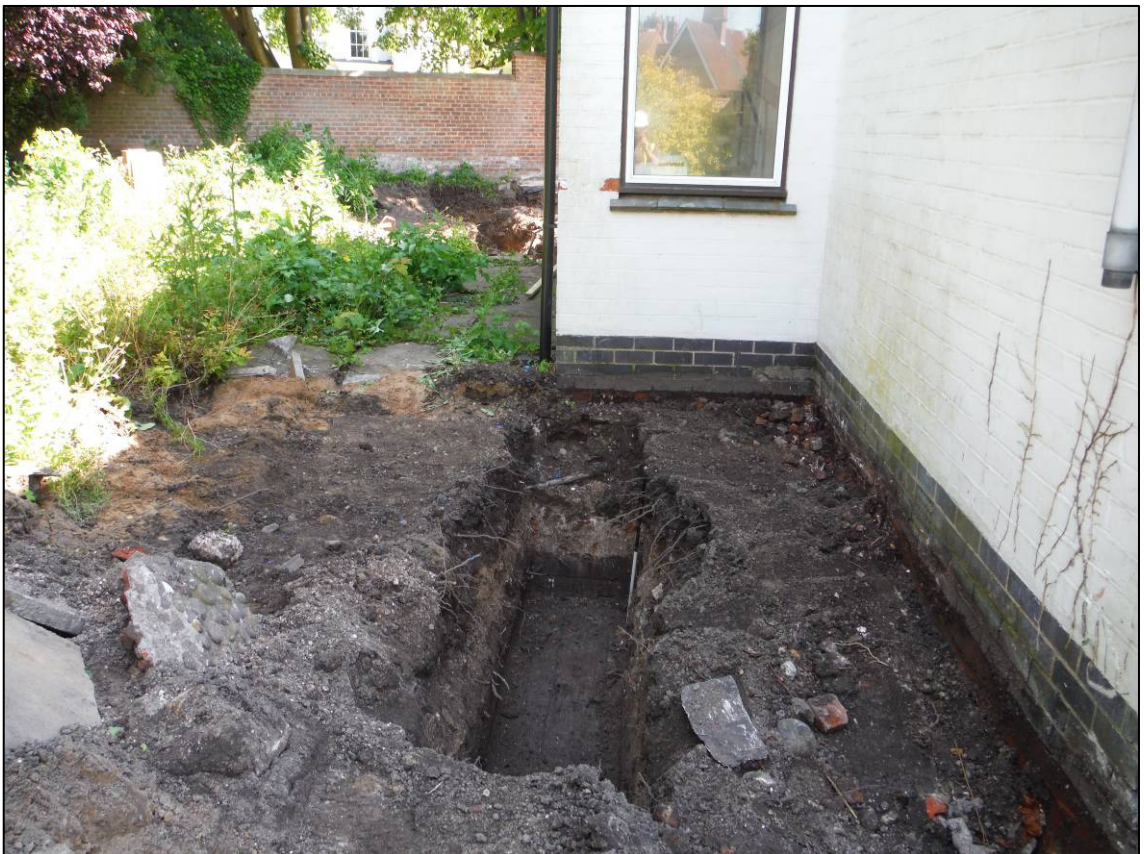
- 5.16 Trench 2 was sited on the north side of the current building and comprised part of the northern foundation trench for the proposed extension. The trench measured roughly 2.35m long east-west, 0.6m wide and 1.04m deep, and was excavated after the turf and topsoil had been partially removed (see plate 4).

Plate 4: General view of Trench 2 for northern extension, looking E.

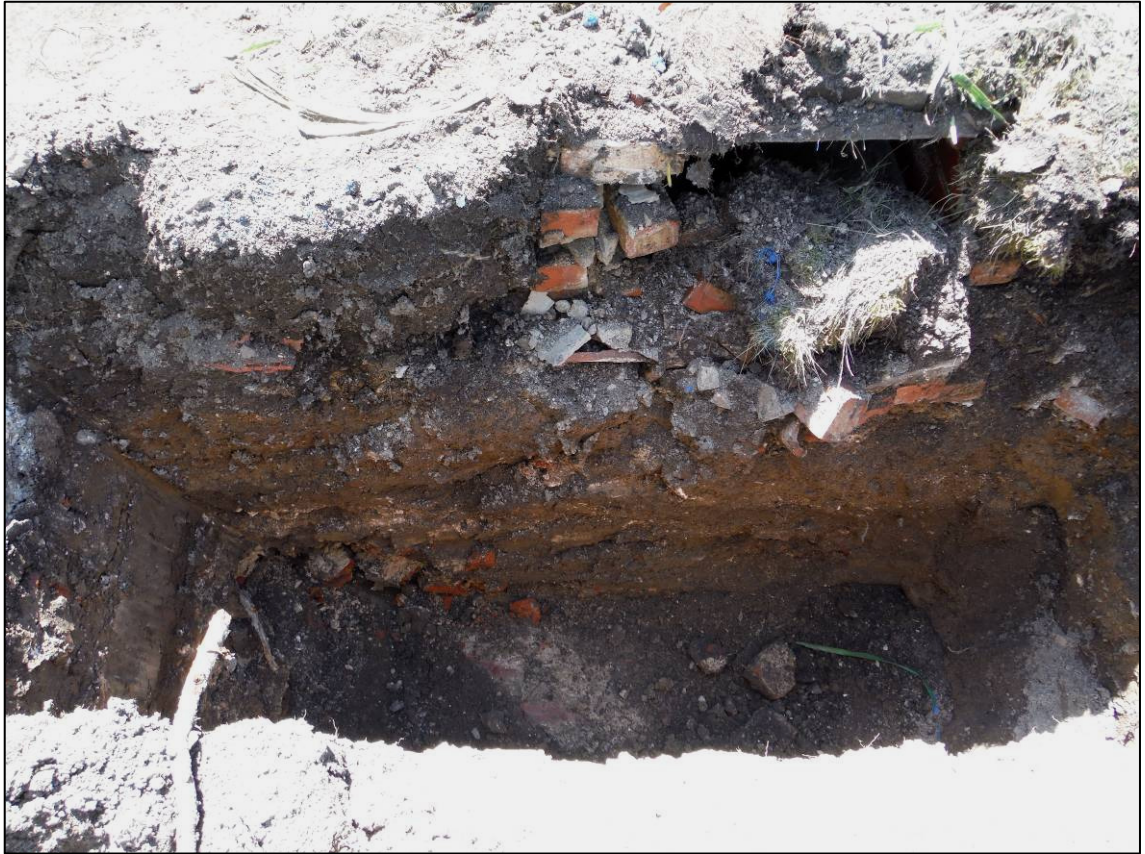
Plate 5: West side of culvert (304) in base of Trench 3 (western extension), with modern manhole above, looking N.

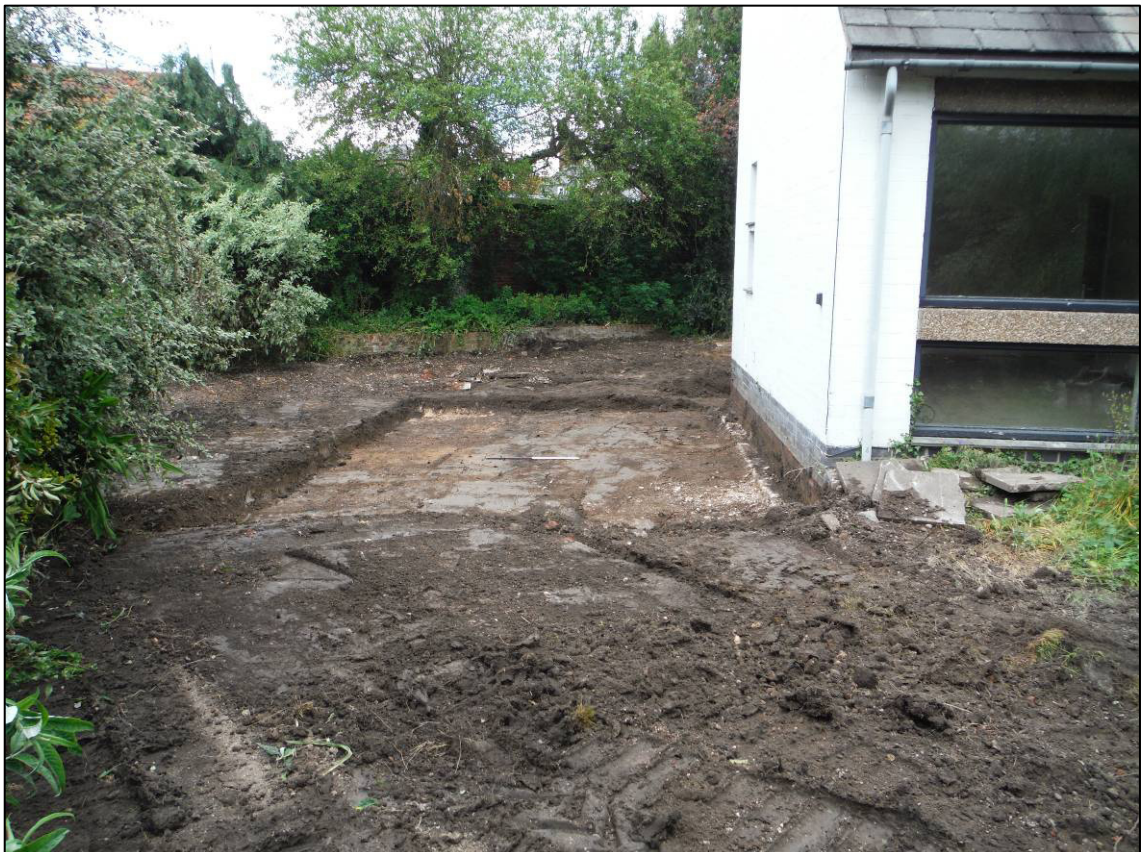
- 5.26 The stripped area for the proposed extension on the west side of the existing building measured up to 6.0m long (north-south) by 4.3m wide (east-west). The ground level was reduced across the area by 0.3m (11.28m AOD), partially removing the topsoil (301) (see plate 6).

Plate 6: General view of stripped area for western extension, looking N.
