EXTERNAL DRAINAGE WORKS,
CHURCH OF ST HILDA,
DANBY, NORTH YORKSHIRE

ARCHAEOLOGICAL OBSERVATION,
INVESTIGATION AND RECORDING

Report no: 2015/496.R01
Version: Final
Date: August 2015
Author: Ed Dennison & Richard Coates

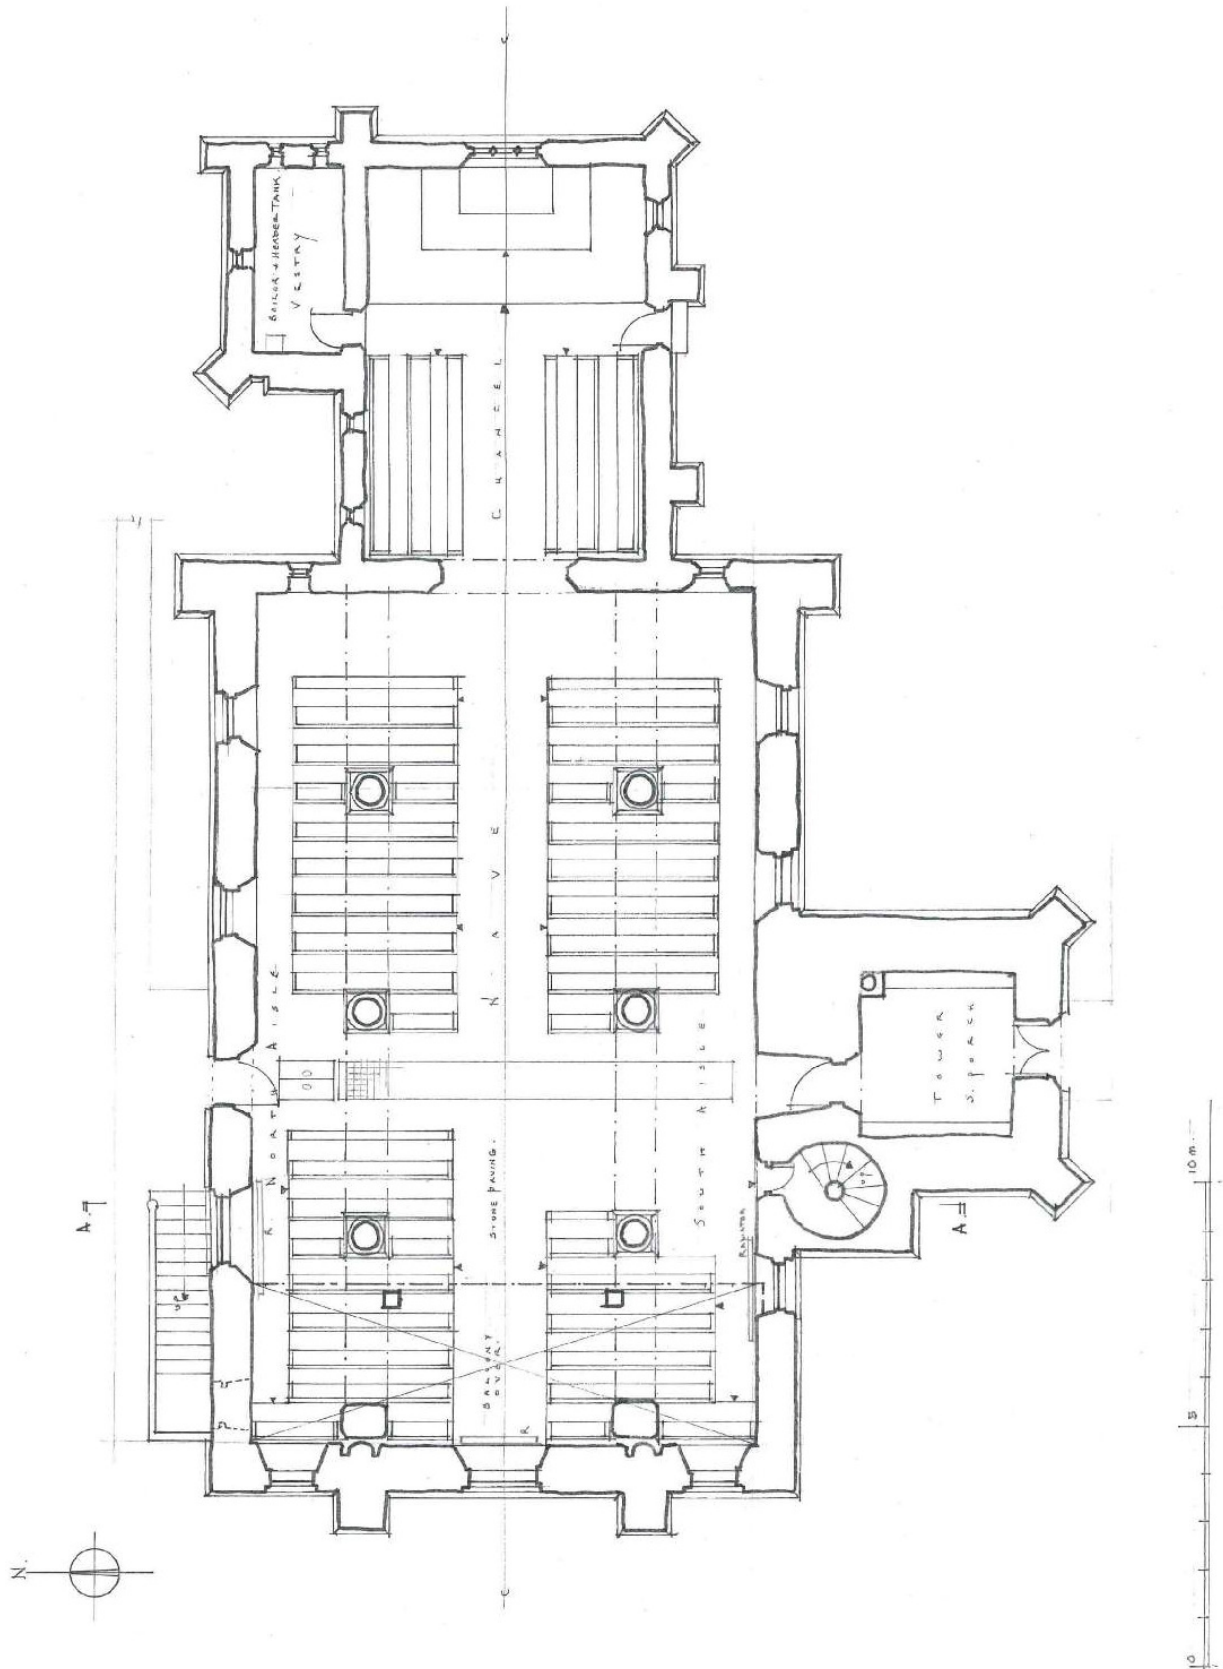
PROJECT		ST HILDA'S CHURCH, DANBY	
TITLE		GROUND PLAN	
SCALE	AS SHOWN	DATE	AUG 2015
EDAS		FIGURE	2

- 2.2 The church consists of a chancel and nave with north and south aisles, a south tower and a small vestry to the north-east of the chancel (see figure 2). The first church on the site was probably of 12th century date, but it seems to have been entirely rebuilt during the first half of the 13th century. The tower is of early 15th century date, and is the earliest remaining fabric. The first of the subsequent recorded restorations was in 1685. The next was by the Parish towards the end of the 18th century, when the double arcade of pillars of the early Norman nave were pulled down. The west end of the church was also taken down and rebuilt at this time, and in 1798 a gallery was built on the north side of the nave and accessed by external stone steps. Another gallery at the west end was erected in 1808. In 1829 the ancient oak pews were removed and deal box pews were put in their place.

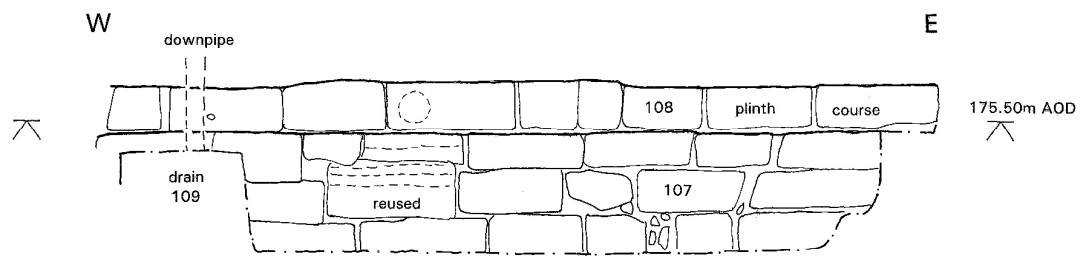
PROJECT		ST HILDA'S CHURCH, DANBY	
TITLE		TRENCHES 1 TO 3	
SCALE	AS SHOWN	DATE	AUG 2015
EDAS		FIGURE	4

Section 1: North side of Trench 1

L1	176.07m	Top of grass, south-east corner
L2	176.08m	Upper foundations of tower (112), east end
L3	176.15m	Upper foundations of south wall (107), north side
L4	175.47m	North side centre, base of excavation
L5	175.43m	Pelvis of skeleton 102 in Grave 1
L6	175.49m	Skull area of skeleton 102 in Grave 1
L7	176.08m	Top of drain casing (109), west end
L8	175.79m	Top of grass, south-west corner
L9	175.65m	West end, base of excavation

L10	176.40m	Top of grass, south-west corner
L11	175.70m	South side of south buttress, base of excavation
L12	176.16m	Foundation stone (208) of south buttress
L13	175.70m	North side of south buttress, base of excavation
L14	176.44m	Top of grass, north side of south buttress
L15	175.65m	South side of north buttress, base of excavation
L16	176.43m	Top of grass, south side of north buttress
L17	176.19m	Foundation stone (207) of north buttress
L18	175.71m	North side of north buttress, base of excavation
L19	176.44m	Top of grass, north side of north buttress
L20	176.39m	Top of grass, north end
L21	175.73m	North end, base of excavation
L22	176.23m	East return at north end, base of excavation

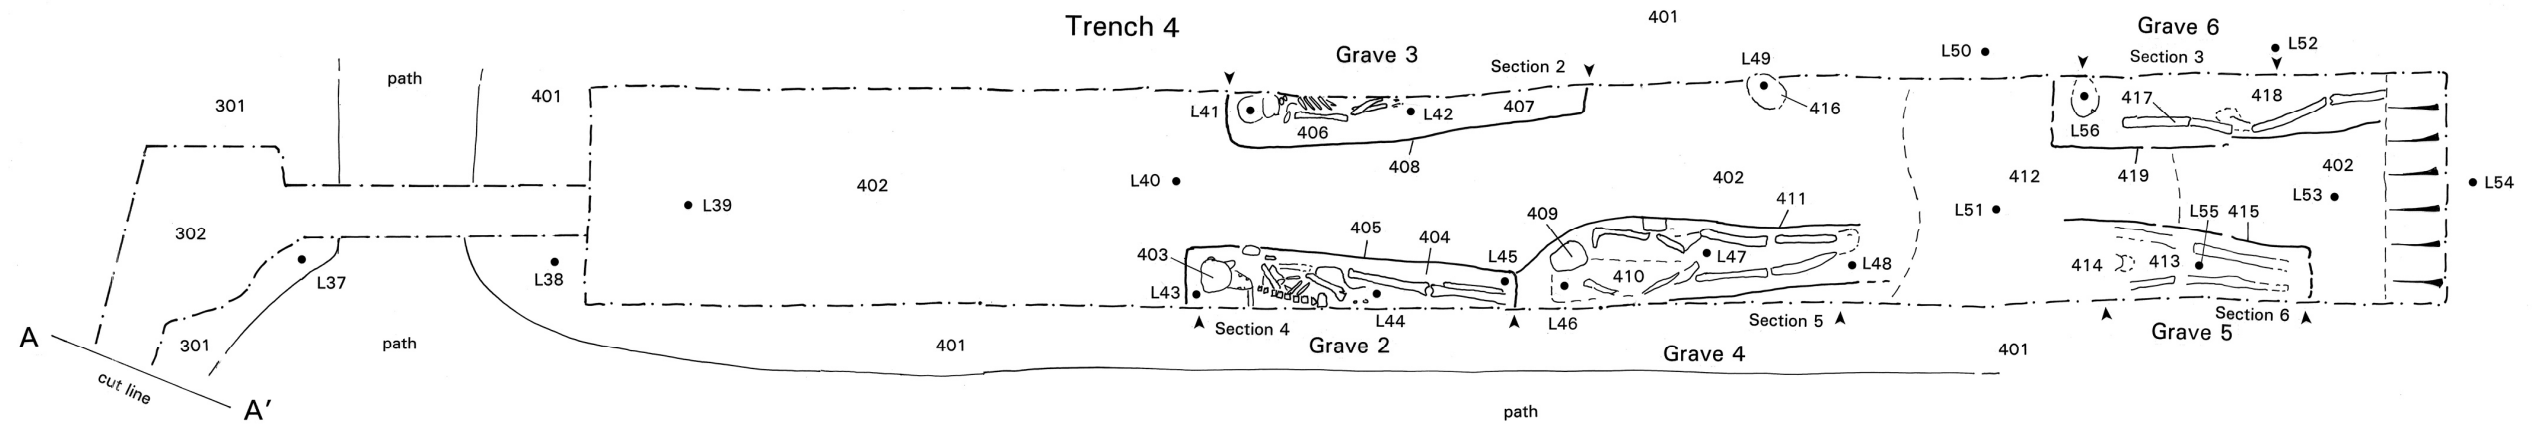
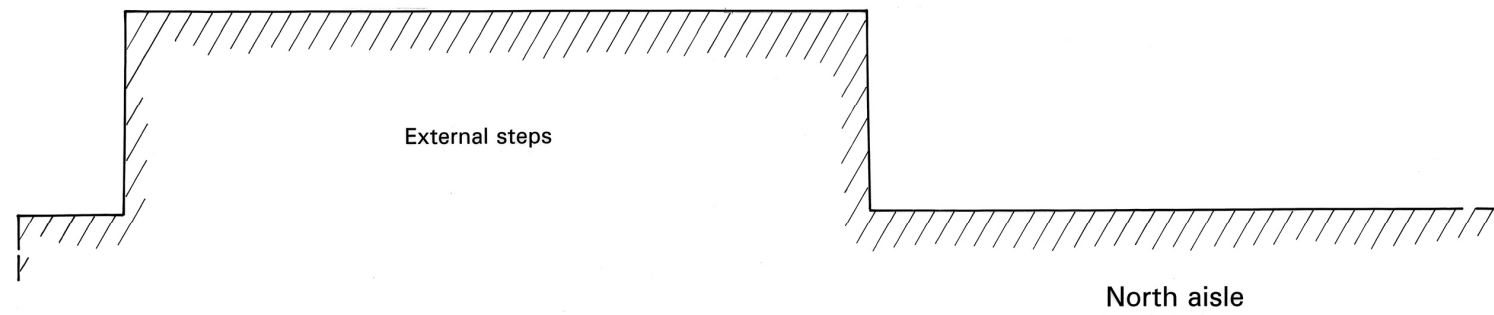
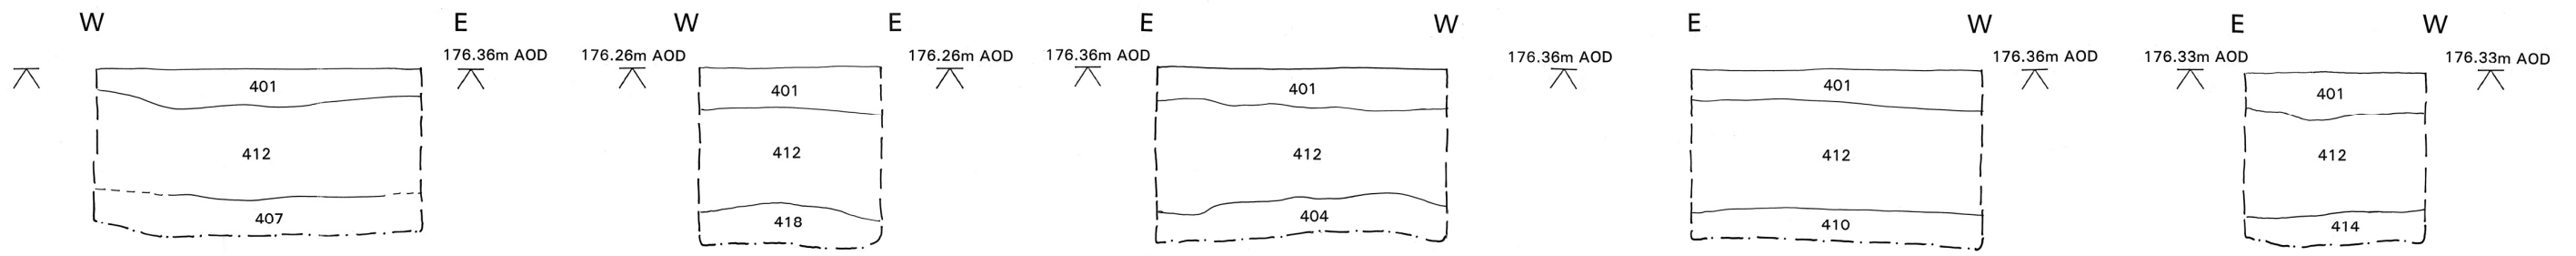
Section 2: North side of Trench 4 (Grave 3)

Section 3: North side of Trench 4 (Grave 6)

- 4.20 All of the burials were overlain by a c.0.53m-0.65m thick loose dark brown clay silt deposit (412) representing made ground which contained c.10-25% stones and some sandstone ashlar blocks (see Sections 2 to 6 on figure 4). The blocks were very concentrated in an area 7.00m-8.00m from the west end of the trench. Also recovered from this context was a Victorian half-penny stamped 1896 (see plate 14), 14 sherds of later 13th-14th century pottery, three coffin fittings, and some fragments of disarticulated human bone. Extensive root damage/activity was noted at the east end of this trench.

L38	176.35m	Top of grass, south-west corner
L39	175.53m	West end, base of excavation
L40	175.52m	West end central area, base of excavation
L41	175.48m	Skull of skeleton 406 in Grave 3
L42	175.37m	Right hand area of skeleton 406 in Grave 3
L43	175.51m	Skull of skeleton 403 in Grave 2
L44	175.46m	Pelvis of skeleton 403 in Grave 2

L45	175.43m	Feet of skeleton 403 in Grave 2
L46	175.64m	Skull of skeleton 409 in Grave 4
L47	175.53m	Pelvis of skeleton 409 in Grave 4
L48	175.60m	Feet of skeleton 409 in Grave 4
L49	175.59m	Skull 416
L50	176.23m	Top of grass, north central side
L51	175.38m	East end central area, base of excavation
L52	176.26m	Top of grass, north-east corner
L53	175.40m	East end, base of excavation
L54	176.28m	Top of grass, east end
L55	175.54m	Leg bones of skeleton 413 in Grave 5
L56	175.52m	Skull of skeleton 417 in Grave 6

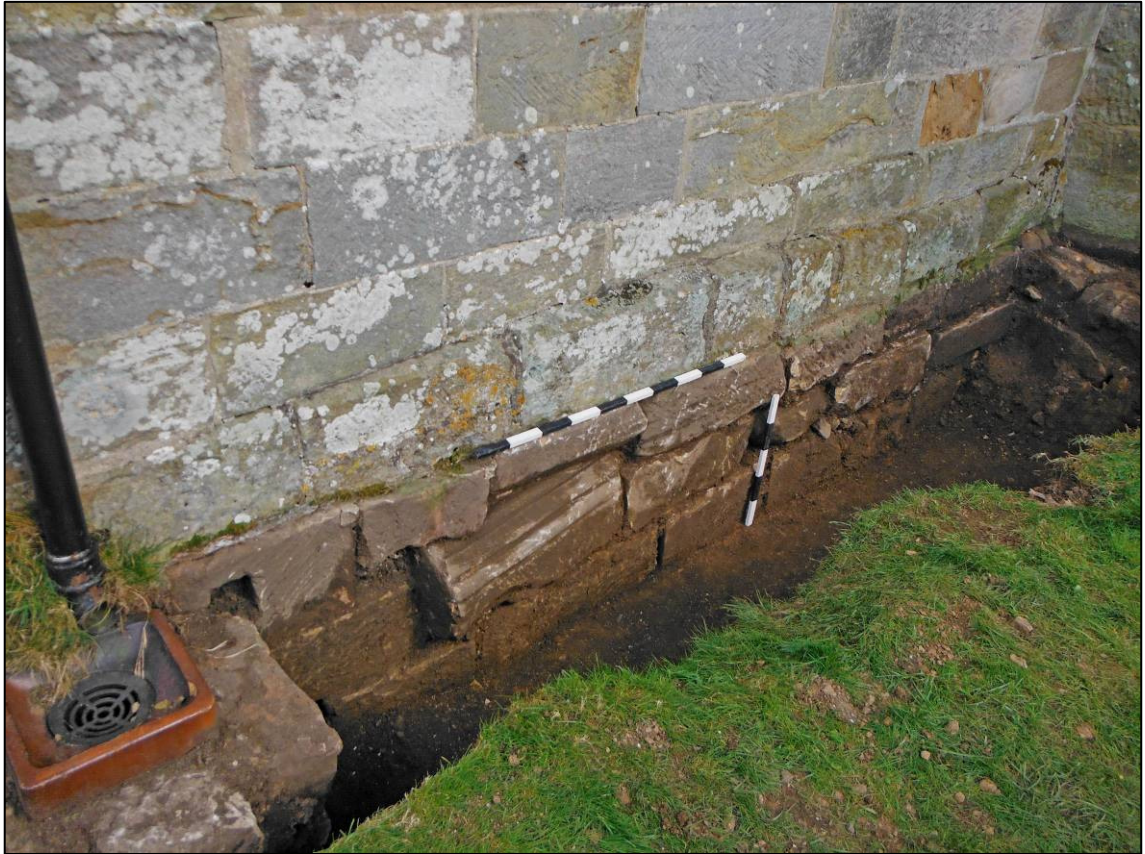
Plate 1: Excavated Trench 1, showing reused stone in foundations (107) of south wall of church, looking NE.

comprised three courses of dressed ashlar sandstone blocks up to 0.70m long by up to 0.27m high, with occasional roughly squared sandstone blocks and at least two pieces of reused decorative masonry (perhaps representing part of a column), projecting out by 0.10m from the overlying wall face. Only the top course of the foundations, which was encountered at 176.15m AOD, was bonded with lime mortar; no bonding was visible in the lower two courses. It could not be determined whether the footings (107) extended below the limit of excavation, but it seemed likely. The stone rubble footings of the west side of the tower were also exposed in the east end of the trench (112), at 176.08m AOD.

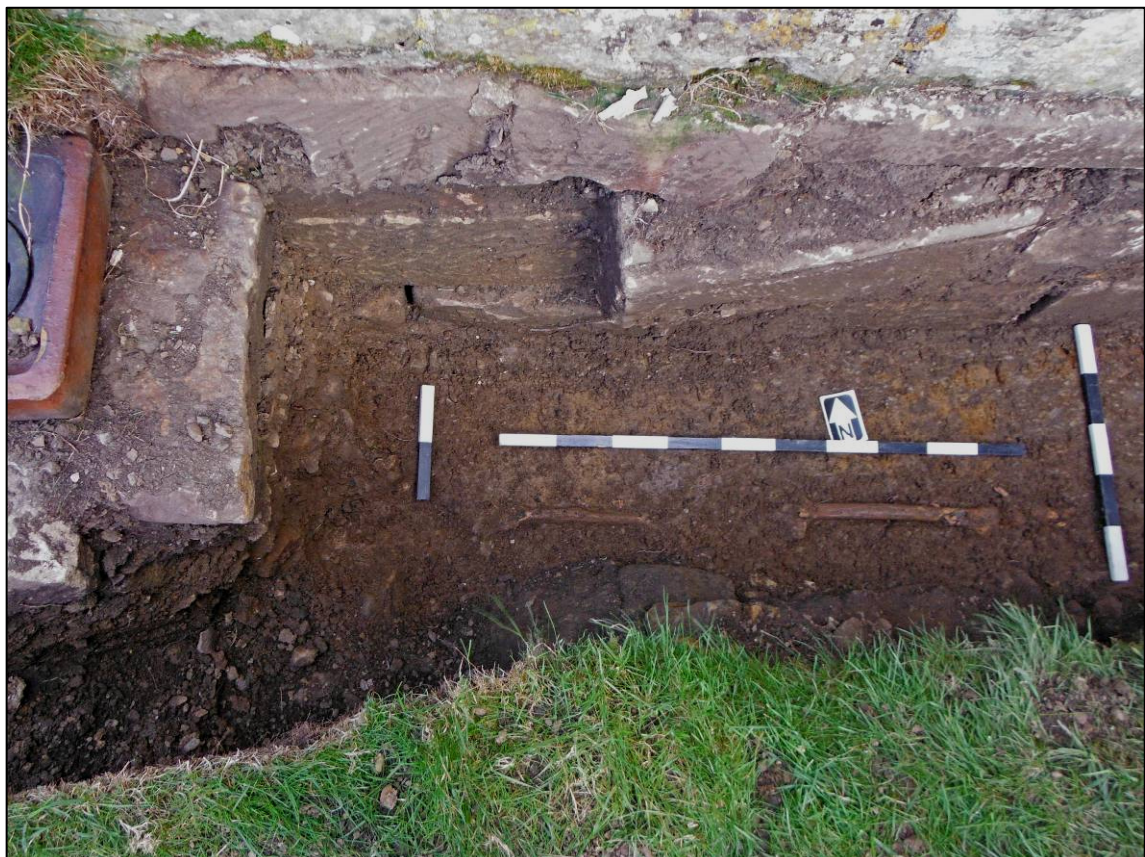
Plate 2: Remains of skeleton 102 in Grave 1 [104] (Trench 1), looking N.

- 4.4 Cut into the stiff mid-brown/yellow clay silt (105) on the south side of the trench was an east-west orientated grave [104] (Grave 1) over 1.80m long and more than 0.20m wide, containing the partial remains of a supine articulated skeleton (102) and an associated loose mid-dark grey clay silt grave fill (103) (see plate 2). Only the left side of the skeleton (102) was exposed in the excavated trench, with only the poorly preserved upper left arm and upper left leg surviving with fragments of the left hand; it was encountered at 0.69m BGL (175.43m AOD). A small number of skull fragments were recovered from the vicinity of a cut [110] and fill (111) for a modern salt-glazed drain (109) to the west of the grave [104], which had probably disturbed the west end of the skeleton (102) during its excavation. A small assemblage of disarticulated human bone was also recovered from the loose mid-brown sandy silt backfill (111) of the drain.

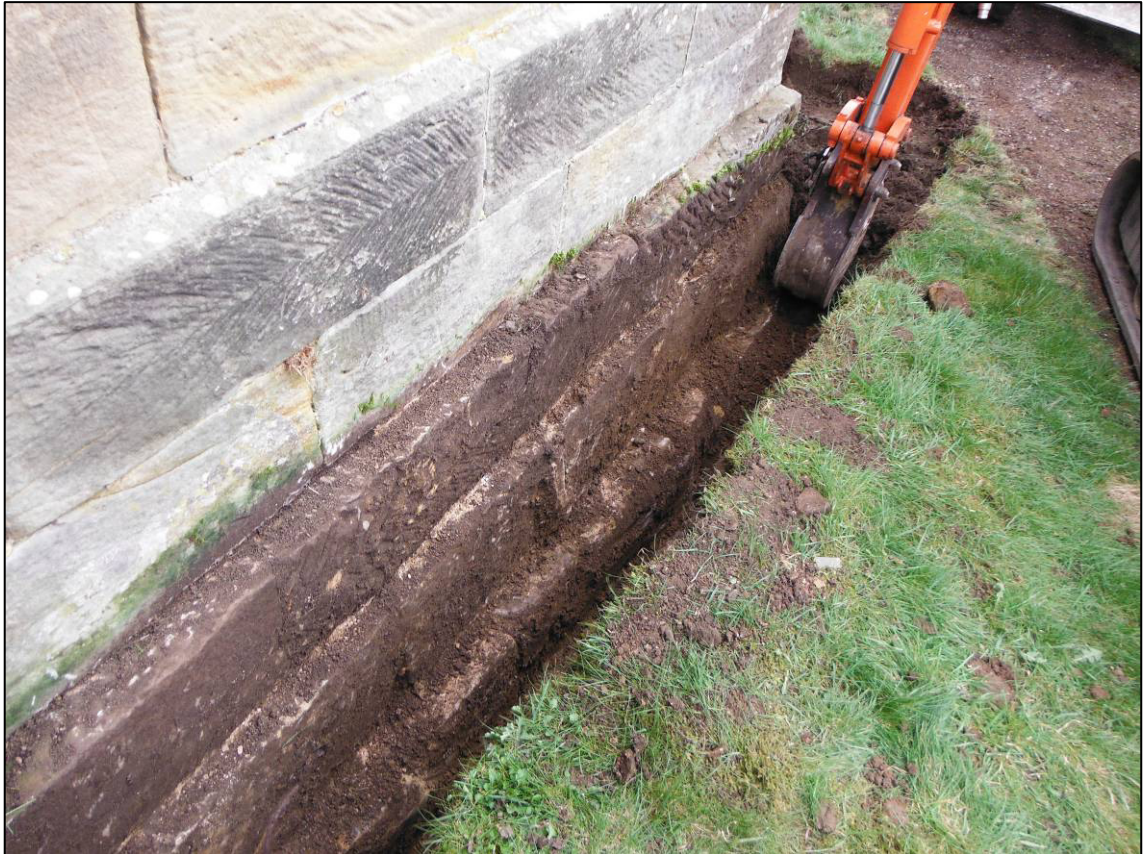
Plate 3: Trench 2 under excavation, showed stepped footings (205) of west wall, looking SE.

- 4.8 Abutting the footings (205) of the west wall of the church between and either side of the two buttresses, was a backfill deposit of a loose mid-brown clay silt (203) of unknown depth, exposed in the base of the trench, which presumably results from the earlier restorations. Between the two buttresses, this deposit was overlain by a c.0.50m thick loose mid-brown sandy silt (202) containing frequent small stones; this deposit (202), which is likely to represent an upper fill of a construction trench forming part of the earlier restorations, was very difficult to distinguish from the similar deposit (203) below. A very small assemblage of disarticulated human bone was recovered from deposit 202. In the areas around the north and south buttresses, a 0.40m thick construction backfill of brown sand silt (204) containing numerous fragments of unworked sandstone blocks and sandstone ashlar overlay the basal loose mid-brown clay silt (203); it was probably the same as deposit 106 seen in Trench 1.

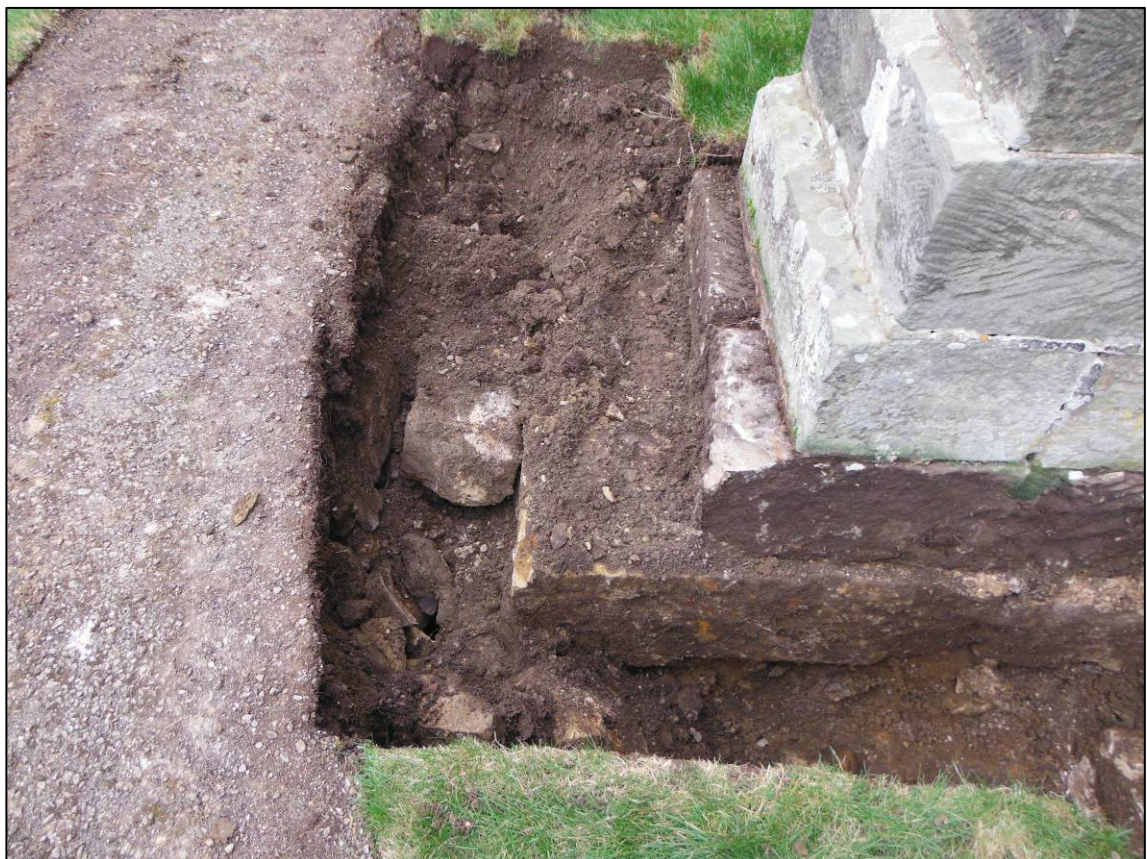
Plate 4: Trench 2 under excavation, showing foundations of southern buttress (208) and construction backfill (204), looking N.

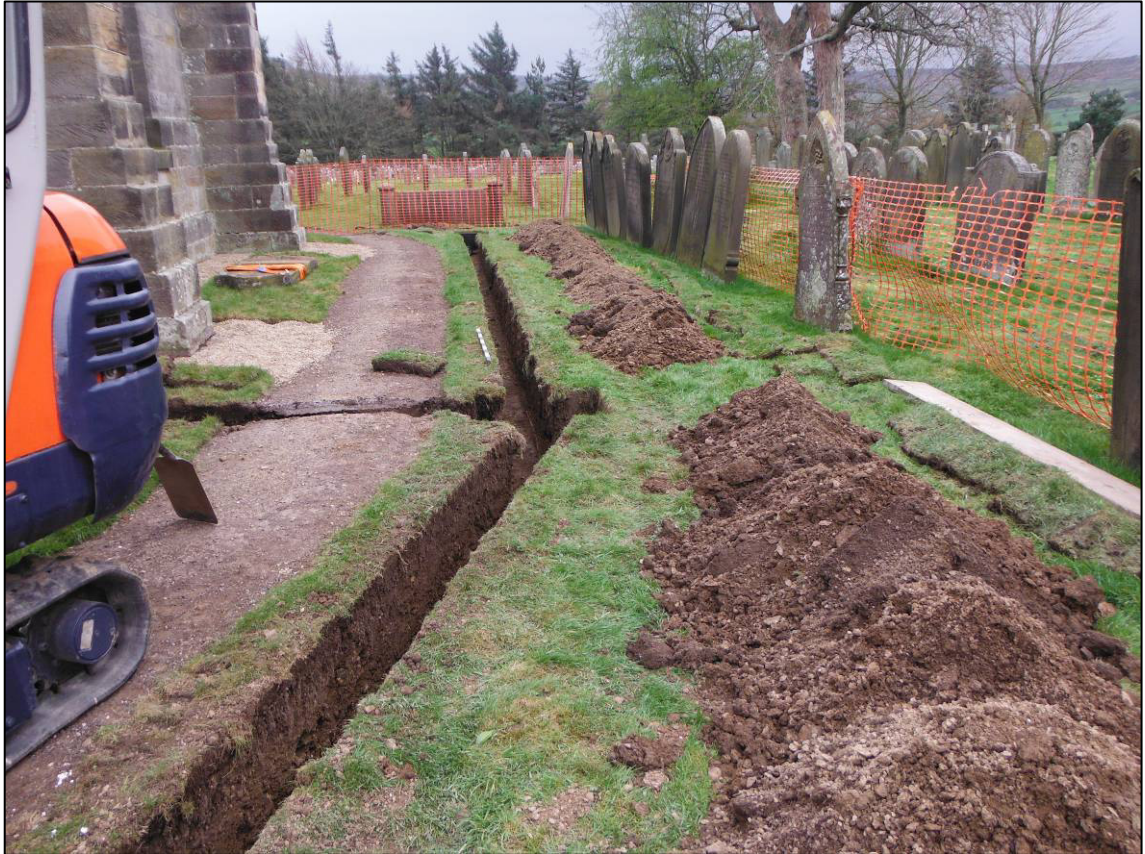
Plate 5: Trench 3 under excavation, looking S.

- 4.11 The trench cut across the east end of eight marked graves and at least three unmarked graves, although these were not disturbed by the works. The lowest deposit seen in the trench was a loose mid-brown clay silt (302) more than 0.56m thick containing small stones, which probably represented made ground above the graves to the west. Although no grave cuts were visible, an assemblage of disarticulated human bone was recovered from this deposit. This deposit (302) was encountered throughout the length of the trench, and was overlain by a 0.16m thick layer of loose mid-grey/brown sandy silt topsoil (301), which formed the current ground surface, encountered at 175.97m AOD at the south end of the trench, rising to 176.34m AOD at the north end.

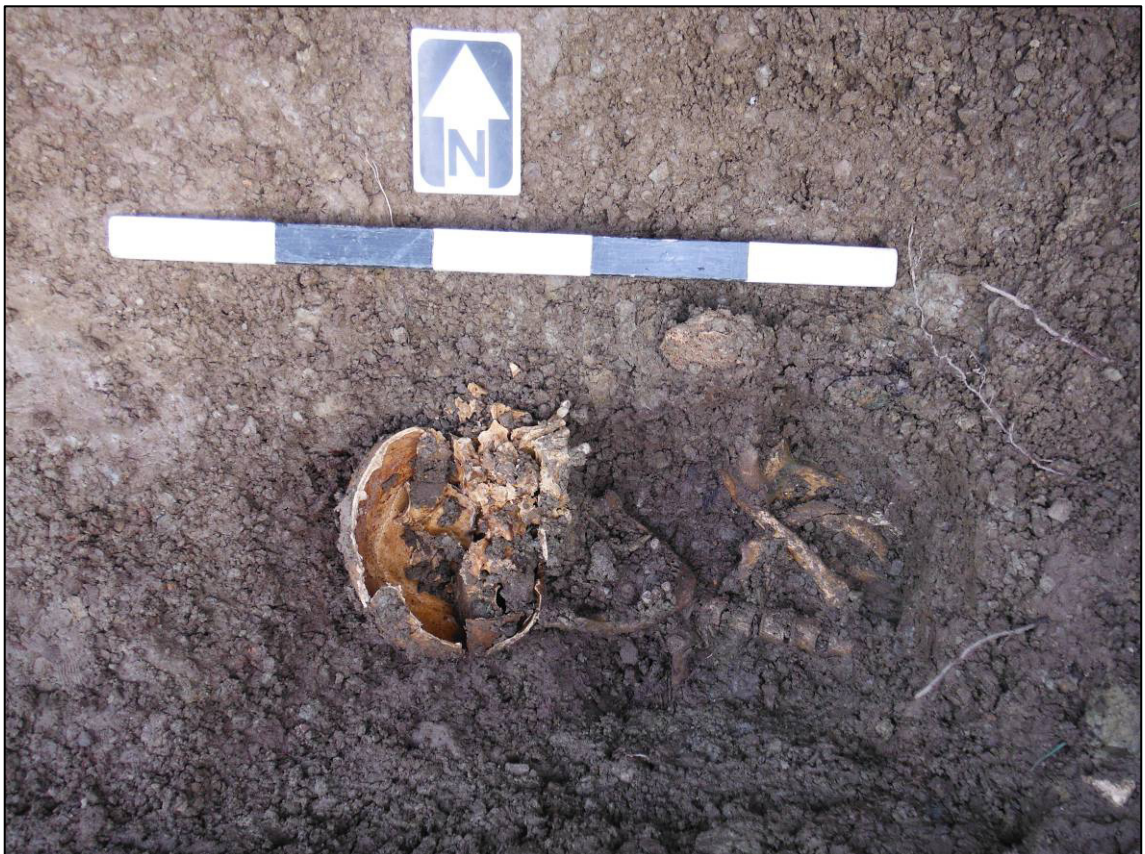
Plate 6: Skull of skeleton 403 in Grave 2 [405] (Trench 4).

- 4.14 Grave 2 [405] was located on the south side of the trench, c.4.20m from the west end, and measured 1.64m long (east-west) by more than 0.30m wide. It contained a supine articulated skeleton (403) and an associated loose mid-light grey-brown clay silt grave fill (404). The skull, encountered at 0.85m BGL (175.51m AOD), and the entire left side of the skeleton were exposed including the ribs, vertebra and pelvis, as well as the right lower leg bone (see plates 6 and 7). The skeleton was in a good condition, with the exception of the skull which had been clipped by the machine during excavation of the trench, and the left foot that may not have been intact. The right side of the burial remained *in situ* within the south side of the trench. The small size of the mandible and mastoid process suggested that the burial was a female. The skeleton was buried in what remained of a wooden coffin, and a number of coffin fittings were also present, namely a single iron coffin handle at both the head and feet (possibly dating to c.1763-1837), a copper alloy riveted hinge attached to small piece of wood (coffin) at the head, and the degraded traces of a tinned sheet probably from the hand grip at the foot.

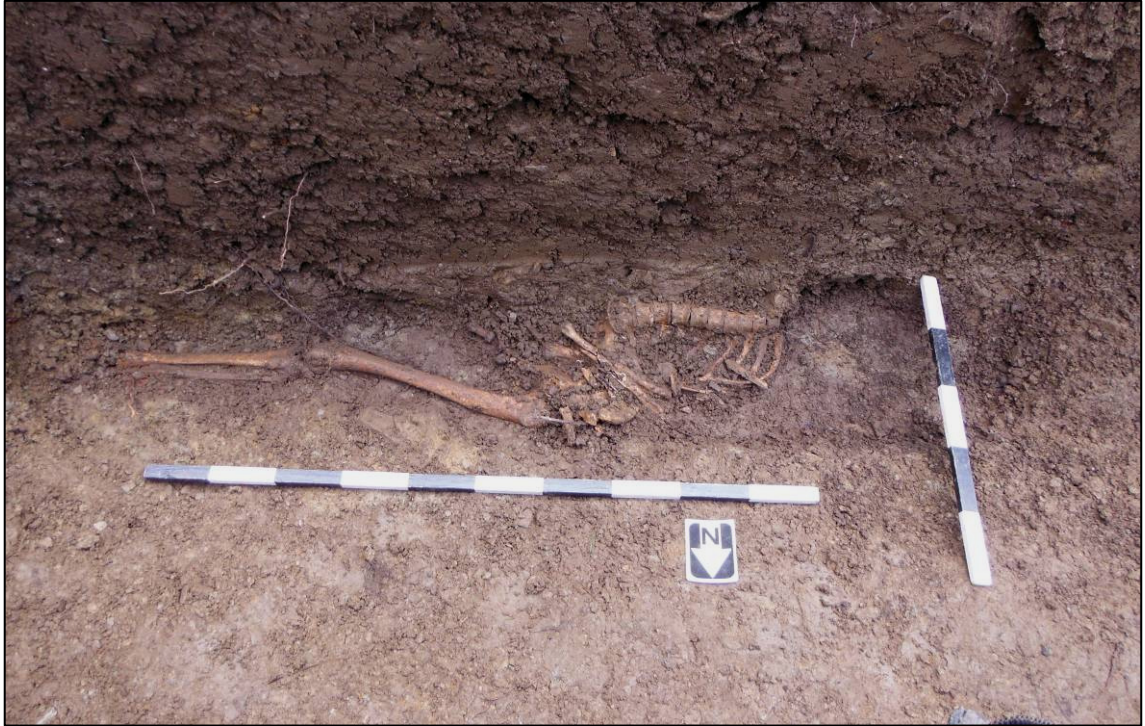
Plate 7: Skeleton 403 in Grave 2 [405], skull removed (Trench 4).

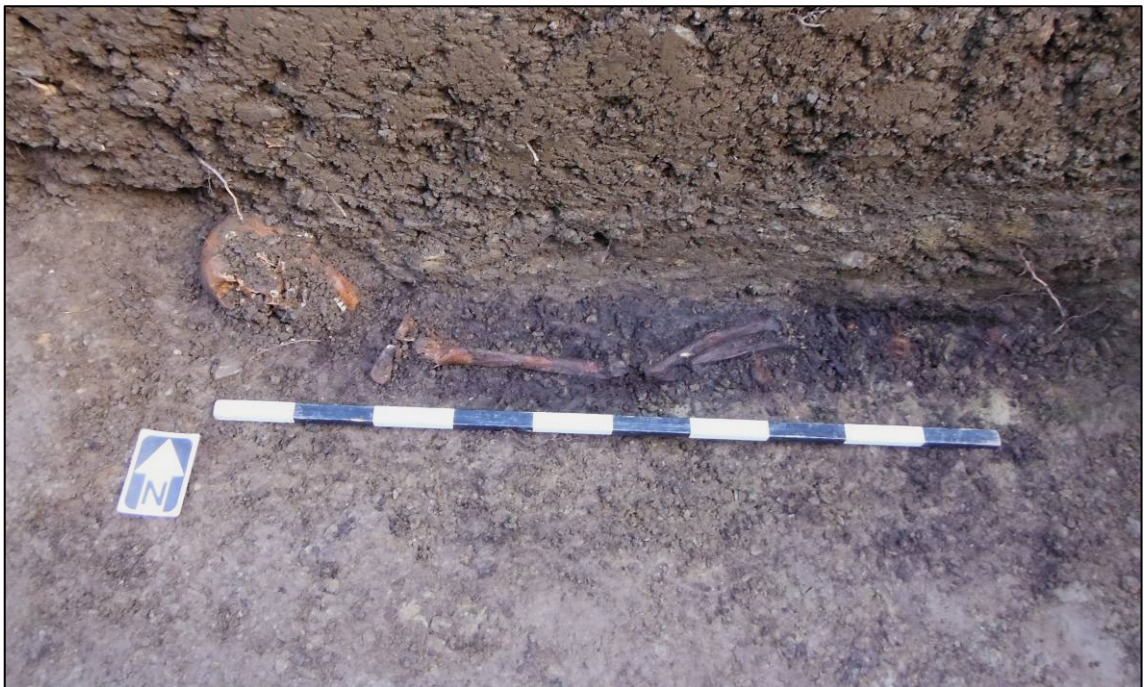
Plate 8: Skeleton 406 in Grave 3 [408] (Trench 4).

- 4.15 Grave 3 [408] was located on the north side of the trench, also c.4.20m from the west end, and measured 1.80m long (east-west) by more than 0.30m wide. It contained a supine articulated skeleton (406) and an associated loose mid-grey/brown clay grave fill (407). Only the skull, encountered at 0.70m BGL (175.48m AOD), some ribs and the right arm and hand of the skeleton were exposed, the rest remaining *in situ* under the north side of the trench (see plate 8). The skull was in reasonable condition (minimal damage to left eye socket), although the arm and hand were in fair/poor condition. The size and narrowness of the mandible suggested that the burial may have been female. The fill (407) around the skeleton was stained black, which on analysis, was found to be organic although its origin could not be determined (see Appendix 2). A very worn, but otherwise in excellent condition, silver long cross penny (RF1) of medieval date was found in the vicinity of the right hand (see below and plate 13).

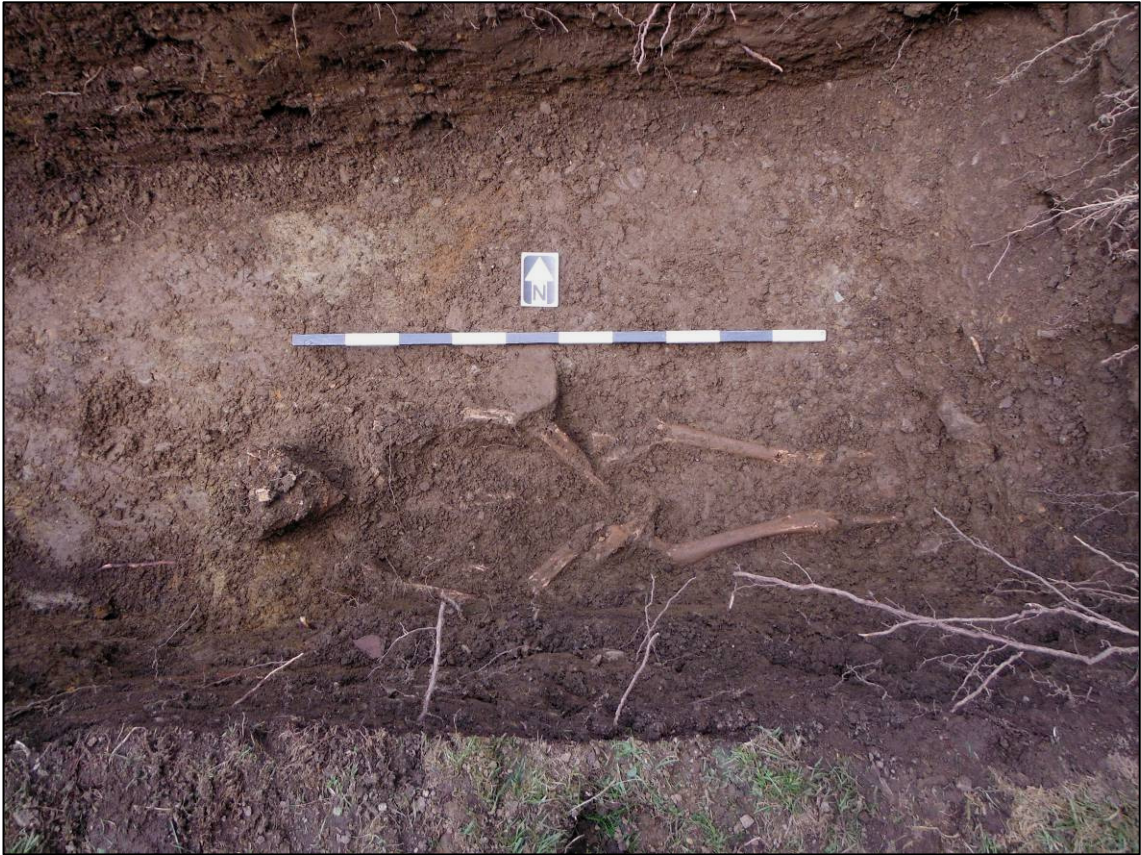
Plate 9: Skeleton 409 in Grave 4 [411] (Trench 4).

- 4.16 Grave 4 [411] was located on the south side of the trench, c.4.00m from the east end, and measured c.1.70m long (east-west) by 0.40m wide. It contained a supine articulated skeleton (409) and an associated loose mid-light brown-grey clay silt grave fill (410). All of the skeletal remains were in very poor degraded condition, with only the skull and long bones being distinguishable; a few very fragmentary remains of the ribs, vertebrae, scapula and pelvis were also present (see plate 9). The skull was encountered at 0.80m BGL (175.64m AOD). Three sherds of pottery dated to the 12th-early 13th century were recovered from the grave fill (410). There was no evidence of a coffin or any fittings.

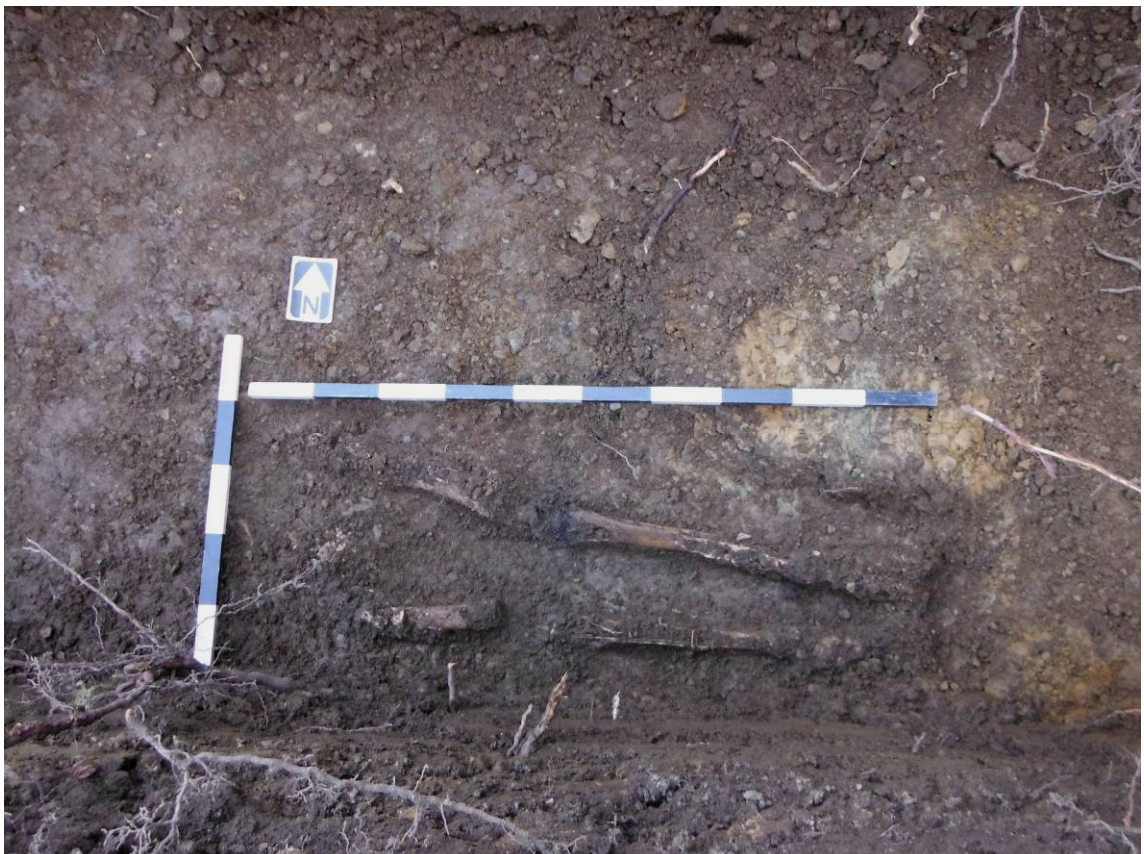
Plate 10: Skeleton 413 in Grave 5 [415] (Trench 4).

- 4.17 Grave 5 [415] was located on the south side of the trench, c.1.40m from the east end, and measured at least 1.25m long (east-west) by c.0.40m wide. It contained a supine articulated skeleton (413) and an associated loose dark grey clay silt grave fill (414). The skeleton was in a poor condition, with only the lower half being present; the right and left leg long bones with some fragments of the pelvis, were encountered at 0.74m BGL (175.54m AOD), and there were very few foot bones (see plate 10). There was no evidence of a coffin or any associated finds.

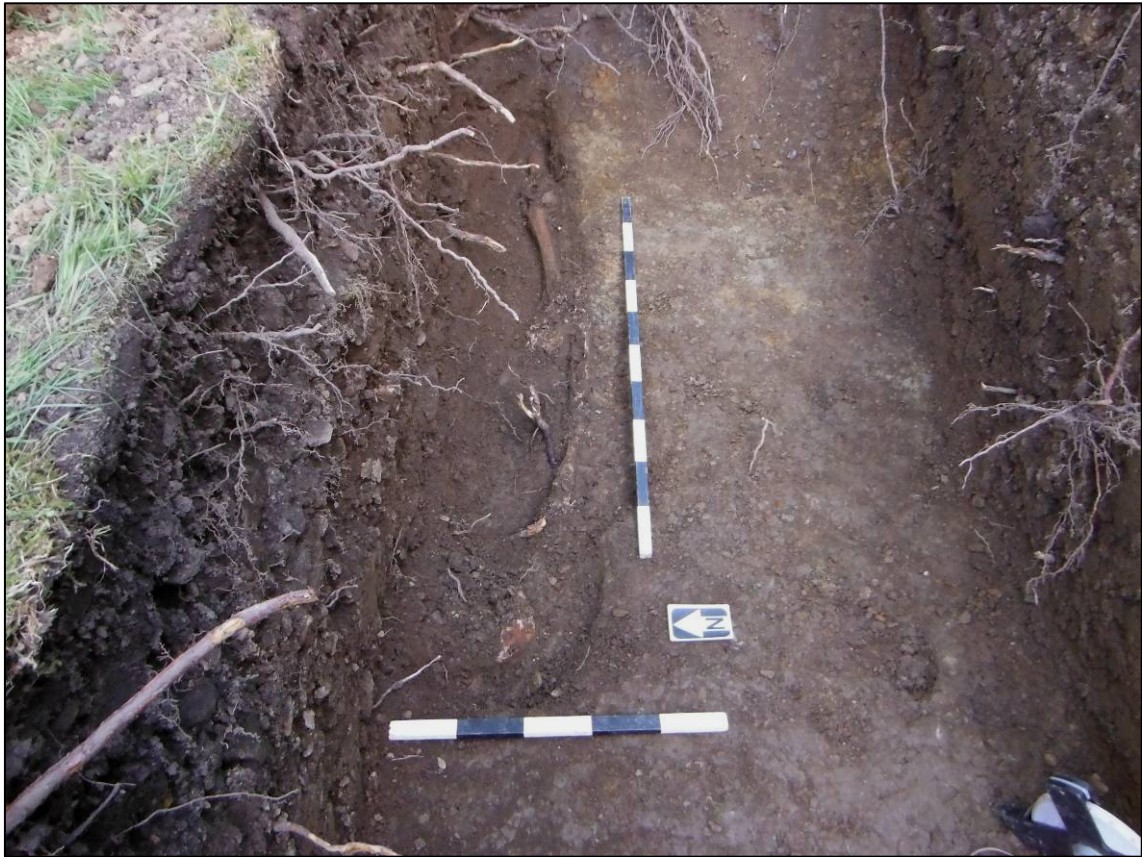
Plate 11: Skeleton 417 in Grave 6 [419] (Trench 4).

- 4.18 Grave 6 [419] was located on the north side of the trench, c.1.40m from the east end, and measured at least 1.65m long (east-west) by c.0.40m wide. It contained a supine articulated skeleton (417) and an associated loose dark grey-brown clay silt grave fill (418). Only the skull, encountered at 0.74m BGL (175.52m AOD), and right side of the skeleton were exposed (see plate 11). The skull and right arm were in a very poor condition, although the right upper leg including the patella were in a fair condition. The right lower leg continued under the northern edge of

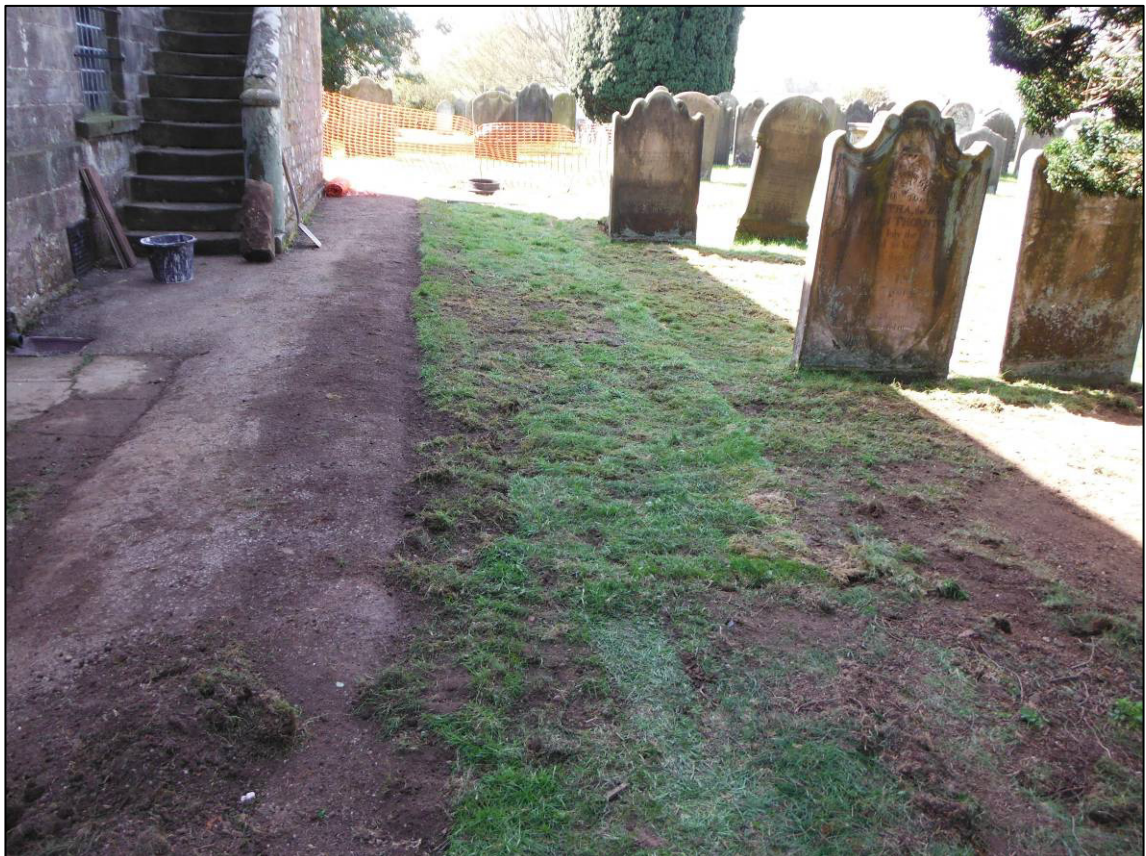
Plate 12: Trench 4 reinstated after installation of Trench Arch worm bed drainage system, looking W.

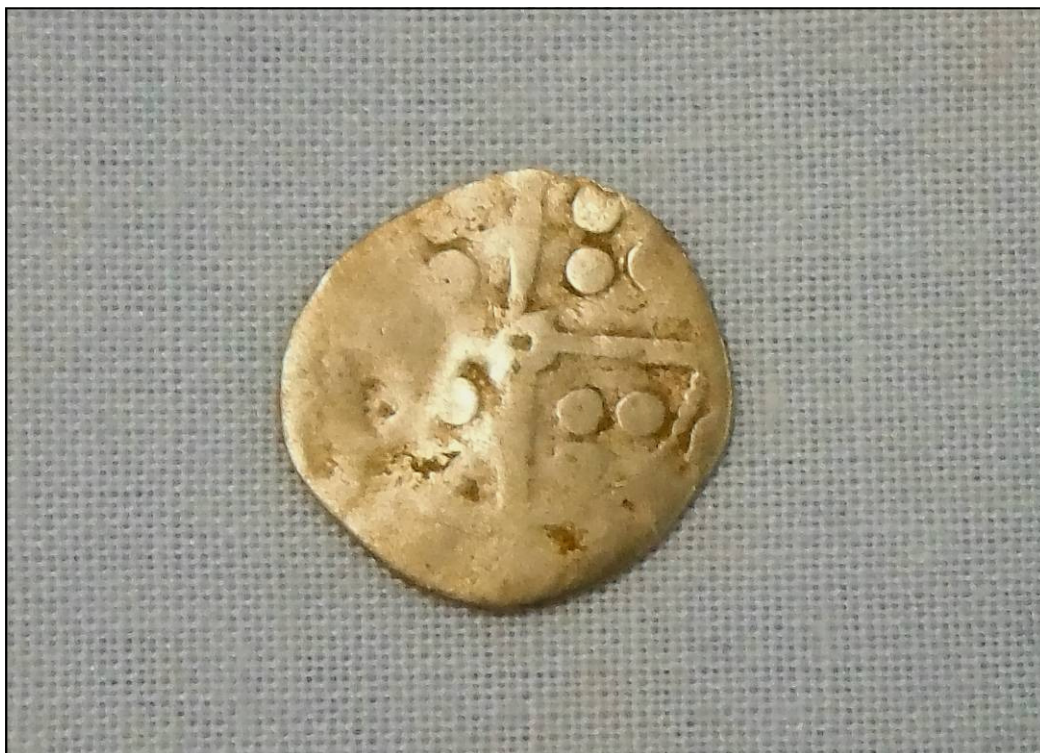
Plate 13: Medieval silver Long cross penny (RF1) from Grave 3 [406], Trench 4 (reverse side).

- 4.28 RF1 is a silver long cross penny of medieval date. It is near complete and in a very good condition although the surfaces are heavily worn (blank in some areas). The obverse is not distinguishable, but the reverse has a long cross with three pellets within each quadrant (see plate 13). The coin may have been intentionally placed with the burial, but it could also have been a chance loss when the burial was interred or may be intrusive as a result of later Victorian restoration work. The lack of any clear distinguishing marks means it was not possible to provide a more specific date other than the general medieval period.

Medieval. Near complete. Very good condition although surfaces are heavily worn (blank in some areas). No concretions adhering to the surfaces. Obverse: legend and bust? Not distinguishable. Reverse: long cross with 3 pellets within each quadrant. Recovered from the hand area of human burial (406) [SK 3], fill (407) cut [408].

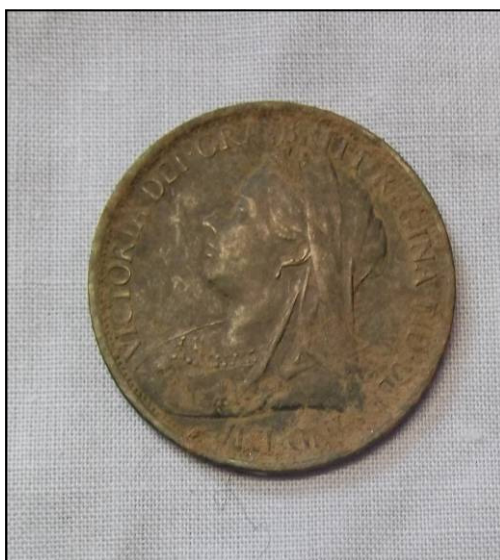
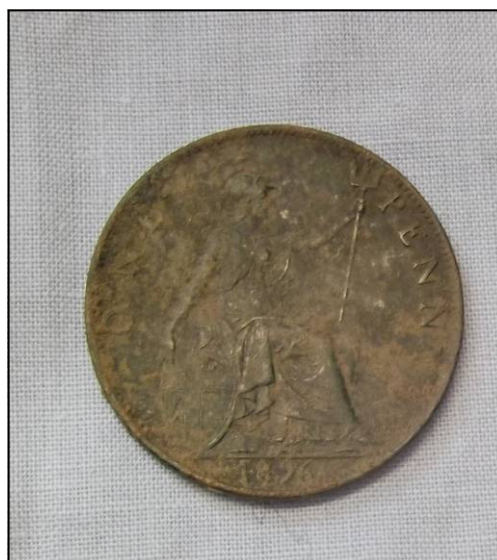
Plate 14: Victorian copper alloy half penny (Old head issue) from made ground deposit (412), Trench 4. Obverse (left): crowned bust facing left 'VICTORIA DEI GRA BRITANNIA REGINA FID DEF IND IMP'. Reverse (right): Britannia seated facing right. Trident in left hand, right hand resting on shield. 'HALF PENNY' '1896'.

- 4.29 RF2 is a copper alloy half-penny of Victorian date (Old head issue) (see plate 14). It is complete, and in a good condition with soil adhering to the surfaces. The obverse shows a crowned bust facing left with inscription 'VICTORIA DEI GRA BRITT REGINA FID DEF IND IMP'. The reverse shows Britannia seated facing right, with a trident in the left hand and the right hand resting on the shield, inscribed 'HALF PENNY' '1896'. The coin is of no archaeological significance and probably reflects a chance loss.

Victorian (Old head issue). Complete. Good condition with soil adhering to surfaces. Obverse: crowned bust facing left 'VICTORIA DEI GRA BRITT REGINA FID DEF IND IMP'. Reverse: Britannia seated facing right. Trident in left hand, right hand resting on shield. 'HALF PENNY' '1896'.
