EXTERNAL DRAINAGE WORKS,  
CHURCH OF ST JOHN THE BAPTIST,  
WADWORTH, SOUTH YORKSHIRE

ARCHAEOLOGICAL OBSERVATION,  
INVESTIGATION AND RECORDING

Report no: 2015/499.R01  
Version: Final  
Date: November 2015  
Author: Ed Dennison & Richard Coates

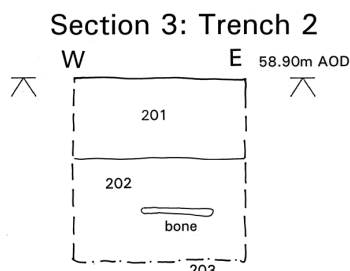
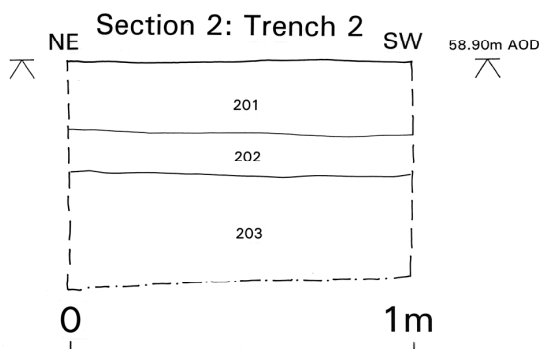
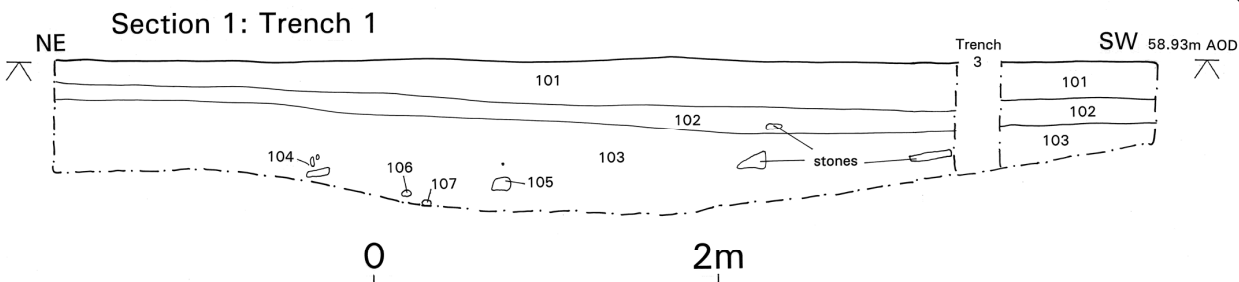
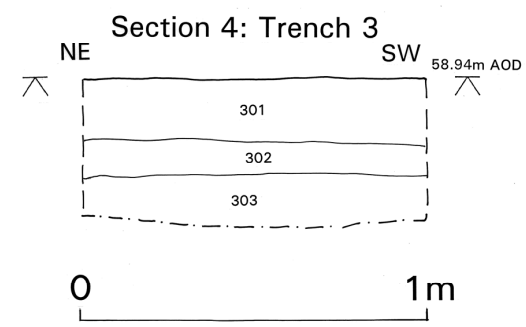
PROJECT <b>ST JOHN'S CHURCH, WADWORTH</b>	
TITLE <b>TRENCHES 1 TO 3</b>	
SCALE <b>AS SHOWN</b>	DATE <b>NOV 2015</b>
<b>EDAS</b>	FIGURE <b>4</b>

- 4.12 Overlying deposit 203 was a 0.13m-0.30m thick loose mid grey-brown sandy silt layer (202) also representing made-ground (see Section 2 on figure 4). It was encountered at 0.24m BGL (58.66m AOD) and contained c.50% small to medium sized unworked chalk fragments. Adjacent to the west wall of the church, the metal earthing-straps for the church lightning protection system ran throughout deposit 202 (see plate 5). A small assemblage of disarticulated bones was recovered from this area and a disarticulated human long bone was exposed in the north side of the trench (see Section 3 on figure 4 and plate 6).
- 4.13 Overlying layer 202 and forming the current ground surface at 58.90m AOD was a 0.24m thick layer of very loose mid-dark grey loamy sandy silt topsoil (201). One iron nail was recovered from this deposit. There were no other archaeological features recorded within this trench.

- 4.15 The earliest deposit was a loose light-mid brown sandy silt (303) over 0.16m thick, with a small clay component containing frequent small chalk fragments (see Section 4 on figure 4); it represented made-ground and was encountered at 0.30m BGL (58.59m-58.63m AOD). Overlying this deposit was a further 0.11m thick layer of made-ground, of loose mid grey-brown sandy silt (302) containing c.50% small to medium sized unworked chalk fragments. It was encountered at 0.19m BGL (58.70m-58.74m AOD) and a small assemblage of disarticulated bones was recovered from the deposit.

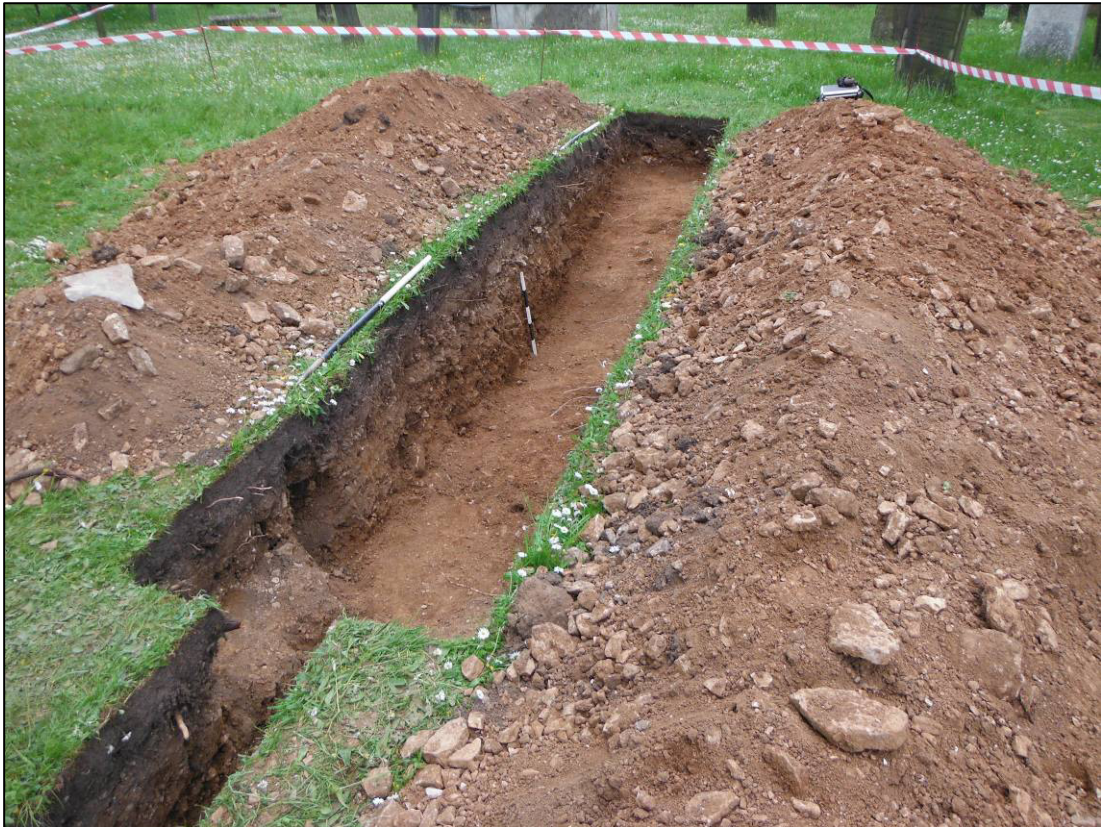
Plate 1: General view of excavated Trench 1 (Trench Arch Drain), looking S.

- 4.1 Trench 1 measured 6.50m long (north-east/south-west) by between 0.90m-1.00m wide and up to 0.89m deep BGL, and was excavated at an angle off the west wall of the tower (see figure 4 and plate 1). There were no marked or known graves in this area.

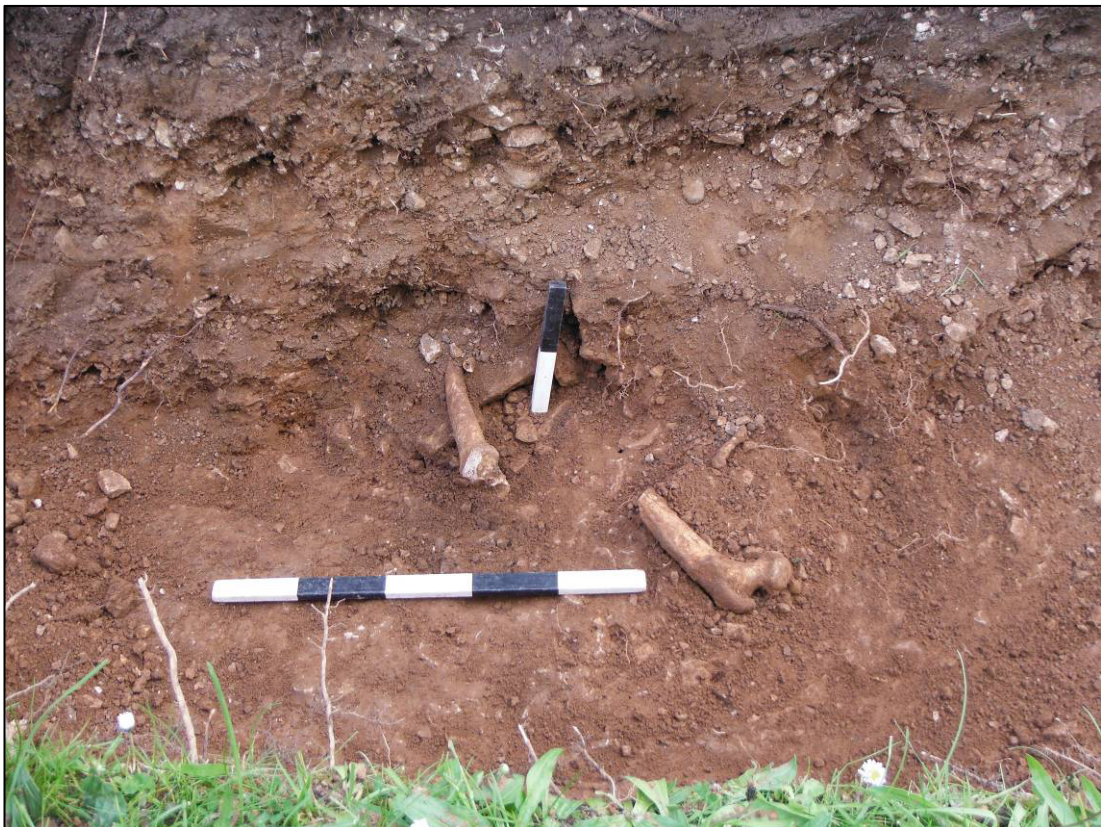
Plate 2: Skeleton 1 (104) in Trench 1 - long bones in situ in east side of trench, looking SE.

- 4.3 There were no discernable grave cuts in the trench, but within deposit 103, four skeletons (104, 105, 106 and 107) were recorded.
- 4.4 Skeleton 1 (104) was located 1.60m from the north end of the trench, at 0.57m BGL (58.36m AOD); no grave cut was distinguishable. The partial remains of the upper and a lower leg - femur, tibia and possible fibula (left or right side not determinable) - of an adult were exposed, continuing beyond the east section of the trench (see plate 2). No evidence of the upper body was encountered either within the trench or the opposing section. Due to the paucity of the remains, the type or position of the burial (e.g. extended, supine) could not be determined, although it was probably east-west. The bones were in good condition and no associated coffin or coffin fittings were evident.

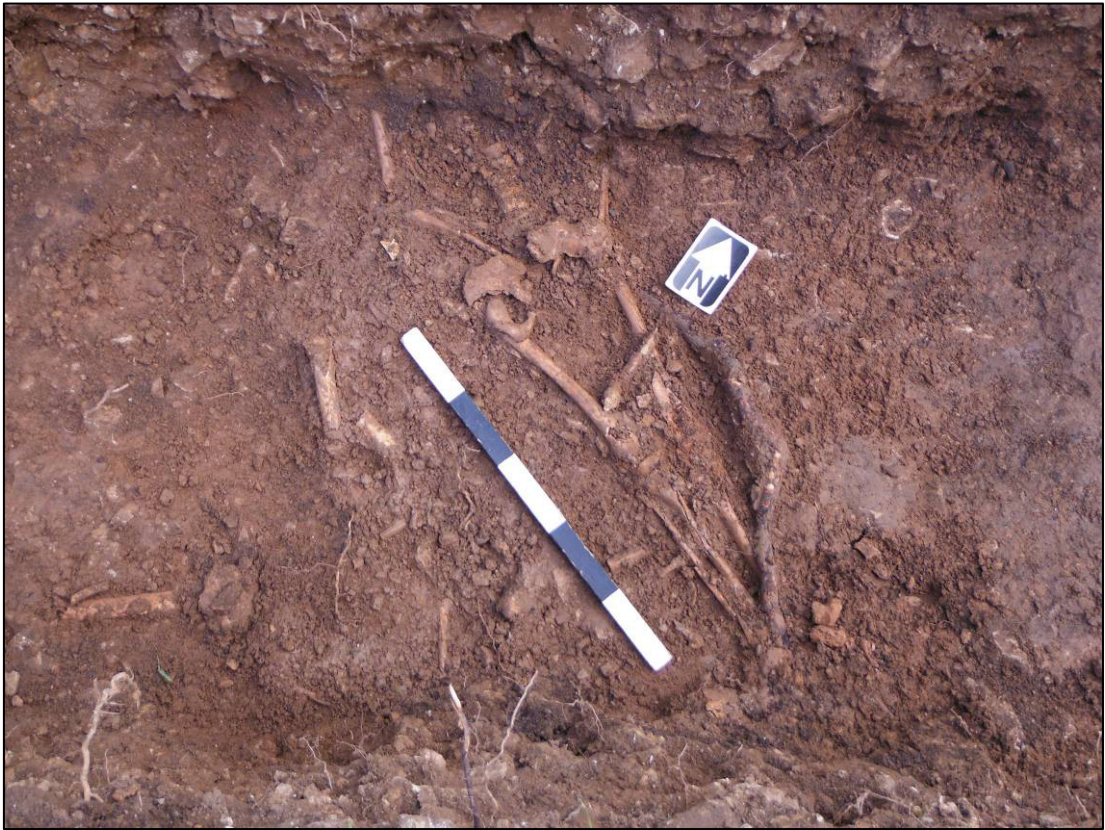
Plate 3: Skeleton 3 (106) in Trench 1, looking NW.

- 4.6 Skeleton 3 (106) was located c.2.30m from the north end of the trench, between 0.77m-0.79m BGL (58.14m-58.16m AOD). The east-west orientated burial was in a supine position with the hands over the pelvic area. The upper part of the burial continued beyond the west section of the trench and the lower extremities continued beyond the east (see plate 3). The legs bones (femora, tibiae, fibulae), pelvis, vertebrae, right arm (humerus, radius, ulna) and lower left arm (radius and ulna) were exposed. The sizes of the bones would suggest a juvenile or child burial, and the bones of skeleton 2 (105) were alongside or close to the feet area. The condition of the bones was good and no associated grave cut, coffin or coffin fittings were present.

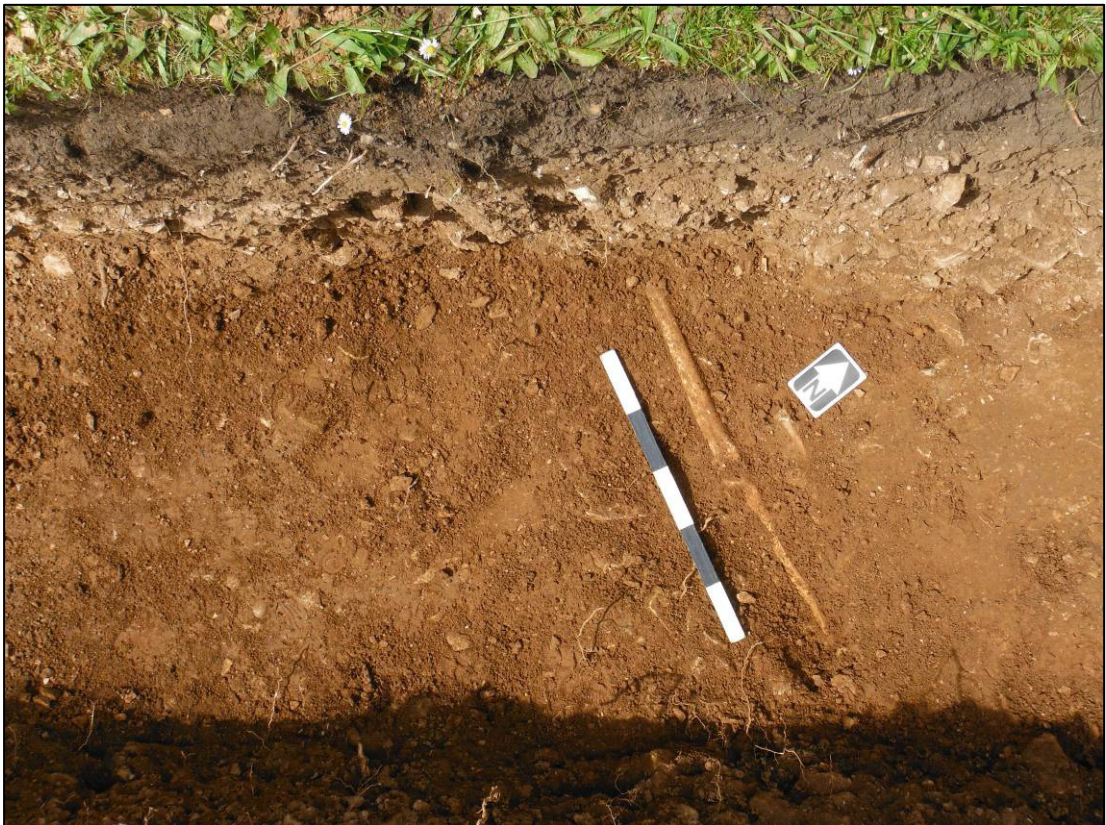
Plate 4: Skeleton 4 (107) (long bones) in Trench 1, looking SE.

- 4.7 Skeleton 4 (107) was an adult, located c.2.15m from the north end of the trench and lay directly below skeleton 3 (106), at 0.82m BGL (58.11m AOD). Only the articulated remains of the upper and lower leg bones - femur, tibia, fibula (left or right side not determinable) - and a fragment of sacrum were present (see plate 4). It is possible that the burial was orientated east-west, but this could not be confirmed with so few remains visible. There was no associated grave cut, coffin or coffin fittings.

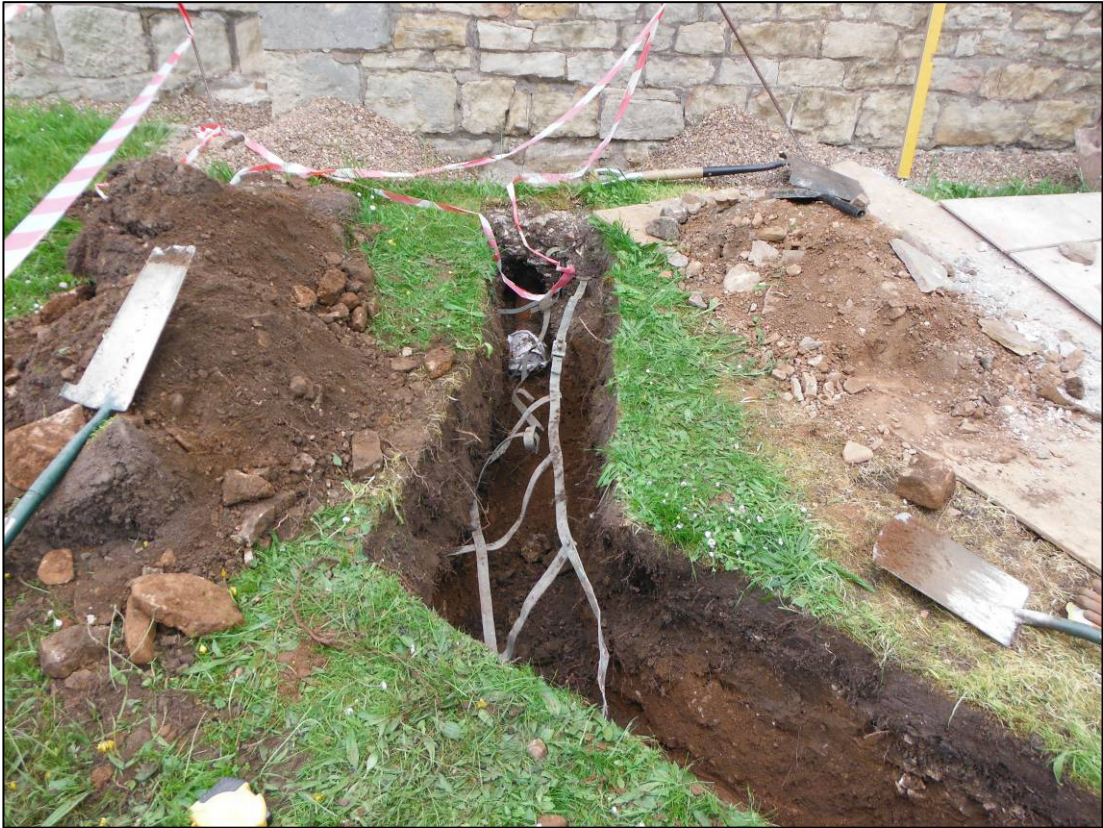
Plate 5: Trench 2 under excavation, showing metal-earthing straps, looking E.

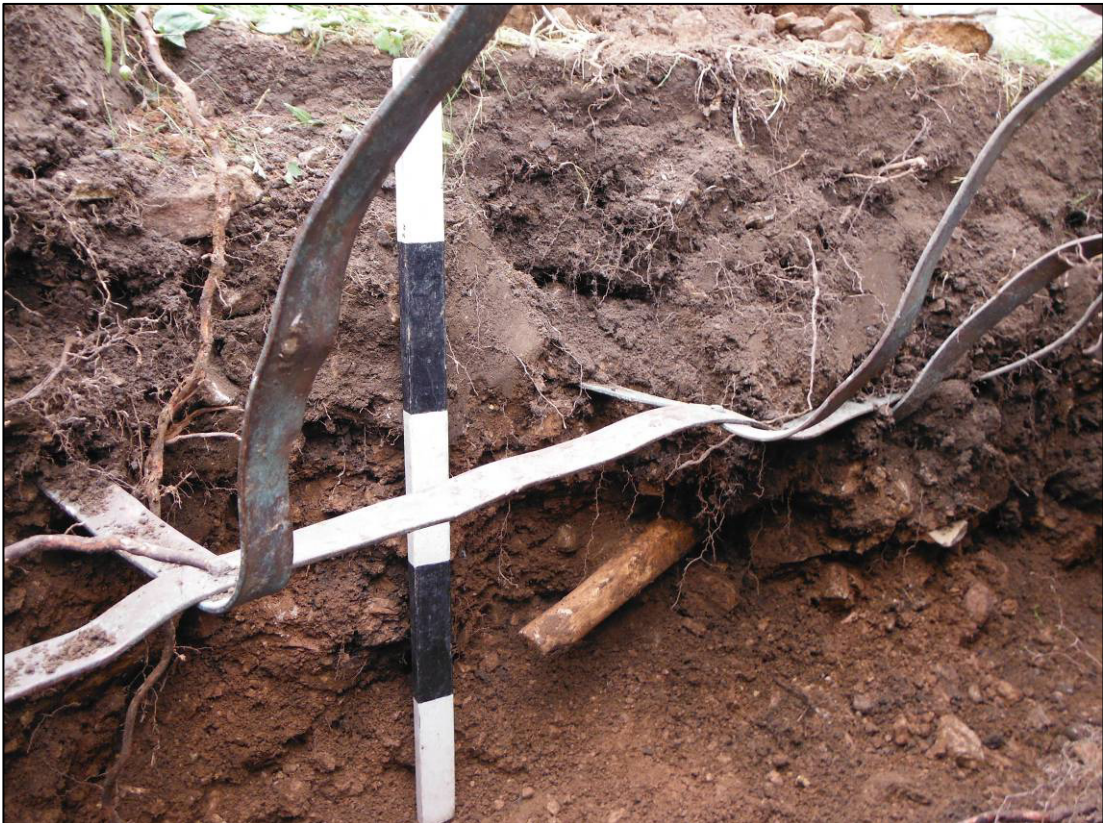
Plate 6: Disarticulated long bone exposed in north side of Trench 2, looking NE.

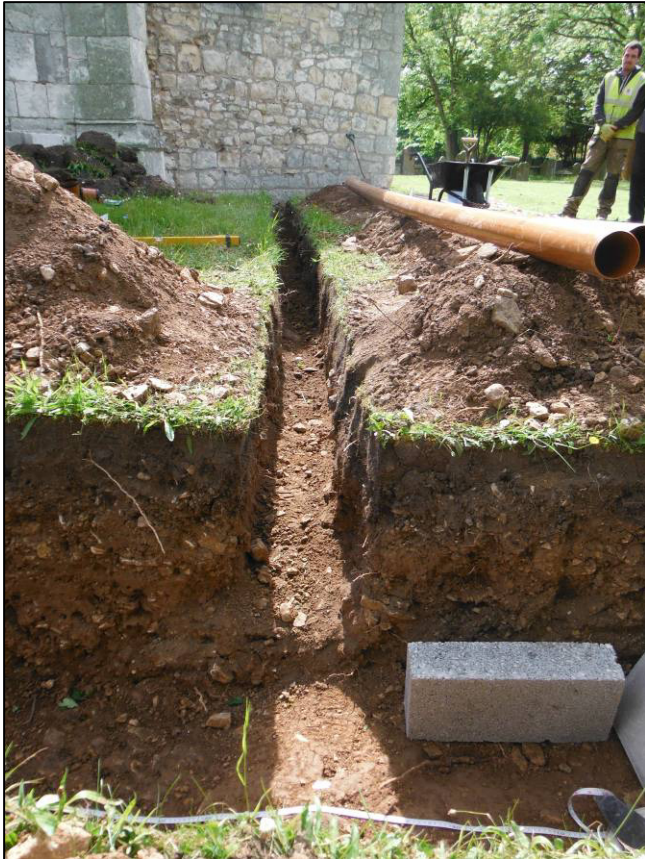
Plate 7: Trench 3 under excavation, looking SE.

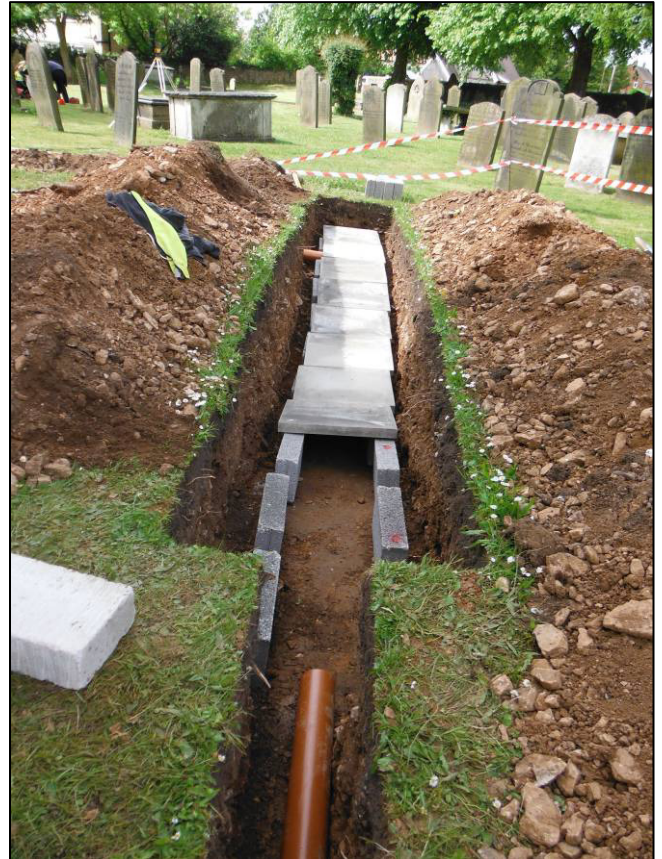
Plate 8: Construction of Trench Arch drain in Trench 1, looking SW.

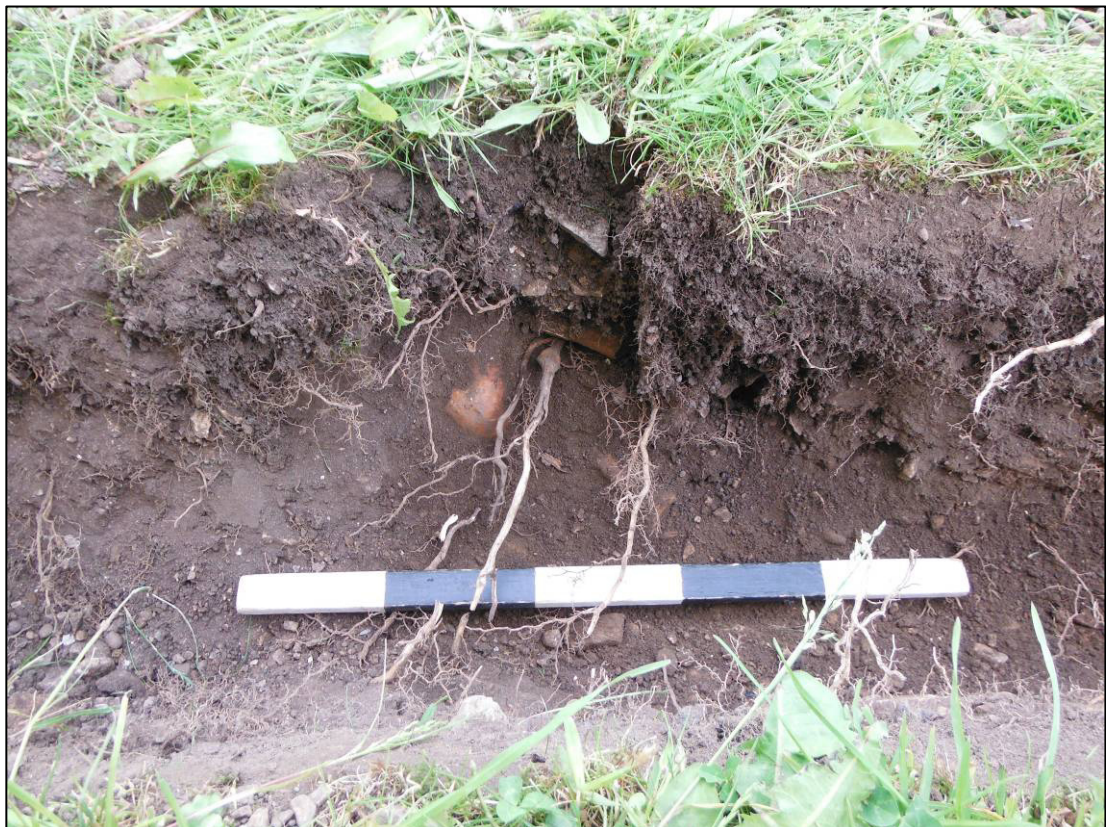
Plate 9: Skull of skeleton 5 (304) in Trench 3, looking SW.

- 4.17 Recorded within the topsoil (301), at the east end of the trench, was a localised assemblage of human remains (Skeleton 5 - 304). The remains comprised a partial skull that overlay a small assemblage of disarticulated bones including a pelvis, vertebrae, ribs, long bones (including an ulna and tibia), together with one fragment of clay pipe stem, of c.19th century appearance (see plate 9). Research by Revd. Price indicates the presence of two grave markers in this area, prior to the insertion of the French drain along the west wall of the church, and it is possible that these localised remains represent the re-interment of a burial disturbed by the earlier drainage works. No other archaeological features were recorded within this trench.
