CIRCULAR SILAGE SILO, WEST SHAW FARM,
SLEDDALE, NEAR HAWES,
NORTH YORKSHIRE

ARCHAEOLOGICAL SURVEY

Report no: 2015/502.R01
Version: Final
Date: September 2015
Author: Shaun Richardson & Ed Dennison

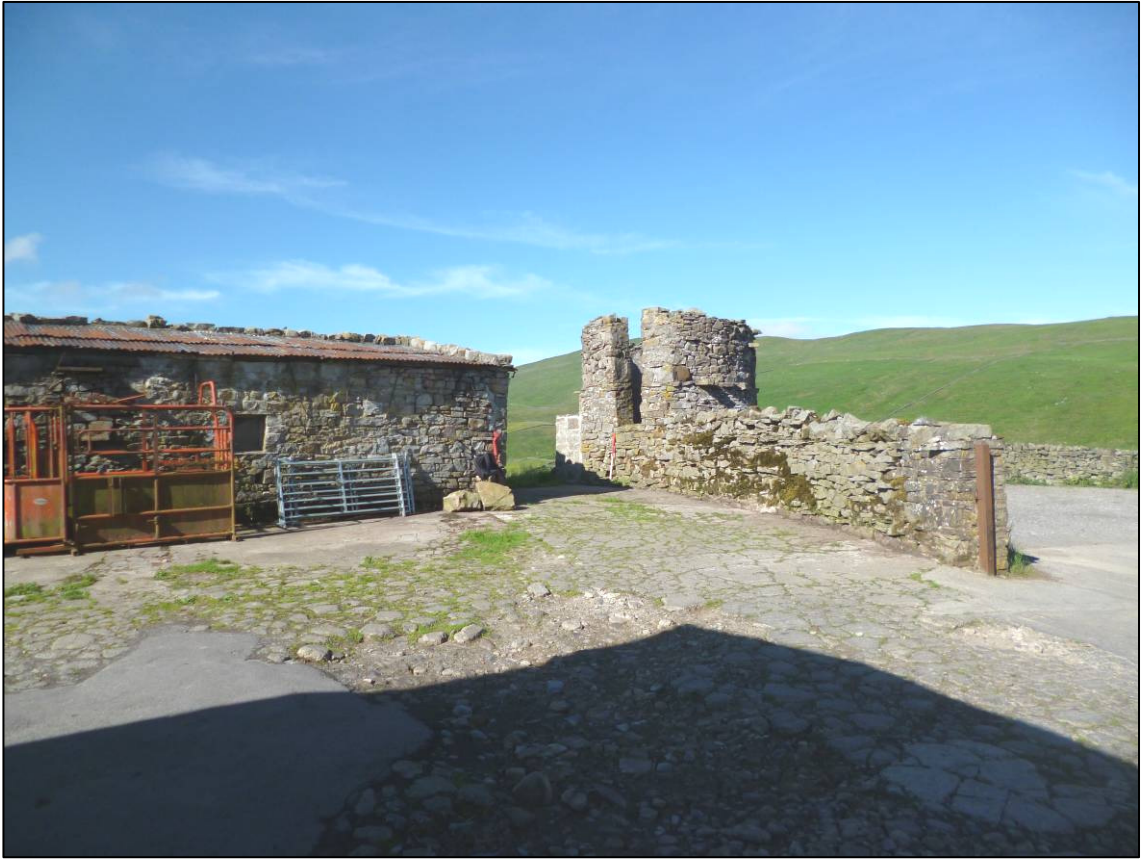
Plate 1: General view of silo in corner of yard, looking SW (photo 1/361).

- 4.2 As already noted above, the silo stands within the main group of farm buildings on the west side of Beggarman's Road, at the south end of the farm yard. The silo is actually set almost wholly within the corner of a small enclosure to the immediate west of the yard [1/408, 1/413], although it was always accessed from the south end of the yard itself (see below). The silo stands adjacent to the gateway [1/358, 1/361, 1/399, 1/414-416, 1/418] leading from the yard into the hay meadow to the south [1/366, 1/401] (see plates 1 and 5); there is another building opposite on the immediate east side of the gateway, which has a muck midden parallel to its southern wall [1/417, 1/420]. Its location means that the silo receives little shelter from wind or weather from any adjacent structures.

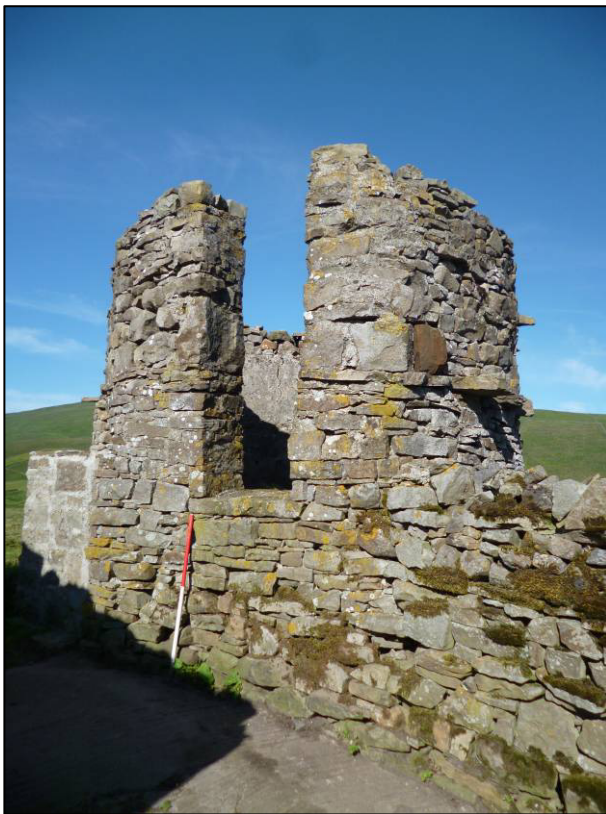
Plate 2: East side of silo, looking SW (photo 1/359).

- 4.5 The external walls preserve evidence for several different phases of construction. As already noted, the east and south sides rise from earlier drystone walls. The wall stands 1.40m high, and is built of roughly coursed and squared limestone rubble. It measures 0.60m across the base and tapers slightly to the upper part, which has some surviving slanted rubble coping. There are no courses of throughstones to the south side [1/368], but two intermittent courses to the east side, beyond the limits of the silo [1/362]; the south-east corner is an entirely modern rebuild [1/400]. To the north [1/375, 1/377] and west [1/369, 1/380, 1/409] sides of the silo, the lower 2.30m above ground level are built of better coursed and squared limestone rubble, set with a friable light-grey lime mortar (see plate 3); the rubble tends to be laid in bands of roughly squared pieces alternating with thinly coursed bands. There are three courses of intermittent throughstones, set at 0.70m, 1.30m and 2.30m above ground level [1/376, 1/381, 1/384]. The uppermost course projects up to 0.30m from the wall face, and rises slightly towards the south side; it is carried around to the south [1/365, 1/367] and east sides of the silo. The upper part of the silo appears to be a later heightening. It is built of larger pieces of limestone rubble, which are more poorly coursed than below, and is also set with less mortar, although there is a great deal of mortar around the doorway in the east side [1/357, 1/359, 1/360, 1/363, 1/364, 1/403-1/406] (see plate 2).

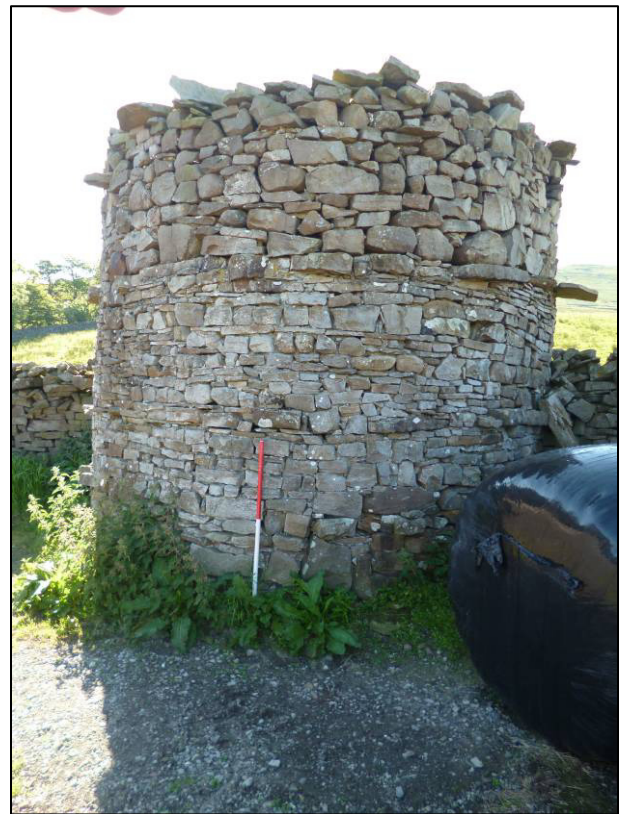
Plate 3: West side of silo, looking E (photo 1/380).

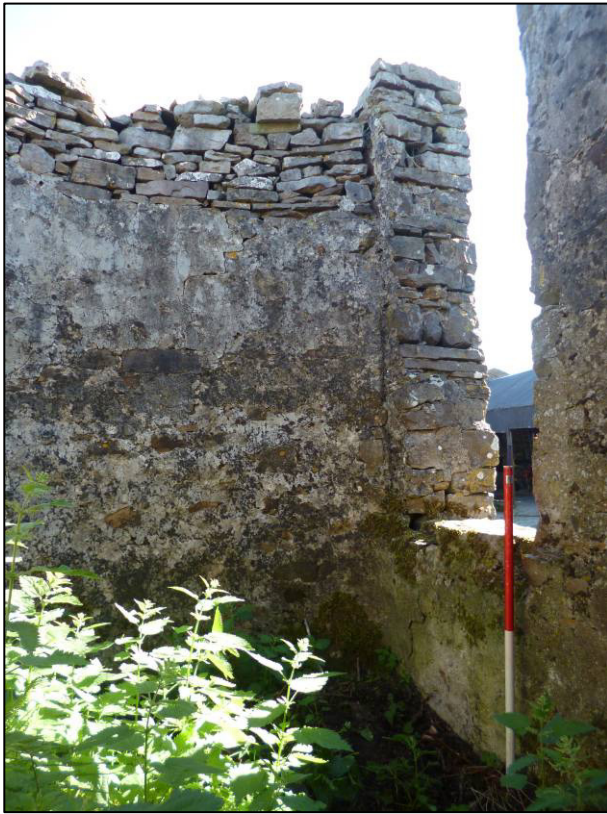
Plate 4: Interior of silo, looking N
(photo 1/388).

- 4.6 The 0.75m wide doorway is the only access to the interior of the silo. The base of the doorway, formed from a stone slab, is set 1.25m above ground level, and the doorway has a total height of 2.40m above the base. It has quoined jambs, and a shallow rebate to the interior [1/385-1/388, 1/394] (see plates 4 and 5). The rebate rises only to 1.96m above the sill (i.e. not the full height of the doorway opening) and there are no traces of pintles or other fittings associated with a fixed door; it is therefore assumed that some kind of removable wooden partition was set into the doorway's internal rebate.

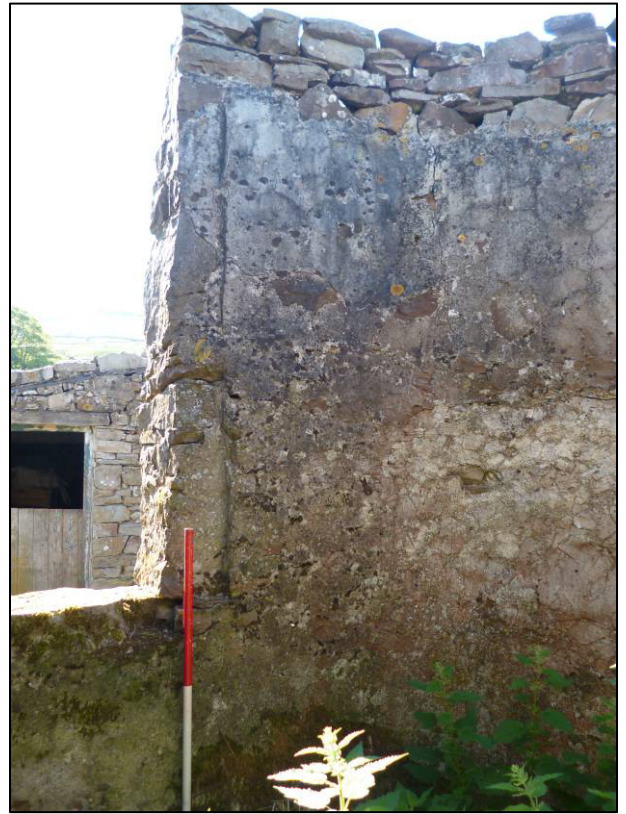
Plate 5: Interior of silo, looking E
(photo 1/386).

- 4.7 Most of the visible parts of the interior of the silo are rendered to a thickness of 0.03m with what appears to be a lime mortar and sand mix [1/389-1/391, 1/395] (see plate 5). There is a horizontal joint to the render, set at the same level as the highest course of throughstones externally. Below the joint, the render has a higher content of hard white lime mortar, whilst above the joint, it is sandier and slightly darker in colour. The uppermost 0.40m of the interior is not rendered, and the top of the render is placed at this same level around the interior [1/392, 1/393, 1/396-1/398, 1/402] (see plate 4). It may have stopped because some kind of cover or roof structure was present at this level but, as has already been described, there is no clear surviving structural evidence for one.

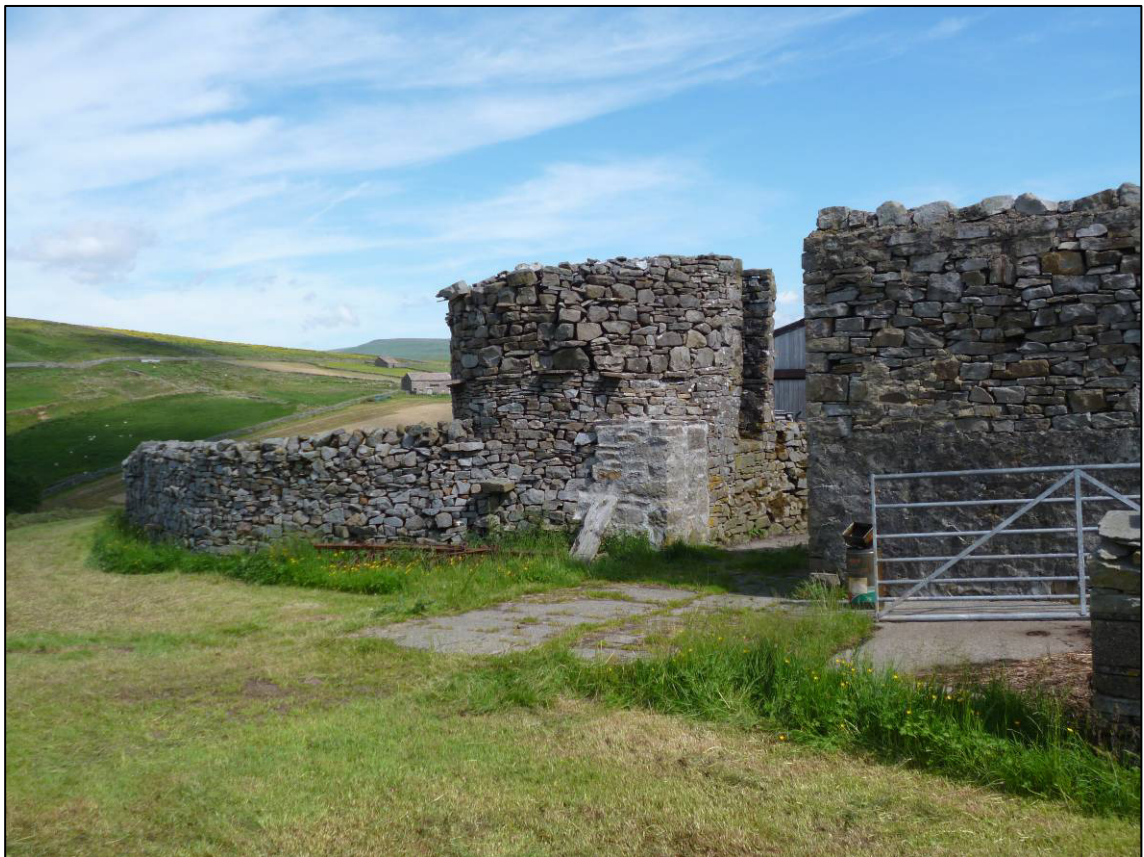
Plate 5: General view of silage silo, looking NW (photo 1/414).
