STRUCTURAL/EARTHWORK COMPLEX,
WEST OF NEW MILL,
ARKENGARTHDALE, NORTH YORKSHIRE

ARCHAEOLOGICAL SURVEY

Report no: 2012/432.R05
Version: Final
Date: August 2016
Author: Shaun Richardson & Ed Dennison

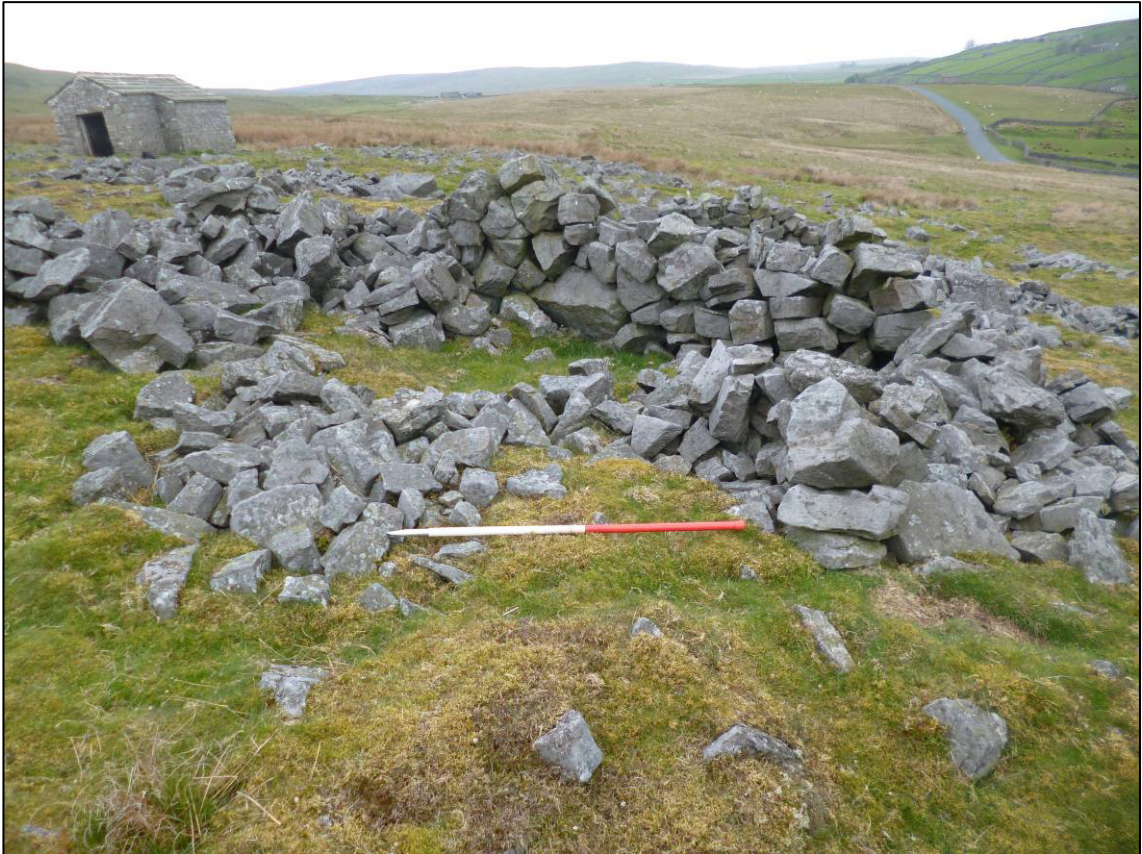
- 3.4 To the south-east of these features, the area is characterised by spreads or rubble, rubble banks (some of which have short sections of wall facing), collapsed structures and possible collapsed wall lines. The westernmost group (**Site 2**) may be a small sub-rectangular enclosure, measuring c.10.0m long by c.6.0m wide, and defined by linear spreads of rubble standing up to 0.5m in height. The spread defining the north side turns inward at its east end, possibly defining a gateway or entrance gap some 2.0m wide. On the north-east side of this gap, there is a small enclosure or structure (**Site 3**), sub-rectangular in plan, and measuring c.6.0m by 4.0m overall [1/981]. The rubble bank defining the north side stands up to 0.75m high, but the south side is much lower, generally less than 0.5m and in some places visible in plan only. The interior is open, but there is no obvious access, even in the sections where the bank is very low; the north-west internal side has placed or built rubble standing up to 0.6m in height [1/982] (see plate 1). To the north, an isolated but substantial linear rubble spread, aligned north-east/south-west, has a later sub-square structure (**Site 4**) built against the south end of the east side, where a section of crude wall facing survives [1/990] (see plate 2). The structure measures c.1.6m along each side and the interior is open but again with no obvious evidence for any access.

Plate 1: Site 3 structure/enclosure, looking SW (photo 1/982).

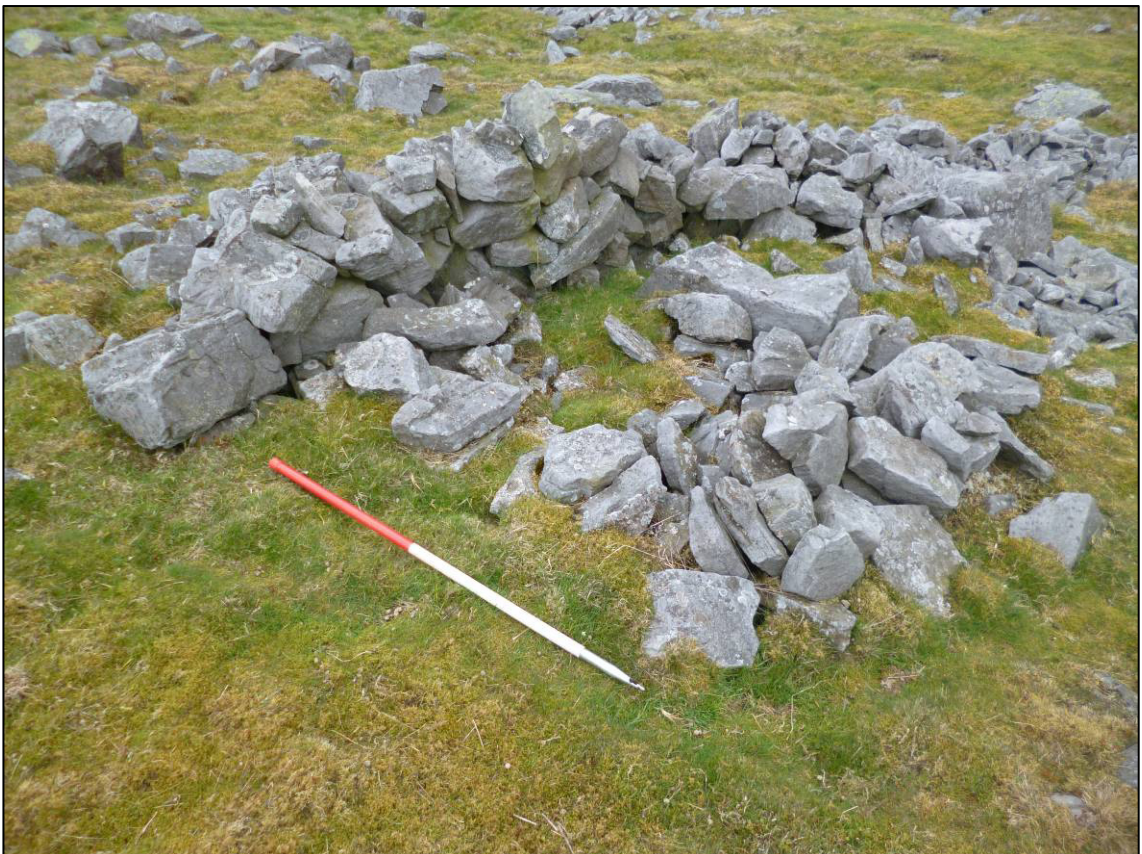
Plate 2: Site 4 structure, looking NE (photo 1/990).

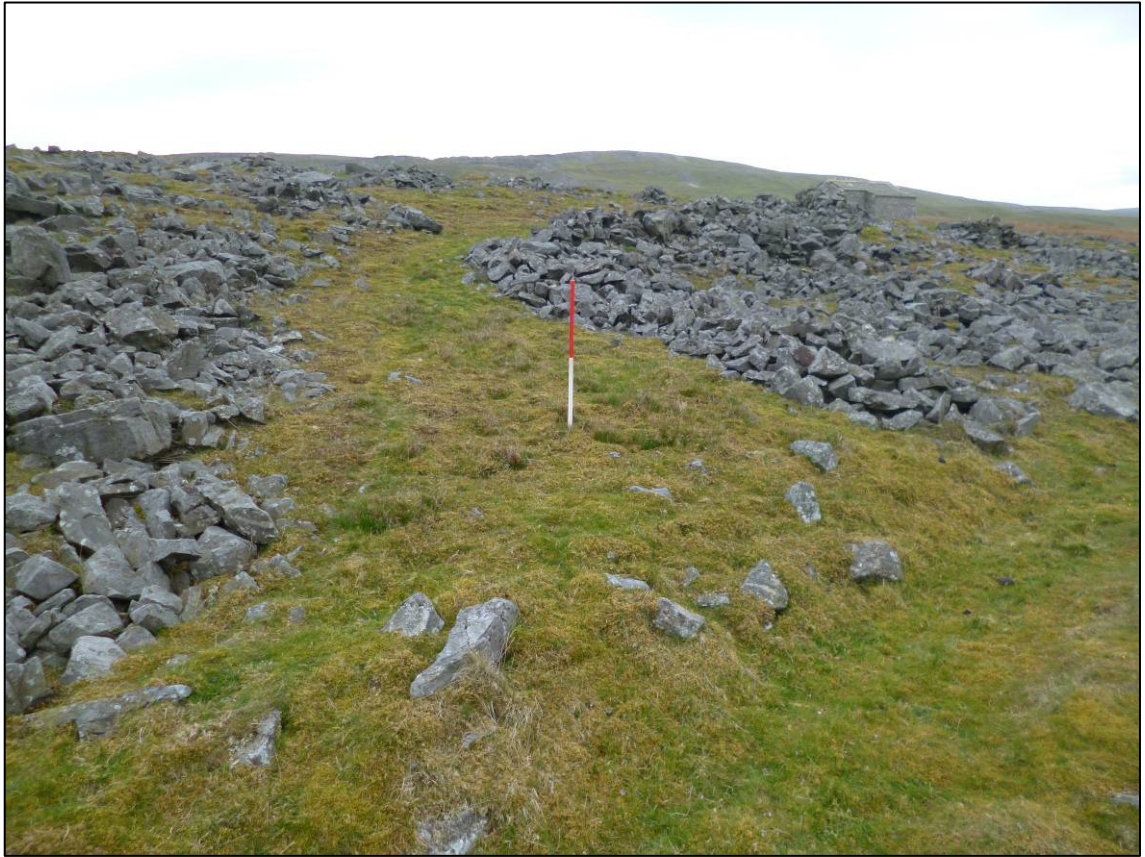
- 3.6 This rubble bank defines one side of a trackway (**Site 6**), which follows its line, climbing as it moves south away from the contour leat [1/983] (see plate 3). Both the bank and the trackway are almost certainly visible to the north of the contour leat; the bank for a short distance only [1/994], although the trackway could continue north-east for a further 30m down the natural slope here as a shallow linear depression. There may be further linear earthworks, perhaps shallow terracing, running between the trackway and a scarp some 28m to the north-west (see Site 1). To the south of the contour leat, the other side of the trackway (Site 6) is defined by a narrower rubble bank, 1.0m wide and up to 0.6m in height. Immediately adjacent to the leat, between the two rubble banks, the trackway has a width of over 4.0m but it narrows to less than 2.0m where it angles to the south-west, before opening out again.

Plate 3: Site 6 trackway, south of contour leat, looking SW (photo 1/983).

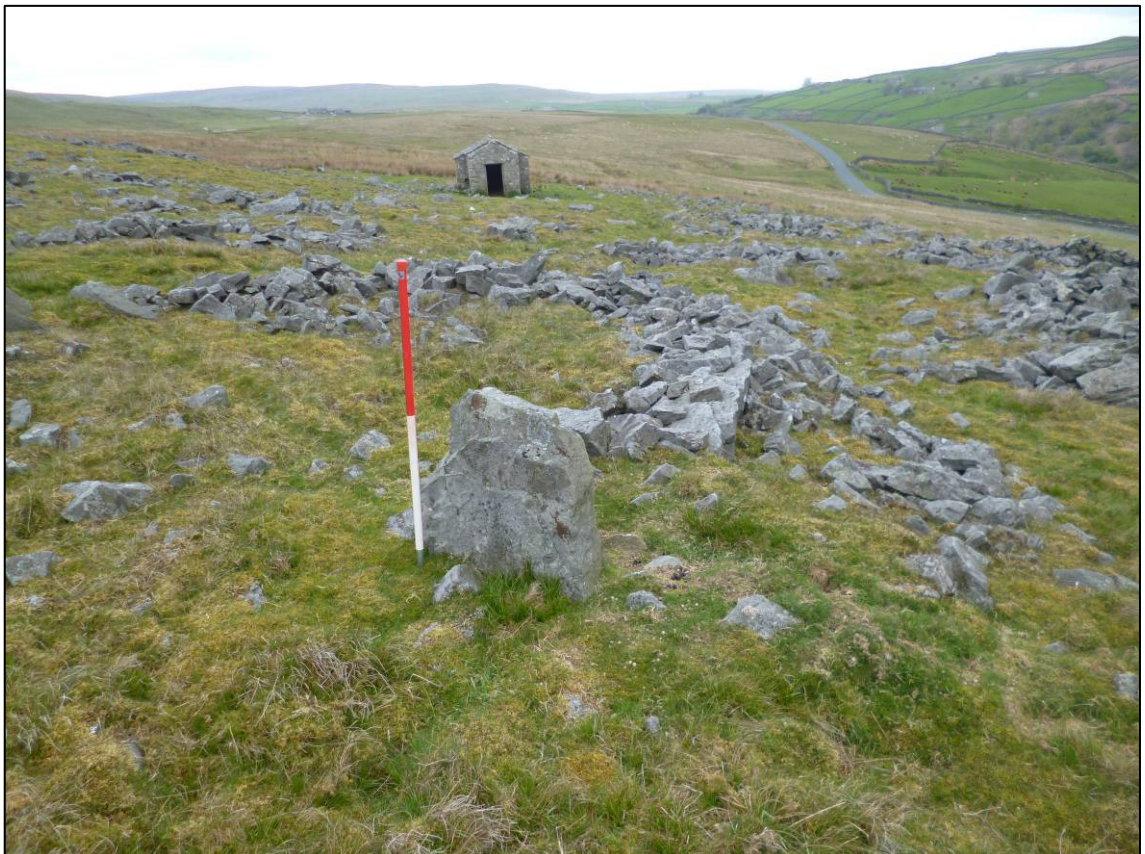
Plate 4: Site 14 enclosure, entrance to north-east side, looking NW (photo 1/985).

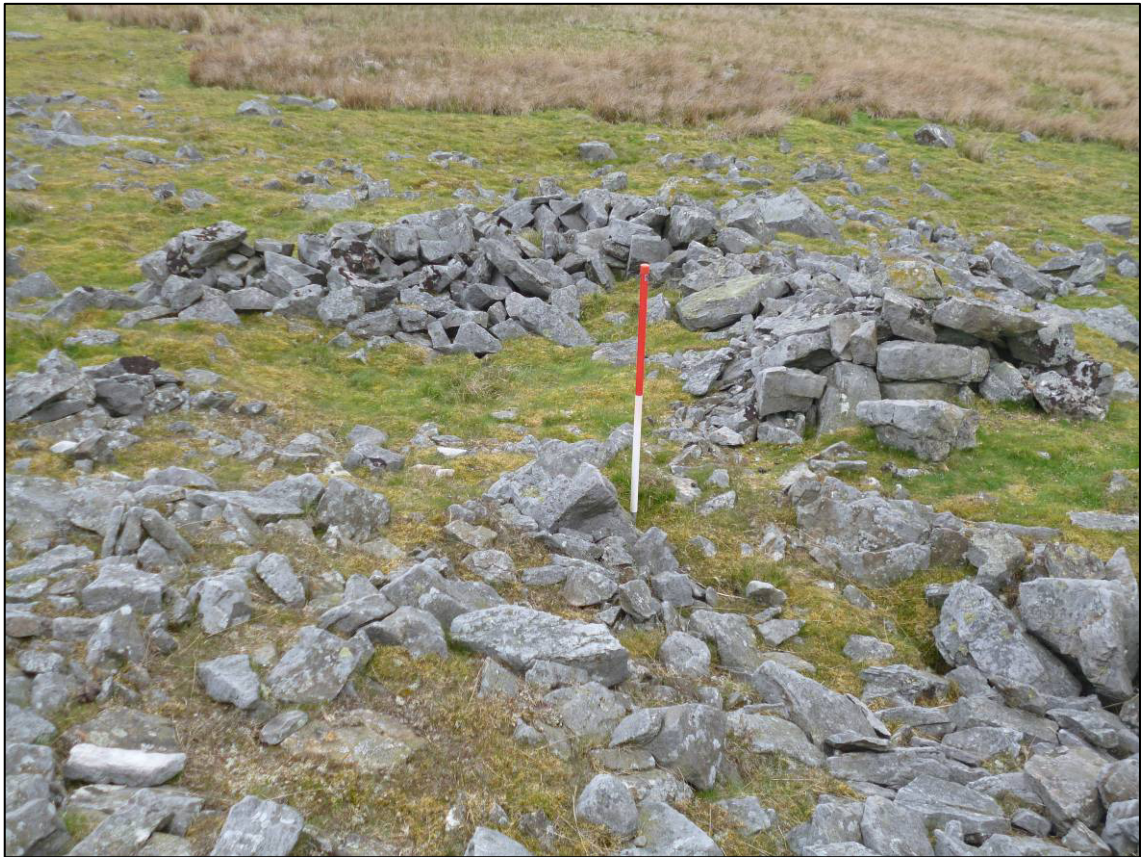
- 3.12 The upper (southern) terrace again supports a number of rubble banks of varying form and width (**Site 18**). Two broadly parallel linear banks, set between 1.0m-3.0m apart, may define a trackway leading up onto the higher terrace [1/979]. Like much of the rest of the survey area, the surface of the higher terrace is scattered thinly with rubble, within which there are other features, some only slightly more prominent than the rubble itself. For example, there appear to be two broadly right-angled banks of stone [1/977], one revetting a shallow north-facing scarp but the other free standing. This, the larger of the two, measures 4.0m along each arm and stands up to 0.5m high [1/978] (see plate 5). There is some evidence at the base of the east arm that stones have been deliberately placed or laid to resemble a wall, but otherwise the structure is built purely of rubble. There are almost certainly further earthworks to the south and west, but again, these are very denuded.

Plate 5: Site 18 L-shaped structure, looking NW (photo 1/978).

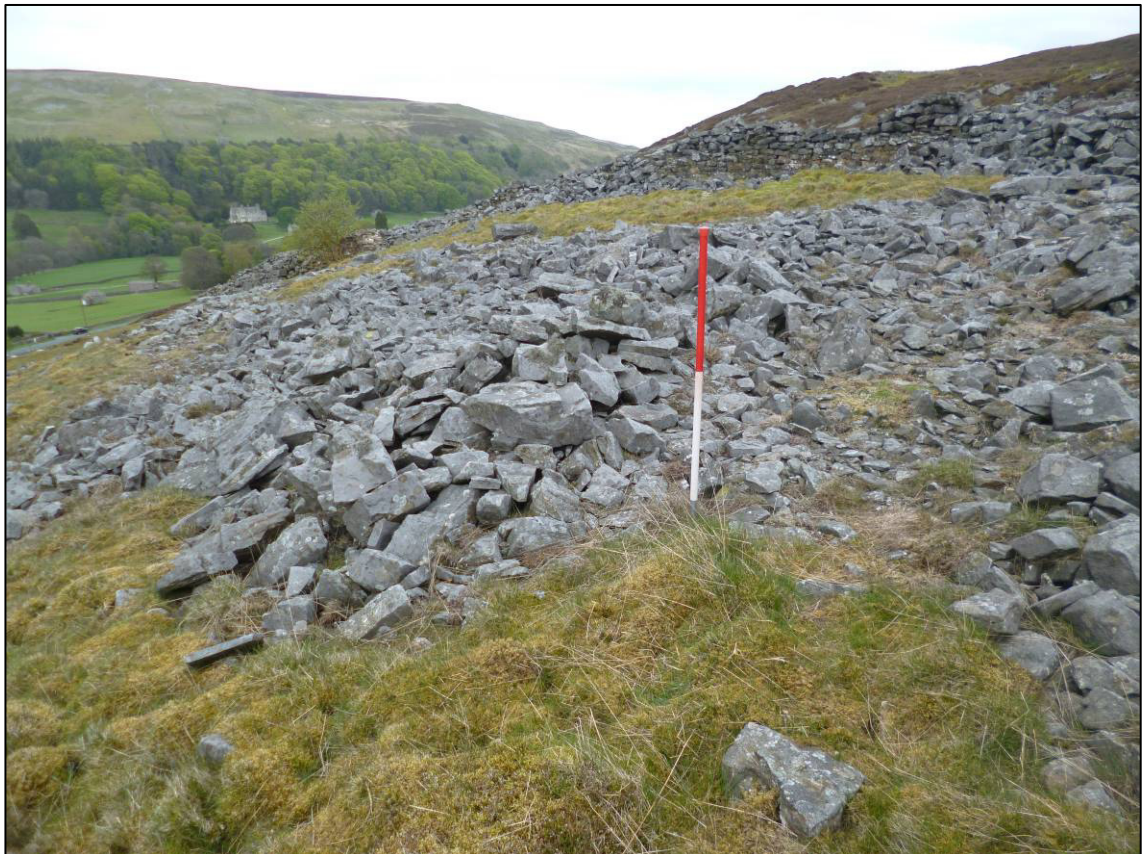
platform (**Site 21**), perhaps retaining some stone edging, sub-square in plan and measuring c.4.0m across. It may have a narrow trackway curving around its south-west side [1/996] (see plate 6). Further to the east, there is a second possible sub-rectangular structure (**Site 22**), measuring 14.0m east-west by 6.0m north-south, and appearing to comprise two or three cells, with the largest cell at the east end. The north side of this structure overlies a continuation of the former contour leat seen to the west of the Octagon Mill flue; as noted above, this leat was almost certainly constructed in the very early 1800s by Easterby Hall and Company to supply a dressing floor at Moulds Low Level, and this particular section was abandoned in the 1820s when the leat was diverted to supply the New Mill (Dennison & Richardson 2016). A short stretch of possible terraced trackway, defined by a linear rubble spread on the downslope side, may run towards the structure from the north-west.

Plate 6: Site 21 structure and possible trackway, looking E (photo 1/996).

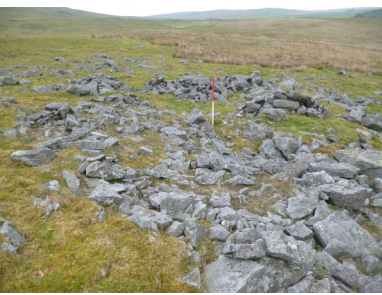
1-977.JPG

<i>Film</i>	<i>Frame</i>	<i>Subject</i>	<i>Scale</i>
1	977	Site 18: L-shaped structures, looking NW	1m
1	978	Site 18: L-shaped structure, looking NW	1m
1	979	Site 18: possible trackway defined by rubble banks, looking N	-
1	980	Site 17: possible platform, looking NE	-
1	981	Site 3: structure/enclosure, looking NE	1m
1	982	Site 3: structure/enclosure, looking SW	1m
1	983	Site 6: trackway, S of contour leat, looking SW	1m
1	984	Site 6: trackway, NE end at junction with contour leat, looking NW	-
1	985	Site 14: enclosure, entrance to NE side, looking NW	1m
1	986	Site 11: rubble banks, upright? stones within spread, looking S	1m
1	987	Site 7: rubble spread, looking NW	-
1	988	Site 12: possible trackway, looking NW	1m
1	989	Site 9: enclosure, entrance to SW side, looking NE	1m
1	990	Site 4: structure, looking NE	1m
1	994	Site 6: rubble bank to trackway to N of contour leat, looking N	1m
1	995	Contour leat across N edge of survey area, looking SE	1m

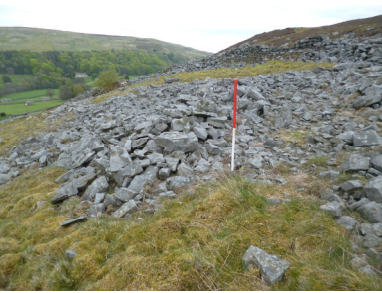
1-996.JPG

1	996	Site 21: structure and possible trackway, looking E	1m
1	997	Site 20: structure and possible surface, looking W	1m
1	998	Site 20: structure and possible surface, looking W	-
