STONE CREEK HEAVY ANTI-AIRCRAFT BATTERY,
SUNK ISLAND, EAST YORKSHIRE

ARCHAEOLOGICAL SURVEY

Report no: 2013/463.R01
Version: Final
Date: April 2017
Author: Ed Dennison & Shaun Richardson

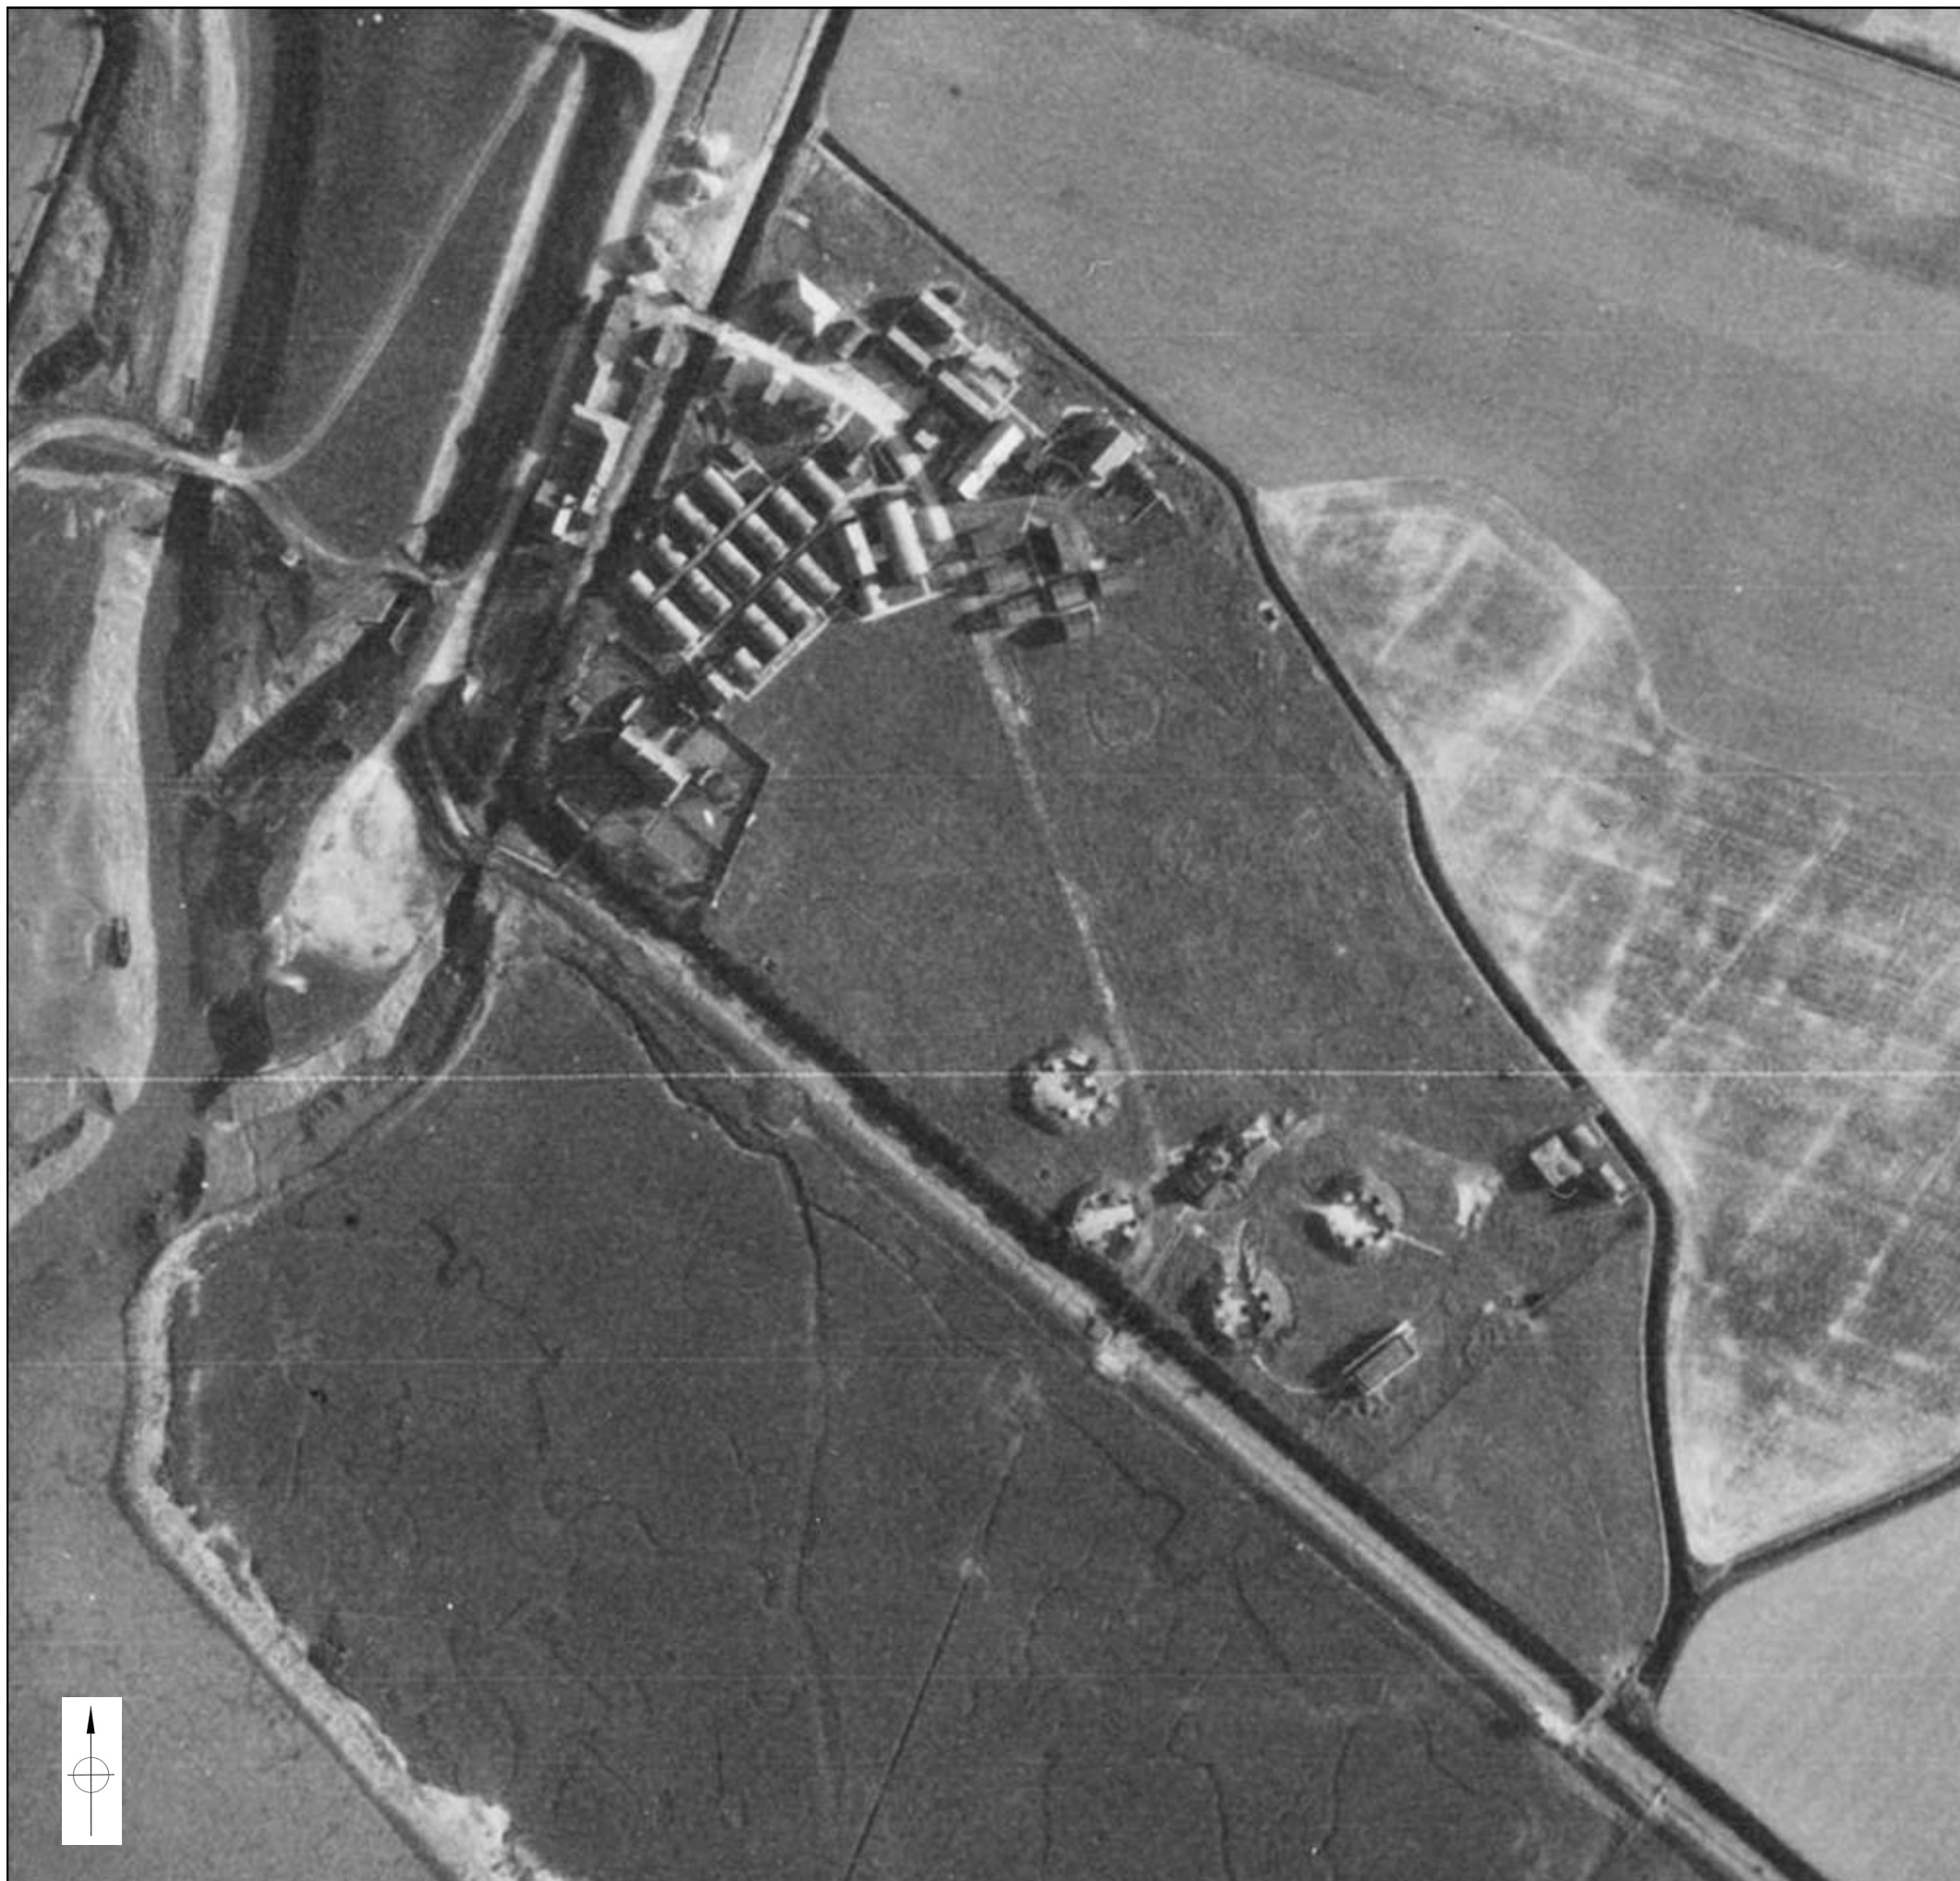
PROJECT		STONE CREEK HAA BATTERY	
TITLE		1947 AERIAL PHOTOGRAPH	
SCALE	NTS	DATE	APR 2017
EDAS		FIGURE	5

RAF black and white vertical aerial photograph (CPE/UK/2043 frame 2077) taken 29th April 1947 (English Heritage Archives).

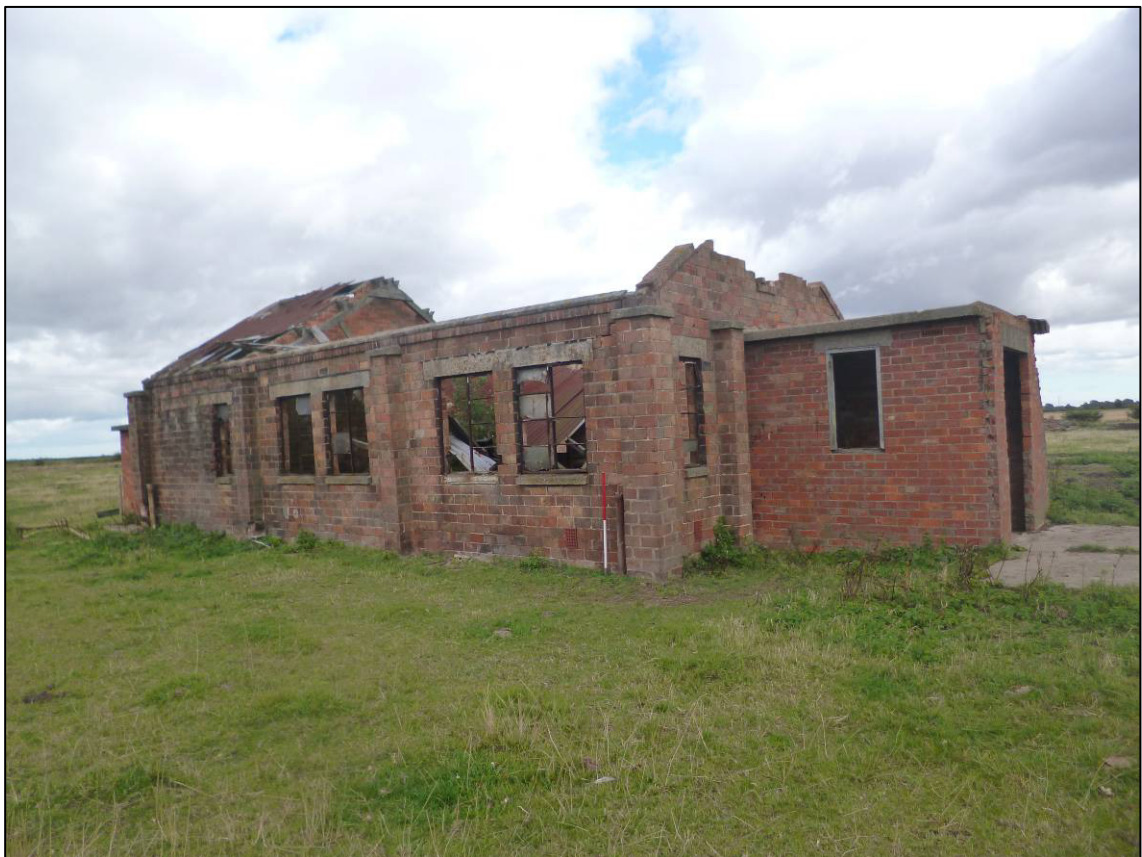
storey, and once had a pitched corrugated asbestos cement sheet roof, although this had largely collapsed at the time of the EDAS survey [1/578, 1/593] (see plate 10); it was subsequently replaced and the gables rebuilt as part of the repair works. All original external walls of the hut are built of reddish-brown machine-made bricks (average dimensions 225mm by 105mm by 70mm) set with a cement mortar and laid on edge in stretcher bond; the latter was presumably done to cut down the number of bricks that were used. Where damage has occurred, it can be seen that the upper surface of the bricks are frogged and impressed 'LBC PHORPRES 6'. These were produced by the London Brick Company (LBC), based at Stewartby in Bedfordshire, who operated the largest brick-producing factory in the world at the outbreak of the Second World War. At first, the war severely affected their business but they were subsequently awarded Government contracts for air-raid shelters, airfield buildings and other official structures (Antrobus 2011, 1-3). The trade name of 'Phorpres' relates to the four separate presses that were applied to the powdered clay in the brick moulds - the bricks were dry-fired producing a hard outer surface but a nodular internal mass. The external walls have an average thickness of 0.24m.

Plate 10: Structure A3 (cookhouse), west elevation with south linking structure, looking NE (photo 1/706).

- 3.43 As part of the repair and conservation works, the tops of the walls and gables were rebuilt, new trusses installed and a new corrugated iron roof added [4/853, 4/857, 4/859]. Other works included putting slats at the windows to prevent birds entering and external rails to protect the building from stock [4/854, 4/870-4/874] (see plates 17 and 18).

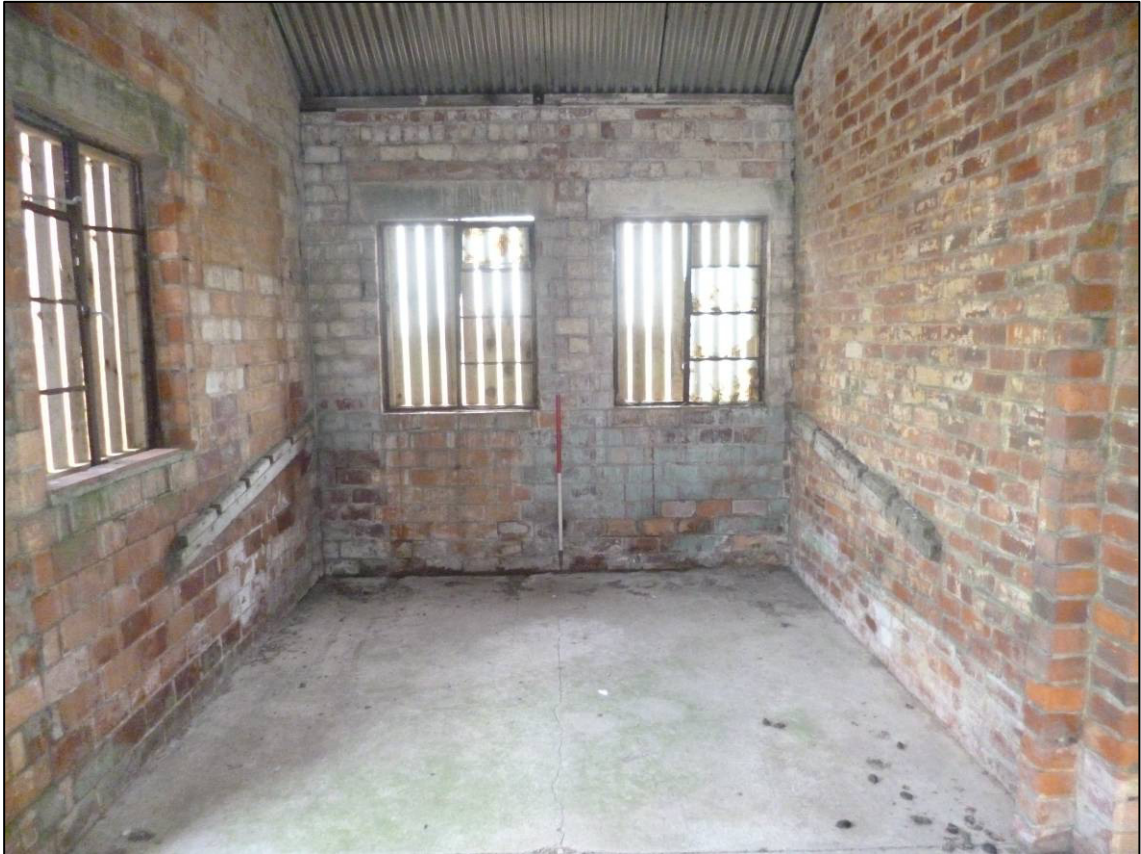
Plate 17: Structure A3 (cookhouse), interior of north cell after clearance and repairs, showing sloping timbers, looking E (photo 4/866).

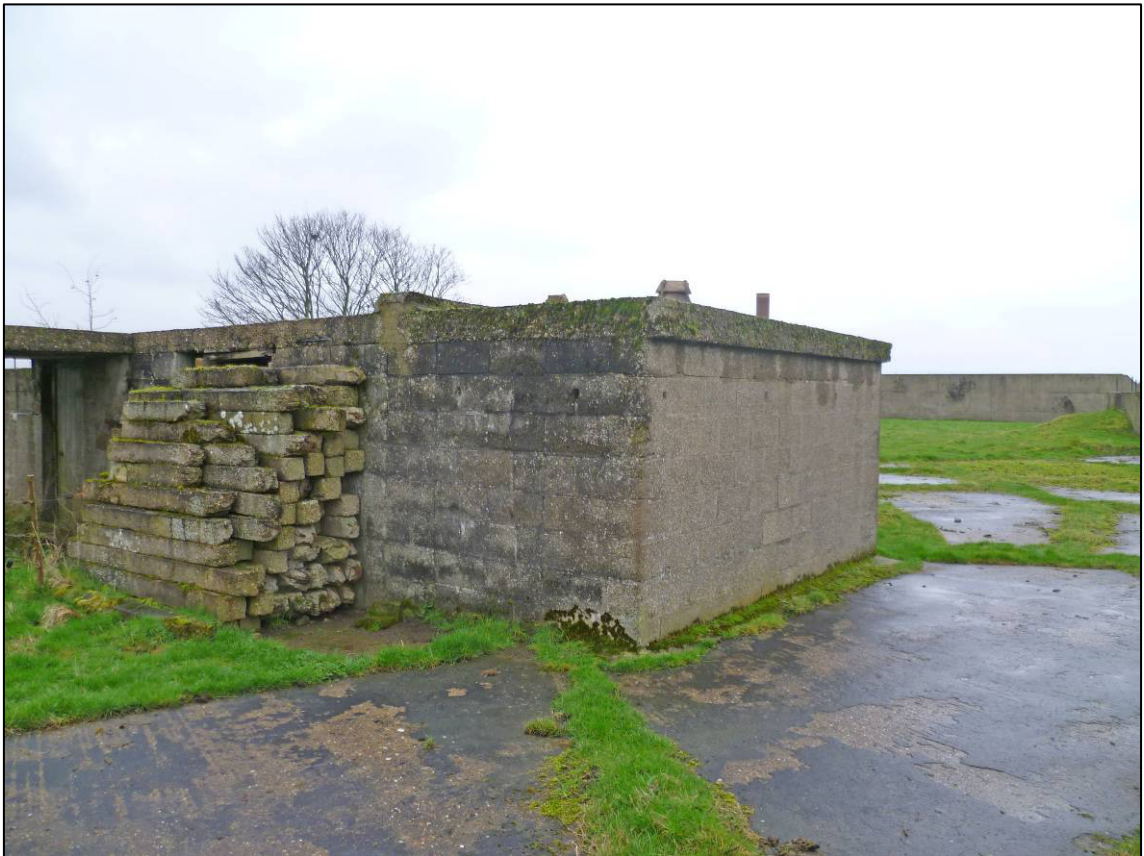
- 3.53 Against the north wall of the command post (Structure B; see below), there is a pile of c.60 reinforced concrete posts [2/176; 6/708] (see plate 23). These are all 0.15m square and the most complete examples are 2.50m long, although all are broken off at the bottom, demonstrating that they were originally longer. These have seven small diameter holes to the upper part of one face only, set at 0.24m centres. As has already been noted above, similar posts survive along the drain forming the eastern boundary of the survey area. It has been suggested that the

Plate 23: Structure B (command post), west end of north elevation, showing blocked doorway and extension to Room 3, looking SE (photo 6/699).

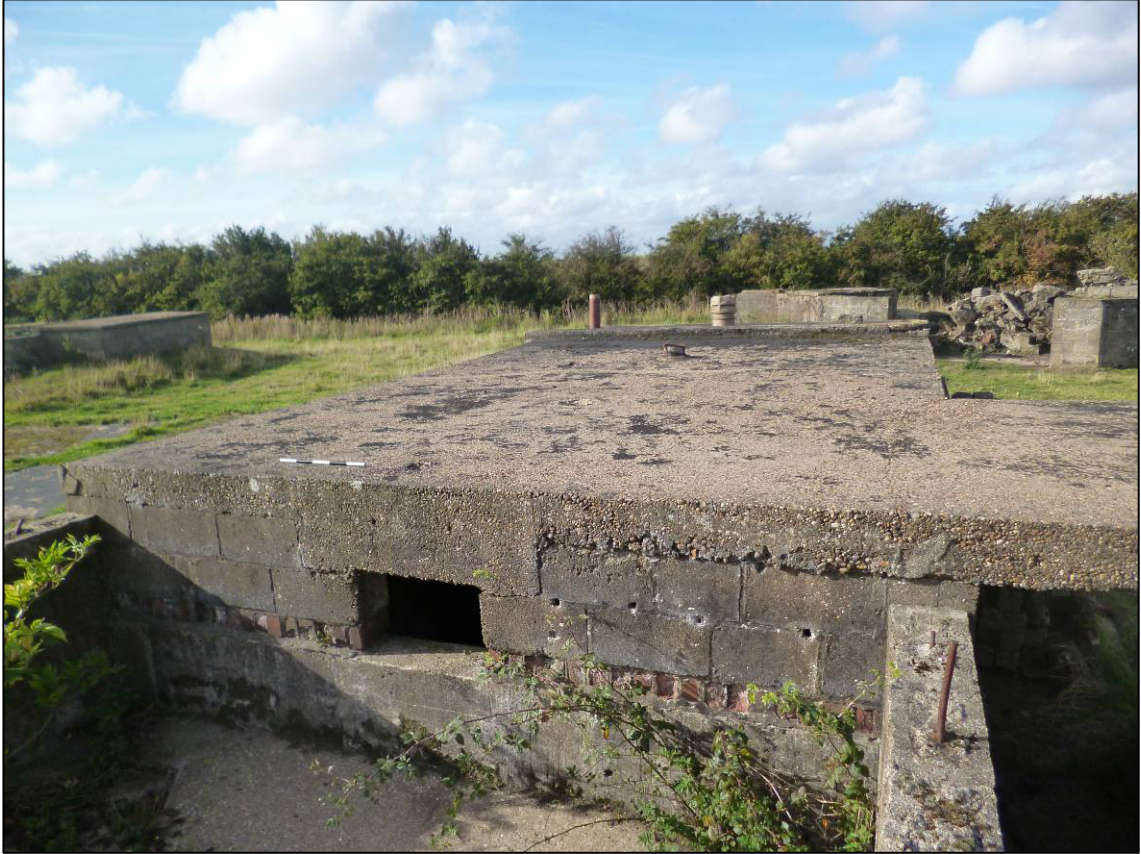
that some of these vents are access points for overhead cables from the height finder and predictor equipment; an overhead cable from the predictor is shown on a contemporary photograph (see figure 4C). At the north-west corner of this part of the roof, the rusted remains of four bolts with square nuts, forming a rectangular pattern 0.50m long in plan, project from the concrete surface [3/321]. Close to the bolts, a raised ridge of concrete, 0.10m high, runs north-south across the roof. It is to the west of this ridge only that the roof overhangs the external wall faces below, and the ridge also coincides with the straight joints in the north and south elevations. There are two features beyond the ridge projecting from the roof, a chimney pot and a ceramic pipe [3/320] (see plate 38).

Plate 38: Structure B (command post), east end and roof of Room 3, looking SW (photo 2/162).

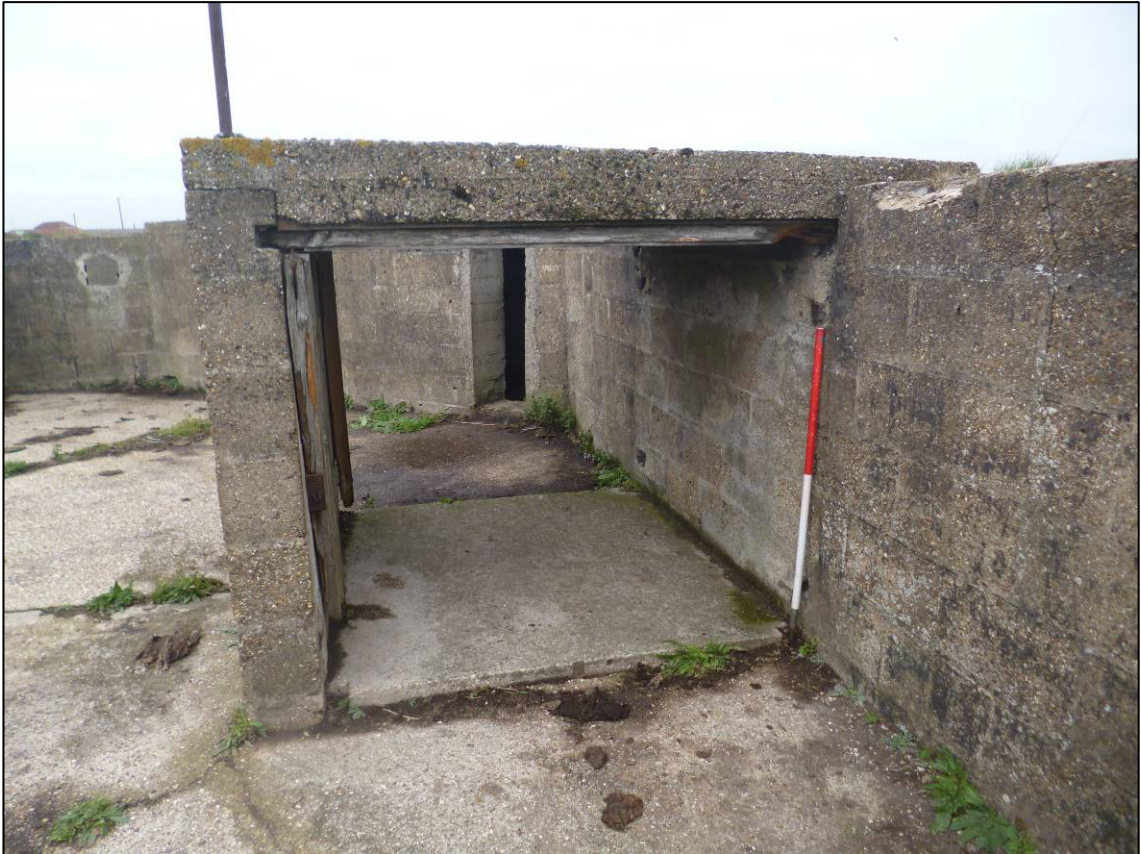
Plate 42: Structure C (gun emplacement), Type 1 ammunition recess, looking N (photo 3/303).

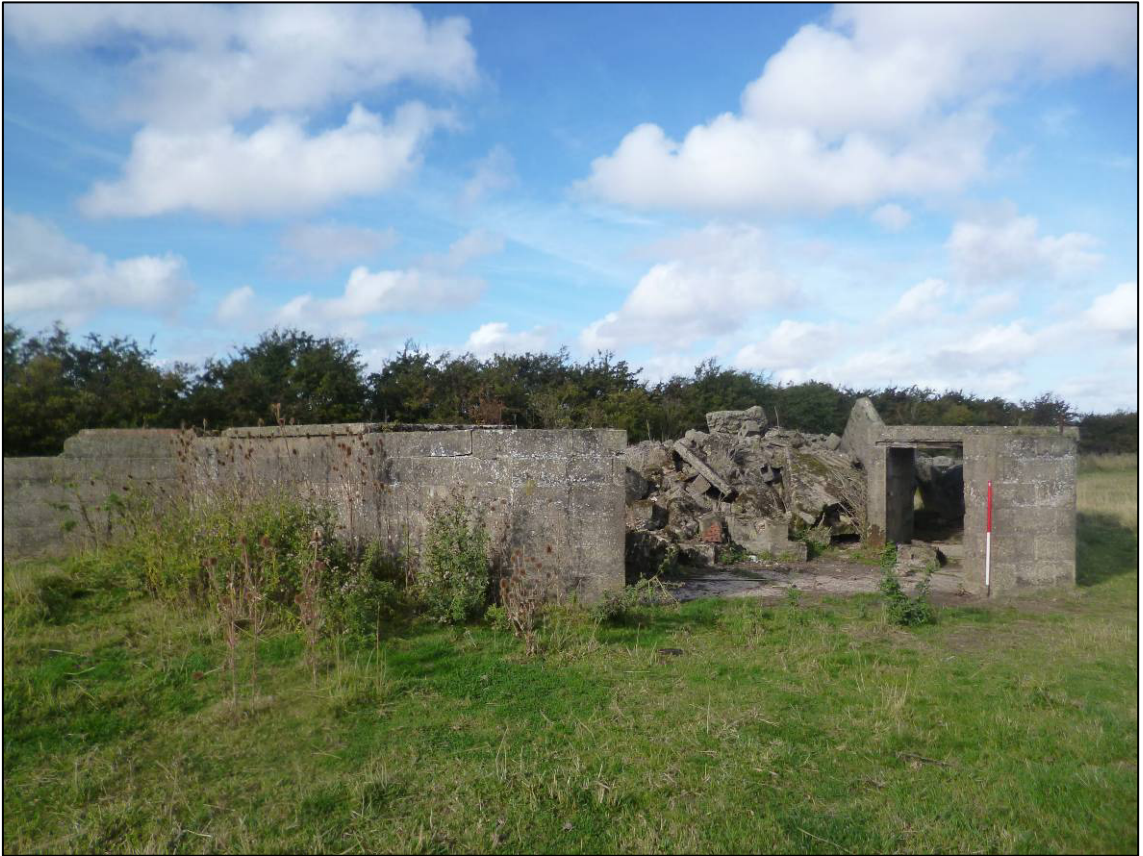
- 3.80 This emplacement was in a poor condition at the time of the EDAS survey, with well over half of the structure having been demolished [2/178] (see plate 47). However, when first built, it had a rectangular octagonal plan form, with a maximum external dimension (excluding the gun detachments' shelter) of 13.50m; each face of the octagon measures on average 5.70m long externally. Like Emplacement C, it is set out on the March 1938 pattern, with a single shelter for the gun detachment added to the outer south side at a later date. This shelter once projected beyond the south external face of the emplacement, but it has been almost completely demolished, leaving some sections of walling and footings; it measured c.5.70m east-west by 2.20m north-south [3/301, 3/302] (see plate 48). It is noticeable, however, like Emplacement C (but not Emplacements F and G), that the shelter incorporated one of the external angles of the emplacement, and that the eastern end had been extended as in Emplacement C [3/298]. The wall defining the emplacement is of concrete blockwork, standing 1.55m high and with an average width of 0.50m [2/183].

Plate 47: Structure D (gun emplacement), south side, looking NW (photo 2/178).

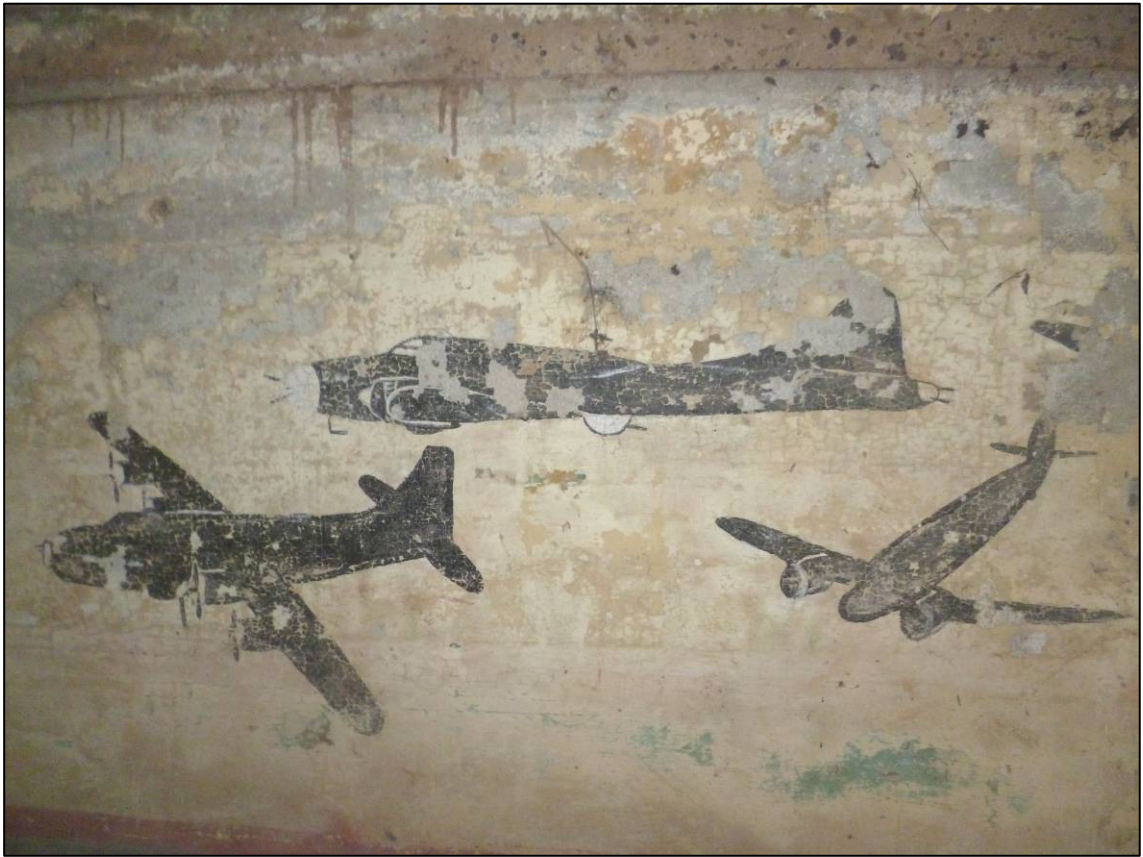
Plate 59: Structure G (gun emplacement), wall paintings to internal south wall of shelter: US Consolidated Privateer (left), B17 Flying Fortress (centre) and Bristol Beaufighter or Douglas C47 Dakota (right) (photo 2/258).

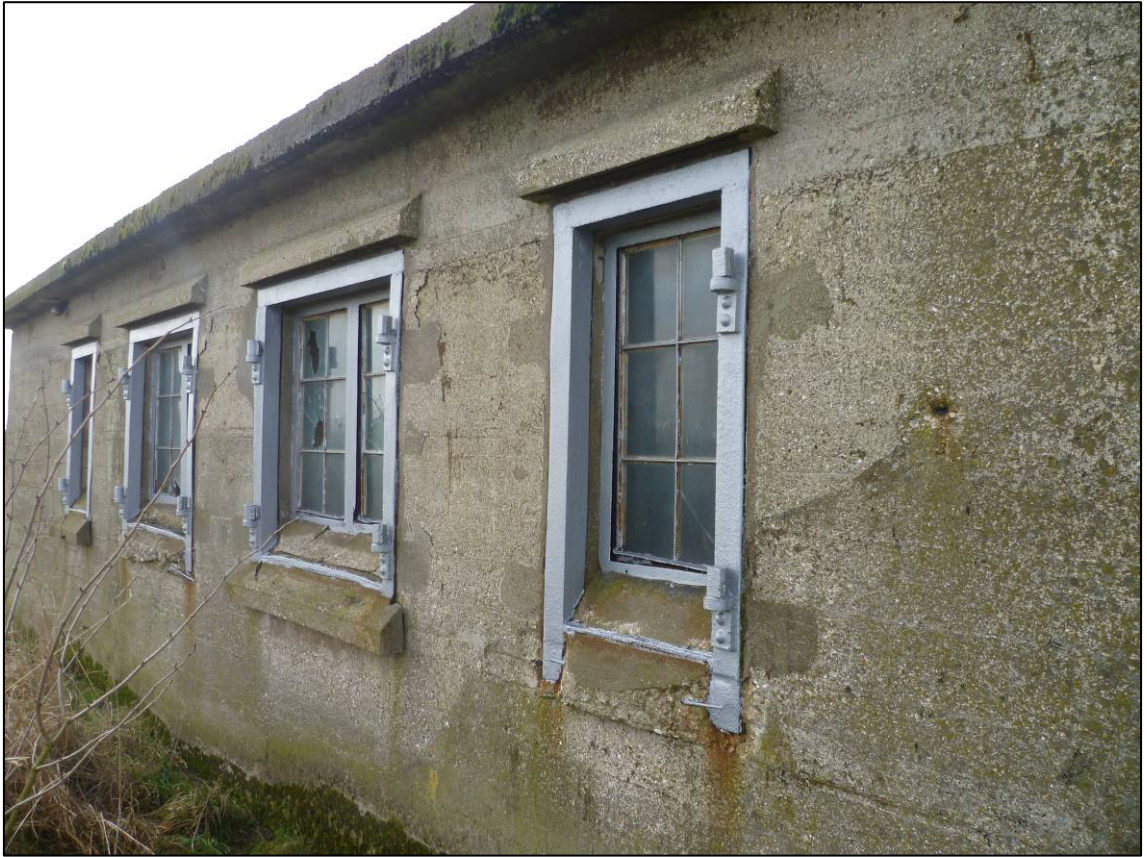
Plate 64: Structure E (gun store), east elevation windows during conservation, looking SW (photo 4/708).
