ERECTION OF AGRICULTURAL WORKER'S DWELLING  
AND ERECTION OF GENERAL PURPOSE  
AGRICULTURAL BUILDING,  
NEW GRIMWITH FARM, GREENHOW HILL,  
PATELEY BRIDGE, NORTH YORKSHIRE HG3 5JL  
(application C/02/148A)

ARCHAEOLOGICAL ASSESSMENT

Report no: 2018/578.R01  
Version: Final  
Date: October 2018  
Author: Shaun Richardson & Ed Dennison

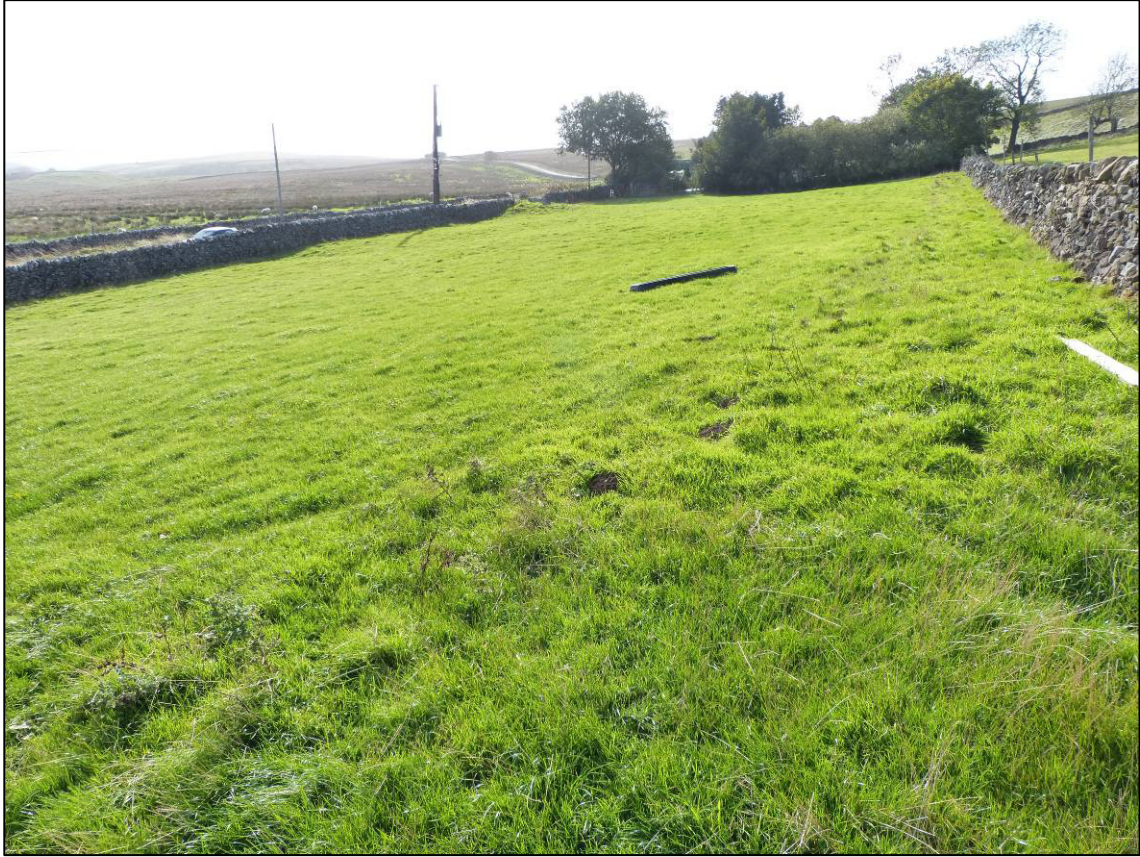
- 2.2 The pasture field is set at an elevation of c.312m AOD, with the ground surface sloping down from north to south, and also less markedly from west to east (see plate 1). The mining remains are represented by a number of denuded earthworks which are concentrated at the western end of the field. The underlying geology is represented by the Alston Formation of Carboniferous sedimentary bedrock formed some 328-337 million years ago, principally argillaceous limestones interbedded with subordinate sandstones, while mudstones and gritstones also occur slightly further to the north (<http://mapapps.bgs.ac.uk/geologyofbritain/home.html>). The predominant soil type is a Cambic stagnohumic gley soil of the Wilcocks Association, a slowly permeable but seasonally waterlogged fine loam with a peaty surface horizon, although there is an area of typical brown earth of the Malham 2 Association immediately adjacent, forming a well drained silty soil (Soil Survey 1983).

Plate 1: General view of survey area, looking SW (photo 1/391).

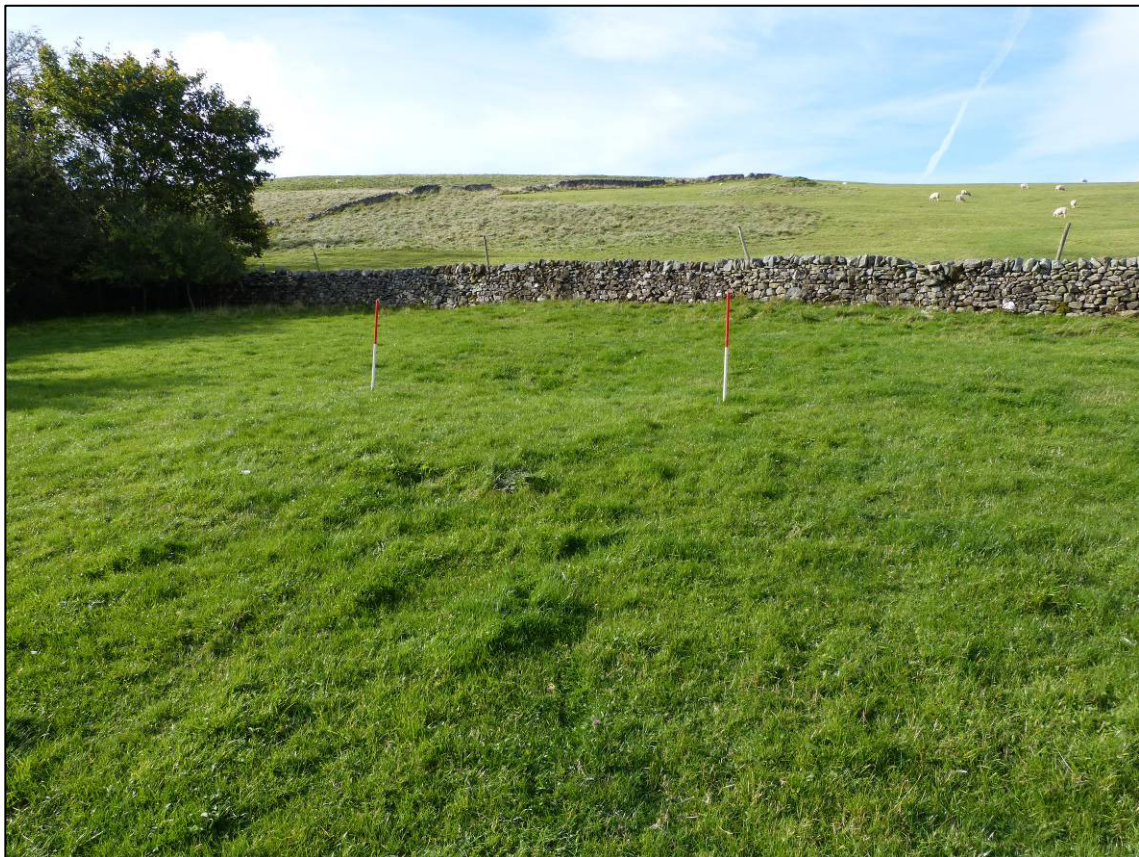
- 5.3 To the south-east of this spoil collar (B), there is the only complete shaft mound (C) within the survey area. The collapsed/backfilled shaft is formed by a sub-oval depression, measuring c.4m north-south by c.3m east-west, and up to 0.5m deep on the north side (see plate 2). The collar of spoil comprises a flat-topped bank, most prominent to the east and south of the shaft, where it stands up to 0.6m high; together, the shaft and collar have a combined average diameter of between c.10m-12m.

Plate 2: Shaft mound (earthwork C), looking NW (photo 1/396).

- 6.6 As presently proposed, the east end of the new agricultural dwelling coincides with shaft mound C, and will cause the destruction of all surface earthworks, resulting in a substantial or major adverse impact on this low value asset. Although the precise form of any foundation design is currently unknown, it seems likely that the c.10m-12m diameter and 0.6m high earthwork will need to be levelled to, and probably below, the existing ground surface to create a level building platform. Limited excavation showed that the central shaft within the shaft mound was sub-oval in plan, c.1.80m north-south by 1.30m east-west, and that it extended to at least 2.40m below ground level. Its full depth is unknown, but experience and local knowledge suggests it is unlikely to be more than 10m deep, although it must be stressed that this is professional judgement rather than fact. The shaft was also backfilled (either partially or completely) after use, and in the late 19th century it was partially re-excavated to receive domestic rubbish.

- 6.7 A structural engineer will be required to examine the shaft mound and determine whether construction of the new dwelling will be practicable and safe over it. However, given the relatively small size and potential depth of the shaft, and the

fact that it is rock cut, suggests that an engineering solution sufficient to bear the weight of the new construction could be formulated - such a solution would presumably involve backfilling and capping the shaft after a certain amount of ground-reduction, followed by an appropriately-sized concrete raft placed over the top.

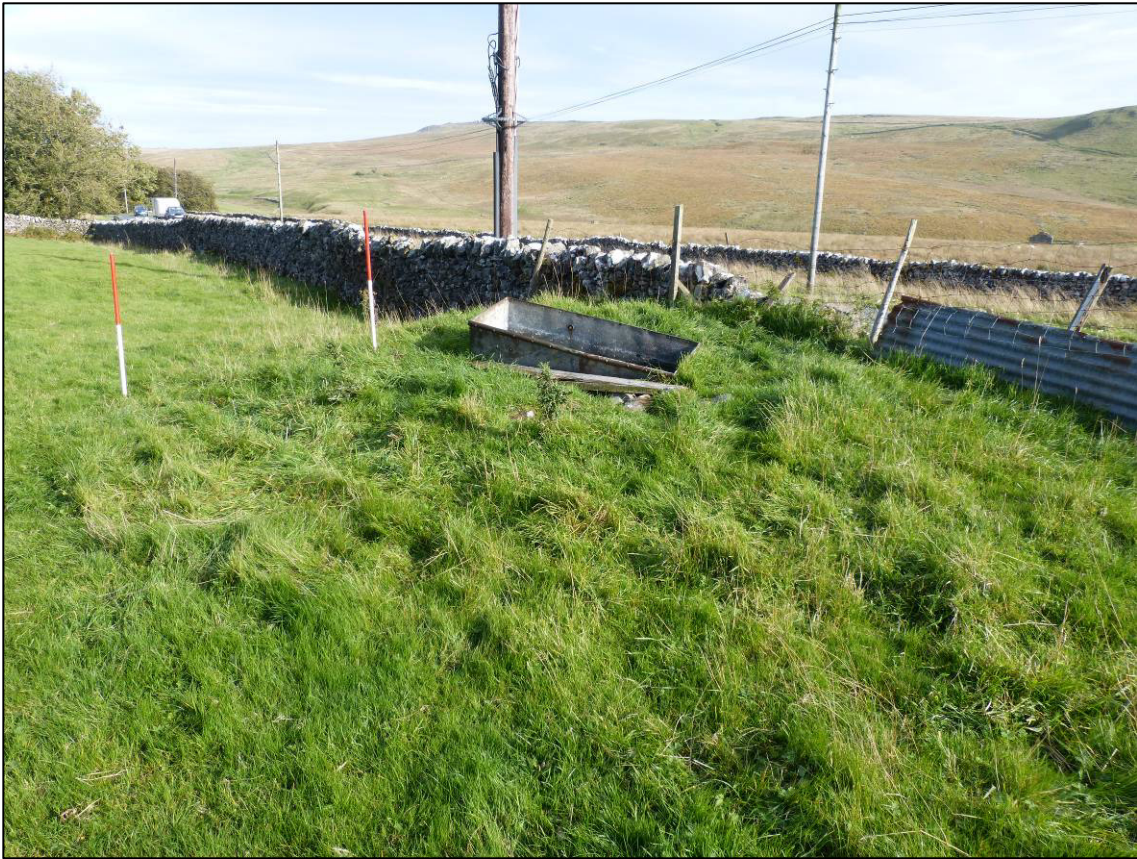
- 5.4 To the south of the shaft mound, set against the drystone wall forming the southern boundary of the survey area, is a prominent semi-circular mound (D), measuring a maximum of 10m across and standing up to 0.6m in height (see plate 3). In the approximate centre of the mound, an old metal trough and some timbers cover a stone-lined circular shaft, c.1.0m in diameter. The shaft is lined with roughly coursed and squared blocks of stone rubble, and is at least several metres deep, with water in the bottom. The shaft is placed in the same position as the 'Pump' marked on the Ordnance Survey maps of 1891 and 1909. It is thought that the shaft is a well, which formerly served Fancarl House but which fell out of use when Grimwith Reservoir (originally constructed in 1864) was massively extended after 1970, altering the local water table (Mr S Hall, *pers. comm.*). The mound in which the shaft is positioned is markedly better defined than the rest of the earthworks within the field. It is also noticeable that the adjacent drystone wall does not run over the mound, as is common practice in the area to create a stock-proof barrier when a wall line crosses an earlier shaft mound (e.g. as with shaft mound B to the north), but that the mound is apparently built up against the wall, rising to the same height (Mr S Hall, *pers. comm.*). Although there is a possibility that the mound might originally have been a shaft mound which has been re-used at a later date, the characteristics described above strongly suggest that it is not mining-related, and that it is a water source sunk in the second half of the 19th century.

Plate 3: Mound with well (earthwork D), looking SE (photo 1/393).

- 5.18 Although it is on a similar alignment to the shaft mounds described above, and the possibility that it makes use of an earlier shaft cannot be completely discounted, the prominent semi-circular mound (D) positioned against the southern boundary of the survey area is most likely to be a well sunk in the second half of the 19th century to serve Fancarl House. A pump was set on the mound adjacent to the wall in 1891 and 1909, and is named on the historic Ordnance Survey maps.

- 6.8 The construction of the new small-scale sewage plant, to the east of the mound and well (D) located against the south side of the site, will not affect this feature, and it will be retained; this sewage plant may affect other earthworks (e.g. Site E), but it was noted above that these were not of archaeological origin. The section of other shaft mound (B) within the northern part of the survey area does not appear to be affected by the proposed development, and this should be retained if at all possible.
- 6.9 As can be seen from the table below, the proposed development will affect two of the identified assets. Of these, one is considered to be of Low value and one is of Negligible value. In the case of the shaft mound, the magnitude of impact is considered to be substantial, and so a Slight negative overall significance of effect results.

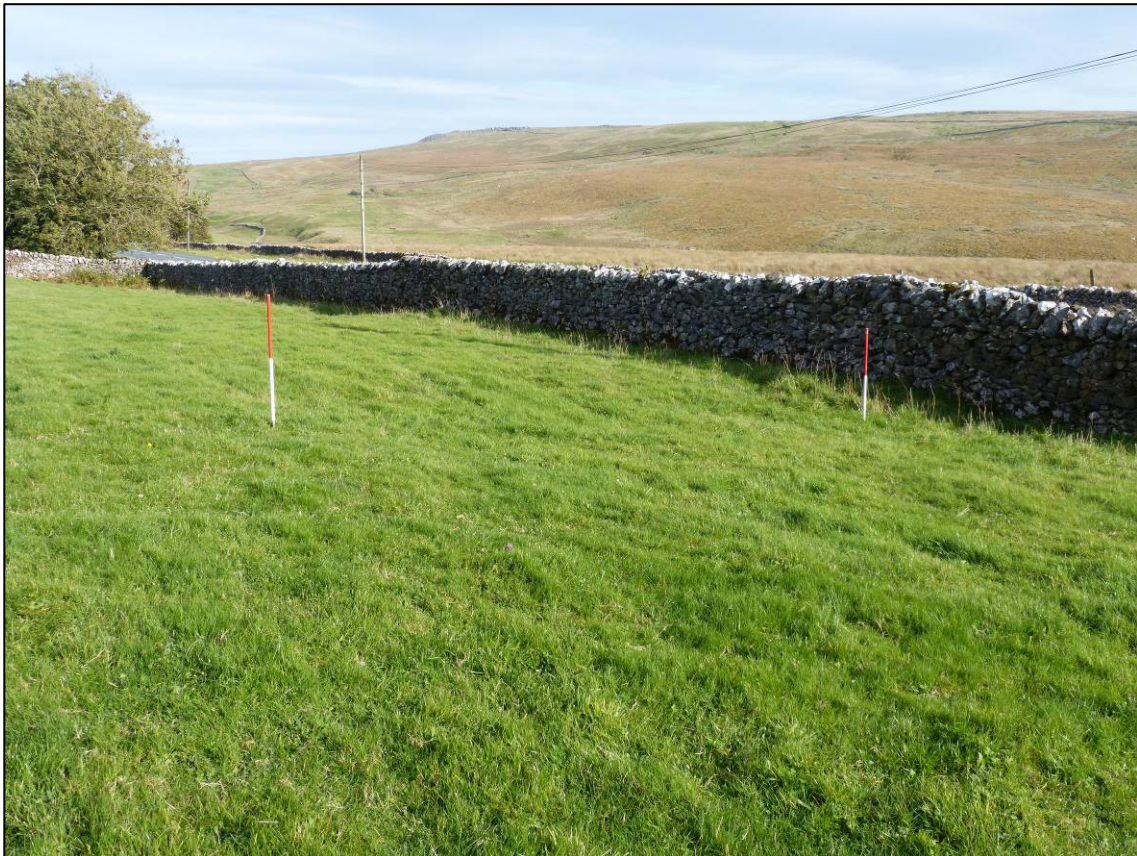
- 5.5 There are fewer earthworks in the eastern two thirds of the field. Adjacent to the drystone wall forming the field's southern boundary, there is a shallow, curvilinear depression (E), broadly aligned north-south. It is a maximum of 9.0m long, 4.0m wide and up to 0.3m deep (see plate 4). A shallow, semi-circular depression (F), set c.6m to the north, continues the line of the curvilinear depression, and may be associated with it. Approximately 15m to the east of the above curvilinear depression, there is a second such feature (G), shorter and slightly deeper than the first. To the north and east of this, the remainder of the field is empty, except for a few very faint south-facing scarps.

Plate 4: Shallow depression (earthwork E), looking E (photo 1/399).

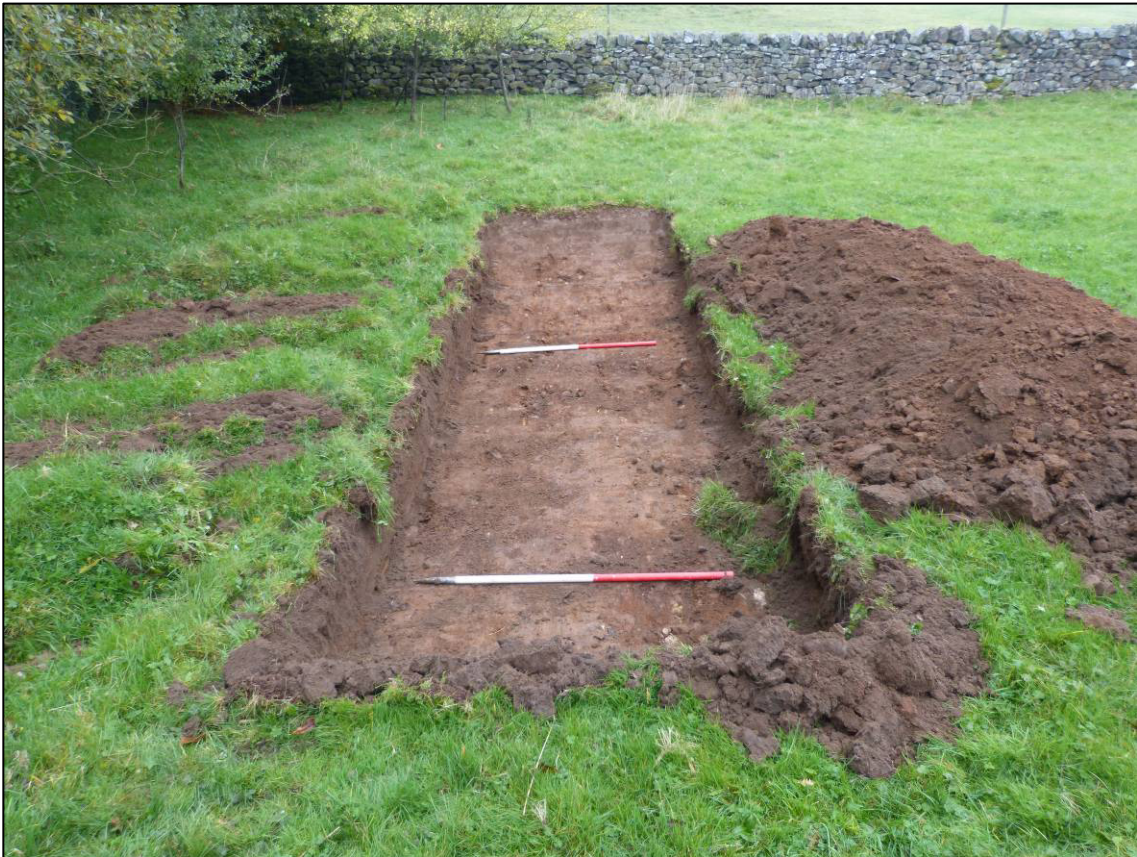
- 5.7 The first trench was aligned north-west/south east across the main curvilinear earthwork within the group of scarps (A) at the western end of the field. The trench

measured 6.0m long by 1.80m wide, and was excavated to a maximum depth of 0.30m below ground level (BGL).

- 5.8 The uppermost deposit was the friable mid-brown sandy silt topsoil and turf (001) which extended on average to between 0.20m-0.30m BGL. The topsoil overlay a light brown/orange sandy clay sub-soil (007), which contained occasional inclusions of angular stone rubble up to 0.30m across (see plate 5). The subsoil (007) extended below the base of the trench. No archaeological features or deposits were exposed.

Plate 5: Trench 1 excavated across curvilinear earthwork (A), looking N (photo 2/471).

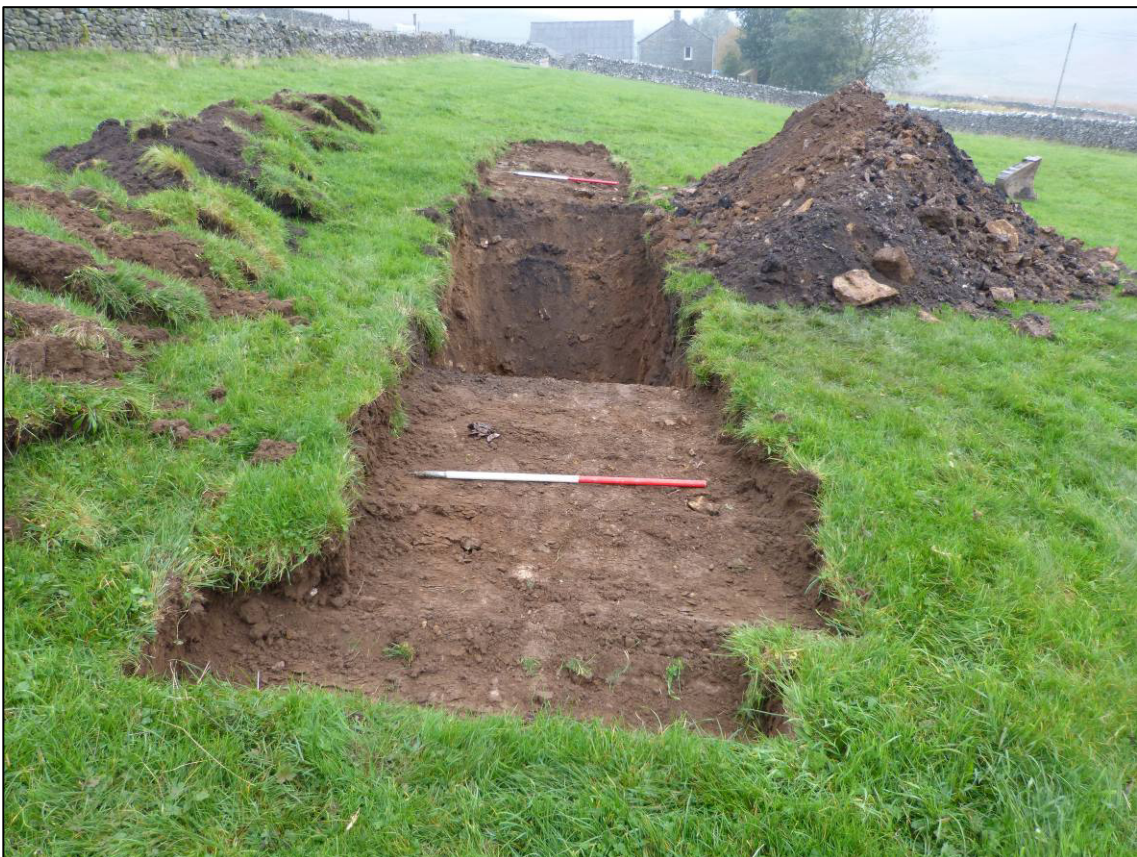
- 5.9 The second trench was aligned north-east/south-west across the shaft mound (C). The trench measured 10.10m long by 1.80m wide, and was excavated to a maximum depth of 2.30m BGL (c.309.60m AOD) (see plate 6).

Plate 6: Trench 2 excavated across shaft mound (C), looking E (photo 2/461).

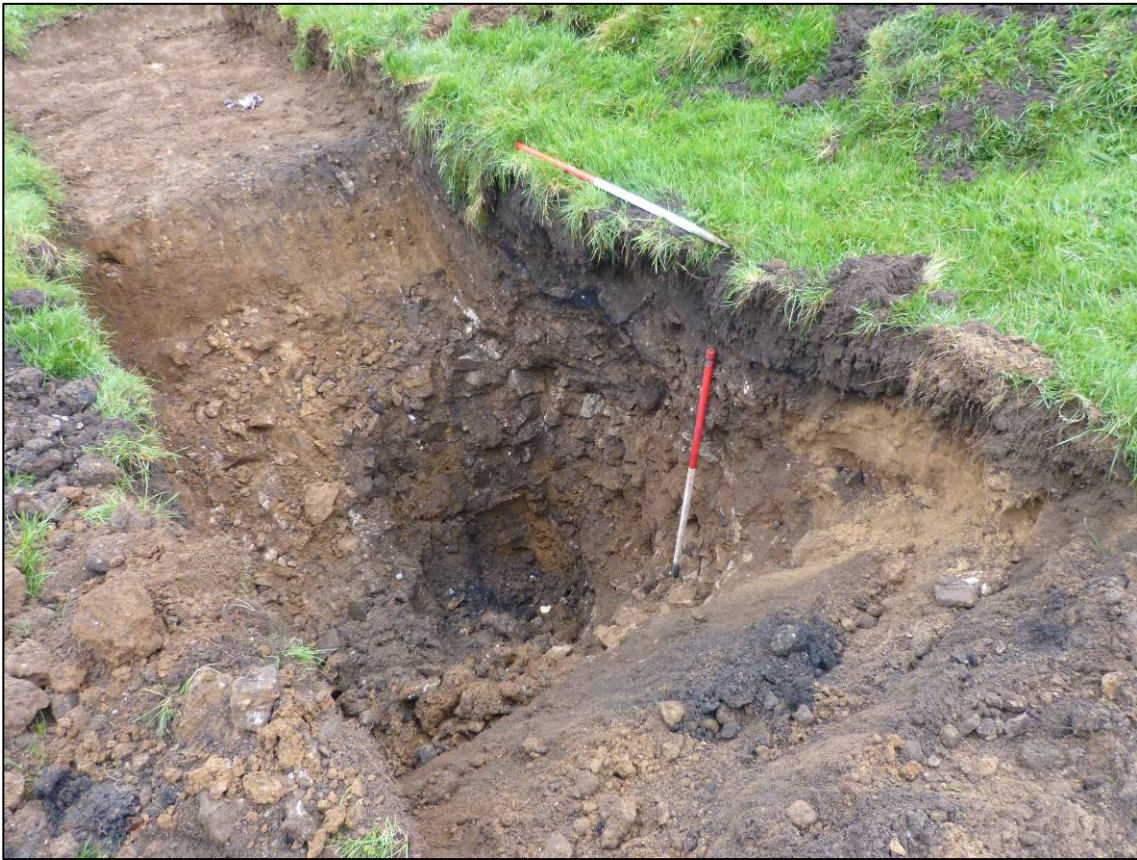
- 5.11 Within the trench, the upcast from the shaft (009) had largely been thrown to the east, and it resembled the sub-soil (007), but had a higher frequency of angular stone rubble. The cut for the shaft [010] was not clearly defined due to subsequent collapse, backfilling and possible re-cutting at a later date. At its lowest level, the shaft appeared to be defined by the edges of the fractured bedrock (008) through which it cut. It had a sub-oval plan, measuring c.1.80m north-south by 1.30m east-west (see plates 8 and 9). This is close to the dimensions recorded for stone-lined mine shafts elsewhere in the Dales (for example, at the Tan Hill colliery, North Yorkshire (Richardson & Dennison, forthcoming), although there is no evidence that the shaft at New Grimwith Farm was ever stone-lined. The lowest visible level of the shaft appeared to terminate just short of the south side of the trench, but to continue beyond the north side of the trench. The sides of the cut [010] appeared to be reasonably vertical where they passed through the bedrock (008), but above this level (at c.1.20m BGL) the east side of the cut rose upwards at an angle of 45 degrees for a short distance before becoming much steeper and rising to meet the topsoil (001). The west side of the cut [010] was not clearly visible at an upper level in the south-facing section of the trench, probably because at a later date, a second cut [006] had been made (see below). The lowest fill (005) of the original cut for the shaft was a mixture of light brown/orange sandy clay and angular stone rubble; it was compacted, but not solid, and appeared to be looser in the north-east quadrant of the shaft. It seems likely that this represents a mixture of collapse and deliberate backfilling after the shaft was abandoned.

Plate 7: Trench 2, exposed shaft (C), looking NW (photo 2/466).

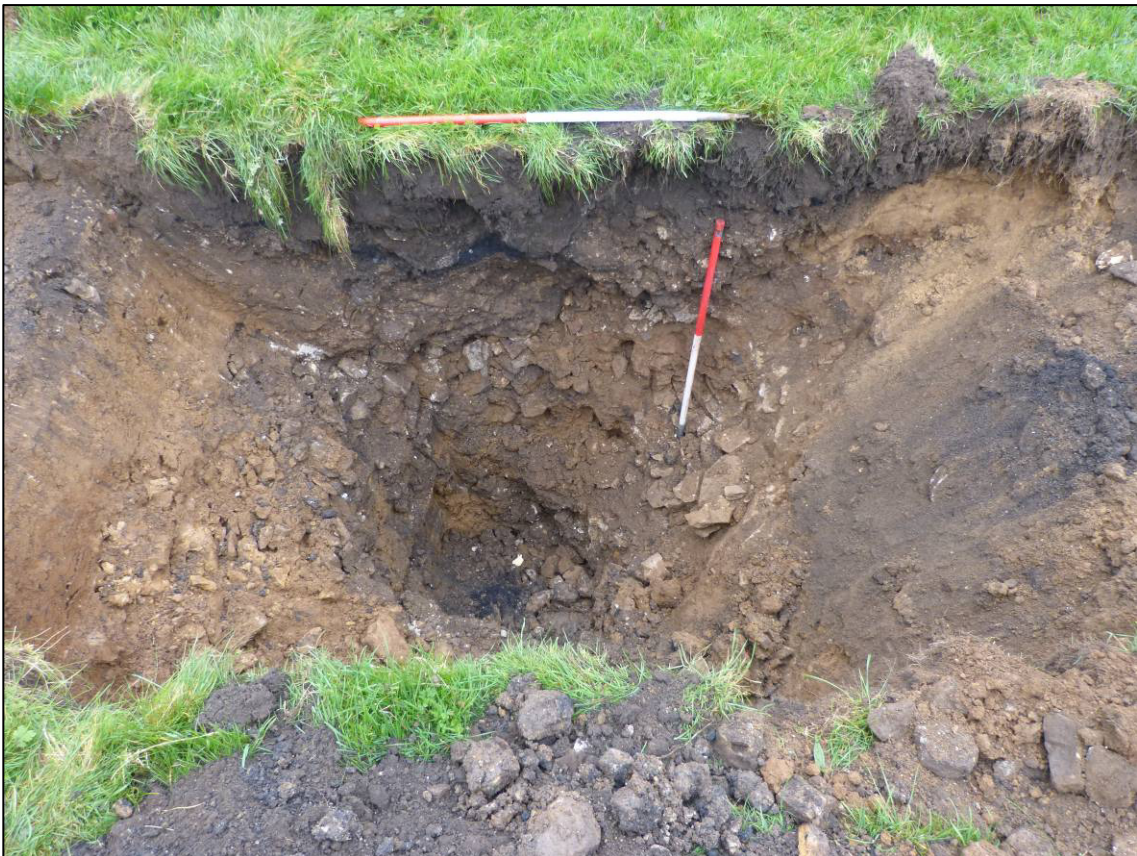
Plate 8: Trench 2, exposed shaft (C), looking N (photo 2/466).

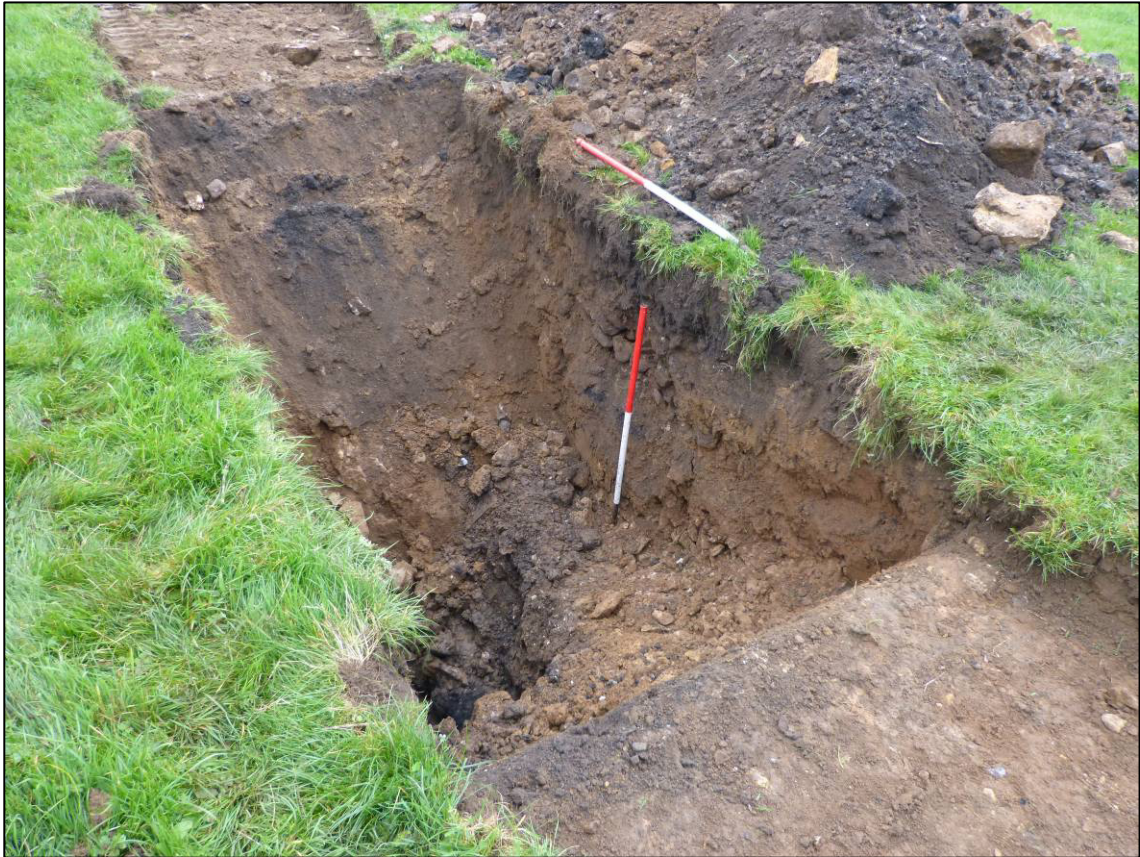
- 5.12 At a later date, almost certainly in the later 19th century, a second cut [006] was made into the upper part of the collapsed/backfilled shaft. This cut was sub-circular in plan, measuring a maximum of c.2.40m across and extending to a maximum depth of 1.10m BGL. In the trench's south-facing section, the west side

Plate 9: Trench 2, exposed shaft (C), looking SE (photo 2/470).

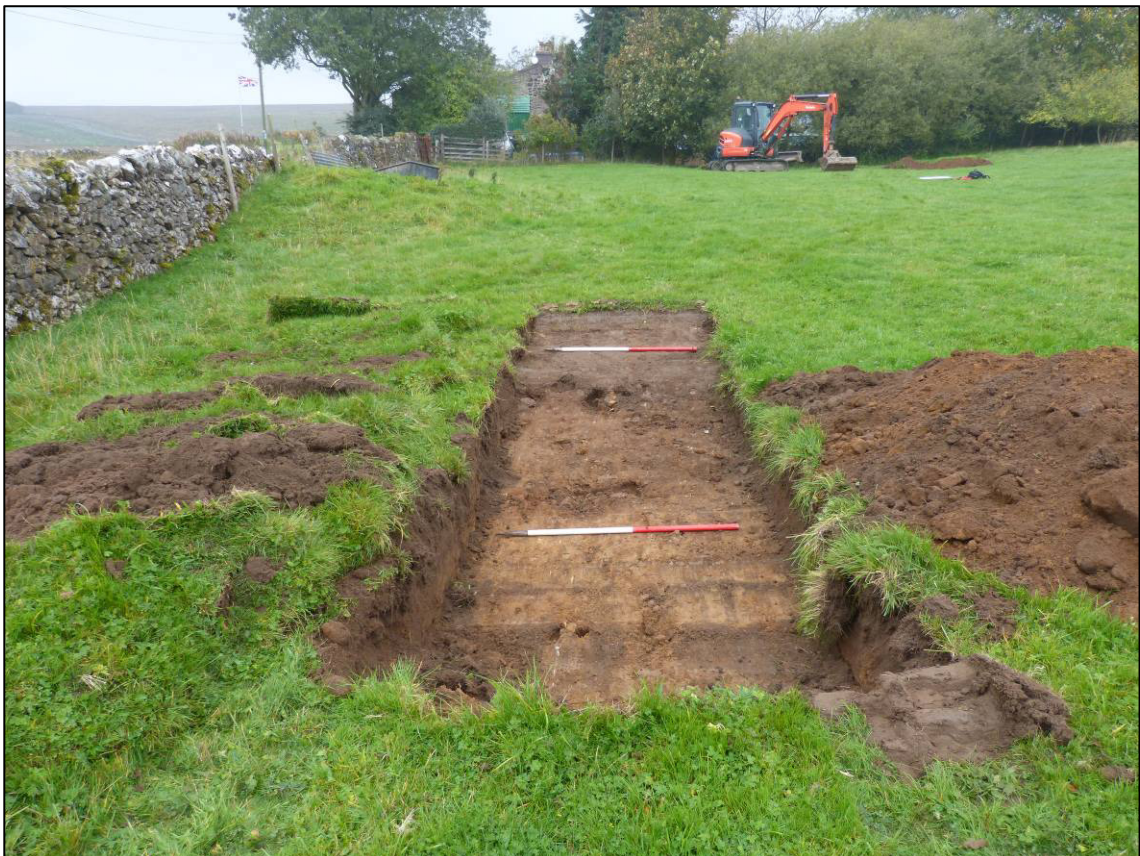
- 5.13 The third trench was aligned east-west across the shallow curvilinear depression (E) on the southern side of the field. The trench measured 4.00m long by 1.80m wide, and was excavated to a maximum depth of 0.30m below ground level (BGL).
- 5.14 As in the other two trenches, the uppermost deposit was the friable mid-brown sandy silt topsoil and turf (001) which extended on average to between 0.20m to 0.30m BGL. This topsoil overlay a light brown/orange sandy clay sub-soil (007), with occasional inclusions of angular stone rubble up to 0.30m across. The subsoil (007) extended below the base of the trench (see plate 10). No archaeological features or deposits were exposed.

Plate 10: Trench 3 excavated across shallow depression (earthwork E), looking W (photo 2/474).
