**PROPOSED CHANGE OF USE AND CONVERSION
OF OUTBUILDINGS, PARK FARM, MAIN STREET,
CATWICK, EAST YORKSHIRE HU17 5PJ**

HERITAGE STATEMENT

Report no: 2018/564.R01
Version: Final
Date: May 2018
Author: Ed Dennison & Shaun Richardson

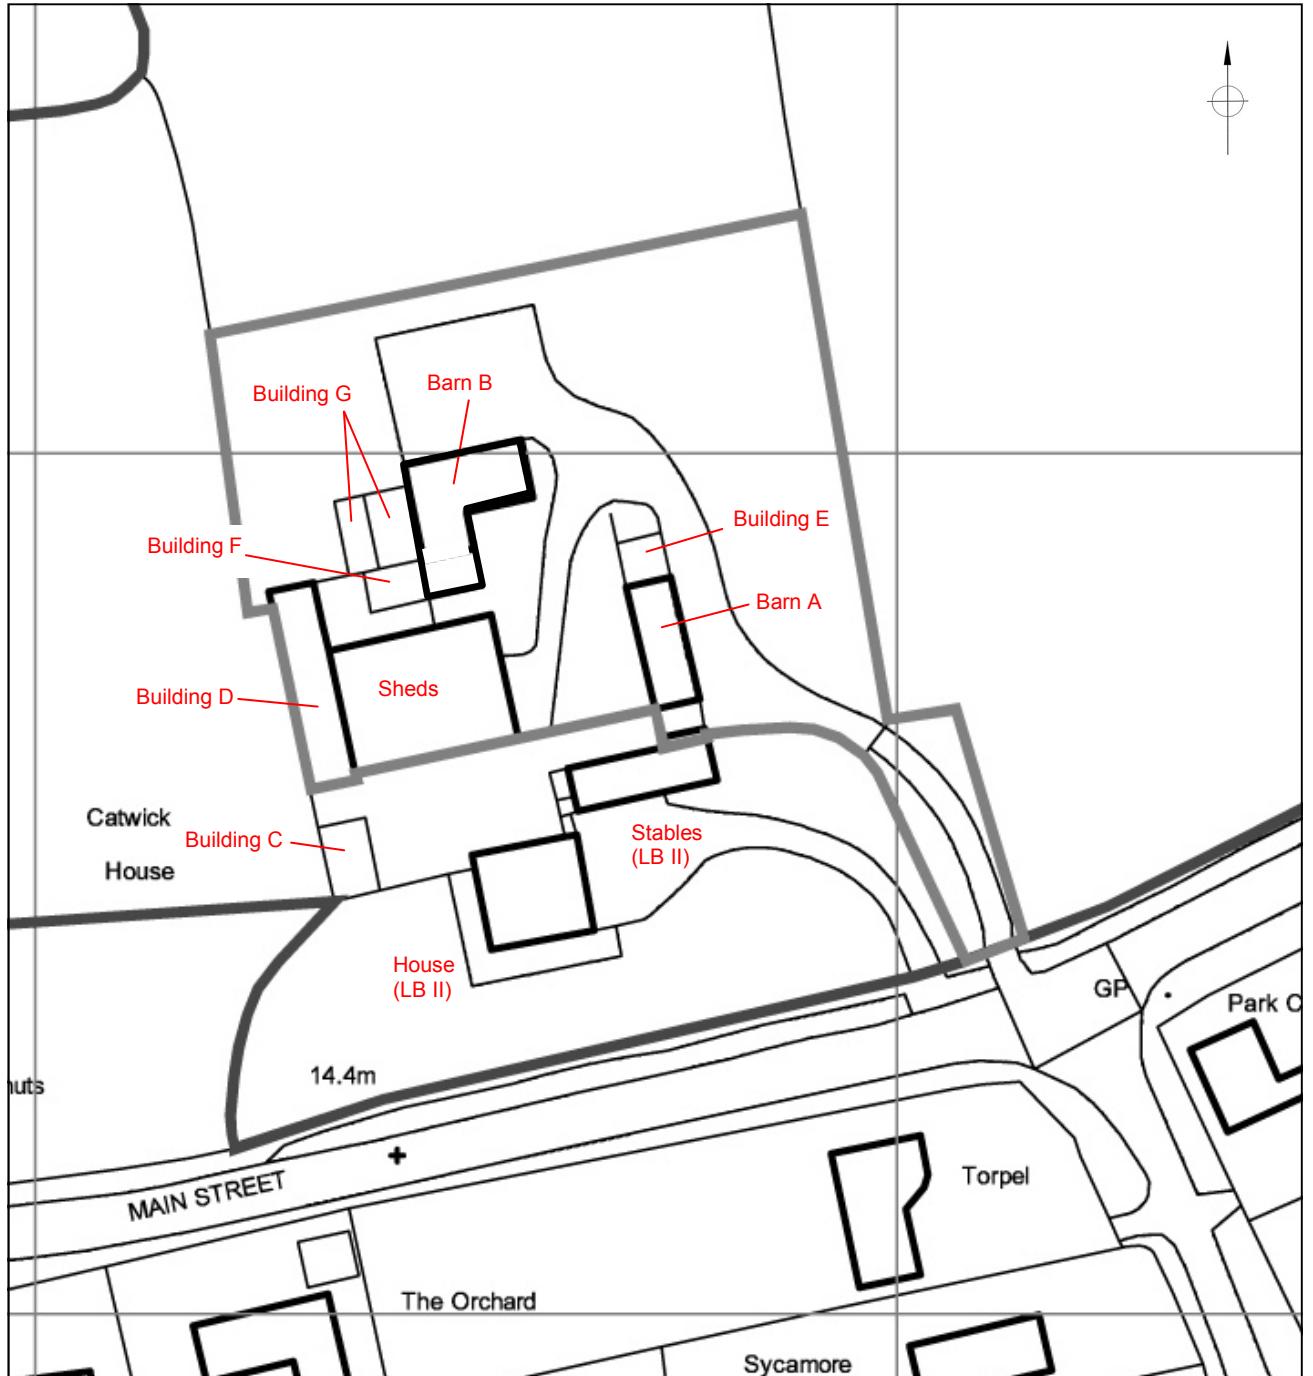
PROJECT	
PARK FARM, CATWICK	
TITLE	
SCALE	DATE
NTS	MAY 2018
EDAS	FIGURE 9

Plan provided by Paul Taylor Architectural Services, reproduced with permission.

- 6.24 The positions of the farm buildings described in this section of the report are shown on figure 9. All of the buildings are set either on shallow north-west/south-east or north-east/south-west alignments but, for the purposes of description, they are considered to be aligned either north-south or east-west. Unless otherwise noted, the terms used to describe the roof structures are taken from Alcock *et al* (1996) and Campbell (2000), and fixtures and fittings from Alcock and Hall (1999). Where possible, specific architectural terms used in the text are as defined by Curl (1977). Finally, in the following text, 'modern' is used to denote features or phasing dating to after c.1945.

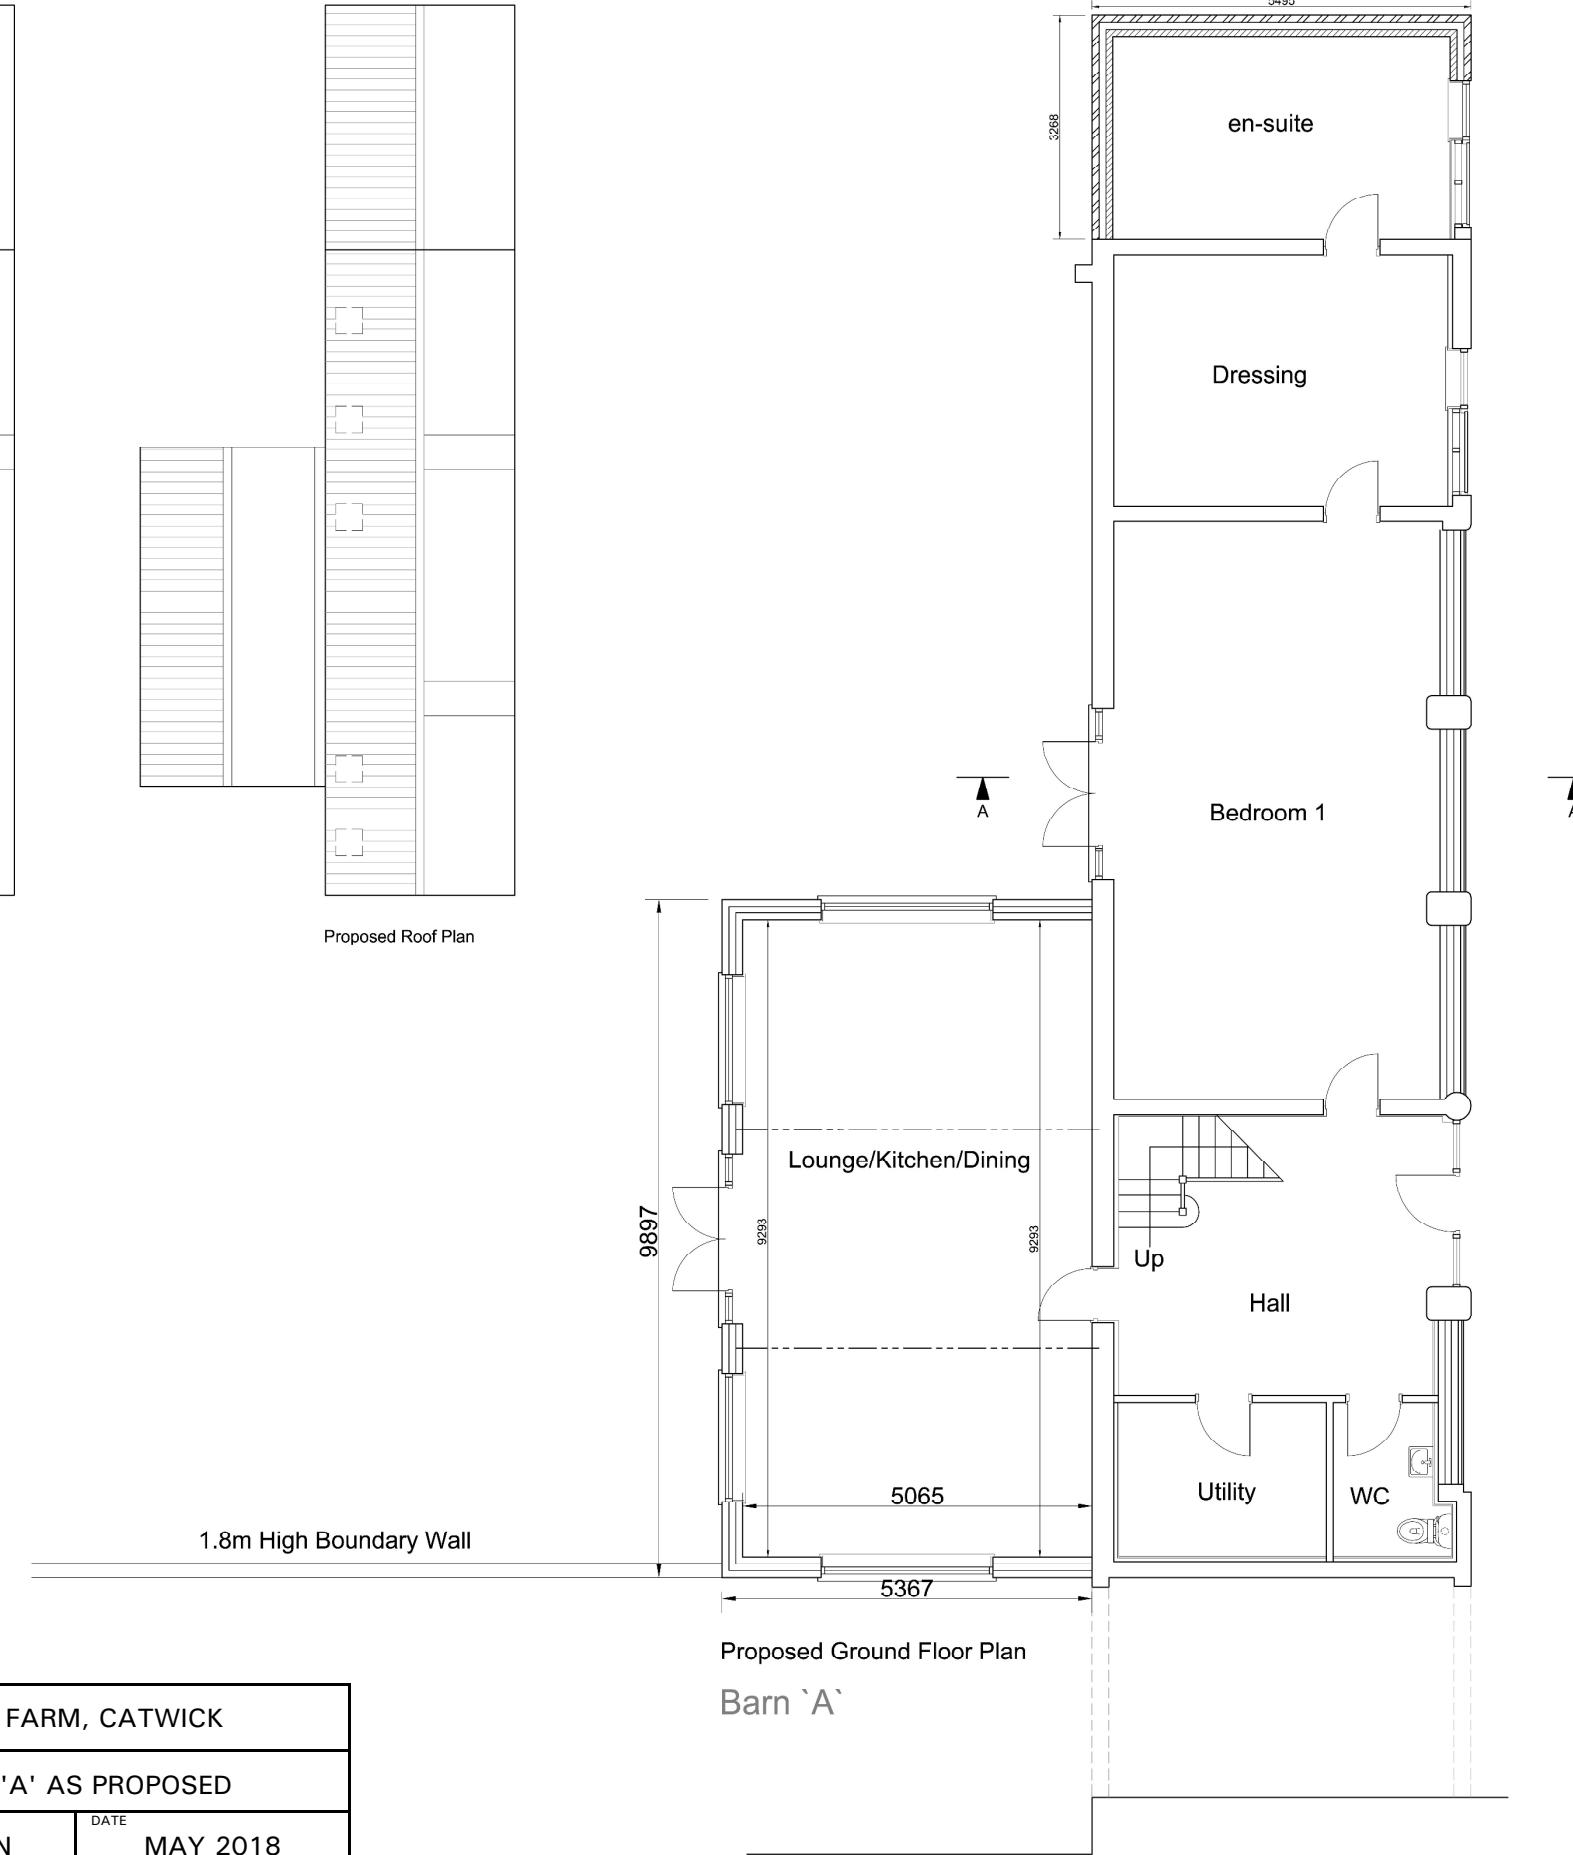
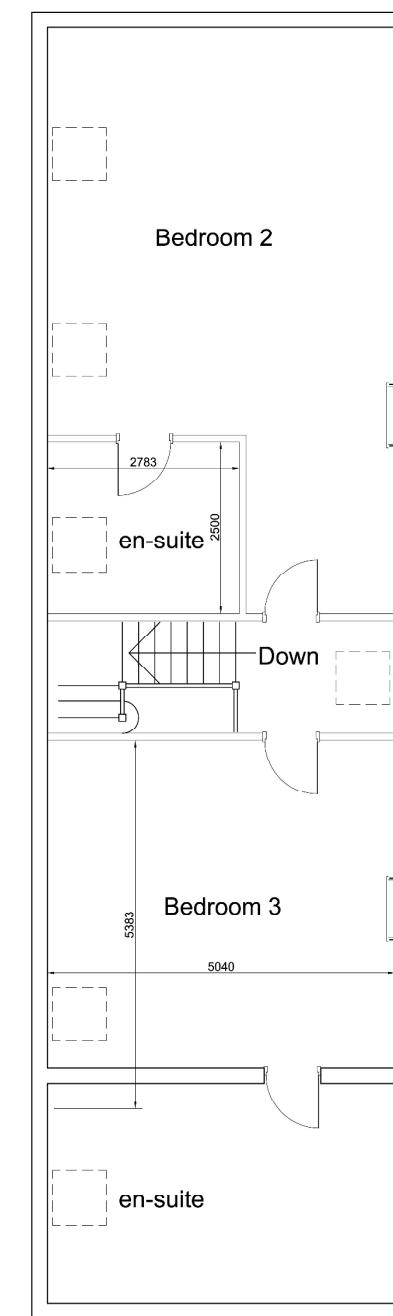
PROJECT	PARK FARM, CATWICK	
TITLE	BARN 'A' AS PROPOSED	
SCALE	AS SHOWN	DATE MAY 2018
EDAS	FIGURE 11

Proposed First Floor Plan

Barn 'A'

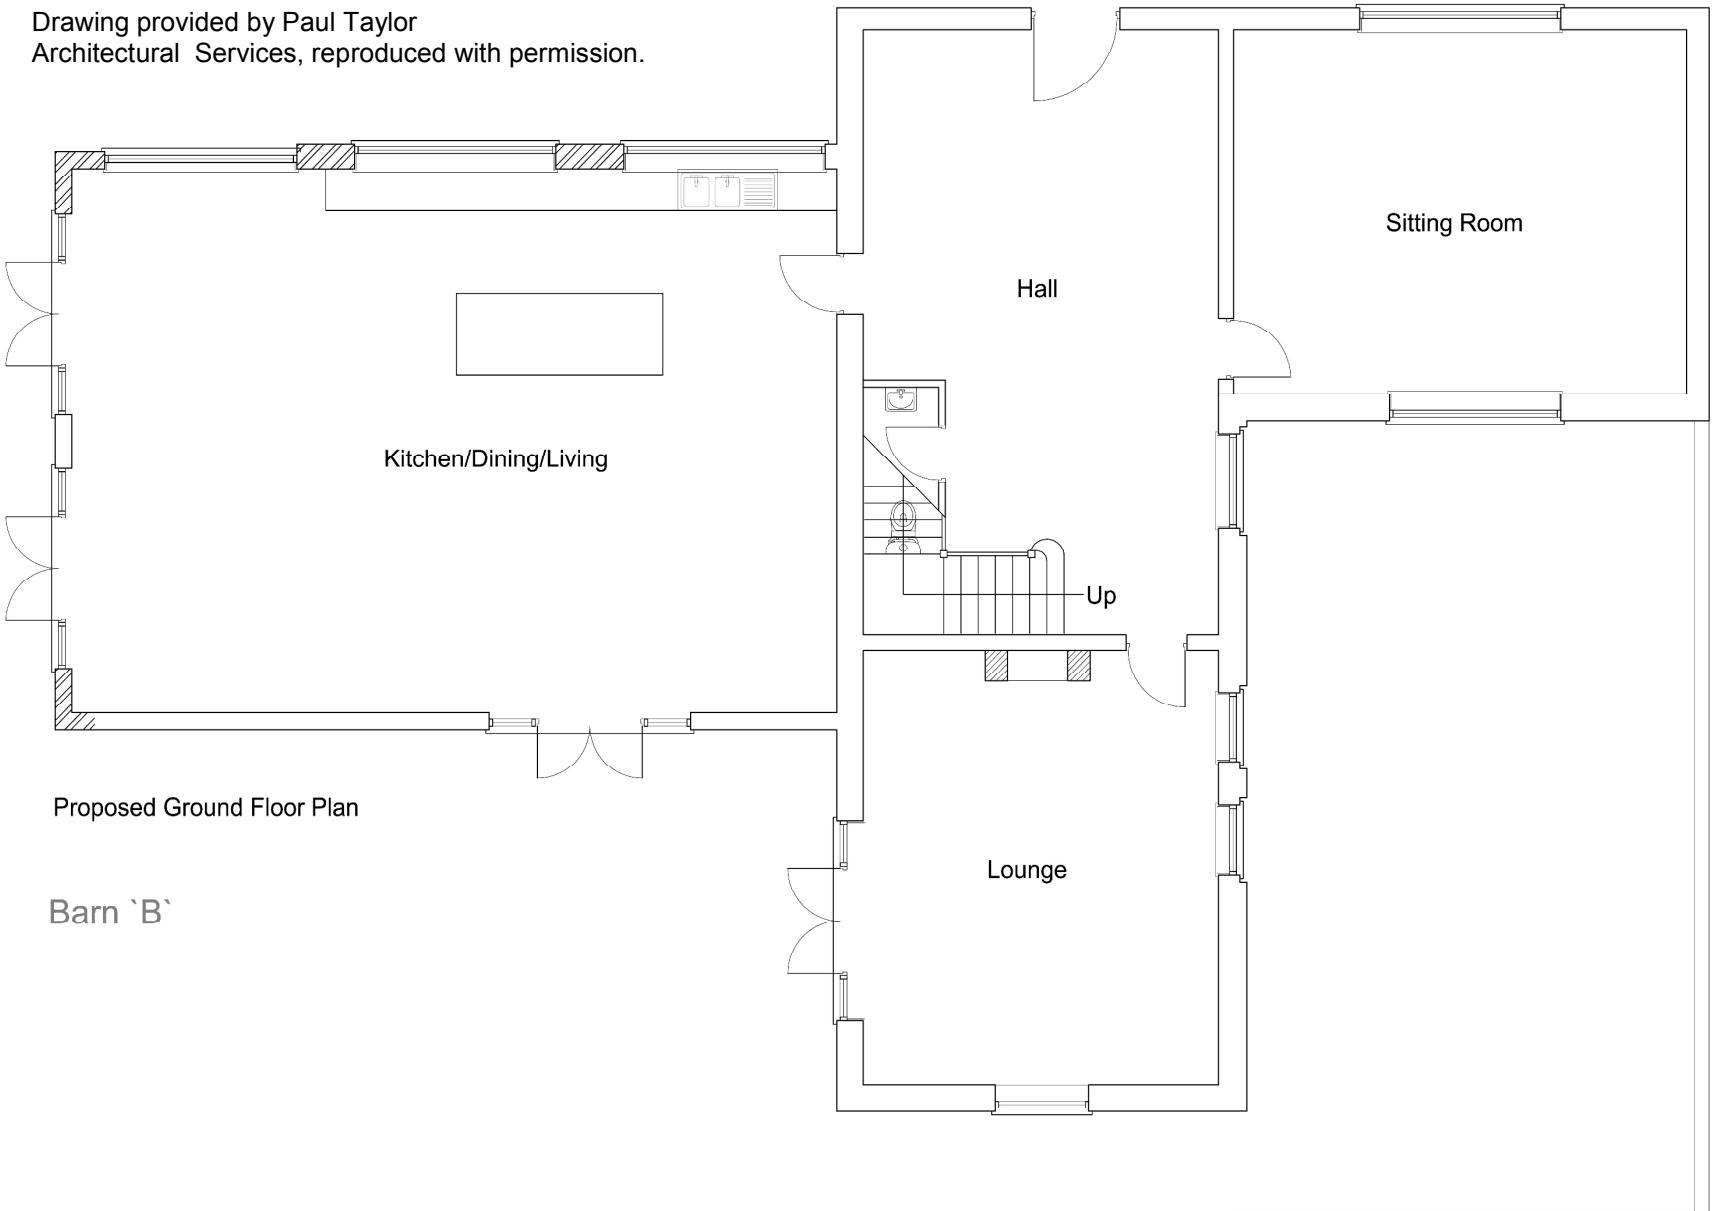
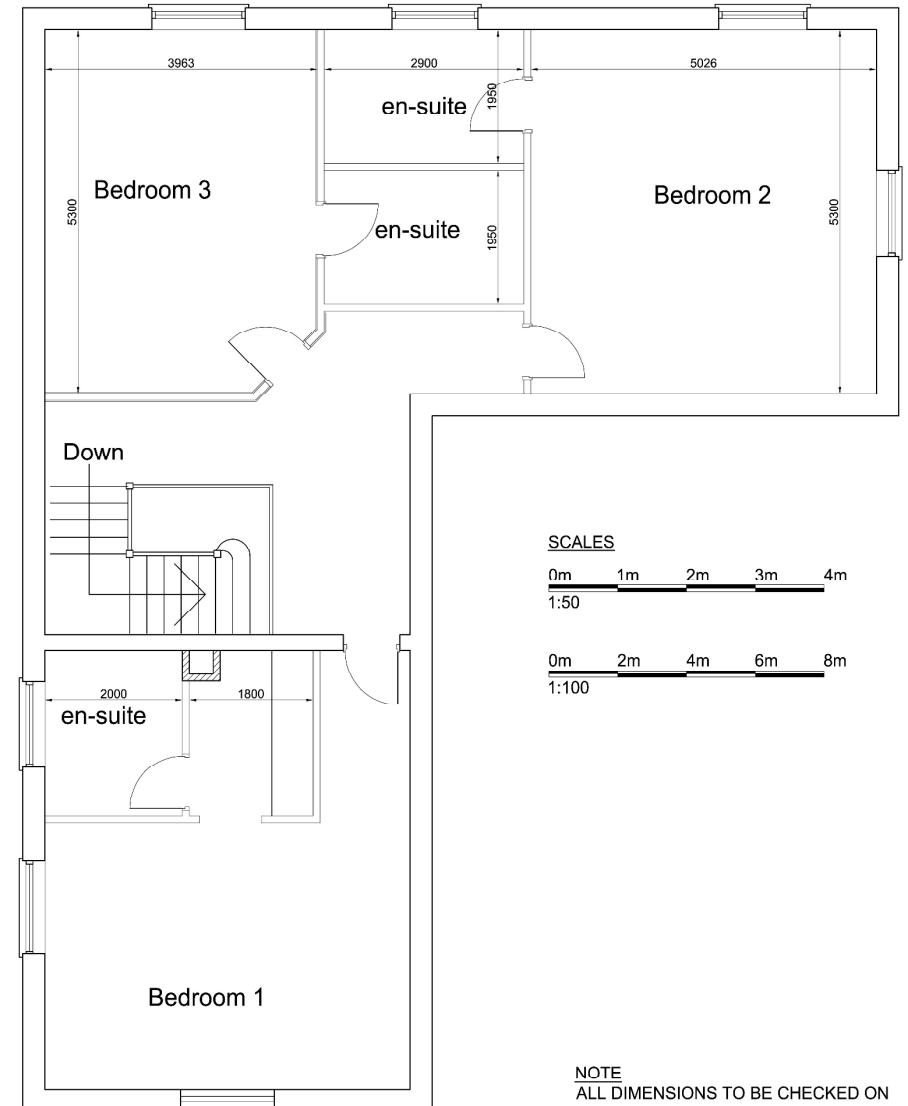
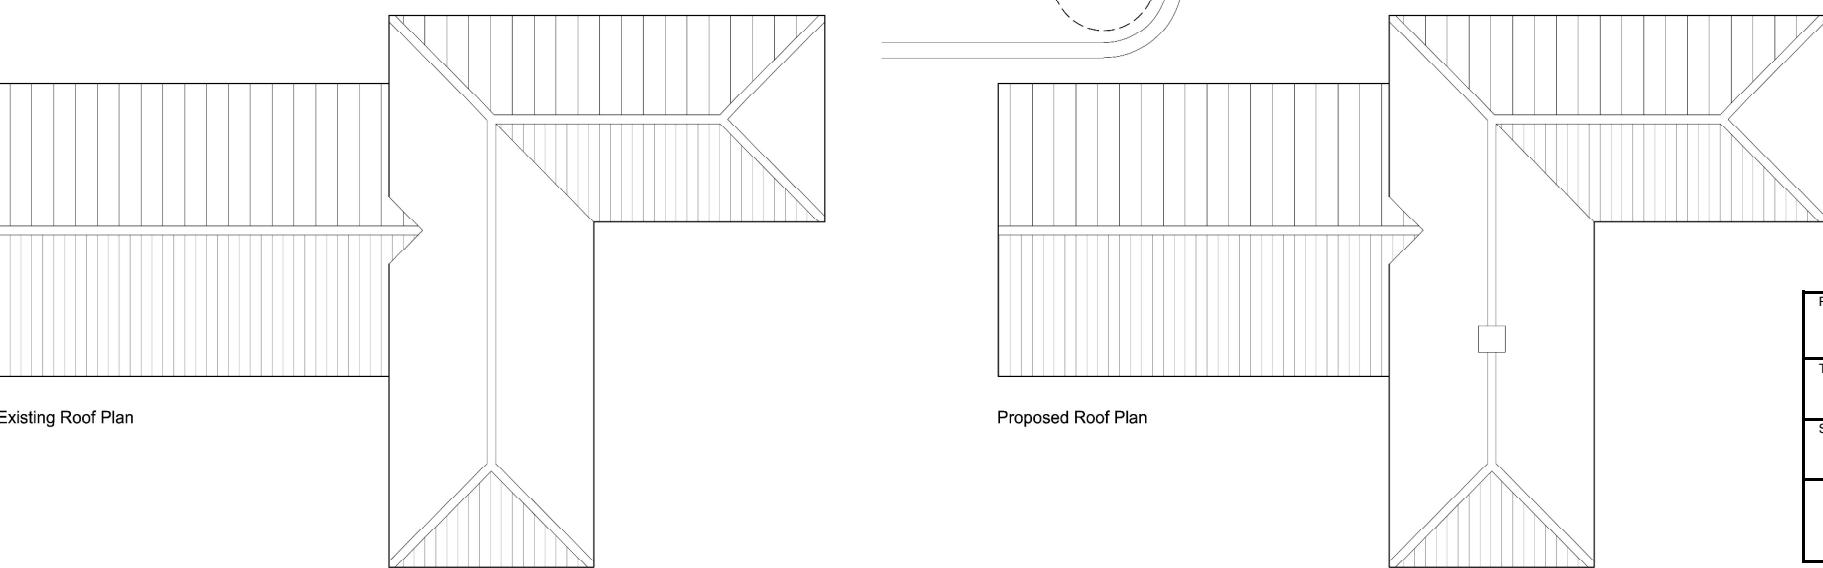
PROJECT	PARK FARM, CATWICK	
TITLE	BARN 'B' AS PROPOSED	
SCALE	AS SHOWN	DATE MAY 2018
EDAS	FIGURE	12

Title: Proposed Floor Plans Barn B
Park Farm
Main Street
Catwick
BEVERLEY
HU17 5PJ

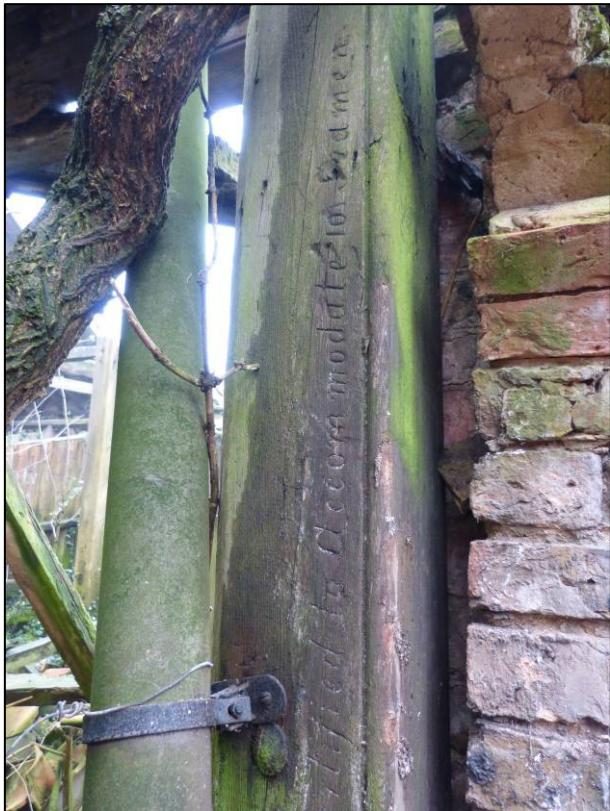
Plate 7: West range (Building D), re-used timber to collapsed doorway in east elevation, looking NW (photo 1/722).

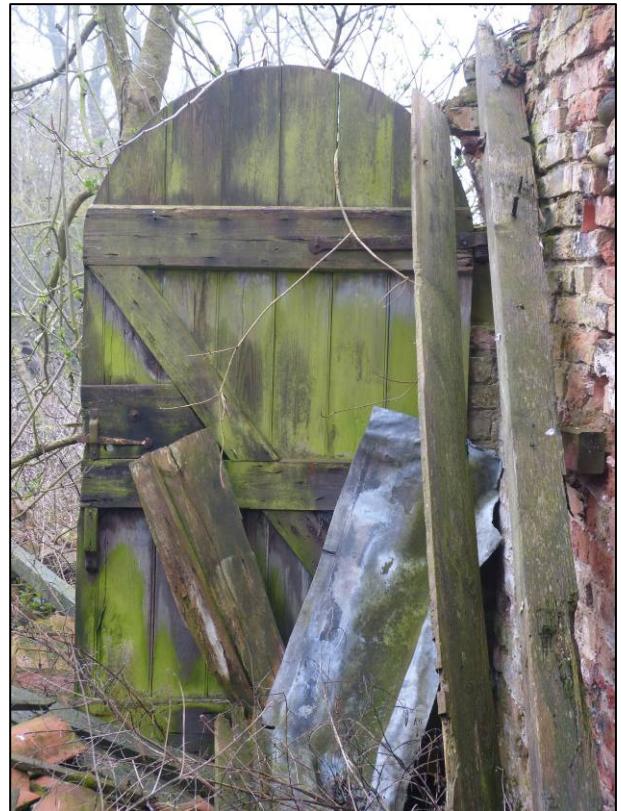
Plate 8: West range (Building D), round-headed door at collapsed north end, looking N (photo 1/723).

- 6.36 The cells to the north, entered through the doorways in the east elevation, have hay racks and wooden mangers to their internal west walls; these are almost certainly the '2 Loose-Boxes' noted in the 1934 sale catalogue (HCC C DBHT/9/1037). In both cells, there is evidence in the north and south internal walls that the roof of the building has been raised at some point by approximately 0.5m, probably at the same time as the upper part of the south gable was rebuilt. The surviving roof trusses are all of nailed softwood, comprising a plank tie-beam, and a raised plank collar running between a pair of common rafters. The northern half of the west range was apparently formed by a single space, and has the remains of six horse stalls set along the west side. This is the '8-Stall Stable' noted in the 1934 sale catalogue (HCC C DBHT/9/1037), the missing two stalls presumably being located in the range's collapsed north end. Each stall had a hay rack and wooden manger, and they are separated by well-built timber partitions with heel posts [1/724]. A partially collapsed doorway in the east wall of this part of the range retains a re-used ship's timber as part of its frame. The timber, which is c.0.2m square, has a roll-moulding to the original soffit, and bears the italicised inscription "Certified to accommodate 10 Seamen" [1/722] (see plate 7). Under the terms of the 1867 Merchant Shipping Act, such a beam was required over the doorway or hatchway leading to an area of seaman's accommodation, so that this space could be deducted from the Registered Tonnage of the ship (https://en.wikisource.org/wiki/Merchant_Shipping_Act_1867). The remains of a round-headed doorway at the collapsed north end of the range retain the only surviving original round-headed door noted within the complex [1/723] (see plate 8).

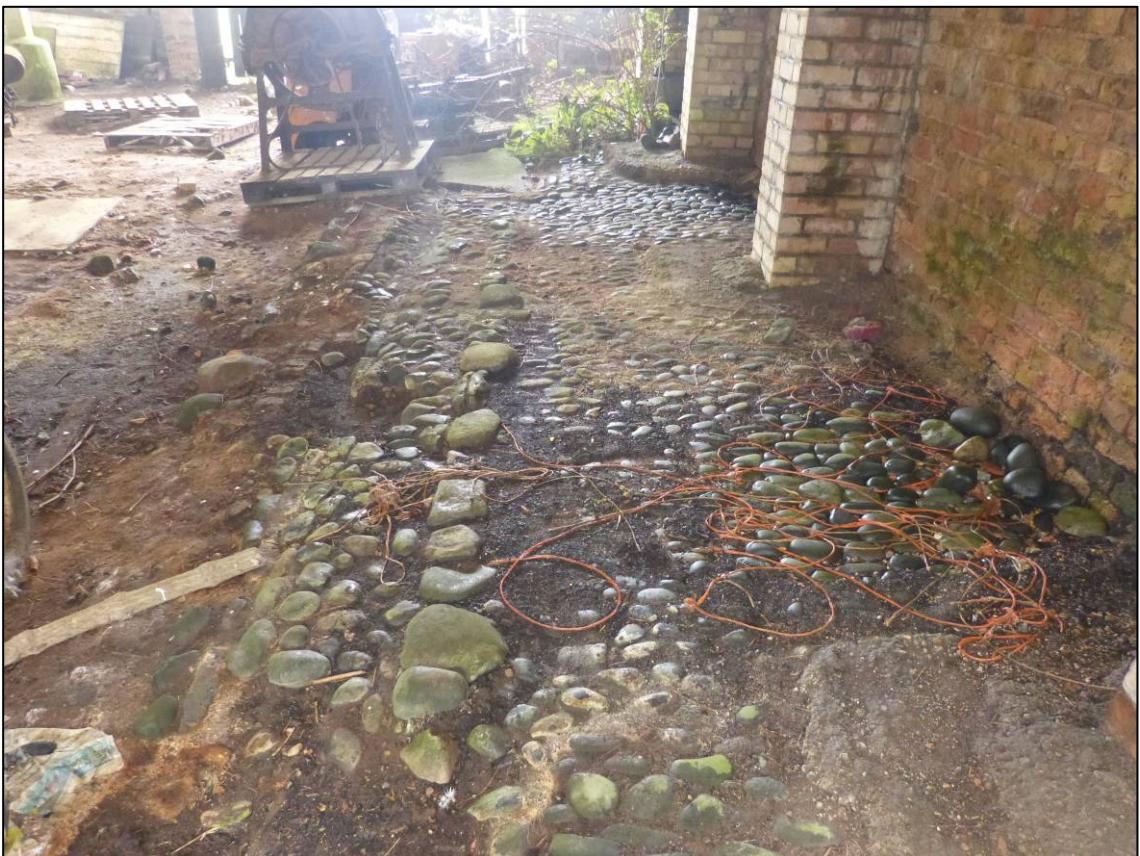
Plate 9: Covered fold yard, cobbling adjacent to Building D, looking S (photo 1/770).

- 6.38 The narrow strip shown adjacent to the west range in 1855 survives as an area of cobbling, with a drain running along the east side [1/770] (see plate 9), and it is probable that other strips marked in 1855 represented similar cobbling. This was laid down adjacent to areas where animals, predominantly horse and cattle, needed a drier firmer surface to walk along, set slightly above the level of the rest of the fold yard. For example, the surviving strip of cobbling is next to the loose boxes and former 8-stall stable in the west range. The arrangement shown on the 1855 6" map suggests that working horses were brought in through a gateway at the south-west corner of the farmyard, along the south end of the west range and then up along the range's west side to reach the loose boxes and stables; it was common practice to place stables for working horses where there was convenient access to and from the fields (Barnwell & Giles 1997, 86).

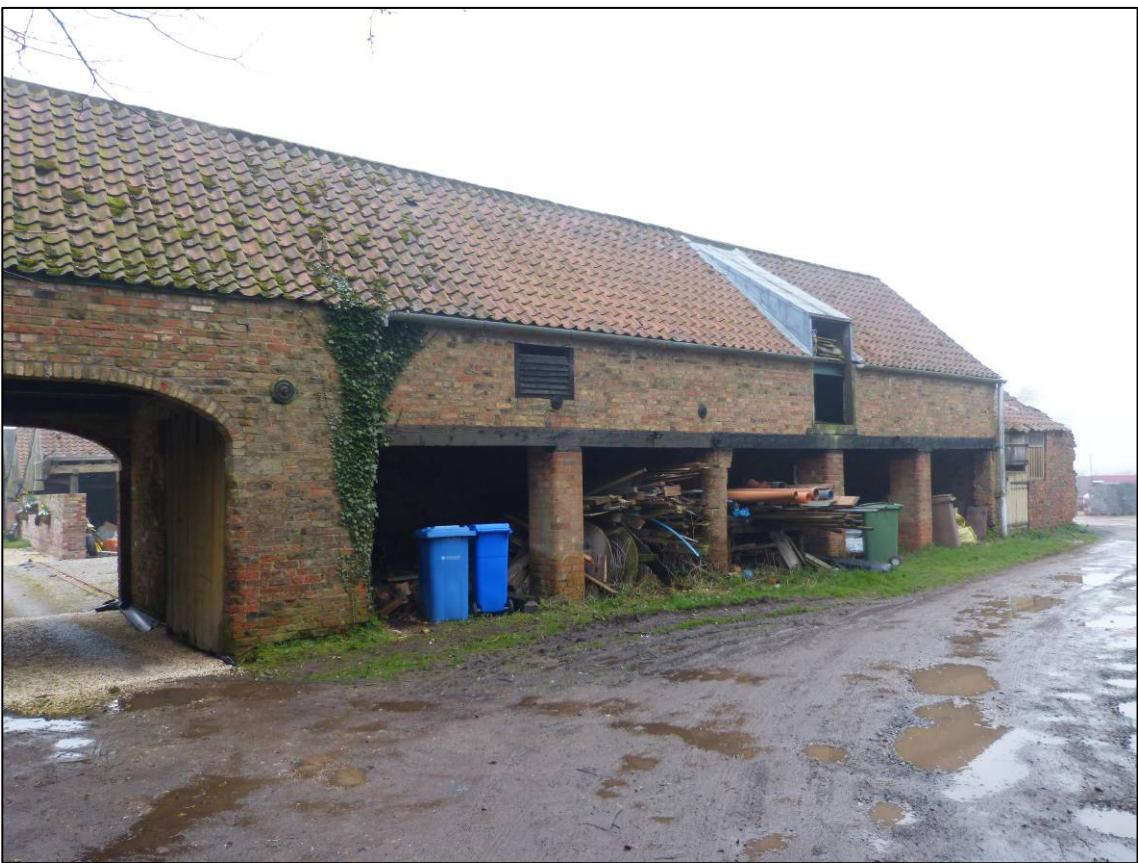
Plate 12: East range (Barn A), east elevation, looking NW (photo 1/744).

- 6.41 Barn A is most probably the '5 Bay Cartshed' noted in the 1934 sale catalogue (HCC C DBHT/9/1037), forming the main surviving part of the east range. It is bounded to the east by the approach from Main Street, to the west by the now open yard, to the south by the listed stable block and to the north by a small single cell structure formerly joined to the remains of the east end of the north range. At the time of the site inspection, the majority of the ground floor was used to store wood, and the upper internal area was inaccessible, although it is believed to have been repaired relatively recently and to contain few surviving features of historic interest.

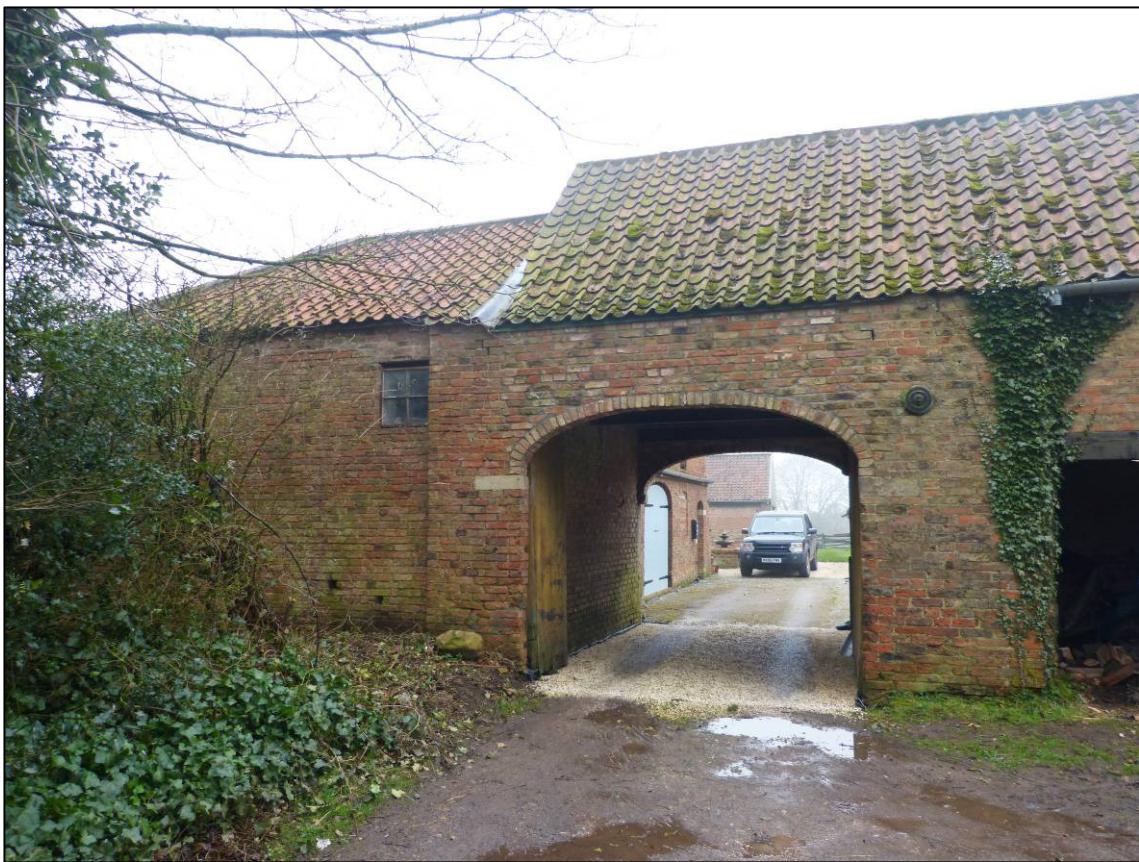
Plate 15: East range (Barn A), cart passage at south end, looking W (photo 1/743).

- 6.46 The interior of the cart passage, in particular the roof over, has been substantially repaired following recent partial collapse (Mr J Hugill, *pers. comm.*) [1/741]. The

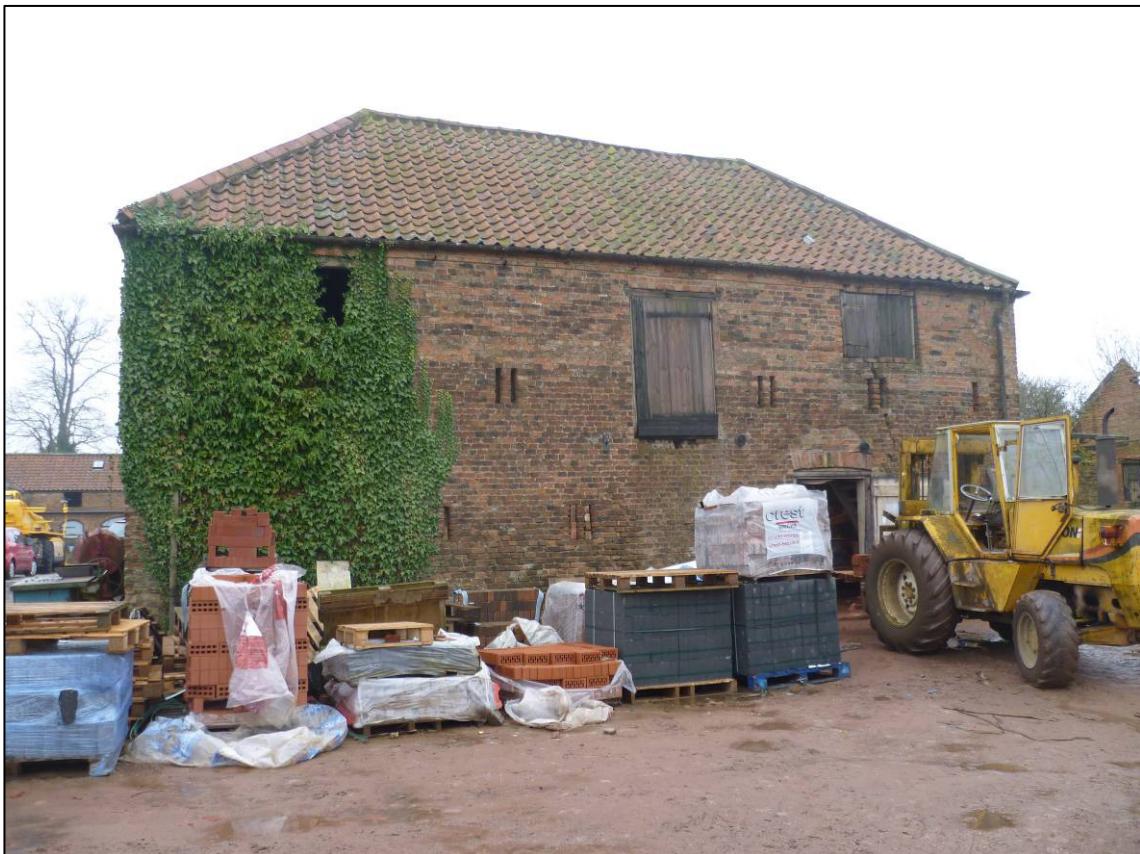
Plate 20: Barn B, north elevation, looking S (photo 1/904).

- 6.57 At the time of the site inspection, the main access into the ground floor of the barn was through the doorway in the north elevation [1/700]. This leads into the larger (northern) of the two spaces of the building's main body. This is floored with worn brick paving and is crossed by two substantial softwood east-west ceiling beams, with joists lodged over. One of the beams projects rather crudely through the east wall into the ground floor of the east wing, and bears incised marks to one side. These marks take the form of rows of characters, some simple slashes, others more complex, and they occur in strings. They are characteristic of the so-called 'Baltic timber marks', relating to the export of softwood from the Baltic into Britain through ports such as Hull. The marks were clearly made after the trees had been squared but before they were quartered or otherwise divided, as some strings are truncated at the top or bottom. They are generally thought to be put onto the timber in Baltic ports by timber merchants there, and may denote the merchant, the port from which the timber was shipped and/or other information. There is no internal access to the smaller (southern) space of the barn's main body. A doorway in the east wall provides internal access to the ground floor of the east wing. The north jamb of the door frame is made from a re-used timber, moulded to one side [1/701] (see plate 24). The east wing again is floored with worn brick paving, and is crossed by two east-west softwood ceiling beams, supporting lodged joists.

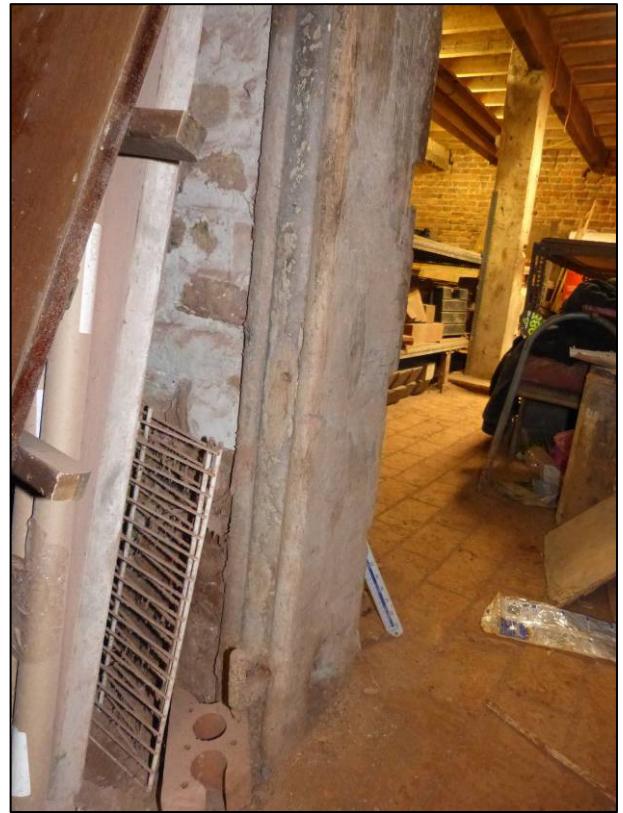
Plate 24: Barn B, ground floor of north space of main part, re-used timber in doorway, looking E (photo 1/701).

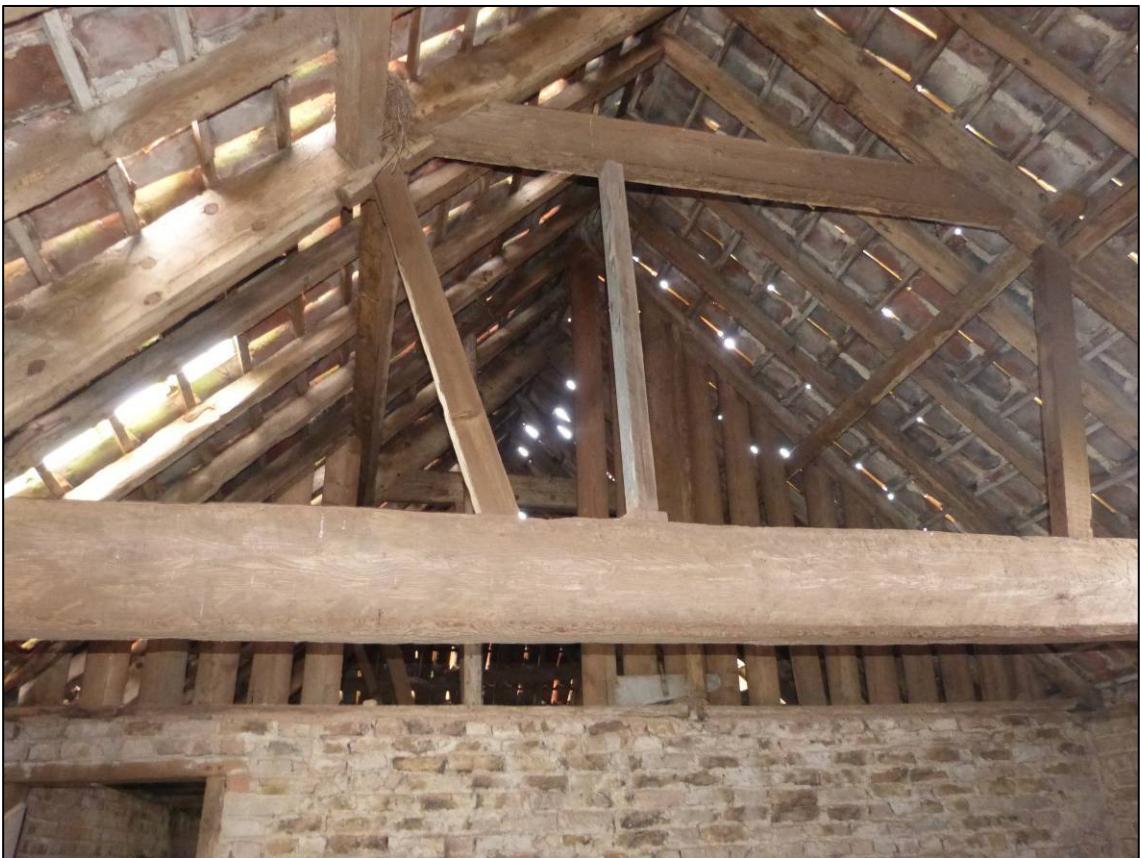
Plate 25: Barn B, first floor, truss over main body, looking S (photo 1/712).

- 6.59 The main surviving feature of interest to the first floor is the roof structure. There are six roof trusses in all, two to the east wing, three to the main body, and a single truss running across the angle between the two; the trusses within the east wing and the main body are all set at equal centres. All roof trusses appear to be of softwood, although some of the tie-beams are deeper than others or appear more worn, and are perhaps re-used hardwood. The trusses are of pegged construction throughout, but no evidence was noted for carpenters' or other assembly marks. With the exception of the angled example, all the roof trusses are of the same form. The tie-beam rests on a wall plate at either end, with short diagonal timbers set across the four corners of the first floor between the wall plates where the roof is hipped. Some of the tie-beams have wrought-iron straps where the feet of the principal rafters meet them. Angled struts rise from the tie-beam to the principled rafters, and there is a collar between the principals above the level of the struts. Each principal supports a single staggered purlin with pegged through tenons. The common rafters are softwood, and there is a plank ridge-piece [1/704, 1/712] (see plate 25). The angled roof truss has a king-post, rather than a collar, with raking struts to the principals; one of the struts is now missing. Additional timbers run at angle of 45 degrees from the tie-beam of the angled truss to the wall plates [1/707] (see plate 26).

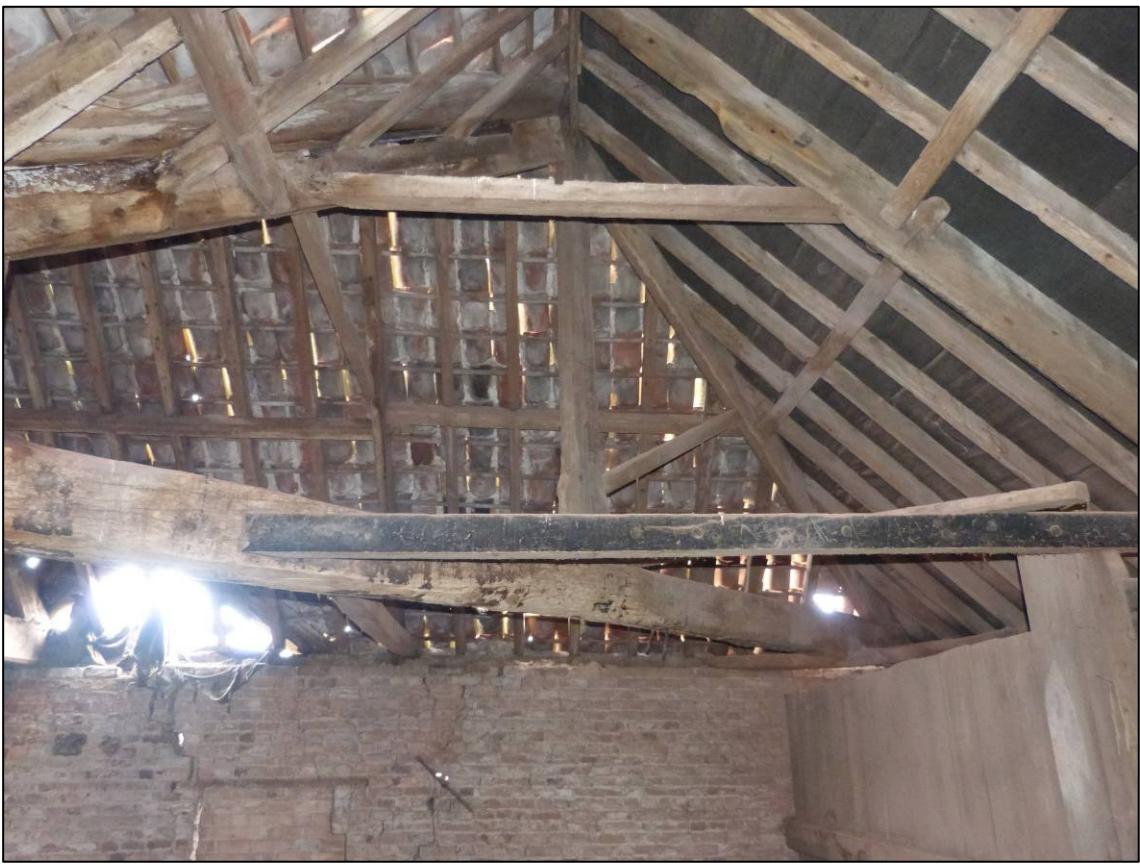
Plate 26: Barn B, first floor, angle truss, looking W (photo 1/707).

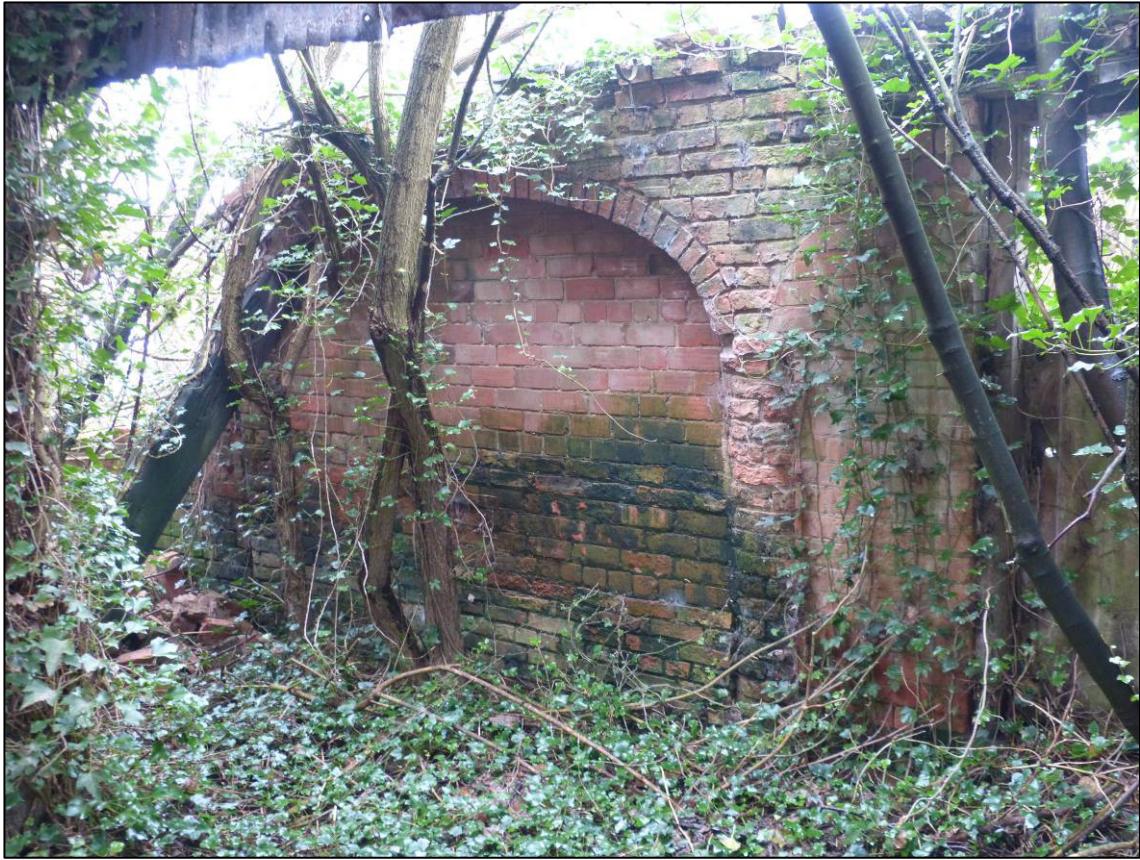
Plate 28: Building F, south elevation, looking NW (photo 1/768).

- 6.62 Building F was in very poor structural condition at the time of the site inspection, and was largely collapsed; no detailed inspection was therefore able to be carried out due to Health and Safety concerns. It was formerly rectangular in plan, aligned east-west, running between the barn and the west range, measuring c.10m long by 4.5m wide. It was of a single storey with a pitched roof, the shadow of which can still be seen on the barn's west elevation. It had load-bearing external walls built of red handmade brick, similar to that used in the lower part of the west elevation of Barn A, set with a lime mortar. The south external elevation, which once faced into the fold yard, contained either four or five cart entrances with segmental arches, separated by circular brick pillars, again similar to the surviving example described above in the east elevation of Barn A [1/768, 1/769] (see plate 28). It is therefore possible that this part of the north range once formed a cart or implement shed, although this seems unlikely latterly, given the need to negotiate through the sheds of the covered fold yard; it may have been a shelter shed instead. Many of these cart entrances were later completely blocked or narrowed to form doorways. The north external wall contained at least two round-headed doorways, similar to those

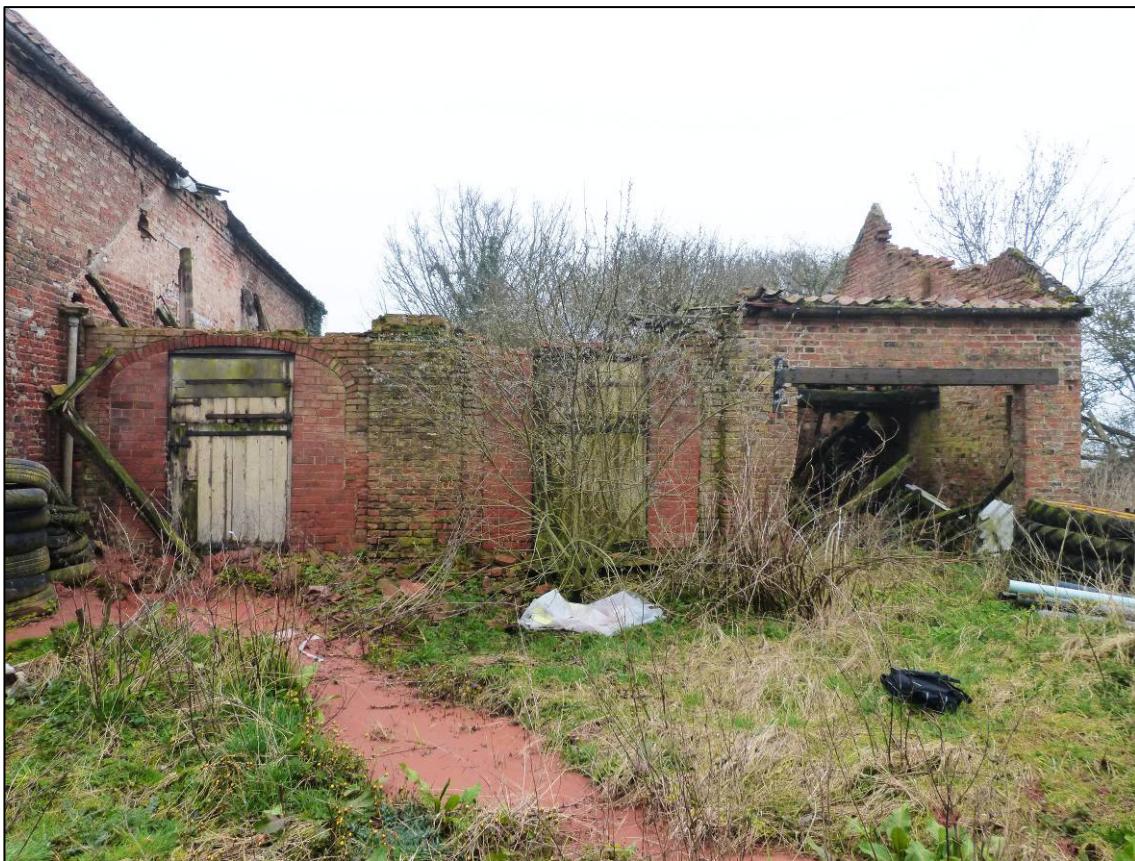
Plate 30: Building G, north elevation, looking S (photo 1/729).

- 6.65 That part of the north elevation to the east, built before 1855, is two bays in length, each bay having a cart entrance with a segmental-head that has either been completely blocked or narrowed to accommodate stable-type doors [1/729, 1/730] (see plate 30); this side is shown as open-fronted in 1891. The north elevation contains at least two round-headed doorways, as noted above. The interior is choked with debris, but one of the fallen north-south beams is very substantial, and may have been re-used here [1/731].
