CORONATION GARDEN,  
NORTH BAR WITHIN, BEVERLEY,  
EAST YORKSHIRE

ARCHAEOLOGICAL OBSERVATION,  
INVESTIGATION AND RECORDING

Report no: 2018/561.R01  
Version: Final  
Date: April 2018  
Author: Ed Dennison & Lisa Johnson

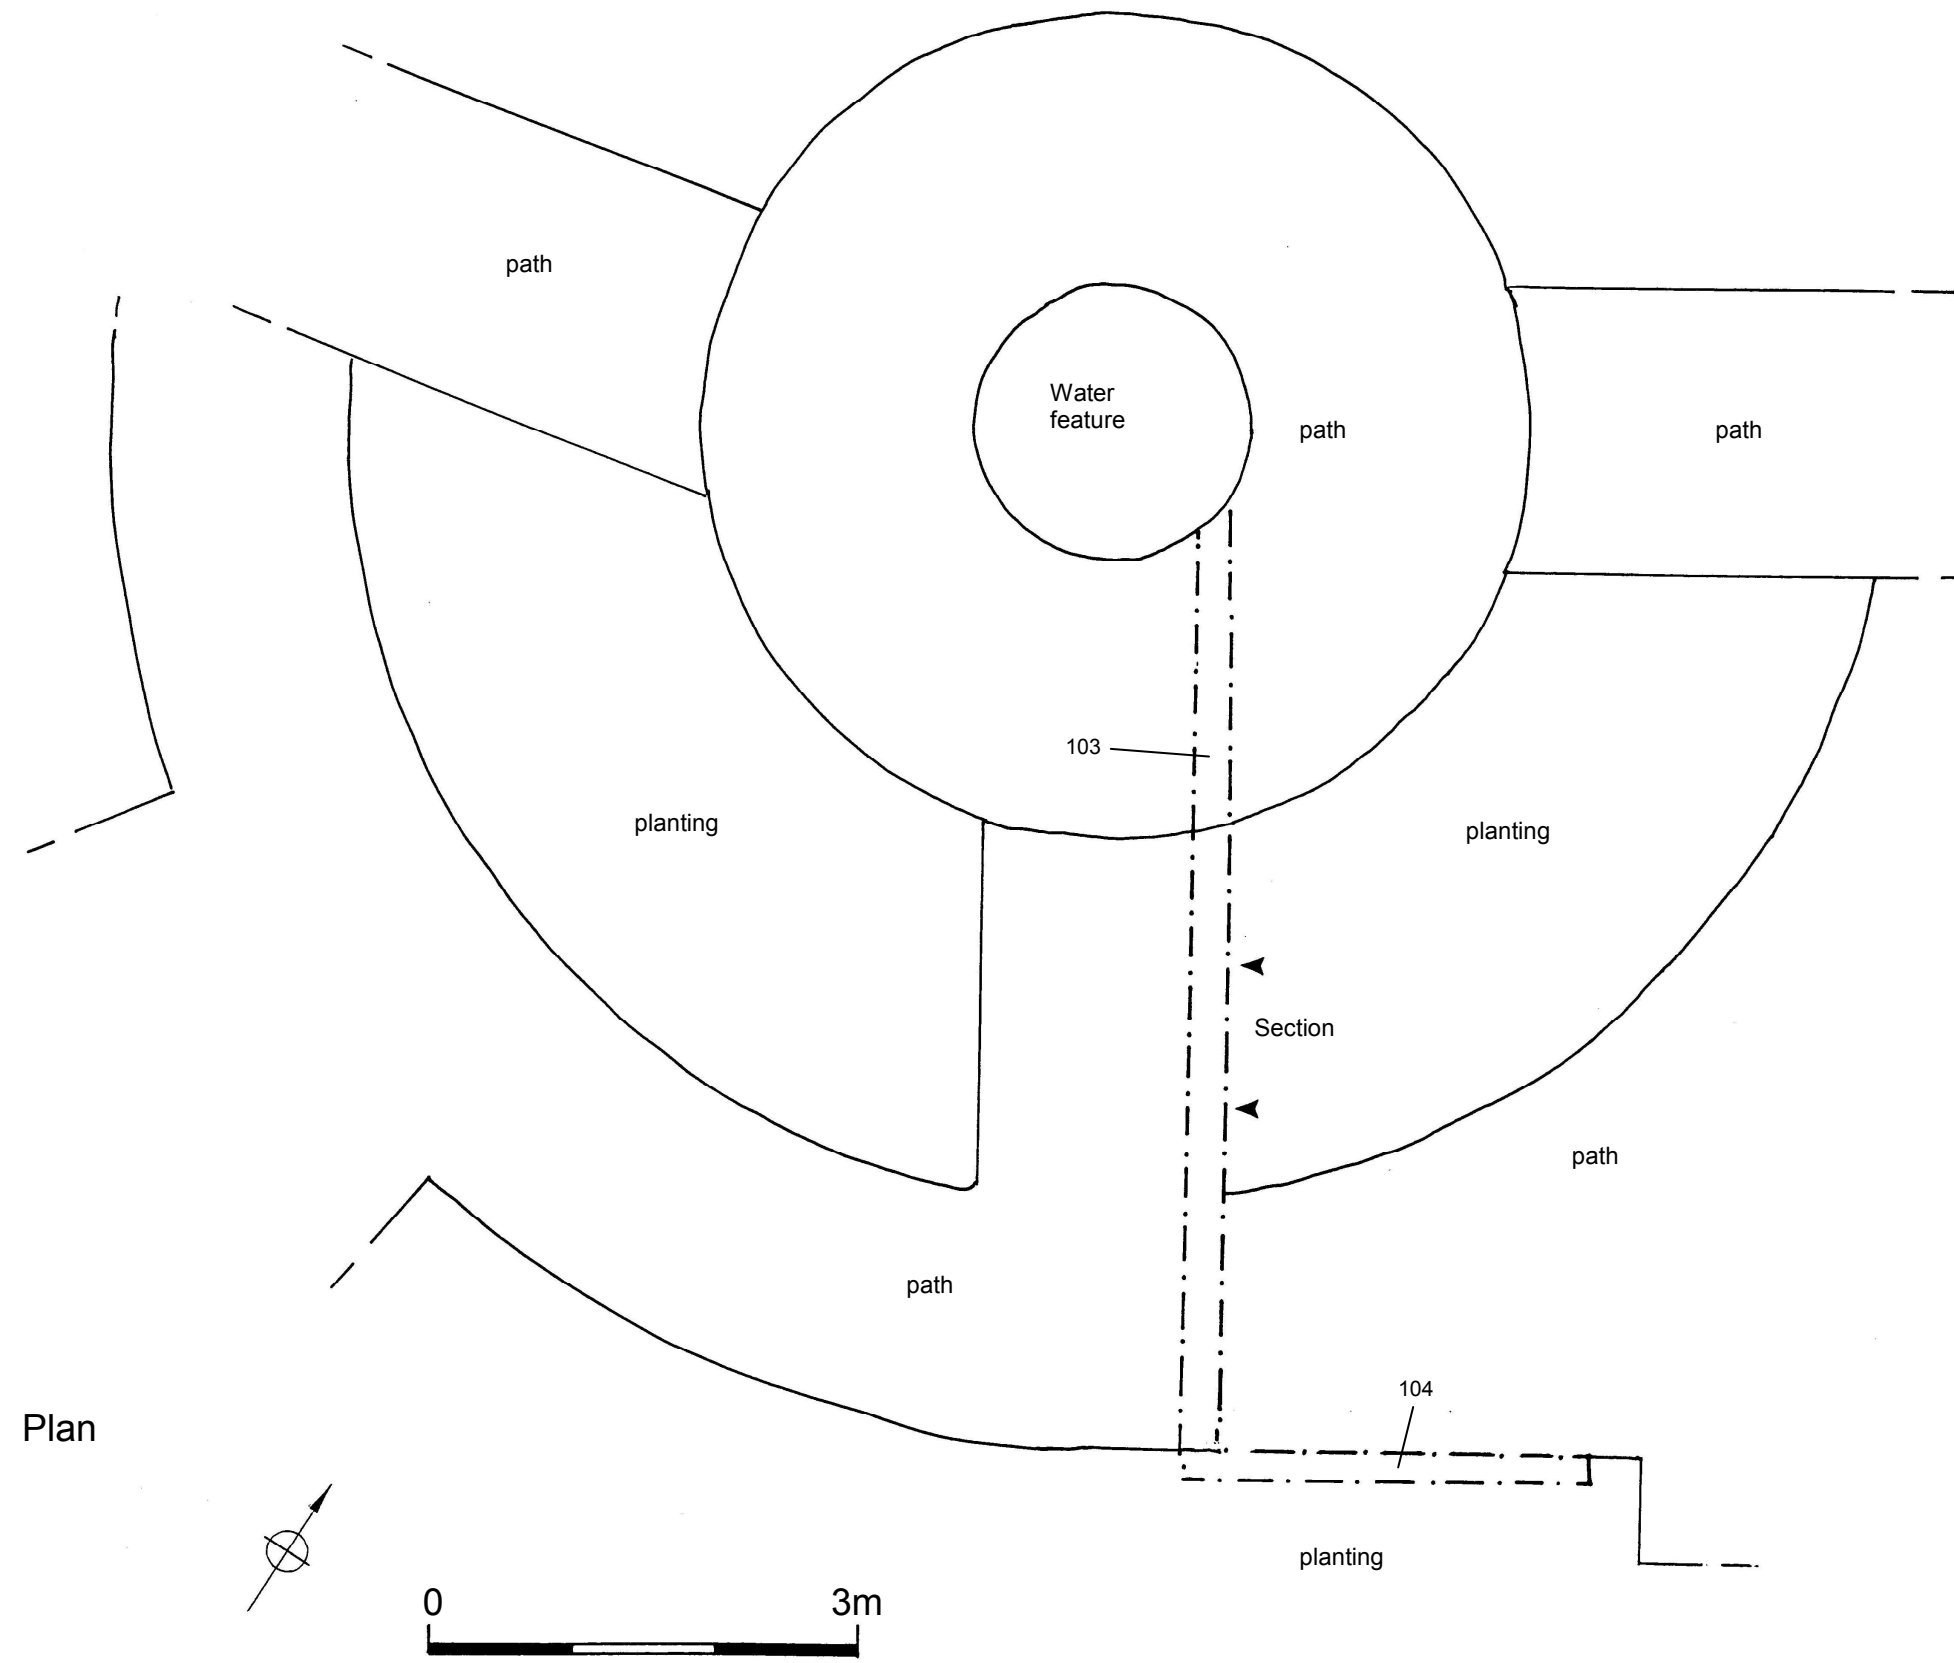
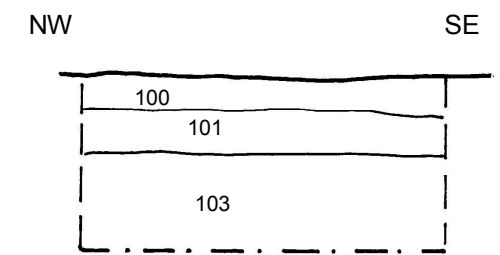
PROJECT CORONATION GARDEN, BEVERLEY	
TITLE WATCHING BRIEF RESULTS	
SCALE AS SHOWN	DATE APR 2018
EDAS	FIGURE 4

Typical section of main trench

Plan

- 5.1 As noted above, the maximum depth of excavation along the 0.27m wide L-shaped trench was 0.40m. The shorter north-east/south-west aligned arm of the trench measured 2.60m long while the longer north-west/south-east trench measured 6.60m long (see figure 4).

- 5.2 Unsurprisingly, given the depth of excavation, natural deposits were not encountered during the groundworks. The earliest deposit encountered in the longer trench arm was a layer of firm, mid-brown, silt clay (103) over 0.20m thick, containing occasional small fragments of brick and chalk (see plate 1). A small assemblage of disarticulated human bone, animal bone and two oyster shells were noted in this deposit. The human bone comprised two fragments of cranium (skull), a metacarpal (finger bone), a rib, and fragments of a vertebra, humerus and possible femur, while the animal bone comprised a cattle phalange and four unidentifiable fragments from a large mammal, probably cattle or horse.

- 5.3 The south-eastern extent of the silt clay deposit (103) was overlain by a 0.14m thick deposit of compacted creamy-white coarse gravel hardcore bedding (101) for a red brick decorative border for the existing flowerbeds. This brick border had been removed prior to the start of the ground works to facilitate trench excavation. The north-western extent of the silt clay deposit (103), extending 2.00m out from the base of the existing water feature, was overlain by a 0.17m thick deposit of crushed grey tarmac hardcore (102), replacing the hardcore bedding (101). Over this was a layer of resin-bonded gravel (100), 0.10m thick, which also overlies the hardcore bedding (101) throughout the rest of the trench, to form the current ground surface.

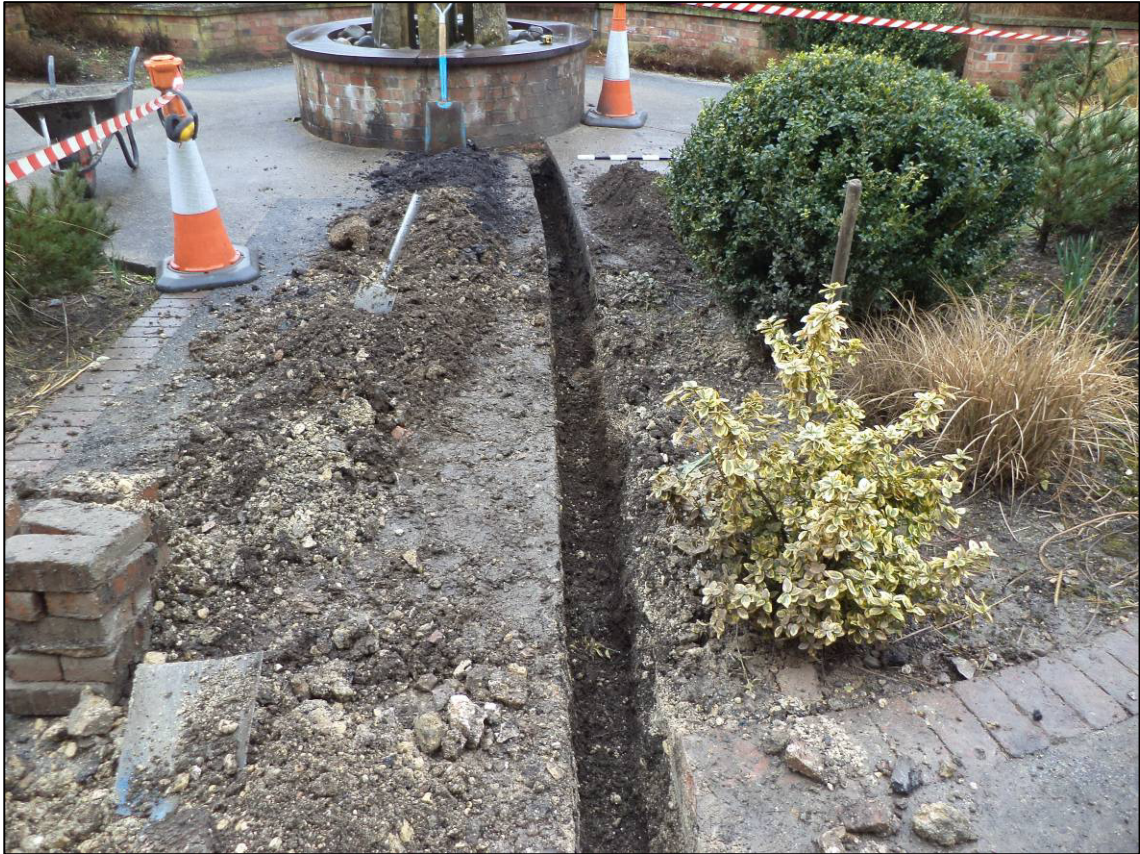
Plate 1: General view of excavated longer trench arm, looking NW towards water feature.

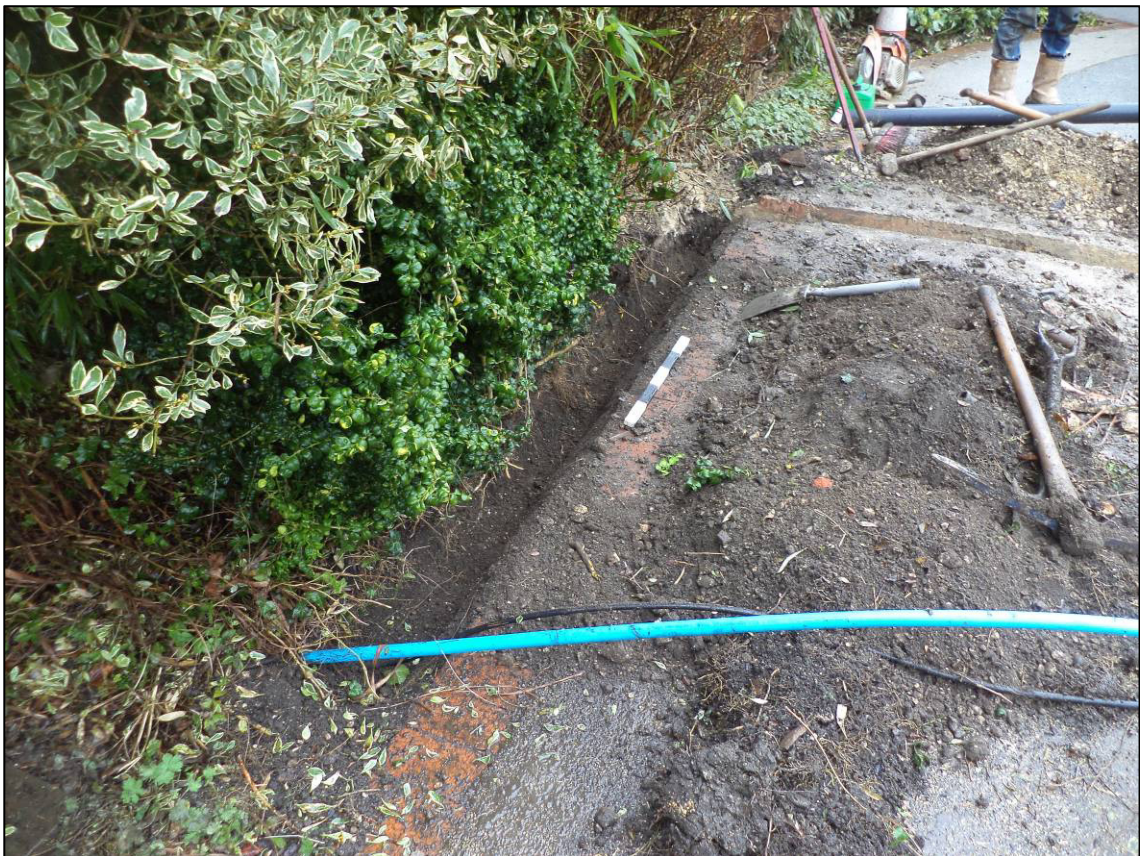
Plate 2: General view of excavated shorter trench arm, looking SW.

- 5.4 The only deposit encountered within the shorter arm of the trench was a loose, dark brown, loamy garden soil (104) more than 0.40m thick forming an existing flowerbed (see plate 2). One sherd of 19th century Pearlware pottery and a fragment of vertebrae from a juvenile large mammal (cattle or horse) were recovered from this deposit.
