ERECTION OF PIG FINISHING BUILDINGS,  
ST LOIS FARM, HIGH LANE, SUTTON UPON DERWENT,  
EAST YORKSHIRE YO41 4BY  
(Applications DC/18/02664/PLF and DC/18/02665/PLF)

HERITAGE STATEMENT

Report no: 2018/580.R01  
Version: Final  
Date: November 2018  
Author: Ed Dennison

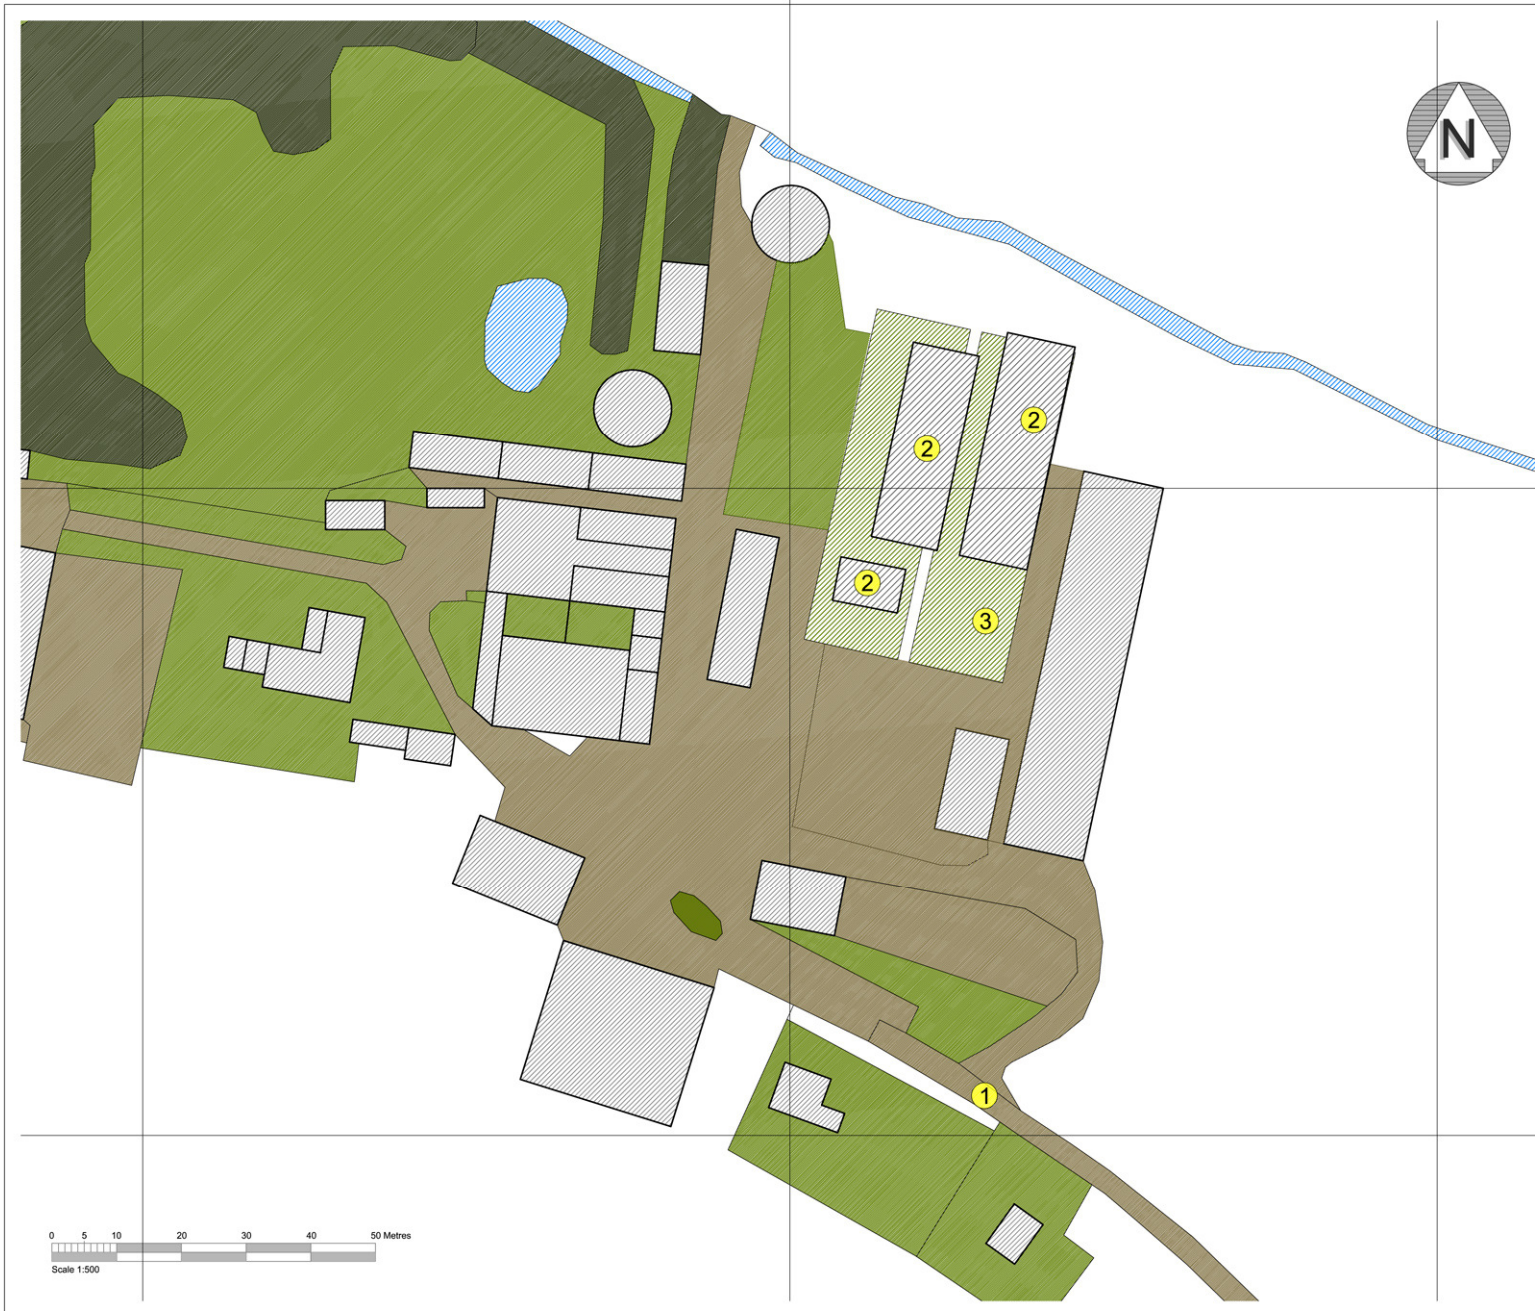
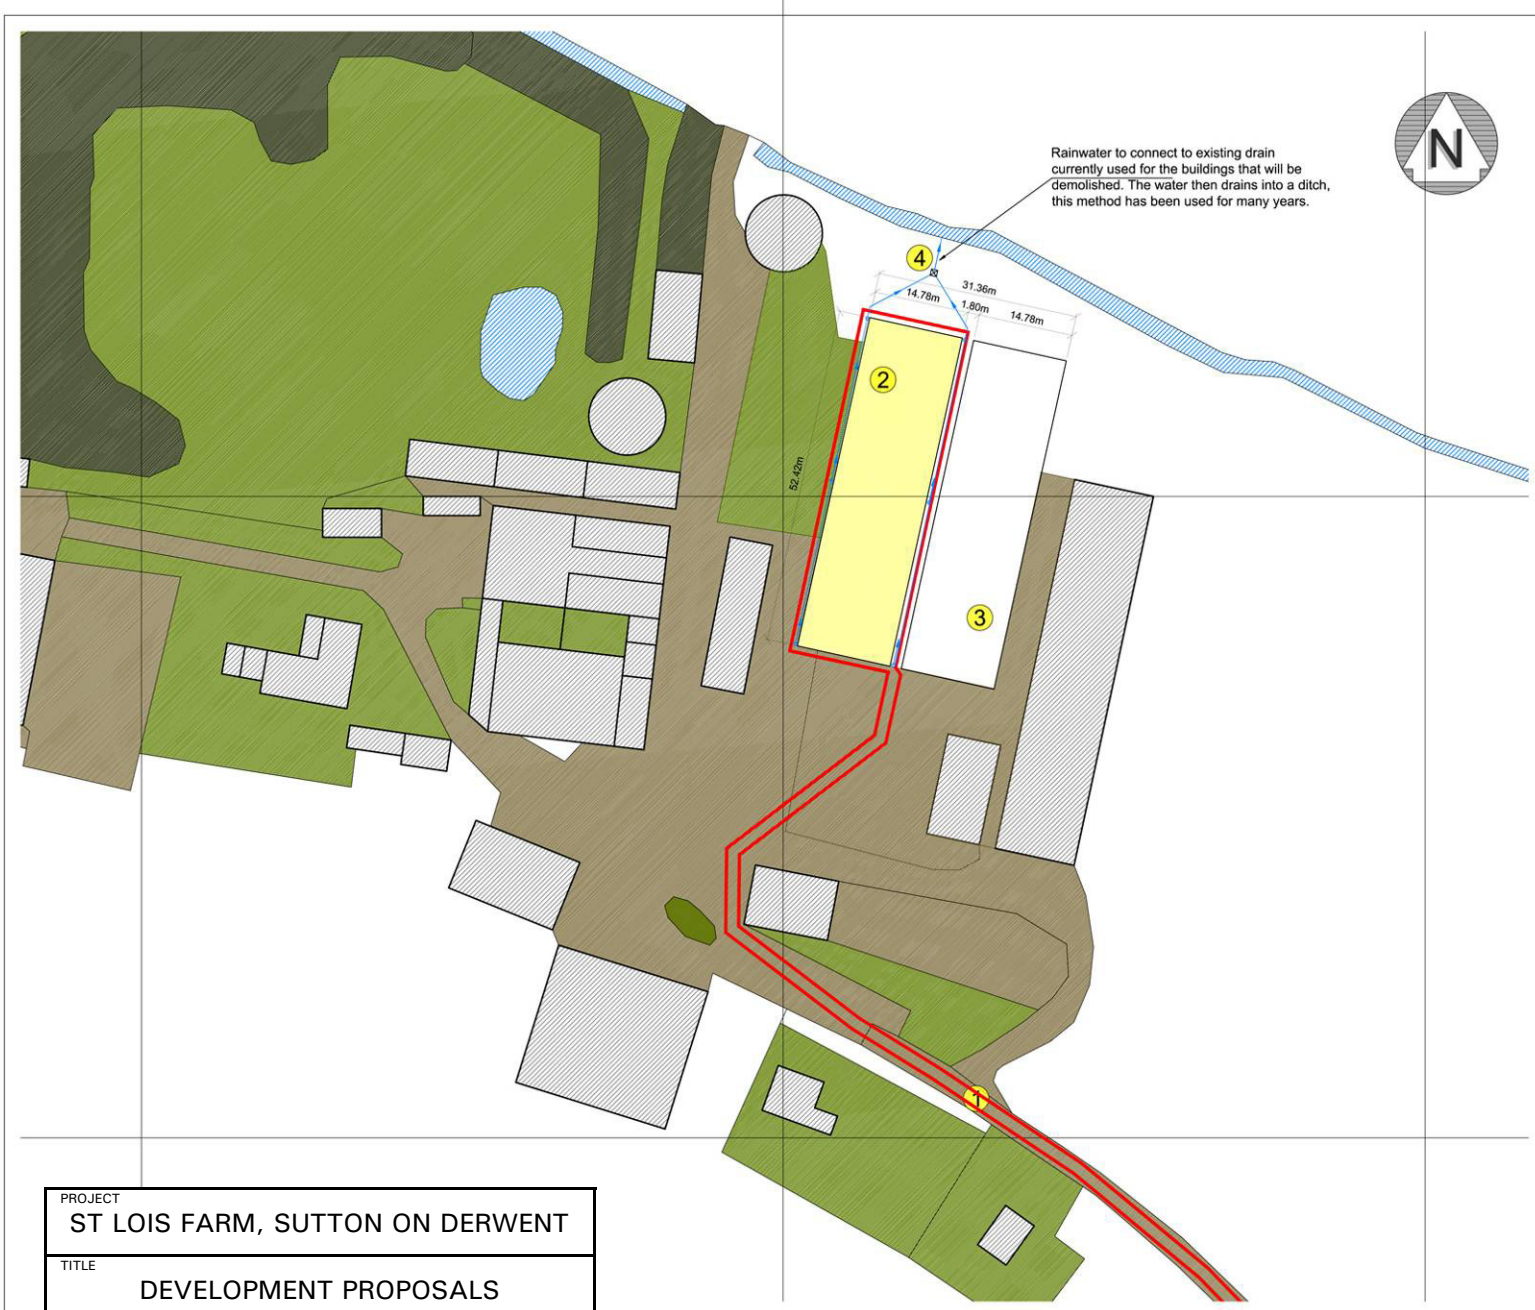
PROJECT ST LOIS FARM, SUTTON ON DERWENT	
TITLE DEVELOPMENT PROPOSALS	
SCALE AS SHOWN	DATE NOV 2018
EDAS	FIGURE 9

Plans provided by ARM Buildings Ltd, reproduced with permission.

- 7.3 No new landscaping works are proposed, as the proposed development site is already screened to the north and east by existing trees and a hedgerow and the surrounding farm buildings to the south and west. No new services will be required, as the development will utilise the existing drainage provision. Further details of the development can be found in the Design and Access Statements and associated drawings which accompany the current planning applications (DC/18/02664/PLF and DC/18/02665/PLF) (ARM Buildings 2018).

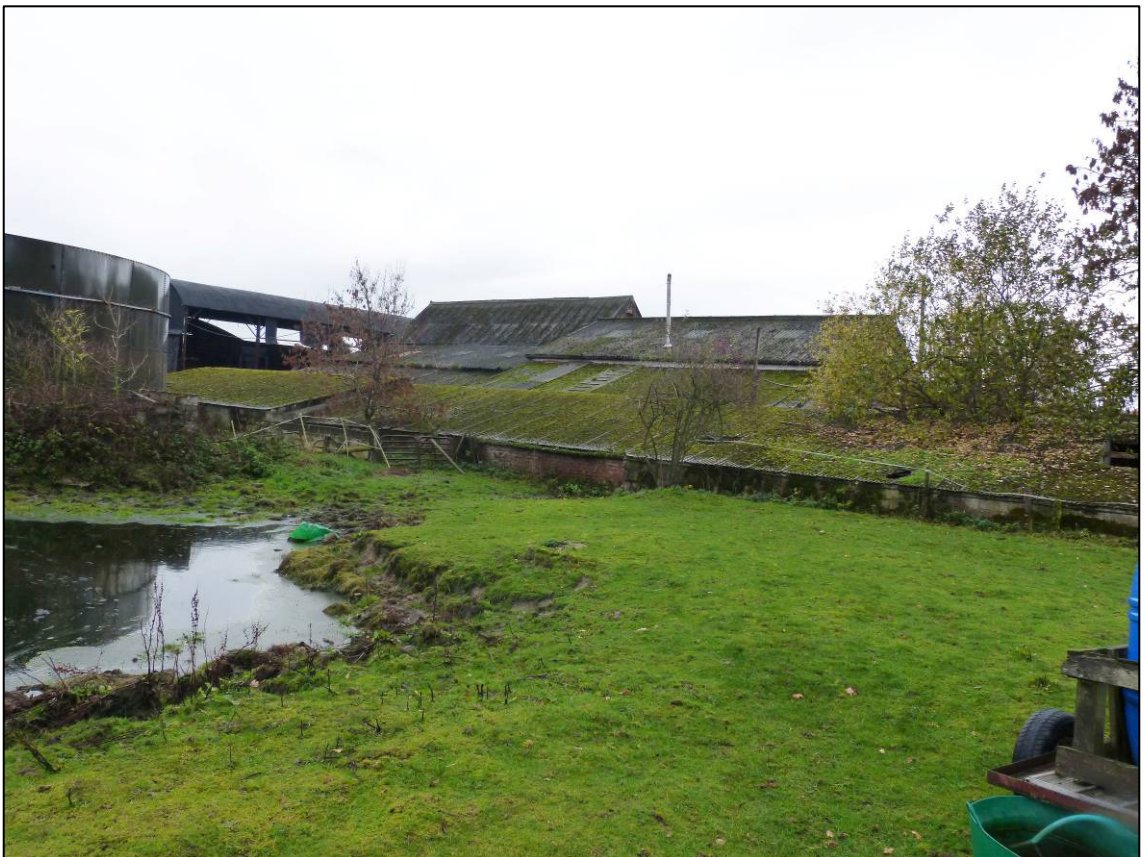
Plate 4: Moated site, east part, backfilled south-east corner (buildings N2), looking SE (photo 1/658).

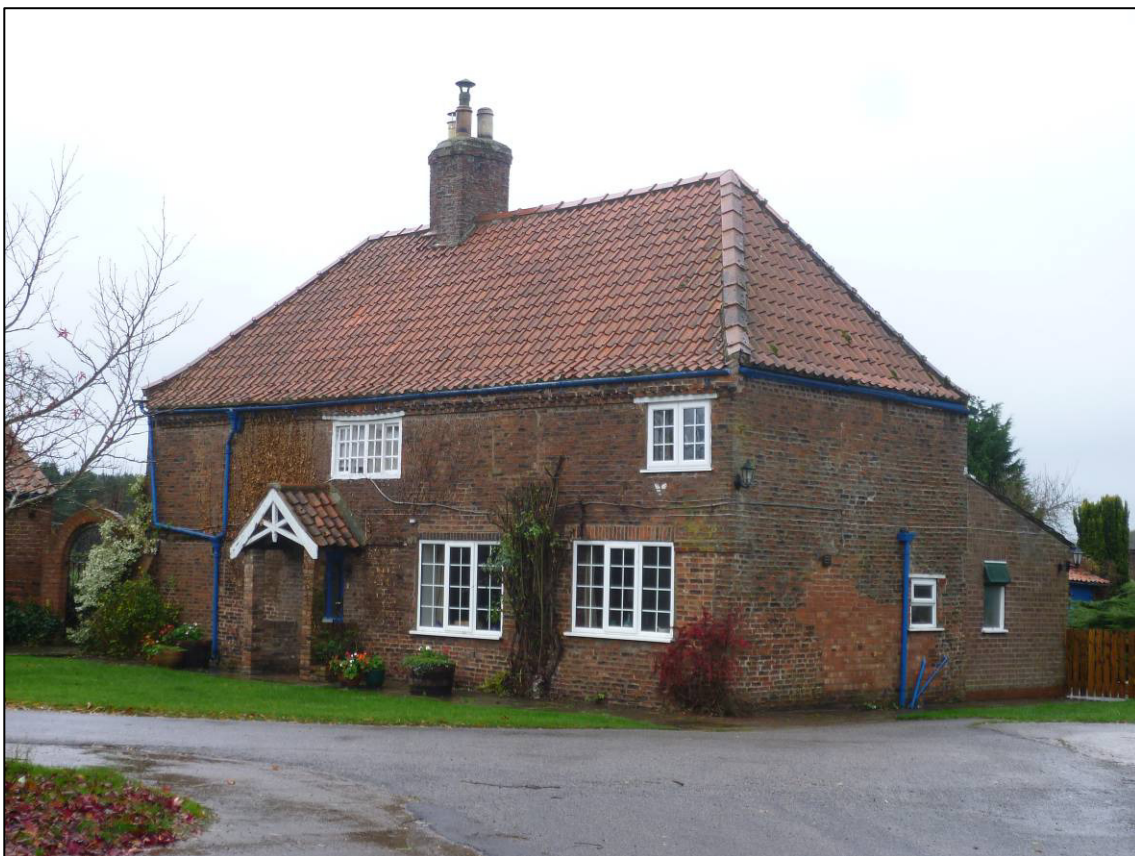
Plate 6: Farmhouse (Building A), north-south range, looking SW (photo 2/018).

“House. Probably late C16/early C17, remodelled in early C18, with mid C18 rear wing. Red brick (possibly concealing timber frame) in English garden wall bond, pantiled roof. Lobby-entry plan. 2 storeys, 4 bays. C20 porch to panelled door: two C20 replacement windows to right. First-floor band. First floor: quadripartite sliding sash with glazing bars over door; 2-light sliding sash with glazing bars to extreme right. Dentilled and stepped brick eaves cornice, hipped roof, axial stack. Interior: fragments of an early roof remain over the main range; they include one almost complete principal rafter truss with tie-beam, collar and clasped purlins, and rafters pegged at the apex. The rear range retains an intact principal-rafter roof with tusked and tenoned side purlins and numbered joints”.

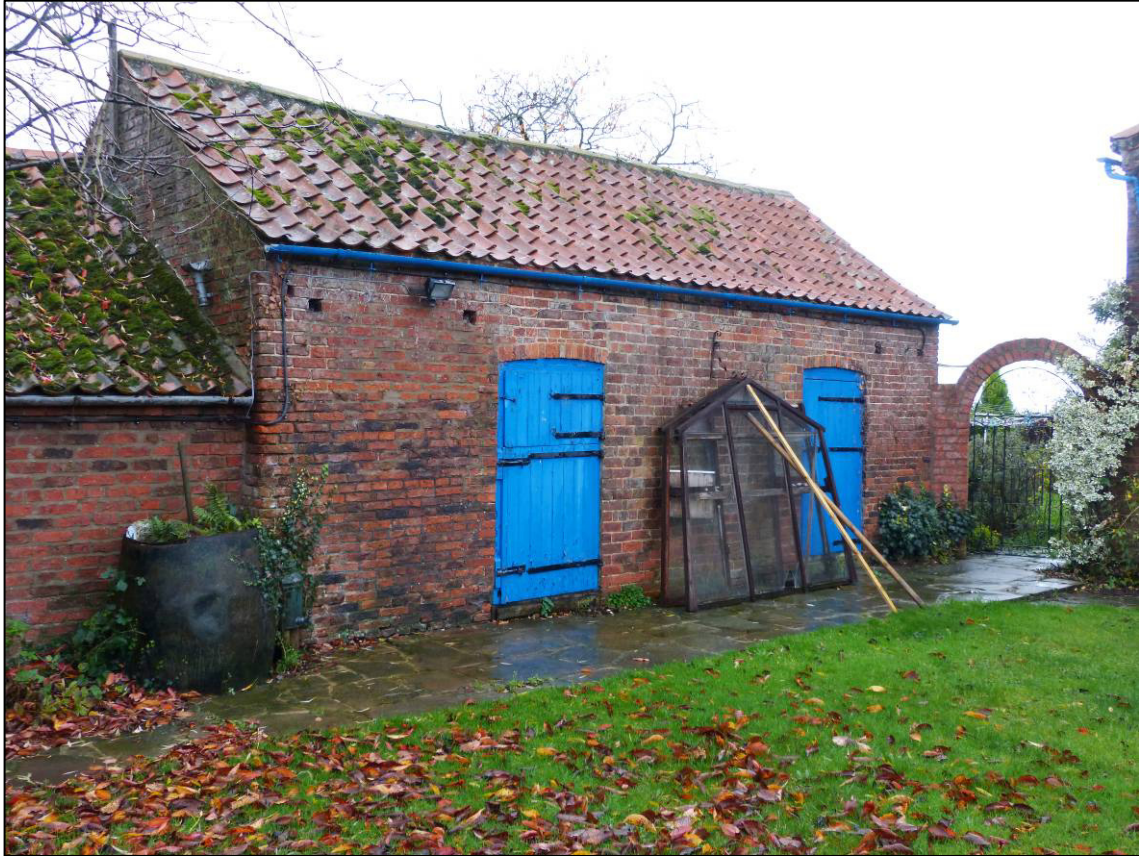
Plate 9: Stables, part of building B, looking SW (photo 1/625).

- 6.23 To the immediate east of the farmhouse, there is a short range comprising a small stables and a second slightly wider building to the east [B]. Map evidence suggests that both were present by 1854 (see figure 6A). The stables is of a single storey, brick built, with a pitched pantiled roof (see plate 9). The interior is divided into two loose boxes, each served by a doorway in the north elevation with a cambered head fitted with a stable door. The second building, at the east end of the stables, is of a low single storey, brick built, and also with a pitched pantiled

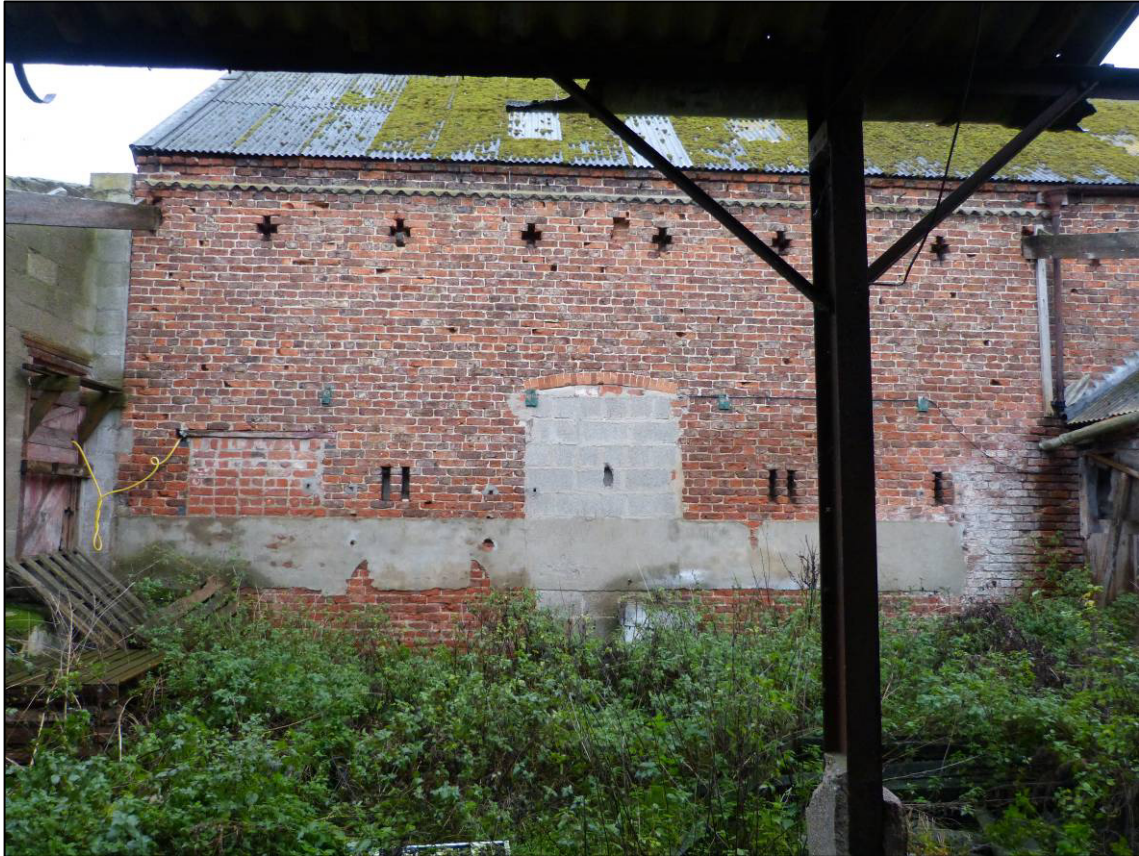
Plate 11: Barn (Building C), south elevation, looking N (photo 1/640).

- 6.37 With the exception of the farmhouse, the earliest surviving building within the farm complex is the barn [**C**], which probably dates to either the late 18th or early 19th centuries. At a later date, but before 1854, the east range [**D**] was constructed and probably originally formed a cow house with associated structures such as loose boxes. By 1854, the barn formed part of a longer north range; the building to the west has since been demolished and replaced by a modern structure, but it might originally have formed stables with a granary over. The north and east ranges formed two sides of an enclosed foldyard; a second yard to the north of the north range may have been the stackyard. This had gone by 1892, in conjunction with the addition of a horse-engine house to the barn's north elevation. The west range [**E**] was built between 1854 and 1892, and probably originally functioned as an implement or cart shed, as otherwise there appears to have been little provision for such within the farm complex. The nature of the farm as given in the various sales in 1896 (see above) present a typical small mixed farm in the Vale of York at the end of the 19th century, and its various stages of growth and development accord with the national picture generally (Barnwell & Giles 1997, 5-7).

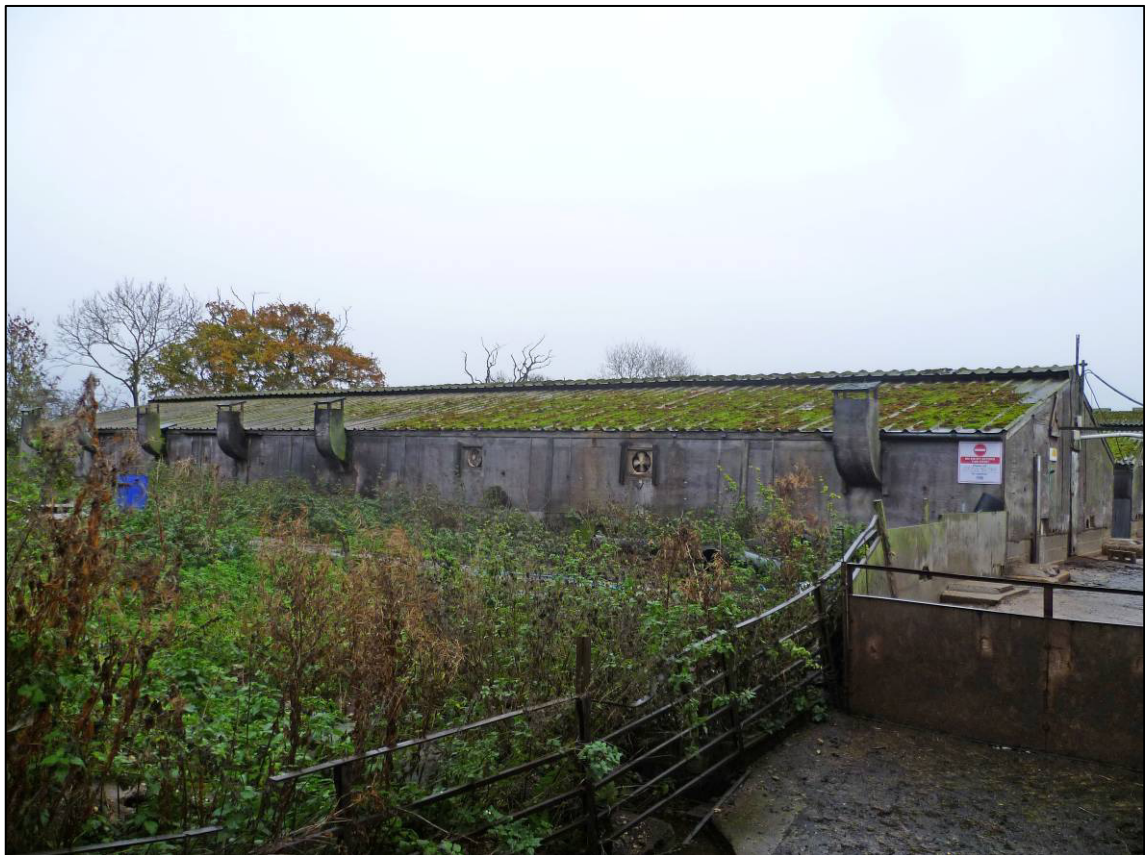
Plate 14: Pig finishing shed (Building J1), looking E (photo 2/020).

- 7.1 In summary, the development proposals at St Lois Farm involve the demolition of three existing 20th century agricultural structures, built in the 1970s (Buildings J1, J2 and K on figure 8), and their replacement with two new pig finishing structures (see figure 9). These new buildings will provide a more environmentally friendly, highly insulated, energy efficient, design to that which currently exists. The existing surfaced track leading to the farm complex from High Lane will be utilised for the new development, and it is not envisaged that any major upgrade of this route will be required.

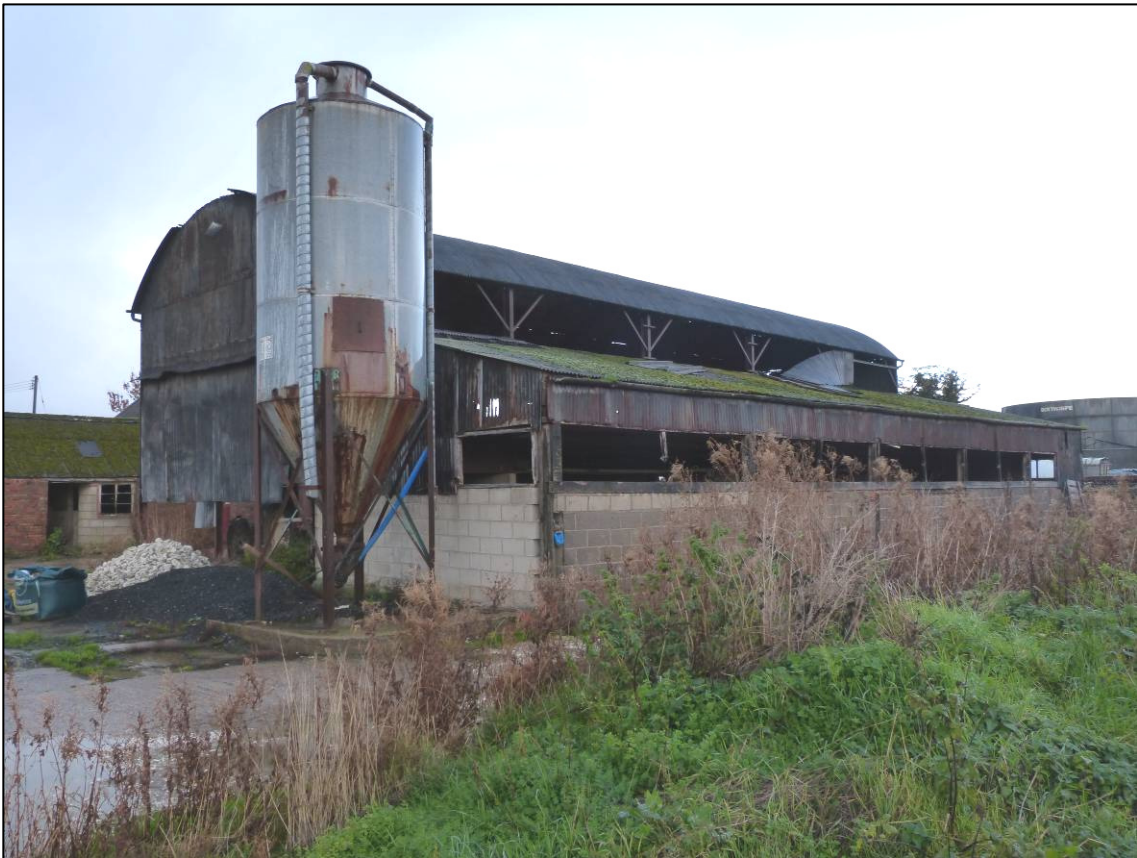
Plate 15: Dutch barn (Building M), looking NW (photo 1/592).

- 6.34 To the immediate east of the east range of the earlier core of the farm complex, there is a Dutch barn [**M**] (see plate 15). An open-sided structure is shown here in 1910 (see figure 6C), but the existing barn is considerably shorter; it may therefore represent either a remnant of the structure shown in 1910, or more likely be a later replacement of it, perhaps dating to the 1940s (MAAF 1945, 149-155). The barn is two storeys high and five bays long, being open to the east and west sides; the north and south ends are covered with galvanised corrugated-iron sheeting to ground level, a recommendation in exposed districts where there was exposure to wind (Hanley 1950, 110; Gunn 1952, 70). The galvanised corrugated-iron sheeting of the roof is set over curved angle-steel trusses, themselves supported by paired I-section steel stanchions, with struts from the top of the stanchions to a horizontal steel joist forming a wall-plate. The Dutch barn has a modern addition to its east side.

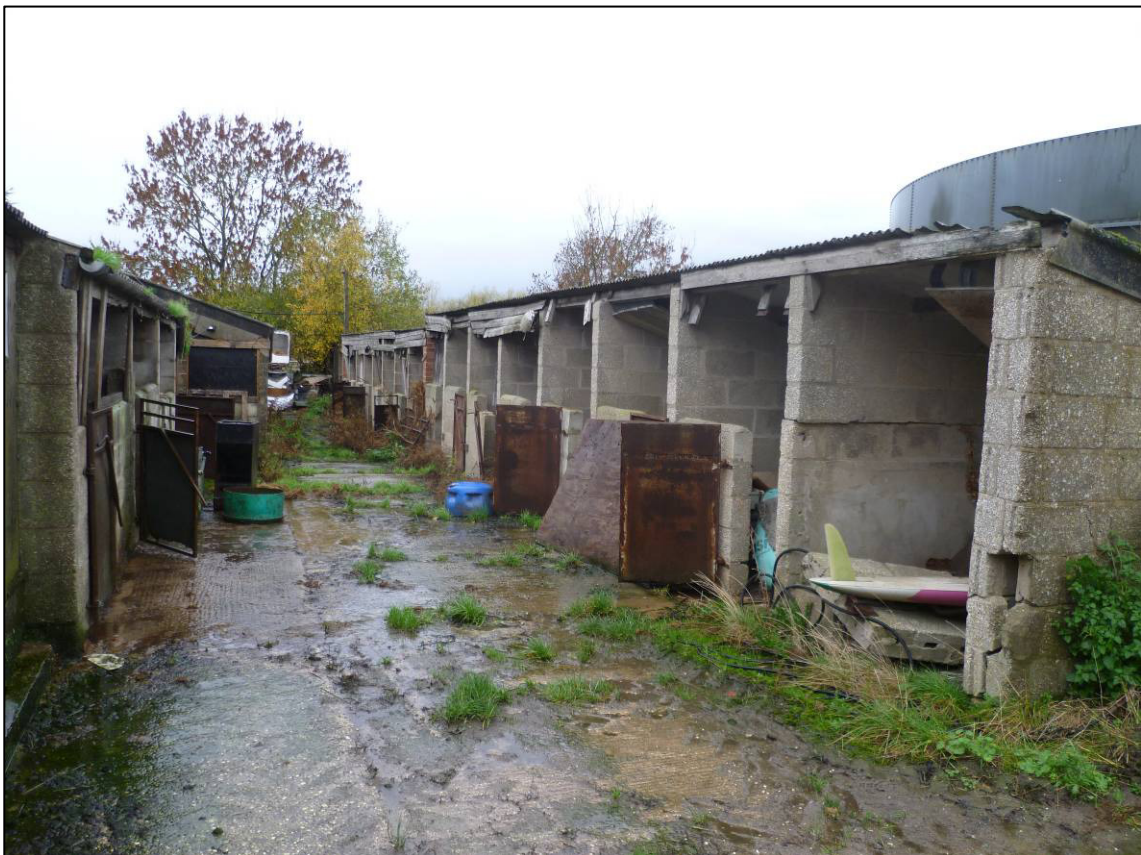
Plate 16: Pigsties (Building N2), looking NW (photo 1/611).

- 6.35 To the north-west of the Dutch barn, and to the north of the barn in the earlier core of the farm complex, there are two rows of east-west aligned modern concrete pigsties [**N1** and **N2**] (see plate 16). The northern row replaced two earlier buildings shown here in 1910 (see figure 6C), and its follows the line of the backfilled south arm of the west moat. To the north of the north row, there is a large slurry tank with an old railway goods wagon adjacent, a north-south aligned modern lean-to shed [**O**] and another large slurry tank. Finally, at the western end of the trackway through the farm complex, to the west of the farmhouse, there is another group of modern buildings of varying sizes, varying from large sheds to a stable [**P1** to **P5**].
