ST PETER'S CHURCH, BARNBURGH,  
SOUTH YORKSHIRE

ARCHAEOLOGICAL OBSERVATION,  
INVESTIGATION AND RECORDING

Report no: 2018/566.R01  
Version: Final  
Date: June 2018  
Author: Shaun Richardson & Ed Dennison

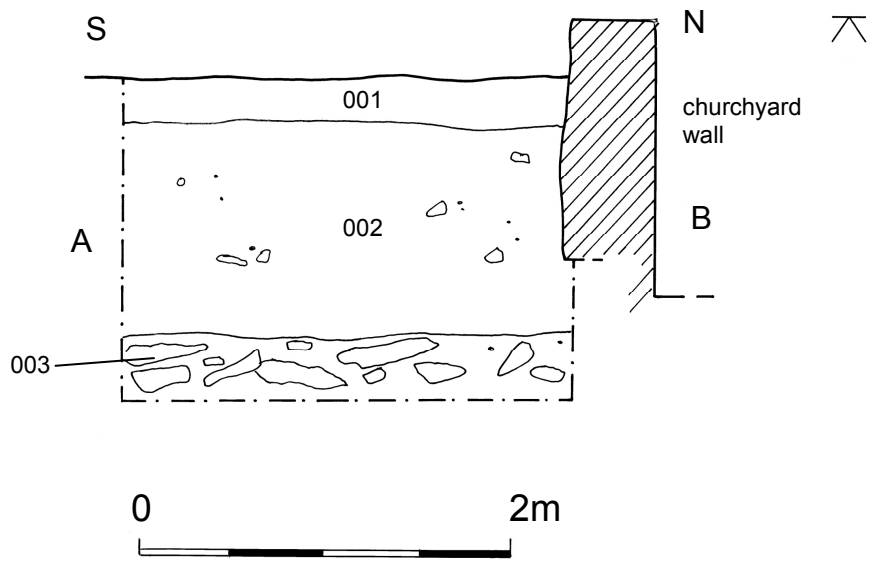
Section A-B through northern inspection chamber

- 5.3 The deposits encountered in all parts of the drainage trench and inspection pits were very similar. A mid-to-dark brown sandy silt topsoil (001) extended on average to 0.20m BGL, and overlay a mid-brown compacted sandy clay (002) with infrequent inclusions of angular sandstone pieces (up to 0.15m across), containing a very small quantity of disarticulated human bone. For the majority of the drainage trench, the sandy clay (002) formed the lowest visible deposit. However, in the northern inspection chamber, it was observed to extend to c.1.40m BGL

(56.23m AOD), and to overlie a firm orange-brown sandy clay (003) with very frequent inclusions of angular sandstone pieces up to 0.50m long. This continued below the base of the inspection chamber (55.93m AOD).

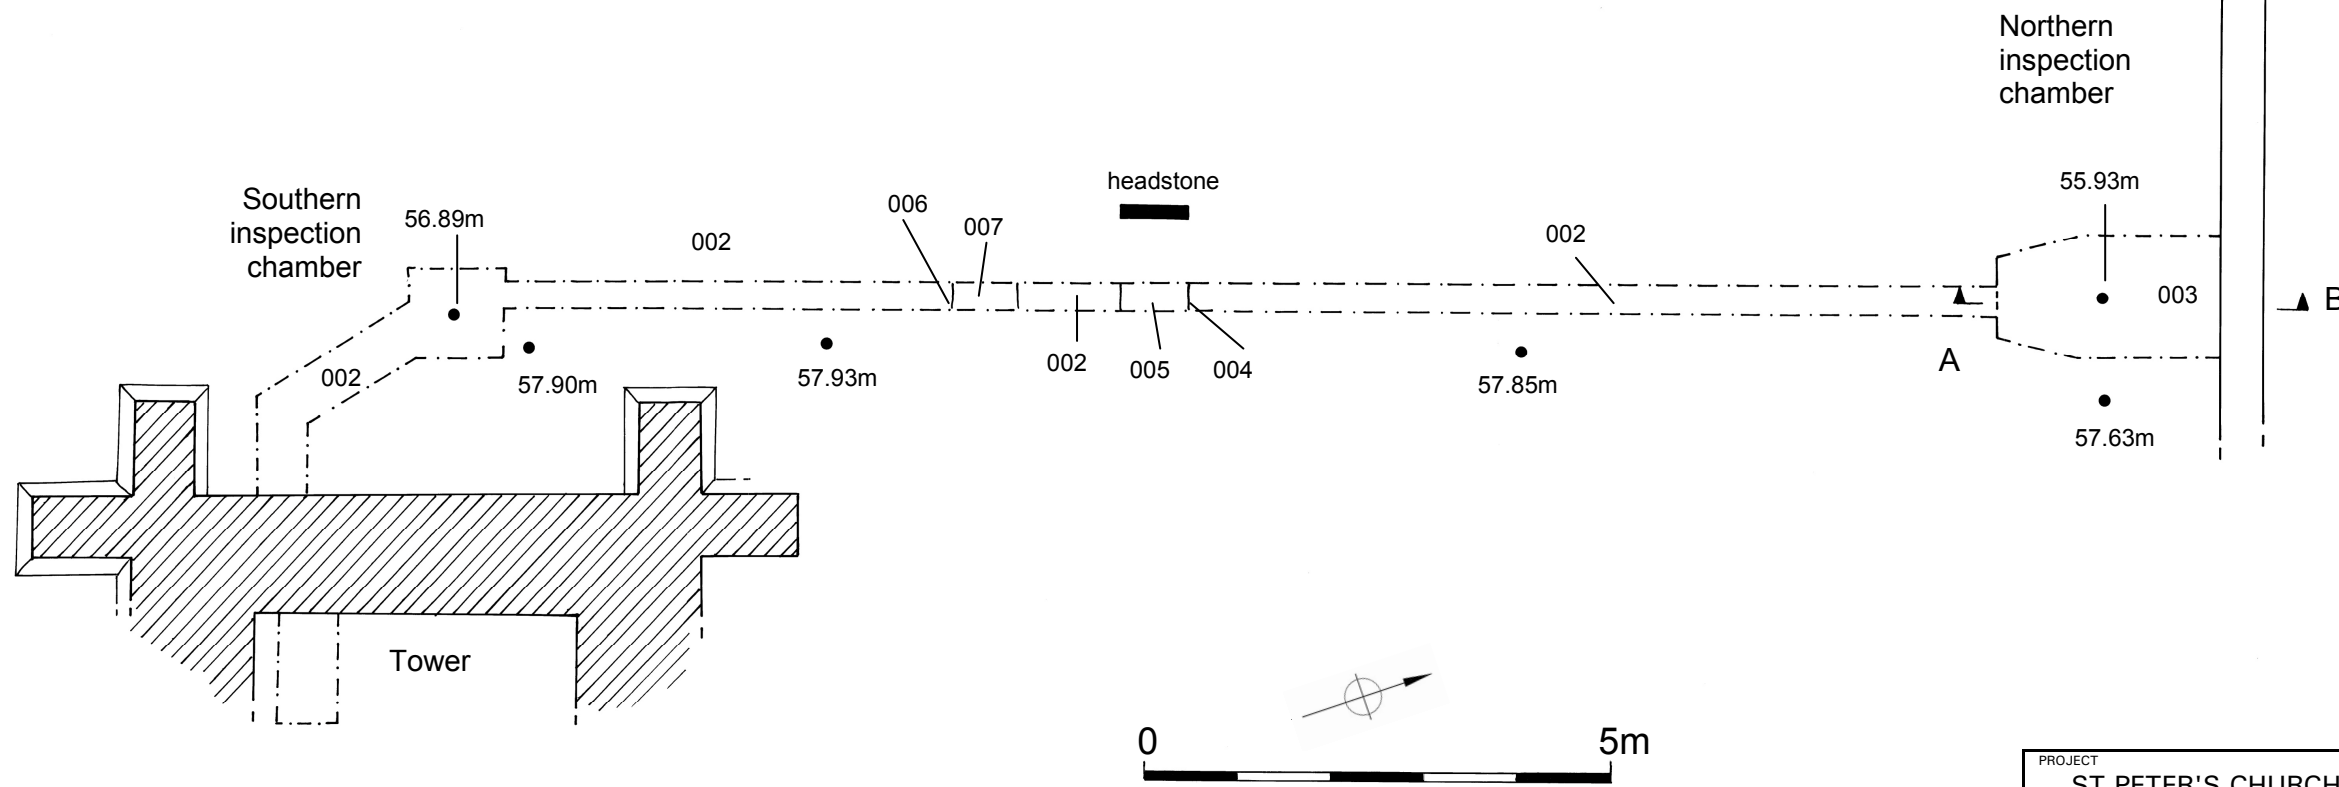
Site plan

- 5.1 The main drainage trench was set on a slight north-east/south-west alignment, but for ease of description, it is considered to be aligned north-south. As noted above, the average depth of excavation along the 21.00m long trench was between 1.10m-1.20m BGL (giving an average reduced height of between 56.89m AOD and 56.53m AOD); the northern inspection chamber adjacent to the churchyard wall reached a maximum depth of 1.70m BGL (55.93m AOD). The drainage trench left the west wall of the tower at a right angle for 1.20m and then angled sharply to the north-west for 2.00m to meet the first, southern, inspection chamber. This inspection chamber measured c.1.00m square, and was excavated to a maximum depth of 1.00m BGL (56.89m AOD) (see plate 1). The trench then ran north towards the churchyard wall, to meet the second inspection chamber (see plate 2). This second inspection chamber measured 2.40m north-south by 1.30m east-west (see plate 3).

- 5.4 Two probable grave cuts were observed within the southern half of the drainage trench, both aligned east-west and both 0.70m wide. The northern cut [004] was associated with the burial of Harry James, who died May 24th 1864 aged four years, and who is commemorated on a standing headstone located just to the west of the trench (see plate 5). The second grave cut [006] was located 1.10m to the south of the first, but this was not associated with any remaining headstone. Both grave cuts commenced at c.0.50m BGL and continued below the base of the drainage trench. Both were backfilled with a loose deposit of mid-brown sandy clay (005 and 007 respectively), and no articulated burials were visible.

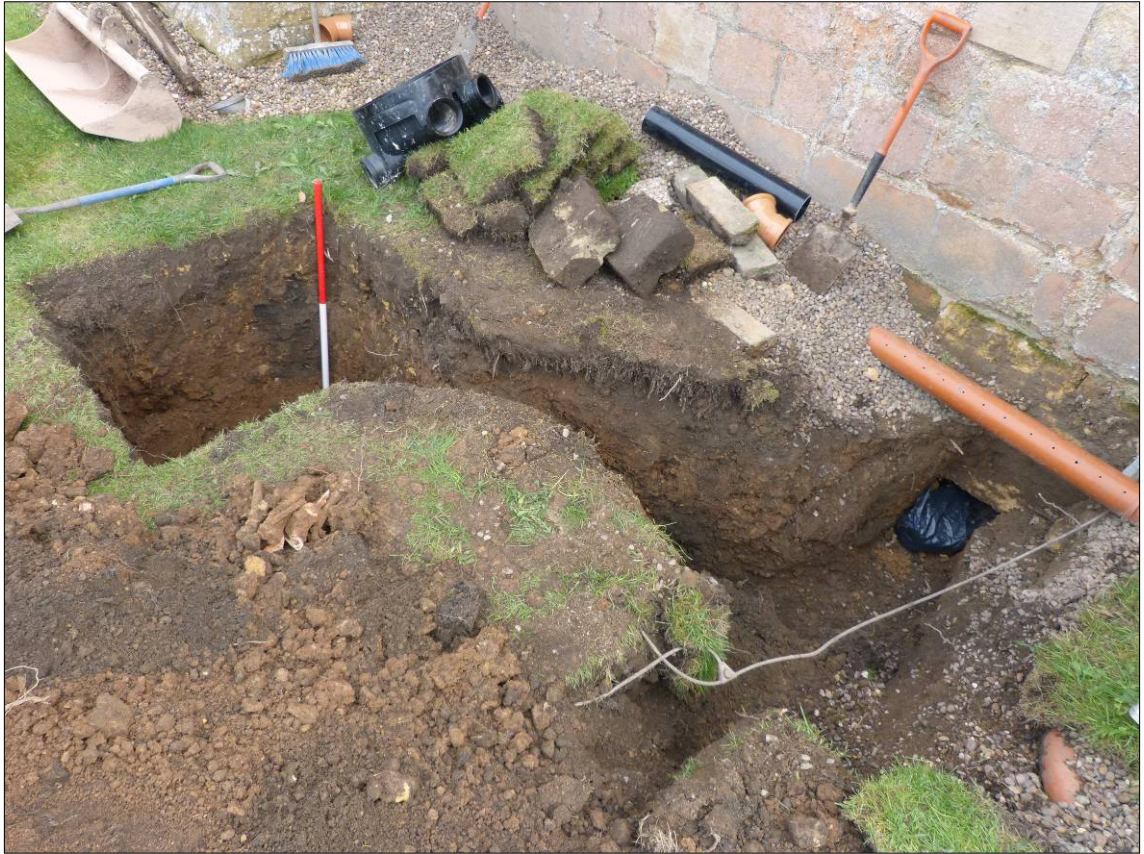
Plate 1: Drainage trench and inspection chamber adjacent to tower, looking NE.

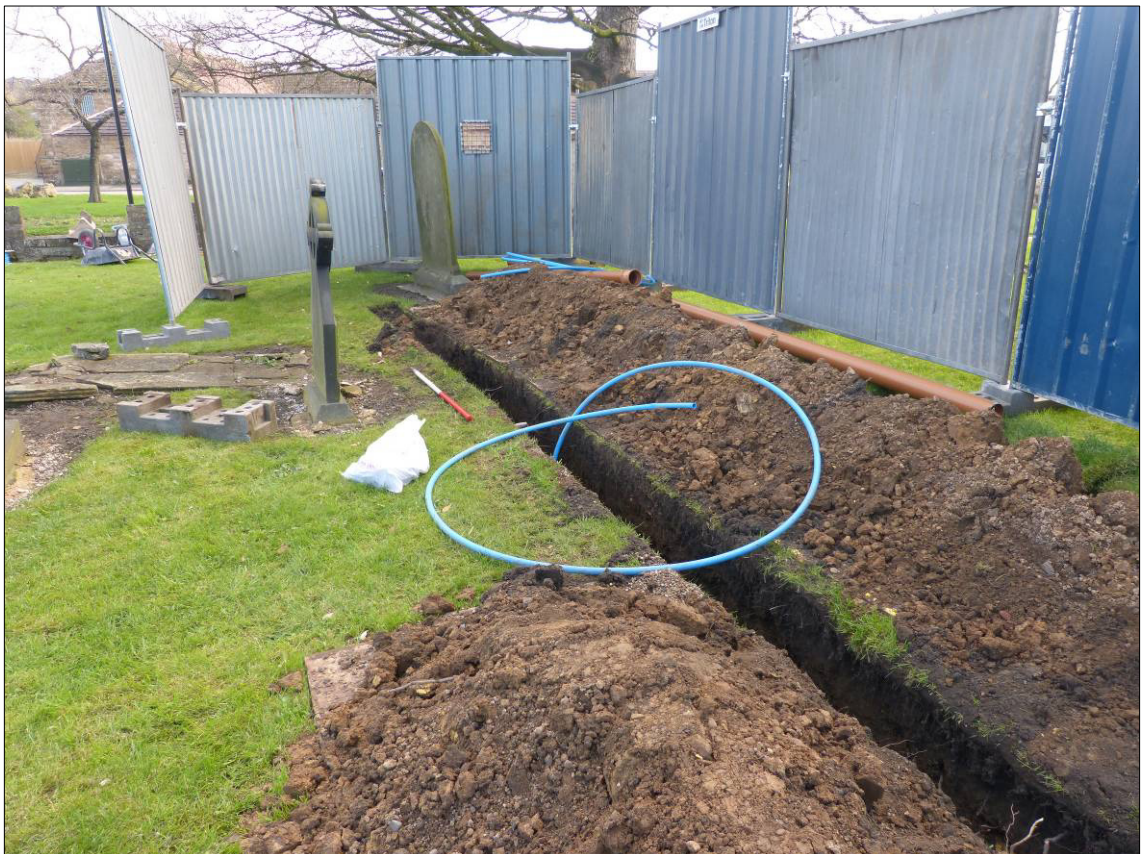
Plate 2: General view of drainage trench, central section, looking NE.

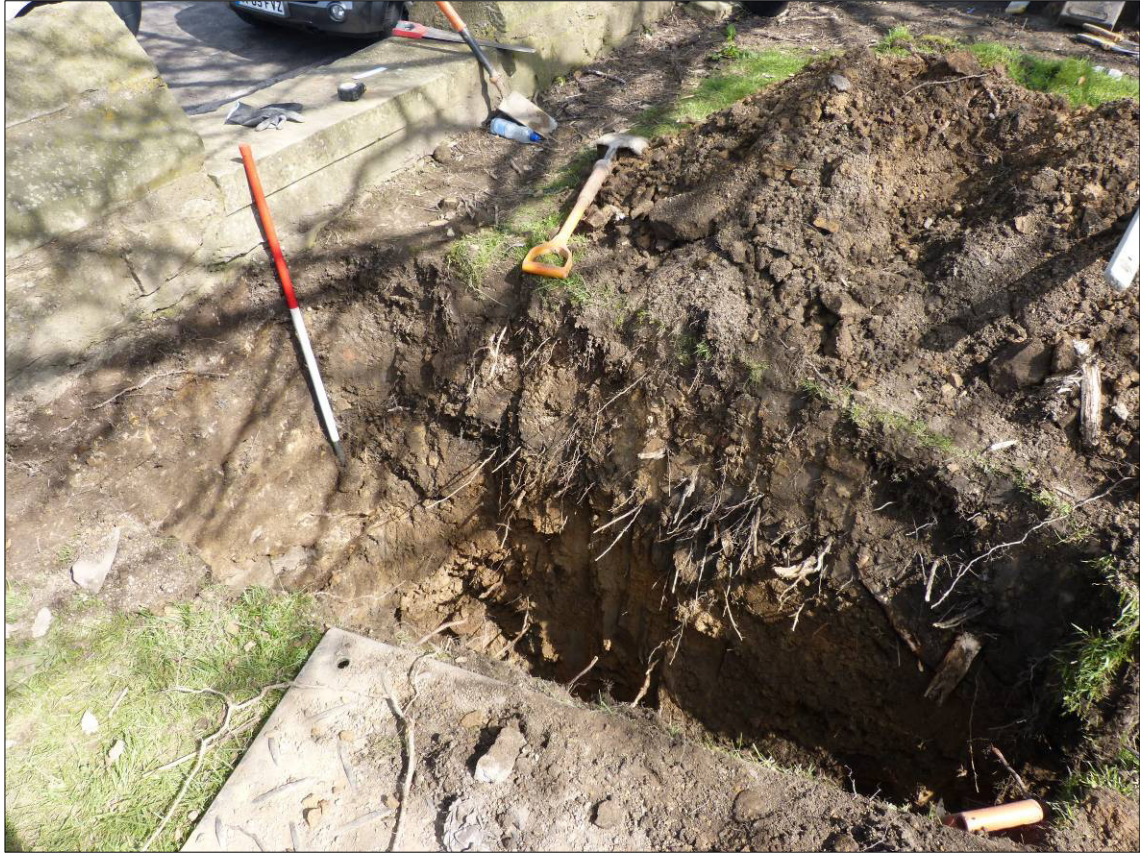
Plate 3: Inspection chamber, adjacent to churchyard wall, looking E.

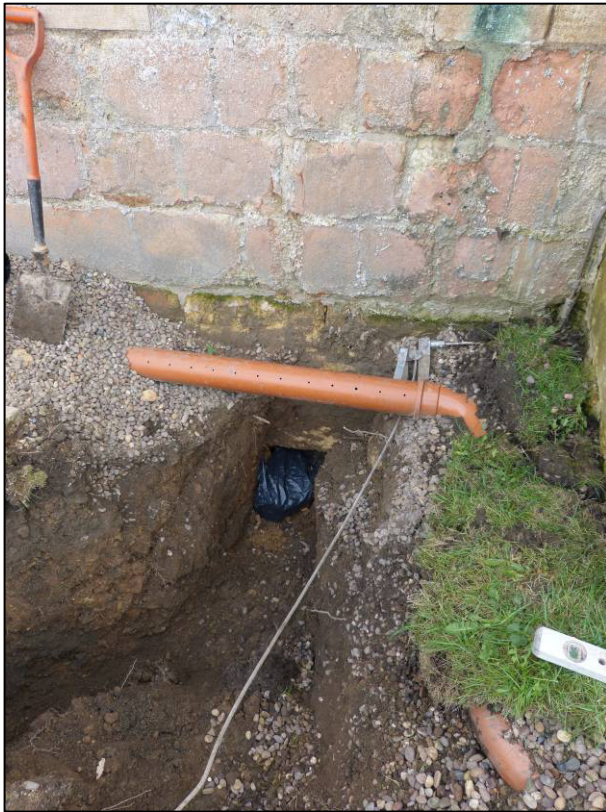
- 5.2 At the south-west end of the drainage trench, the footings of the tower were seen to comprise a further two courses of dressed stone below that which was initially visible, extending to 57.38m AOD (see plate 4). Below the lowest course of dressed stone, the wall face stepped out on average 0.08m and then continued as rubble footings, beyond the base of the trench (56.89m AOD). In the second inspection chamber at the north end of the drainage trench, the churchyard wall was seen to extend to 1.30m BGL (56.33m BGL), some 0.20m short of the base of the north face of the wall against the adjacent pavement. Below ground level, the face of the wall was rough, and battered outwards c.0.10m from top to bottom.

Plate 4: Tower footings in drainage trench, looking E.

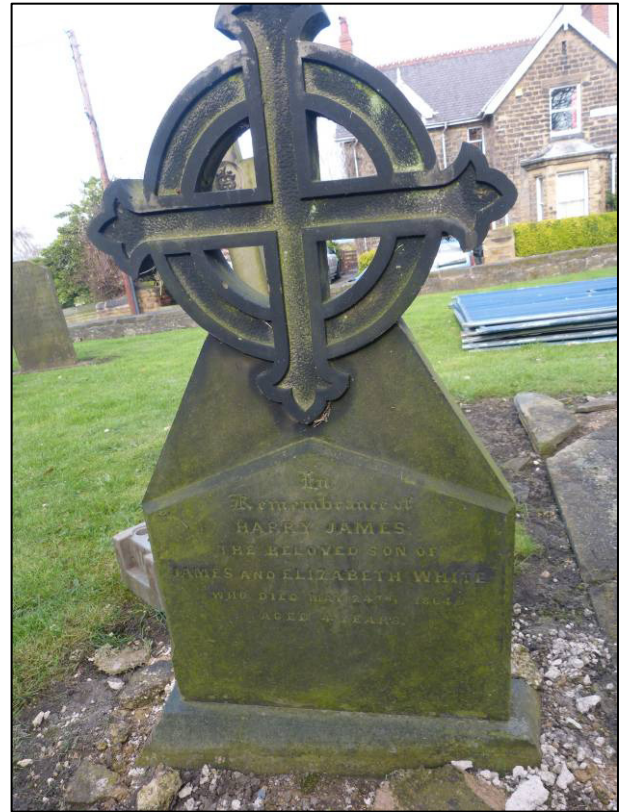
Plate 5: Headstone for Harry James (d.24th May 1864), looking W.
