ERECTION OF A SINGLE STOREY EXTENSION,
11 ALBERT TERRACE, BEVERLEY,
EAST YORKSHIRE HU17 8JU

ARCHAEOLOGICAL OBSERVATION,
INVESTIGATION AND RECORDING

Report no: 2019/592.R01
Version: Final
Date: November 2019
Author: Ed Dennison & Jim Fraser

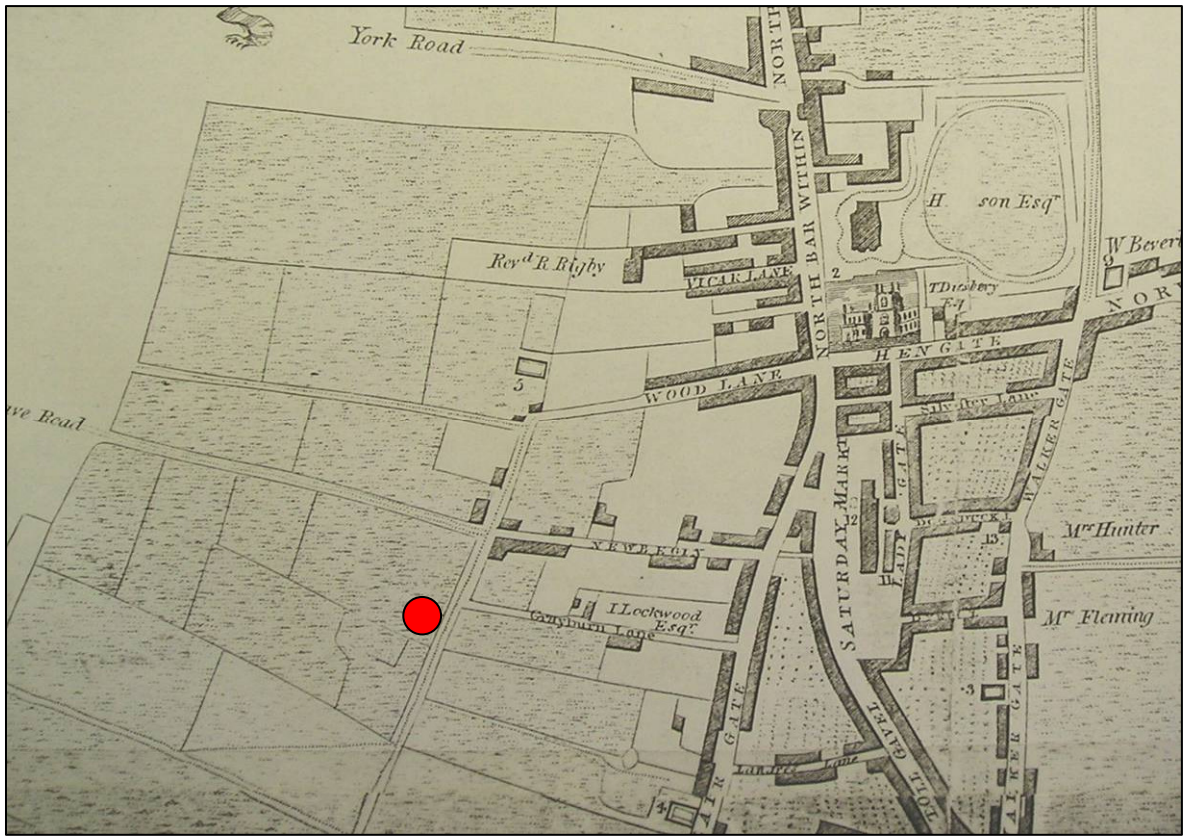
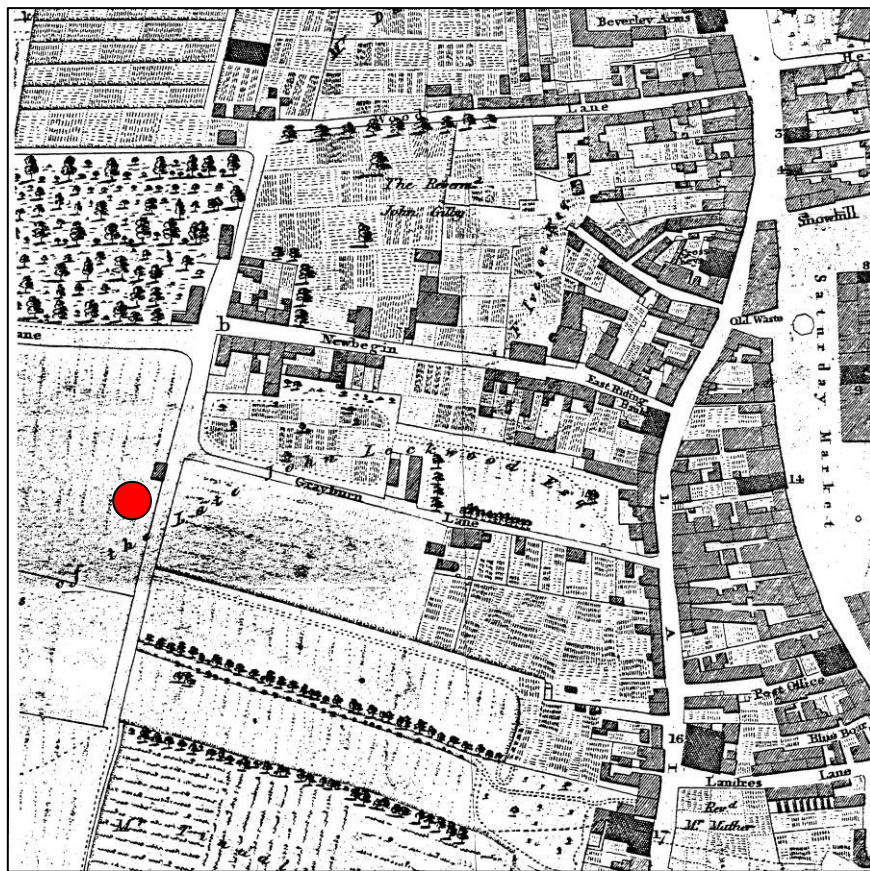
| EDAS | | FIGURE | 3 |

Top: David Hick's plan of Beverley, 1811.
 Bottom: John Wood's plan of Beverley, 1828.

Red circle denotes approximate site of 11 Albert Terrace.

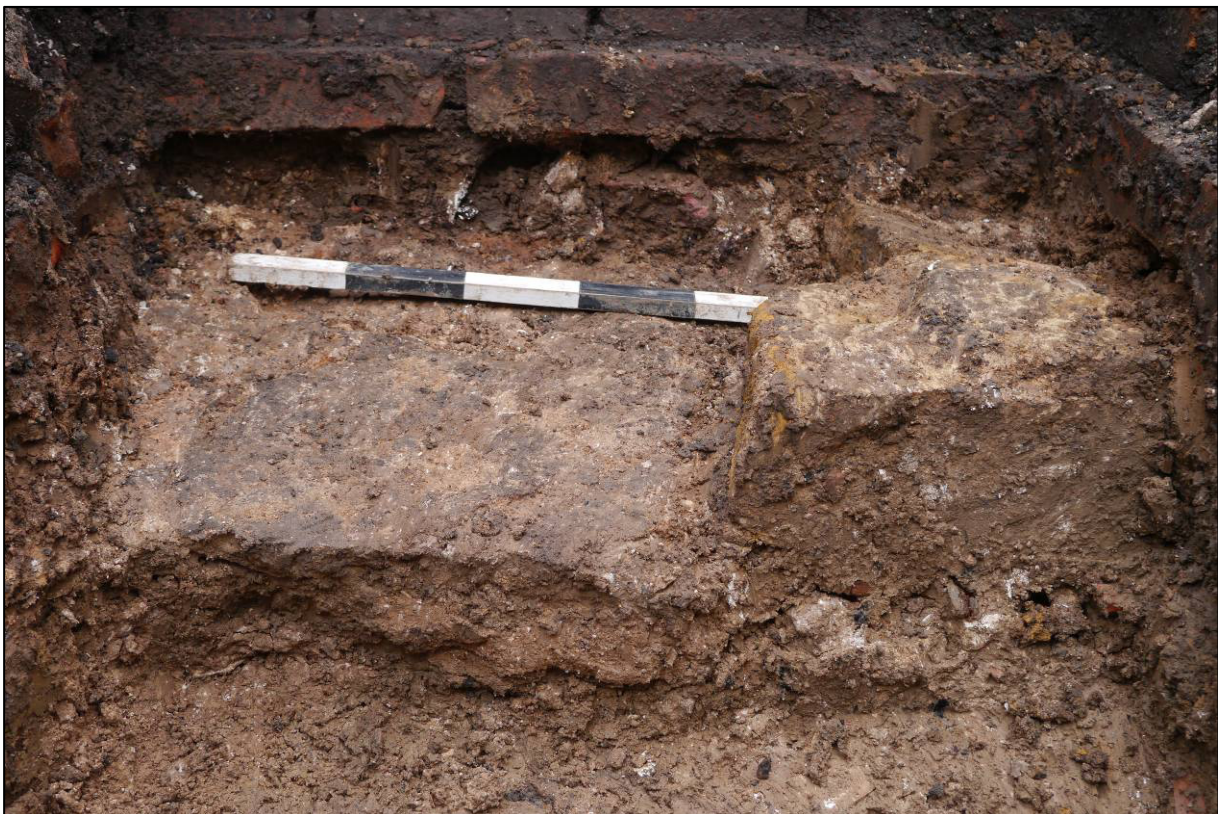
Plate 2: North end of Trench 1, stone wall or foundation (113), looking N.

- 5.3 Built on this consolidation deposit (114) was a 1.50m wide, roughly south-west/north east aligned wall foundation (113/303/314/315), constructed of roughly hewn chalk and limestone blocks measuring up to 0.40m long by 0.15m thick, bonded with a sandy mortar (304) (see plans 3 and 7, and sections 3 and 5). This foundation/wall, the top of which was encountered 0.25m BGL (13.20m AOD), was up to two courses (0.25m) high and extended 0.70m into the trench before terminating (see plate 2). No evidence for any construction cuts was exposed. The foundation had to be removed to allow construction to proceed (see plate 6).

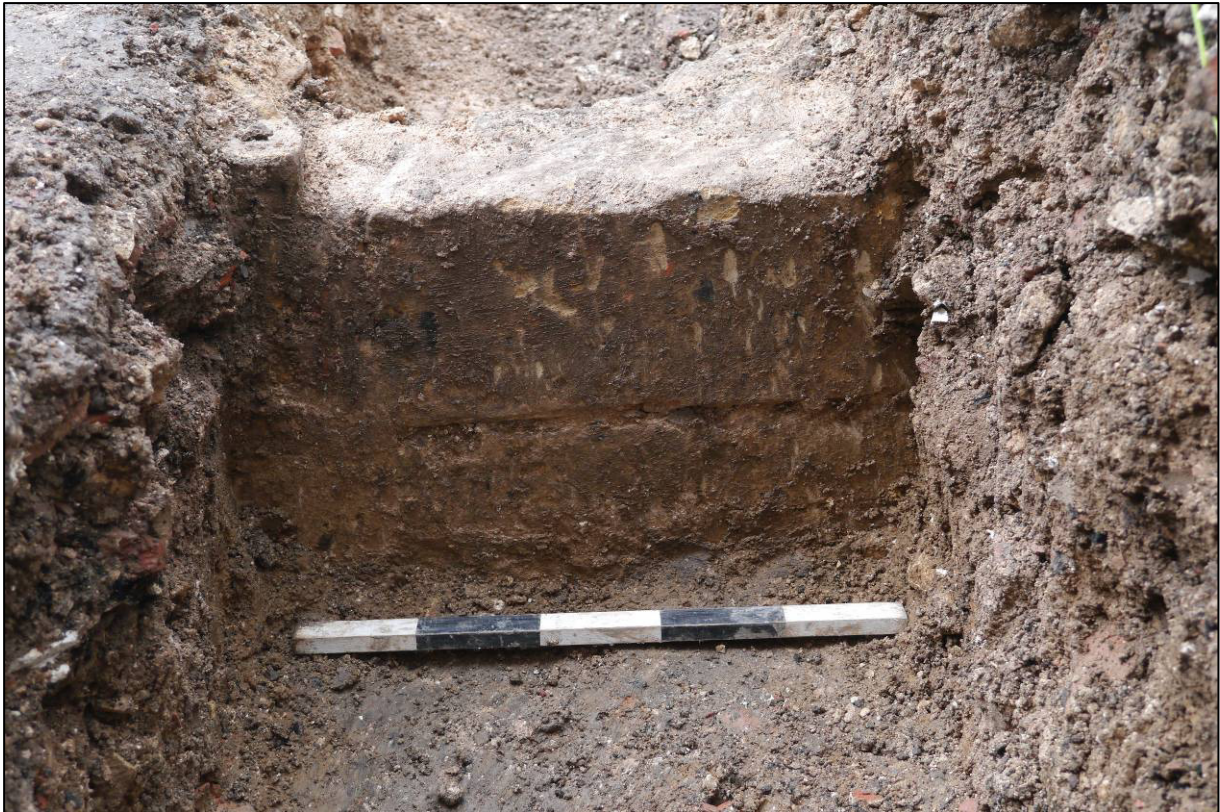
Plate 3: Trench 3, re-used ashlar wall foundation (305), looking W.

- 5.4 Towards the eastern end of Trench 3, a further wall foundation (305) over 0.75m wide and up to three courses high (c.0.40m) was exposed running north-west/south-east parallel to the larger foundation (113/303/314/315), which continued beyond the south and north edges of the trench (see plans 3 and 4). This second wall foundation (305) had been constructed of re-used masonry, including several dressed ashlar blocks measuring up to 450mm x 300mm x 200mm in size, bonded with a pale brown sandy mortar, the top of which was encountered 0.13m BGL (13.32m AOD); its full extent was not revealed although it was at least 0.75m wide, and it continued below the bottom of the trench (see plate 3). No evidence of any construction cuts was exposed. As the foundation (305) had to be removed for construction (see plate 6), three samples of the stonework were lifted and retained for further assessment (M1-M3); they displayed neatly squared faces, with fine claw-chisel, bolster/chisel tooling and coarse bolster/chisel tooling, suggesting a broad 13th to 15th/16th century date, while a very pale brown sandy mortar over all broken faces and surfaces indicated that the stone was reused (see Appendix 2 and plate 11).

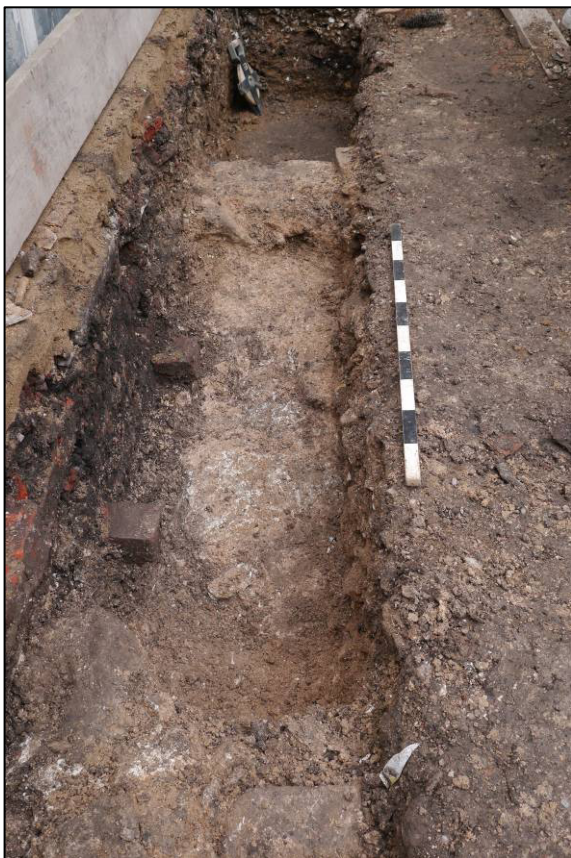
Plate 4: Trench 3, probable surface (307/309) between wall foundations (305 and 303), looking W.

- 5.5 A 1.90m long deposit of roughly hewn limestone and chalk fragments (307/309) extended across the area between the two wall foundations, with the larger stone fragments appearing more prevalent toward the top of the deposit (see plate 4). This deposit may have represented the remains of a possible surface between the two wall alignments, or perhaps rubble core or infill from another demolished foundation or wall.

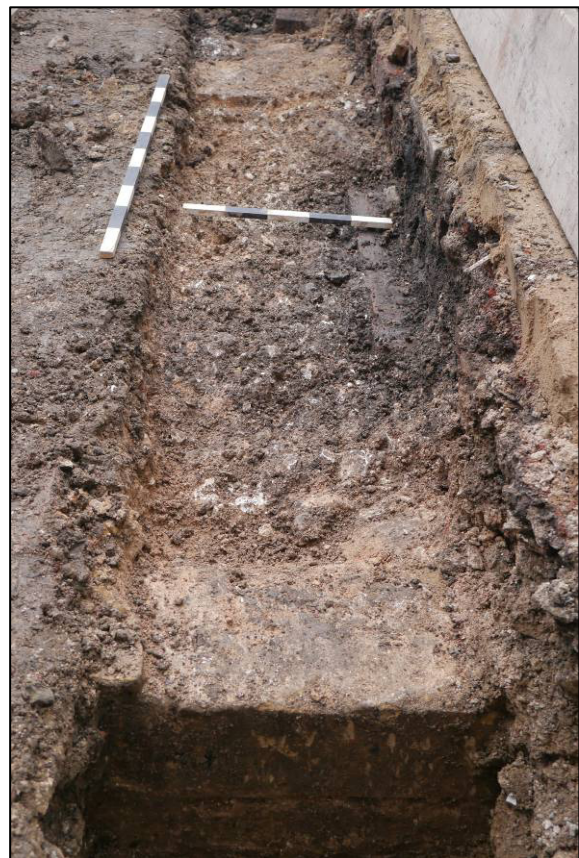
Plate 5: Trench 3, probable surface (301/308) between wall foundations (305 and 303), looking E.

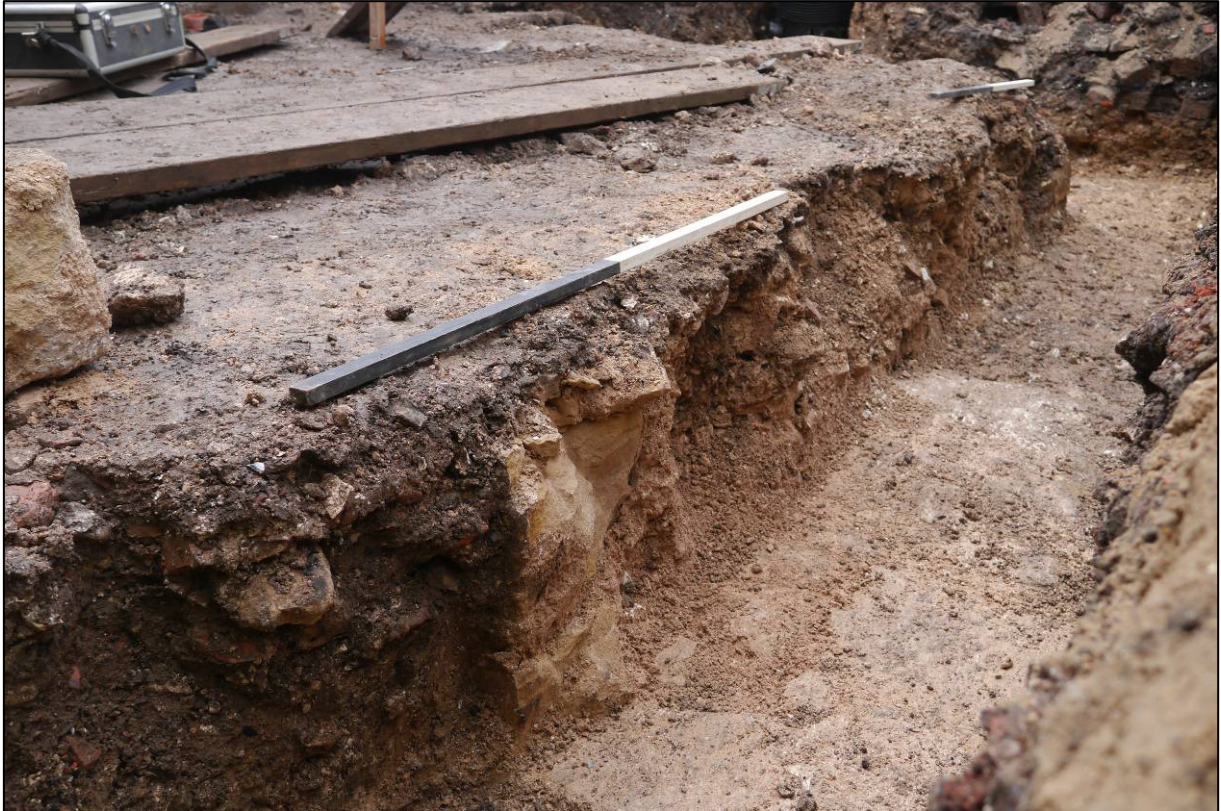
Plate 6: Trench 3, excavation complete, after removal of wall foundations (305 and 303) and associated deposits, looking SW.

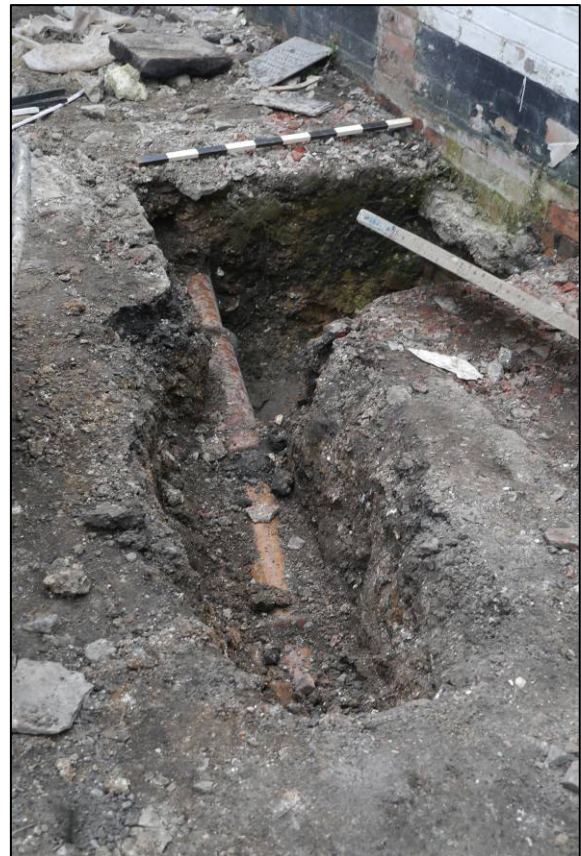
Plate 8: Trench 1, salt-glazed drain (118) and cut [117], looking E.

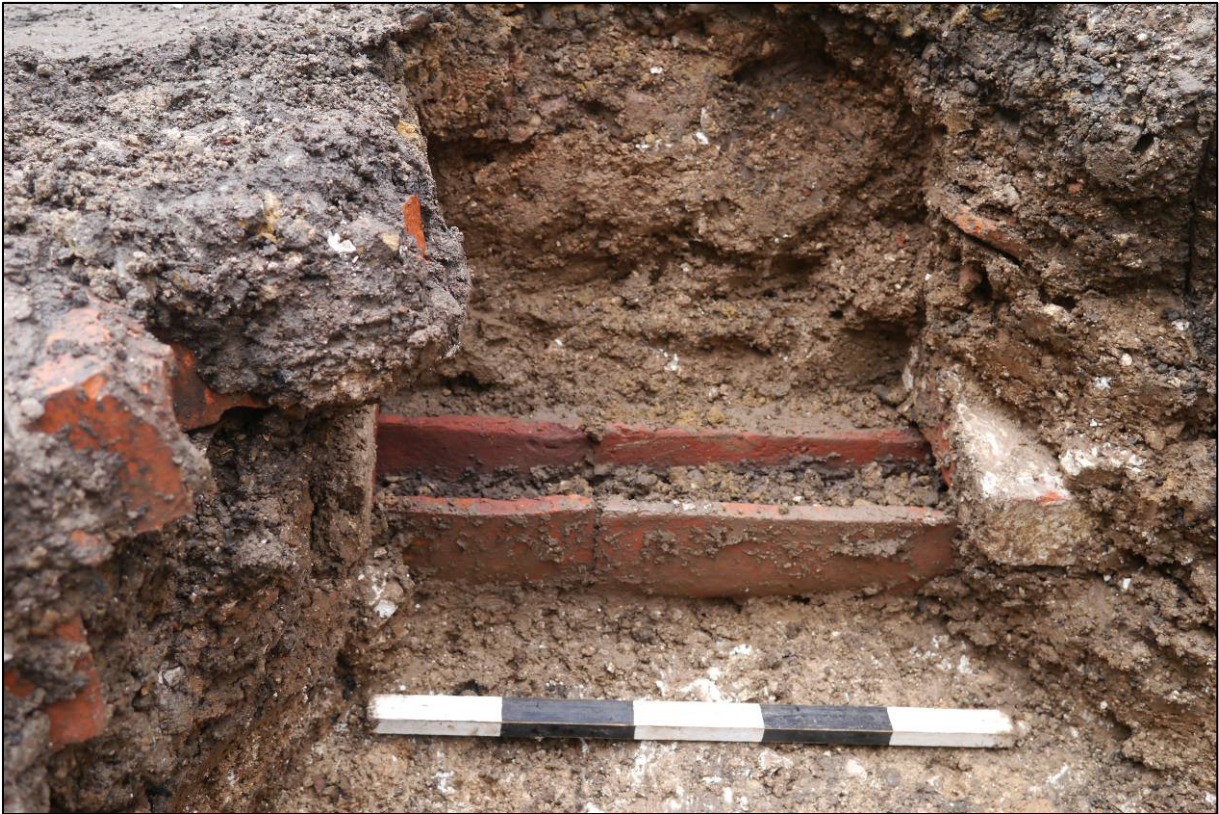
Plate 9: Trench 1, drain 110, constructed using inverted 19th/early 20th century land drains capped with 18th/early 19th century bricks, looking SW.

- 5.9 In Trench 1, to the south of the brick surface (105), an east-west aligned drain (110) was noted; this had been constructed using inverted 19th/early 20th century land drains capped with 18th/early 19th century bricks, and it truncated the earlier ground-raising deposit (122) (see plan 6 and plate 9). A similarly constructed drain (311) was exposed in the northern section of Trench 3, running along the line of the northern property boundary, and visible only in section (see section 5). This drain had been cut into a ground-raising deposit (312), 0.24m thick and composed of loose black clay silt with some small chalk fragments.

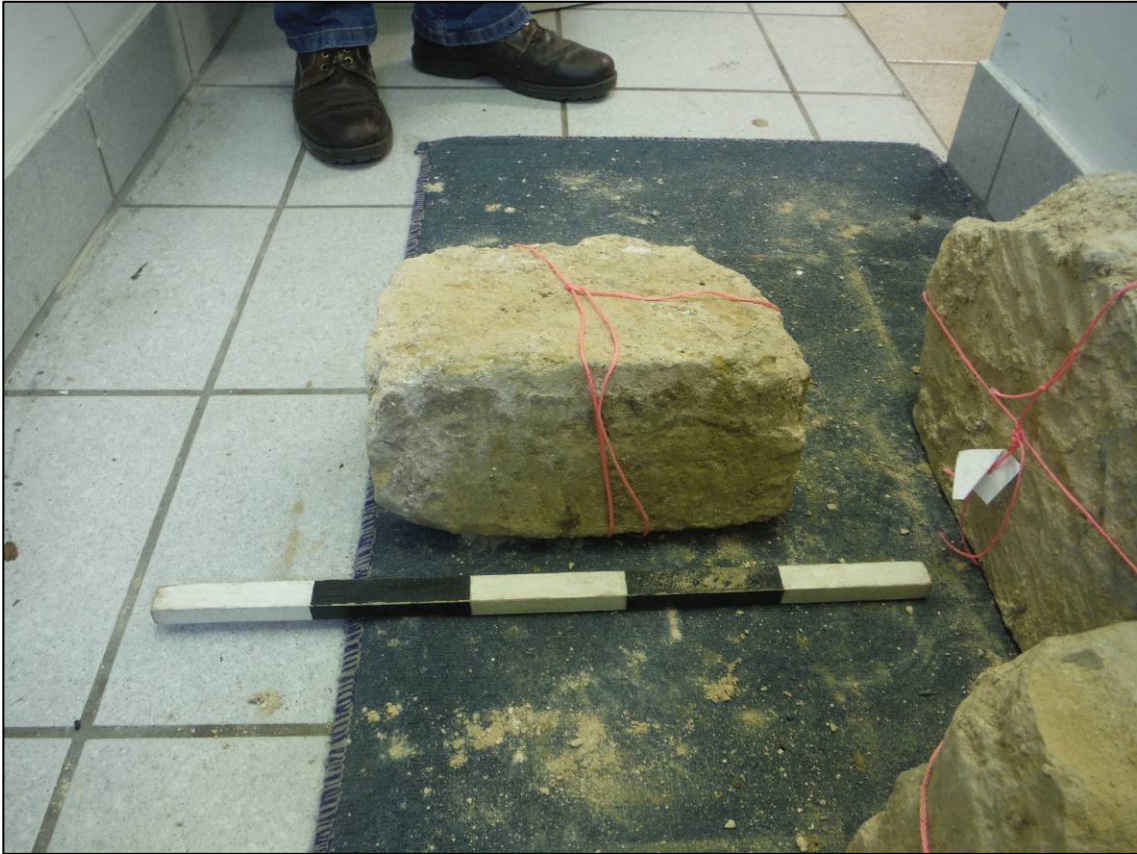
Plate 11: Ashlar M2 (Trench 3, 305) showing neatly squared display faces, with claw and bolster tooling and coarse, covered with very pale brown sandy mortar.

Ashlars M1-M3 (305) displayed neatly squared display faces, with fine claw-chisel, bolster/chisel tooling and coarse bolster/chisel? tooling. A very pale brown (10YR/7/3) sandy mortar was evident on all three examples, including over broken faces/surfaces; this would indicate re-use.

| Context | Masonry no. | Dimensions | Comments |
|---|---|--|--|
| 305 | M2 | Width (max.): 332mm Height: 112mm Depth/Thickness (max.): 252mm. | Ashlar. Limestone. Very Pale Brown (10YR/7/3) sandy mortar on all but the ?display face, including over broken surfaces. Heavily mortared on back face with inclusions of a fragment of un-worked limestone 112mm x 45mm x 6mm (max.) and a fragment of medieval flat-tile 105mm x72mm 15mm (max.). ?Display face: neatly squared. Fine claw-chisel tooling of vertical orientation. Top face: diagonal fine claw-chisel tooling and occasional coarse bolster/chisel tooling. Side faces: 1 face has fine claw-chisel tooling of vertical orientation. Opposing face has no original surfaces, damaged in antiquity (from re-use/salvage?). Bottom face: occasional diagonal coarse bolster tooling (where visible due to mortar adhesions). Back face: vertical coarse bolster/chisel tooling (where visible due to mortar adhesions). Damage to one corner in antiquity (from re-use/salvage?). |

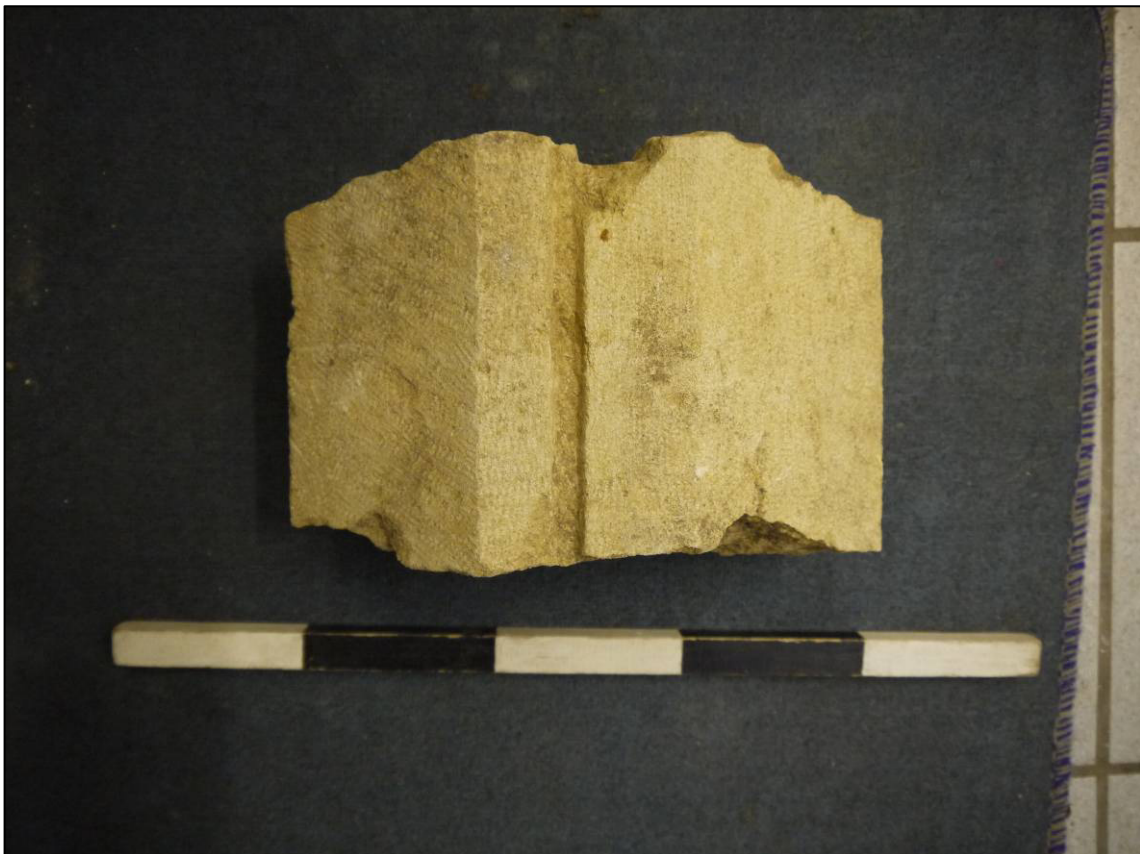
Plate 12: Ashlar M4 (mullion from Trench 1, 119), showing internal and external chamfers and vertical grooves for glazing bars.

The chamfered mullion from (119), M4, was of very good quality, with an internal and external chamfer and central vertical grooves for glazing bars. All original faces were dressed with very fine claw-chisel tooling; the top and bottom faces were broken/damaged in antiquity. A similar example (as described) dated between 14th to 16th centuries was noted at Low Friars to the west (Rawson 2012, 13-14) and at no. 3 Albert Terrace to the north, an example was re-used within a 19th century boundary wall (George 2003, 4).

| Context | Masonry no. | Dimensions | Comments |
|---|---|--|---|
| 119: = 405 | M4 | Width: 30mm to 140mm Height: 178mm Depth/Thickness: 271mm Glazing Bar Groove: Width: 13mm x Depth: 7mm | Chamfered mullion. Fine-grained limestone. Internal and external chamfer. Central, vertical rebate for glazing bars on opposite faces. With the exception of the top and bottom faces which are damaged in antiquity (from re-use/salvage?), all faces dressed with very fine claw-chisel tooling of diagonal and vertical orientation. |
