GRINTON LEAD SMELTING MILL,  
COGDEN GILL, SWALEDALE,  
NORTH YORKSHIRE

ARCHAEOLOGICAL INVESTIGATION AND  
RECORDING DURING  
INTERNAL CLEARANCE WORKS

Report no: 2019/588.R01  
Version: Final  
Date: October 2019  
Author: Shaun Richardson, Richard Lamb & Ed Dennison

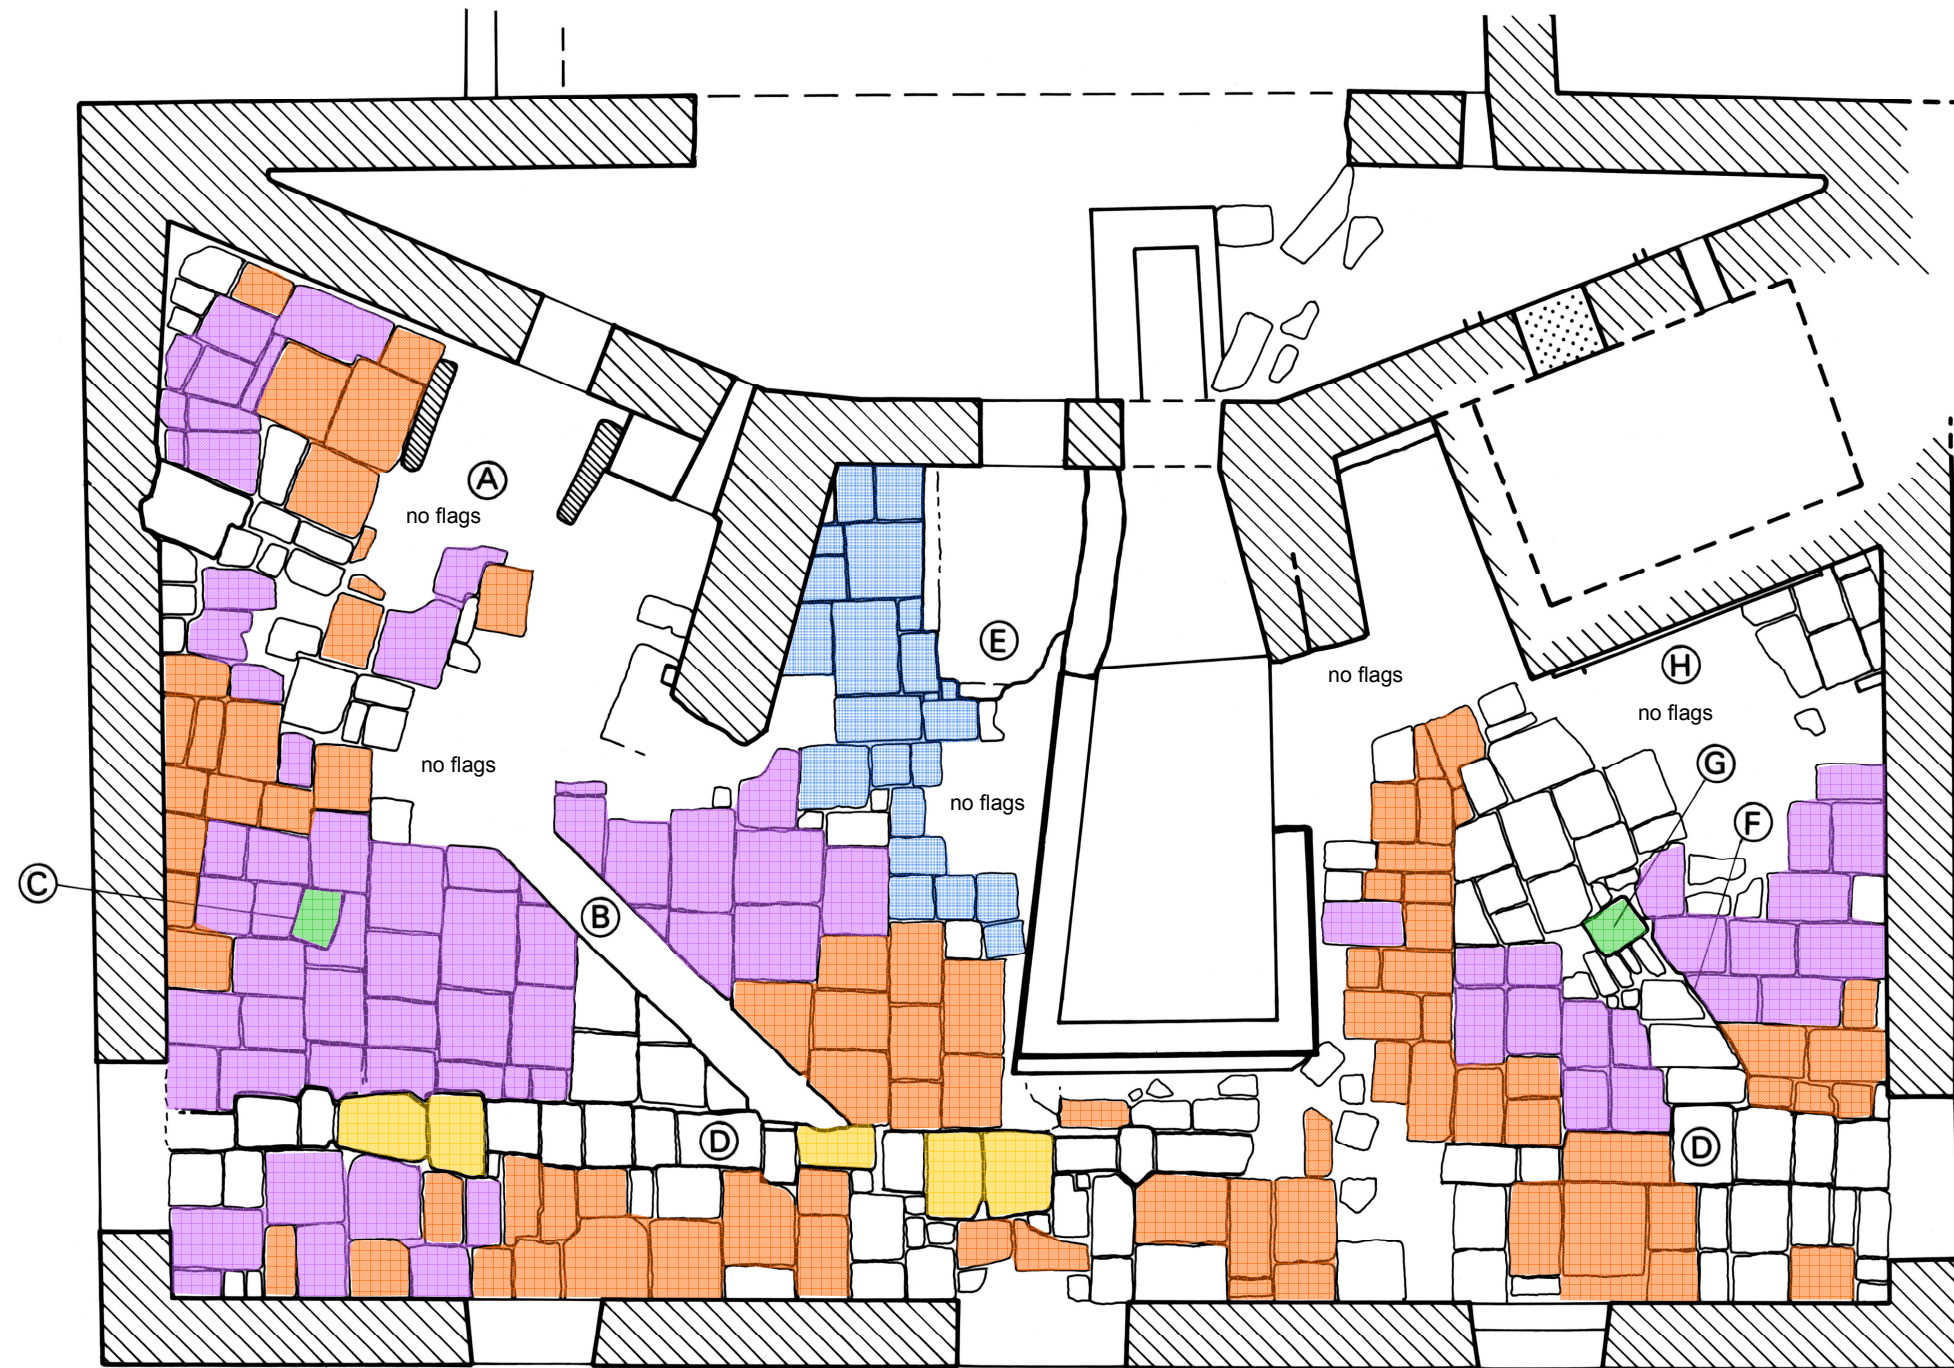
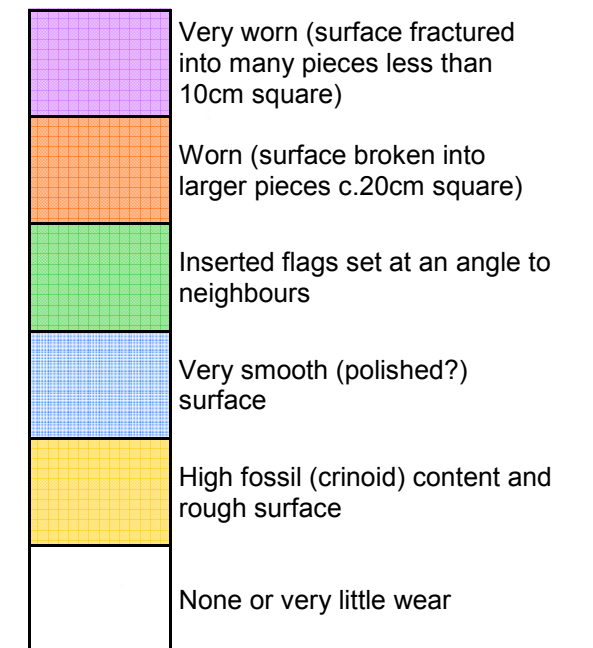
PROJECT GRINTON LEAD SMELTING MILL	
TITLE WEAR ON FLAGSTONE FLOOR	
SCALE AS SHOWN	DATE OCT 2019
EDAS	FIGURE 7

- Features
- (A) Western ore hearth
  - (B) Trench or channel
  - (C) Inserted flag stone
  - (D) Covered culvert or drain
  - (E) Central ore hearth base
  - (F) Edge of trench or channel
  - (G) Inserted flag stone
  - (H) South elevation of slag hearth

- 3.7 In the following description of the exposed flagstone floor, a number of features have been assigned unique letter identifiers (e.g. (A), (B) etc). In addition, the flags have also been colour-coded depending upon the amount of wear they display (with the least worn displaying little or no wear, and the most worn being broken into numerous pieces less than 0.10m across), how they are dressed, and their geological make-up. These various aspects of the floor are brought together in the later Discussion and Conclusions chapter to consider how they contribute to any interpretation of the building's history.

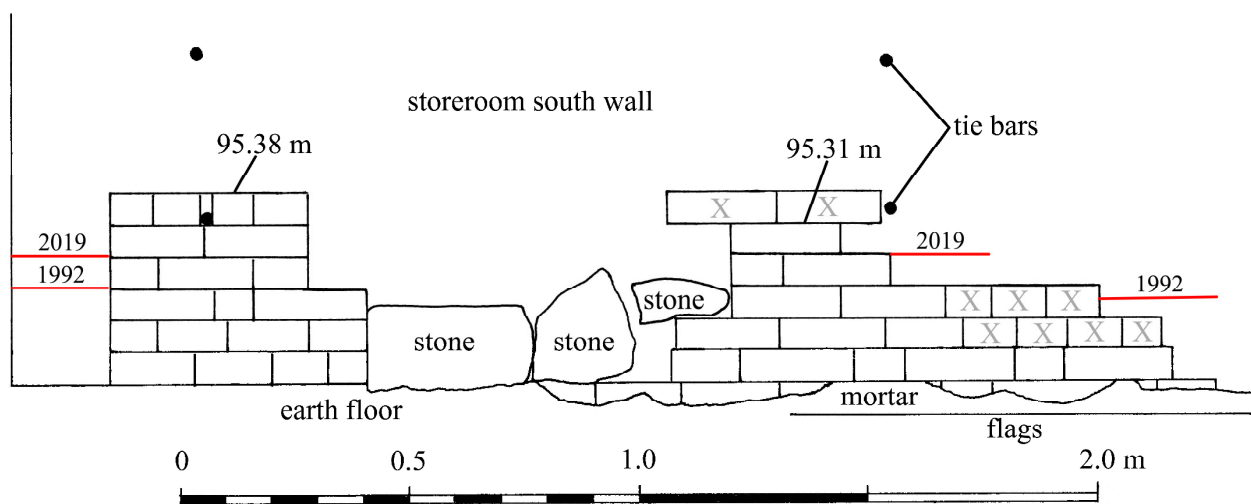
PROJECT		GRINTON LEAD SMELTING MILL	
TITLE		REMAINS OF SLAG HEARTH	
SCALE	AS SHOWN	DATE	OCT 2019
EDAS		FIGURE	8

Shows the remains of the slag hearth, displaying the freshly-exposed firebricks, the positions of the four tie bars, the approximate heights of floor coverings at the dates shown (2019 prior to clearance), the set-back rows of bricks marked with a pale grey X, and the cleared floor levels.

- 4.6 The exposure of the lower parts of the eastern slag hearth, previously unseen, has produced significant new information. The height of the lower tie-bar from the floor compares well with that shown by Percy (1870, 412-416), and the partial infilling across the front (incomplete on the right-hand, east, side) by the lower three courses of bricks may reflect the provision or location of reinforcement for the cast-iron bearers that supported the inner walls. The lowest course of brickwork, i.e. the foundations, may in fact run right the way across between pillars, although it was obscured by the remaining earth floor in this area. What the brick extension to the east of the slag hearth actually represents is unknown at present, but the remains here demonstrate yet another variation on a theme in slag hearth design and operation. Nationally, this subject has suffered from lack of research, caused principally by the almost total lack of surviving components. Although the later 'store room' walls and internal rubble infill built over the slag hearth at Grinton now disguise the extent to which it does survive, it retains the potential to be one of the best, if not the best, surviving examples of a slag hearth in the entire country.

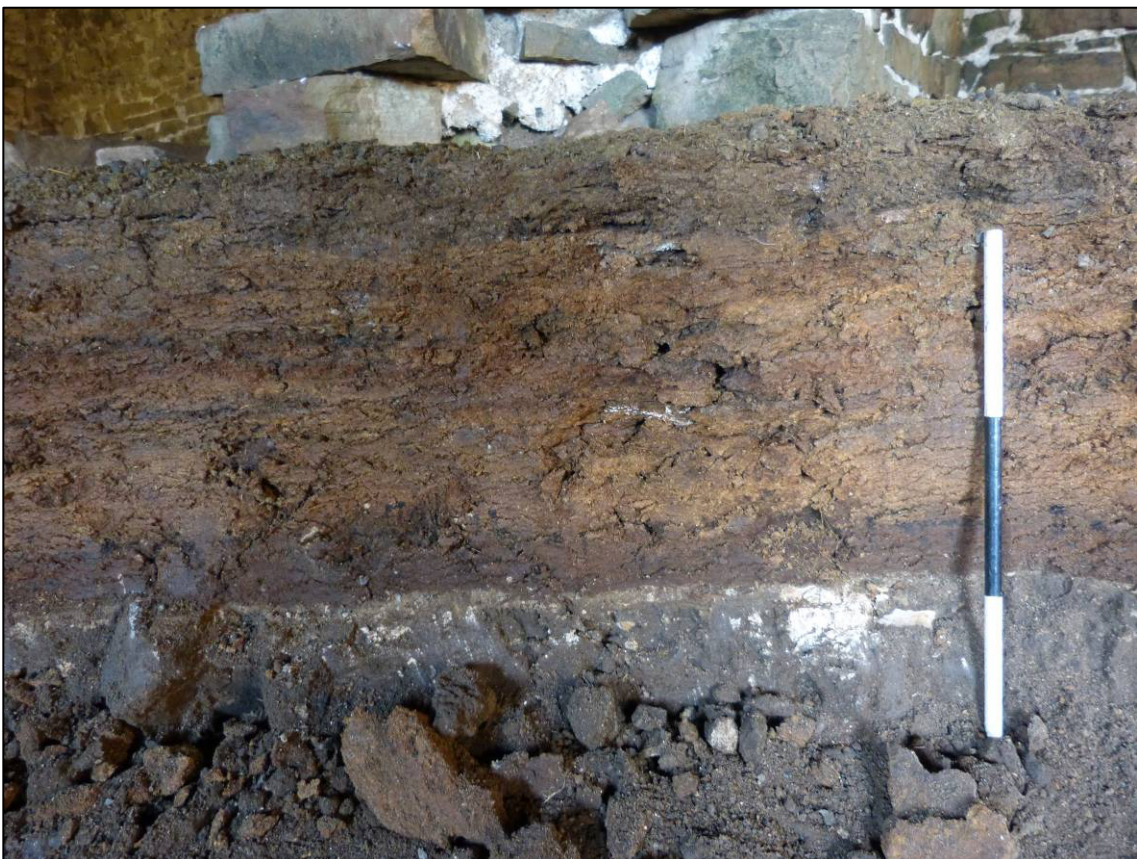
Plate 6: Furnace Room, during clearance, typical section through compacted sheep manure and soil, looking N (photo 1/215).

- 3.3 The deposits recorded during the clearance compared closely to those exposed during the previous survey work in 1996 (Dennison 1998, 19-21). Then, in the furnace room, a single sondage revealed four separate layers of compacted sheep manure or soil, with a total depth of between 0.25m to 0.28m, overlying a flagstone floor. Simple augering suggested that the flagstone floor implied by Clough to exist across the entire furnace room remained in place. Within the bellows room, three sondages were excavated in 1996. One, placed over the wheel pit, found no evidence for the side of the wheel pit and demonstrated that infill extended to more than a depth of 0.50m BGL. One of the other two sondages produced evidence for a possible cobble and rubble floor at 0.15m BGL. Augering suggested that a hard surface was present at depths of between 0.15m and 0.20m BGL across parts of the bellows room. The stone slab on which the western timber uprights of the bellows frame rested was revealed, and augering suggested that a similar slab was present between the eastern timber uprights at a depth of c.0.15m BGL. The slab beneath the western uprights was exposed again as part of the current clearance works, but then re-covered [3/361]. Other than this, only a very small amount of clearance work was undertaken in the bellows room, comprising minor levelling by raking the soil/manure surface [4/180-4/183] (see plate 7).

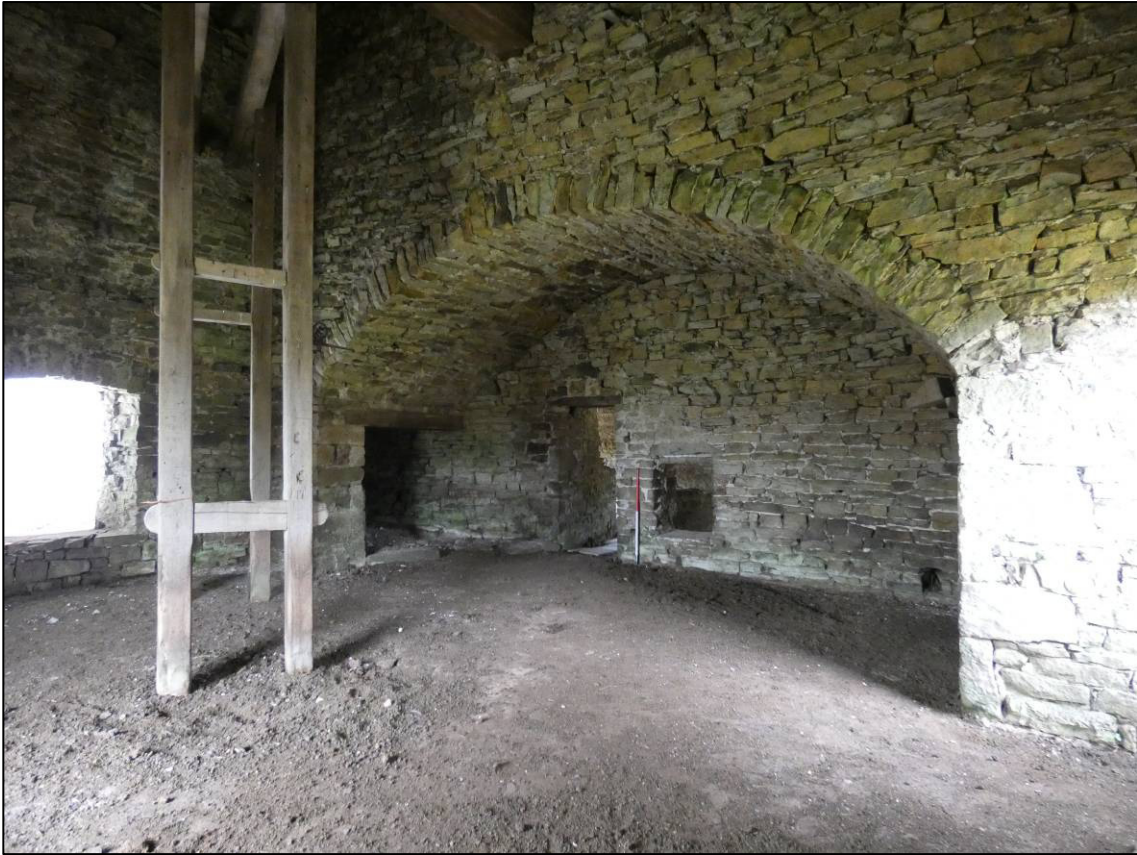
Plate 7: Bellows Room, after limited clearance, looking SE (photo 4/180).

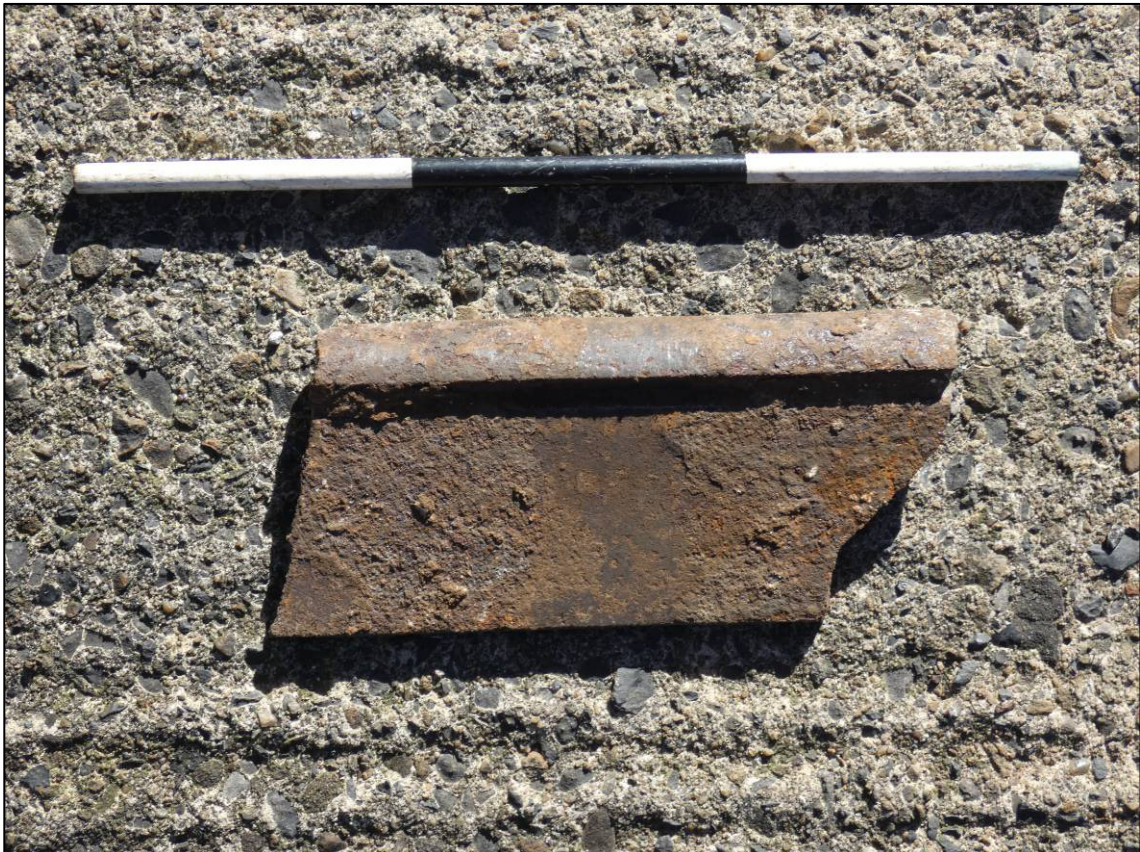
Plate 8: Cast-iron plate, with curved profile to one side, recovered during excavations (photo 5/241).

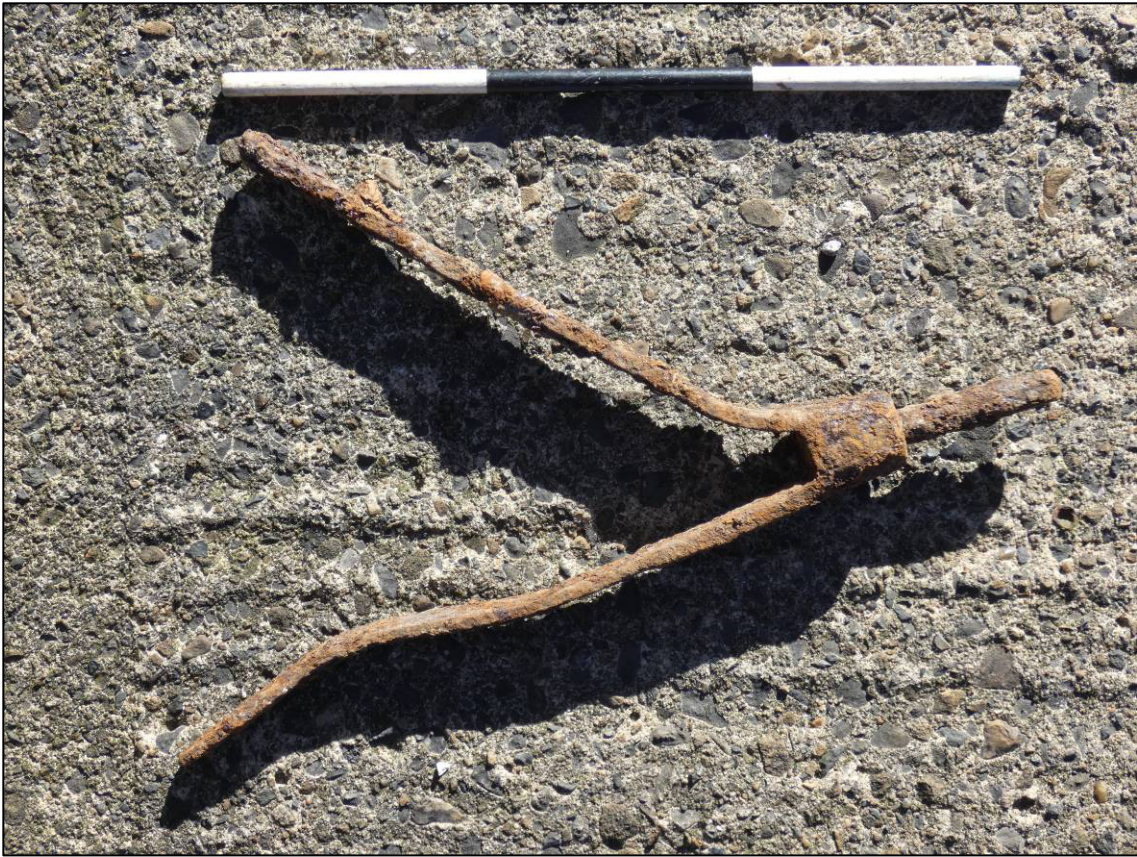
Plate 9: Wrought-iron artefact, possible bifurcated stay, recovered during excavations (photo 5/239).

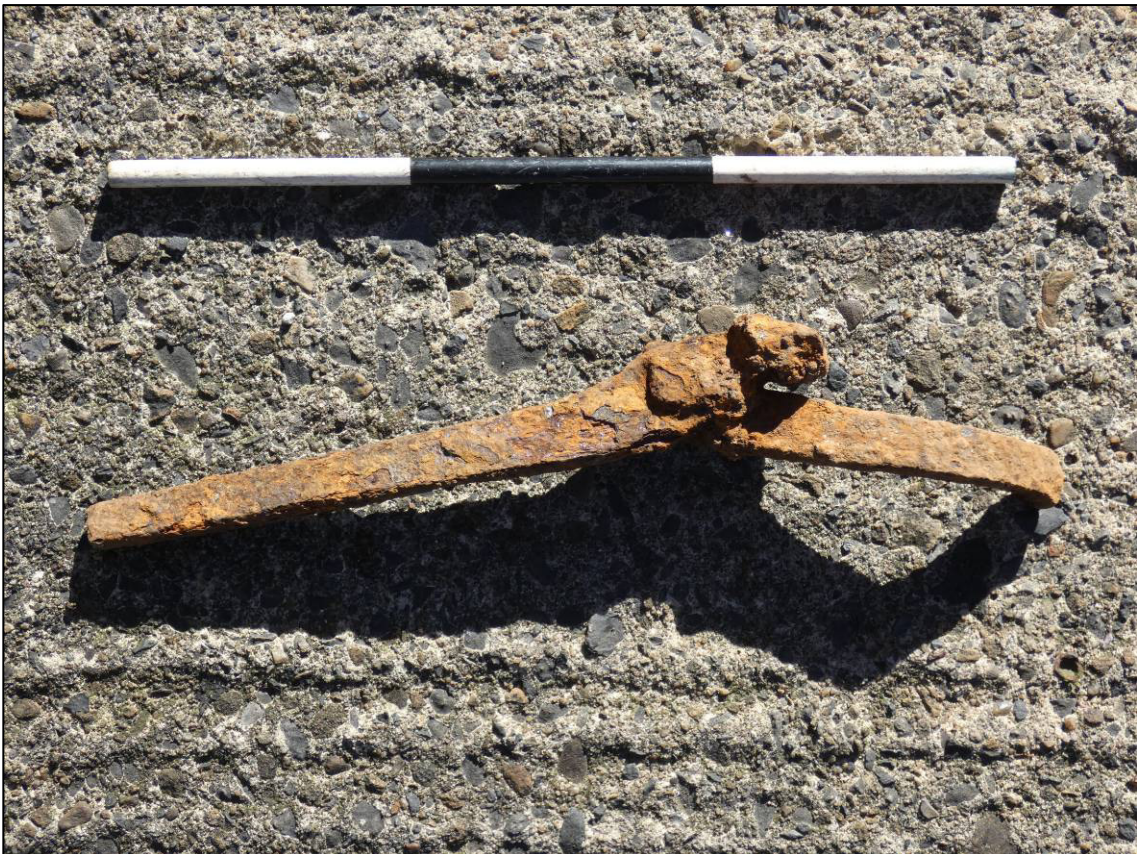
handles are connected by a short bolt held in place by hexagonal nuts [5/240] (see plate 10). Only one handle retained its head, which is also flattened and square in plan, so that it grips rather than cuts. Finally, from the general clearance, a piece of a cast-iron bar was recovered, measuring 0.345m by 0.15m by 0.05m. It was rectangular in cross-section, with rounded edges, and with a fracture across one end. None of the ironwork has an obvious connection to lead smelting, and the two cast-iron pieces do not resemble any of the iron components that would be expected from either an ore hearth or a slag hearth (Richard Lamb, *pers. comm.*).

Plate 10: Wrought-iron artefact, possible two-handed tool or tongs recovered during excavations (photo 5/240).

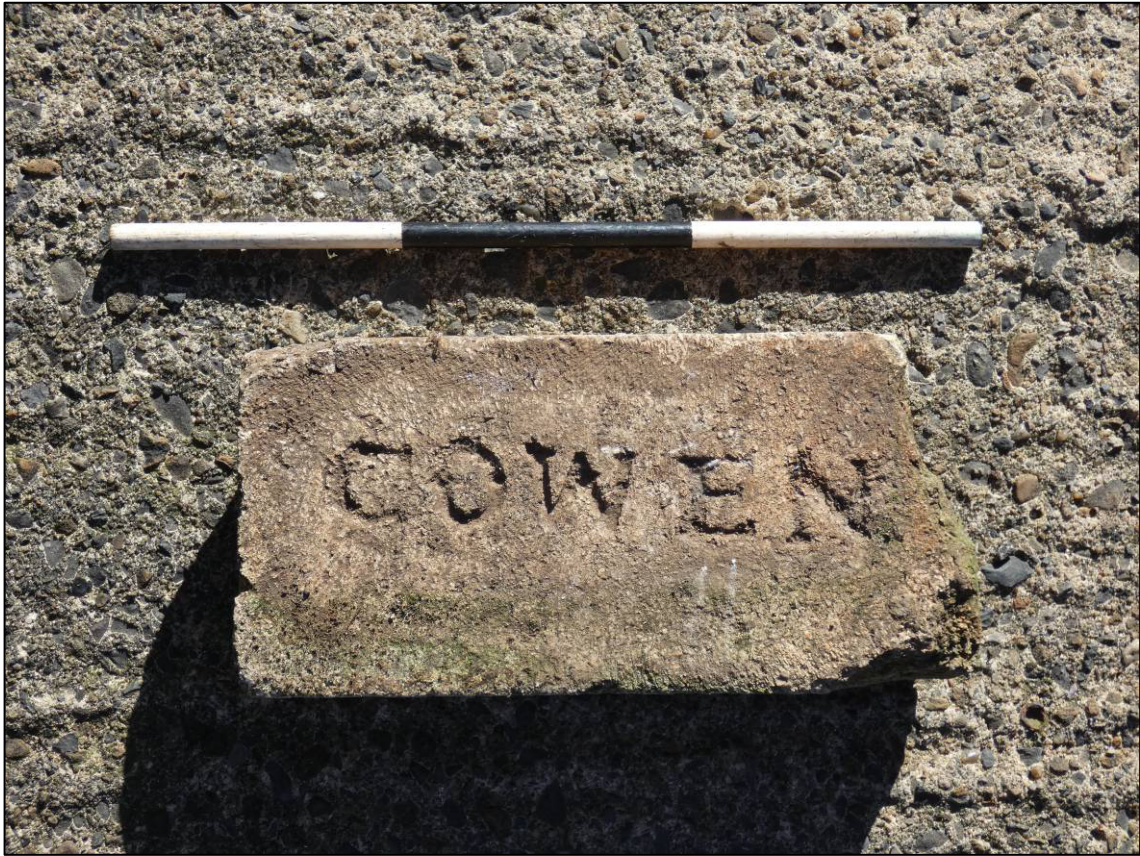
- 3.5 Three firebricks were recovered from very close to the position of the slag hearth. Each was hand-moulded, yellow in colour, and with average dimensions of 230mm by 115mm by 60mm. One bears the stamp 'COWEN' [5/236] (see plate 11), which refers to Joseph Cowen and Company, who operated brickyards at Blaydon Burn on the outskirts of Newcastle-upon-Tyne from the 19th century up to the 1960s (Sallery 2019; Veitch 2019). The second bears the stamp 'N CAP' [5/237] (see plate 12), which refers to Newton Cap Colliery and Brickworks, near Bishop Auckland, County Durham. A firebrick works was set up here in the early 1880s by Henry Stobart and Partners, and it continued to operate into the 1980s, by which date it was owned by the Hepworth Iron Company (Sallery 2019). The third brick is stamped 'L & M' [5/238]; it has not been possible to trace the maker, but it is most likely a North-East brickyard, probably associated with a colliery.

Plate 11: Hand-moulded firebrick, stamped COWEN, recovered during excavations (photo 5/236).

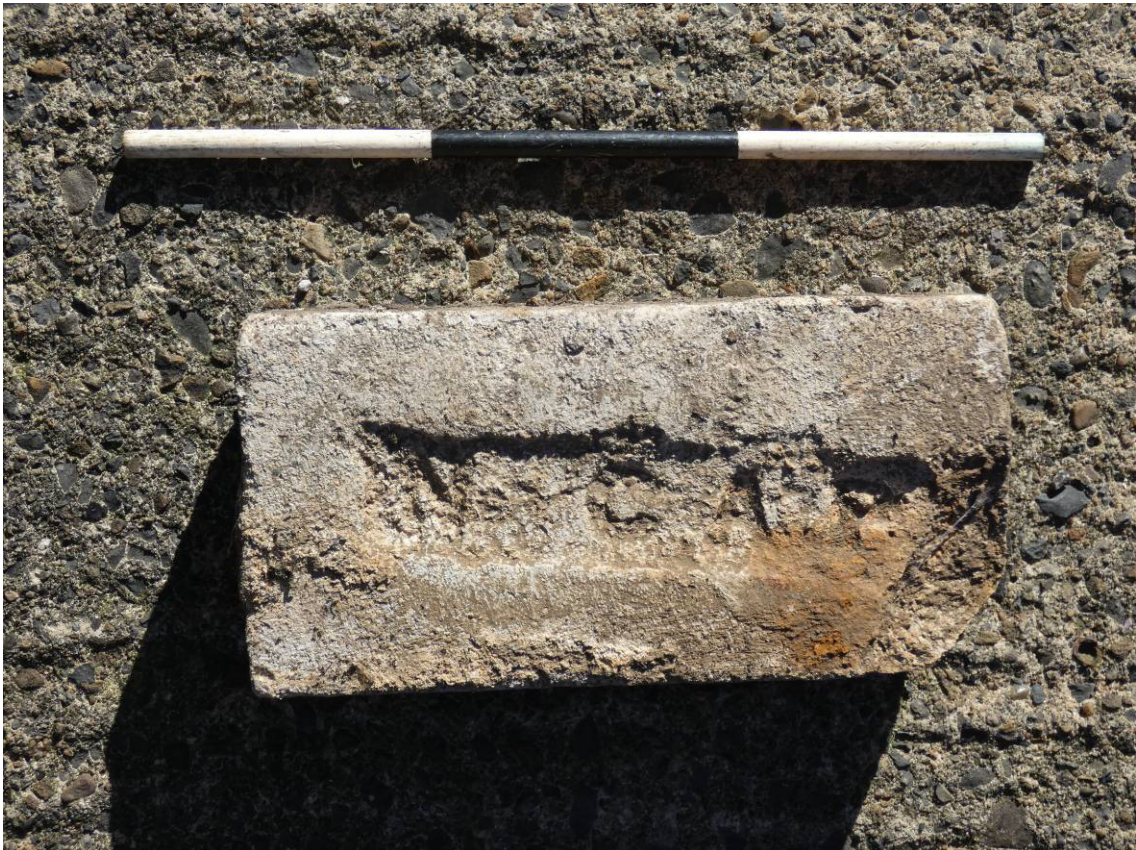
Plate 12: Hand-moulded firebrick, stamped N CAP, recovered during excavations (photo 5/237).

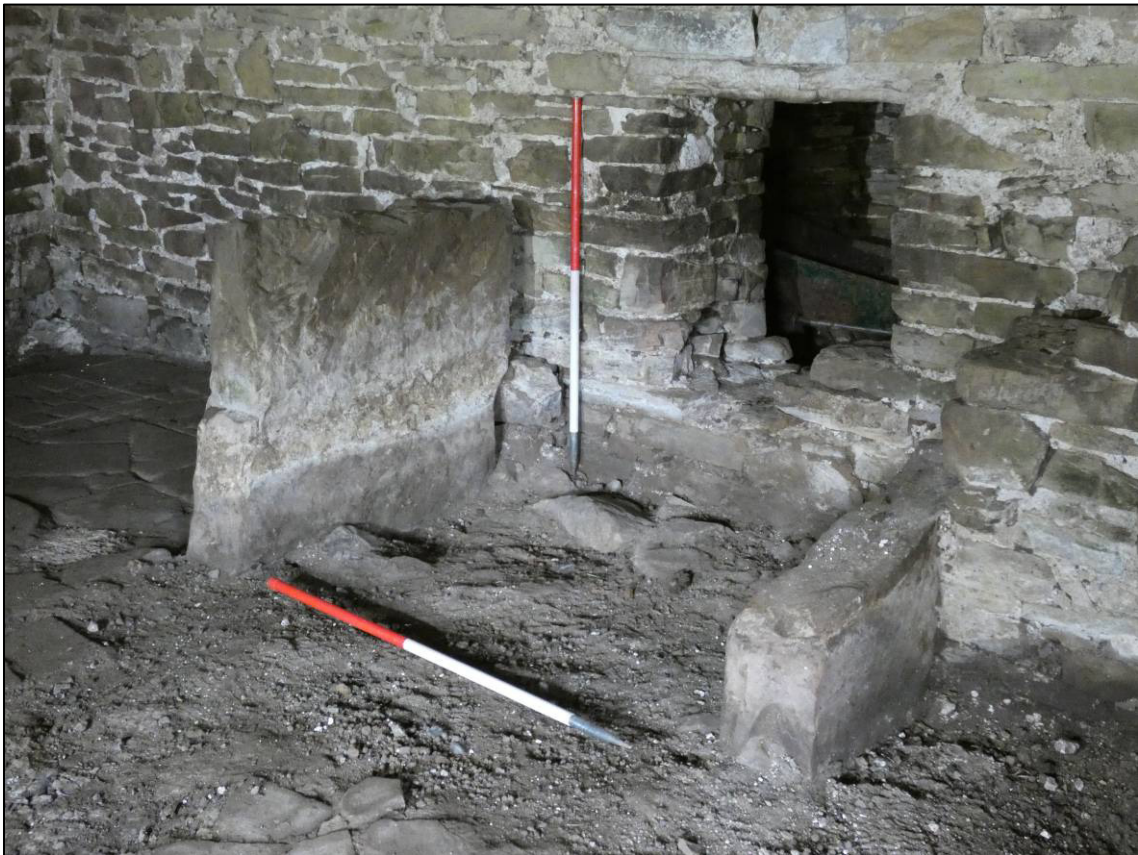
- 3.10 Starting at the north-west corner, to the west of the western keeper stone of the western ore hearth (A), there is an area of worn and very worn flags which run parallel to the tuyère cross wall forming the rear of the furnace arch here. However, at their south-west corner, there is a small area of very worn flags which run parallel to the west wall of the furnace room [4/147, 4/148]. These are bounded to the south by a blank area marking the former west side of the furnace arch. The east side of this furnace arch is marked by a spread of footings with a mortared surface. Unfortunately, nothing of the structure of the ore hearth itself survived, although the keeper stones were exposed to a greater height than previously, the western one being 0.85m high and the eastern one being 0.40m high [4/140-4/144] (see plate 14).

Plate 14: Western ore hearth in furnace room, after clearance and cleaning, looking NW (photo 4/142).

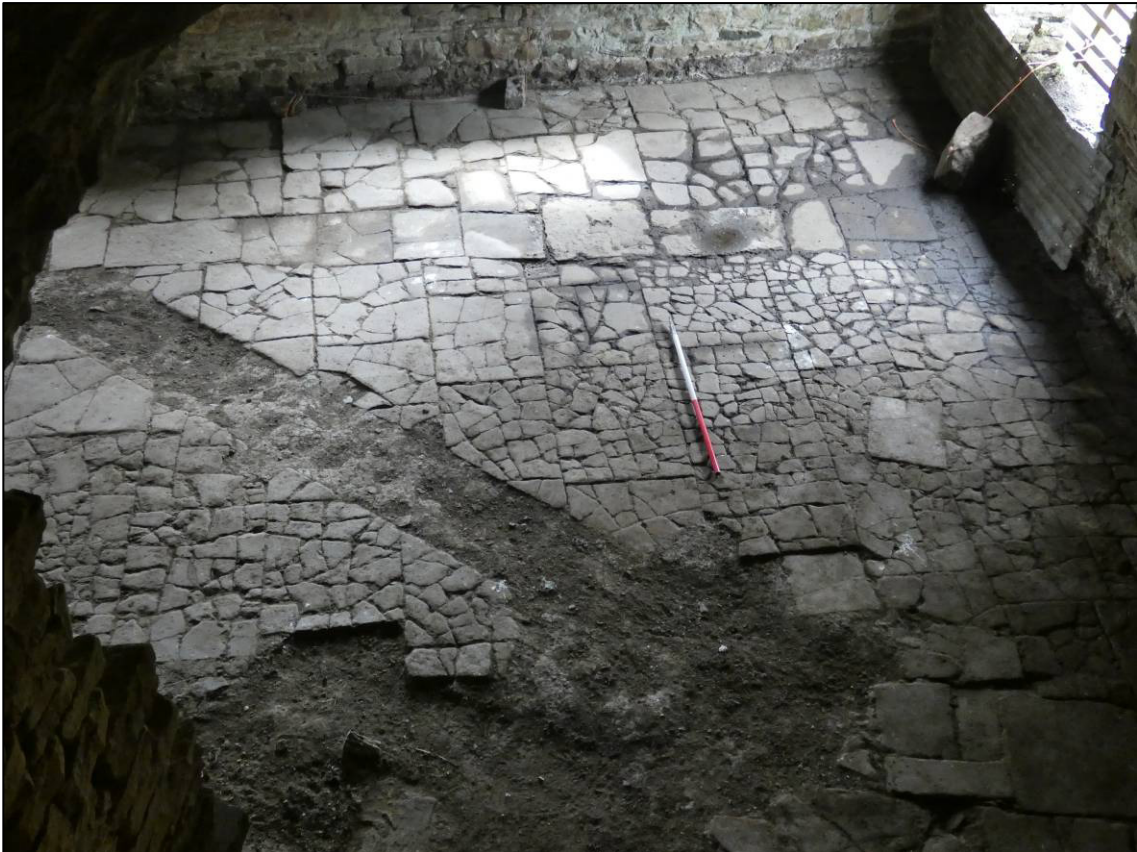
- 3.12 Moving south, the south-west part of the furnace room's floor comprises a large expanse of worn or very worn flags running in north-south lines broadly parallel to the west wall [4/131, 4/138, 4/166, 4/169, 4/170], although a narrower area adjacent to the west wall run east-west instead. The very worn flags are concentrated in a band starting adjacent to the doorway at the south end of the west wall and then running east [4/133, 4/134]. The floor in this area contains two features of interest. The most prominent is a north-west/south-east aligned trench or channel (B), running from the area south of the ore hearth where the flags are missing towards a covered drain or culvert (see D below) [4/132, 4/135, 4/139, 4/167, 4/168] (see plate 16). This channel is on average 0.50m wide and has a

Plate 16: Flagstone floor in west side of furnace room, after clearance and cleaning, looking S (photo 4/168).

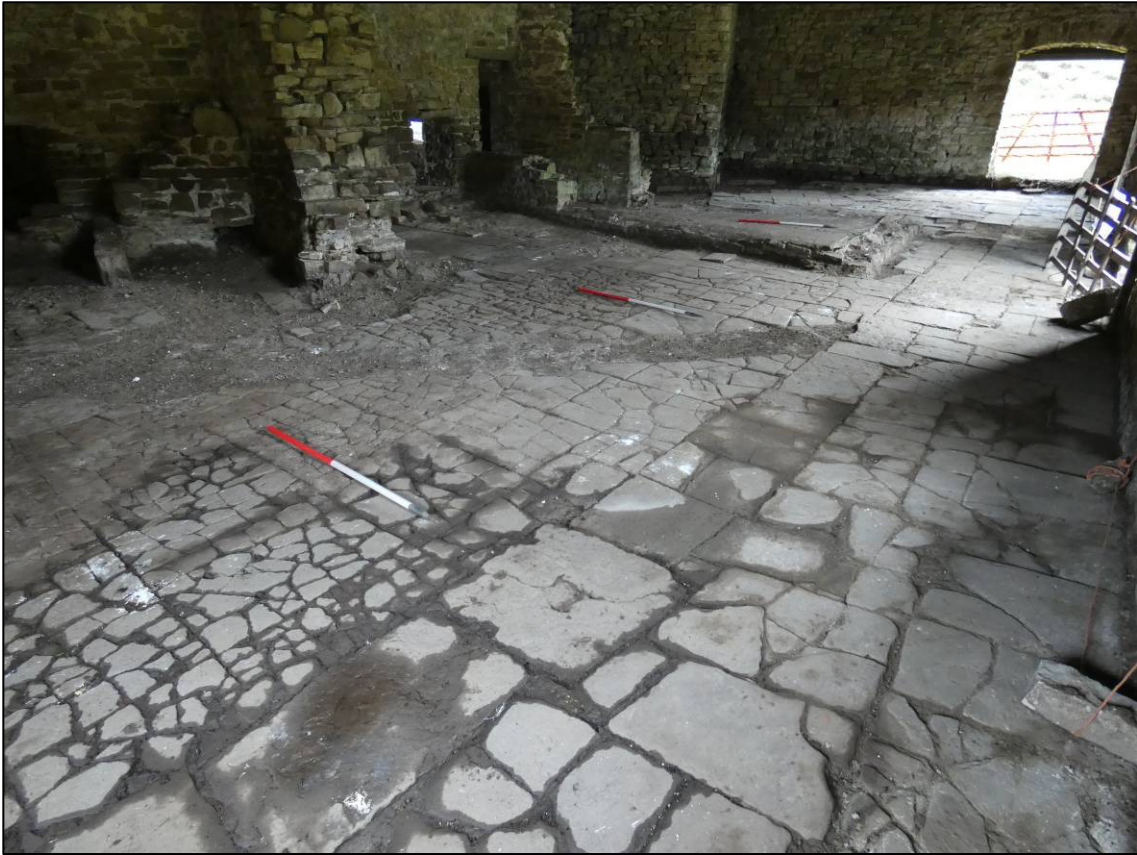
- 3.13 A covered culvert or drain (D) appears to run parallel to the south wall of the furnace room, across the full width of the building [4/136, 4/178, 4/179] (see plate 17). The centre of the culvert is set on average 1.40m to the north of the south wall, although the surface width varies according to the flags which have been used to cover it. The construction of the culvert suggests that new flags were brought in to the furnace room specifically for this purpose; the stones are noticeably less worn than those to either side, and there are several examples of stones with a rough surface and high fossil (crinoid) content which occur only on the line of the culvert. There is a slight break in the line of the culvert to the south-east of the former sheep dip, but it then resumes to run to the doorway at the south end of the east wall [4/158] (see plate 20). The alignment of the culvert between the two doorways is significant, as during heavy rain a significant amount of water drips off the building's eaves and then runs into the interior of the furnace room; indeed, during the recording work, water was noted running in through the east doorway, pooling on the line of the culvert and then draining into it through a joint between two stones.

Plate 17: Flagstone floor in furnace room, after clearance and cleaning, showing west end of covered culvert (D), looking E (photo 4/136).

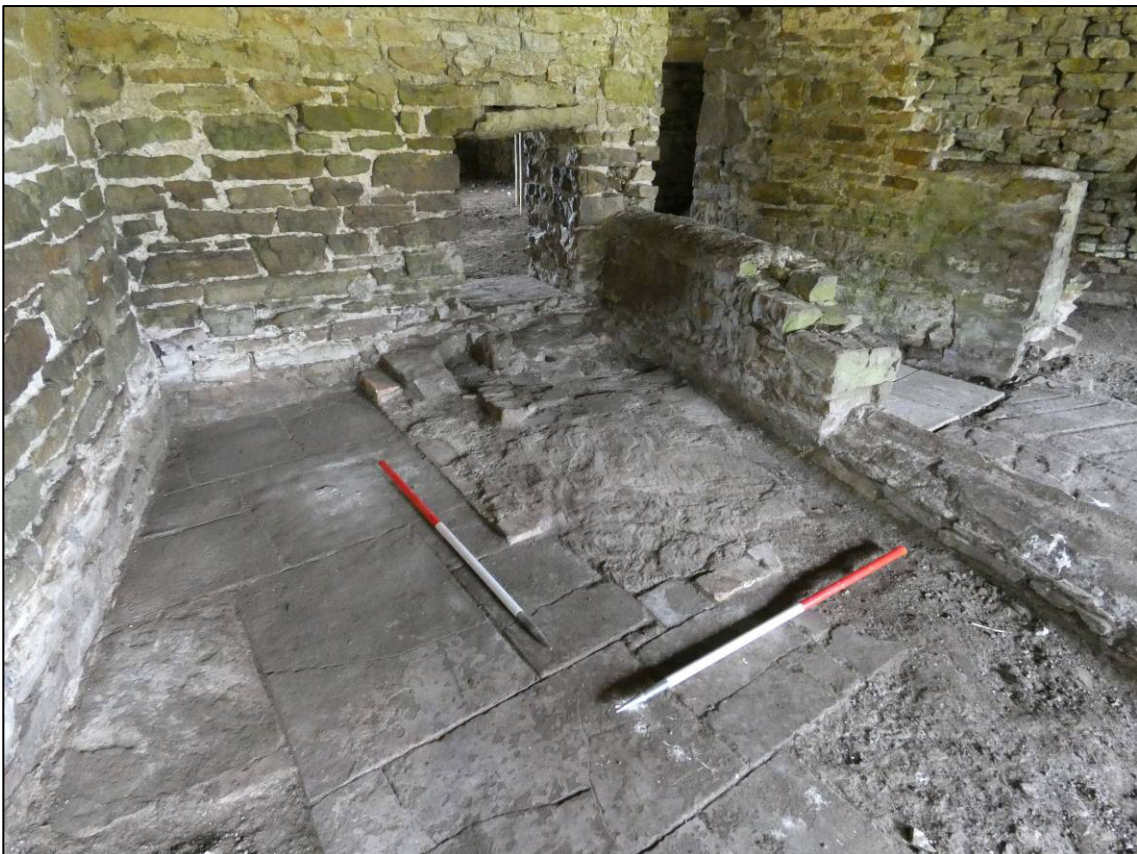
Plate 18: Furnace Room, base of central ore hearth, after clearance and cleaning, looking NE (photo 4/150).

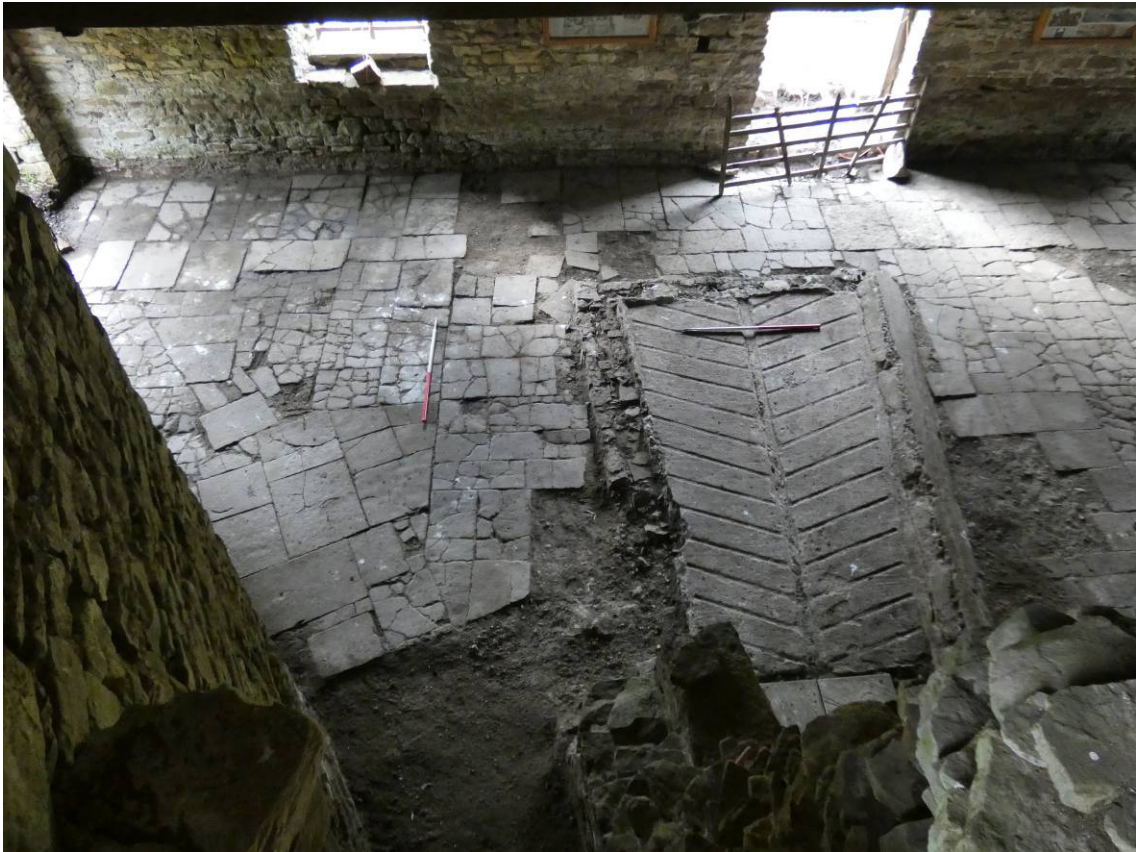
Plate 19: East side of furnace room, after clearance and cleaning, showing sheep dip and differential wear to flagstone floor, looking S (photo 4/160).

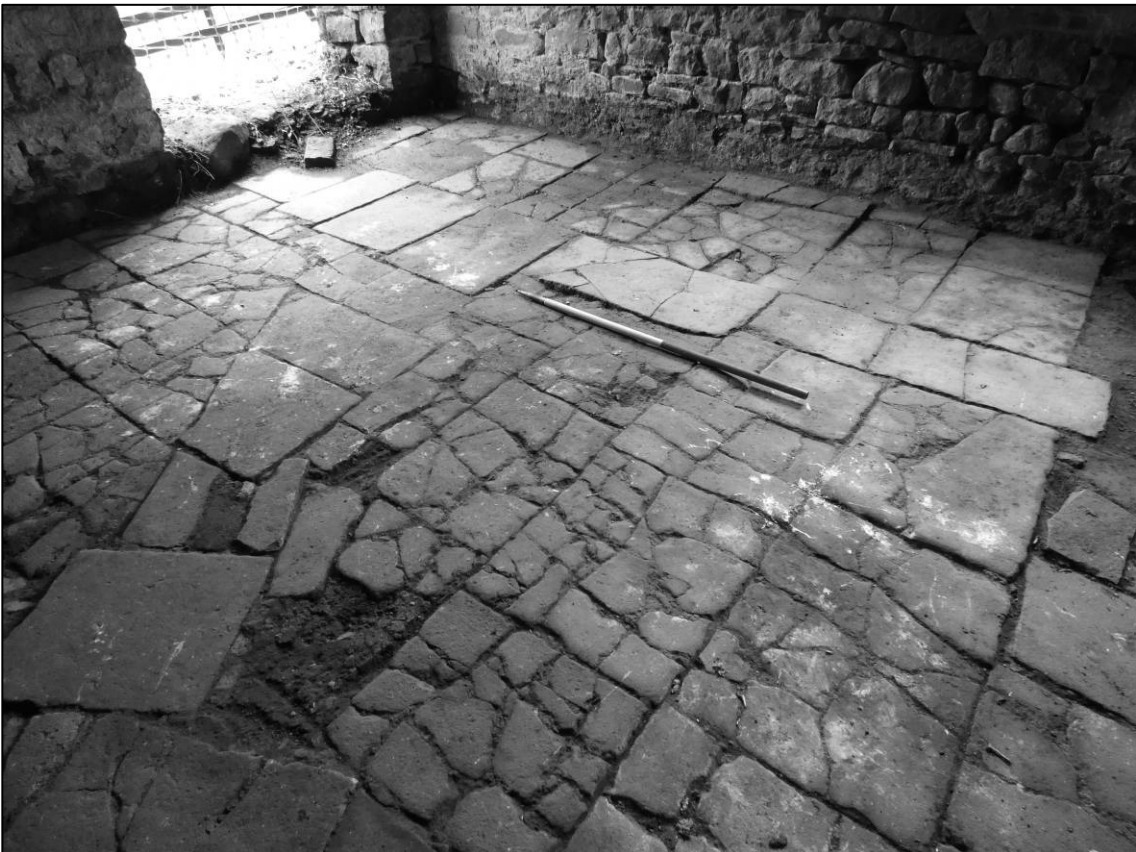
Plate 20: Flagstone floor in east side of furnace room, after clearance and cleaning, showing east end of covered culvert (D) and angled channel (F), looking SE (photo 4/158).

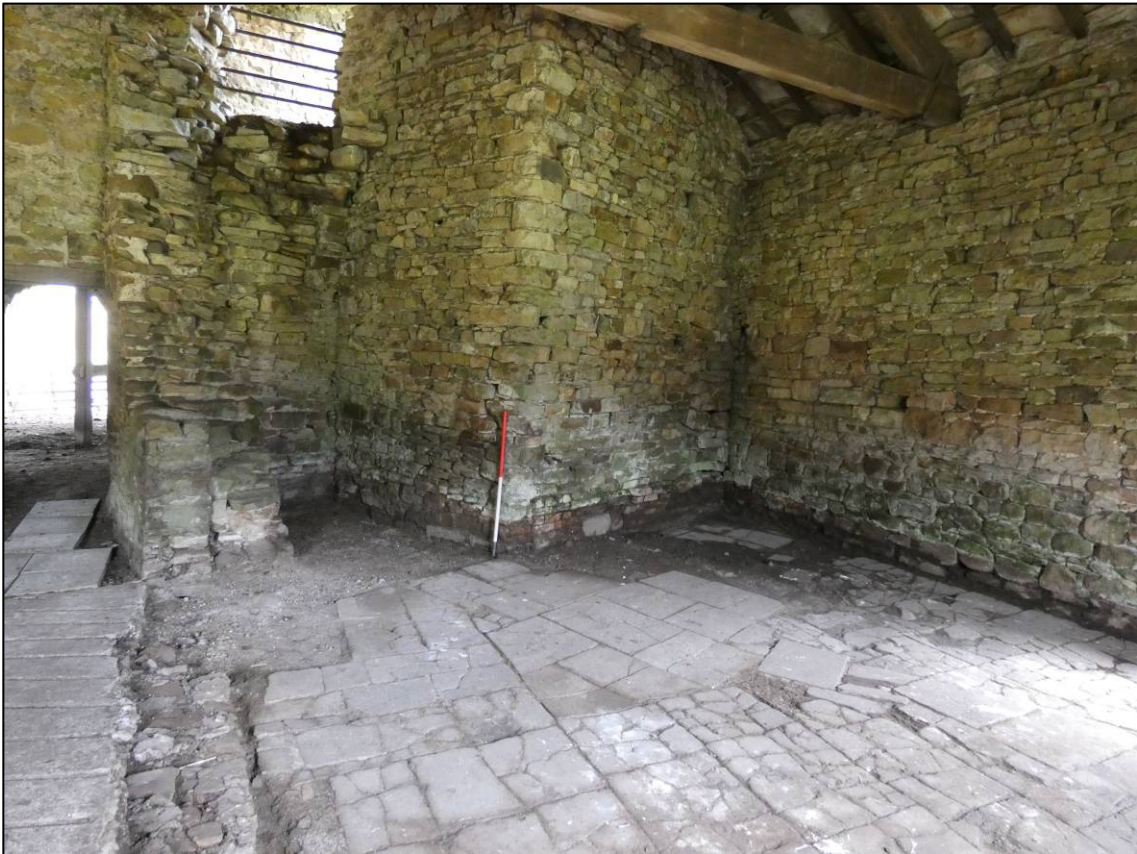
- 3.17 To the north, there are two areas of flags displaying little wear, which run parallel to the angled rear wall of the arch formerly containing the slag hearth [4/173, 4/175] (see plate 21); following clearance, a step or plinth was exposed at the base of the west part of the wall. The plinth may once have run the entire width of the slag hearth bay, and might possibly represent later rebuilding or alteration here; no similar plinths were exposed anywhere else in the furnace room. The two areas of flags are separated by a space where the floor is missing, and it is noticeable that the whole surface of the eastern area is set slightly lower than that of the western area. What appears to be a small diameter iron pipe set into the floor leaves the east wall of the furnace room to run parallel to the southern side of the eastern area of flags.

Plate 21: North-east corner of furnace room, after clearance and cleaning, showing store room and slag hearth position, looking NE (photo 4/173).

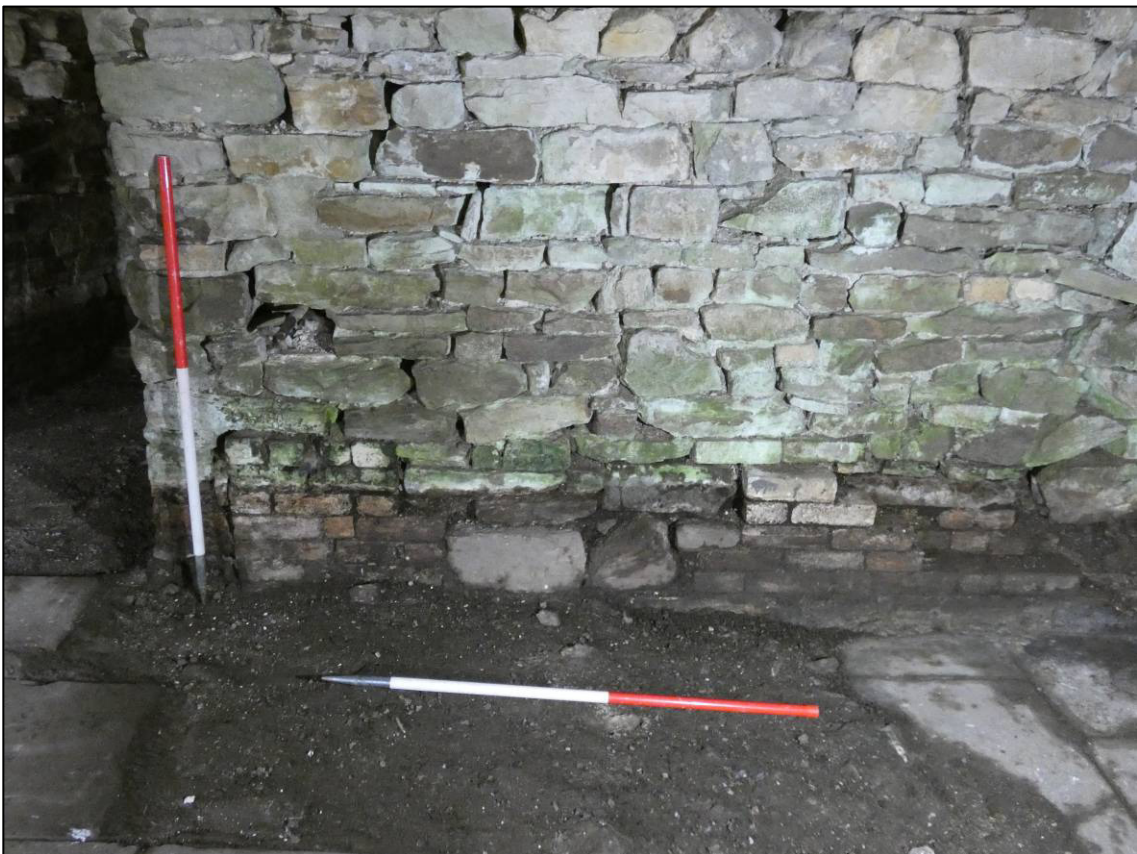
- 3.18 The reduction in height of the floor level through the removal of the sheep manure exposed more of the south elevation of the slag hearth (H) than had previously been visible [4/153-4/156, 4/176, 4/177] (see plate 22); as a result, a previous drawing of the slag hearth made from measurements taken in 1992-93 (Lamb 2017, 4) was re-drawn (see figure 8). The top left-hand tie-bar associated with the slag hearth could be seen as it passed into the loose masonry behind; it was of circular, rather than of flat, cross section and more than 0.51m in length. The one inch (25 mm) diameter matched that of the other tie-bars emerging from the tuyère cross wall, although this does not prove that they actually passed right through. The removal of the sheep manure revealed three or four lower courses of bricks forming some sort of plinth to the east of the hearth; some of the bricks to the lowest course, assumed to be a foundation layer running under the whole structure, retained a coating of mortar. Several large stones filled the gap between the two brick columns of the slag hearth. It was also noticeable that there were two firebricks immediately on top of the east column set back into the line of the later stone wall over and, to the east end of the basal structure, two courses of firebricks were set half a brick back from the main face. In view of the unexpected brickwork exposed to the east of the hearth, totally unlike any known illustrations of slag hearths, it is suggested that a later rebuilding or alteration took place to the structure, the extent of which is currently unknown. Given what has been noted about the central ore hearth above, it is possible that any rebuilding of the slag hearth also took place in the early 1890s.

Plate 22: Furnace Room, south side of store room, after clearance and cleaning, showing remains of slag hearth, looking N (photo 4/153).
