ALL SAINTS' CHURCH, BRANDSBY,  
NORTH YORKSHIRE

ARCHAEOLOGICAL OBSERVATION,  
INVESTIGATION AND RECORDING

EXTERNAL DRAINAGE WORKS,  
ALL SAINTS' CHURCH,  
BRANDBY, NORTH YORKSHIRE

Report no: 2018/563.R01  
Version: Final  
Date: March 2019  
Author: Ed Dennison & Shaun Richardson

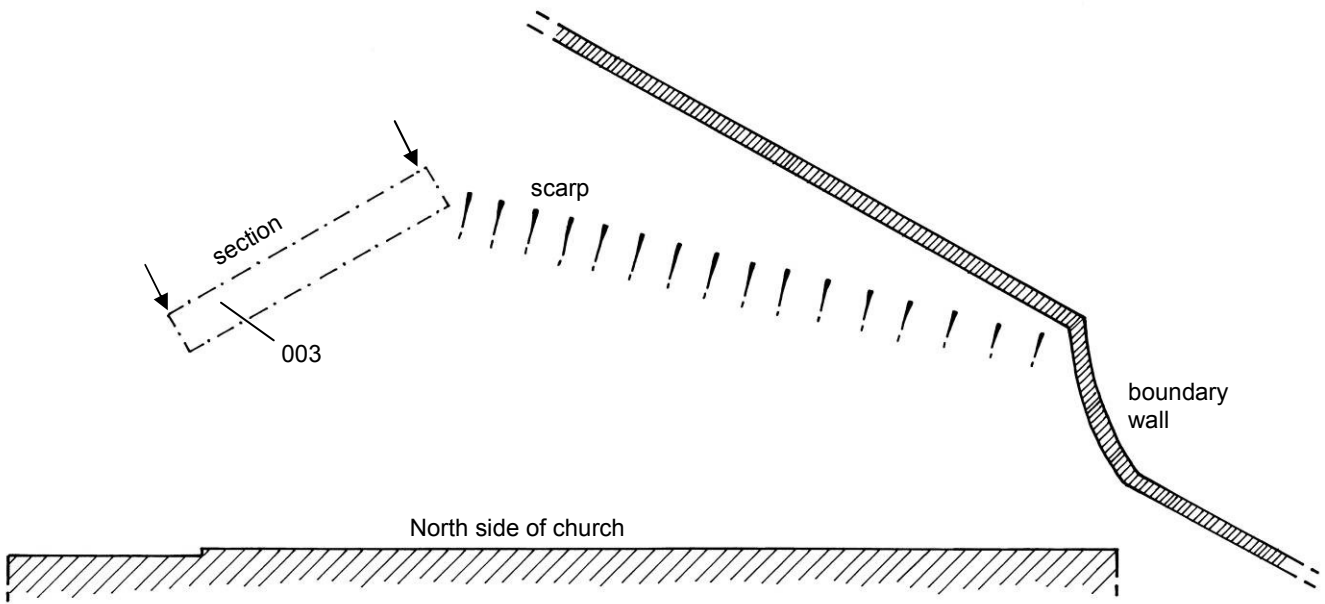
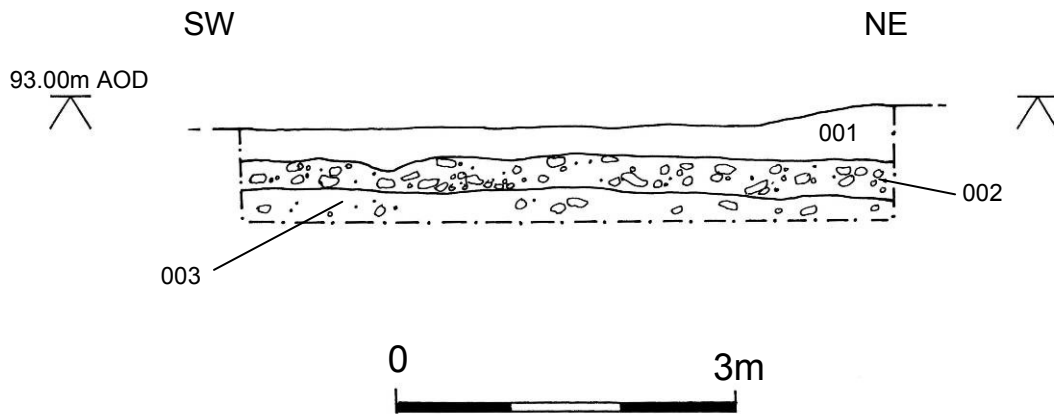
PROJECT ALL SAINTS' CHURCH, BRANDSBY	
TITLE WATCHING BRIEF RESULTS	
SCALE AS SHOWN	DATE APR 2019
EDAS	FIGURE 3

- 5.1 As noted above, the drainage trench was set on a north-east/south-west alignment. Prior to the excavation, the site was a grassed area on the north side of the church, with no grave stones or other grave markers present. The majority of the ground surface was relatively level, with an average height of 92.57m AOD, although a spread, south-facing scarp, on a north-west/south-east alignment crossed the area close to the churchyard wall. The line of this scarp was just intercepted by the north-east end of the drain trench.

- 5.2 The average depth of excavation along the length of the 5.80m long trench was 0.80m, giving an average reduced height of between 91.76m AOD and 91.78m AOD. The deposits encountered in all parts of the trench were very similar (see plates 1 and 2). A black sandy silt topsoil (001) extended on average to 0.25m below ground level (BGL). At one point to the south-west end of the trench, the topsoil increased to 0.40m in depth, but there was no clear evidence that it filled a cut or other similar feature. The topsoil (001) overlay a reddish-brown silty sand (002), containing frequent inclusions of rounded stones up to 0.15m across; on average, it extended to 0.55m BGL. The lowest deposit exposed in the trench was a reddish-brown silt sand (003), which contained fewer stones than the similar layer (002) above. The silty sand (003), representing a natural deposit, continued below the base of the trench. No finds or *ex situ* human remains were recovered from any of the three contexts, nor were any grave cuts observed. The aforementioned scarp that was just crossed by the north-east end of the trench had no left visible trace in the archaeological deposits, apart from a slightly deeper layer of topsoil (001).

Site plan

South-east facing section of trench

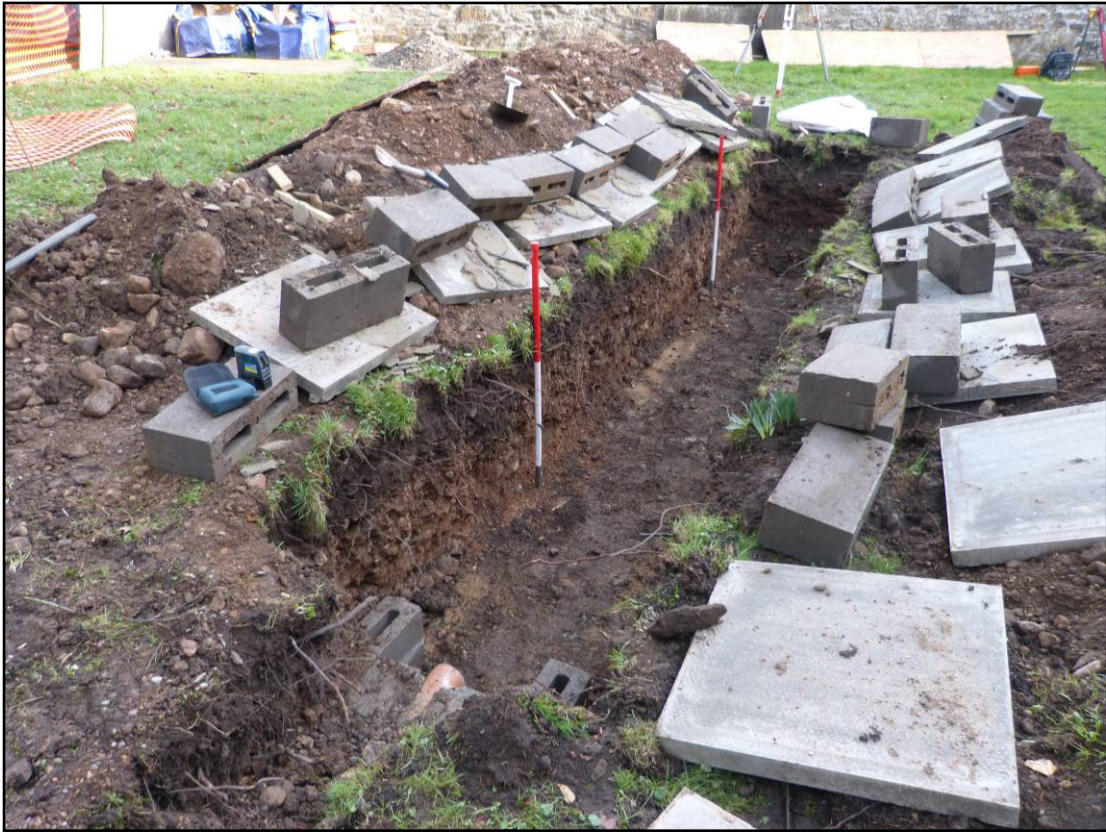
Plate 1: Main drainage trench, north side of church, looking north.

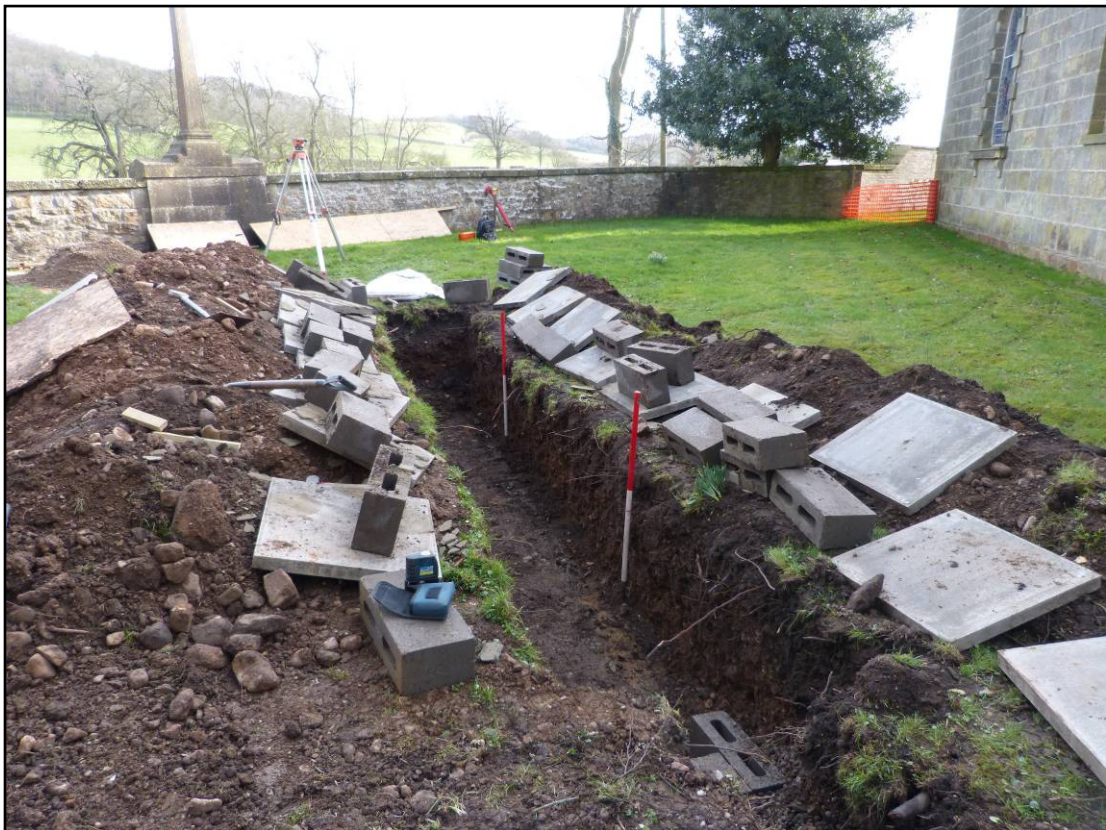
Plate 2: Main drainage trench, north side of church, looking south-east.

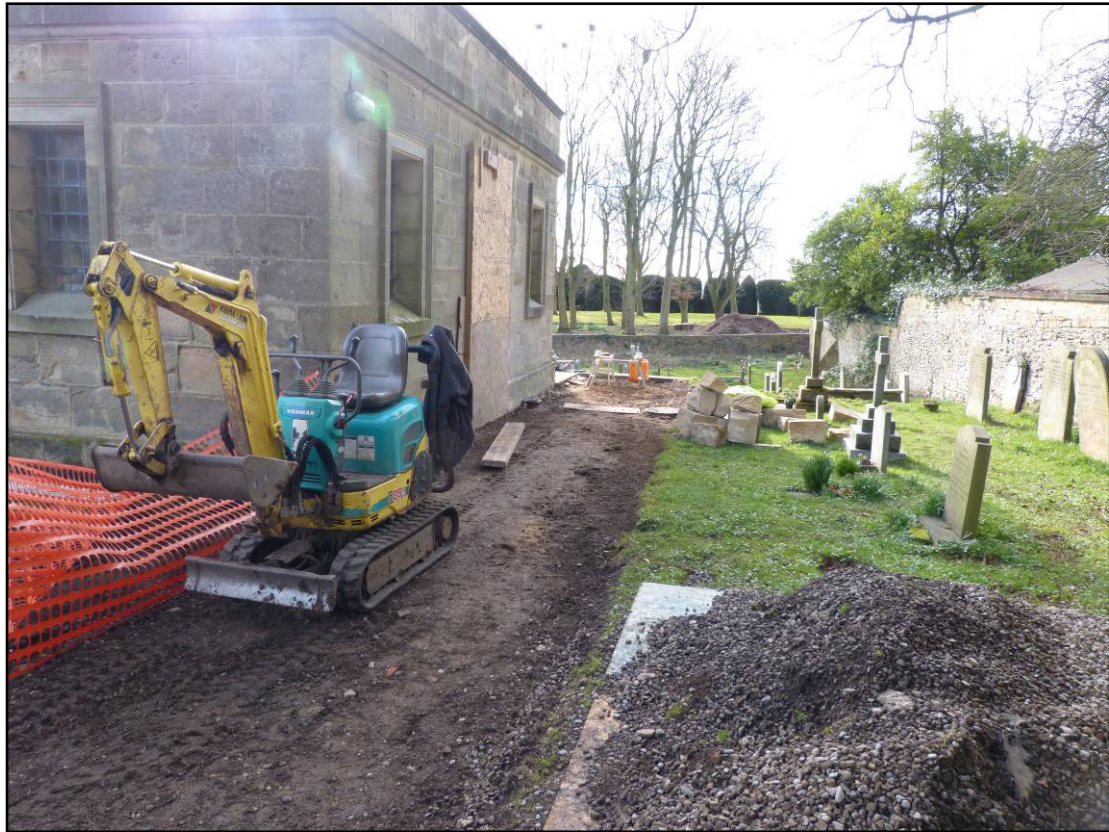
- 5.3 At the time of the site visit, the other drainage works had already been completed and the trenches backfilled. The resurfacing works to the path were ongoing, but nothing of archaeological significance was visible (see plate 3).

Plate 3: Resurfacing of footpath to west of church, looking south.
