LIME KILNS, FELL END,
RAVENSTONEDALE, CUMBRIA

MONUMENTS AT RISK SURVEY

Report no: 2018/559.R01
Version: Final
Date: March 2019
Author: Shaun Richardson & Ed Dennison

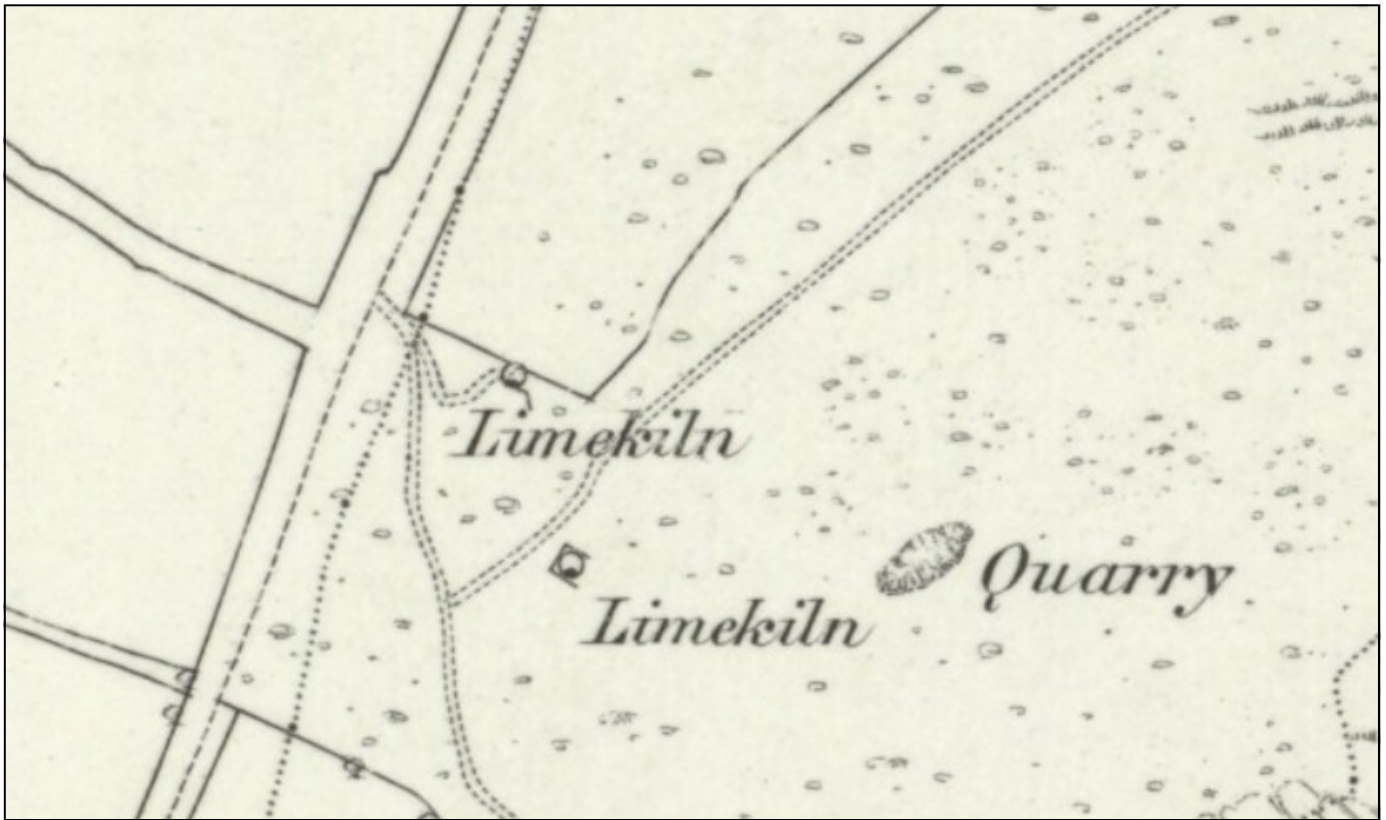
PROJECT		FELL END LIME KILNS	
TITLE			
HISTORIC ORDNANCE SURVEY MAPS			
SCALE	NTS	DATE	MAR 2019
EDAS		FIGURE	3

Top: 1862 Ordnance Survey 6" map Westmorland sheet 36 (surveyed 1857-58).

Bottom: 1898 Ordnance Survey 25" map Westmorland sheet 36/1 (revised 1896).

- 2.7 The kiln is similarly depicted on the more detailed Ordnance Survey 1898 edition; by this date, the retaining wall is angled rather than curving and it may have been

extended slightly further to the south-east (see figure 3 bottom). The late Helga Frankland of Needle House in Uldale was certain that the kiln was fired up by her grandfather (believed to be a Professor of Chemistry) between 1910 and 1912 to make lime to apply on their land (David Johnson, *pers. comm.*). There had been little change by 1914 in terms of map depiction, and the kiln continued to be marked on maps until at least 1954. It was previously examined and described by David Johnson as part of his survey of lime kilns in Westmorland (Ravenstonedale 21).

- 2.17 The kiln is similarly depicted on the more detailed Ordnance Survey 1898 edition, when the walls of the kiln are shown extending back some distance from the mouth of the bowl (see figure 3 bottom). Furthermore, a short branch or spur runs from the adjacent trackway to the north-east to the base of the kiln itself. There had been little change by 1914, although a small area of quarrying may be indicated to the immediate north-east of the kiln itself. The lime kiln continued to be marked on maps as late as 1954, with the quarry to the east named as 'Old Quarry'. The kiln was previously examined and described by David Johnson as part of his survey of lime kilns in Westmorland (Ravenstonedale 22).

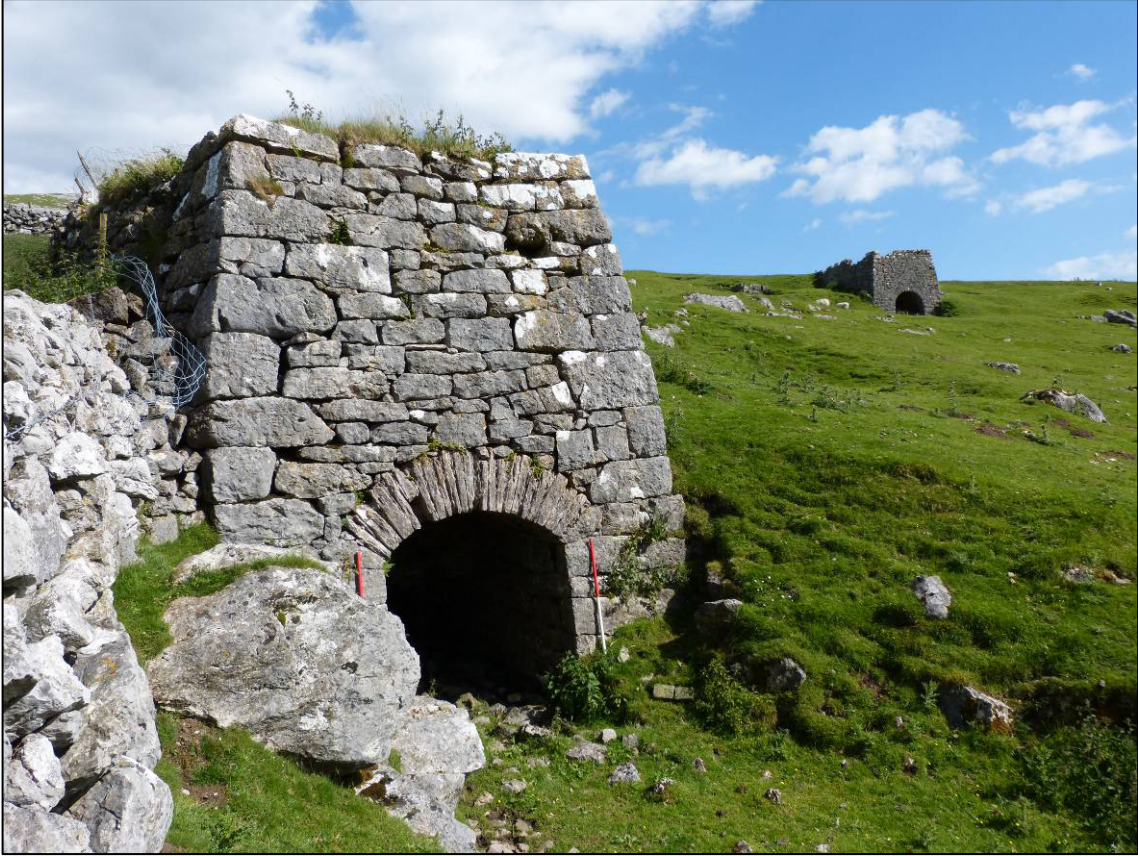
Plate 1: Kilns 1 and 2, looking SE (photo 1/155).

- 2.11 The west elevation forms the main elevation of the kiln, the kiln itself facing to the north-west (see plate 1). The elevation is 4.50m wide across the base, tapering to 3.45m across the top. The draw arch itself is 1.60m wide and is placed slightly to the north of centre, standing to a maximum of c.1.30m high. It has a broad, segmental head of thin, mortared limestone rubble voussoirs [1/101, 1/151-1/153] (see plate 3). Internally, the draw arch of the kiln is 1.60m wide by 2.95m deep; the roof over is of sandstone, with limestone to the side walls. At the time of the survey, the interior was partly filled with soil and rubble, and so it was not possible to tell if it was provided with a floor surface, such as, for example, flagstones. There is a single, low, flat-headed draw opening in the east wall, 0.5m wide. The jambs of the draw opening are formed by large limestone blocks, but the deteriorating head is built from firebricks [1/105, 1/106] (see plate 4). There is no visible evidence in the draw opening for a grate, iron bars or any similar structural features. Almost immediately above the draw opening, the face of the east wall is corbelled out markedly; it appears to contain a small, single poking hole above the draw hole.

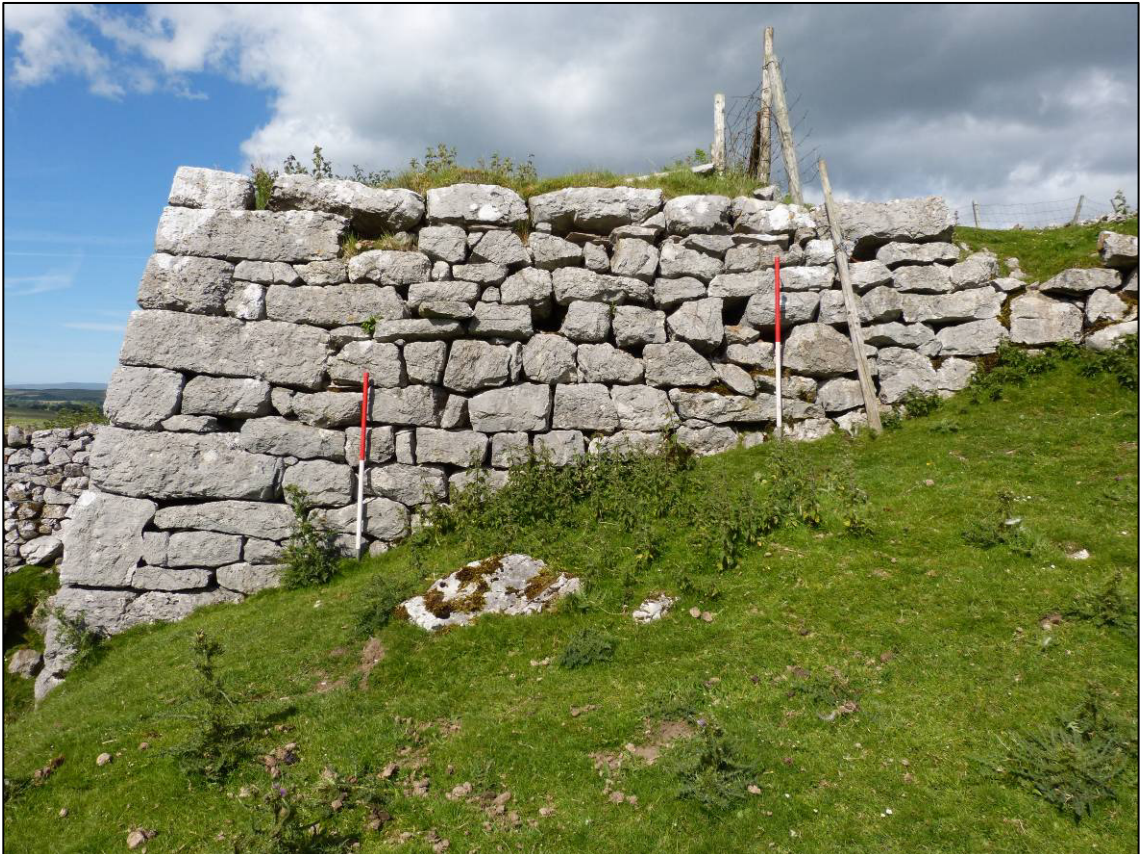
Plate 2: Kiln 1, south elevation, looking N (photo 1/148).

- 2.10 The north elevation of the kiln is difficult to view clearly as it faces into the enclosed field to the north, to which there was no access, and because it was partly obscured by nettles at the time of the survey [1/154]. The south elevation stands up to c.2.6m high at the west end. There are a number of holes in the elevation where stones have fallen out or been removed, but otherwise the elevation appears to stand to close to its original height [1/148-1/150] (see plate 2).

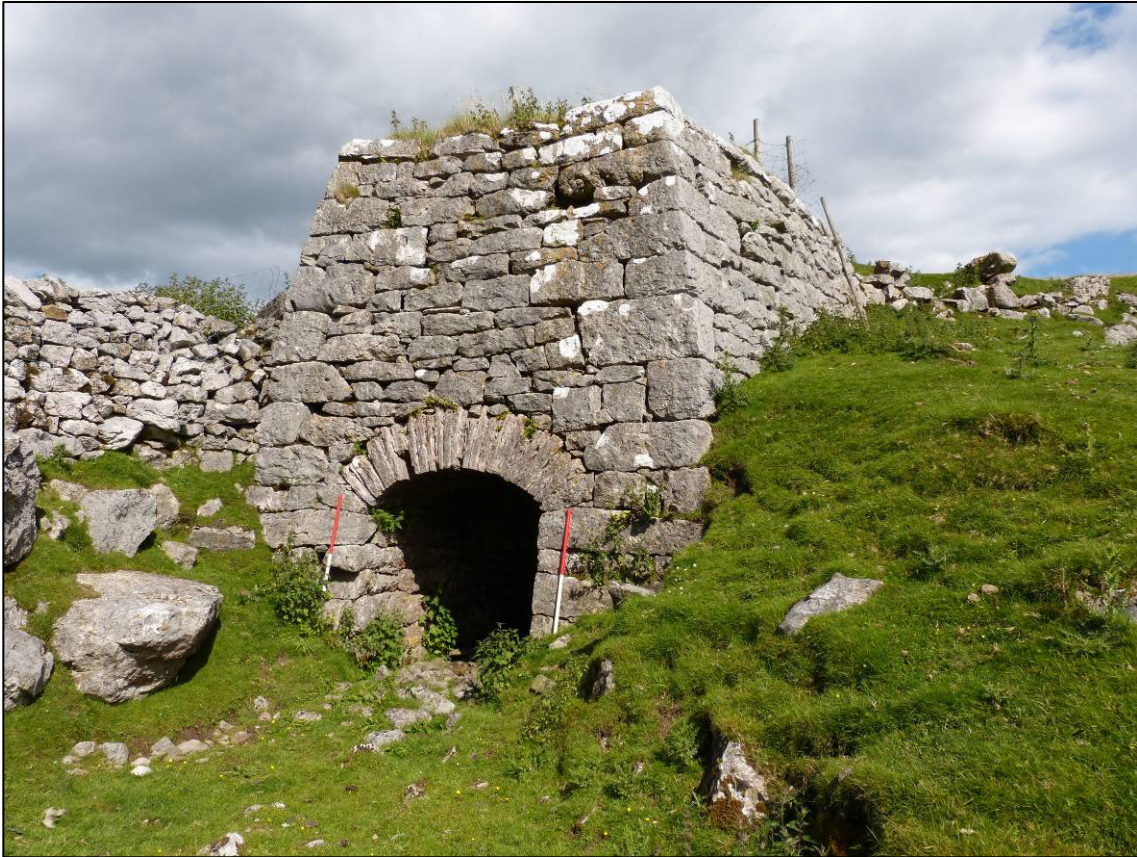
Plate 3: Kiln 1, west elevation, looking E (photo 1/152).

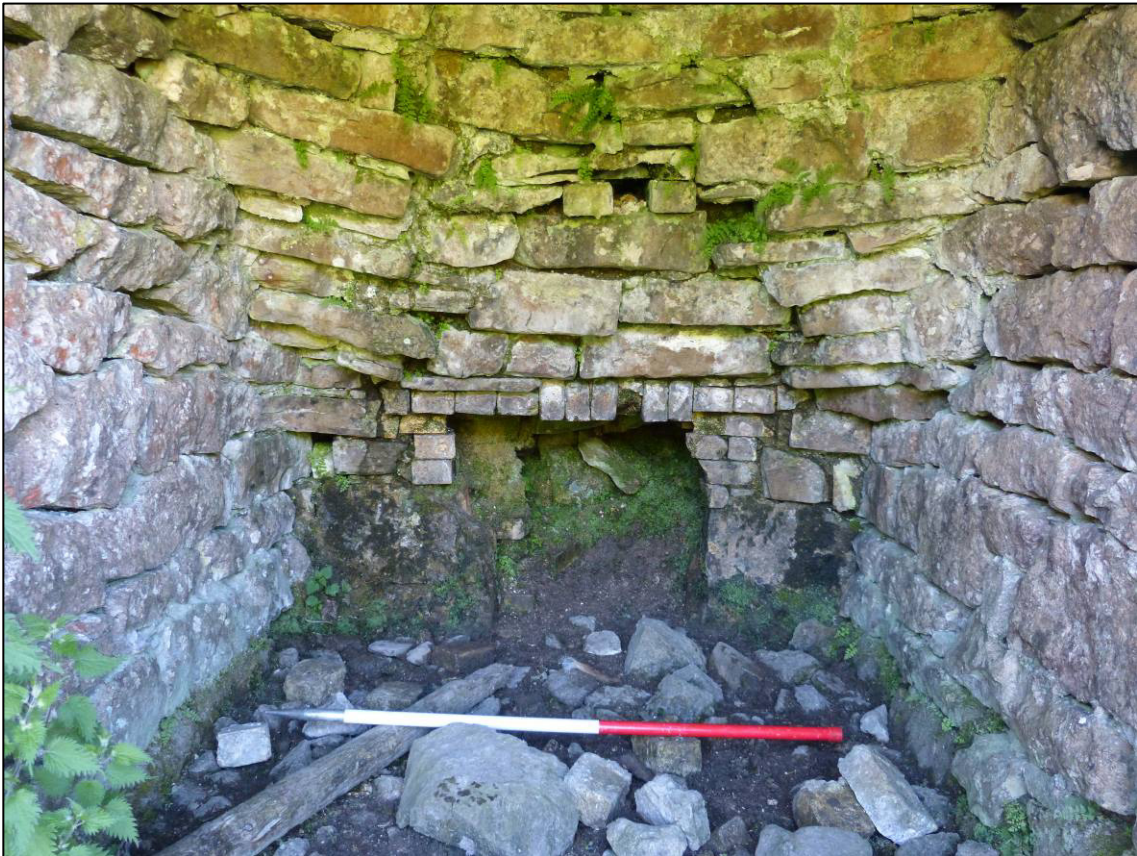
Plate 4: Kiln 1, draw arch interior, looking E (photo 1/105).

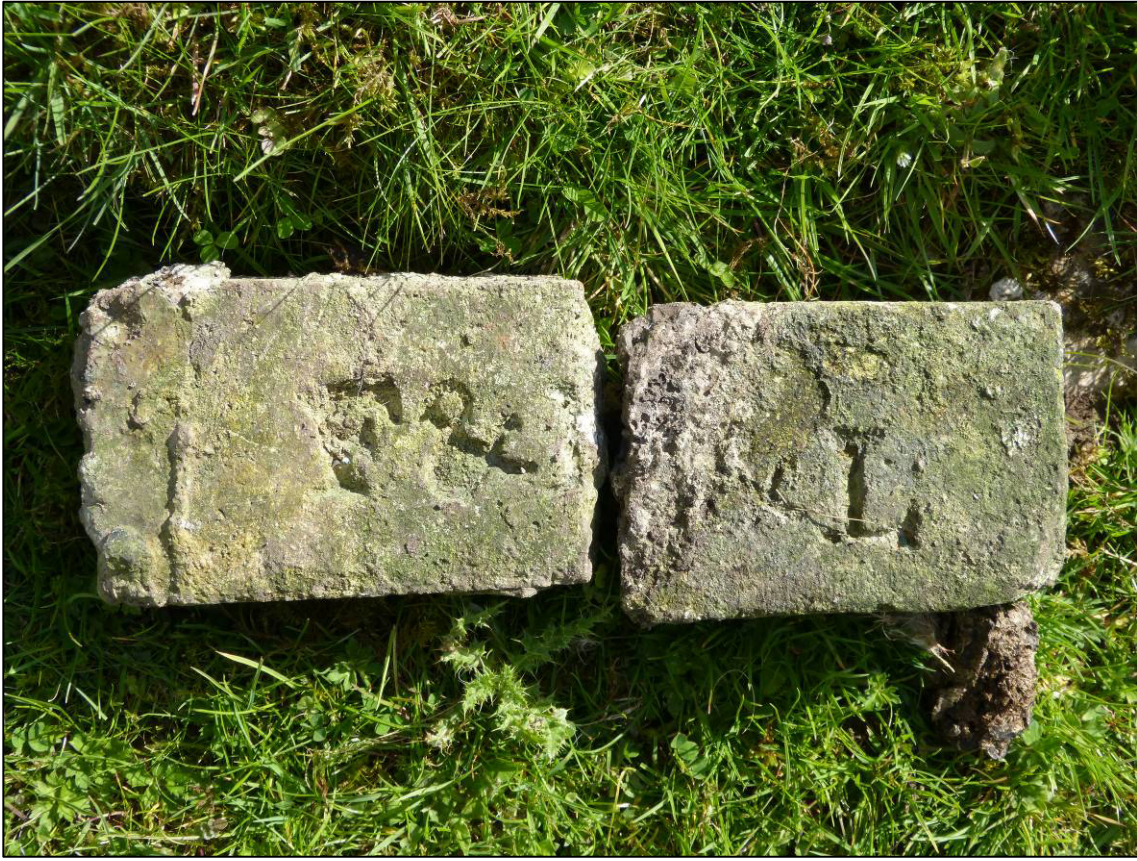
Plate 5: Kiln 1, impressed fire brick 'F & L' (photo 1/156).

- 2.12 The firebricks of the draw opening appear to be neatly handmade, with a yellowish fabric, and average dimensions of 225mm by 110mm by 60mm. Some *ex situ* examples bear the impressed mark 'F & L' [1/156, 1/157] (see plate 5). This denotes Ferens and Love, the company which owned Cornsay Colliery in County Durham. The company was formed in 1857 when Robin Ferens married Sarah Love, and they acquired a number of collieries. Probably principal amongst these was Cornsay, which was sunk in 1863 and opened in 1868, and worked until the 1950s. As well as producing coal, a superb fireclay was mined at the site and a large brick, tile and sanitary pipe works was built adjacent to the colliery, although fireclay production is apparently not listed at the site until 1896 (<http://www.brocross.com/Bricks/Penmorfa/Pages/england8.htm>; <http://www.dmm.org.uk/colliery/c030.htm>; <https://www.thenorthernecho.co.uk/history/15046381.does-anyone-have-any-ferens-love-bricks-readers-respond/>). Given that the kiln was already present by 1862, before the colliery was sunk or indeed producing fireclay, the bricks lining the draw opening must represent a later rebuilding or alteration; it is possible that they date from the 1910-12 usage by Helga Frankland's grandfather, as the kiln would probably have required considerable work to get it back into working order (David Johnson, *pers. comm.*).

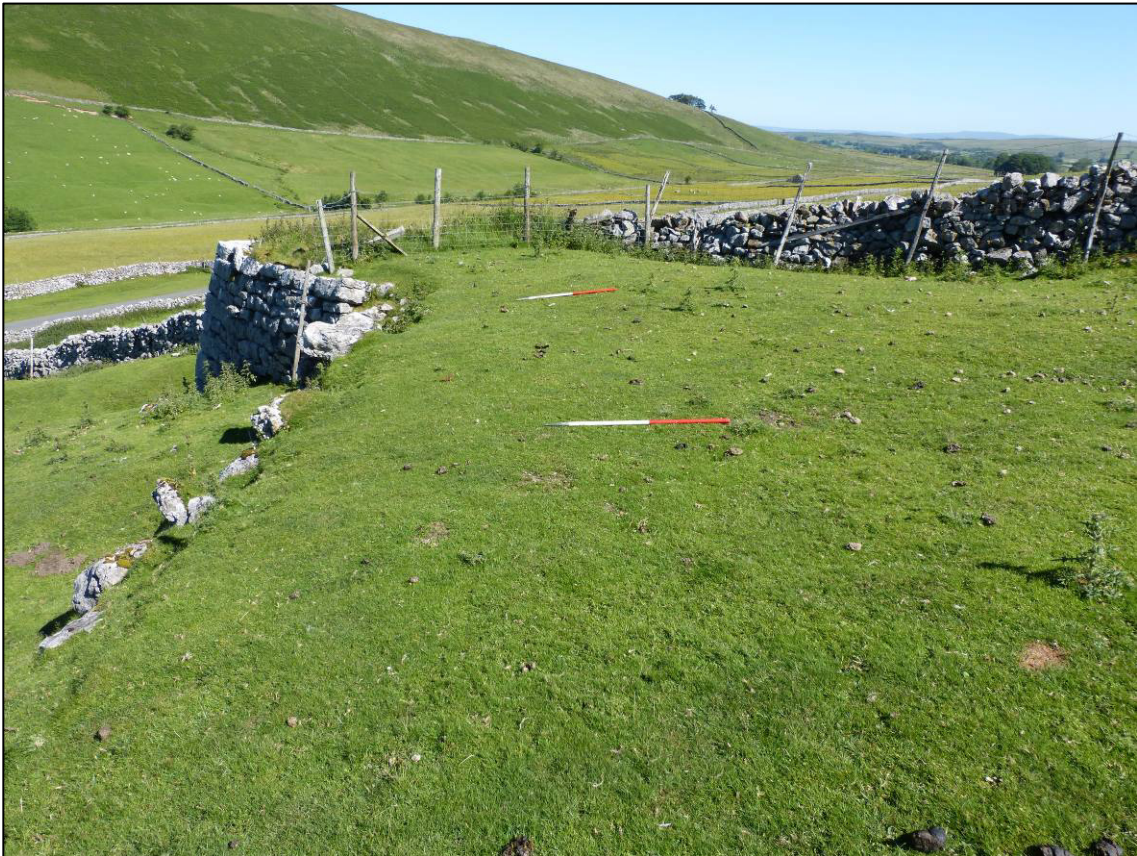
Plate 6: Kiln 1, charging ramp, looking NW (photo 1/097).

- 2.13 The upper level of the kiln was accessed via the charging ramp to the east. The earth ramp approaches the kiln from the south-east for some 11m, and then angles sharply to the north-west [1/097] (see plate 6). The southern approach of the ramp is supported on a collapsing limestone rubble retaining wall, standing up to 1.0m in height (see plate 9); the ramp is shown in 1862, and was possibly extended between 1862 and 1898 - it clearly butts the main body of the kiln itself. There are also the remains of a former fence line crossing the charging ramp, presumably to prevent stock falling into the bowl.

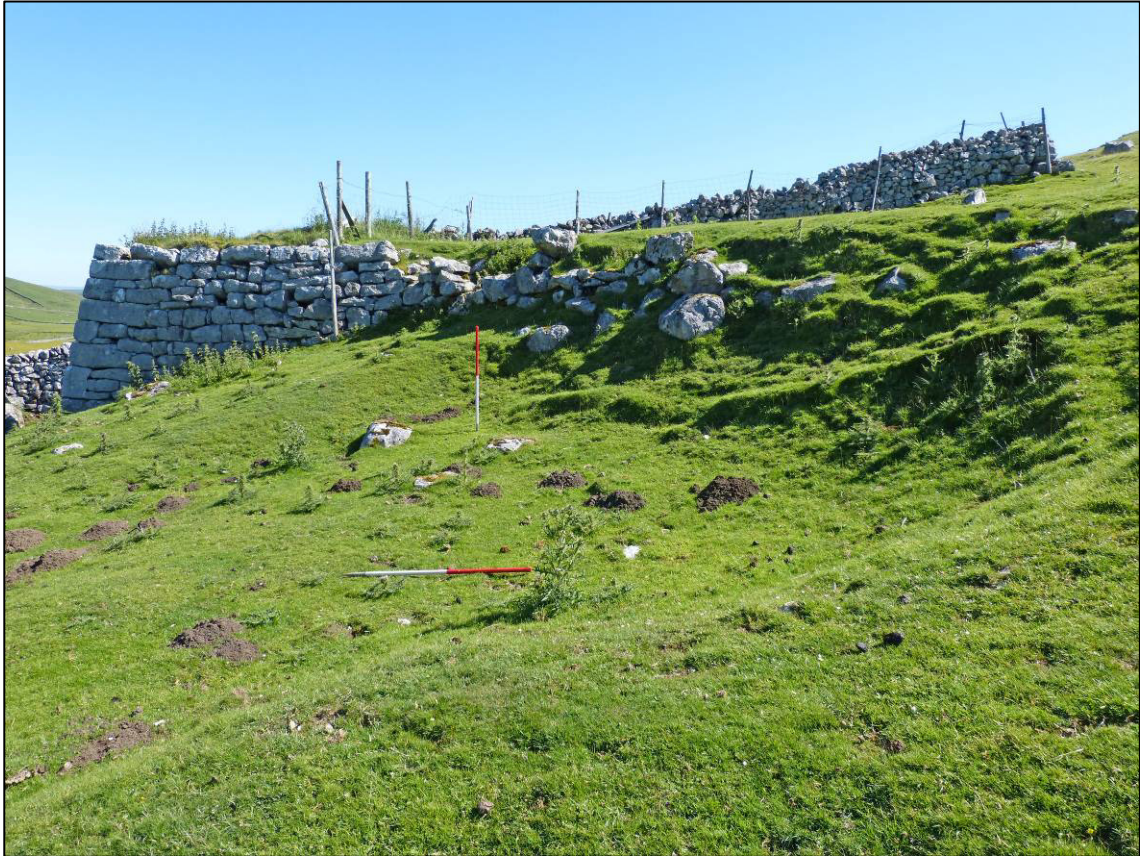
Plate 7: Kiln 1, platform and charging ramp retaining wall, looking N (photo 1/099).

- 2.14 Below and to the south-west of the charging ramp retaining wall, there is a sub-rectangular depression, possibly a platform, slightly terraced into the natural slope here although it still has a prominent fall from east to west; it measures c.8.0m by 5.0m [1/099] (see plate 7). It has been suggested that this, and 'a pair of hollows' perhaps mark the position of former kilns robbed to make the extant ones (www.pastscape.org.uk). This seems unlikely in the case of the platform, which appears too regular to be a quarry and so might mark the position of a short-lived structure or storage area associated with the kiln. Some kilns were provided with an adjacent lime shed (usually a drystone structure formerly equipped with a single pitch roof) in which to store quicklime (Johnson 2010, 259), although no such feature is shown on any historic maps at Fell End.

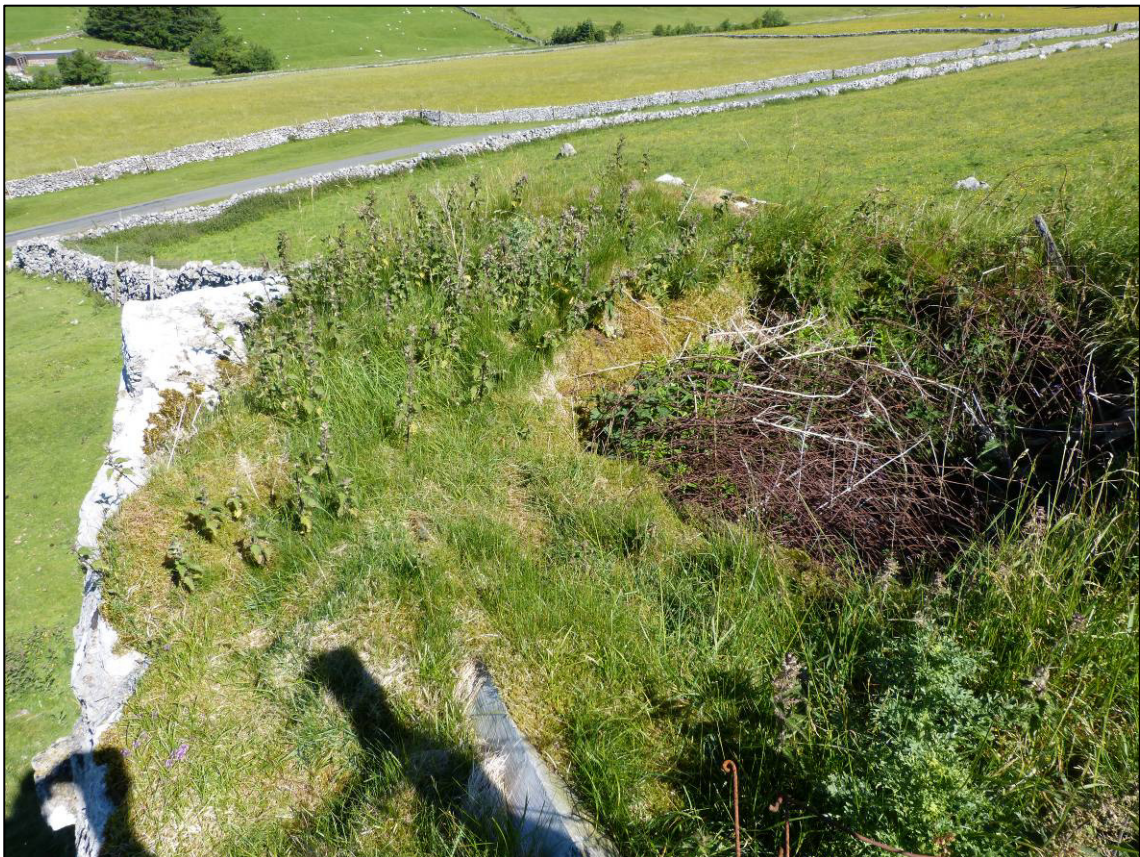
Plate 8: Kiln 1, bowl mouth, looking NW (photo 1/098).

- 2.15 The mouth of the kiln bowl remains visible, although the majority has been backfilled with soil and some debris including barbed wire. The bowl is slightly oval in plan, measuring c.2.20m across. The bowl lining is of sandstone rubble, which displays some evidence for burning [1/098] (see plate 8). In October 2005, it was noted by David Johnson that there was a 0.30m wide ledge running around the interior of the bowl, set 1.10m below the top (David Johnson, field notes), but this was not visible at the time of the current survey.

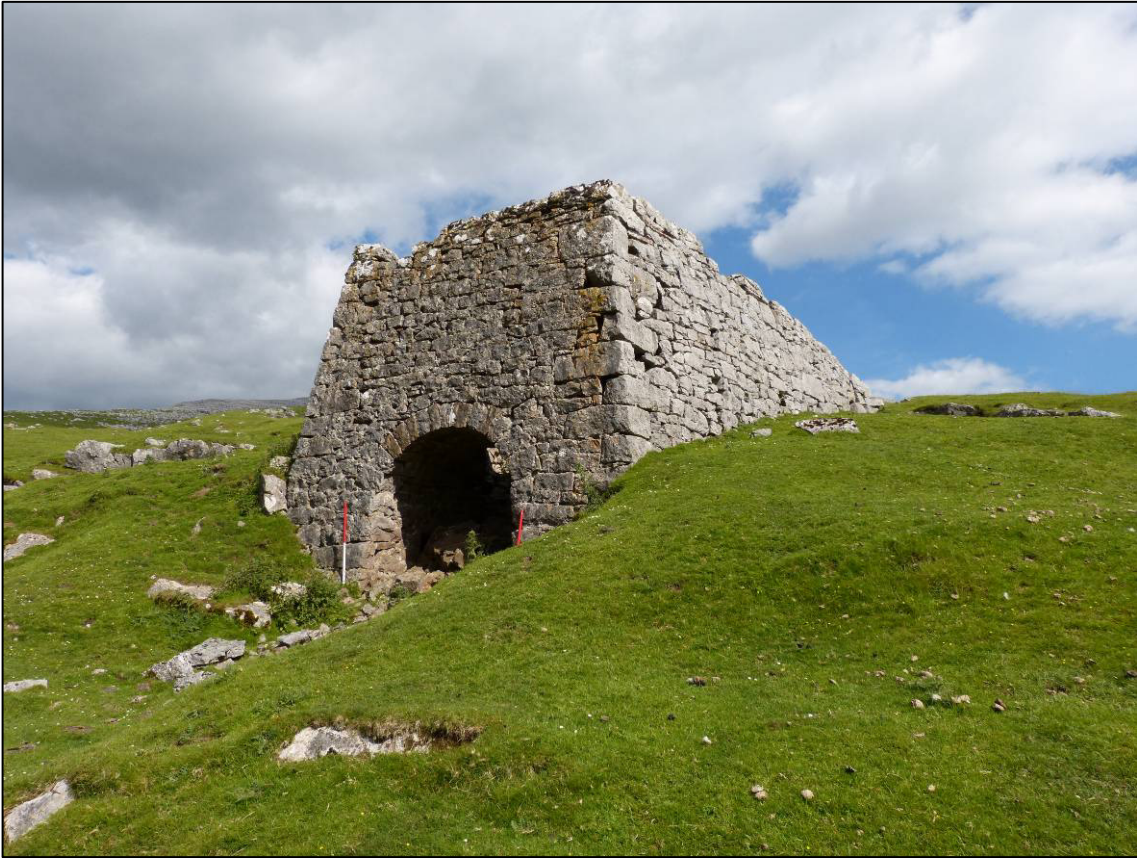
Plate 9: Kiln 2, looking NE (photo 1/141).

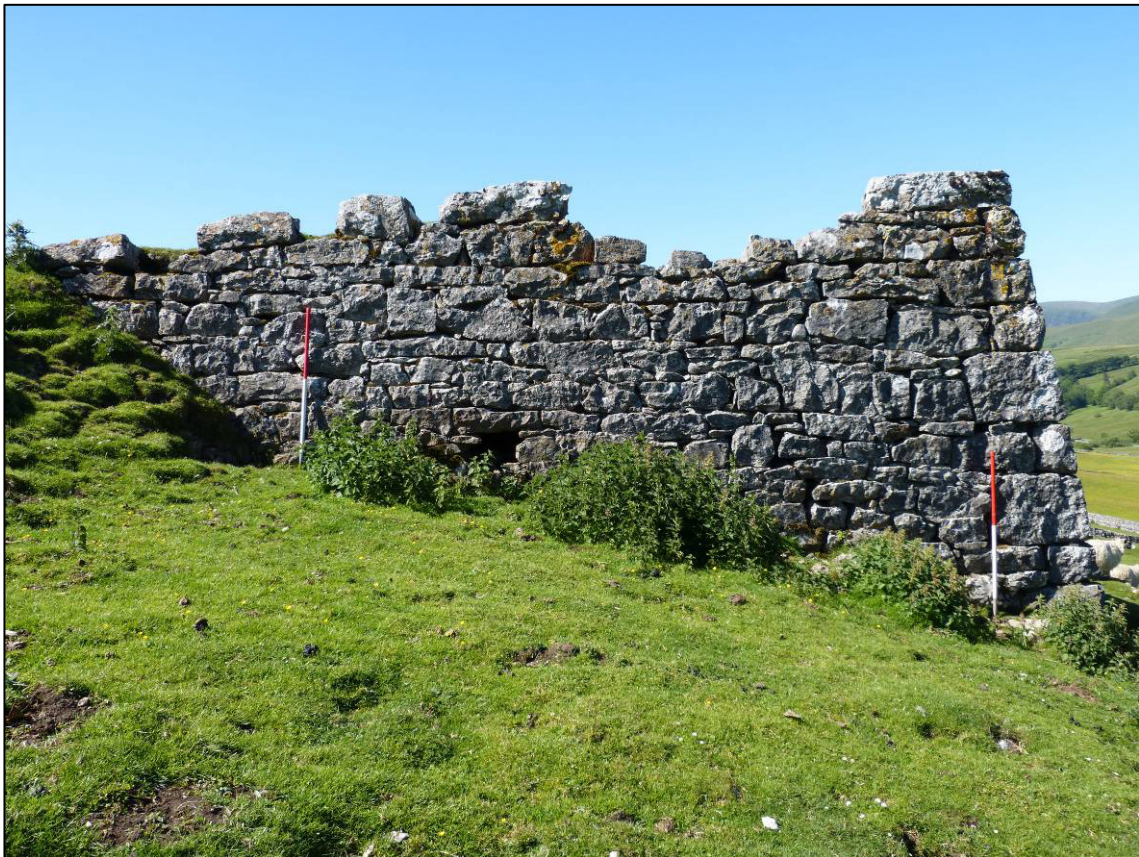
Plate 10: Kiln 2, N elevation, looking S (photo 1/108).

- 2.20 The north elevation of the kiln stands up to c.3m high at the west end [1/108] (see plate 10). There are a number of holes in the elevation where stones have fallen out, and some of the upper parts are missing. However, approximately half way along its length, there is an opening, 0.30m square with a stone lintel, set towards the base of the elevation [1/109]. This opening leads into a narrow level passage or flue with a flagstone roof, which extends for a distance of 2.80m through the body of the kiln [1/143], angling to the west at its southern end to emerge as a narrow slit-like feature in the east side of the kiln's bowl (see below) (see plate 11). This passage must be original, as it would have been impossible to insert it into the kiln's structure at a later date. The south elevation of the kiln stands up to c.3m high at the west end [1/132-1/135] (see plate 12). It too has, approximately half way along its length, an opening, 0.25m square with a stone lintel, set towards the base of the elevation [1/136]. This opening leads into a narrow, level, slightly

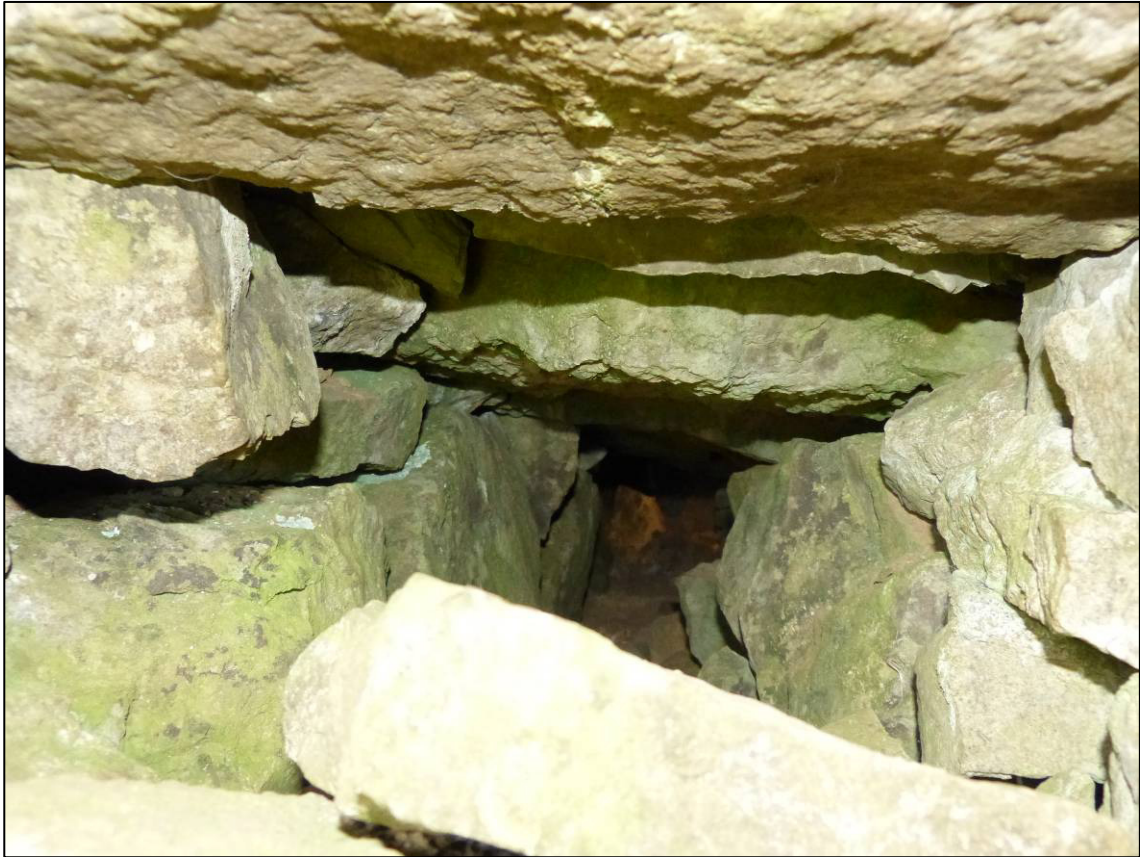
Plate 11: Kiln 2, flue passage in north elevation, looking S (photo 1/143).

curvilinear passage or flue with a flagstone roof, which extends c.3.40m through the body of the kiln, angling to the west at its northern end to emerge in the aforementioned narrow slit-like feature in the east side of the kiln's bowl [1/138]; the precise arrangement as to how the two flues joined could not be seen. Again, this passage must be original.

- 3.5 Kiln 2 does, however, preserve a very rare feature. The passages or flues leading from the longer north and south elevations to the narrow opening in the east side of the bowl are highly unusual, and only one other field kiln with a comparable arrangement (at Great Asby in Cumbria) has been noted in either the Yorkshire Dales or the Westmorland/east Cumberland region. A more complex variation of the same arrangement has also been recorded at a commercial kiln between Masham and Bedale in North Yorkshire. These flues were designed to increase air flow through the central part of the bowl where the calcining process took place i.e. above the cooling zone and below the pre-heating and drying zone, and they may well have been built into the kiln's structure because the lime burners knew (or hypothesised) that a bowl of this height and volume would not draw well (David Johnson, *pers. comm.*).

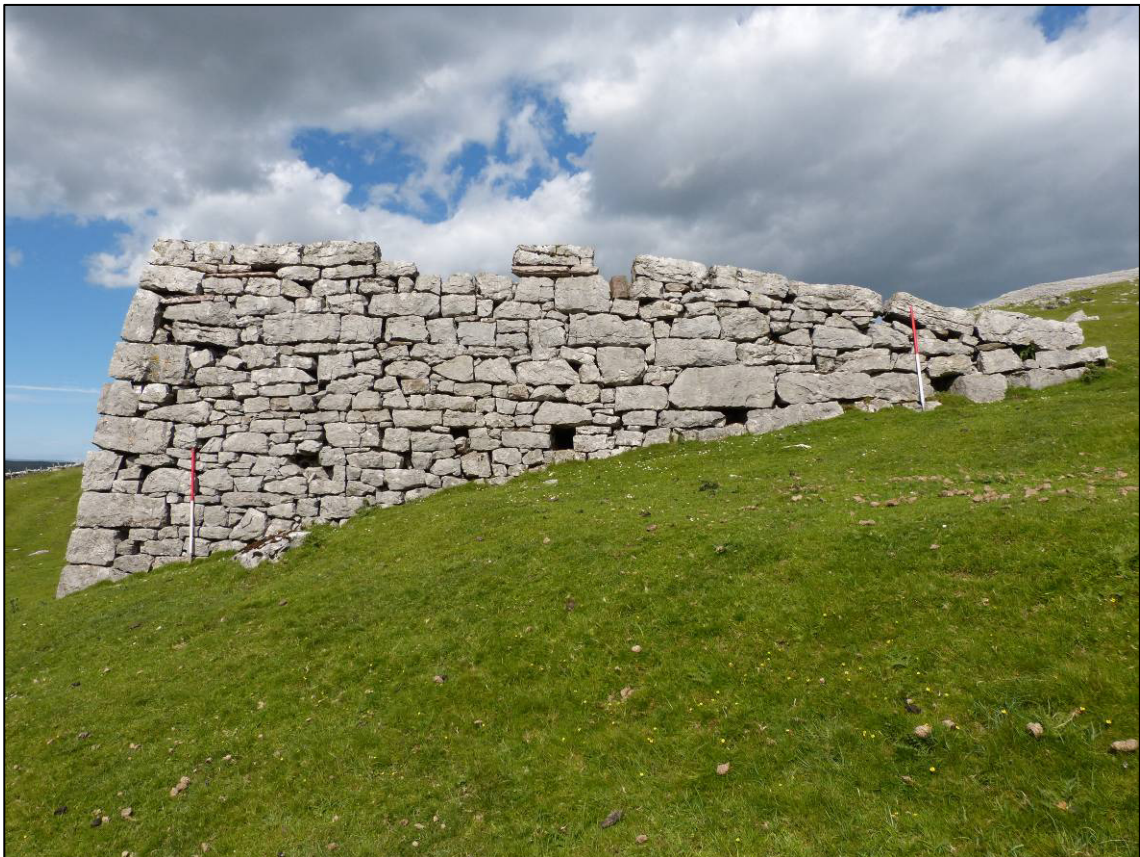
Plate 12: Kiln 2, south elevation, looking N (photo 1/132).

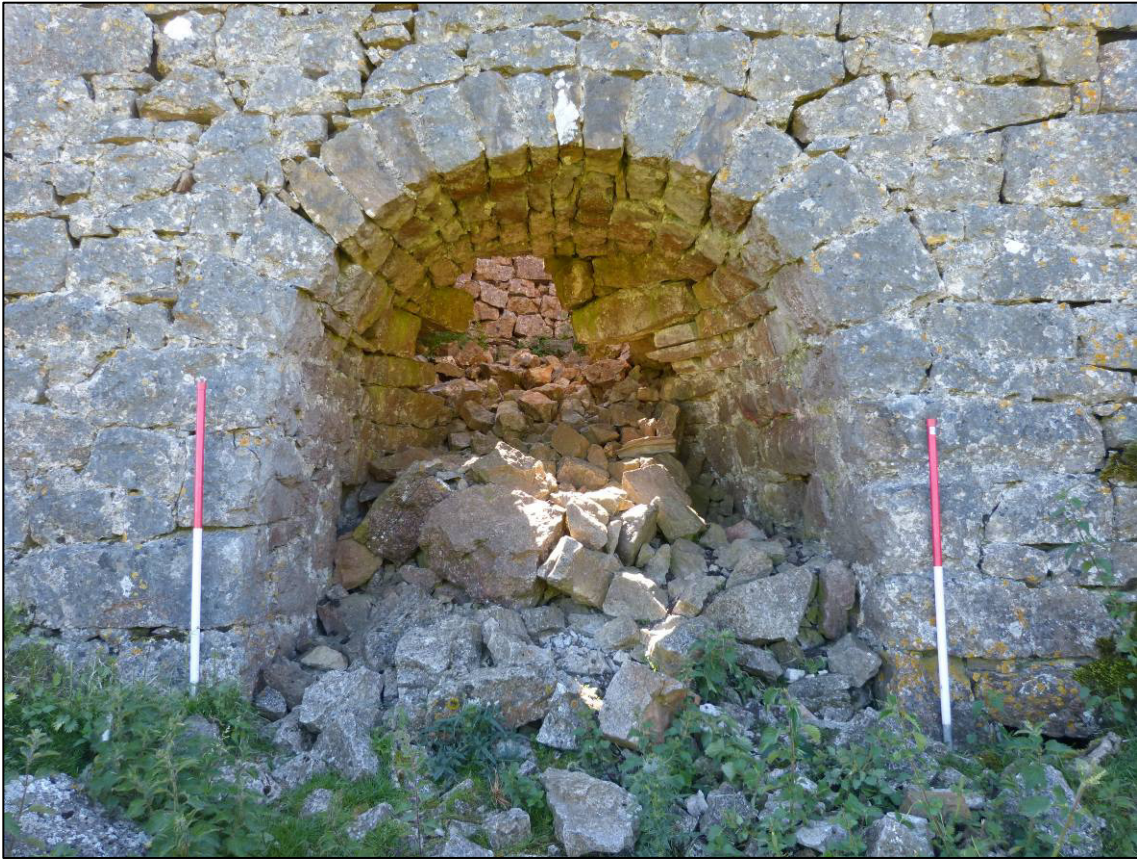
Plate 13: Kiln 2, draw arch in west elevation, looking E (photo 1/122).

- 2.21 The west elevation forms the main elevation of the kiln, the kiln itself facing to the north-west. The elevation is 5.20m wide across the base, tapering to 4.30m across the top (see plate 9). The draw arch itself is 2.15m wide, standing to a maximum of c.2.0m high, and appears to have a low opening to the south. It has a broad head of mortared limestone and sandstone rubble voussoirs [1/122, 1/123, 1/139-1/142] (see plate 13), forming rather more like what Johnson (2010, 253; 2013, 206) describes as a Romanesque arch than a segmental arch. Internally, the walls of the draw arch taper inwards, decreasing in width to 1.60m to the point where the interior has collapsed, exposing the bowl; the depth from the west face of the kiln to the collapse is c.2.20m, and the barrel-vault over is of sandstone. There are small recesses 0.40m square by 0.30m deep, with stone lintels to the north and south internal walls of the draw arch [1/124, 1/125]. At the time of the survey, the interior of the draw arch was choked with rubble, and so it was not possible to tell if there was any floor of, for example, flagstones. The base of the west wall of the bowl has largely collapsed, removing any visible evidence for the draw opening, although it was corbelled out above it.

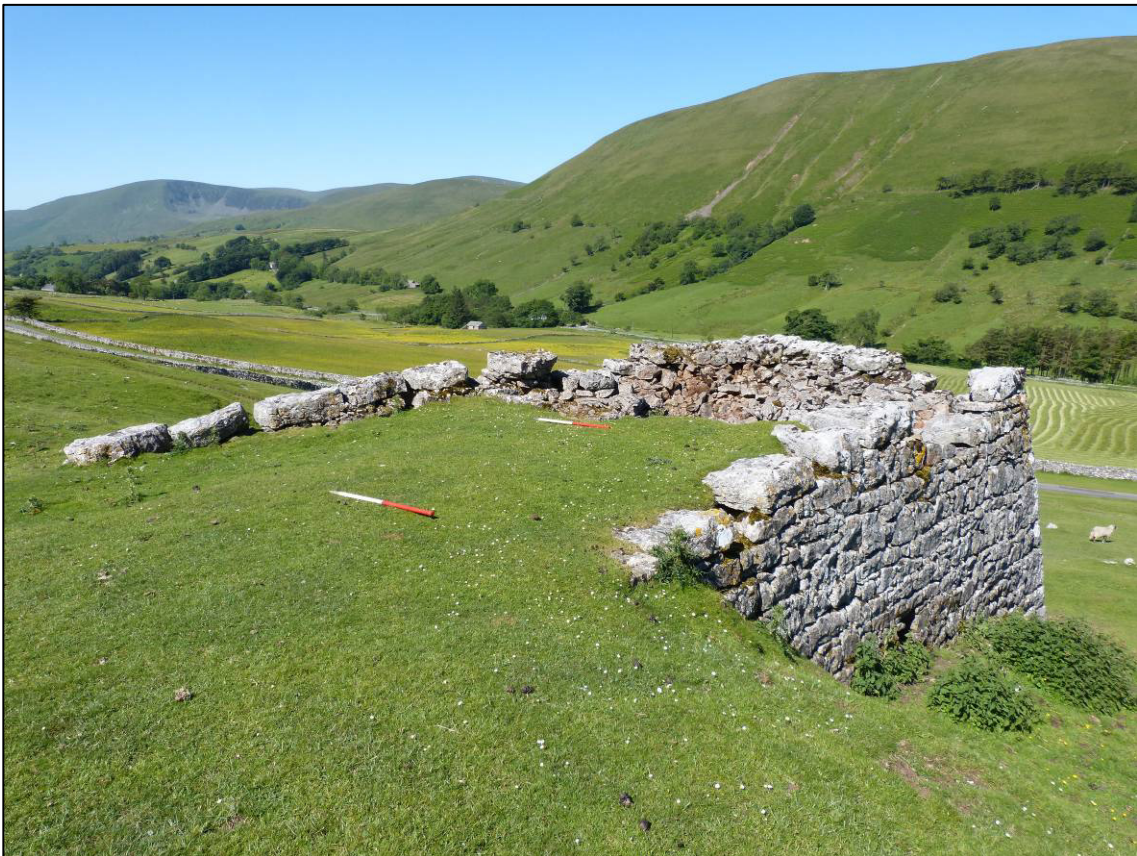
Plate 14: Kiln 2, charging ramp, looking W (photo 1/111).

- 2.22 The upper level of the kiln was accessed via the charging ramp to the east, which survives as a slight earthwork running along the northern side of the area between the top of the kiln's walls [1/110-1/115] (see plate 14). The earth ramp approaches the kiln from the east for c.6m, meeting what appears to be the remains of a stone cross-wall, partially visible in plan and as an earthwork [1/116], beyond which lies the mouth of the bowl. The bowl is slightly sub-circular in plan, measuring c.3m across. The majority of the interior remains visible, and is lined with limestone rubble which displays no evidence for burning [1/126-1/129] (see plate 15). Originally, limestone would never have been used as the inner lining, and so it was probably either heat-resistant flagstone or laminated sandstone which has been subsequently stripped out (David Johnson, *pers. comm.*). The narrow, slit-like, feature referred to above, with which the internal passages communicate, is visible in the east side of the bowl [1/130, 1/131], situated approximately half way down its height (see plate 16); unfortunately, it was not possible to access the interior of the bowl to investigate this feature closely.

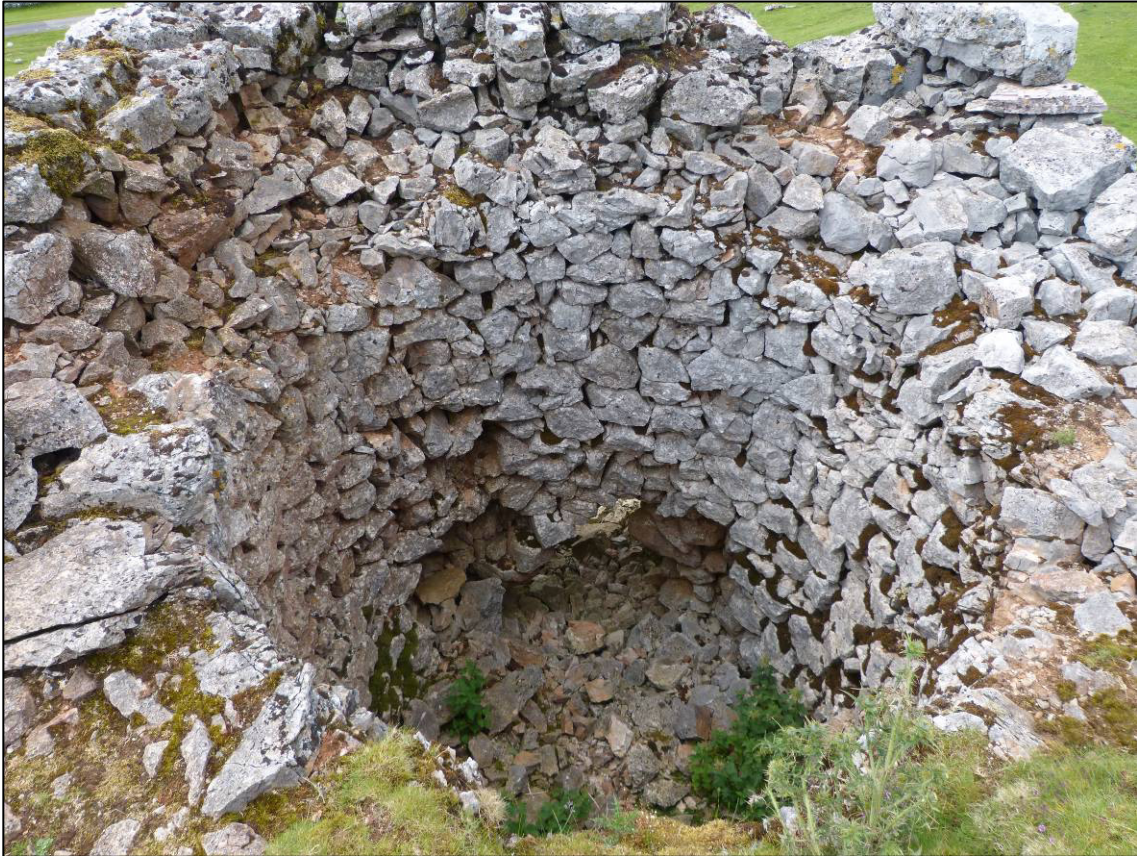
Plate 15: Kiln 2, bowl, looking W (photo 1/127).

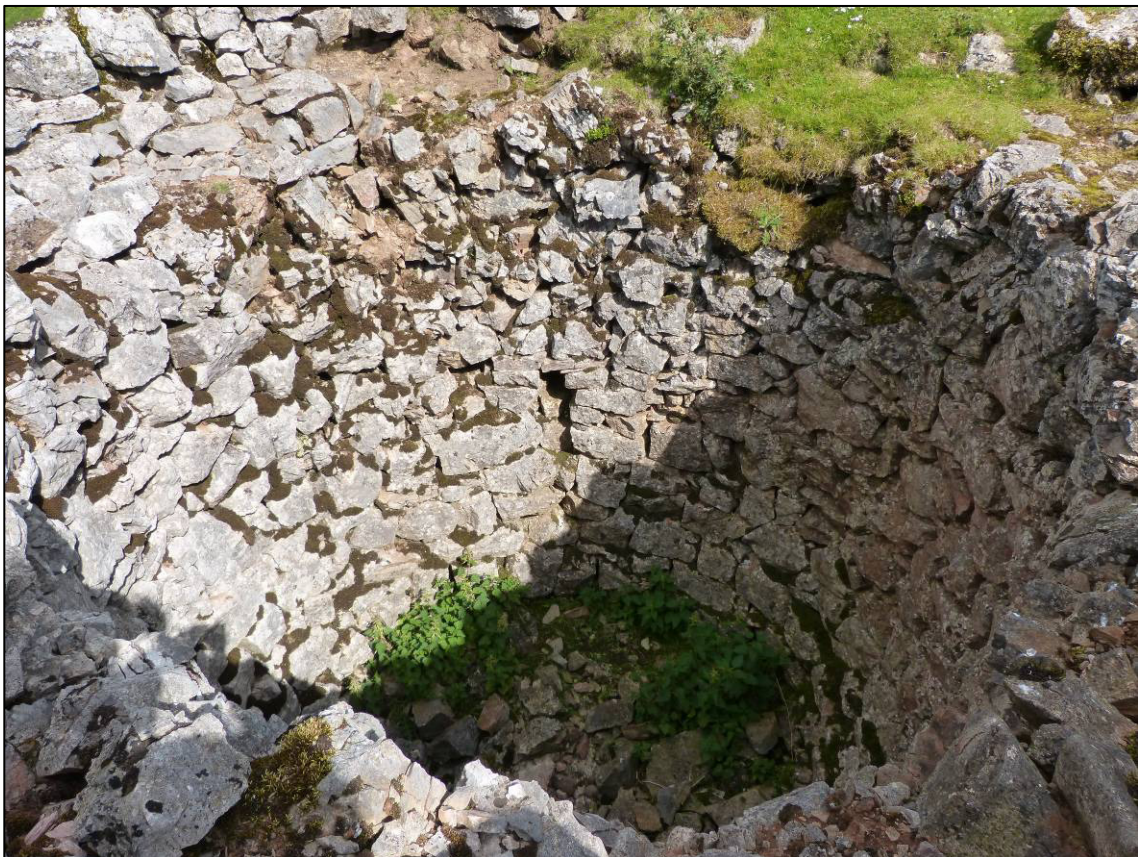
Plate 16: Kiln 2, bowl, showing flue slit to east side, looking SE (photo 1/131).
