EXCAVATION OF TEST PITS,
ALL SAINTS' CHURCH, BISHOP BURTON,
EAST YORKSHIRE

ARCHAEOLOGICAL OBSERVATION,
INVESTIGATION AND RECORDING

Report no: 2019/595.R01
Version: Final
Date: May 2019
Author: Ed Dennison & Shaun Richardson

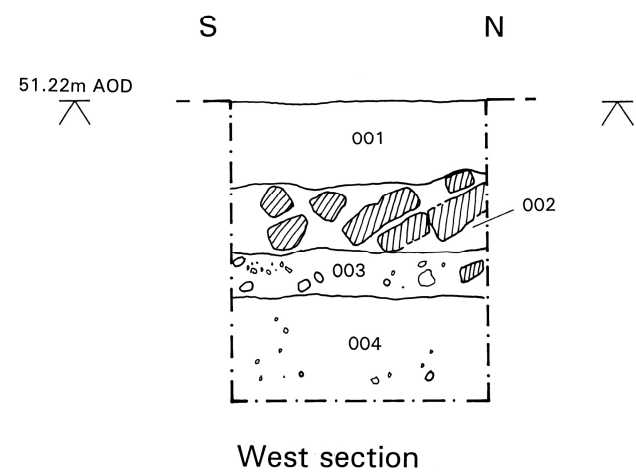
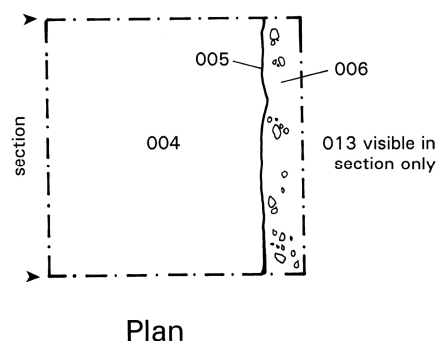
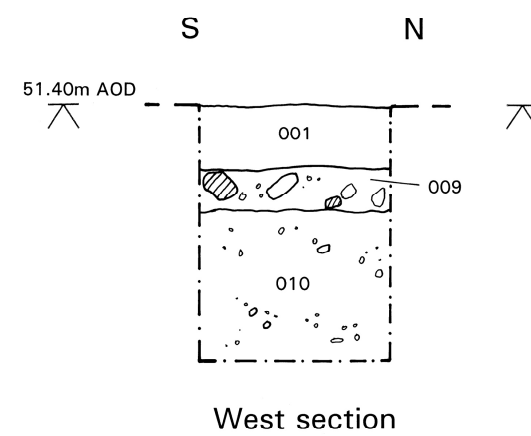
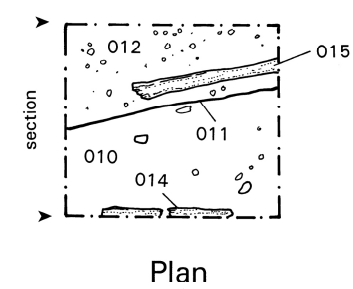
PROJECT		BISHOP BURTON CHURCH	
TITLE		WATCHING BRIEF RESULTS	
SCALE	AS SHOWN	DATE	MAY 2019
EDAS		FIGURE	3

- 6.1 The upper deposits exposed within all three test pits were similar, with a gravel pathway (001) laid over a base of brick and/or chalk rubble hardcore (002, 007 and 009). However, below these deposits, the nature of the pits varied significantly. Test Pit 1 contained one side of a brick structure (013) of probable 19th or 20th century date, which was set within a cut [005] which extended beneath the base of the pit. Very little disarticulated human bone was present in the lowest recorded deposit (004). Test Pit 2 did produce disarticulated human bone, but only from the brick/chalk rubble (007). This overlay a sandy clay (008) which appeared to comprise an undisturbed natural deposit. Test Pit 3 produced disarticulated

human bone from the lowest recorded deposit (010) and also appeared to contain the partial remains of two articulated burials (014) and (015) at a relatively shallow depth, around 0.50m BGL.

- 6.3 It is recommended that the line of the proposed trench arch drain is archaeologically excavated in advance of construction, to the required depth, to ensure that any human remains (both articulated and disarticulated) are properly identified, recorded and, if necessary, removed from the alignment, in accordance with standard procedures (e.g. ADCA 2004; EH/CoE 2005). It is further recommended that the excavation of associated drainage works providing a connection to the trench arch from the new WC facility, is subject to an archaeological watching brief. If accepted, these works will need to be preceded by an appropriate "Written Scheme of Investigation" which should be approved by all relevant bodies.

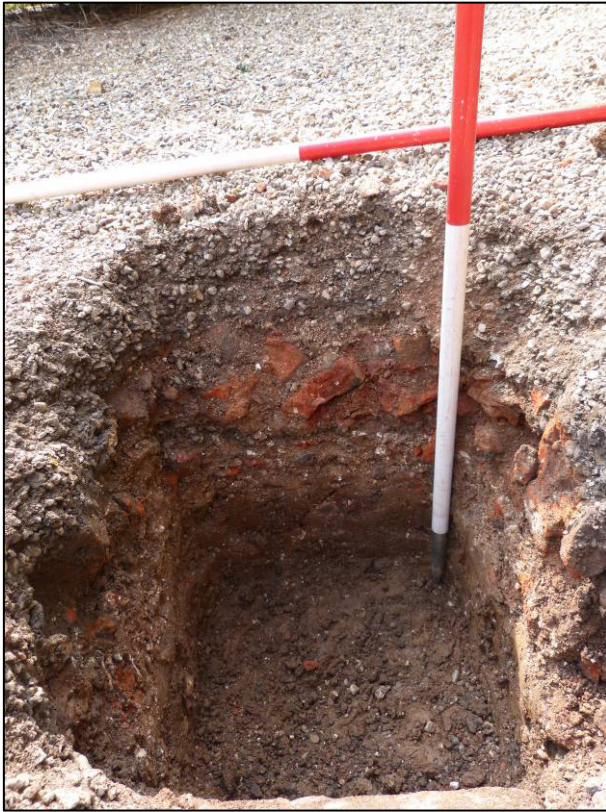
Plate 1: Test Pit 1, west section, looking W.

pit; the cut was filled with a mixture of a gritty black silt soil and gravel (006). In the pit's other three sides, the gravel (001) overlay a compacted layer of brick rubble (002), formed by handmade red bricks (average thickness 60mm) and extending to 0.35m BGL. Beneath the brick rubble, there was a level deposit of compacted sandy clay and lime mortar (003), with an average depth of 0.10m. This overlay a clean, stiff mid-brown sandy clay (004), which continued below the base of the pit. The clay (004) contained a small amount of human bone, visible at the north-west corner of the pit's base, in plan only (see plate 1).

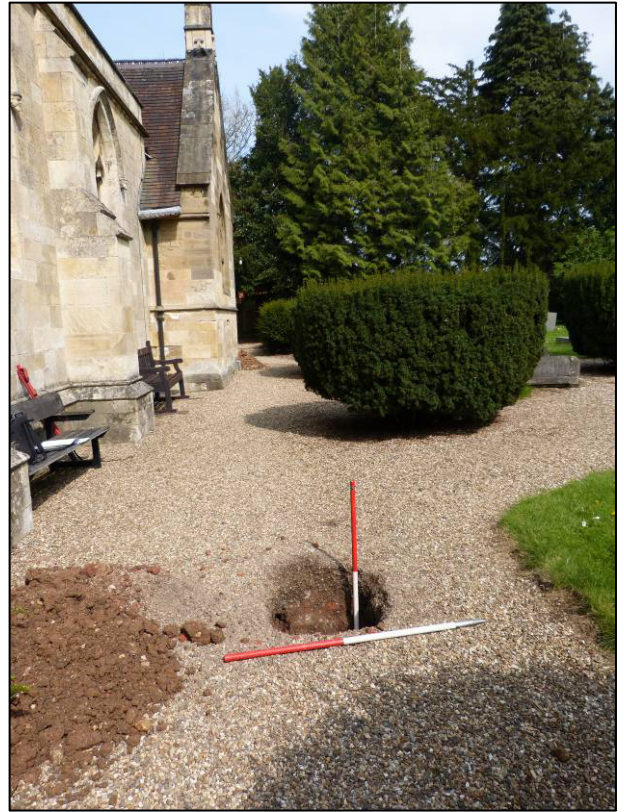
Plate 2: Test Pit 1, looking E.

- 5.2 Test Pit 1 was located 1.70m to the south of the second buttress to the east of the church's south doorway. It measured 0.60m square, and was hand excavated to a depth of 0.70m below ground level (BGL) (50.52m AOD) (see plate 2). The uppermost deposit extended to 0.20m BGL, and was formed by a compacted gravel (001) forming the path surface, composed of angular and rounded stones up to 100mm across. In the pit's east side, the gravel overlay what appeared to be a roughly built mortared brick structure (013), which extend to at least 0.45m BGL. It appeared that the external face or side of the structure was visible in the trench section, and it may once have supported the base of a monument or grave marker, or perhaps was associated with earlier drainage works. The construction of the structure had required a cut [005] to be made, which was visible in the base of the

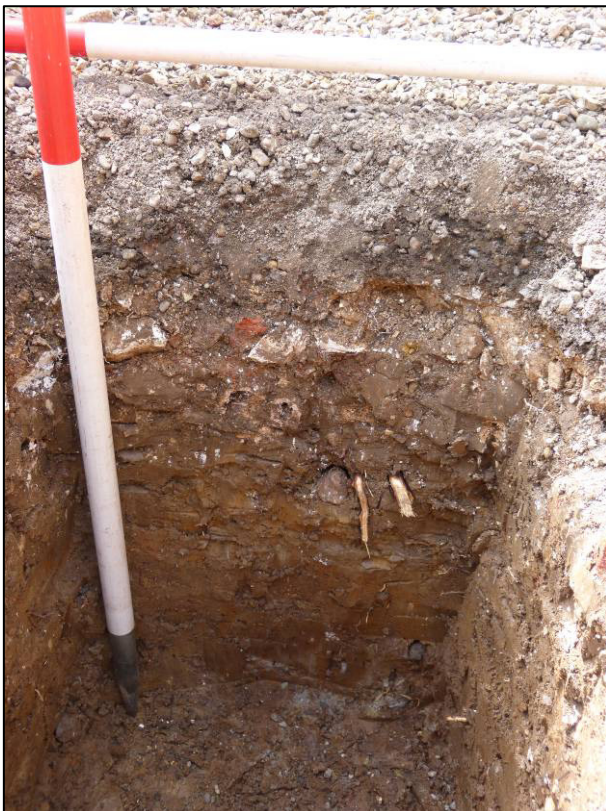
Plate 3: Test Pit 2, west section, looking W.

- 5.3 Test Pit 2 was located 0.90m to the south of the south-east external corner of the vestry. It measured 0.60m east-west by 0.50m north-south and was hand excavated to a maximum depth of 0.70m BGL (50.67m AOD) (see plate 4). The uppermost deposit was the same gravel (001) as seen in Test Pit 1. It extended to 0.15m BGL, and overlay a compacted layer of angular handmade red brick (CBM) and chalk rubble (007) containing a high proportion of disarticulated human bone, and which had an average depth of 0.10m. Beneath the compacted brick/chalk rubble (007), there was a clean, stiff, mottled orange/mid-brown sandy clay (008) which extended below the base of the pit. This sandy clay (008) contained no disarticulated human bone and appeared to be an undisturbed natural deposit (see plate 3).

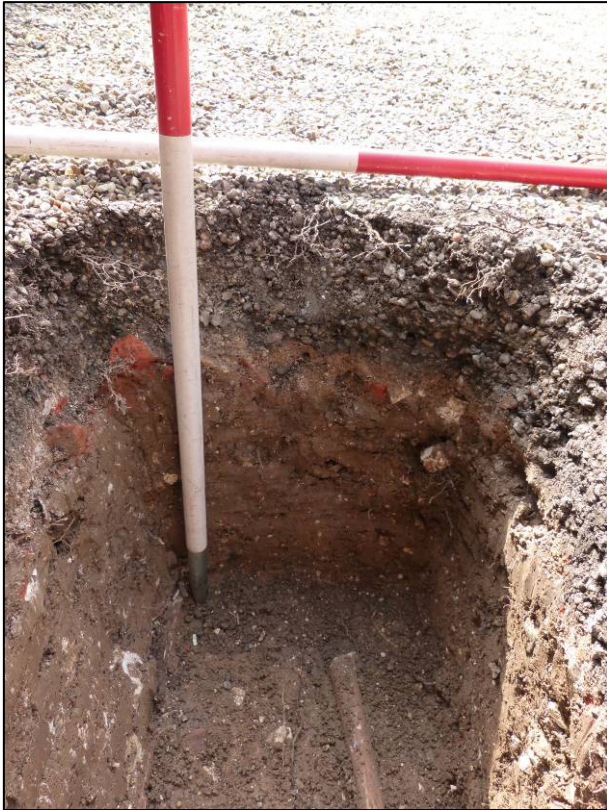
Plate 5: Test Pit 3, W section, looking W.

- 5.4 Test Pit 3 was located 3.96m south of the south-east external corner of the chancel. It measured 0.50m east-west by 0.45m north-south and was excavated to a maximum depth of 0.60m BGL (50.80m AOD) (see plate 6). The uppermost deposit was the same gravel (001) as seen in Test Pits 1 and 2. It extended to 0.15m BGL and overlay a compacted layer of angular handmade red brick and chalk rubble (009), which had an average depth of 0.10m. Beneath this, there was a stiff, light brown silty clay (010) with frequent inclusions of chalk and disarticulated human bone, which continued below the base of the pit. A possible flint tool was also recovered from the deposit; this will be the subject of further assessment. The disarticulated bone was distributed evenly throughout the silty clay (010), and at the base of the pit, two articulated burials may have been exposed. On the north side of the pit, there appeared to be an east-west aligned cut [011], running broadly parallel to the church, which contained part of an articulated leg (015), placed at c.50.80m AOD (see plate 7). The cut was not easily visible in any of the pit sections, and was backfilled with a dark brown silty clay (012). Part of a second articulated burial (014) may have been visible at c.0.55m BGL (c.50.85m AOD) in the south side of the pit. It also appeared to be aligned broadly parallel to the church, but was poorly preserved (see plate 5).
