THE HEARST HOUSE, ST PETER'S CHURCH,  
HACKNESS, NORTH YORKSHIRE

ARCHAEOLOGICAL OBSERVATION,  
INVESTIGATION AND RECORDING

Report no: 2019/604.R01  
Version: Final  
Date: January 2020  
Author: Ed Dennison & Emma Samuel

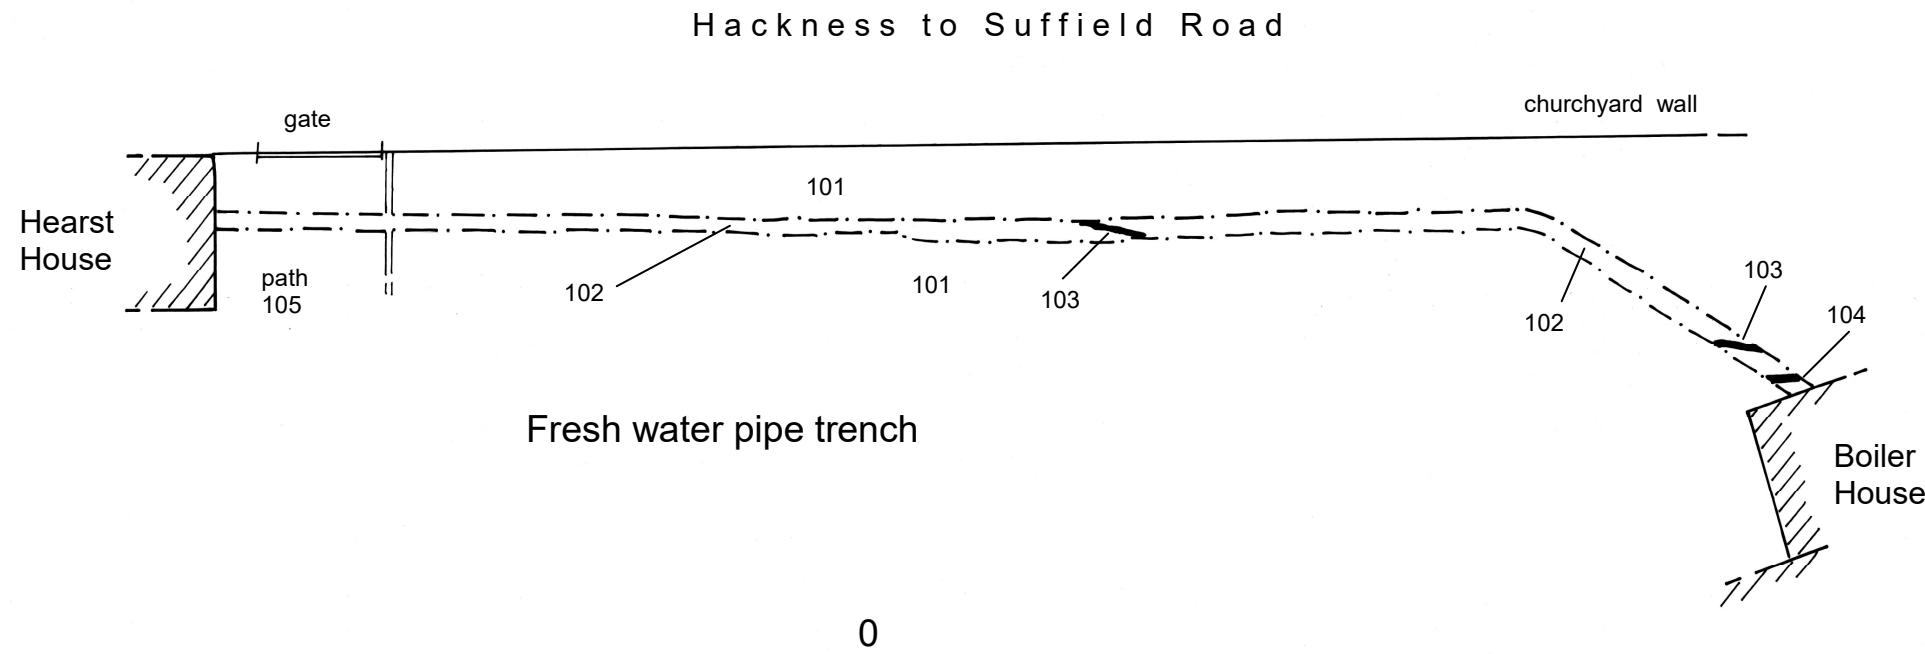
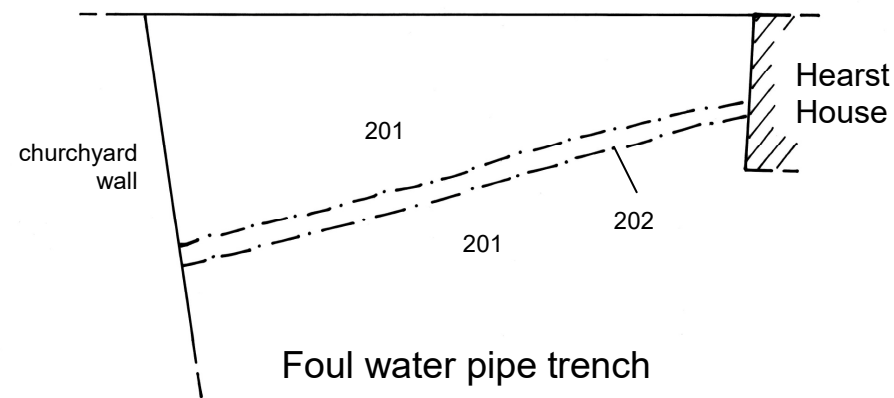
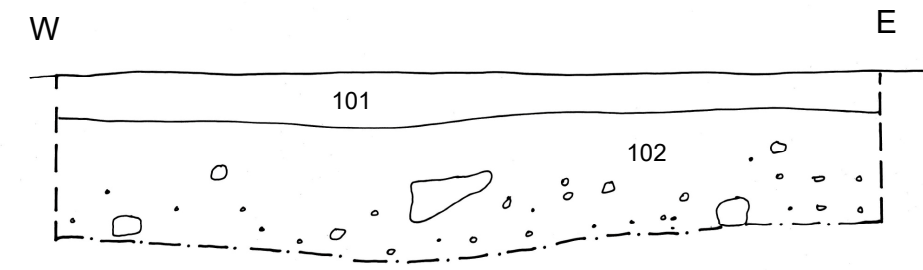
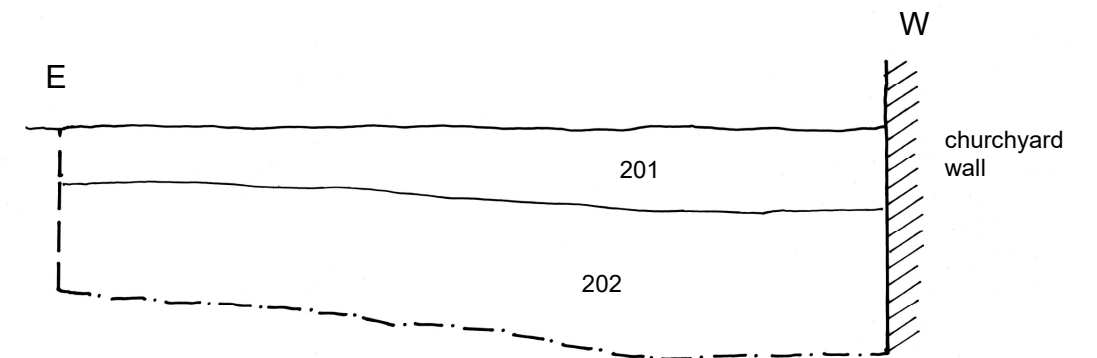
PROJECT ST PETER'S CHURCH, HACKNESS	
TITLE WATCHING BRIEF RESULTS	
SCALE AS SHOWN	DATE JAN 2020
EDAS	FIGURE 4

- 5.2 The earliest deposit exposed in the excavated trench was a layer of firm mid to dark grey-brown silt clay (102) over 0.50m thick, containing frequent medium to large sized fragments of sandstone. A small assemblage of artefacts including medieval, post-medieval and early modern pottery, a 19th century clay pipe bowl, early modern vessel glass, an iron nail, and ceramic building material of medieval and early modern date was recovered from the deposit. Fragments of disarticulated human bone recovered during excavation were returned/re-buried within the trench. This made-ground deposit (102) was encountered 0.14m below existing ground level (hereafter BGL).

- 5.6 The earliest deposit exposed in the trench was a layer of firm mixed dark brown silt clay (202) over 0.52m thick containing lenses of friable mid yellow-brown clay, encountered at 0.20m BGL. Sherds of post-medieval and early 19th century pottery, vessel glass and CBM of early modern date were recovered from this deposit. One fragment of disarticulated human bone recovered during excavation was returned and re-buried within the trench. The silt clay (202) was overlain by a layer of firm dark brown-black loamy clay topsoil and turf (201) over 0.30m thick which contained frequent roots, and which formed the existing ground surface on this side of the Hearst House.

Typical section along fresh water pipe trench

Typical section along foul water pipe trench

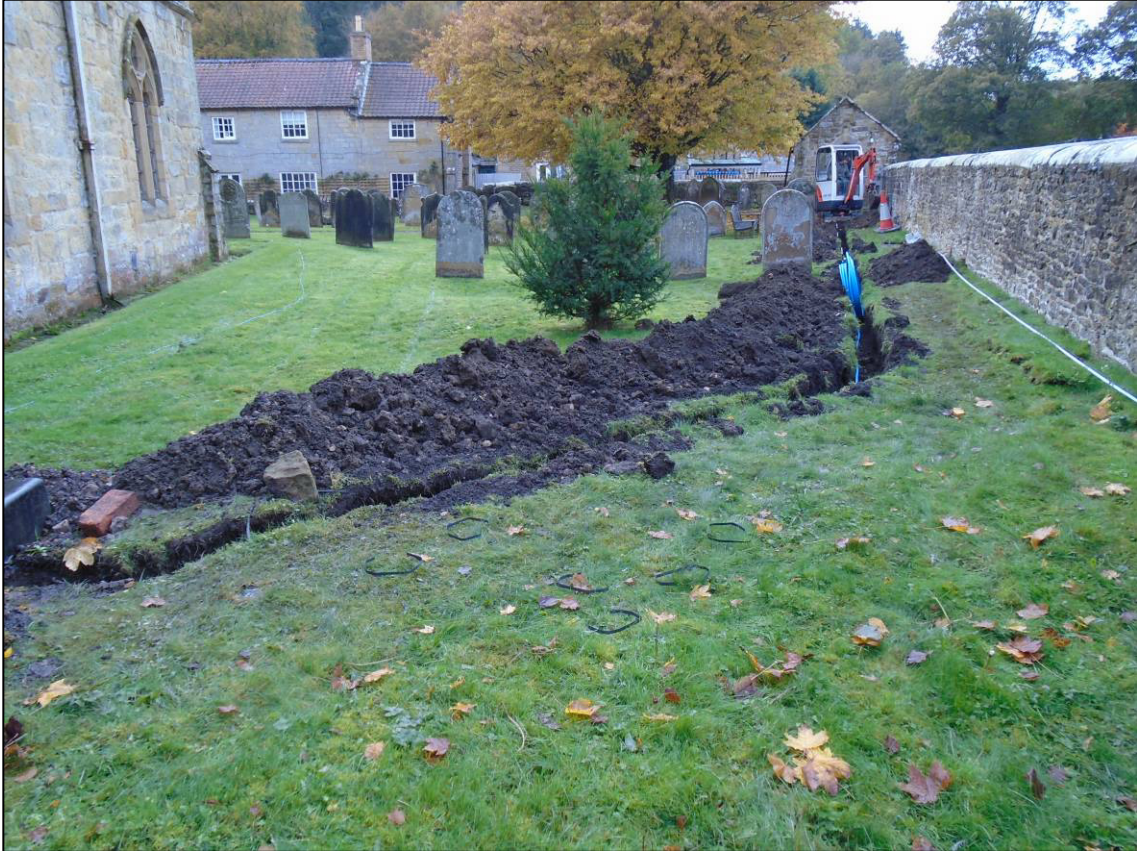
- 5.1 As previously noted, the trench for the new water supply ran from a stop tap to the north of the church, adjacent to a boiler room, to the Hearst House, and was 0.30m wide and up to 0.70m deep (see plates 1 to 3). Natural deposits were not encountered.

Plate 1: Excavation of fresh water pipe trench, looking W.

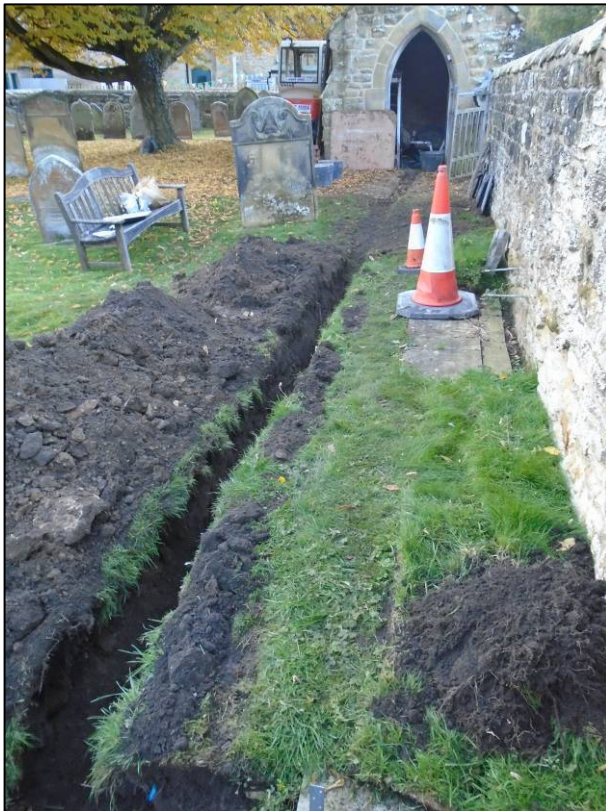
Plate 2: Excavation of fresh water pipe trench, looking W towards Hearst House

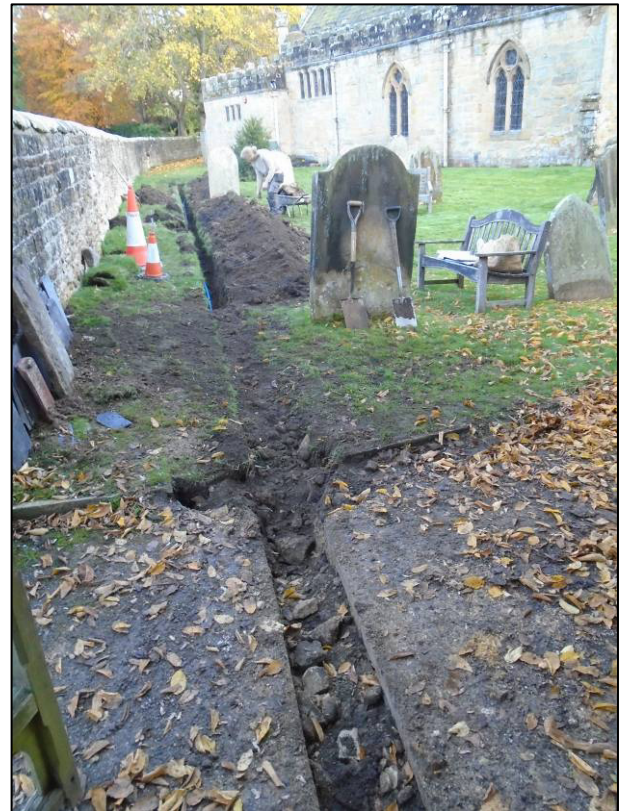
Plate 3: Excavation of fresh water pipe trench, looking E showing cut through path.

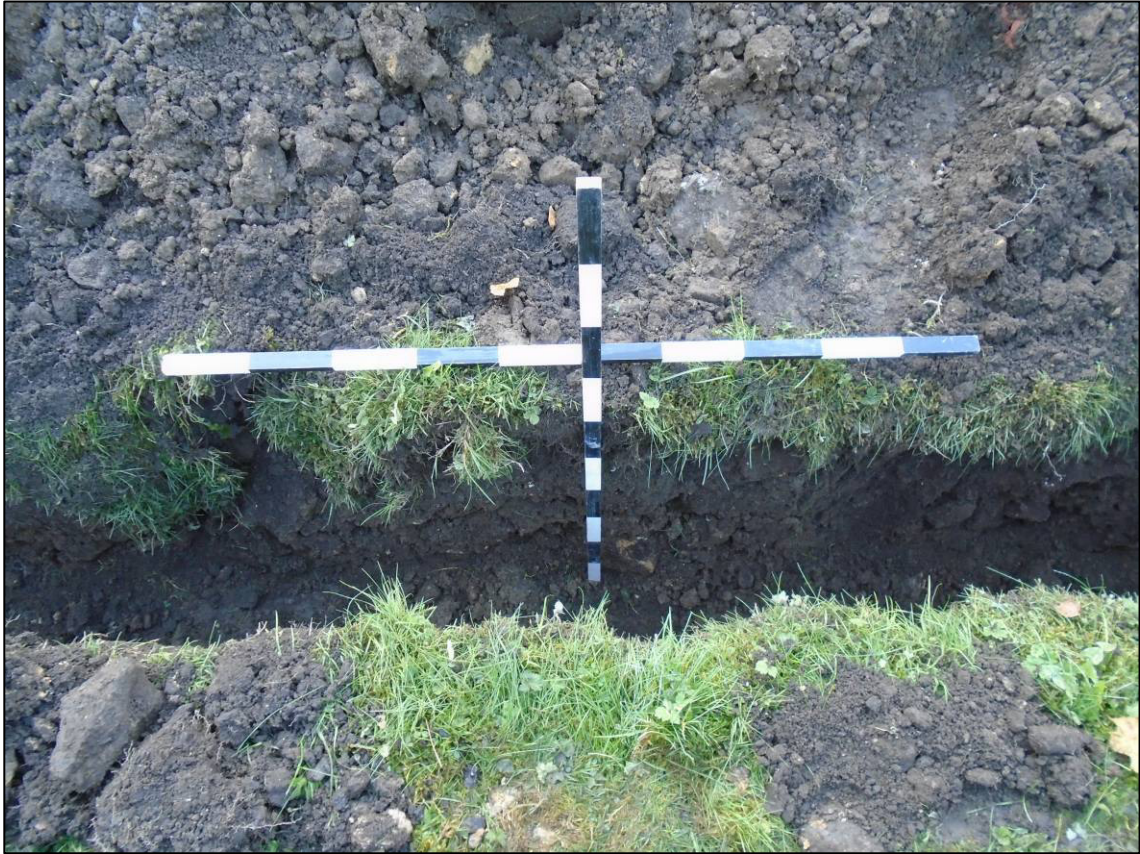
- 5.3 Narrow trenches for two modern services had been cut into the made-ground deposit (102). One, for a roughly north-west/south-east aligned modern plastic-coated cable (103), 0.02m wide, was exposed in two parts of the trench - this provided electricity to the Hearst House. Further to the east, a roughly east-west aligned metal pipe (104), 0.08m wide, was exposed, and this was likely to be the main water conduit from a spring adjacent to Church Cottages (Lord Derwent, *pers. comm.*).

- 5.4 The made-ground deposit (102) and the two service pipes (103 and 104) were overlain by a layer of firm dark brown silty loam topsoil and turf (101) up to 0.20m thick which formed the existing ground surface (see plate 4). The trench also cut across a 3.20m wide, roughly north-south aligned, path formed of concrete over a thin layer of hardcore (105) with a thin stone curb on the east side (see plate 3). This path ran from the gated entrance to the churchyard, immediately to the east of the Hearst House, to the south door of the church.

Plate 4: Typical section of fresh water pipe trench, looking SW.

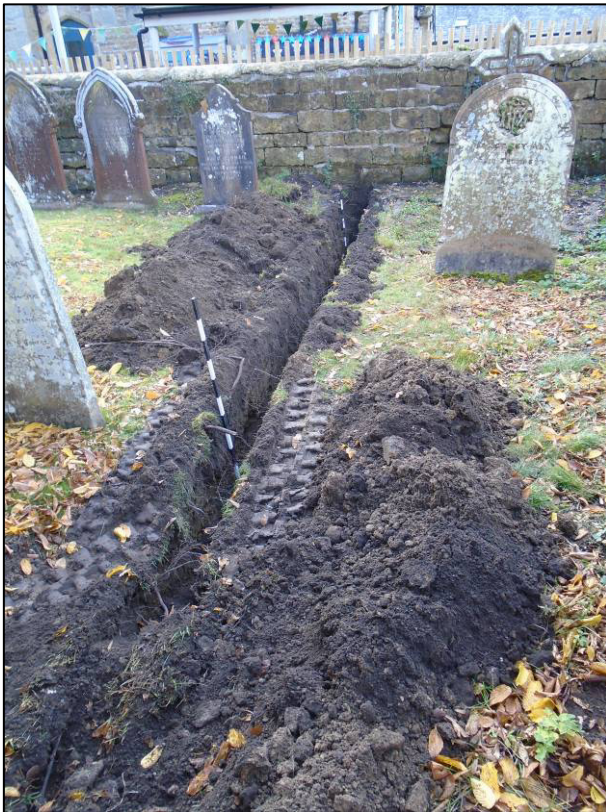
- 5.5 As previously noted, the new foul water pipe trench was excavated in a westerly direction from the Hearst House, and measured 0.30m wide and up to 0.82m deep (see plates 5 and 6). Once again, natural deposits were not encountered.

Plate 5: Excavation of foul water pipe trench, looking W.

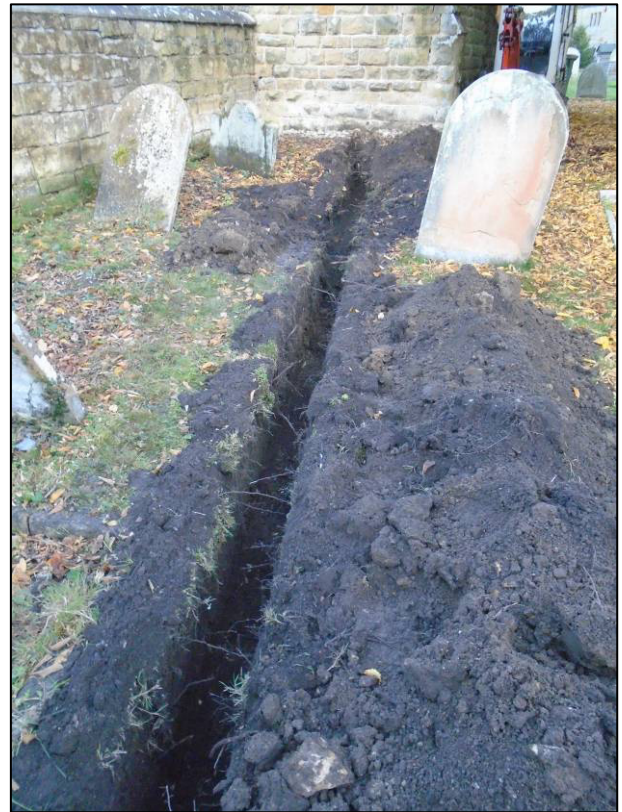
Plate 6: Excavation of foul water pipe trench, looking E towards Hearst House.
