ERECTION OF A PAIR OF SEMI-DETACHED  
HOUSES FOLLOWING DEMOLITION OF  
EXISTING, DOLMAN TERRACE, RAILWAY STREET,  
POCKLINGTON, EAST YORKSHIRE YO42 2QS

ARCHAEOLOGICAL OBSERVATION,  
INVESTIGATION AND RECORDING

Report no: 2019/597.R01  
Version: Final  
Date: February 2020  
Author: Ed Dennison & Emma Samuel

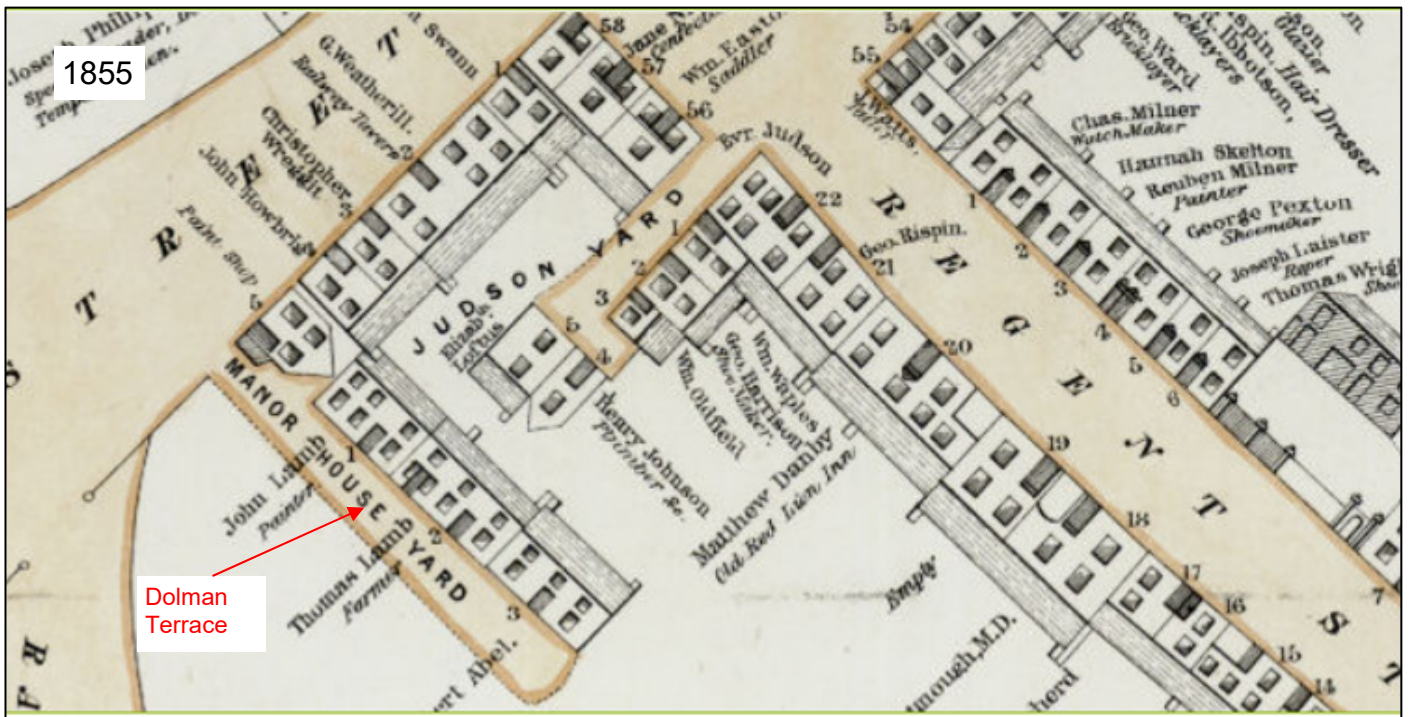
PROJECT		DOLMAN TERRACE, POCKINGTON	
TITLE		WATSON'S MAPS	
SCALE	NTS	DATE	FEB 2020
EDAS		FIGURE	3

- 4.7 Watson's 1844 map shows the area of the development site, located on the south side of Finkle Street (see figure 3 top). A terrace of six buildings is depicted, running back from a building on the Finkle Street frontage, with three enclosures to their west jointly named as 'Manor House Yard'. Easton's 1845 directory shows that the Finkle Street structure (no. 4) is an outbuilding, while the next two (nos. 1 and 2) are both houses occupied by Richard Cook, a painter, and Mrs Judson respectively, and the final three structures are further outbuildings; all of the terrace was owned by Robert Denison. Enclosure no. 5 on Finkle Street is a garden, and the linear track (no. 6) is described as a 'space'. The large field to the south-west of the track is named as 'Manor Garth'. The southern of the two houses in the terrace (no. 2) is labelled as 'Manor House', and this has led to the conclusion by some that this building is the Dolmans' former manor house (<https://pocklingtonhistory.com/history/manorhistory/dolmanmanor/index.php>), although this is unlikely to be the case (see below).

- 4.8 Watson's slightly later map of 1855 depicts the (presumably) west outward-facing side of the terrace, and shows three buildings on 'Manor House Yard' (see figure 3 bottom). The northern house (occupied by John Lamb, painter) is of four bays, the larger central house (occupied by Thomas Lamb, farmer) is of four bays and

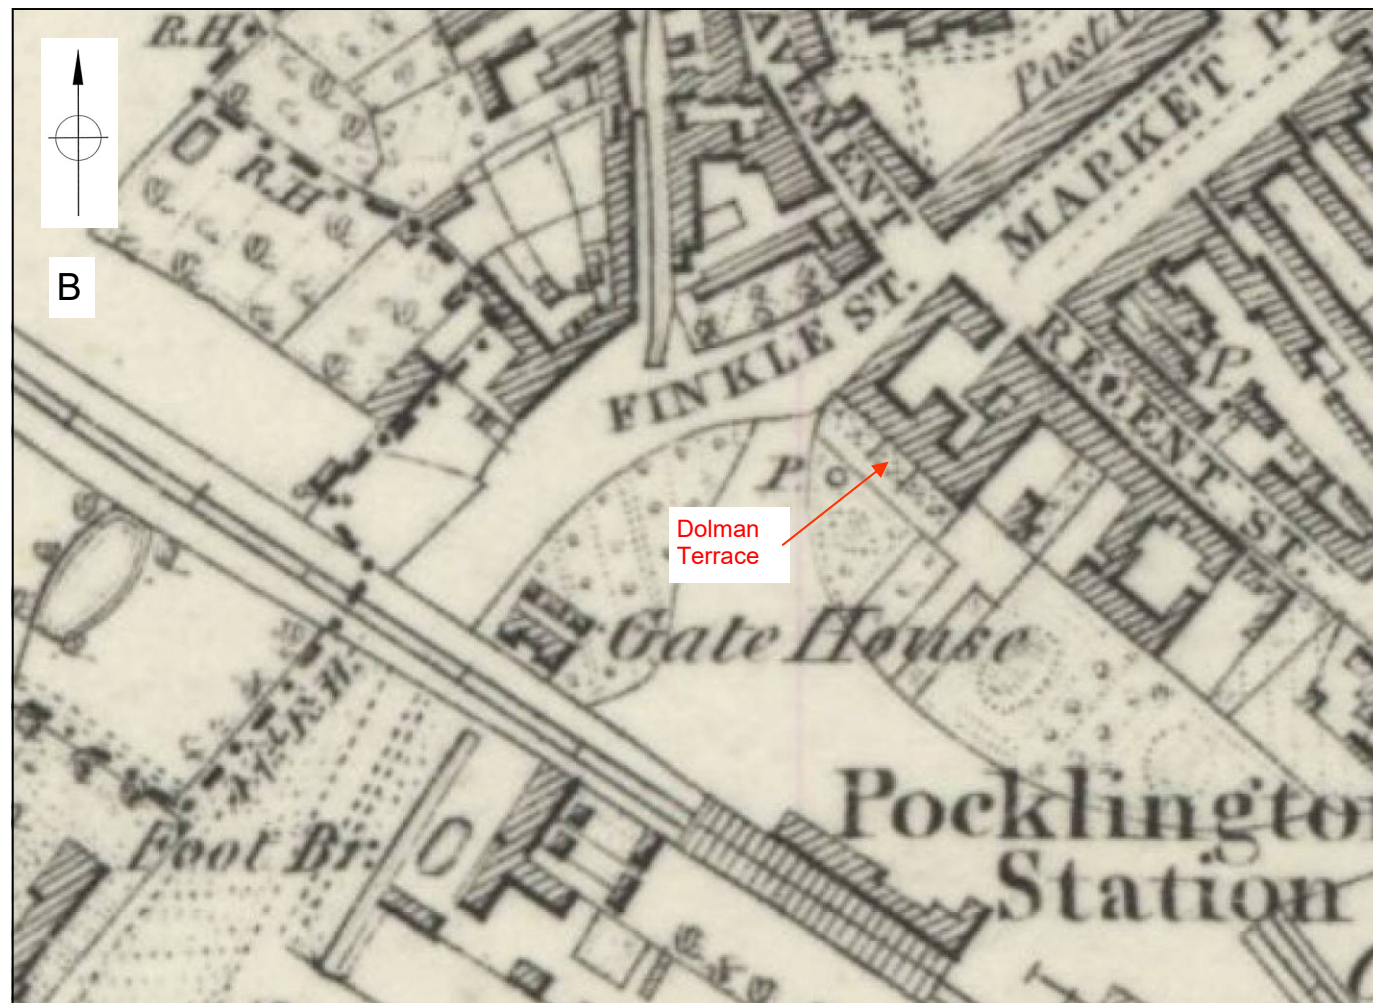
PROJECT DOLMAN TERRACE, POCKLINGTON	
TITLE 19TH CENTURY MAPS	
SCALE NTS	DATE FEB 2020
EDAS	FIGURE 4

A: 1845 York and North Midland Railway plan (ERAO QDP/148 part 1).

C: 1892 Ordnance Survey 25" map sheet 176/15, surveyed 1890.

- 4.9 A plan draw up for the construction of the York and North Midland Railway, dating to 1845, also shows the terrace, with the track on their south-west side (no. 58a) being an 'occupation road' (ERAO QDP/148 parts 1 & 2) (see figure 4A). The 1854 Ordnance Survey 6" map (sheet 176, surveyed 1851) also shows the same situation as that depicted by Watson's plans (see figure 4B), although there is a stronger impression that the terrace forms the south-west side of a larger collection of buildings which have a U-shaped plan and which are grouped around Judson Yard (as named in 1855, now called Lockwood Court) with an entrance off Regent Street to the north-east. The 1854 map also shows three small gardens on the south-west side of the terrace, presumably correlating to the three houses shown in 1855. The more detailed 1892 Ordnance Survey 25" map (sheet 176/15, surveyed 1890) (see figure 4C) shows that the collection of buildings around Judson Yard are still evident, but significantly there are now two ranges of buildings forming the south-west range, representing some infilling of Judson Yard. There are also a number of structures extending out from the south-west side of the south-western range into the former Manor House Yard.

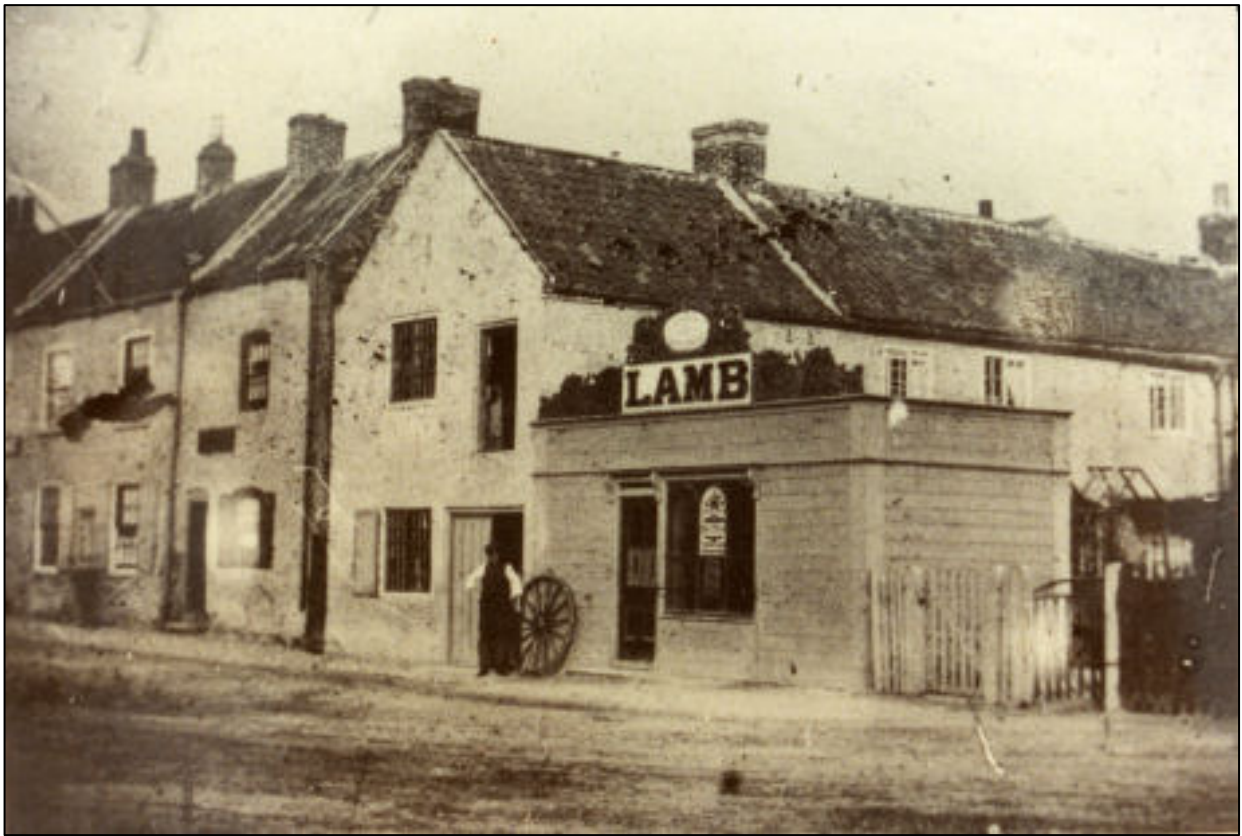
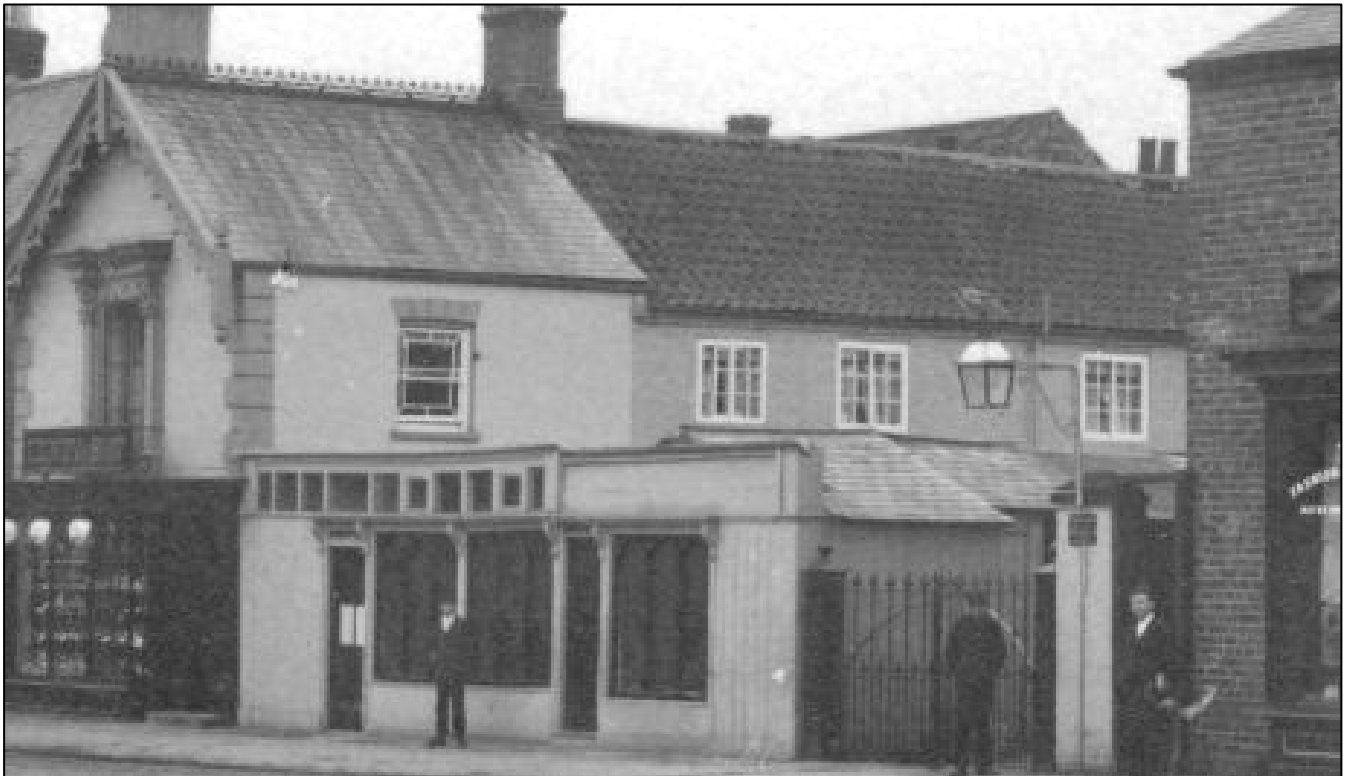
PROJECT		DOLMAN TERRACE, POCKINGTON	
TITLE		HISTORIC PHOTOGRAPHS	
SCALE	NTS	DATE	FEB 2020
EDAS		FIGURE	5

Historic views of no. 11 Railway Street (formerly Finkle Street), with Dolman Terrace to rear.

- 4.11 The buildings of present day Dolman Terrace are clearly of two different builds, the north-west part (comprising buildings 1 and 2 on Watson's 1844 plan) being of probable mid-late 18th century date. This could reflect a rebuilding by the Dolmans, and early photographs, reproduced on the Pocklington History website (<https://pocklingtonhistory.com/history/manorhistory/dolmanmanor/index.php>) show sliding-sash windows to the first floor which are a characteristic of this period (see figure 5); one of these photos (figure 5 top) could be dated to the 1860s (David Neave, *pers. comm.*). The rest of the range, comprising the three outbuildings on Watson's 1844 plan, must also have been rebuilt soon after this plan was produced, as by 1855 they are depicted as a single cottage with the fenestration corresponding exactly to that which existed prior to the start of the current development.

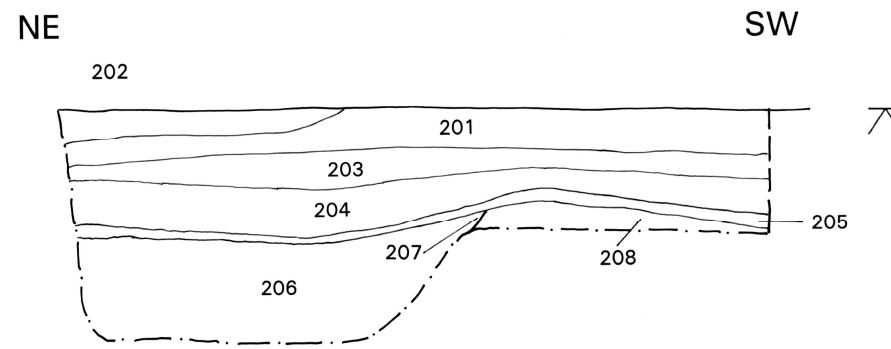
Section 2: East corner of Plot 2

- 5.8 A circular pit [207] over 1.70m in diameter and over 0.42m deep, extended 0.46m into the eastern corner of the plot and was encountered at 0.40m BGL (see Section 2 and plate 9). The pit contained a mixed dark brown-black and yellow-brown clay fill (206) with occasional flint inclusions. A single sherd of 14th-16th century Humberware pottery (Peter Didsbury *pers. comm.*) and a fragment of burnt, unmodified fossiliferous limestone were recovered from the fill. An abundance of soil-dwelling fungus sclerotia (cf. *Cenococcum geophilum* Fr.), a small number of *Sphagnum* moss spores and diatom frustules (*Pinnularia* species) were noted in an environmental sample (S.1) taken of the pit fill (206), in addition to two spheres and a flake of hammerscale, three pieces of amorphous slag (<1mm) and traces of charcoal.

- 5.9 A thin deposit of black silt and ash (205), only 0.06m thick and with occasional inclusions of fragmented brick, sealed the pit and extended over 3.0m along the eastern edge of the eastern foundation trench (see Section 2). This black silt and ash (205), which may have represented a former ground surface, was overlaid by a ground-raising/consolidation deposit of chalk gravel and brick rubble (204) up to 0.20m thick. A further ground-raising/consolidation deposit of a light grey clay (203) with some cement and up to 0.18m thick overlay this across the north-eastern part of the plot; both deposits were encountered 0.20m-0.25m BGL. All these deposits were probably associated with development of the area during the 19th century.

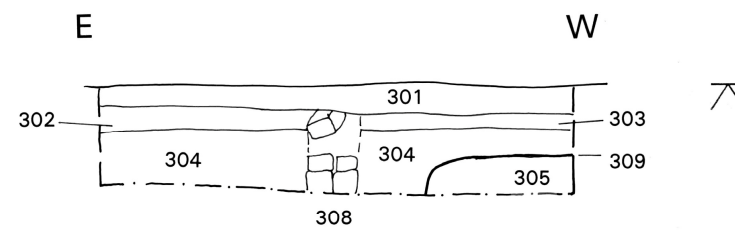
Section 3: South side of service trench

- 5.17 A ground-raising/consolidation deposit of yellow-brown chalk gravel and rubble (304) over 0.22m thick overlay the natural (305), abutted all four foundations (306, 307, 308 and 310) and was encountered 0.18m BGL (see Section 3). This chalk gravel and rubble deposit (304) was overlaid across the eastern end of the trench by another ground-raising/consolidation deposit of black ashy gravel (302) up to 0.12m thick, which in turn overlay foundations 306 and 307 and abutted foundation 308. This probably represented the southern continuation of a similar deposit (204) seen in Plot 2.

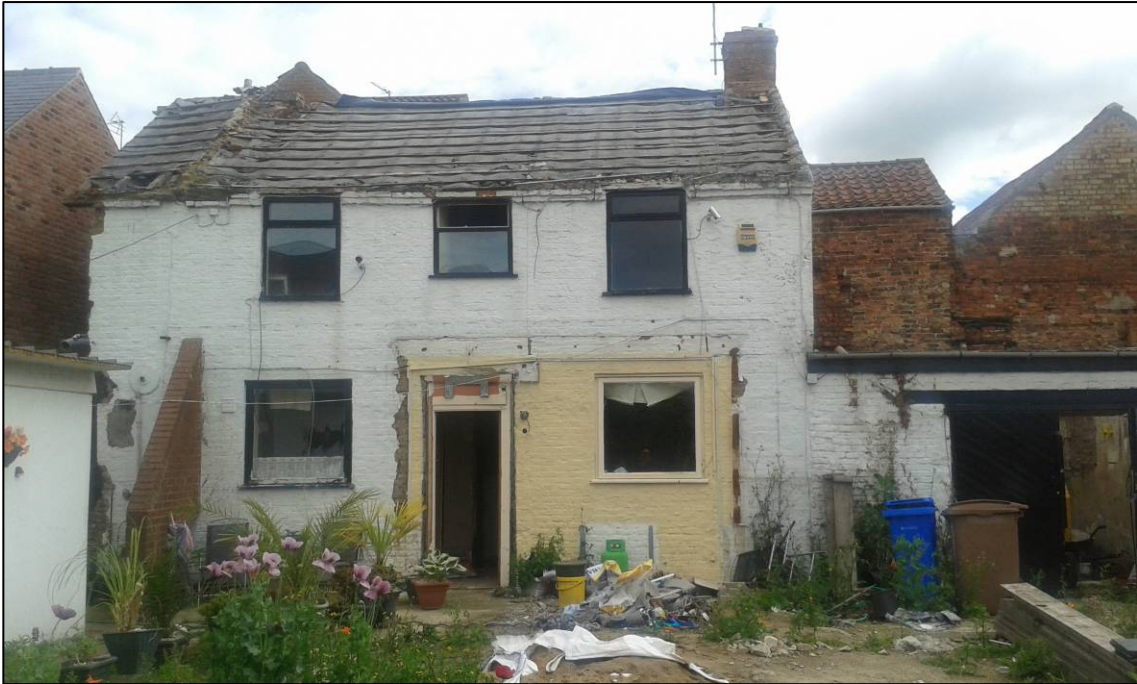
Plate 1: No. 1 Dolman Terrace prior to demolition, looking NE.

- 4.15 As depicted on Watson's 1855 plan (see figure 3 bottom), the main elevation faced south-west and was of three, unequally sized, bays (see plate 1). There was a centrally placed doorway on the ground floor, flanked by two square windows, both with wooden frames. To the north-west there was a modern sloping brick-built buttress with a wall-tie with a circular cast-iron plate beyond; these indicate structural instability. There had been a conservatory attached to the door and left-hand window, as indicated by scarring and a yellow wash on the former interior. To the first floor, there were three square windows, one to each bay, with the central window being smaller than the flanking windows. These upper windows may have been inserted or enlarged, as they disturbed a shallowly corbelled eave course at the top of the elevation. The east gable, above the adjoining garages, had been rendered and was completely blank.

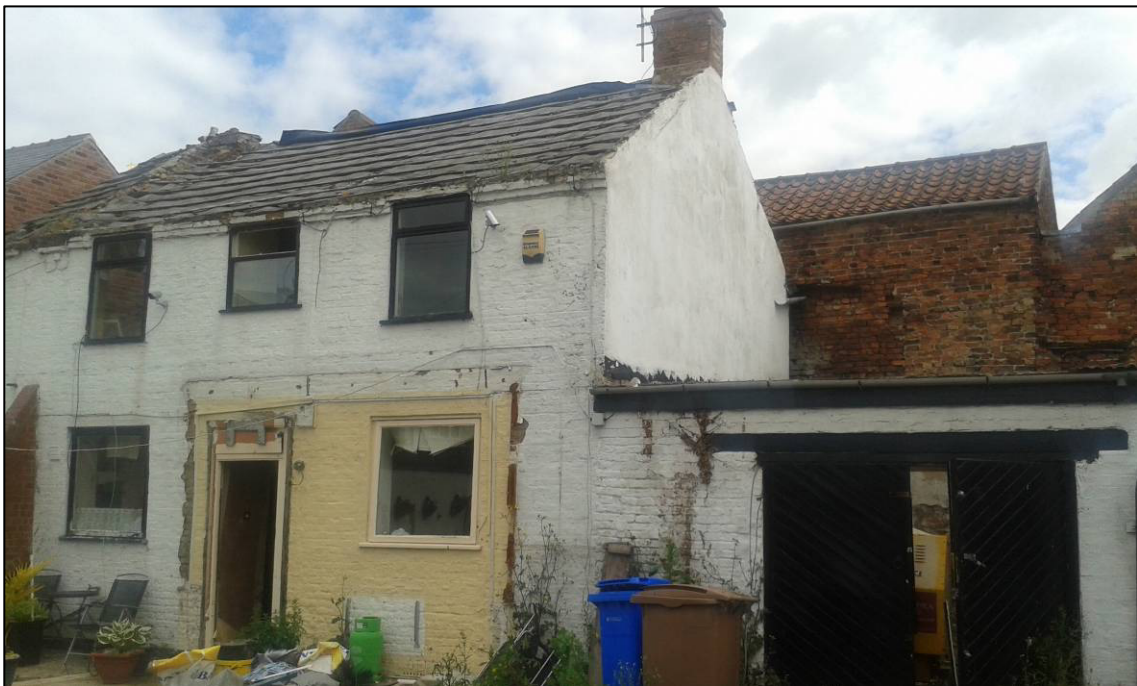
Plate 2: No. 1 Dolman Terrace and adjacent garage, prior to demolition, looking N.

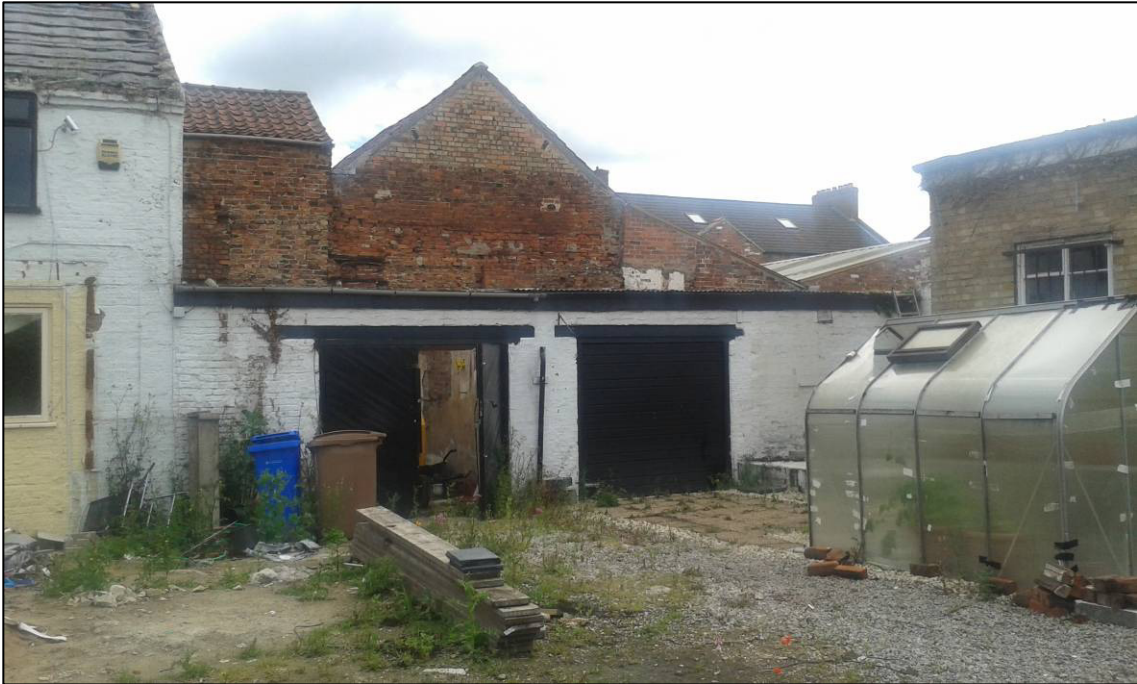
Plate 3: Garages adjacent to No. 1 Dolman Terrace, prior to demolition, looking NE.

- 4.17 To the south-east of the cottage, there was a single storey building, most recently used as a pair of garages, each with a wide entrance. It had a flat, felted roof and was built from handmade bricks set with a lime mortar but not laid to any particular bonding pattern; like the main building, it had a thick coat of whitewash externally (see plate 2). Both garage entrances had wooden lintels, which appeared to be inserted (see plate 3), but there was nothing of any historic interest remaining inside the two spaces. The relationship of the garages to the two storey cottage was unclear. The north-western garage may butt the taller cottage, although it is possible that the first floor of the latter's east gable is actually slightly built over the garage. A building occupying the footprint of the garages is shown as being present on the 1892 Ordnance Survey map (see figure 4C), but it is not certain whether this represents the garages, or another structure which was subsequently converted into the garages. Similarly, buildings are shown in this location on the 1854 Ordnance Survey map and 1845 Railway plan, and seem to correspond to an outhouse shown on Watson's 1844 map (see figure 4A). It is also possible that the left hand garage formed part of the structure shown in 1892 extending out from Dolman Terrace into the yard, although nothing was visible above ground.

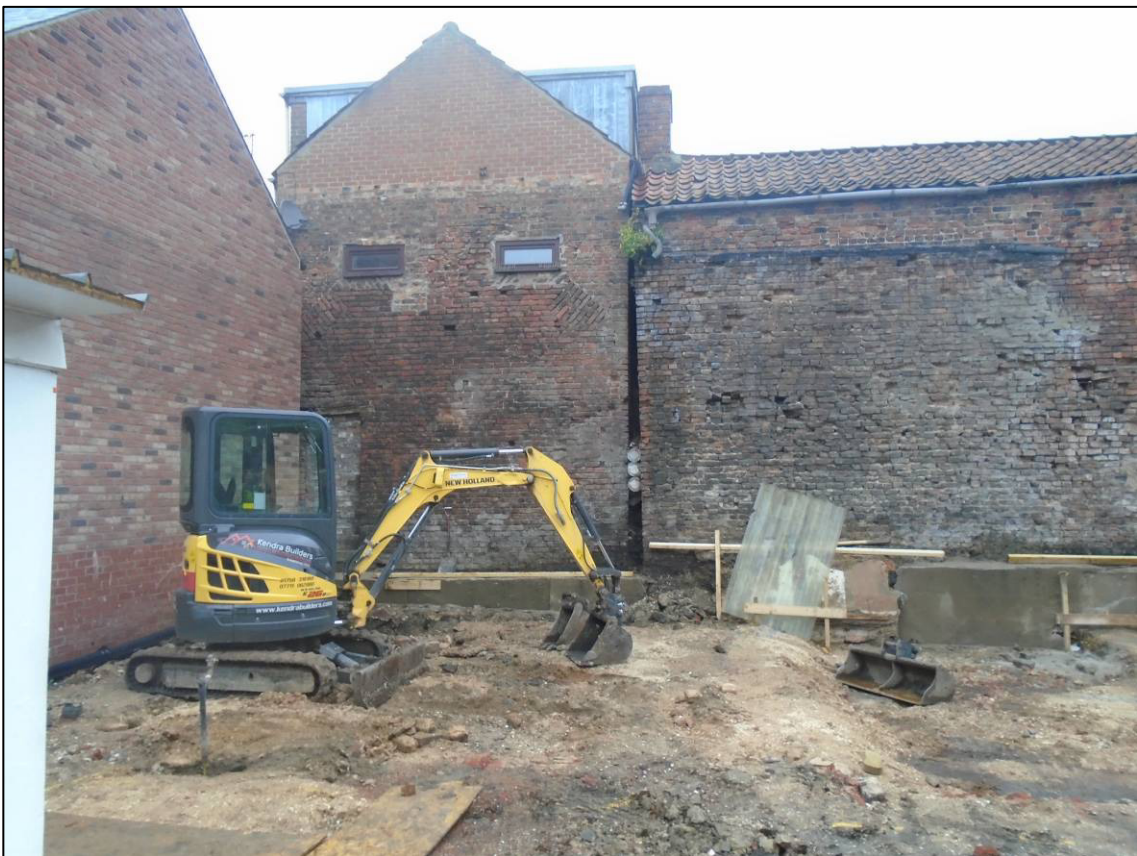
Plate 4: Gable end of No. 2a Lockwood Court, showing tumbled brickwork of former roof line, after demolition of cottage, looking NE..

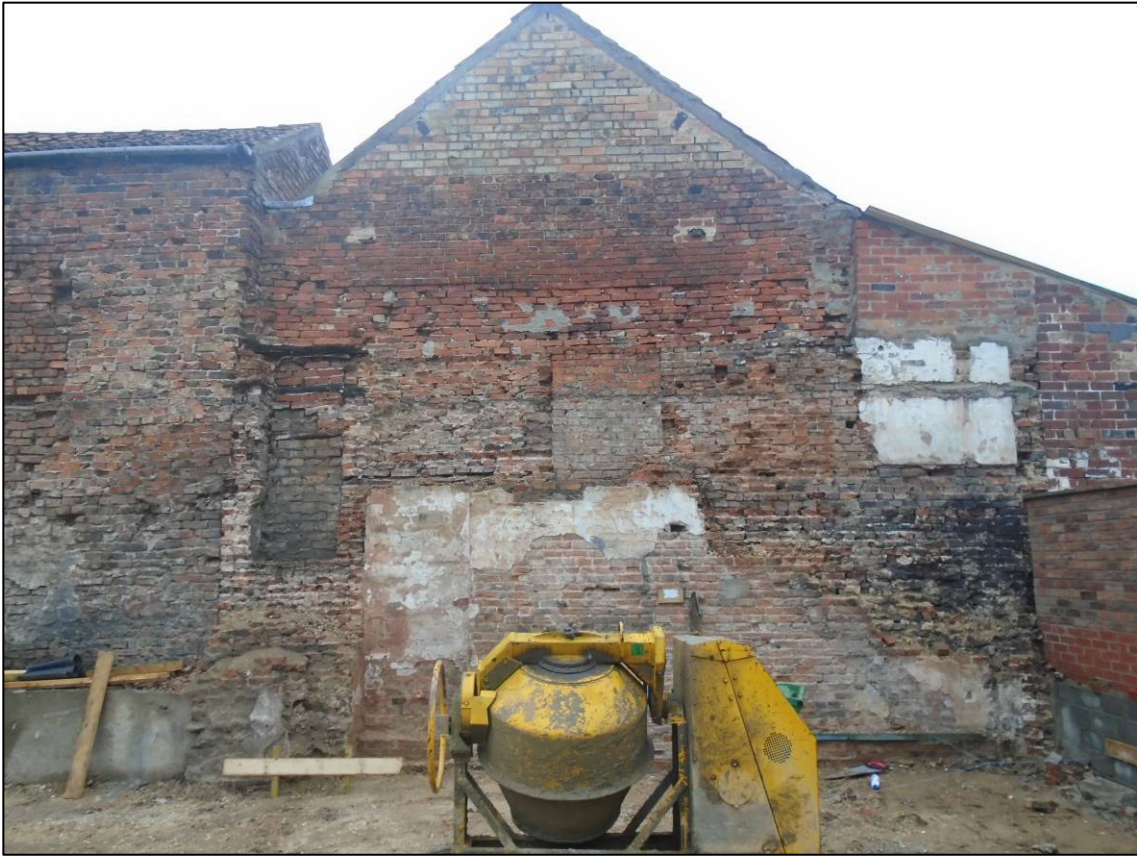
Plate 5: Gable end of Nos. 1-6 Lockwood Court, showing blocked openings, after demolition of cottage, looking NE.

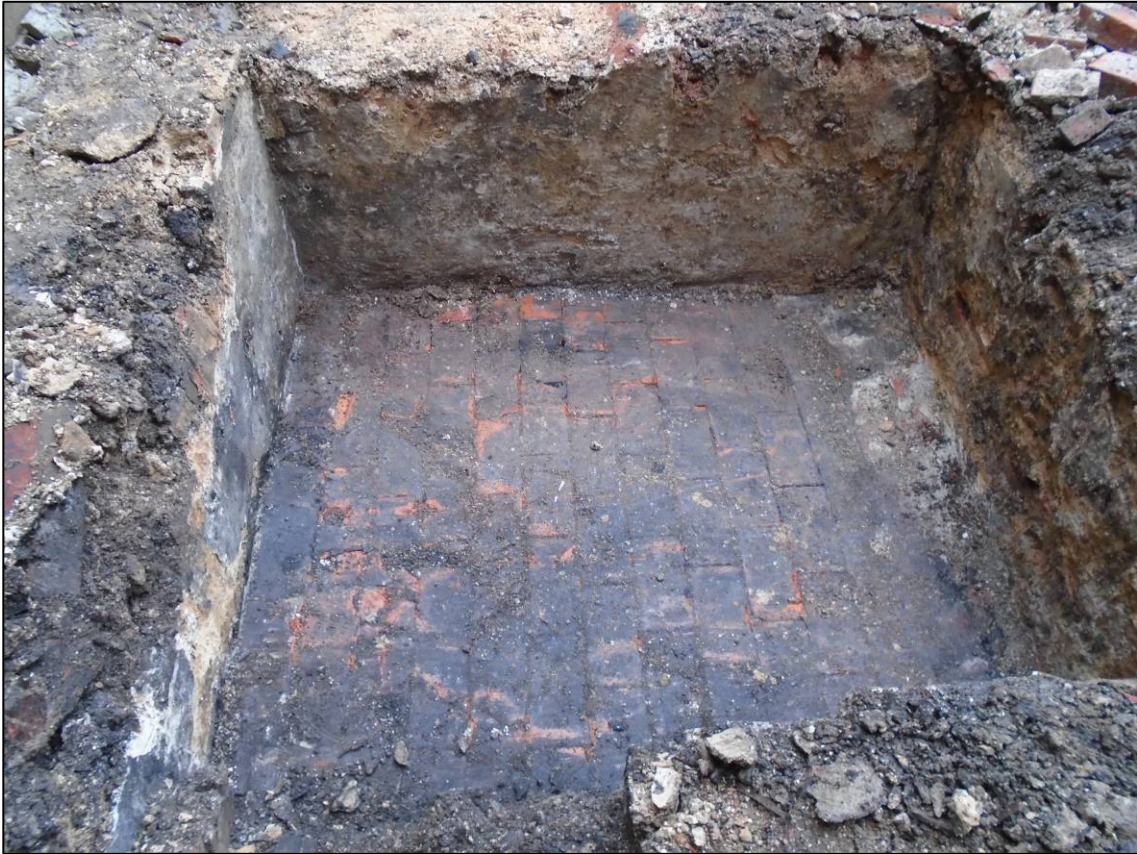
Plate 7: Coal cellar in Plot 1, showing brick floor (102 ) and lime plastered walls (103), looking SE.

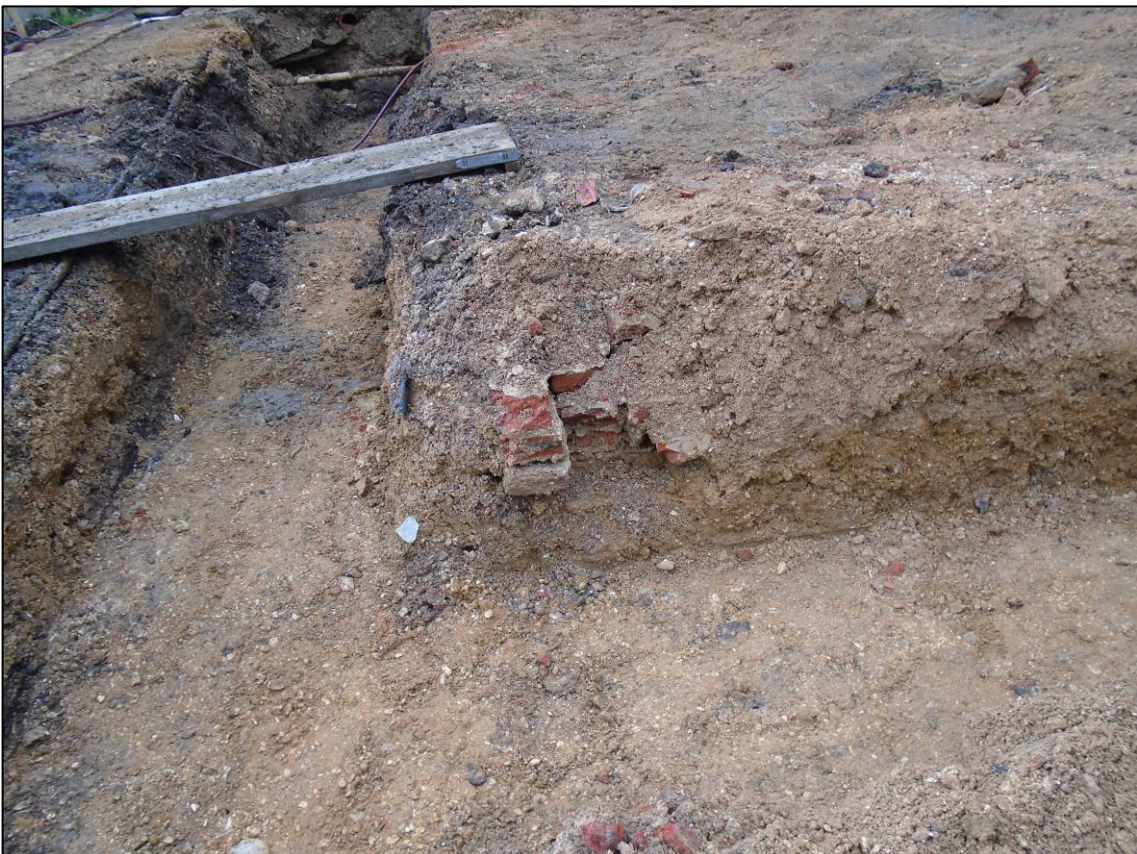
- 5.4 A 3.10m length of brick north-west/south-east aligned foundation (107) was exposed in the northern edge of the southern foundation trench at 0.10m BGL. The foundation comprised up to five courses of buff-red handmade bricks bonded with lime mortar, and was 0.40m wide and 0.35m high; insufficient was revealed to determine any bonding pattern. It was likely to represent the part of the front wall of the previously demolished cottage.
- 5.5 Modern services comprising a 0.06m diameter gas pipe (105) and an electricity cable (106) were exposed in the north-western corner of the plot.
- 5.6 A demolition layer of mixed brick, chalk and gravel rubble (101) up to 0.34m thick, which was associated with the recent clearance of the site, overlay the earlier features and formed the current ground surface.

Plate 8: Wall foundation (107) exposed in Plot 1, looking NW.

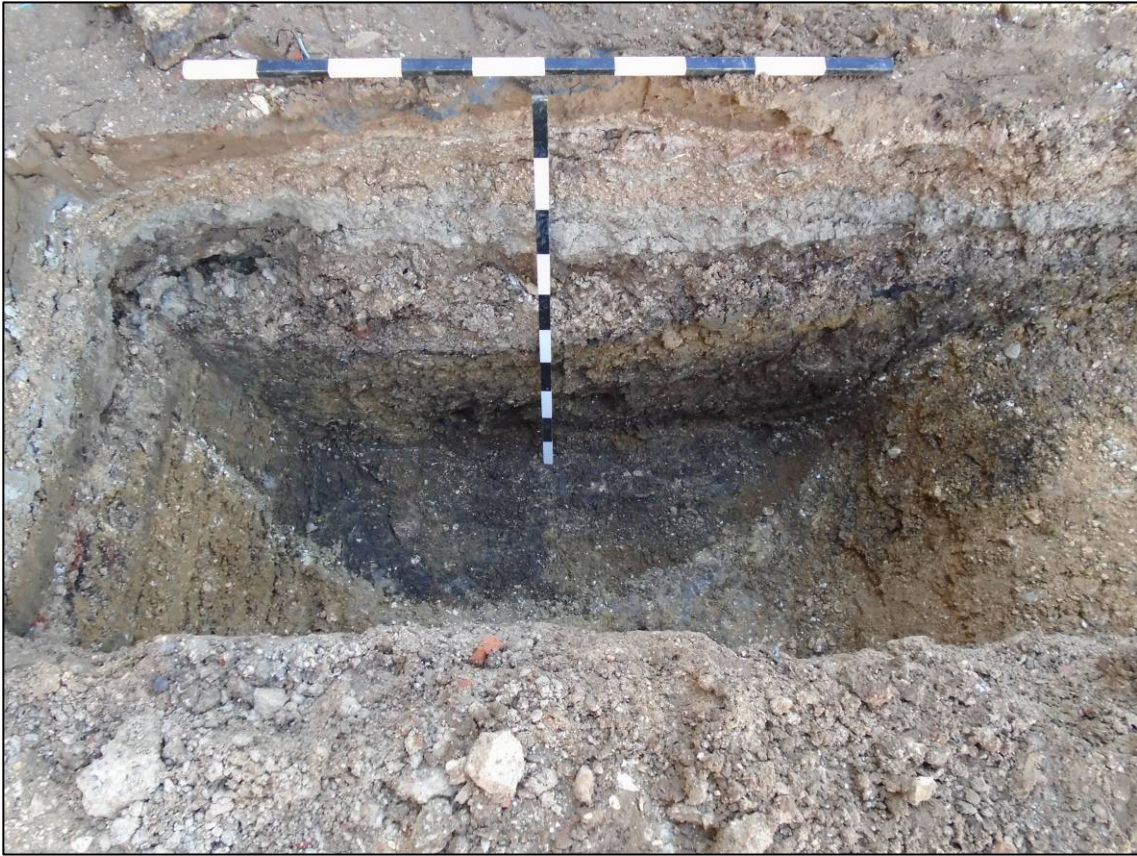
- 6.2 The earliest feature exposed was a circular pit [207] located in the eastern corner of the Plot 2 foundation trenches; based on a single sherd of 14th-16th century Humberware pottery from the fill (206), this has been tentatively dated to the medieval period, although this is by no means certain - only a relatively small segment was revealed by the foundation works. An environmental sample of the fill (206) suggest that the pit had been dug in wet or waterlogged moss-covered ground, possibly within a wooded environment, that it had been left open for some time, and that it had silted up naturally. Although background traces of hammerscale, slag and charcoal (the latter presumably fuel waste) were present, the pit was not used for waste disposal or as a cesspit, and so its function remains unclear.

Plate 9: Circular pit [207] in corner of Plot 2, looking SE.

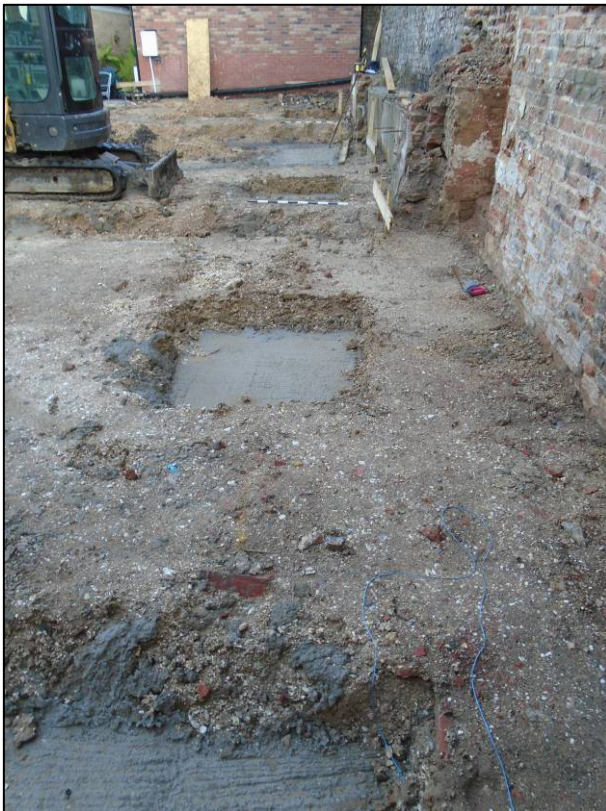
Plate 10: Piecemeal development of back wall foundation, looking N.

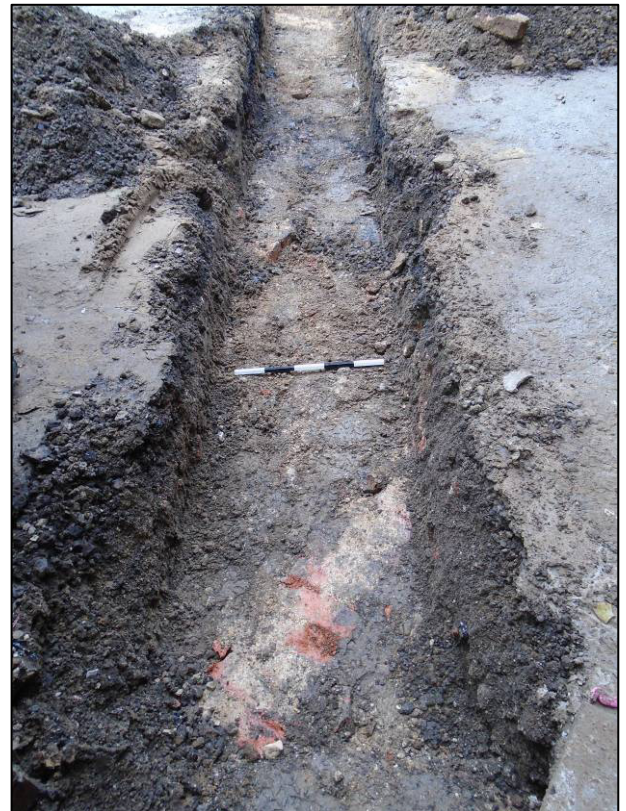
- 5.14 The natural light yellow-white chalk gravel (305) was only encountered in the central part of the trench, at 0.12m BGL.
- 5.15 Sections of four brick foundation walls (306, 307, 308 and 310) were exposed during the excavation of the service trench, encountered at between 0.12m-0.30m BGL (see plate 11). Foundations 306 and 307, at the eastern end of the trench, ran perpendicular to each other. Only one course of the easternmost foundation (306) was exposed, being 0.22m wide and aligned north-west/south-east and comprised of cement mortar-bonded bricks; the bricks were laid end-on-edge and measured 220mm long by 70mm thick. The adjacent, and contemporary foundation (307) was 0.26m wide, aligned north-east/south-west and formed of three courses of cement mortar-bonded brick with dimensions of 240mm x 120mm x 70mm, laid on-bed. No construction cut for these foundations was visible, although this part of the site was heavily disturbed.

Plate 11: Wall foundations 306, 307 and 308 in service trench, looking W.

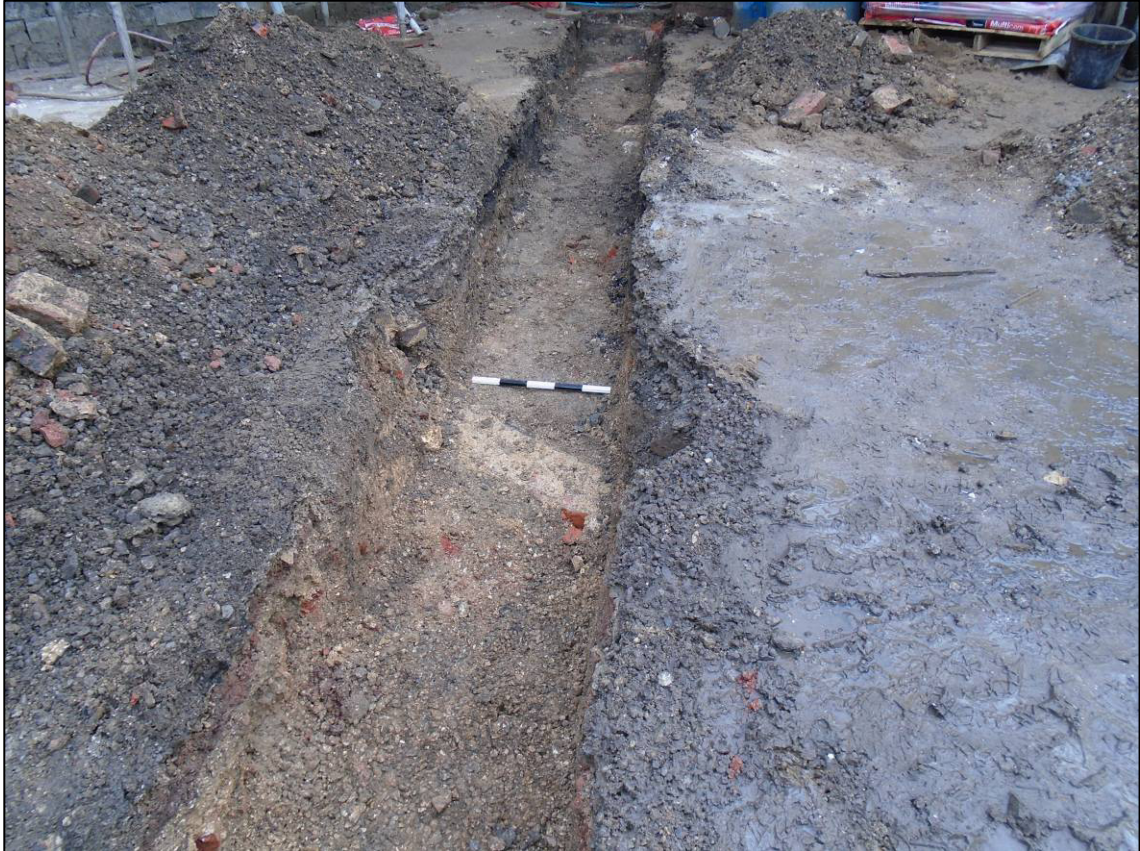
- 5.16 Another length of foundation wall (308) was exposed in the service trench further to the west. This was 0.22m wide, ran parallel to foundation 307, and comprised three courses of cement mortar-bonded brick, measuring 100mm wide and 80mm thick, laid on-bed. Only the western edge of the construction cut [309] for this foundation was exposed, truncating the eastern extent of the natural (305) to the west (see Section 3). The final length of brick foundation (310) was encountered in the central part of the trench and was 0.12m wide, aligned north-east/south-west and formed of two courses of cement mortar-bonded brick, 120mm wide and 80mm thick, laid on-bed.

Plate 12: Wall foundation 308 in service trench, looking E.

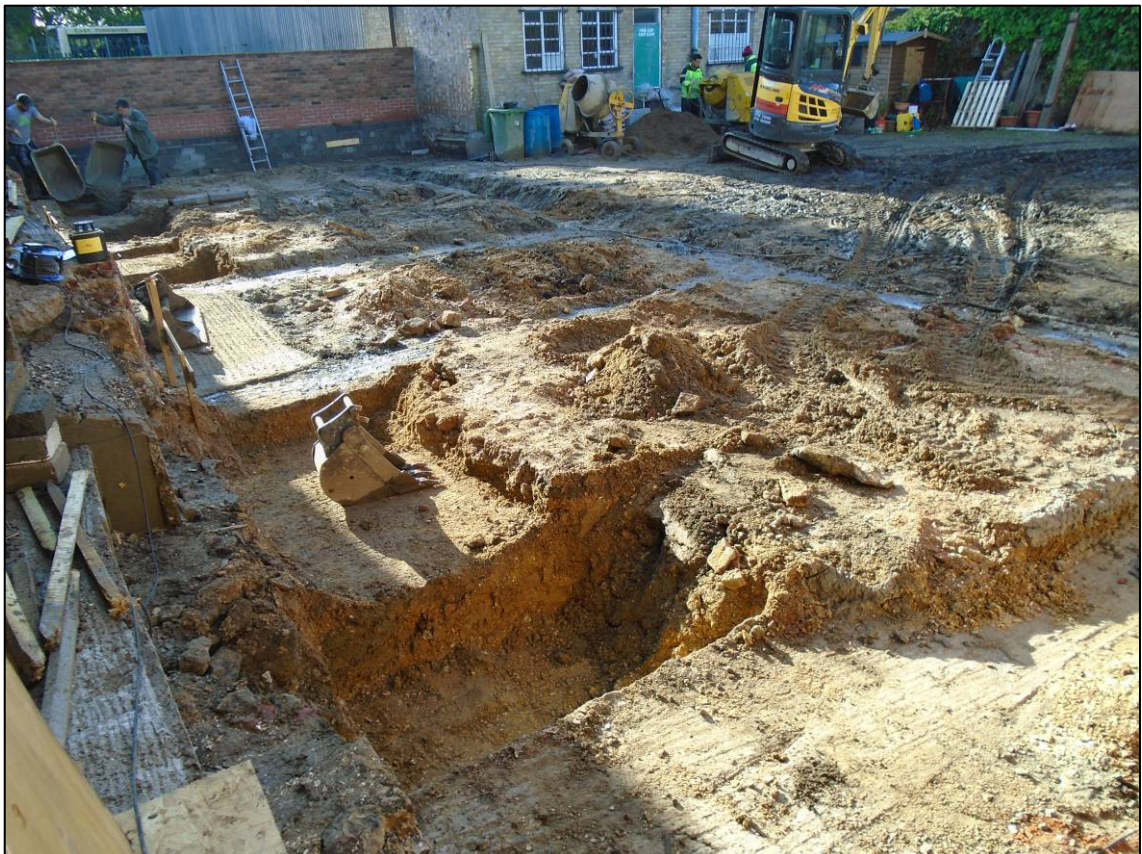
- 3.4 The development site was divided into two plots, which measured 18.05m long (north-west/south-east) by 6.40m wide overall (see plate 13). Plot 1 measured up to 9.60m long by up to 6.40m wide, and the foundation trenches were typically up to 0.90m wide and up to 0.68m deep. Plot 2 measured up to 8.40m long by up to 6.25m wide, and these trenches were typically 0.90m wide and up to 0.96m deep. A new main east-west service trench was excavated to the south-west of the plots, and measured 19.50m long and up to 1.00m wide, and between 0.30m-0.50m deep. The remainder of the service trenches were not monitored as they were to be dug through raised ground deposits.

Plate 13: Completed foundations in Plots 1 and 2, looking S.
