OTLEY MILLS, ILKLEY ROAD, OTLEY,
WEST YORKSHIRE LS21 1QS

ARCHAEOLOGICAL STRUCTURAL
WATCHING BRIEF

Report no: 2019/606.R01
Version: Final
Date: May 2020
Author: Shaun Richardson & Ed Dennison

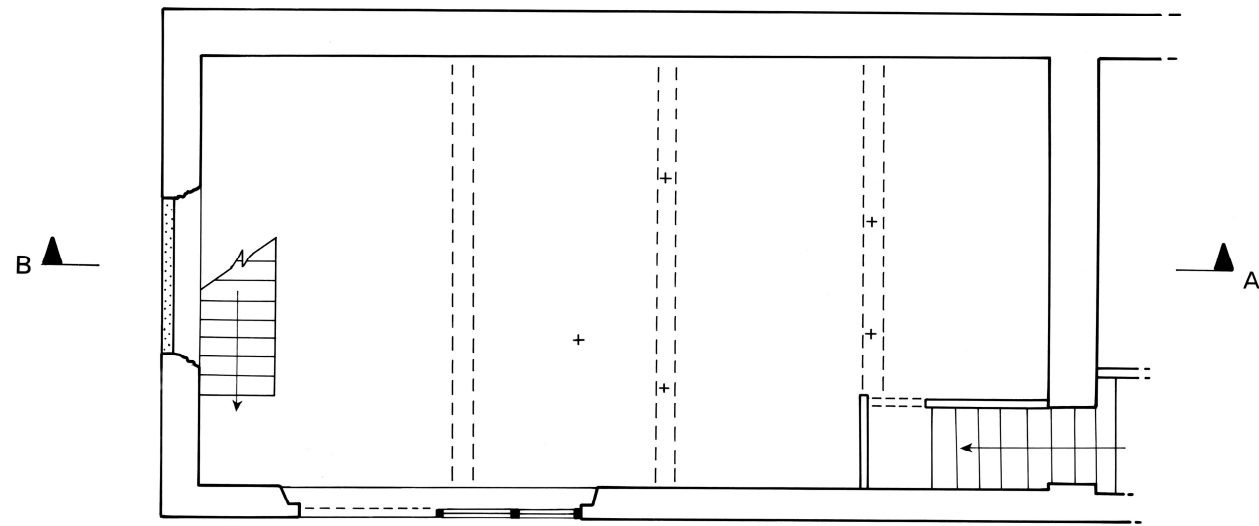
PROJECT		OTLEY MILLS, OTLEY	
TITLE			
ENGINE HOUSE FIRST FLOOR PLAN		AND SECTION	
SCALE	AS SHOWN	DATE	MAY 2020
EDAS		FIGURE	7

First floor plan of northern engine house

Northern engine house
Section through engine house

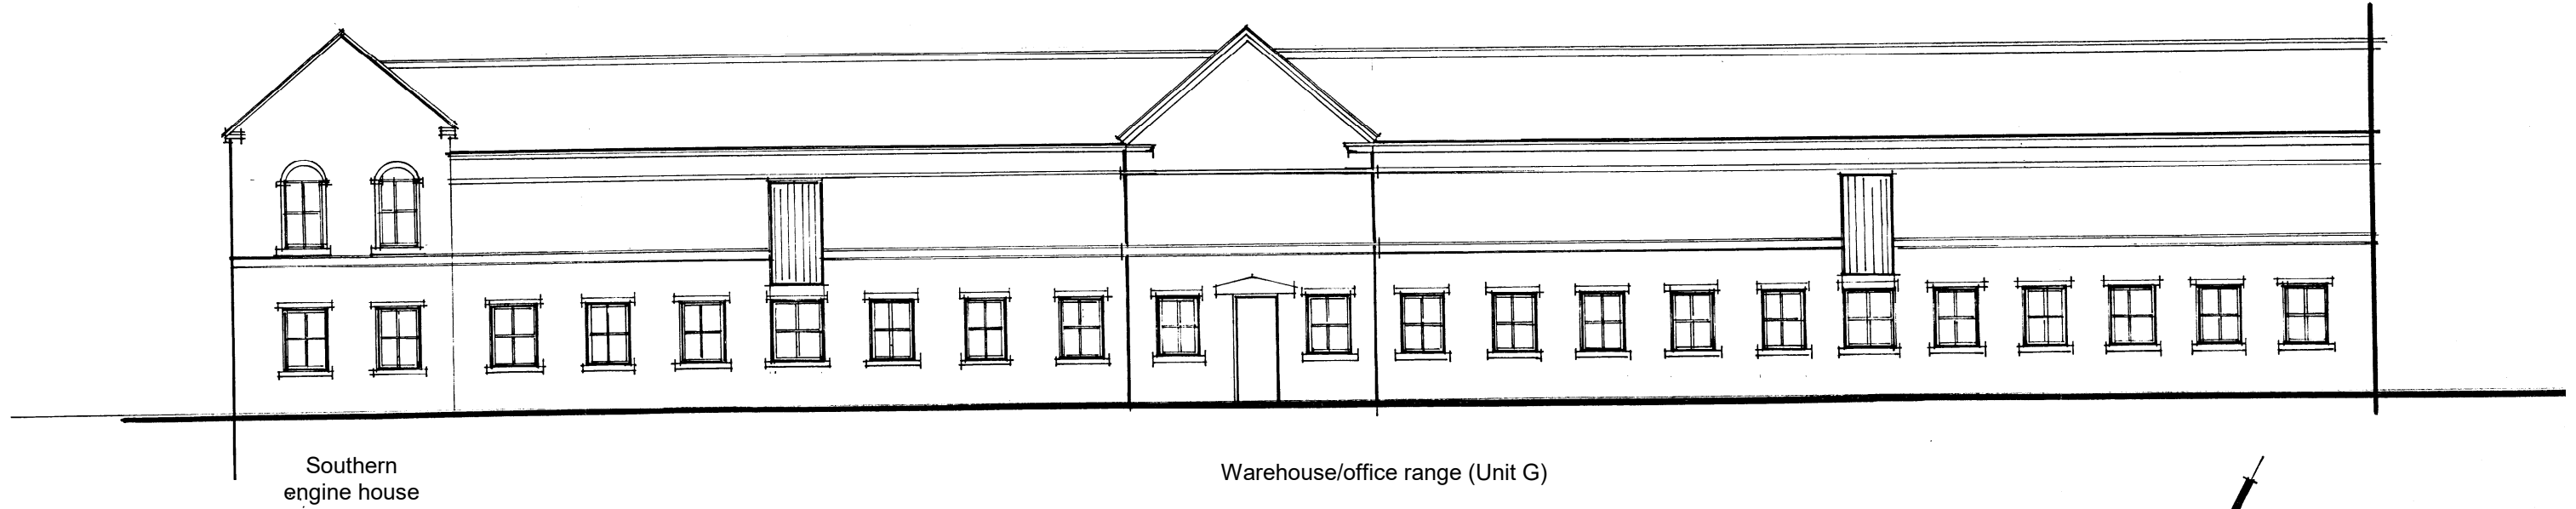
PROJECT		OTLEY MILLS, OTLEY	
TITLE		c.1857 FRONTAGE	
SCALE	NTS	DATE	MAY 2020
EDAS		FIGURE	8

EXISTING ELEVATION. C: C.

- 3.42 Only an exterior description and photographs were required of the Ilkley Road frontage building, and so the following description provides no details of the interior. The facade of Unit G, as well as the engine house to the west, has since been demolished as part of the approved planning permission; the facade of Unit D to the east has been retained. Also, as previously noted, the boiler house was demolished following the collapse of the south gable. The exterior, which has been drawn as part of the approved planning application (see figures 8 and 9), is described from west to east.

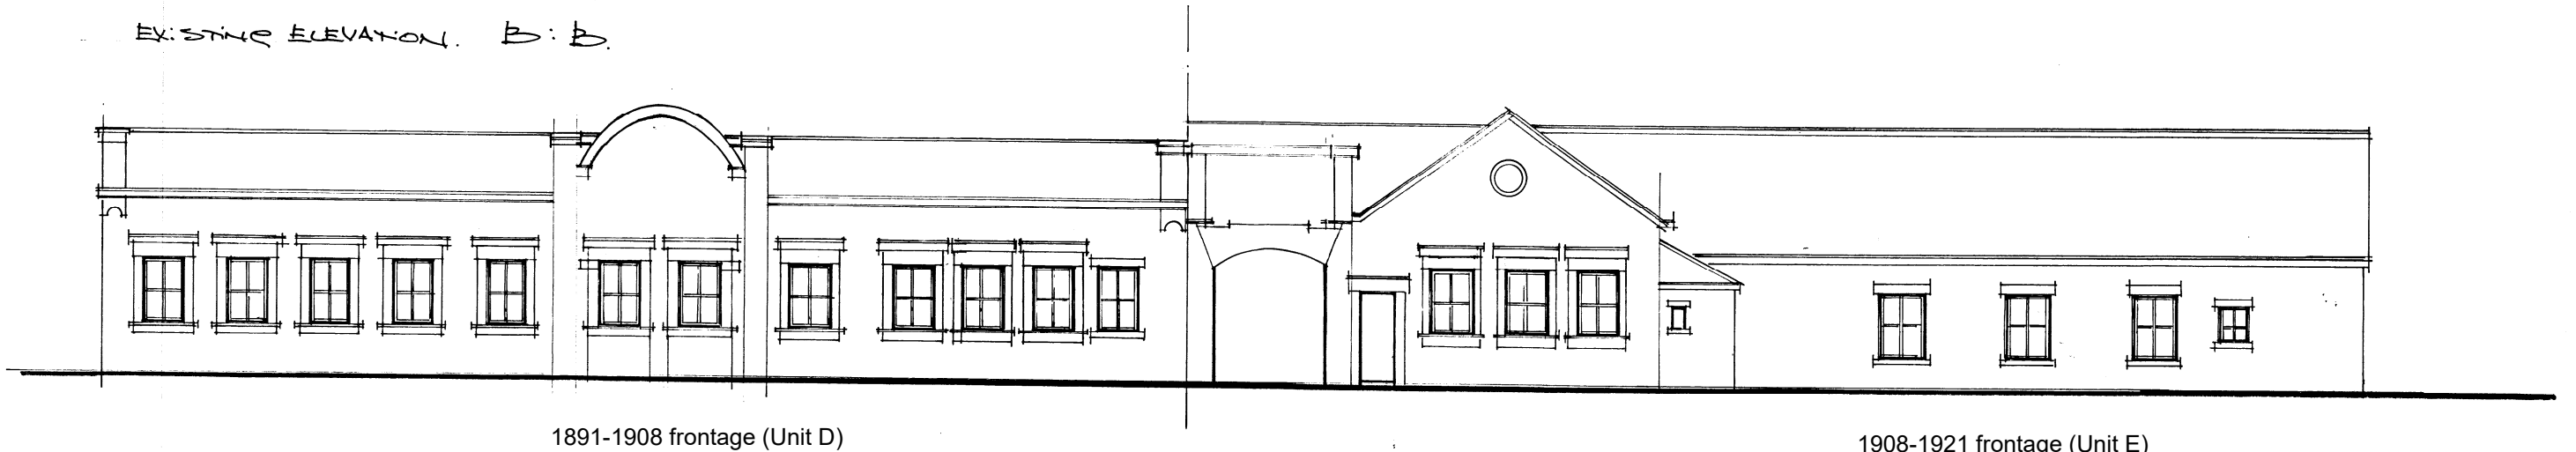
PROJECT		OTLEY MILLS, OTLEY	
TITLE		1891-1921 FRONTAGE	
SCALE	NTS	DATE	MAY 2020
EDAS		FIGURE	9

EXISTING ELEVATION. B:B.

1891-1908 frontage (Unit D)

1908-1921 frontage (Unit E)

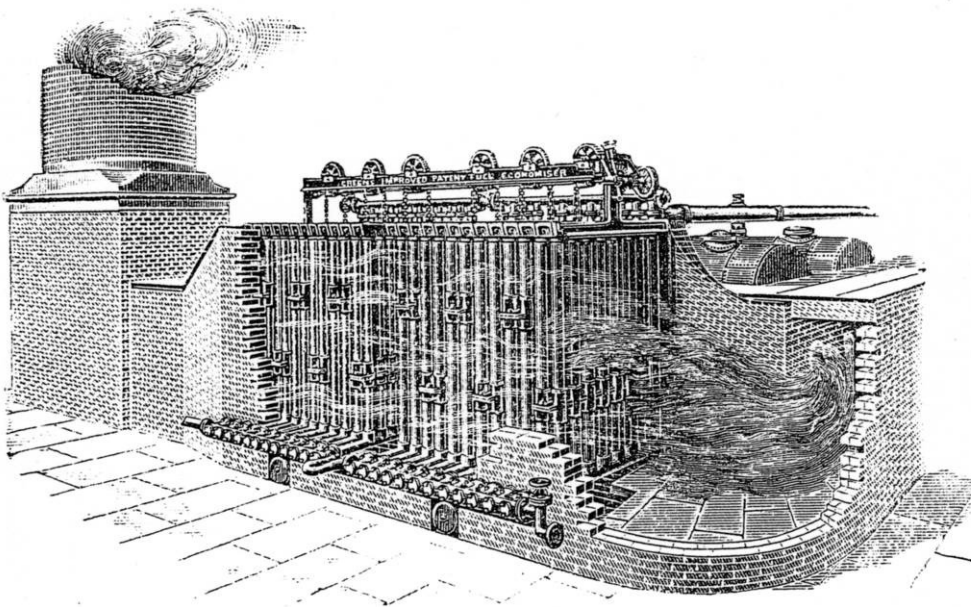
B) Green's c.1909 Economiser in operation.

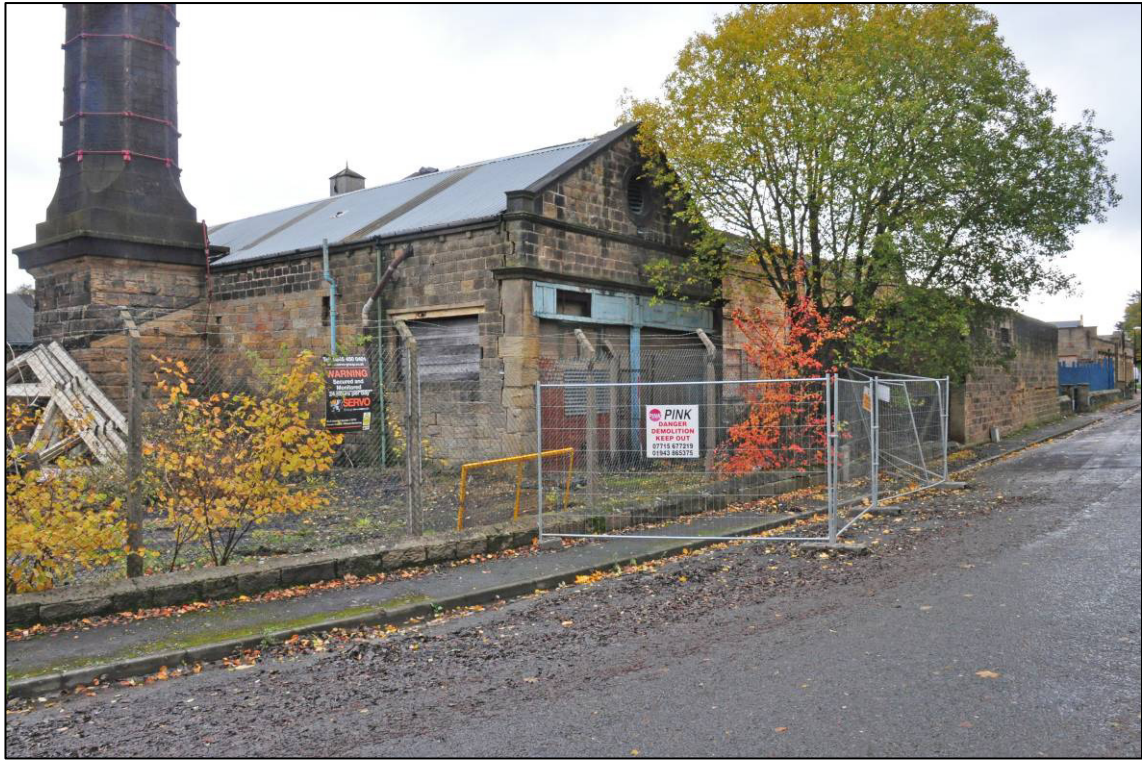
Plate 1: Boiler house, south gable and south end of west elevation, looking NE (photo 11765).

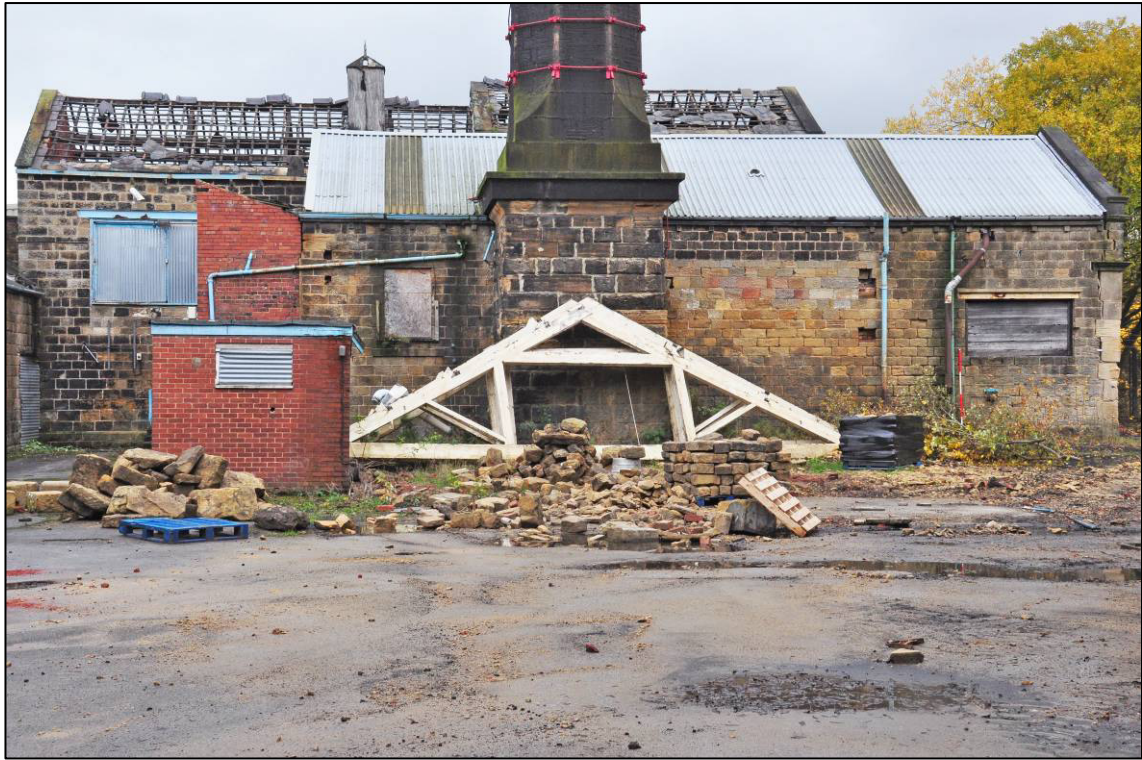
Plate 3: Boiler house, west elevation and chimney, looking E (photo 11772).

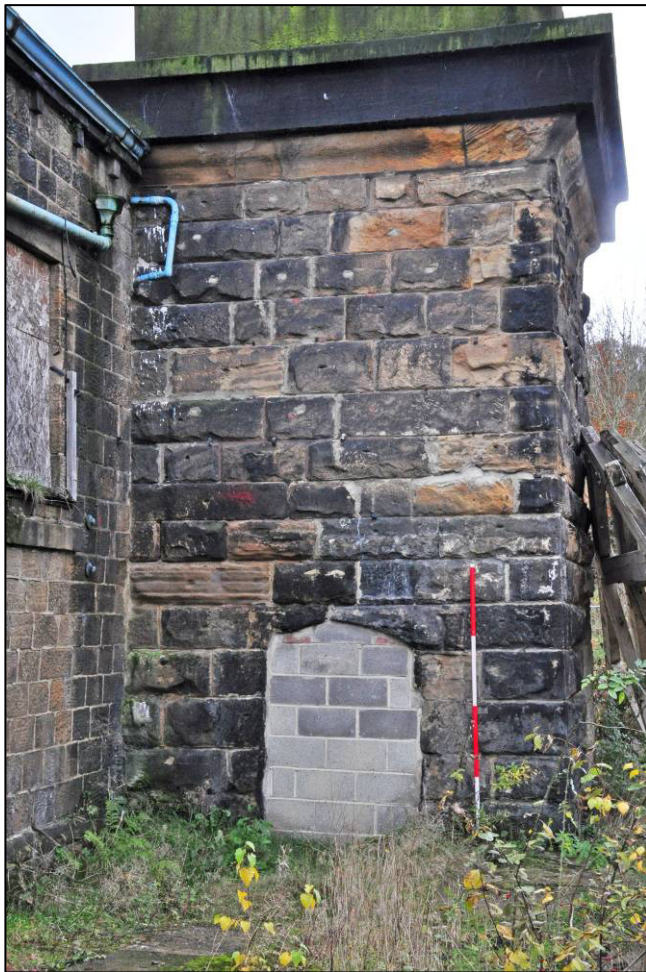
Plate 5: Chimney, north side of base, looking S (photo 11789).

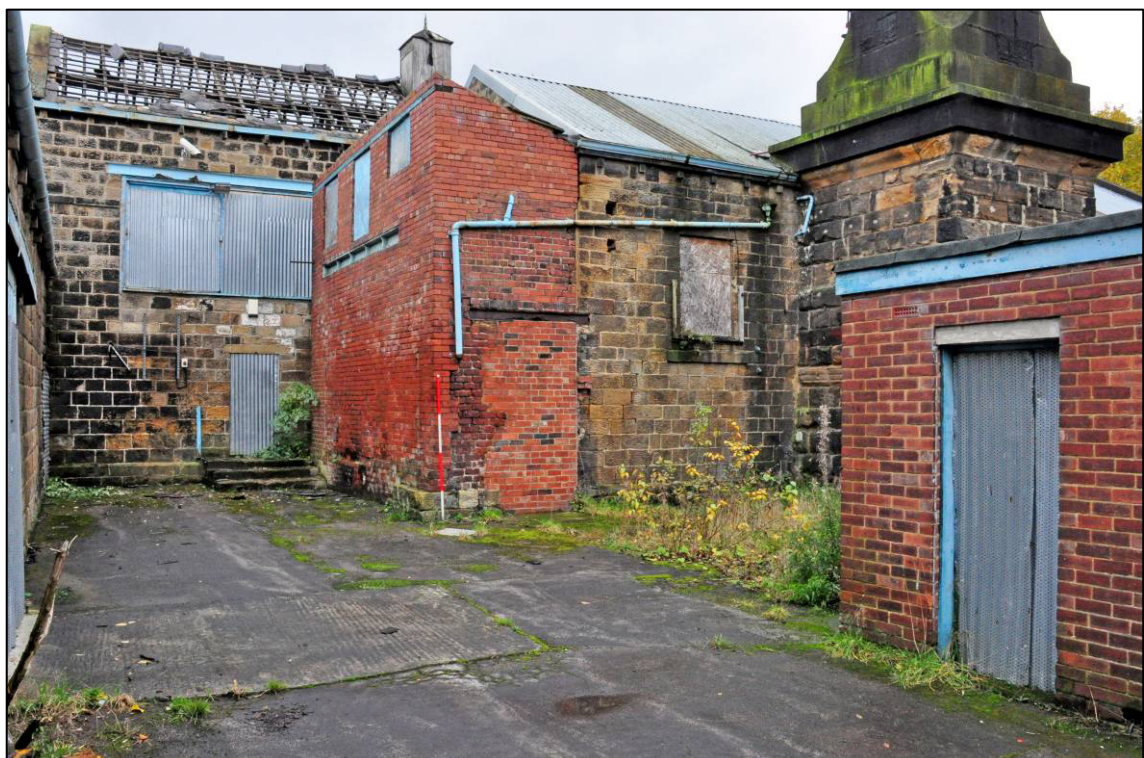
Plate 7: Economiser house, west and north elevations, looking NE (photo 11787).

- 3.13 The economiser house was set at the north end of the boiler house, and was clearly a later addition or alteration to the original structure. It was built largely of machine-made bricks, but preserved evidence for several different phases of construction [11787] (see plate 7). For example, at the base of the north-west corner, there were two courses of stonework, apparently left over from an earlier structure which the economiser replaced and possibly that shown in 1891 (see figure 3B). Map evidence shows that the 1891 structure was partly demolished between 1908 and 1921; a rectangular structure was built out from its former north-west corner, with the gap to the south between it and the chimney infilled (see figures 3C and 3D). This later rectangular structure was itself demolished after 1935, and so it is assumed that the economiser house which remained at the time of the survey was, at least in part, later still.

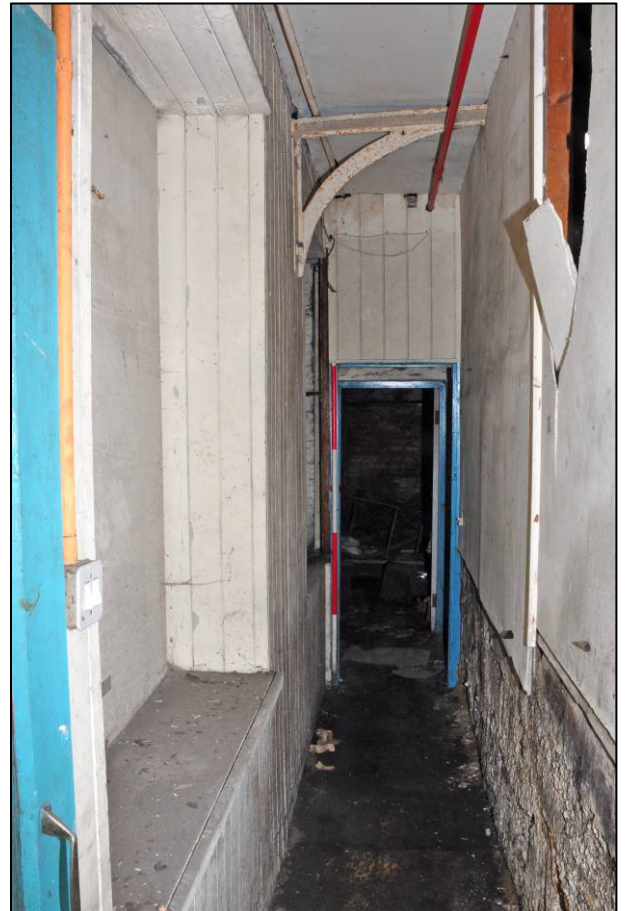
Plate 19: Southern engine house, ground floor east-west passage to south side, looking W (photo 11810).

- 3.28 At the south end of the passage, two stone steps rose to a doorway in the west wall, leading into an east-west aligned passage across the south end of the southern engine house [11810] (see plate 19). This was also floored with worn flagstones, with match boarding to the south wall which continued into the ground floor window jambs. The lower c.1m of the north wall was coursed and squared stone, with concrete capping, which had been used as a base for a modern partition. Above the centre of the passage, between the windows to the top of the south wall, there was a curved cast-iron bracket bolted onto the match boarding wall covering [11813]. At the west end of the passage, a flight of five stone steps [11815] rose c.1m to the north to give access into a modern corridor running along the west side of the southern engine house's ground floor; although the corridor was a modern creation, the west wall retained earlier match board lining, whilst there was also a board floor [11836] (see plate 20).

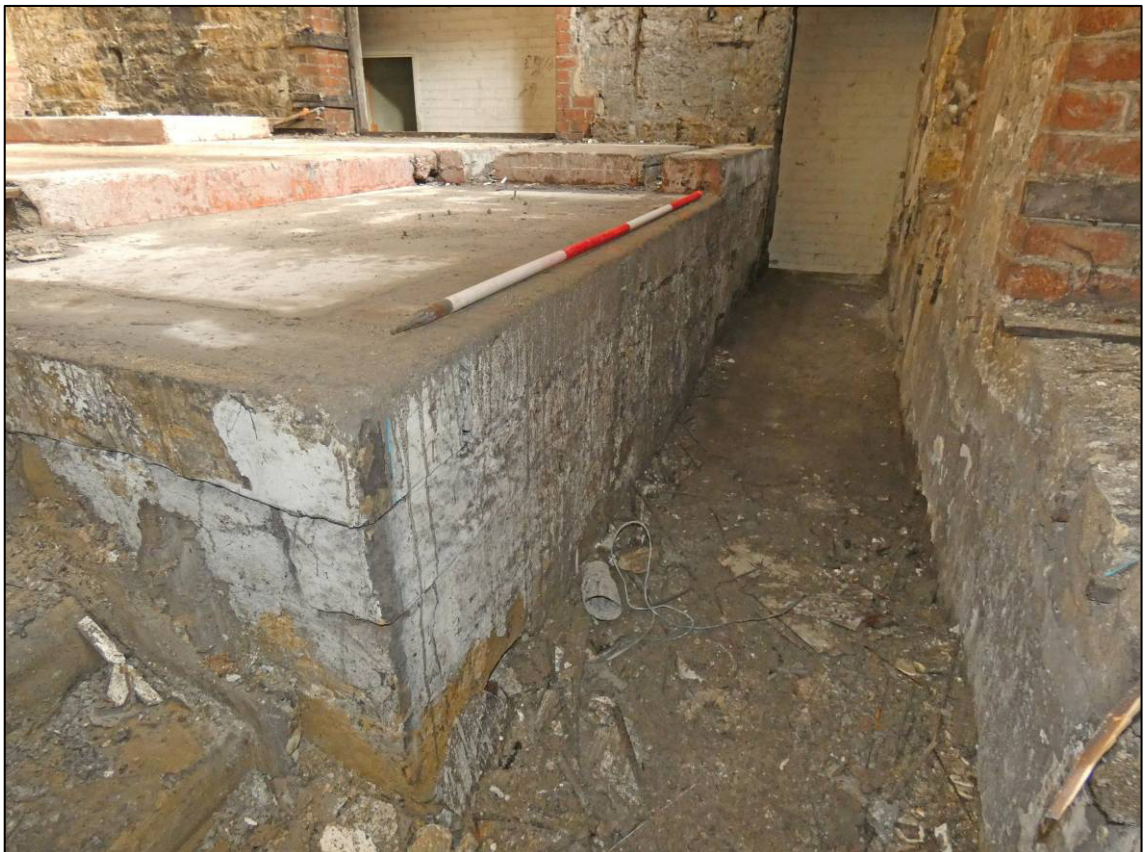
Plate 25: Southern engine house, ground floor after stripping out, original engine bed, looking E (photo 2387).

- 5.13 The concrete base cast over the earlier stone engine bed in the southern engine house, together with some of the other surviving fixtures and fittings recorded at the time of the EDAS survey, suggest that the horizontal steam engine in the northern engine house was eventually replaced by electrical power. In Yorkshire, the earliest known example of a mill powered by electricity is in 1907 at Becks Mill in Keighley, but by 1918 electricity was in common use. Where a mill owner decided to generate his own power, boilers, a steam turbine and an electric generator were required; the alternative to this was to purchase electricity supplies from a public company (Giles & Goodall 1992, 163-164). The horizontal steam engine was therefore removed from the northern engine house, and a first floor inserted. It is possible that boiler plant was retained for a while after the engine was removed, to provide steam for processing and/or hot water for heating, for example, but it too was also subsequently removed from the boiler house, and this was given over to other functions.

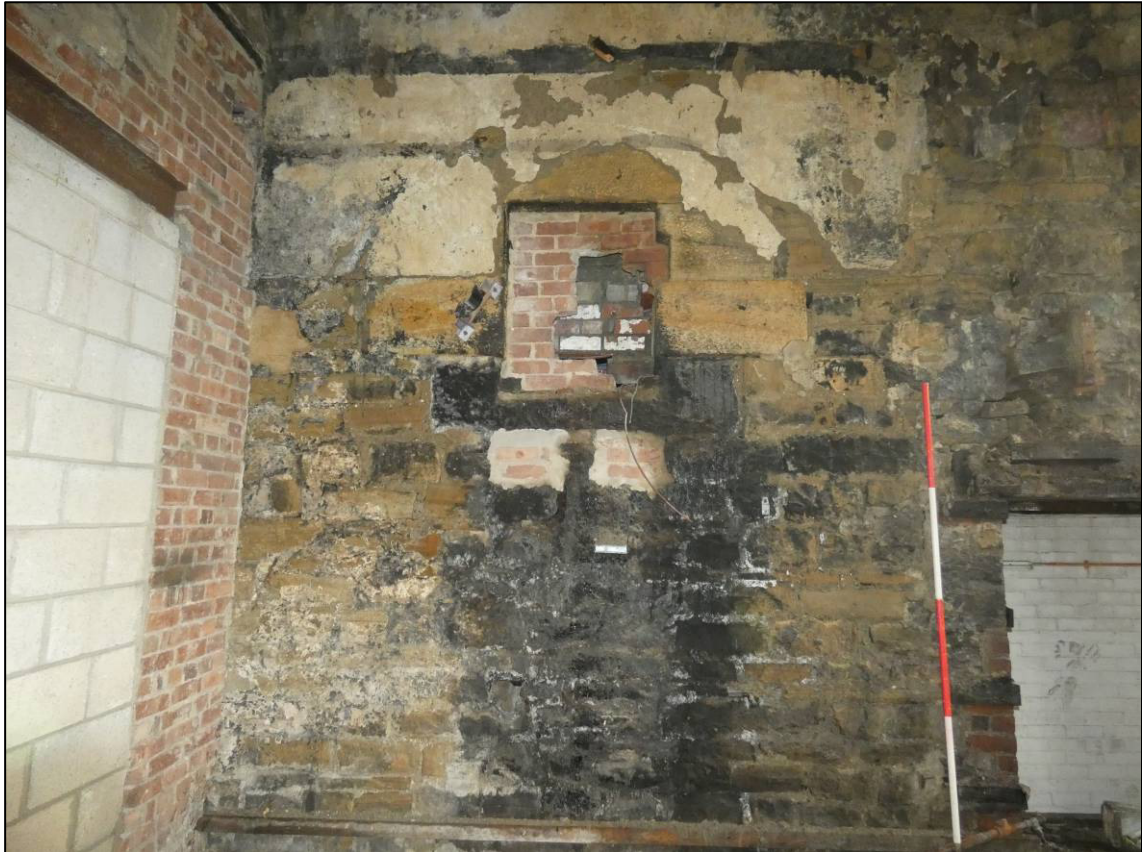
Plate 28: Southern engine house, ground floor after stripping out, bearing box at north end of east wall, looking E (photo 2378).

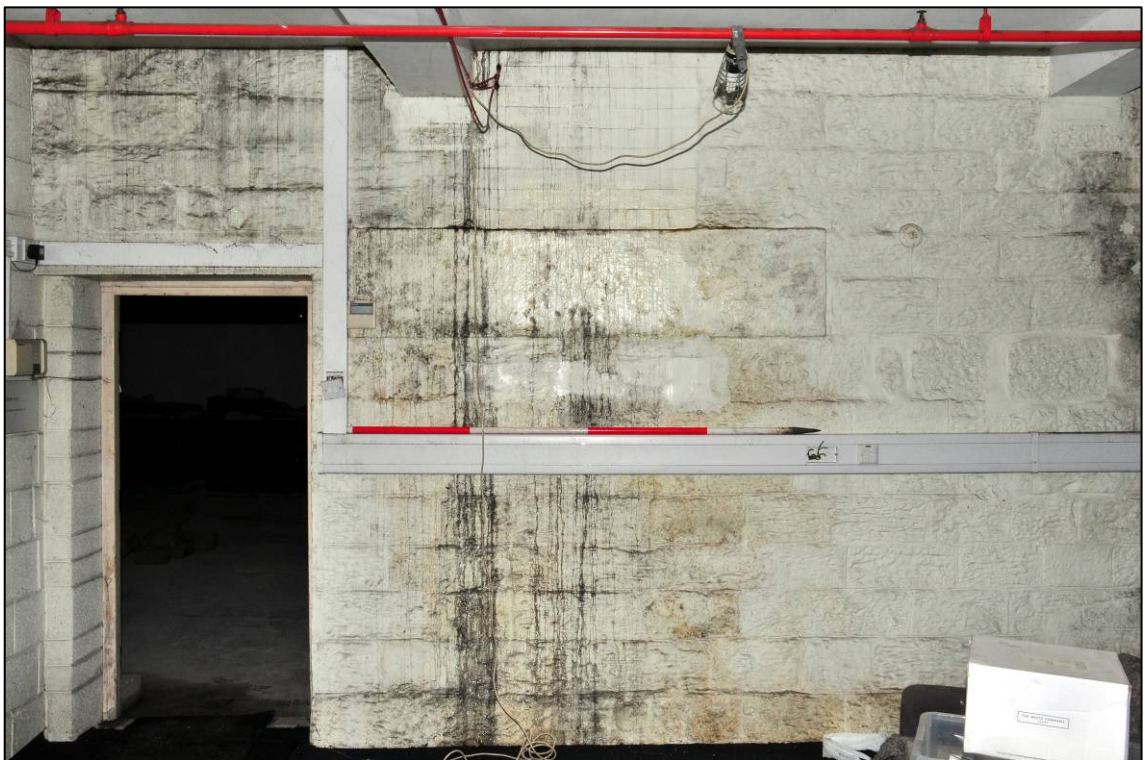
Plate 33: Northern engine house, ground floor, bearing box at north end of east wall, looking E (photo 11803).

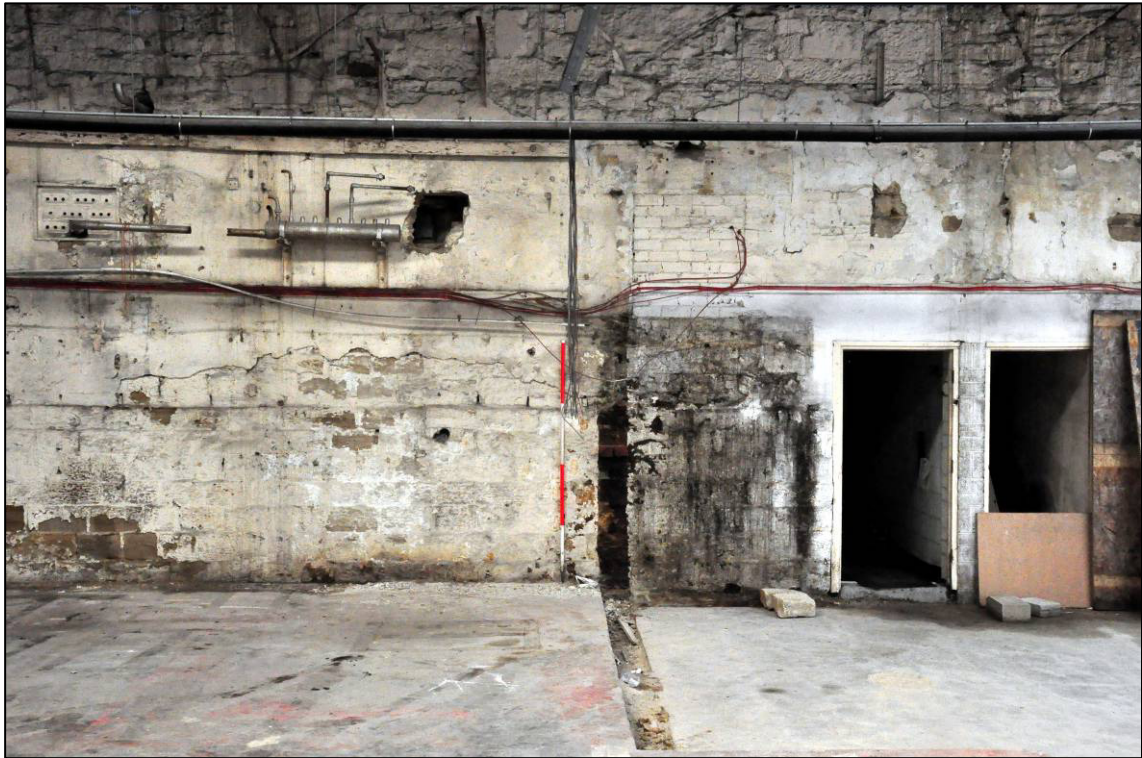
Plate 38: Weaving shed (Unit C), south end of west wall, showing bearing box from northern engine house, looking W (photo 11691).

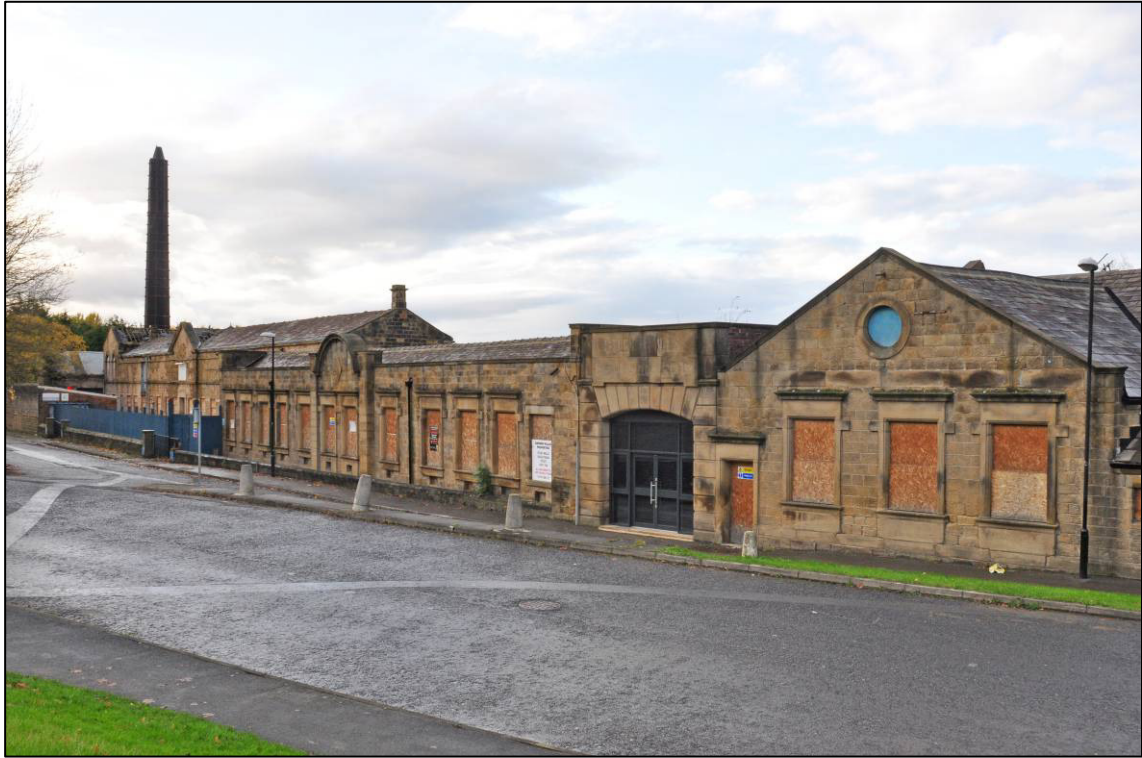
Plate 41: General view of Otley Mills, Ilkley Road frontage, looking NW (photo 11867).

- 3.43 The Ilkley Road frontage comprised three main phases, all built largely from coursed and squared sandstone of the Local Millstone Grit group, perhaps specifically Kinderscout Grit (Govier 2019, 10) [11866, 11867] (see plate 41). Unless otherwise noted, all door and window openings were boarded up at the time of the EDAS survey.

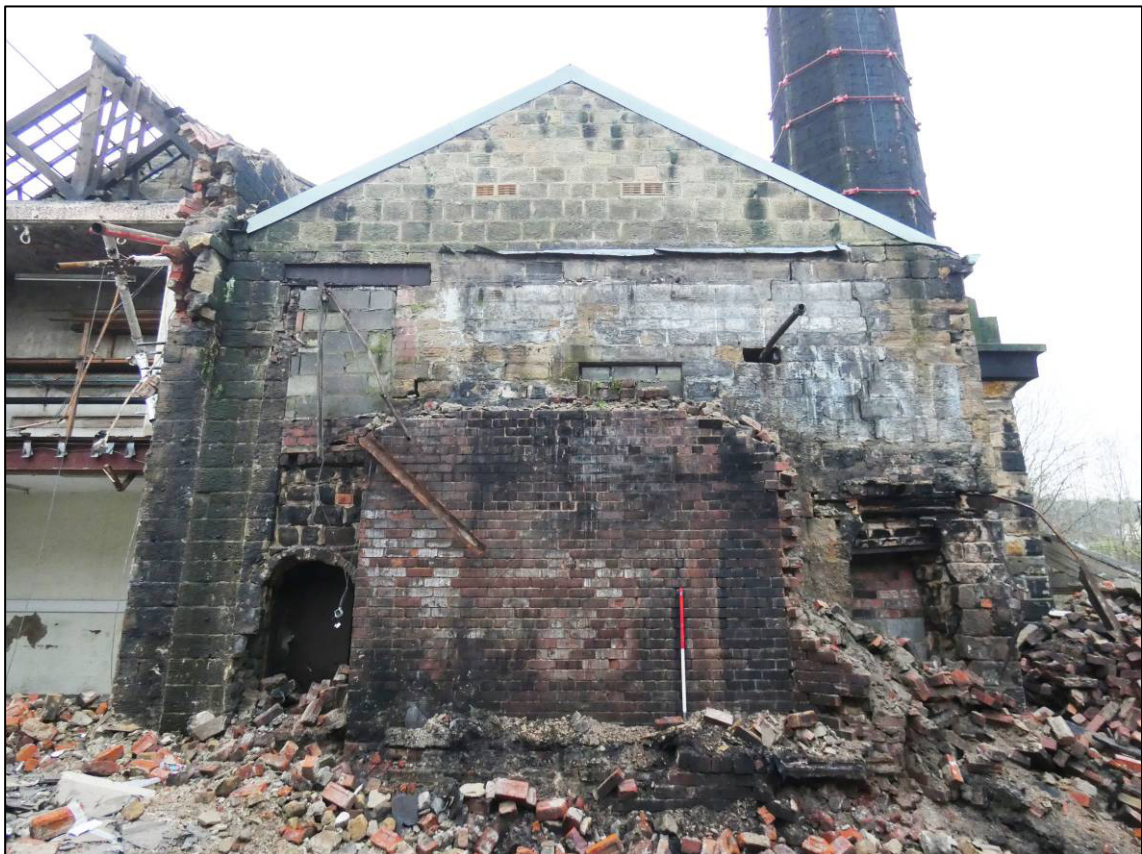
Plate 49: Economiser house after demolition, south wall, looking S (photo 3621).

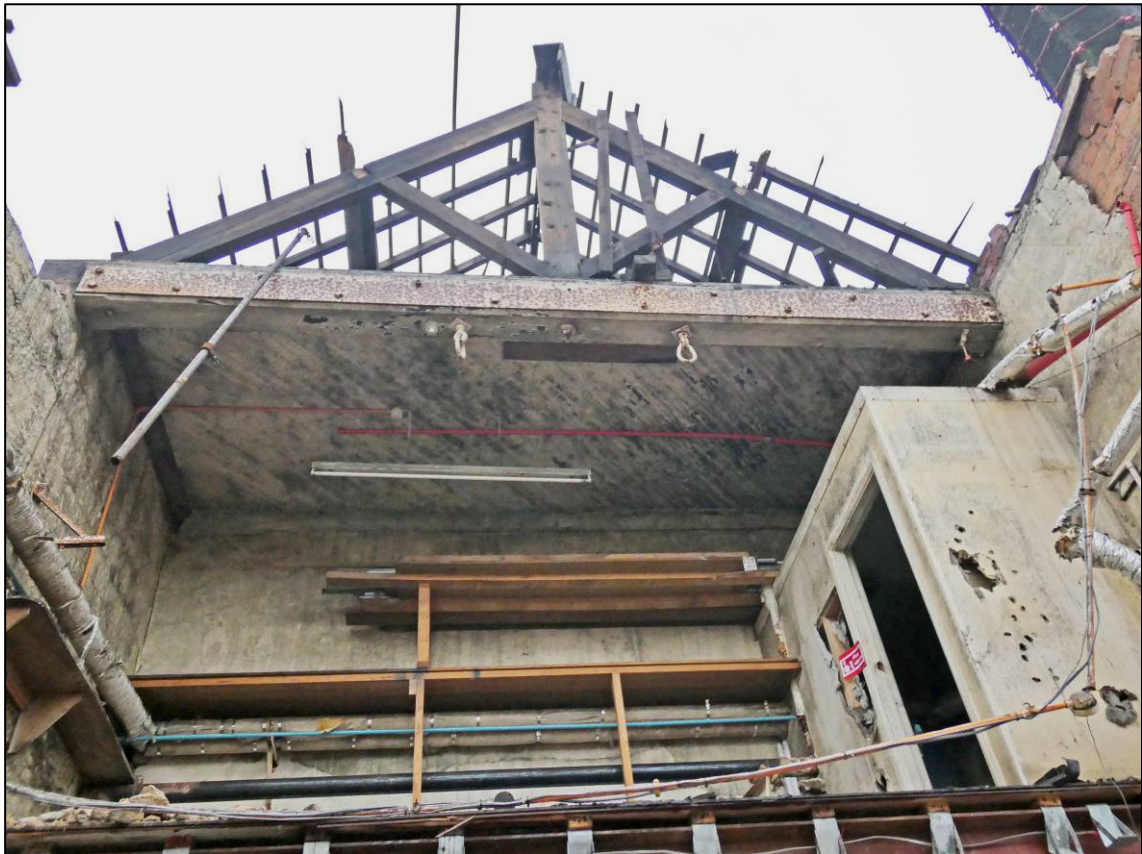
Plate 53: Northern engine house during demolition, southernmost roof truss with lifting rings, looking S (photo 3640).

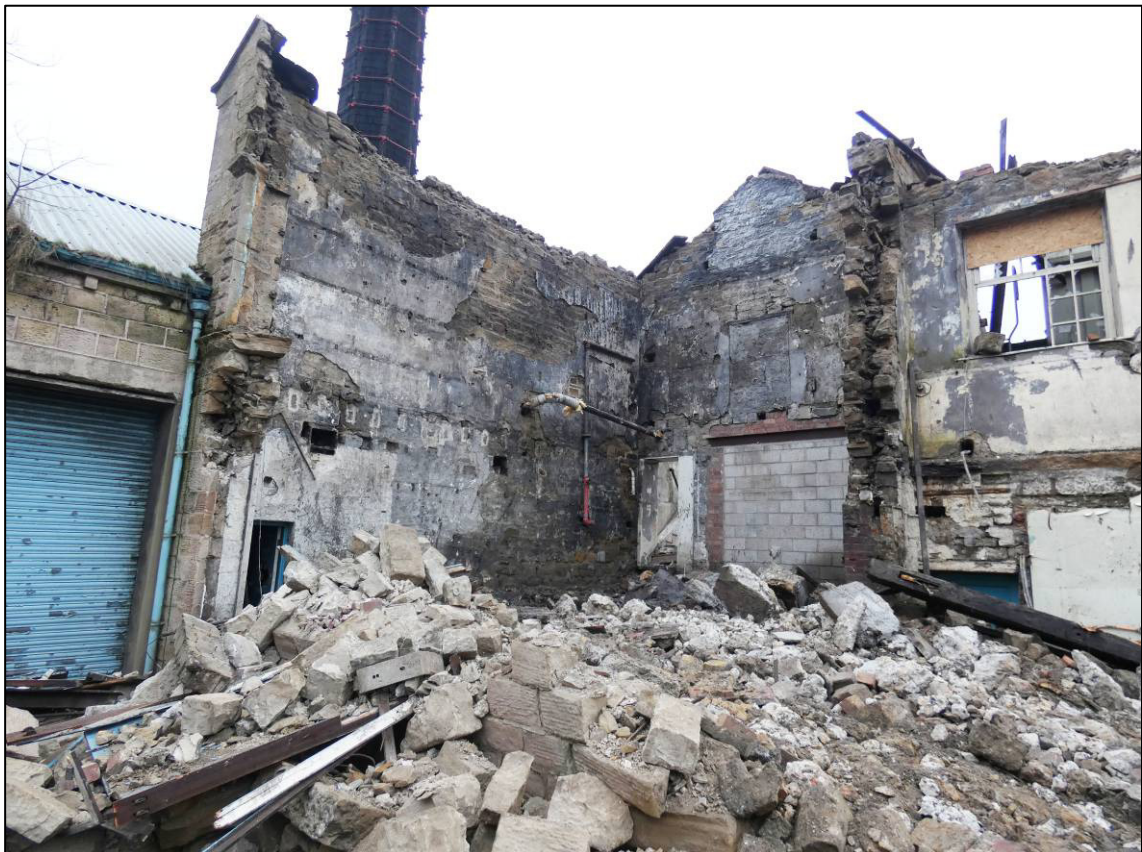
Plate 54: Southern engine house engine bed during demolition, looking NW (photo 4663).

- 4.8 The second watching brief visit, on the 14th January 2020, was undertaken to view the demolition of the engine bed in the southern engine house. As has already been noted, the partial demolition of the engine house, the presence of unsupported two storey walls and the heavy machinery necessary to break up the engine bed meant that the amount of new structural information revealed was limited [4649, 4651, 4663] (see plate 54).

- 4.9 When the engine bed was broken up, the large rectangular raised plinth at the north-east corner was revealed to have been built from large dressed stone blocks, which had later been covered in a cement render [4659]; it therefore presumably formed part of the original stone steam engine bed. To the west of this, much of the concrete surface was seen to be 0.15m thick or less, and to have been cast over rubble infill to larger recesses in the surface of the stone engine bed, although the latter could not be clearly viewed [4660, 4661]. The north [4654, 4656], east
