KESTERS FARM, NAFFERTON,  
EAST YORKSHIRE

ARCHAEOLOGICAL OBSERVATION,  
INVESTIGATION AND RECORDING

Report no: 2005/264.R01  
Version: Final  
Date: November 2006  
Author: Ed Dennison & Kate Dennett

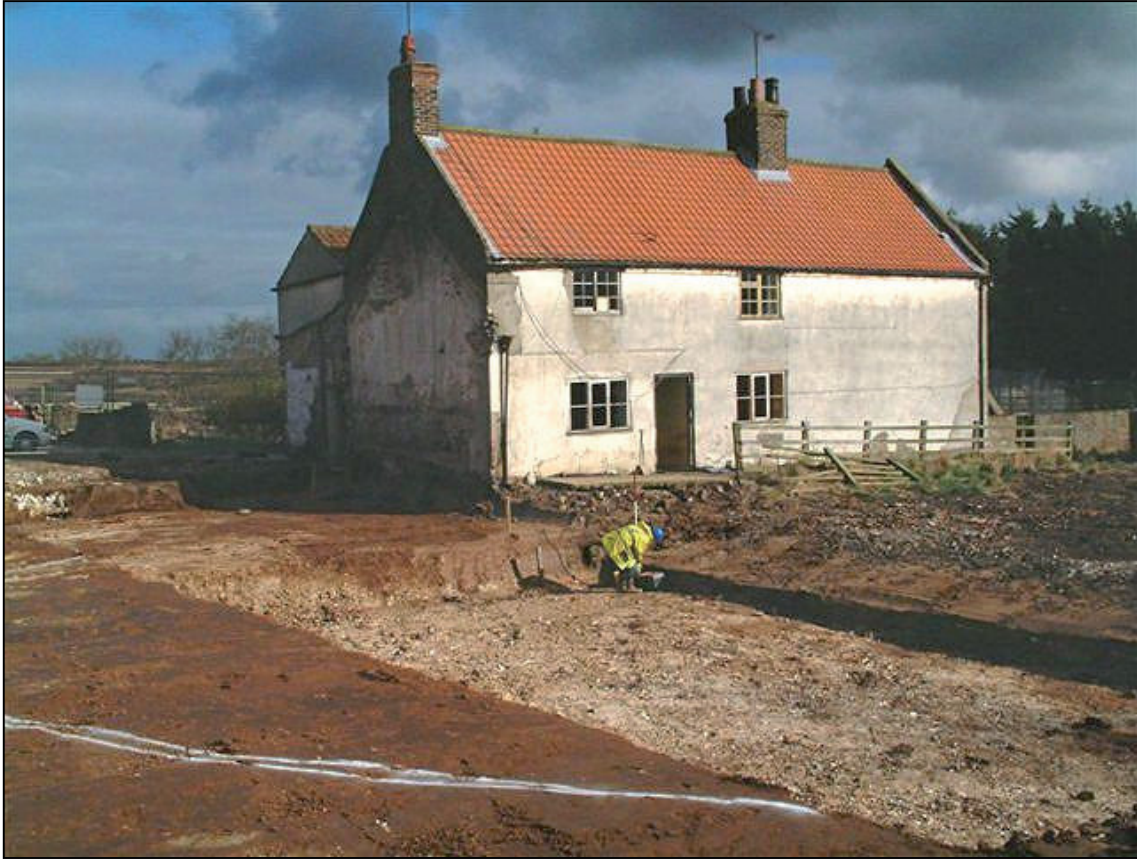
Plate 1: General view showing stripped and excavated areas to the west of the farmhouse, looking east.

- 3.3 At the time of the first inspection, the area for the new west wing had been excavated to form two separate terraces cut into the natural north-south slope. The lower terrace, representing the west part of the west wing, measured c.15m by c.8m and this had been cut well into the natural clay and underlying chalk, leaving a standing section 13m long and over 2m in height along the upper (north) side of the platform; the removal of the upper layers later reduced this section to 1.7m in height. The upper terrace lay nearer the farmhouse and measured c.8m square, with an additional area to the north corresponding to the position of a new garage. The depths of these excavations were such that any archaeological deposits that might have been present in these areas would already have been removed, and the inspection of any foundation trenches for the new west wing was no longer of any value.

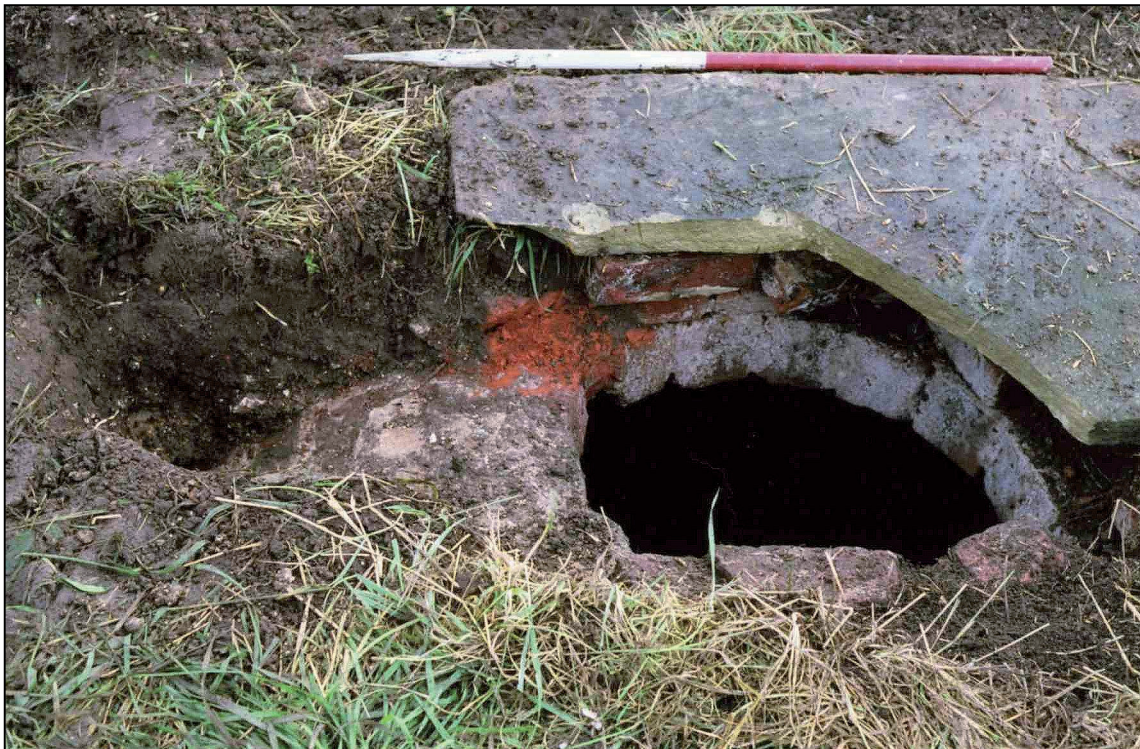
Plate 2: Top of underground water tank (012), showing vaulted shoulder and neck.

- 5.6 Adjacent to the area of drainage work immediately to the north of the original farmhouse, the domed brick roof of an underground water storage tank (012) was noted and recorded, although it was not to be affected by the works. The circular tank measured 1.72m in diameter by 1.65m deep internally (see Section 2). The brick neck (022) was in a poor condition although the shoulder and the internal, rendered, surface appeared to be undamaged. Pottery fragments and part of a narrow clay pipe stem in a deposit of fine chalk rubble with yellow-brown sand and mortar (011) immediately over the shoulder of the tank were of 18th-19th century date. This material was overlain by a brown clayey loam (025), disturbed by the construction work, which probably represented the former garden topsoil.

- 5.7 The neck of the water storage tank was covered by a large single stone flagstone, 1.0m long by 0.58m wide and 0.06m thick (013). The tank itself (012) appeared to be made from a variety of sizes of re-used brick, the header face on the lowest visible brick at the neck being 120mm by 120mm. Some 3.0m to the west, a degraded metal pipe exposed in one of the sewage pipe trenches appeared to be leading from the old house towards the tank, but no inlets were visible in the tank from the surface, and the unstable condition of the neck precluded further detailed inspection. The Ordnance Survey 1910 map marks a "Pump" in the same location as the storage tank (see figure 3), and it was probably used as a domestic water supply.

- 6.3 The watching brief also recorded a brick-built underground storage tank close to the north-east corner of the farmhouse. This was a domed structure, measuring 1.72m in diameter and 1.65m deep internally, which was capped by a large stone slab. These structures are relatively common, and examples have been recorded in domestic, agricultural and even ecclesiastical contexts (Richardson 2005, 243-244; Dennison 2006; Richardson 2007). They were used to store rainwater gathered through guttering and downpipes to ensure a constant supply for domestic use; such “softwater” supplies are often referred to in 19th century farm sale catalogues.
