ST CUTHBERT'S CHURCH,
FISHLAKE, SOUTH YORKSHIRE

ARCHAEOLOGICAL OBSERVATION AND RECORDING

Report no: 2006/288.R01
Version: Final
Date: June 2007
Author: Ed Dennison

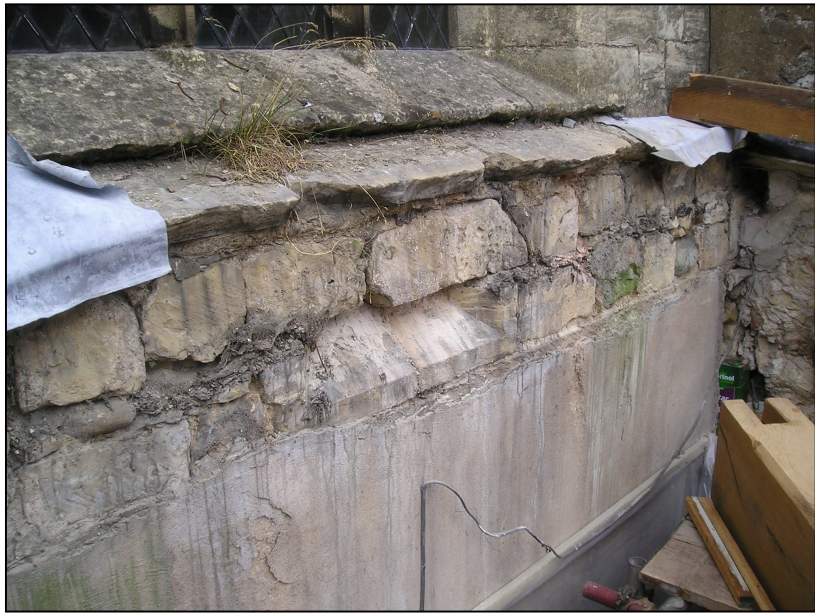
Plate 1: Exposed easternmost window, looking NE.

- 4.2 In general, only the sill and the very bottom of the jambs of each earlier window survived, all carved from Magnesian limestone and with plain chamfers (see plates 1 to 3). The windows were set within coursed squared rubble, markedly less regular than the ashlar of the existing clerestory, and are spaced at c.2.5m centres. The remains of five windows are visible; the spacing strongly suggest that there were originally six but that one has been destroyed by later alterations. Each window was c.0.60m wide internally. Some 0.07m below the base of the windows' sill chamfers (or 0.55m below the chamfered offset marking the base of the clerestory windows), a chamfered drip course was revealed; this had been disturbed in a number of places by the beams of the aisle roof.

- 5.2 Despite the current poor understanding of the complexities of the development of the church, a number of suggestions can be made regarding the windows uncovered by the repairs to the south aisle roof. The windows clearly pre-date those of the existing clerestory and so are earlier than the 15th century. Their location and spacing is suggestive of an earlier clerestory, and their form perhaps indicating narrow lancet windows, possibly dating them to the earlier 13th century. Given that the lower part of the west tower and the nave arcades are also thought to date from the 13th century, it is tempting to see the windows as the remnants of a nave clerestory created at the same time, set above a south aisle that had a slightly lower roof level, as indicated by the chamfered drip course exposed during the repairs. The windows were partly destroyed when the existing clerestory was built in the 15th century, and the drip course concealed by the altered slope of the south aisle roof. It is not known whether there are any corresponding windows on the south wall of the north aisle.

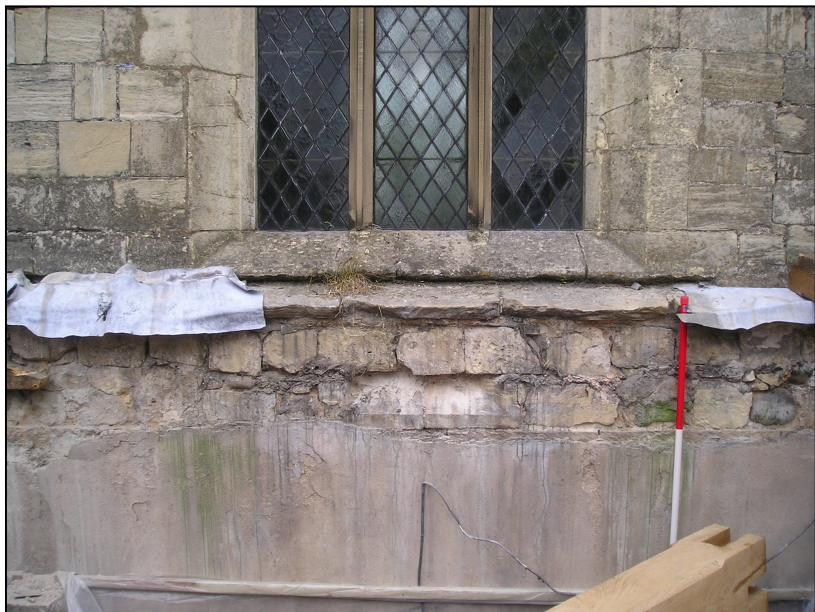
Plate 2: Exposed easternmost window, looking N.

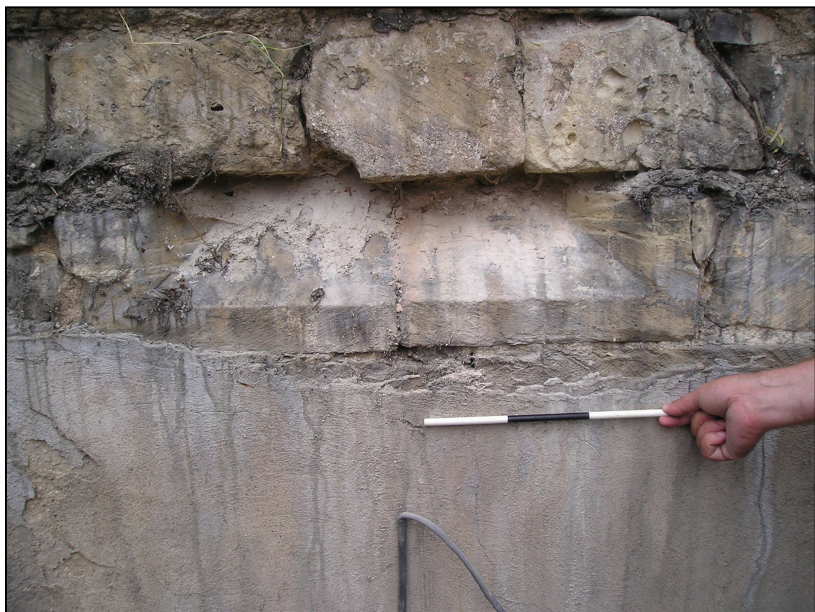
Plate 3: Detail of exposed easternmost window, looking N.
