NEVILLE CASTLE, KIRKBYMOORSIDE

PHOTOGRAPHIC SURVEY AND
ARCHAEOLOGICAL OBSERVATIONS

Report no: 2004/247.R01
Version: Final
Date: October 2007
Author: Shaun Richardson & Ed Dennison

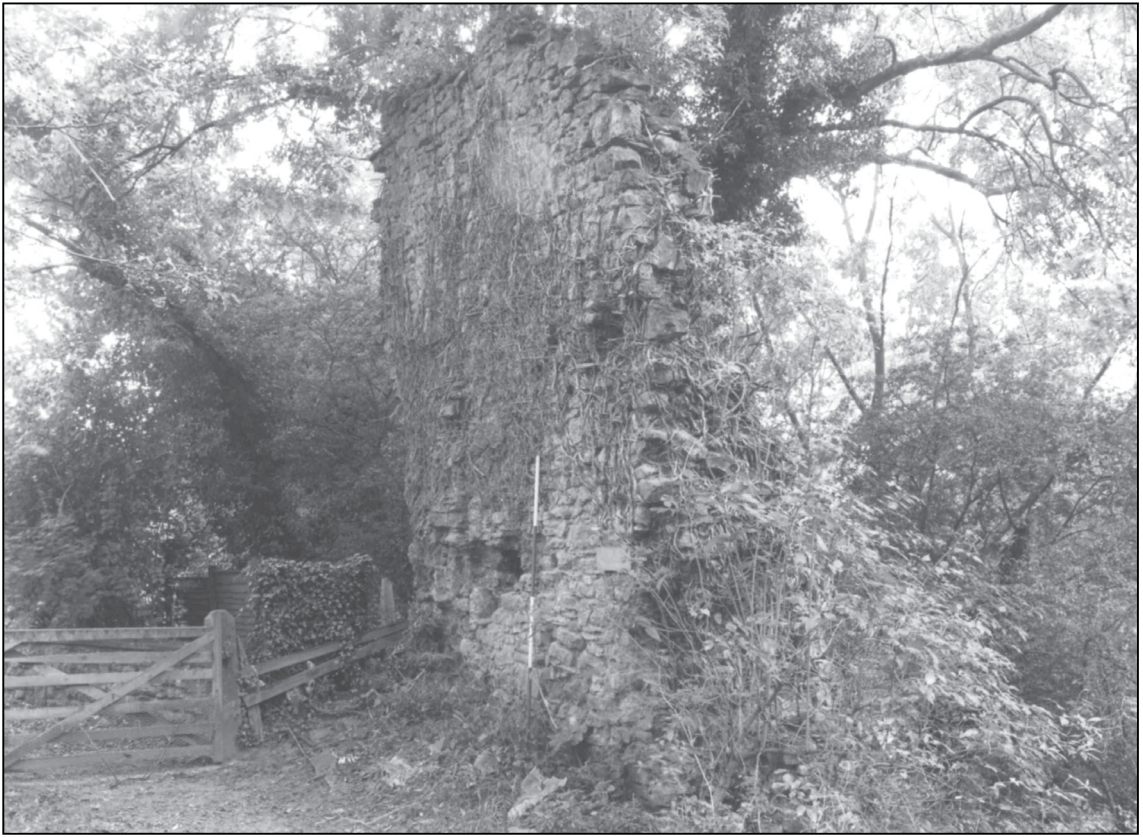
Plate 1: East elevation prior to vegetation clearance and consolidation, looking W (photo 1/1).

- 2.6 The initial site visit and the photographic survey took place on the 30th September 2004, prior to the scaffolding of the structure, when the remains were fairly heavily vegetated (see plates 1 and 2). As a result of the initial survey, EDAS proposed a number of amendments to the interventions / repair scheme put forward by the project architects, Ferrey & Mennim of York. These were discussed on site at a further meeting on the 20th October 2004 with English Heritage (Giles Proctor), Ferrey & Mennim (Dominic Lockett) and Historic Building Restoration (Steve Arrowsuch), following the erection of scaffolding; at the same time, those areas of the monument previously inaccessible or not visible from the ground were inspected and any relevant information was noted and included in the description given below.

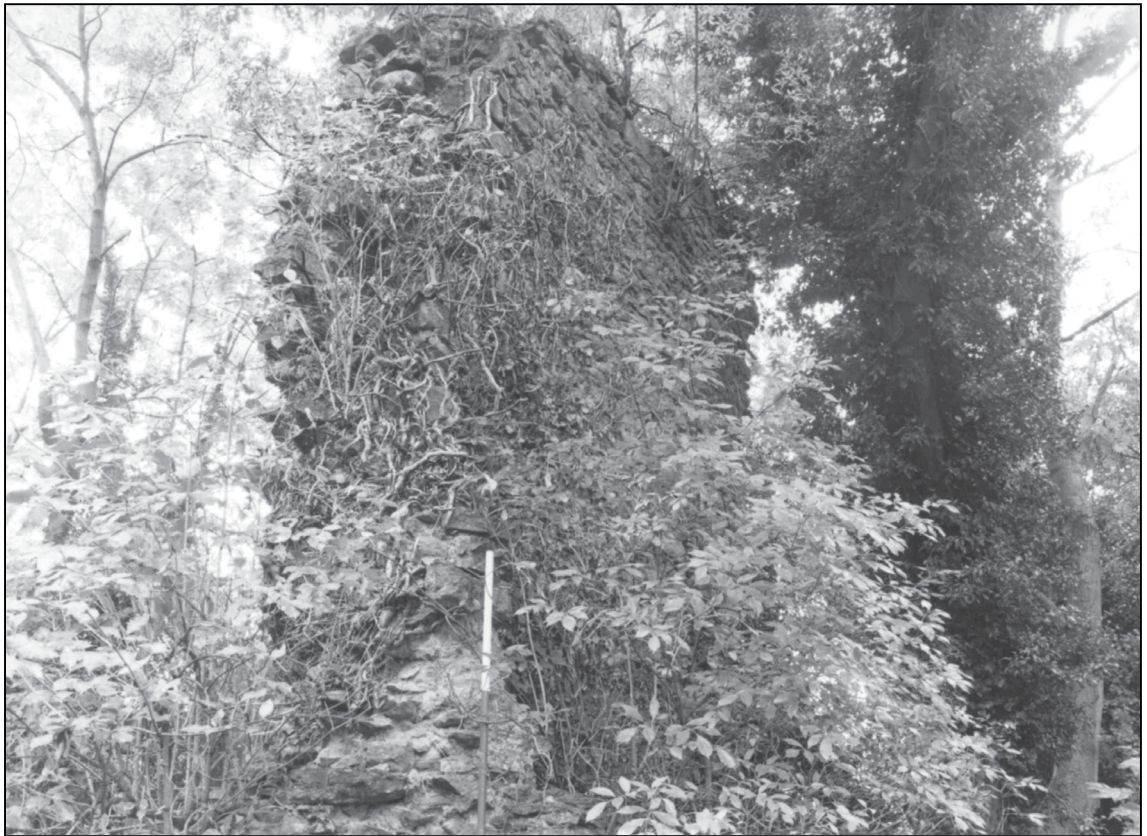
Plate 2: West elevation prior to vegetation clearance and consolidation, looking S (photo 1/13).

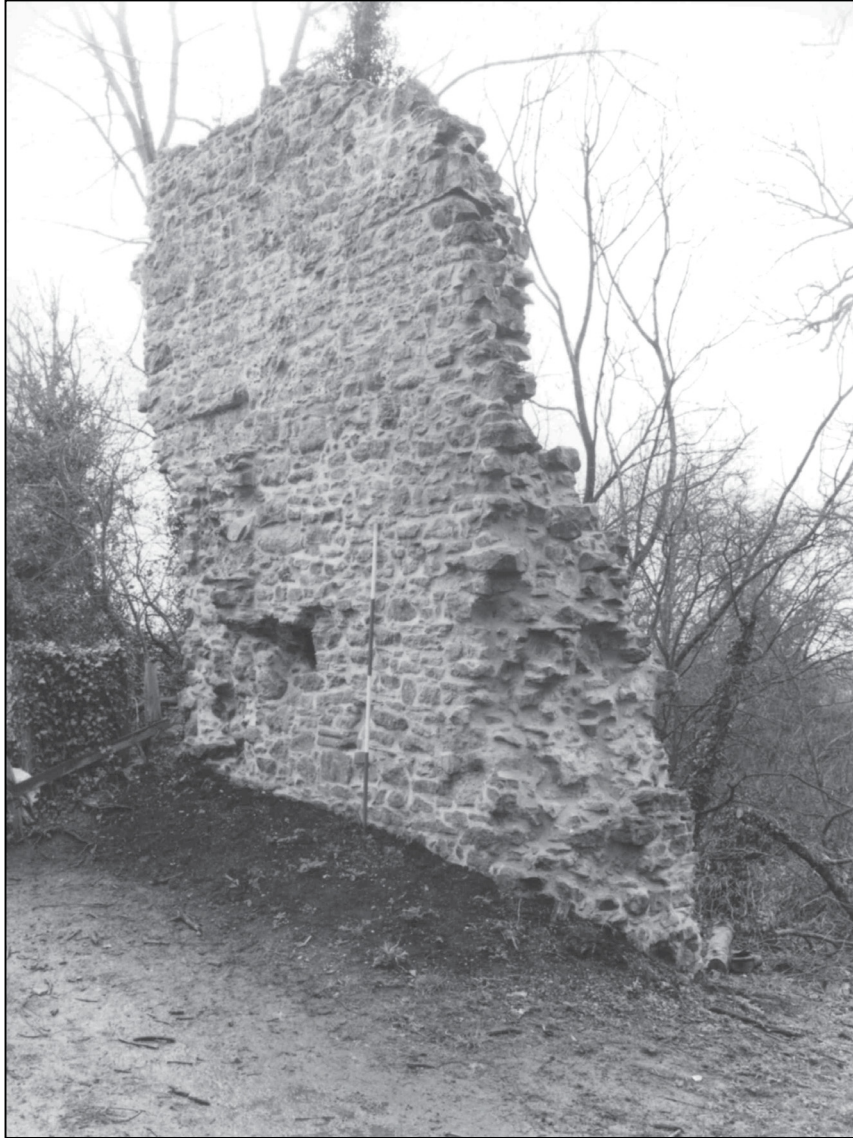
Plate 3: East elevation after consolidation, looking SW (photo 4/3).

- 2.7 The extent of the proposed repairs and consolidation meant that it was not necessary to undertake an archaeological watching brief during the works, and no drawn records were made as part of the project. However, a final site visit was made by the photographer on 22nd March 2005 to record the site following the completion of the works (see plates 3 and 4).

- 2.9 A full copy of the specification for the repairs and consolidation works provided by Ferrey & Mennim is included as part of the project archive. In outline, the work involved the removal of vegetation, followed by selective repointing, rebuilding and the infilling of voids.
