JOHN OF GAUNT'S CASTLE, HAVERAH PARK

PHOTOGRAPHIC SURVEY AND
ARCHAEOLOGICAL OBSERVATIONS

Report no: 2004/247.R05
Version: Final
Date: October 2007
Author: Shaun Richardson & Ed Dennison

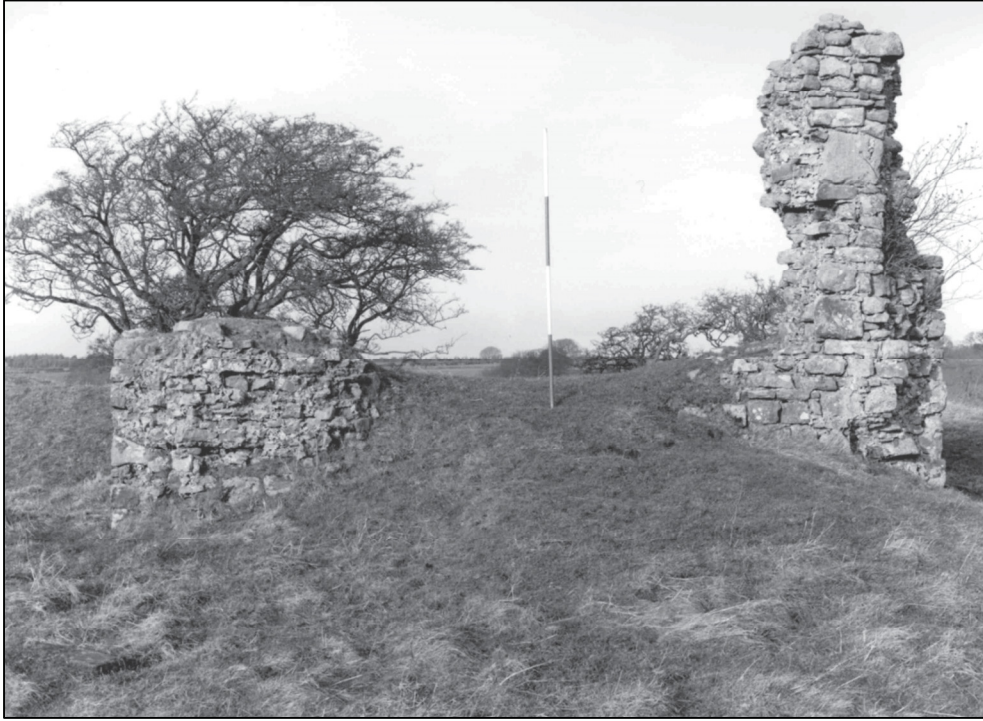
Plate 1: Standing masonry before consolidation, looking N (photo 1/11).

- 4.2 The only substantial piece of standing masonry is located within the inner core of the site, towards to the south side of a sub-square platform at the end of an entrance way; the structure is not surprisingly suggested by the DCMS to represent the remains of a gatehouse. It comprises two fragments of a wall, aligned east-west, separated by a shallow spread of material probably representing fallen masonry but perhaps the remains of a ramp (see plate 1). Each wall fragment is c.2m long and returns to the north at its outer end. The western fragment returns 2m to the north while the eastern fragment returns slightly further to the north (see plate 2), but both end in ragged joints. The eastern fragment stands to c.3m in height but the western is much lower. Both are faced with coursed squared brown sandstone rubble and, where this has been removed, a core of rubble/lime mortar is exposed. The contrasting pattern of core and facing stone at the corner of the eastern fragment suggests that quoins were once present here. No other features such as joints or putlog holes were visible. Extrapolating from the ruins, a building measuring c.6m (east-west) by c.2m (north-south) is suggested.

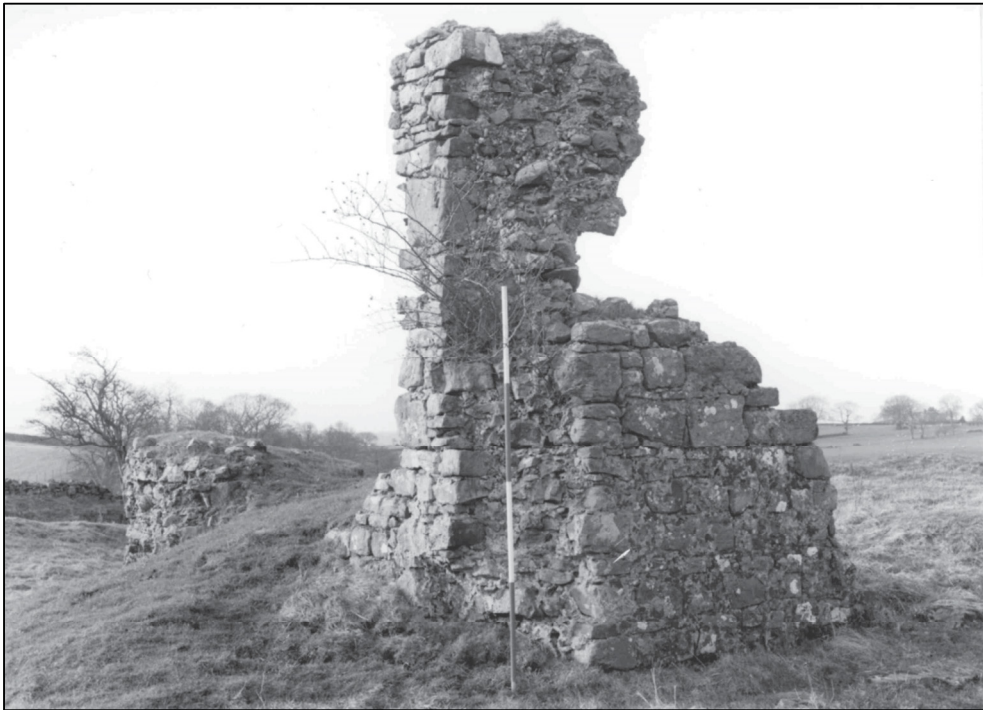
Plate 2: Standing masonry before consolidation, looking NW (photo 1/15).

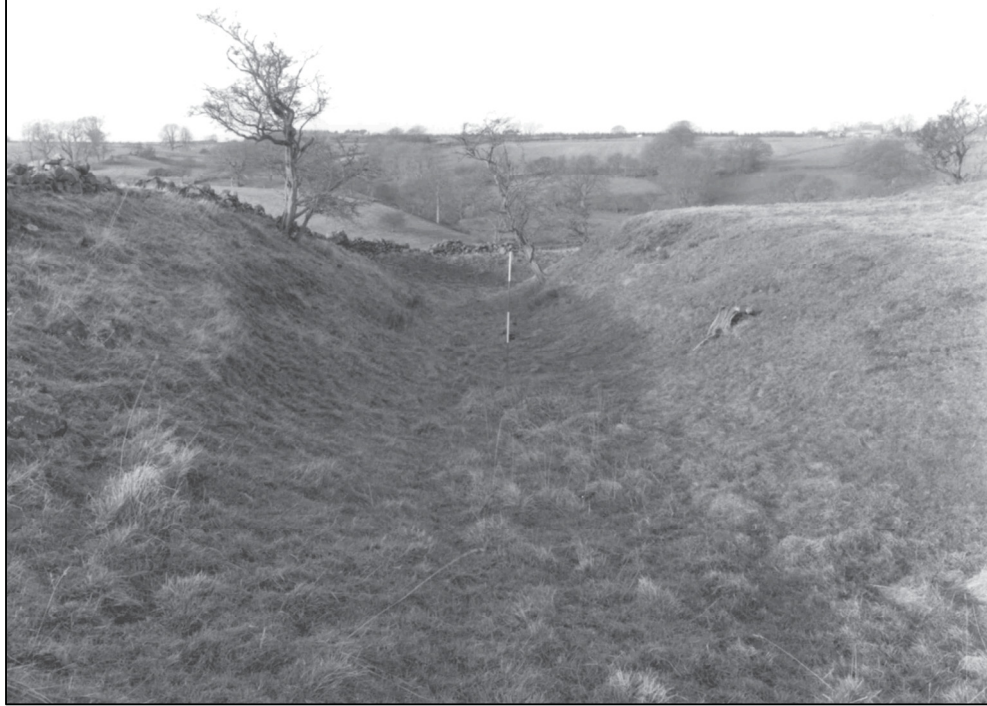
Plate 3: West side of moat, looking N (photo 2/5).

- 4.5 The larger platform is surrounded by a substantial moat, up to c.4m wide at the base and c.2m deep, with steep sides and angled to the north, mirroring the alignment of the north side of the tower platform (see plate 3). The moat is slightly narrower on the east side than on the other three sides, and retains traces of stone revetting to the south-east corner. The outer bank of the moat is also a prominent feature, being up to c.2m high and over c.10m wide to the east and west. It is slightly less substantial on the north side of the moat but wider to the south, reaching a width of c.12m. The south part of the moat is crossed by an earth causeway or ramp, centrally placed, with an inset to the east in the south-east corner of the main platform. Although the ramp is shown depicted in 1853, it may not be the original access onto the main platform and could result from later infilling. A ruined drystone wall runs along the top of the moat's outer bank; where it survives most completely, it is 1.2m high with a battered profile and incorporates several rows of throughstones, although these do not project beyond the wall face.

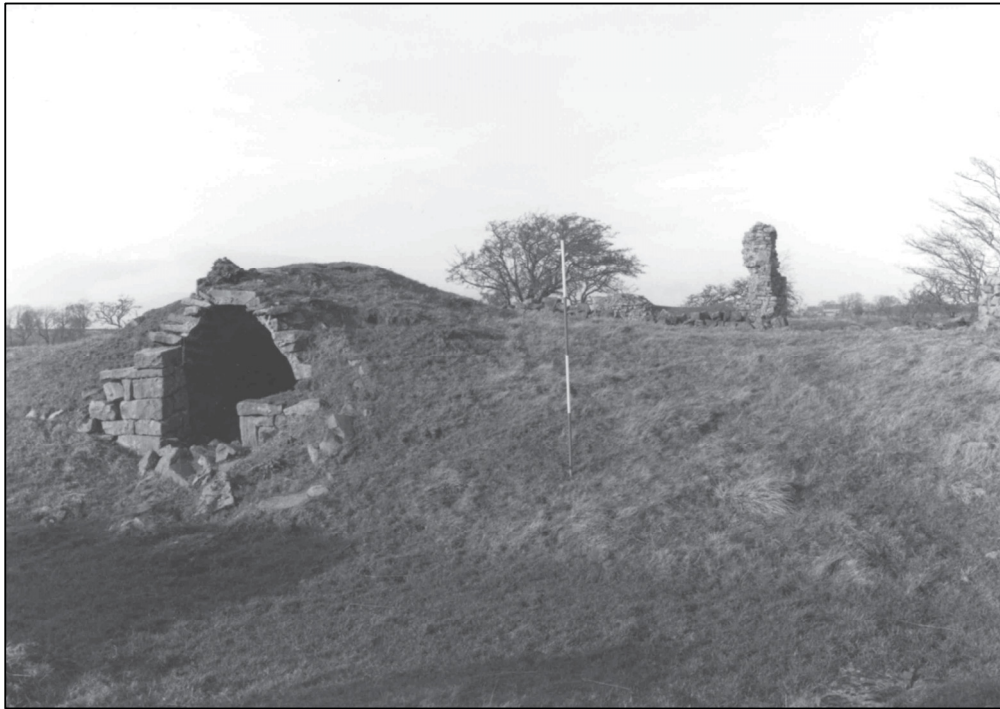
Plate 4: West turnip house before consolidation, looking N (photo 2/14).

- 4.9 Two elements of the farm complex had a direct impact on the lodge, in that they were dug into the south side of the moat's outer bank. There are two structures here, each of a similar form. The western example is the better preserved, and is built of squared coursed sandstone rubble set with lime mortar (see plate 4). The front (south) wall containing a doorway has largely collapsed but the 4.70m long vaulted structure behind is well preserved, and has a small chute at

the north end. The vault itself is built of rubble and has an arched profile rising to an apex of flat slabs. It is 1.99m in height and covered with earth. The vault of the eastern example has largely collapsed, but it was obviously of a similar size and construction to that described above. The end walls survive well; the doorway at the south end has a large stone lintel and there is also a chute in the north wall (see plate 6). Although the DCMS interpreted the structures as being used for the storage of root crops, game or ice, they are actually for turnips and other root crops, and several other examples are known at farms in this area (Steve Haigh, *pers. comm.*). As well as the two turnip stores, there were once other structures terraced into the bank here, now clearly visible as earthworks.

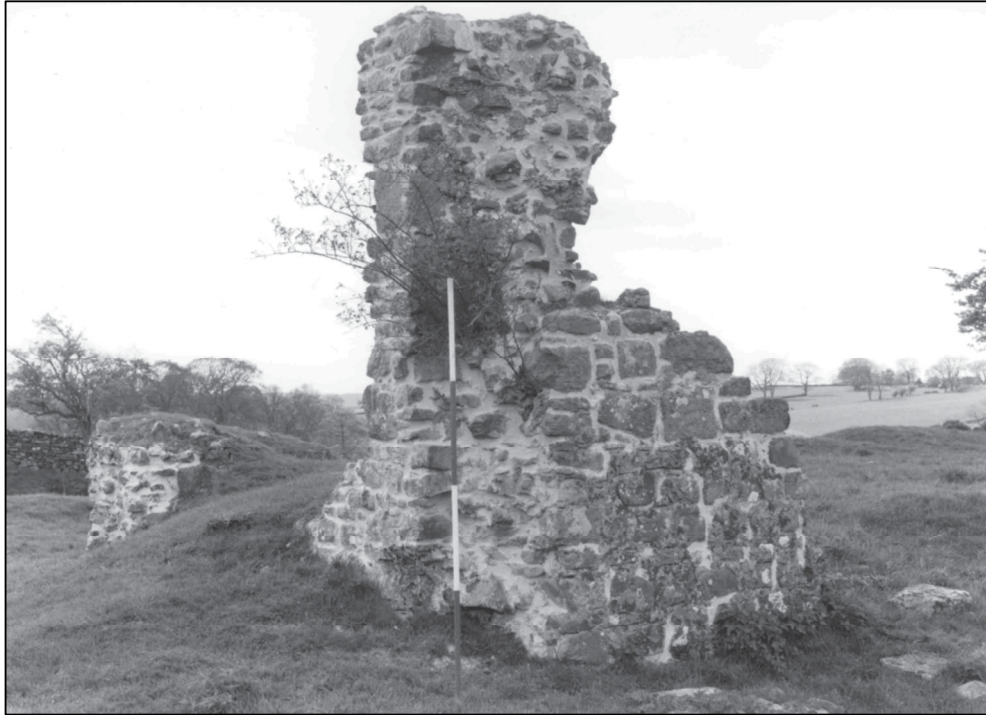
Plate 5: Standing masonry after consolidation, looking NW (photo 4/6).

- 2.7 A full copy of the specification for the consolidation works provided by Ferrey & Mennim is included as part of the project archive. In outline, the work involved selective repointing, the limited resetting and rebuilding of areas of corework and facing stone, and the infilling of voids.

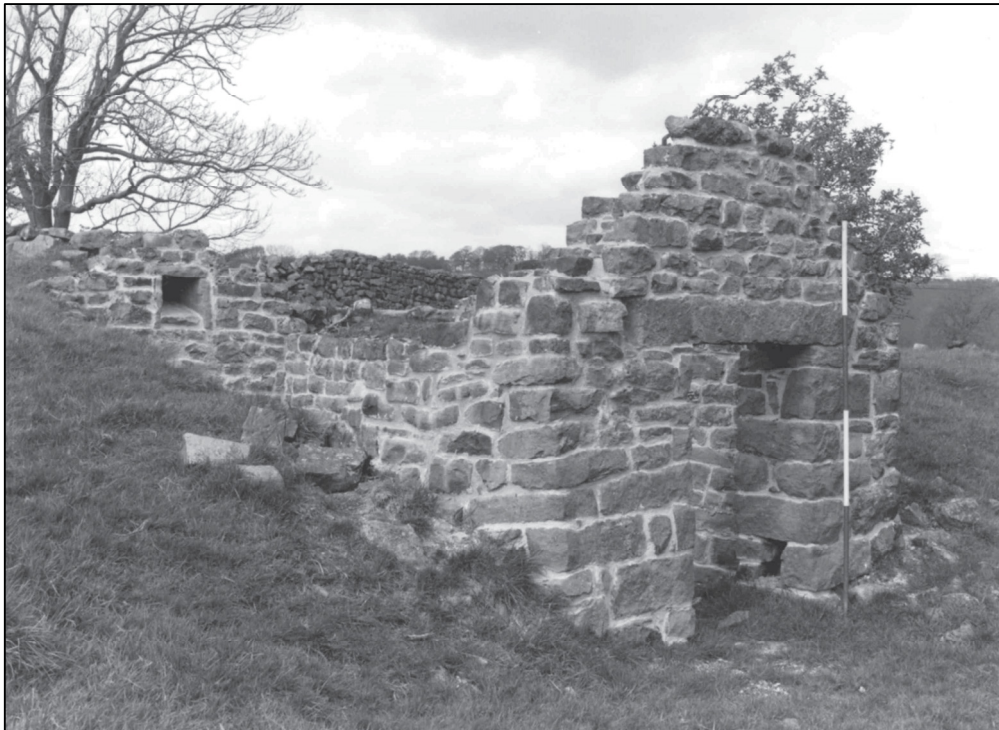
Plate 6: East turnip house after consolidation, looking NE (photo 4/12).
