BUILDING TO REAR OF 19 NORTH BAR WITHIN,
WOOD LANE, BEVERLEY, EAST YORKSHIRE

ARCHITECTURAL AND ARCHAEOLOGICAL
OBSERVATION, INVESTIGATION AND RECORDING

Report no: 2004/255.R01
Version: Final
Date: December 2007
Author: Ed Dennison & Shaun Richardson

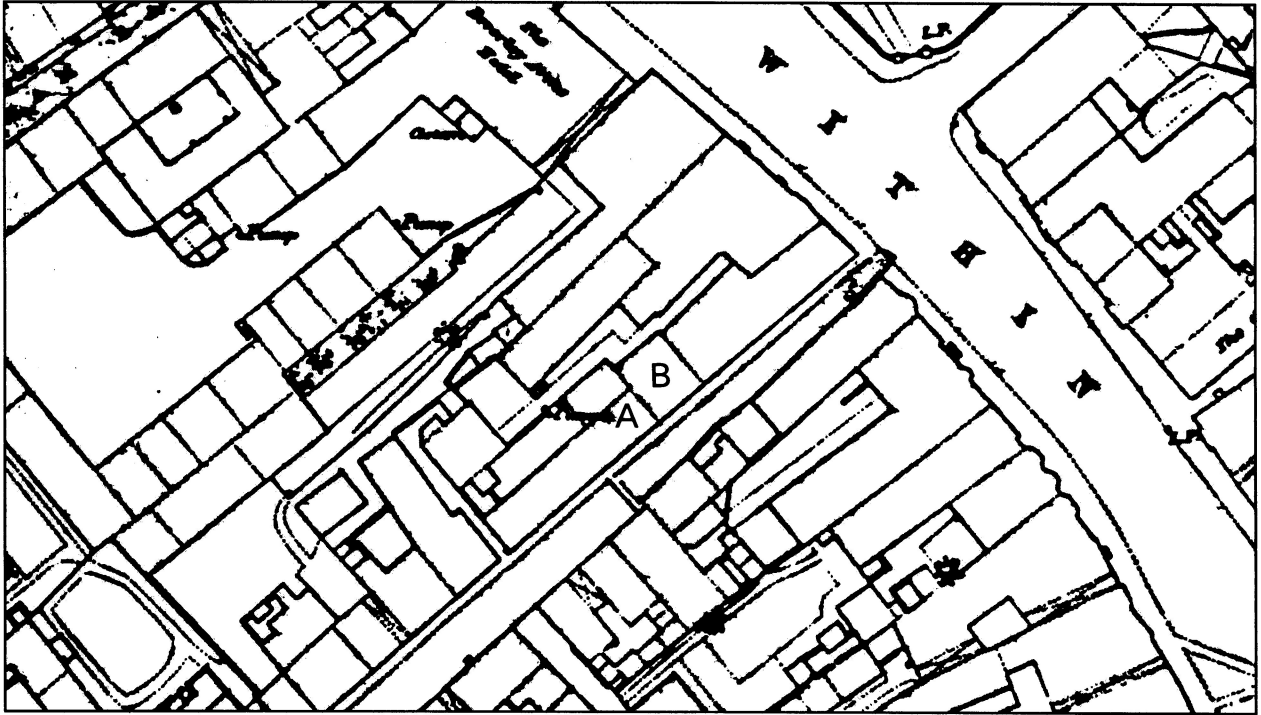
(a) Extract from Ordnance Survey 1853 map (sheet 4)

- 2.12 These buildings are presumably those shown on the first edition 1853 Ordnance Survey map (see figure 3a). This depicts 19 North Bar Within extending west along the Wood Lane frontage, a separate building representing the east part of the recorded building (B), and a narrower longer building to the west, the east end of which forms the other part of the recorded building (A). There is another building attached to the north side of building (A) and a small yard containing a "pump" to the west. There is also a yard to the north of building (B), which appears to be sub-divided along its length. There is nothing on the map to suggest any function for any of the depicted buildings.

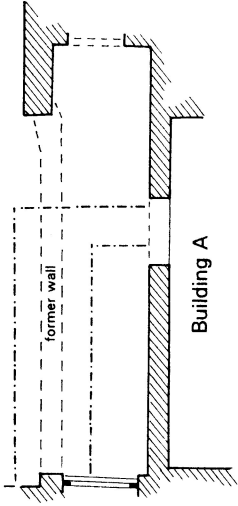
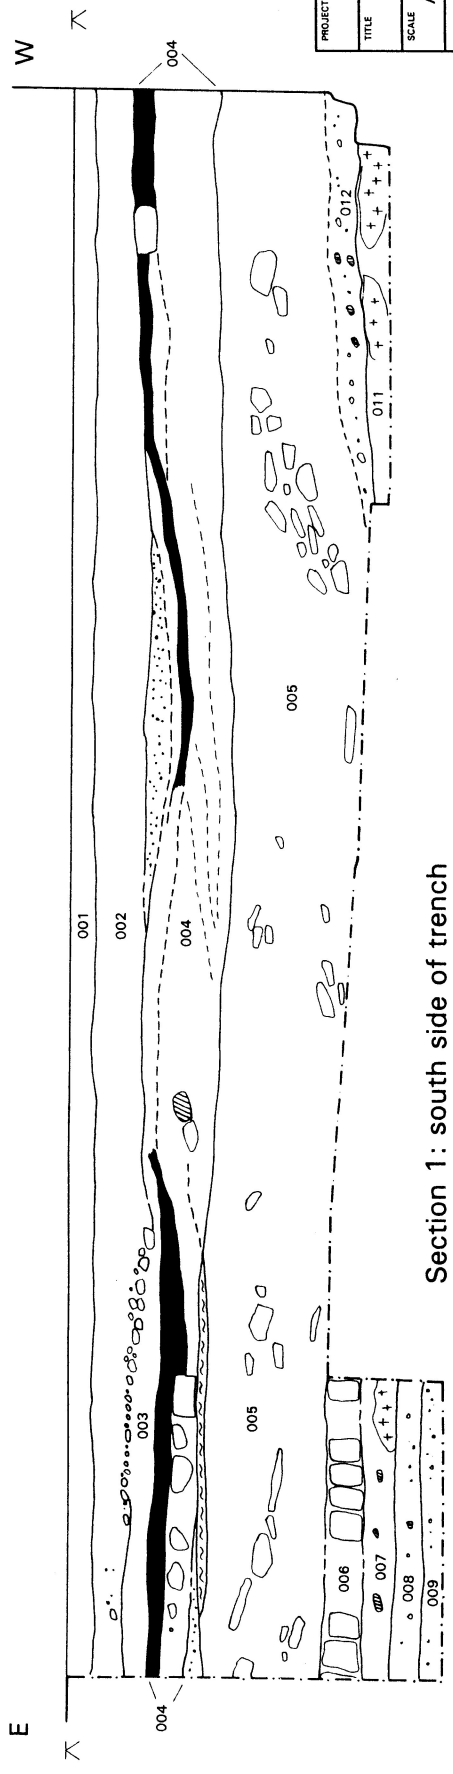
PROJECT	WOOD LANE, BEVERLEY		
TITLE	WATCHING BRIEF RESULTS		
SCALE	AS SHOWN	DATE	DEC. 2007
	EDAS	FIGURE	5

- 4.2 The trench was initially only 0.30m wide but this was subsequently increased to 1.00m wide. It was first excavated to an average depth of 0.75m below the concrete floor of the north aisle (001), where a brick surface (006), suitable for use as a foundation, was encountered (see below). However, a small section of brick surface c.0.80m square at the east end of the trench was removed to ascertain the ground conditions beneath, and here the trench reached a depth of 1.00m; the north-facing section of the trench was recorded at this point. A short arm, 0.40m wide and c.0.75m deep, was then cut south from the south side of the east end of the trench as far as the north wall of west part (A) of the building. A composite plan of the trench was made, showing the brick surface (006) before the 0.80m square section was removed.

- 4.5 In the southern return at the east end of the trench, it was noted that the footings of the north wall of the west (A) part of the building were only two courses deep beneath the concrete, resting on contexts 003, 004 and 005. At between 0.49m and 0.66m below the level of the concrete, the remnants of another wall (010) were visible, butted by floor surface (006). The wall was on the same line as the existing wall above, but set slightly forwards from it. It was two course high and built of red handmade bricks (220mm by 120mm by 60mm), possibly laid in English Garden Wall bond and set with a cream lime mortar.

- 4.6 As stated above, a c.0.80m square section of the brick surface (006) was removed in the east end of the trench in order to investigate the ground conditions beneath. The bricks were seen to be bedded on a shallow layer of light brown sandy lime mortar (007), 0.10m thick, which contained a sherd of brown glazed earthenware, possibly from a dish or platter of perhaps 17th century date. This deposit overlay a shallow layer of pinkish-buff lime mortar (008) and a sticky dark clayey silt with chalk flecks (009), which continued beneath the base of the trench. At the west end of the trench, it was noted that the stepped footings of the garden wall, which were composed of chalk and brick, began c.0.70m below the surface of concrete (001), and were butted by context 005 and all those above.

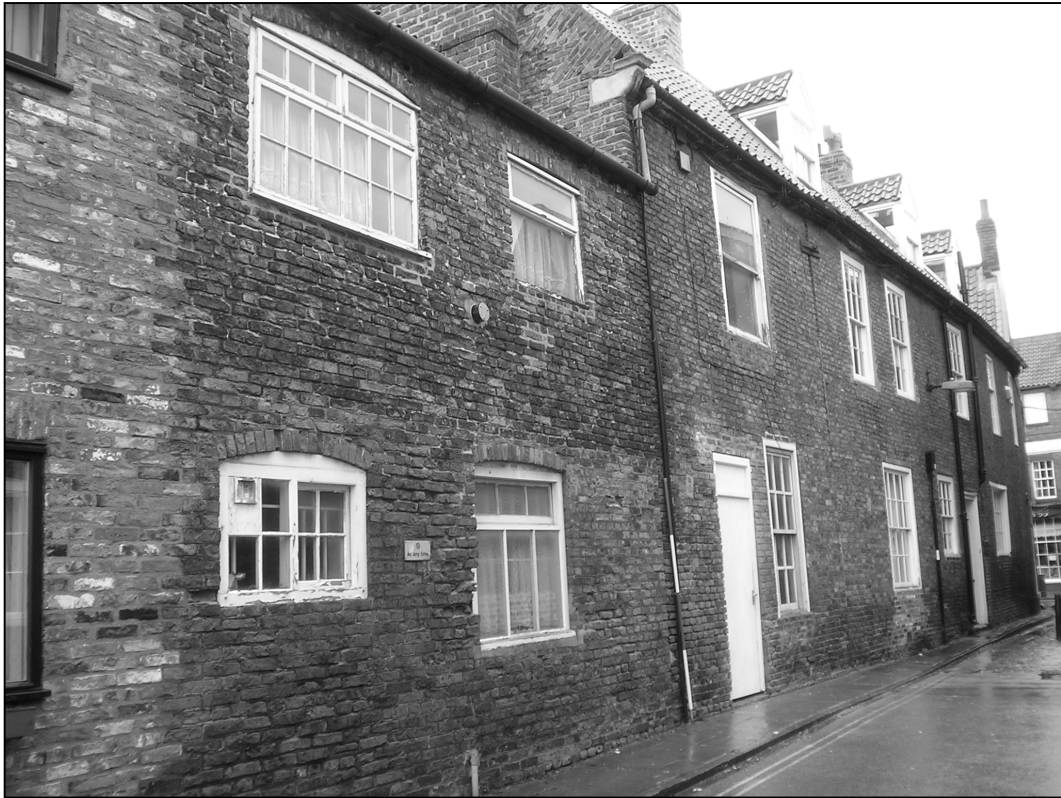
- 3.7 The principal elevation of the building, if it can be called such, faces south onto Wood Lane (see plate 1). The east part (B) is of two bays, built of handmade yellowish-red bricks (average dimensions 220mm by 110mm by 55mm) laid in a variation of English Garden Wall bond (one to three courses of stretchers to each header course) and set with a cream lime mortar. There is a ground floor doorway fitted with a modern door and a 16-pane (8 over 8) unhorned sash to the east. This sash is similar to those in 19 North Bar Within but it appears very clean internally and may be a later replacement of a mid to late 18th century original. There is a blocked inserted doorway at the west end of the south elevation of 19 North Bar Within where it is butted by the east part (B) of the building. The western half of the south elevation of no 19 is built of similar bricks to part (B), laid in English Garden Wall bond, varying from one to three courses of stretchers to each header course; the blocking of the doorway however is in red handmade brick (average dimensions 235mm by 110mm by 50mm) laid in English Bond. The eastern half is built of buff handmade bricks (average dimensions 220mm by 110mm by 50mm) laid in English Garden Wall bond (five stretcher courses to each header course) and with traces of recessed lines to the pointing. There is a ragged joint between the eastern and western halves of the building.

Plate 1: South elevation, looking N (photo 1/1).

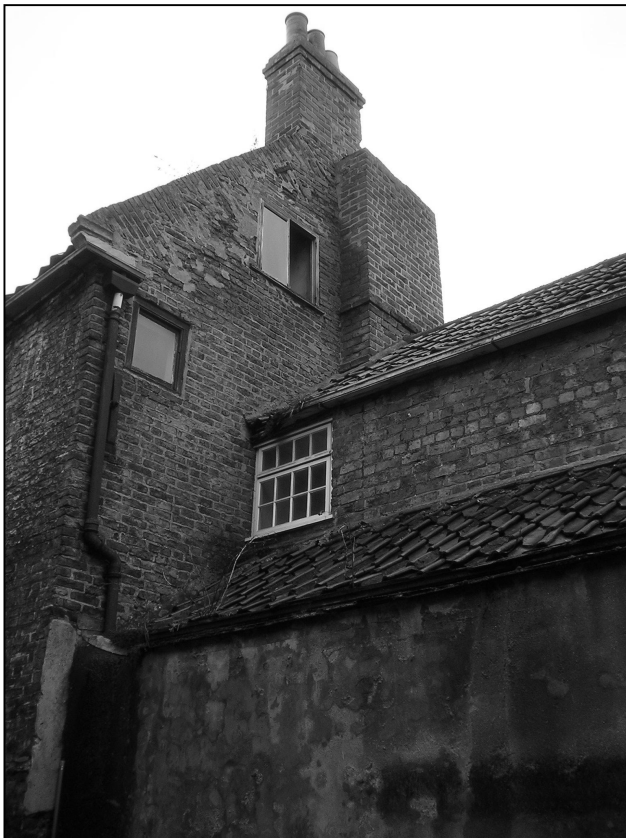
- 3.9 The north elevation of the east part of the building is built of similar brickwork to the south elevation, but is laid with four to six stretcher courses to each header course, retaining traces of whitewash and wooden guttering. The east end could not be inspected as it is obscured by a modern timber lean-to addition to 19 North Bar Within. However, the north elevation appears largely blank, the only feature being a brick blocked doorway at the west end of the ground floor (see plate 3) and a cast-iron rectangular wall-tie with associated strapping at the east end; the door presumably gave access to the sub-divided yard shown on the 1853 map. The north-west corner appears to rise from a block of stone which sits awkwardly with the doorway. The west gable has modern casement windows at first floor and attic levels, the former with a wall-tie below. There is a single fish-tailed wall-tie to the tumbled brickwork of the north slope of the gable, which rises from a moulded stone kneeler (see plate 2). The tall stack is a later rebuild of an original.

Plate 2: East gable of Building B, looking E (photo 1/2).

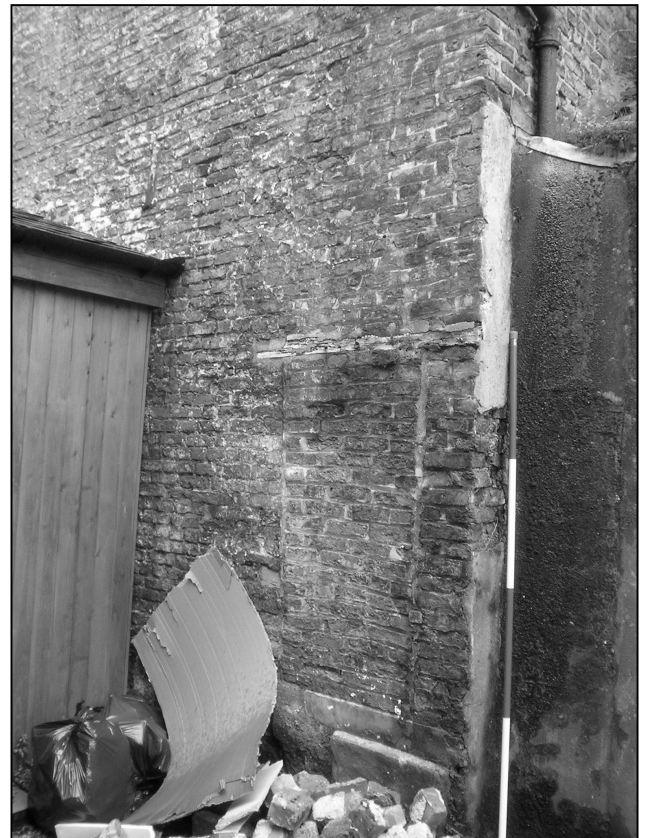
Plate 3: North elevation of Building B, showing blocked doorway, looking SE (photo 1/4).

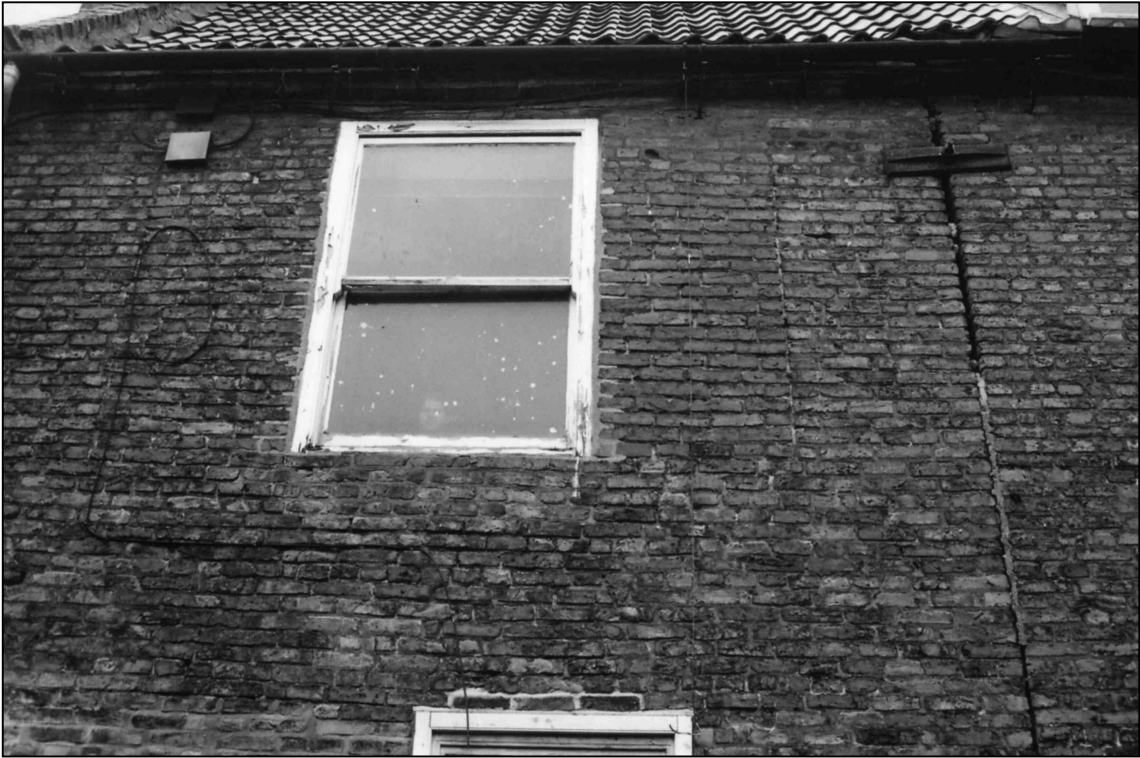
- 3.5 The west part of the building (A) is of two storeys and has a pitched pantiled roof with a tall ridge stack at the east end. The aisle on the north side is of a single storey but also covered with pantiles. The east part of the building (B) is significantly taller, comprising two storeys and an attic (see plate 2). The pitched pantiled roof has a tall stack to the west end of the ridge. The structural framework of both parts of the building is formed by load bearing external walls with wooden beams and joists supporting the internal floors. The brickwork of the east part (B) is not tied into the east gable of 19 North Bar Within and consequently a slight gap has opened up between the two; a rectangular cast-iron wall-tie has been inserted at the top of the gap to try to alleviate this problem (see plate 4).

- 3.8 The first floor of the east part has a single 2-pane (1 over 1) horned sash, with extensive areas of blocking to either side (see plate 4). The width of the blocking and comparison with the first floor of 19 North Bar Within suggests that there may originally have been two 16-pane sash windows here, although it is possible that there was a single wide opening. There is a straight joint between the south elevation of the east part (B) and that of the west part (A) of the building.

Plate 4: Blocking to first floor window, south elevation of Building B, looking N (photo 2/5).

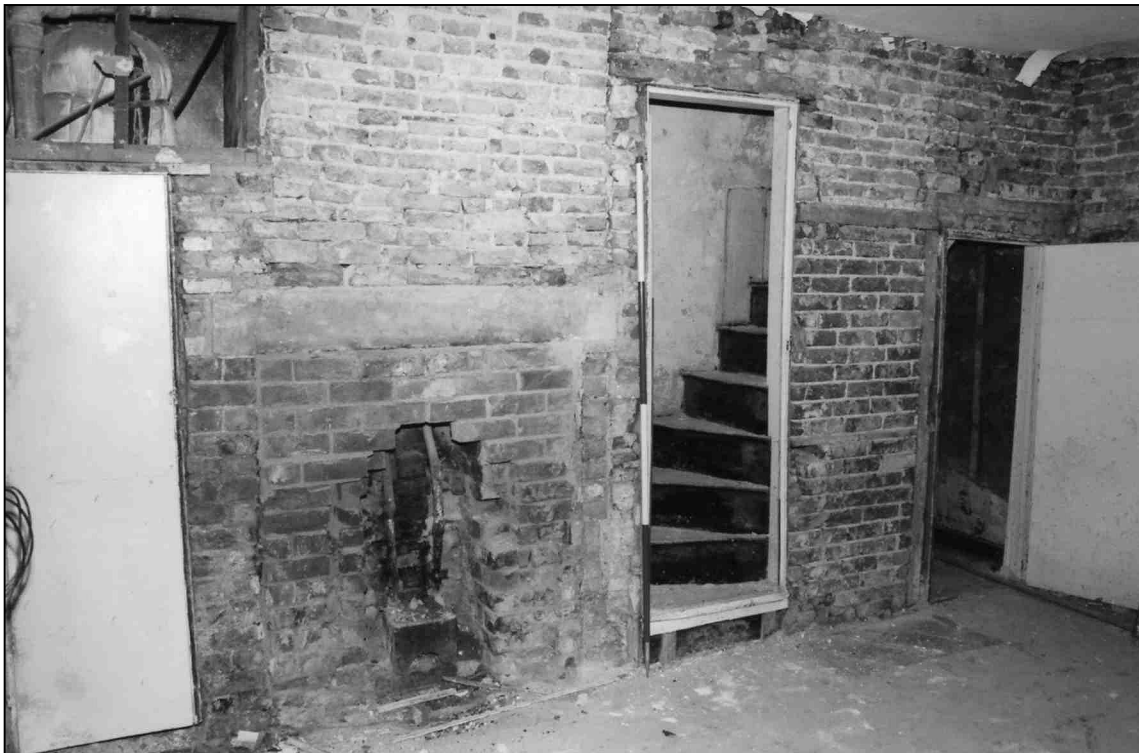
Plate 5: Ground floor of Building B, looking NW (photo 3/10).

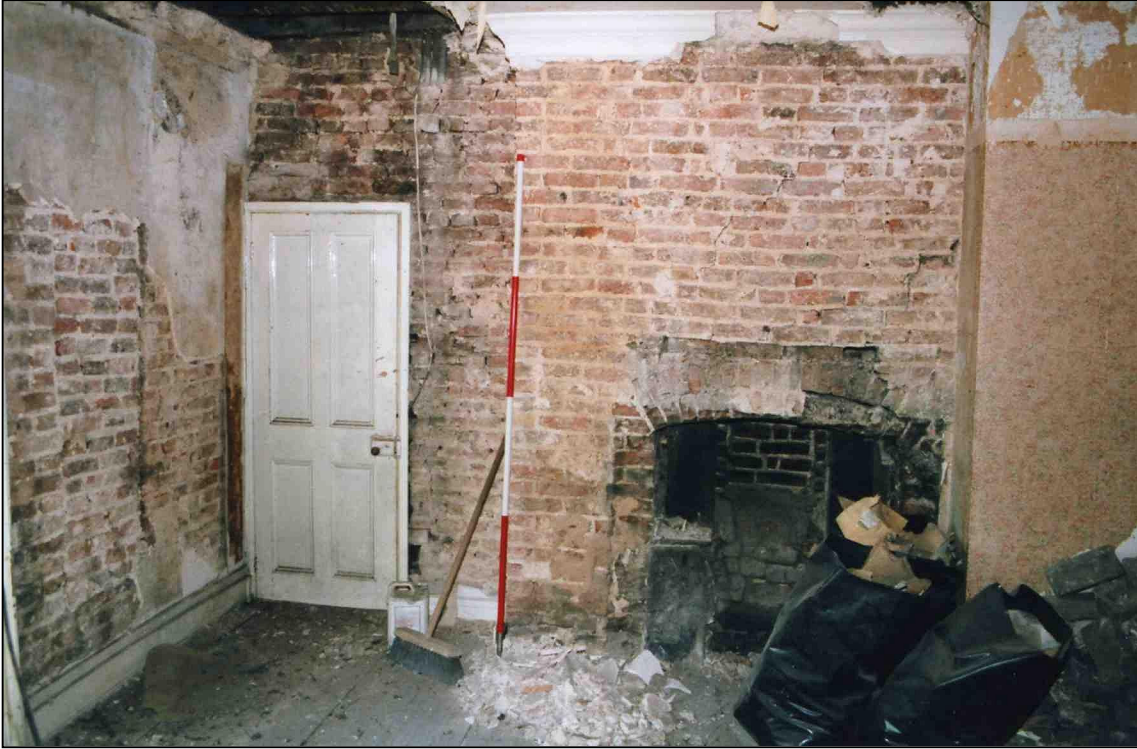
Plate 6: First floor of Building B, looking S (photo 4/10).

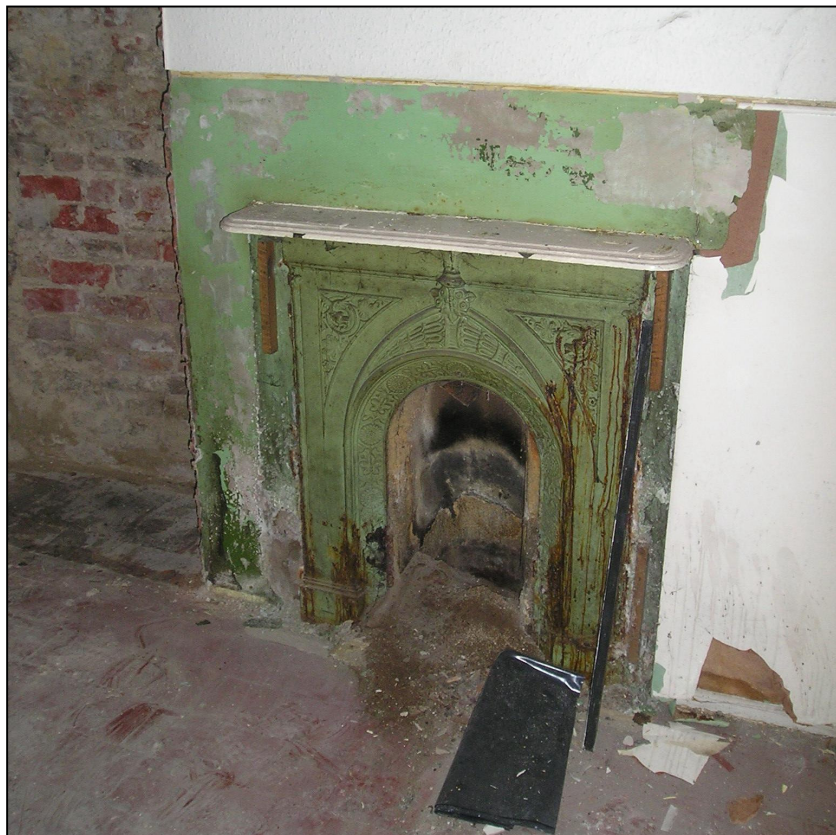
Plate 7: Fireplace in ground floor of Building A, looking NE (photo 1/23).

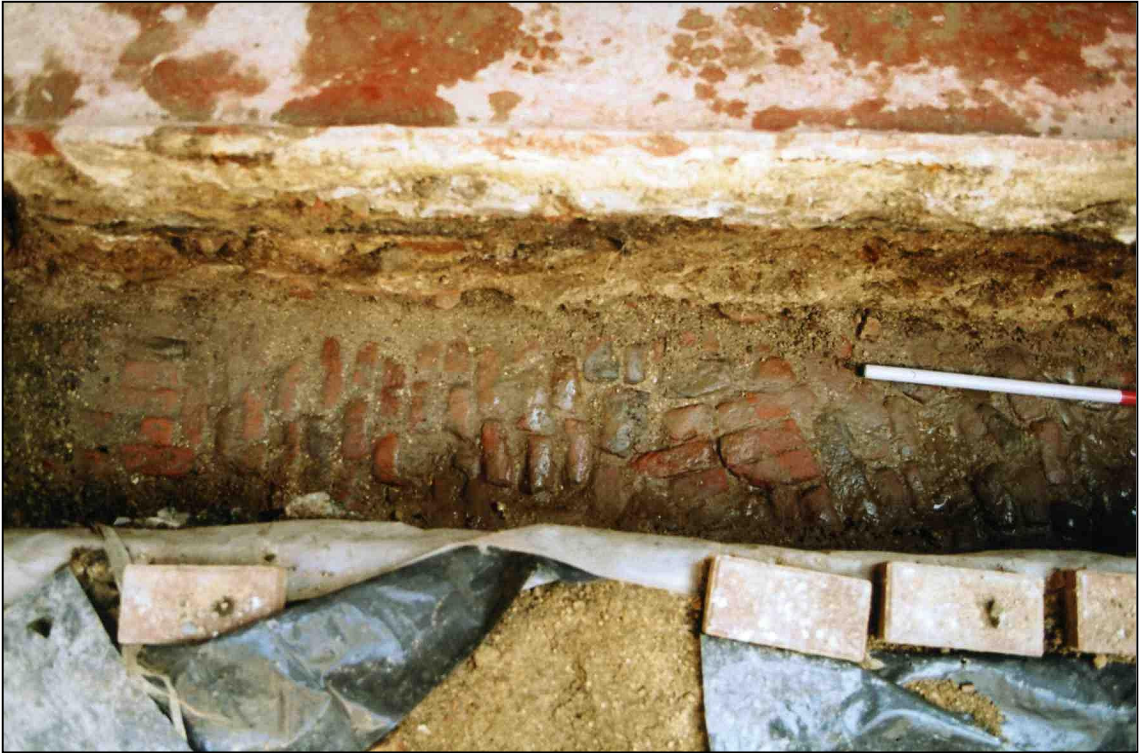
Plate 8: Excavated trench showing brick surface (006).

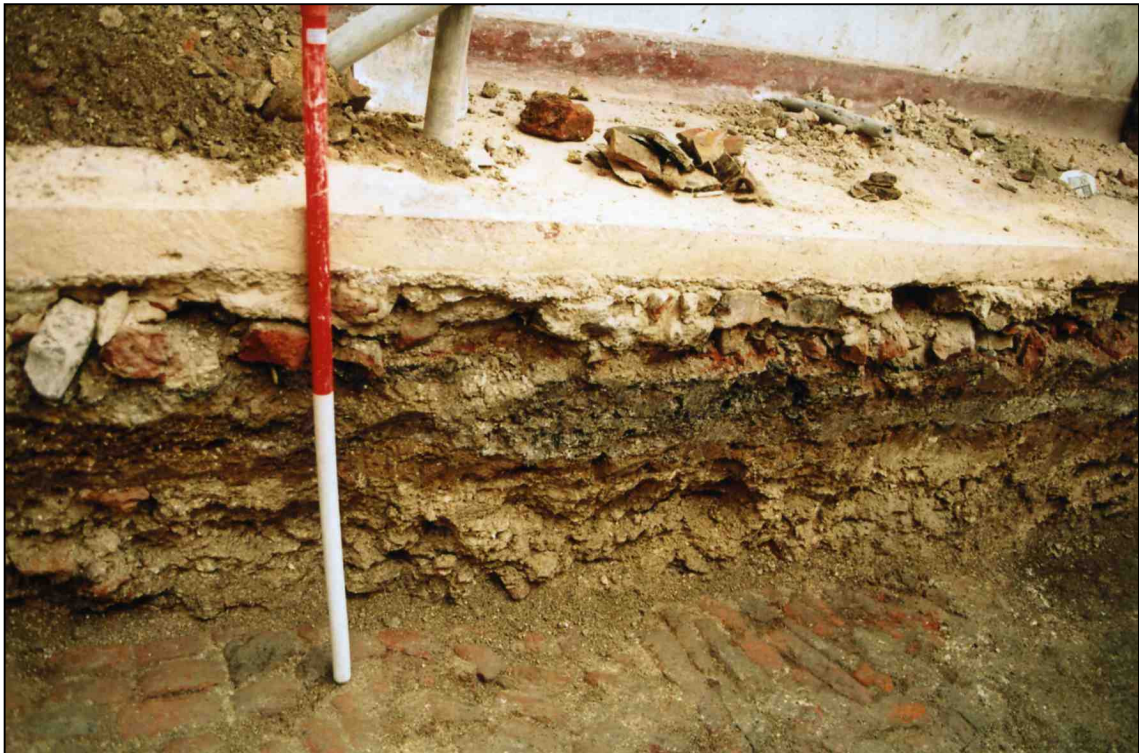
Plate 9: Excavated trench showing north facing section.

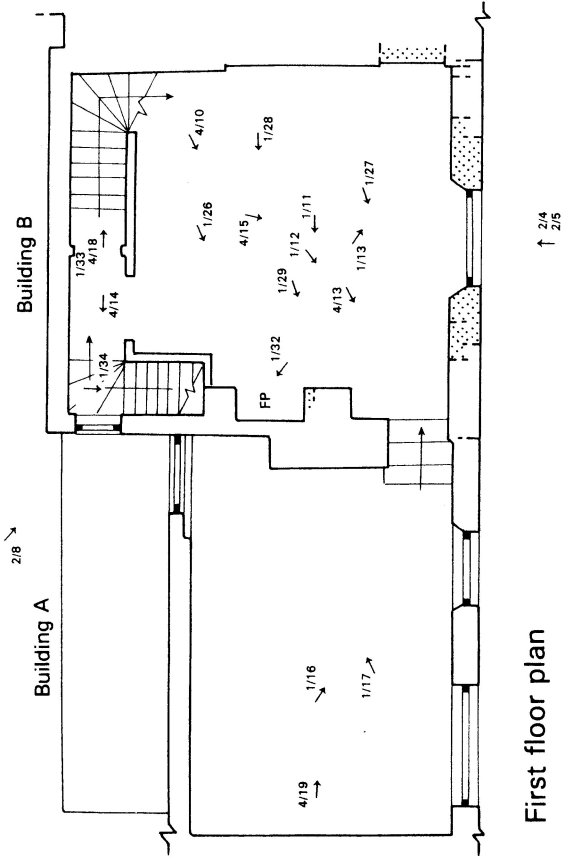
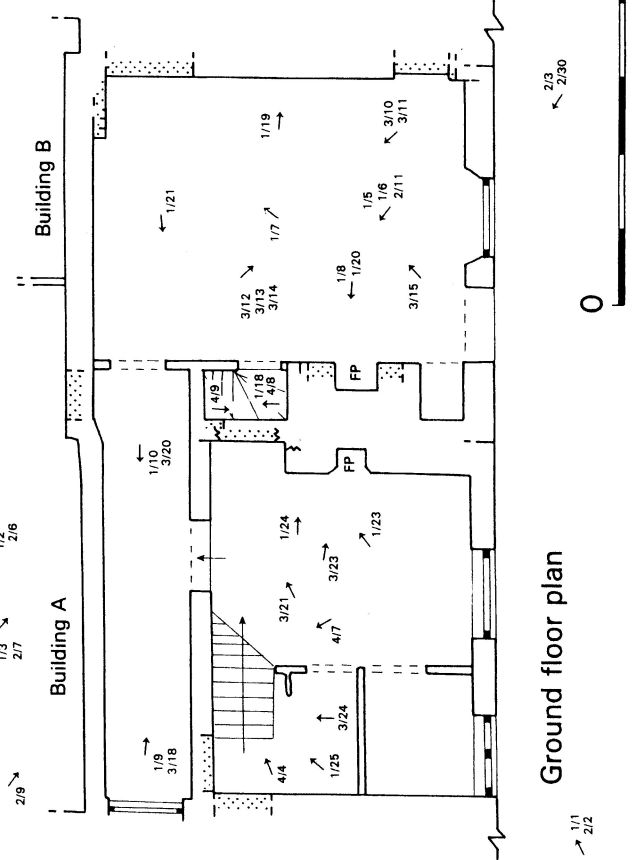
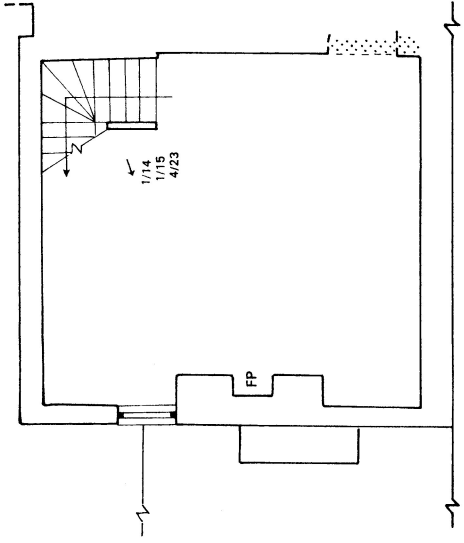
PROJECT	WOOD LANE, BEVERLEY		
TITLE	FLOOR PLANS AND SECTION		
SCALE	AS SHOWN	DATE	DEC 2007
	EDAS	FIGURE	4

- 3.1 As stated above, for ease of description, the building which is the subject of this report has been divided into two parts, with each assigned a unique letter reference code which is used in the following text and figure 4. The west part (A) is continuous with the building immediately to the west of the site, which has already been converted to residential accommodation. The east part of the building (B) is set between the west part (A) and the rear of 19 North Bar Within to the east (see figure 2). In addition, in the following text, "modern" is taken to mean dating to after c.1945.
- 3.2 Appendix 1 provides a catalogue of all the photographs taken during the project, as well as a figure showing the photographic location points. Some of the photographs have been used to illustrate this report. Reference should also be made to the floor plans of the building (see figure 4).
