ALL SAINTS CHURCH,
SKIPSEA, EAST YORKSHIRE
ARCHAEOLOGICAL WATCHING BRIEF

ARCHAEOLOGICAL WATCHING BRIEF

Report no: 2005/258.R01
Version: Final
Date: September 2007
Author: Ed Dennison & Kate Dennett

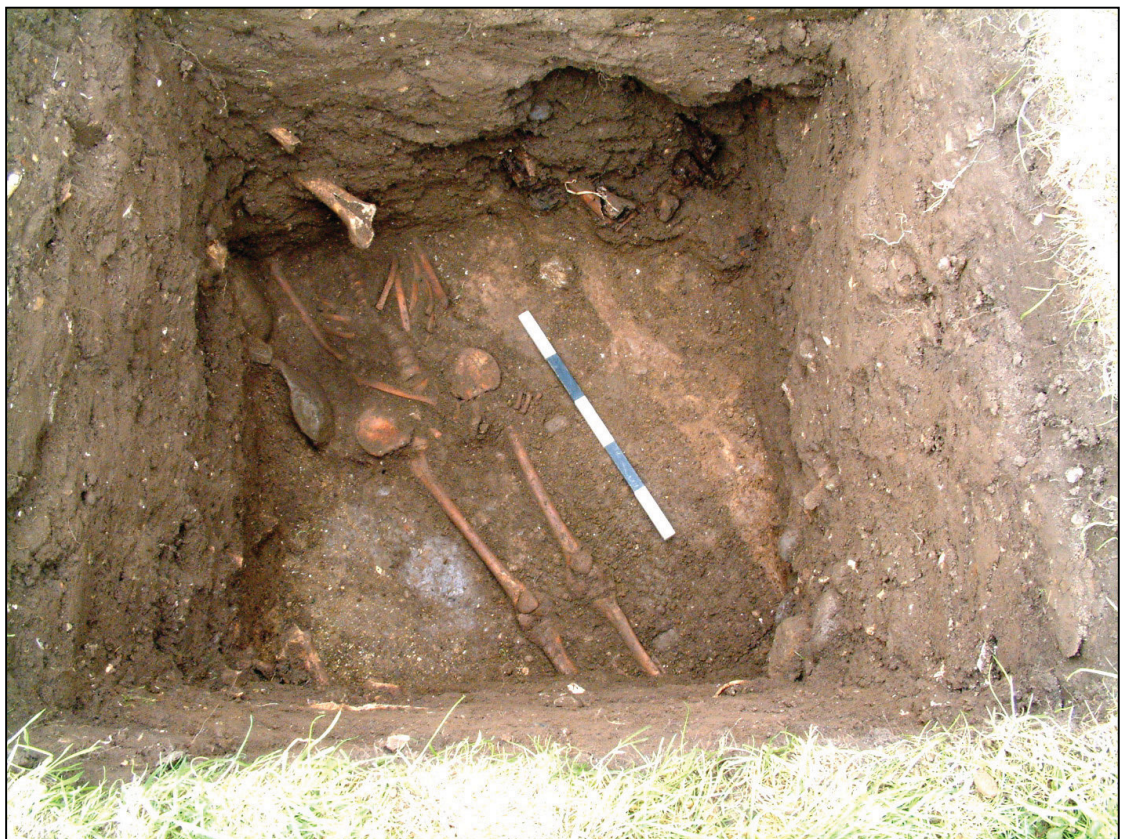
Plate 2: Exposed in-situ burial (011) in soakaway pit, looking NW.

- 4.4 At a depth of 1.26m below ground level, in the base of the soakaway pit, a largely undisturbed extended adult skeleton (011) was revealed, lying east-west across the centre of the pit (see plate 2). The burial was in good condition, but only sufficient was exposed for recording purposes. The surrounding mid-brown loamy backfilled soil (010) was dry and firm and there was no evidence of a coffin, and no dating material was recovered. What appeared to be the base of a linear cut (008) for this burial, cut into the brown natural clay (003), was clear on the north side but less clear on the south.

- 4.5 On the south side of the skeleton, adjacent to the abdominal and thoracic area, were four cobbles (009) apparently set on edge, aligned parallel to the skeleton, which formed an edging to the grave. The cobbles typically measured at least 0.40m long by up to 0.06m wide, and they appeared to be continuing towards the west, although it was not possible without further excavation to ascertain that this was actually the case. Whilst it is possible that the cobbles were merely part of the grave backfill (010) fallen up against a coffin edge, their position, proximity and orientation makes this unlikely. Only one piece of cobble was present on the opposite side of the burial, but if a similar kerbing had existed here, it is likely to have been removed by the digging of the grave for the adjacent skeleton (025) immediately to the north.

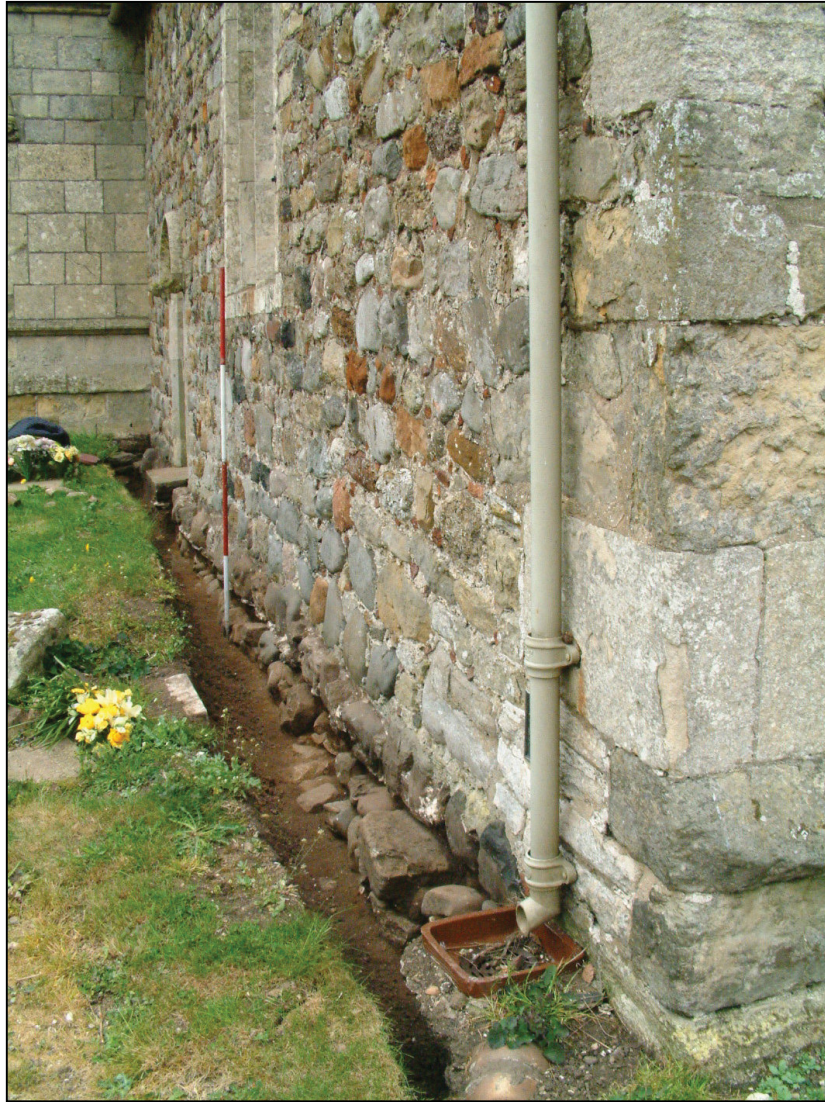
Plate 3: Exposed foundations (021) of south chancel wall, looking W.

- 4.8 The drainage trench dug along the base of the much-repaired south wall of the chancel (020) revealed a 0.36m depth of mid-brown firm sandy loam (012) underneath the topsoil/turf (001). The wall was founded on a varied limestone and cobble foundation (021), with stones varying in size from between 0.20m-0.29m long and 0.14m-0.20m deep (see plate 3). They were quite different in character from the more uniform and larger foundations (016) (cobblestones typically up to 0.50m long and 0.23m deep) beneath the dressed south wall of the south aisle (017) (see plate 4).

- 4.9 The foundation of the south wall of the chancel (021) was bedded on a 0.05-0.09m thick layer of creamy-grey lime mortar (022) which tipped slightly inwards, which was laid over an earlier deposit of smaller cobbles (023). In places, the lime mortar layer had been laid over a firm mid-brown loamy soil layer (013) which had built up over the lower cobbles. These lower cobbles (023) would appear to be the remains of the earlier chancel, which was thought to have been built entirely of this material. In places, fragments of human bone were embedded in this lower deposit.

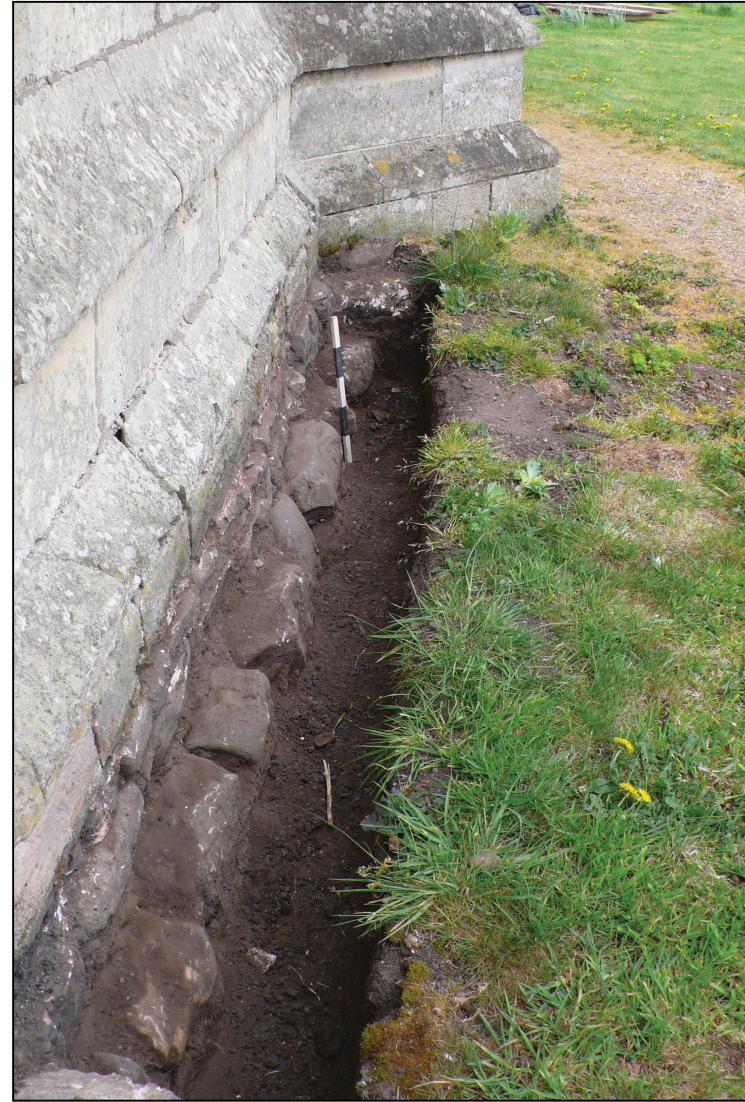
Plate 4: Exposed foundations (016) of south aisle wall, looking E.
