HOYLE MILL, THURLSTONE,
SOUTH YORKSHIRE

ENHANCED ARCHAEOLOGICAL
DESK-BASED ASSESSMENT

Report no: 2006/281.R01
Version: Final
Date: March 2006
Author: Shaun Richardson & Ed Dennison

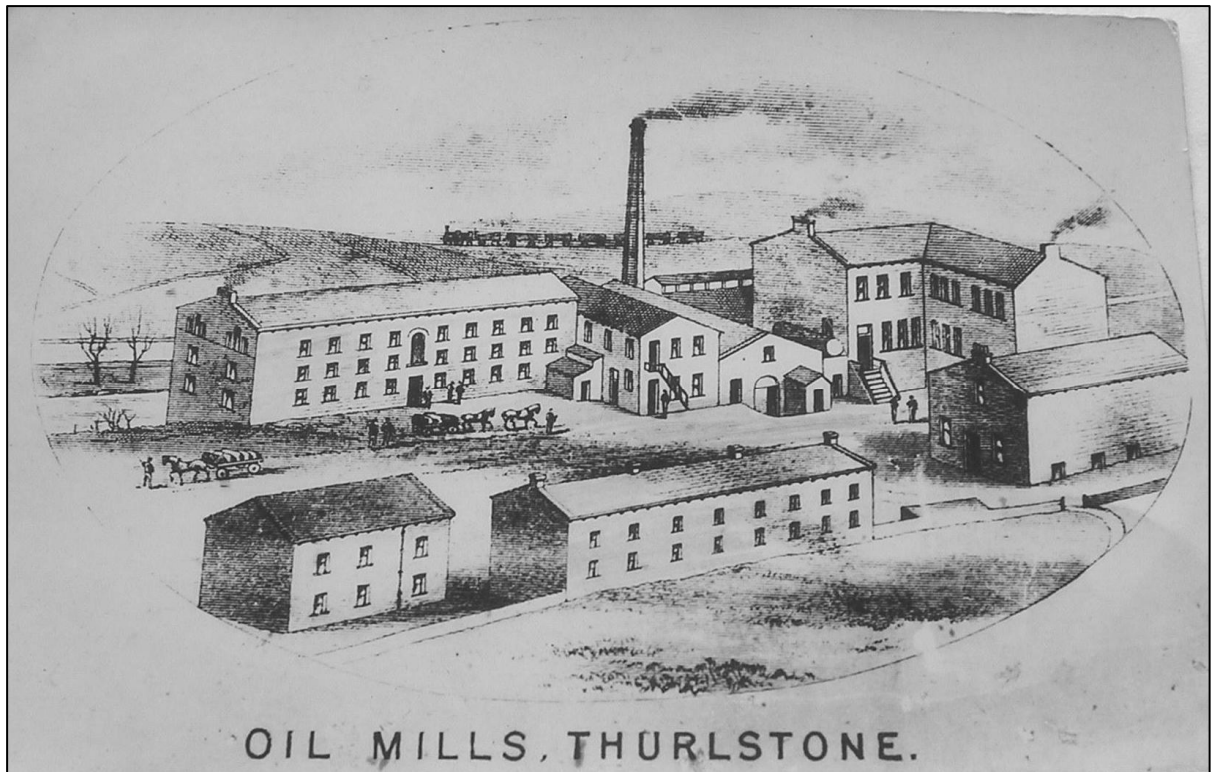
Plate 1: c.1900 bill-head showing the Oil Mill complex, looking south-west

- 2.20 The c.1886 plan is supplemented by a drawing of the site, almost certainly from a bill-head, also reproduced by Nicholson (2001, 100); a copy is also held by the site owner, Mr J Hutchings (see plate 1). The view is undated, but it closely resembles the site as depicted on the 1893 Ordnance Survey map (see figure 3). Although the bill-head probably gives an idealised picture of the works, it appears to be broadly accurate in terms of the position, relative sizes and number of storeys of the buildings, to judge from the surviving evidence (see Chapter 3 below). The bill-head shows that the U-shaped building forming the western end of the main range was actually a two or three storey L-shaped structure with a pitched roof, end stacks and external steps leading to the first floor. There was a lower apparently detached two-storey building at its north end; low-level windows in the north elevation suggest that it had a cellar / basement. A building with a raised ridge-light is depicted to the south of the L-shaped building.

- 2.21 The wider end of the long part of the complex was formed by two parallel north-south aligned buildings, the western of which was an engine / boiler house served by a tall chimney. This appears to have infilled the gap between the two separate ranges shown in 1854, suggesting that steam-power was introduced at Hoyle Mill only after this date. The eastern of the two buildings was of two storeys, with a small lean-to at its junction with a large ten-bay building running parallel to the river. The latter was built into a steep bank and was of three storeys to the north elevation, with a central doorway and probable loading door above. To the north, the mill cottages are shown as an eight-bay two storey range; the distribution of chimney stacks suggests that it was divided into four separate dwellings which concurs with the census information. A smaller two storey three bay building, possibly of two phases, appears to the east; this was not shown in c.1886 but it does appear on the Ordnance Survey 1893 25” map (see figure 3). The bill-head also depicts the railway line on the south side of the valley, and various figures and activity within the mill complex.

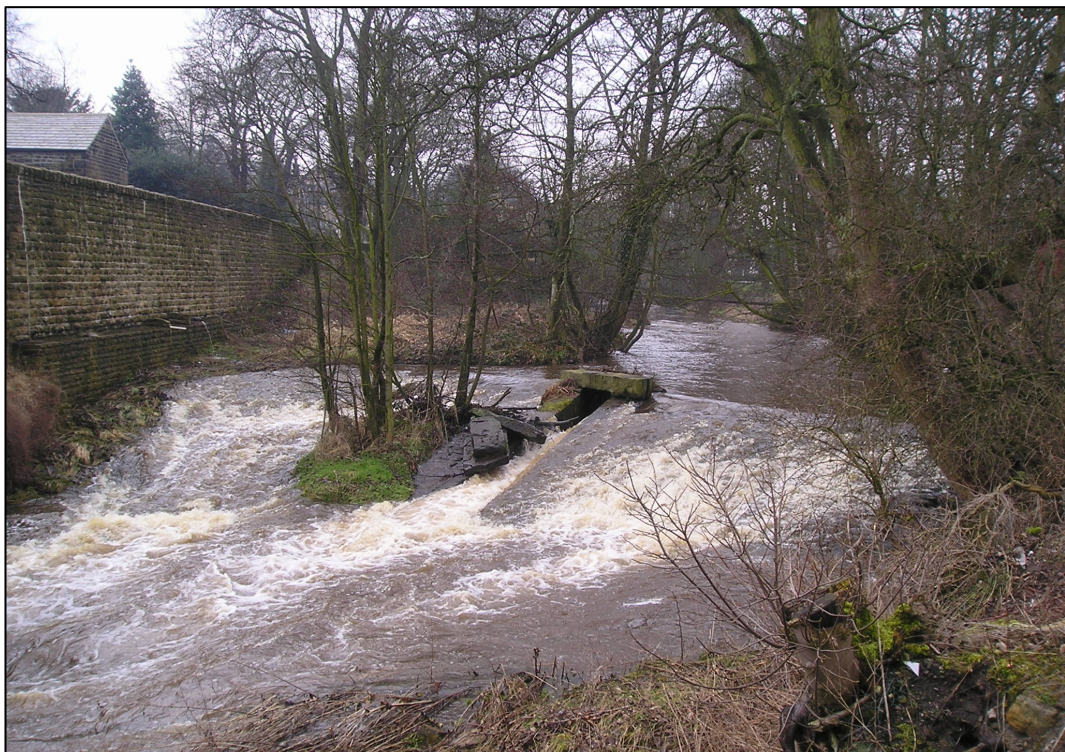
Plate 2: View of weir and overflow channel, looking west

- 3.6 Water was originally diverted into the mill pond which powered the mill's waterwheel by an angled weir built across the width of the Don. At the time of the site visit, a large volume of water was passing over the weir, and much of its form was obscured (see plate 2). However, photographs taken during a drier period (Nicholson 2001, 104-105) and a c.1920s photograph held by the site owner, Mr Hutchings, show that the top of the weir comprises a line of stones containing a shallow central groove. Below these, the base of the weir, formed by sloping stones or cobbles, stretches some 10m to the east, where another line of stones marks the line of a second much narrower weir depicted in 1893 and 1906. The upper weir is effectively divided into two parts by a central overflow channel, lined with large dressed gritstone blocks and originally fitted with a sluice at the upper end. This channel survives today.

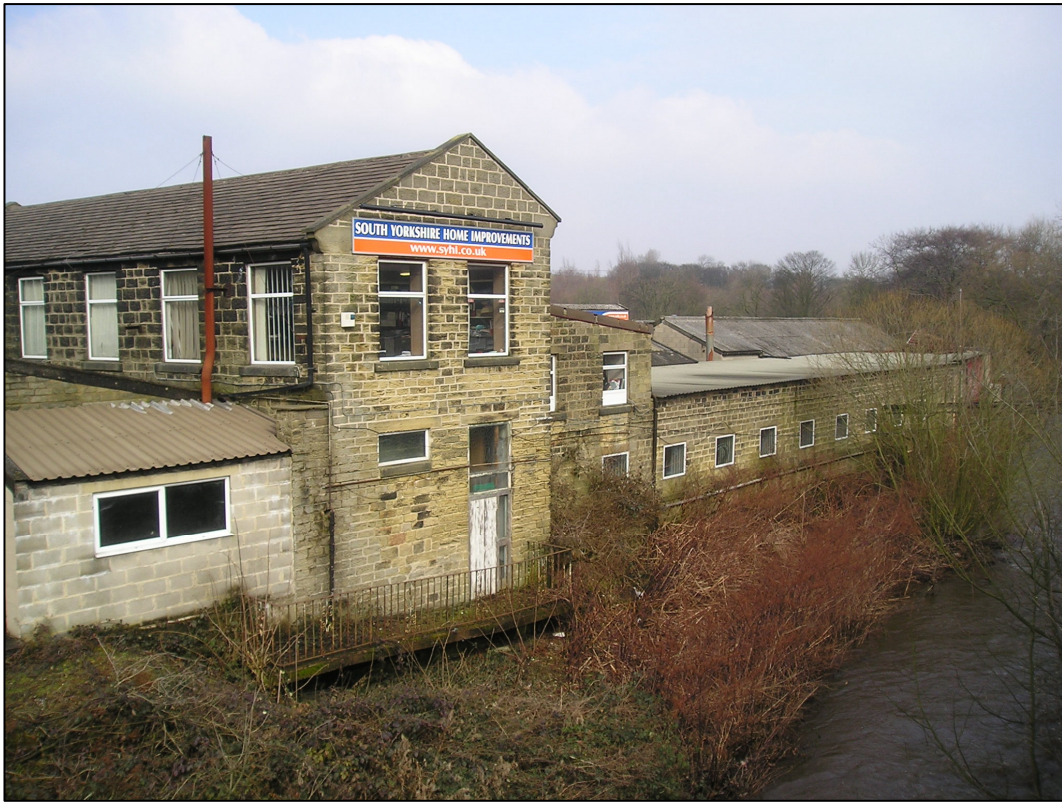
Plate 3: South side of mill complex, Buildings B, C and D, looking north-east

- 3.12 At the time of site visit, Building B remained much as shown on the aerial photograph, although the asbestos roof had been replaced with felt. It is aligned north-south and is c.12m long by 5m wide. The visible parts of the exterior are built of neat thinly coursed squared gritstone set with a cement mortar. The north elevation is partly obscured by a modern flight of steps which lead up to the first floor of Building C, and a blockwork lean-to has been erected against the south elevation since 1989 (see plate 3). The interior contains no features of historic interest.

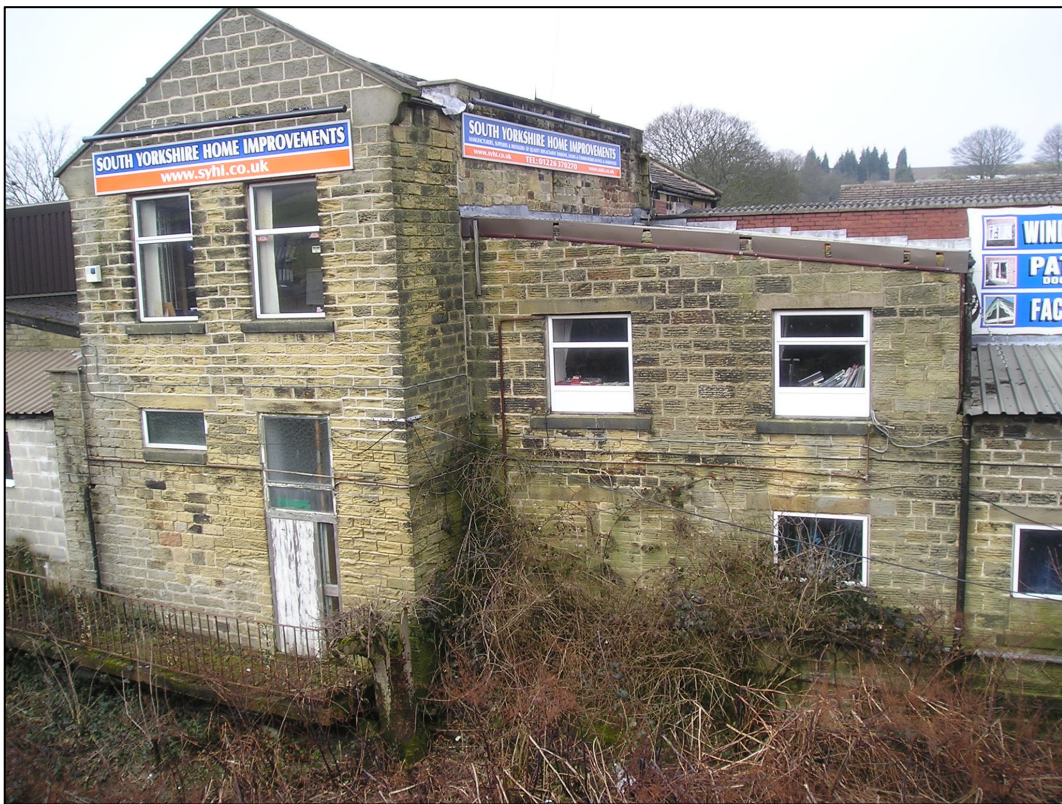
Plate 4: South side of Building C and west end of Building D, looking north

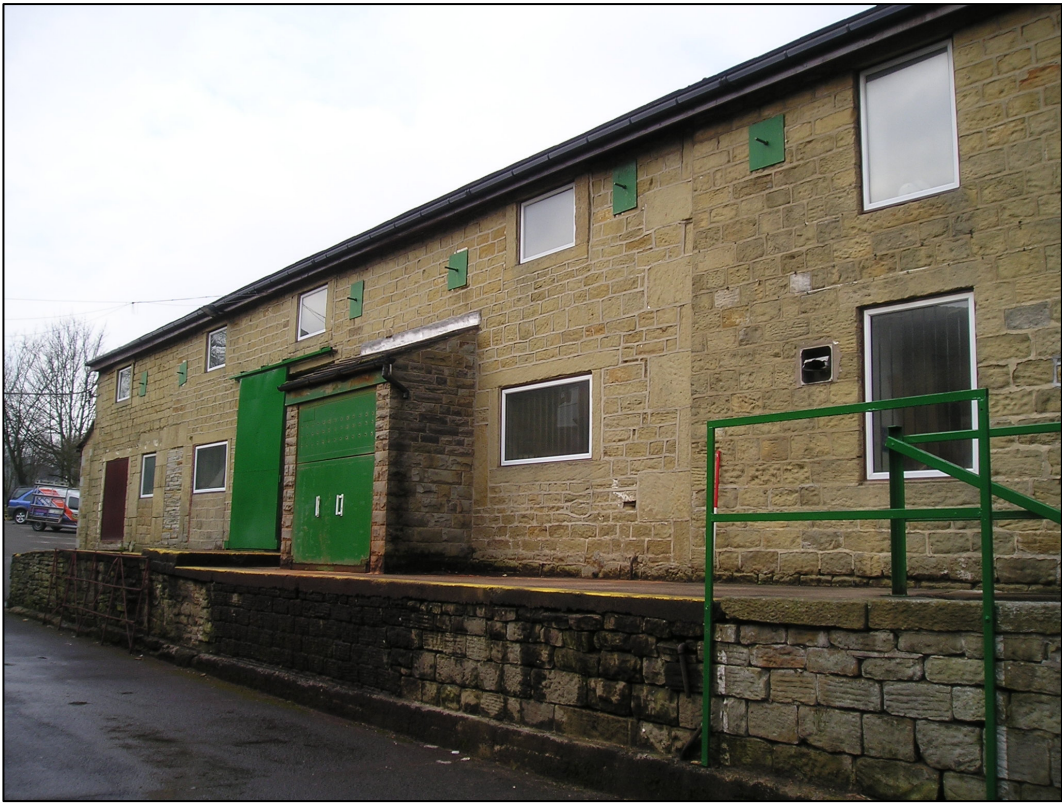
Plate 5: South side of former cottages (Building H), looking north-west

- 3.28 When the site was taken over by South Yorkshire Home Improvements in 1982, the building had apparently been fired and was in poor condition (Mr Hutchings, *pers. comm.*). All internal floor levels and historic roof structures have now been removed, a concrete floor inserted and the interior lined throughout with blockwork.

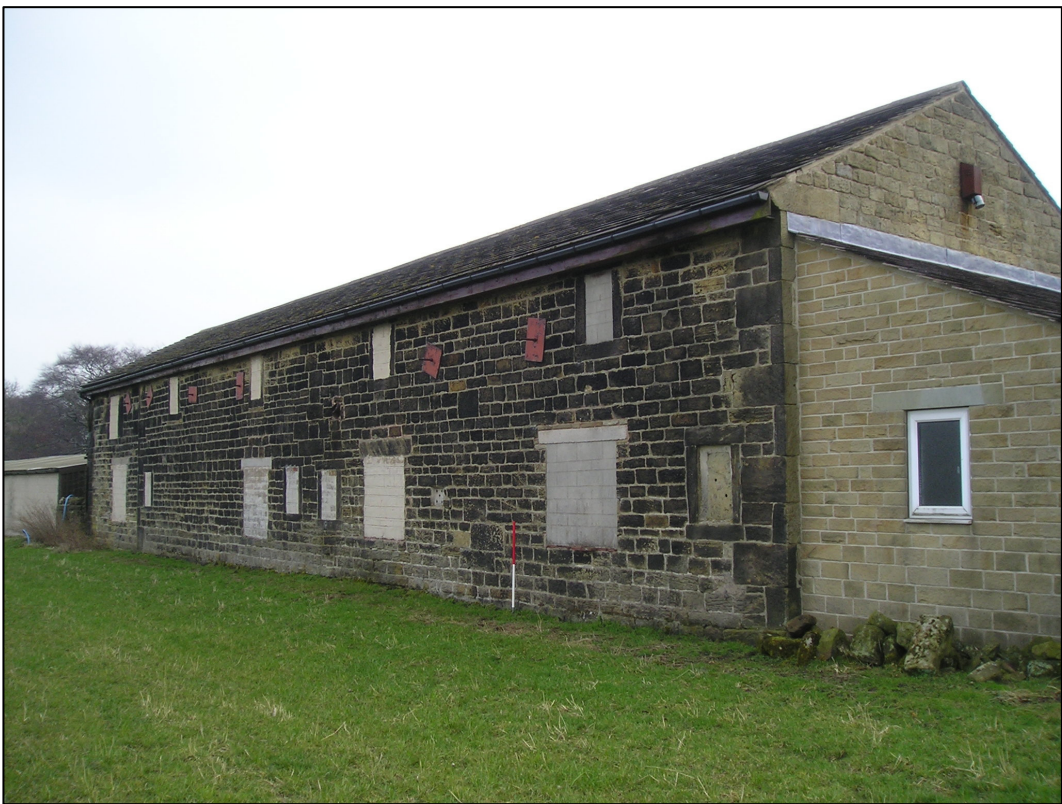
Plate 6: North side of former cottages (Building H), looking south-east
