BURTON FLEMING GRANGE,  
BURTON FLEMING, EAST YORKSHIRE

ARCHAEOLOGICAL OBSERVATION,  
INVESTIGATION AND RECORDING

Report no: 2004/254.R01  
Version: Final  
Date: April 2006  
Author: Ed Dennison & Kate Dennett

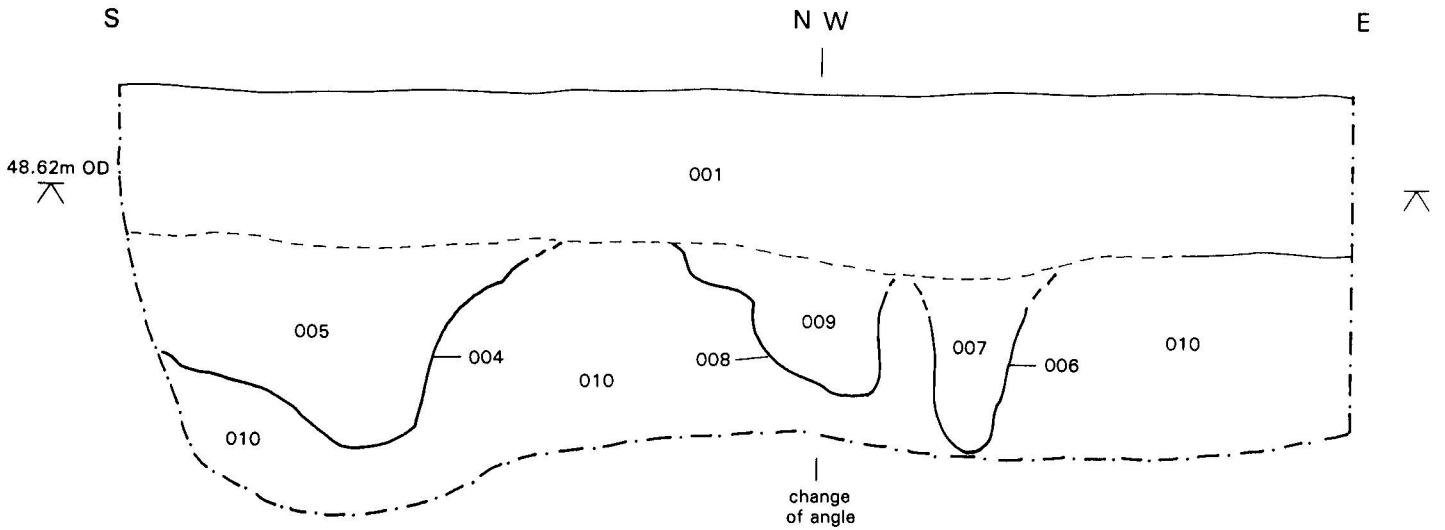
Trench 8 Section 2

- 5.3 The south-west corner of Trench 8, this time in the centre of the northern row of trenches, contained a possible small pit (004) 0.66m in depth and with an irregular U-shape, visible in the east facing section (see plate 2); no stratification was visible in the mid-brown loam fill (005). In the north-west corner of the same trench, a further pit (008) of a similar depth was visible, adjacent to a circular post hole (006), 0.25m in diameter and 0.66m deep with steeply angled sides, probably produced by a driven stake. The fill of the pit (009) was a very fine brown loam with flint and chalk, as was the fill of the posthole (007). It was not possible to establish the horizon from which these features were cut, but they did not appear to be of recent origin. No dating evidence was present in the fills or in the excavated plough soil.

- 5.4 The pits and posthole in Trench 8 may be associated with each other and it is possible that they relate to an earlier agricultural feature, such as a temporary shelter. However, the small size of the foundation trenches, the lack of a general site-wide topsoil strip, and the absence of any dating evidence makes further, more focussed, interpretation unrealistic. It was not possible to accurately tie in the cropmarks of the north-south linear ditch system with the development site, but the recorded features did not appear to be part of this system and it is concluded that the ditches lie slightly further to the east.

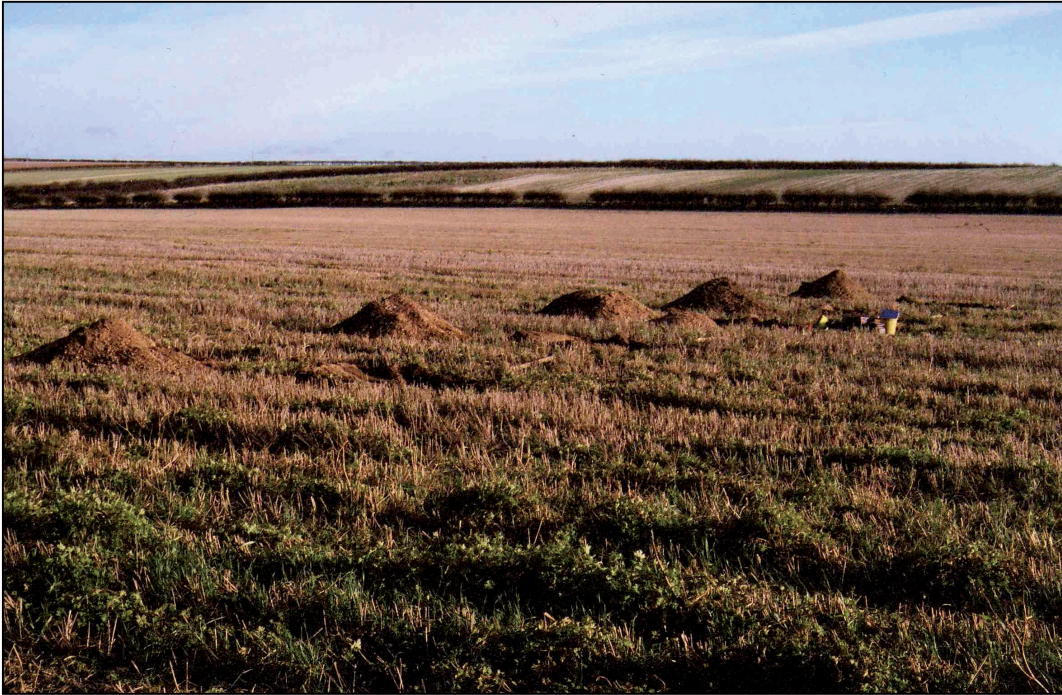
- 4.2 Ten small foundation trenches, in two rows of five, 24m apart, were dug for the steel framework of the building using a 360 degree wheeled, mechanical, excavator with a toothed 2ft wide bucket. Each trench measured c.1m by 1.2m and was dug to a maximum depth of 0.6m, sloping upwards towards the back edge. These trenches were dug through the topsoil and no general site-wide topsoil strip was undertaken (see plate 1). A temporary bench mark was established on site, which was subsequently tied to a permanent bench mark located at the end of the access into the farm. All the excavations were dug under constant archaeological supervision, on 10th January 2005.

Plate 1: General view of trenches 6 to 10, looking north-east.

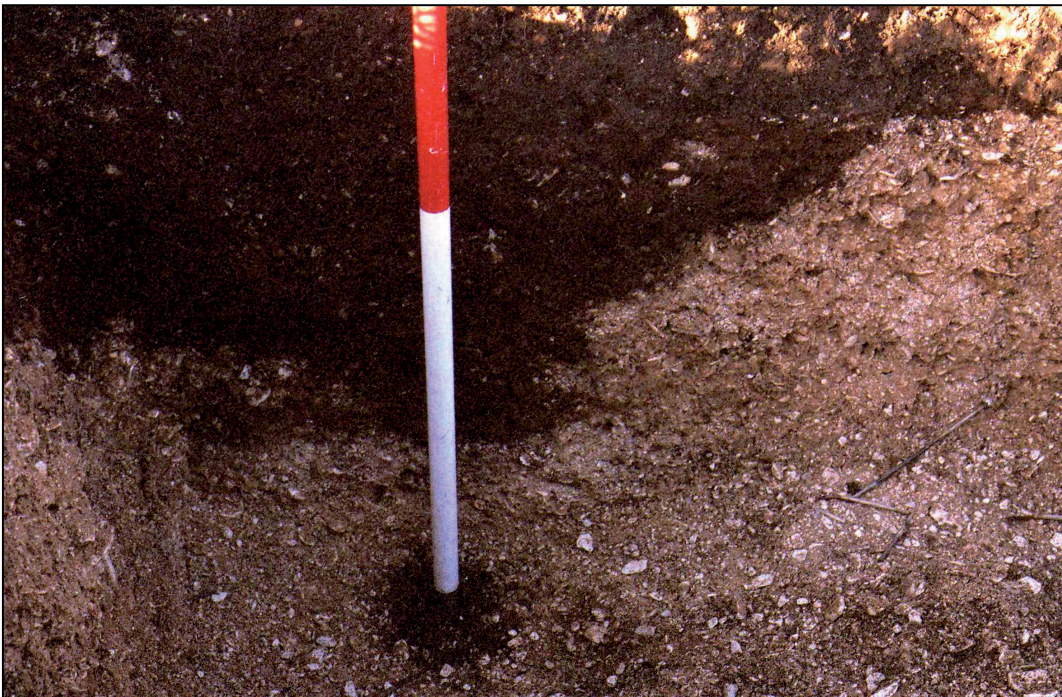
Plate 2: Cut feature 004 in west side of trench 8.
