ALL SAINTS CHURCH,
SANCTON, EAST YORKSHIRE

ARCHAEOLOGICAL OBSERVATION,
INVESTIGATION AND RECORDING

Report no: 2005/257.R01
Version: Final
Date: April 2006
Author: Ed Dennison & Shaun Richardson

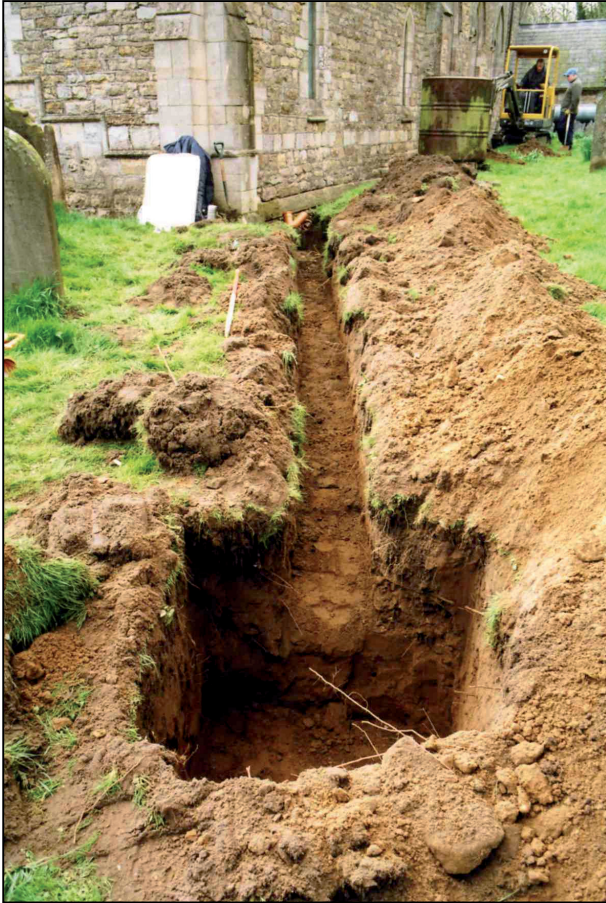
- 5.5 Trench 3 was located adjacent to the north-east corner of the chancel. It commenced on the west side of the north angle buttress and ran north-east for a distance of 6.50m, maintaining a width of 0.40m and 0.6m below ground level, terminating in a 1.00m square soakaway pit which was excavated to a maximum depth of 1m BGL (8.91m AOD) (see plate 1).

- 5.6 Following the removal of a 0.18m depth of turf and topsoil (001), a single context was exposed, comprising a compact clean orange-brown sand (004), very similar to that noted in Trench 2 (002). Like the latter, this sand contained a relatively small amount of disarticulated human bone. The possible remnants of a partly disturbed *in situ* burial were noted just above the base of the west side of the soakaway pit (at approximately 8.80m AOD). It may have comprised the lower vertebrae and upper leg bones of an adult, orientated north-west/south-east but this was not certain, and so it was not assigned a separate context number. The orange brown sand (004) continued beneath the base of the soakaway pit and contained infrequent angular pieces of limestone / sandstone rubble in its lowest visible parts.

Plate 1: Trench 3, looking south-west.

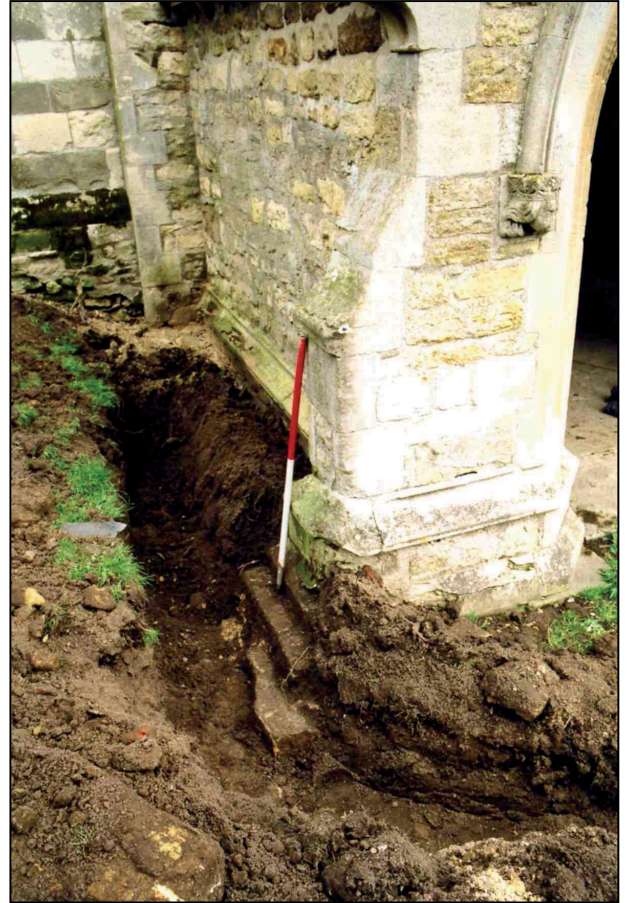
- 5.12 Trench 7 was located to either side and to the south of the south porch. Separate trenches, each c.5.00m long (north-south), were excavated on either side of the porch, converging to the south of the porch and continuing southwards for a further 4.00m, terminating in a test pit measuring 3.00m by 1.00m. The main body of the trench maintained a width of 0.40m and a depth of 0.60m, whilst the soakaway was excavated to a maximum depth of 1.00m BGL (9.00m AOD). The trench on the west side of the porch followed an earlier drainage channel (see plate 2).

Plate 2: Trench 7 on west side of south porch, looking north.

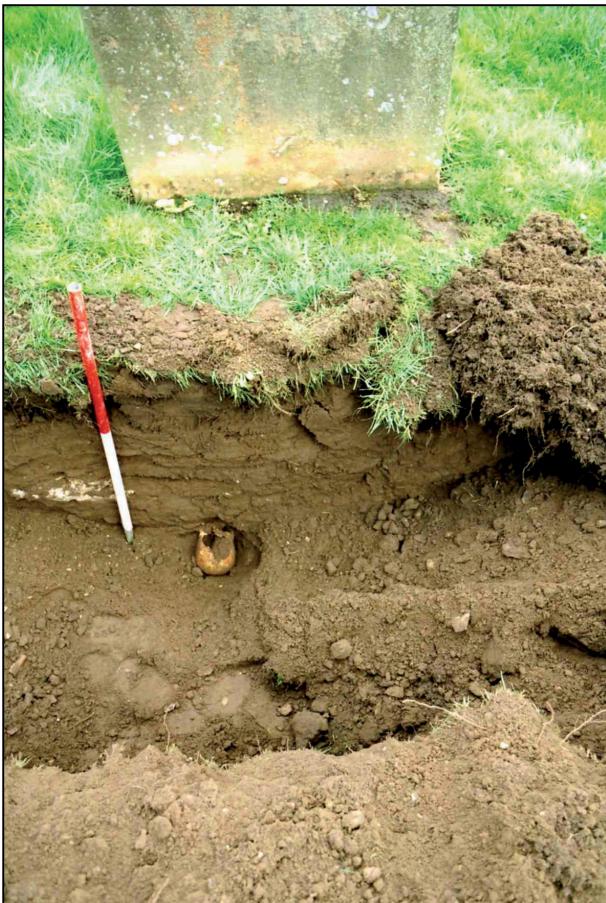
- 5.13 Following the removal of the 0.18m depth of turf and topsoil (001), a compact very clean dark brown sand (007) containing a relatively small amount of disarticulated human bone was exposed. This dark brown sand continued beneath the base of the soakaway pit, where it began to contain infrequent pieces of angular stone rubble (see figure 3). The rubble appeared to be concentrated around two *in situ* burials that were partly exposed in the base of the soakaway pit. The first burial (008) was that of a child, aligned east-west, visible in the west-facing section of the soakaway pit (at 9.20m AOD). Only the skull was exposed within the soakaway pit and no evidence for a coffin, shroud pins or associated artefacts were noted (see plate 3). The second burial (009) was visible at the base of the north side of the soakaway (at 9.00m AOD), and comprised the left arm bones and some ribs. It was again that of an infant or child, aligned east-west, with no evidence for a coffin or other associated artefacts. No grave cut was apparent for either burial.

Plate 3: Burial 008 in west side of Trench 7 soakaway.
