MANOR FARMHOUSE, CARLTON-IN-CLEVELAND,
NORTH YORKSHIRE

PRELIMINARY ARCHITECTURAL
APPRAISAL

Report no: 2006/287R.01
Version: Final
Date: July 2006
Author: Shaun Richardson & Ed Dennison

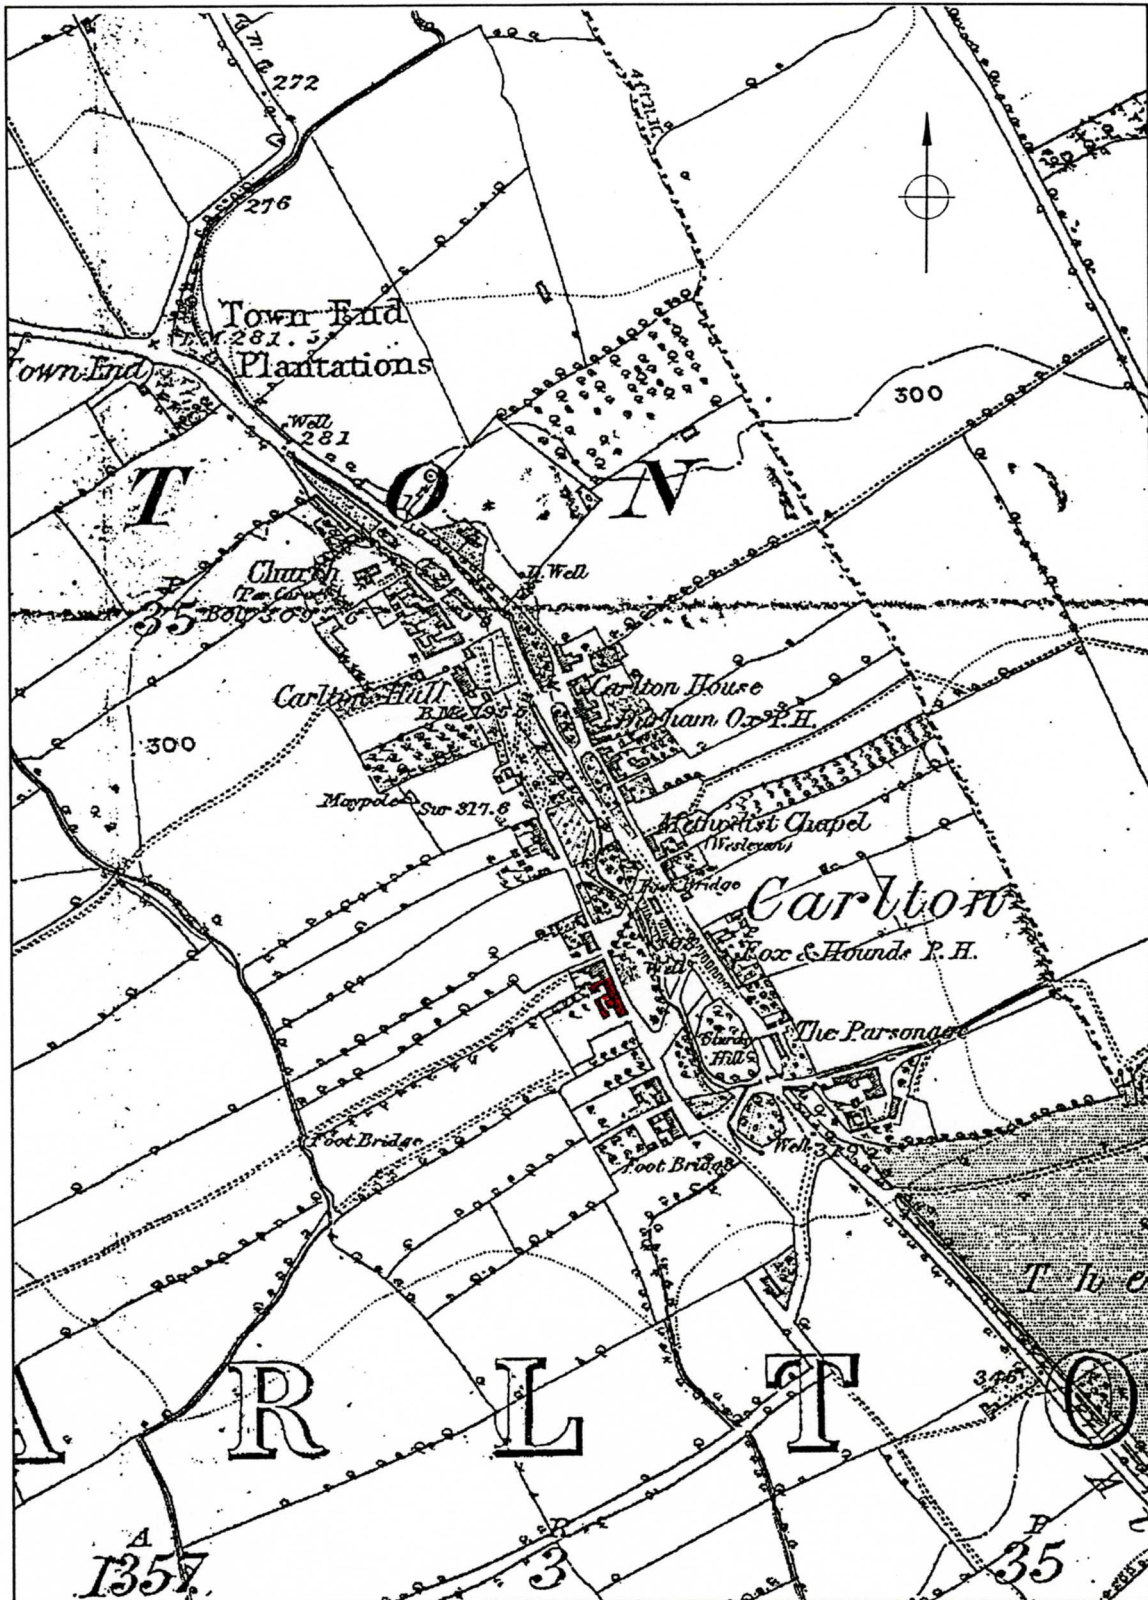
PROJECT		MANOR FARMHOUSE, CARLTON	
TITLE		OS 1857 6" MAP (SHEET 42)	
SCALE	DATE	NTS	JUL 2006
EDAS		FIGURE	2

- 1.8 The 1st edition Ordnance Survey 1857 6" map (see figure 2) shows Manor farmhouse with a similar ground floor plan to that now existing, although there are several attached structures to the rear which are no longer present. At that date, there was no gap between the farmhouse and the property immediately to the north, whilst there was no house to the immediate south.

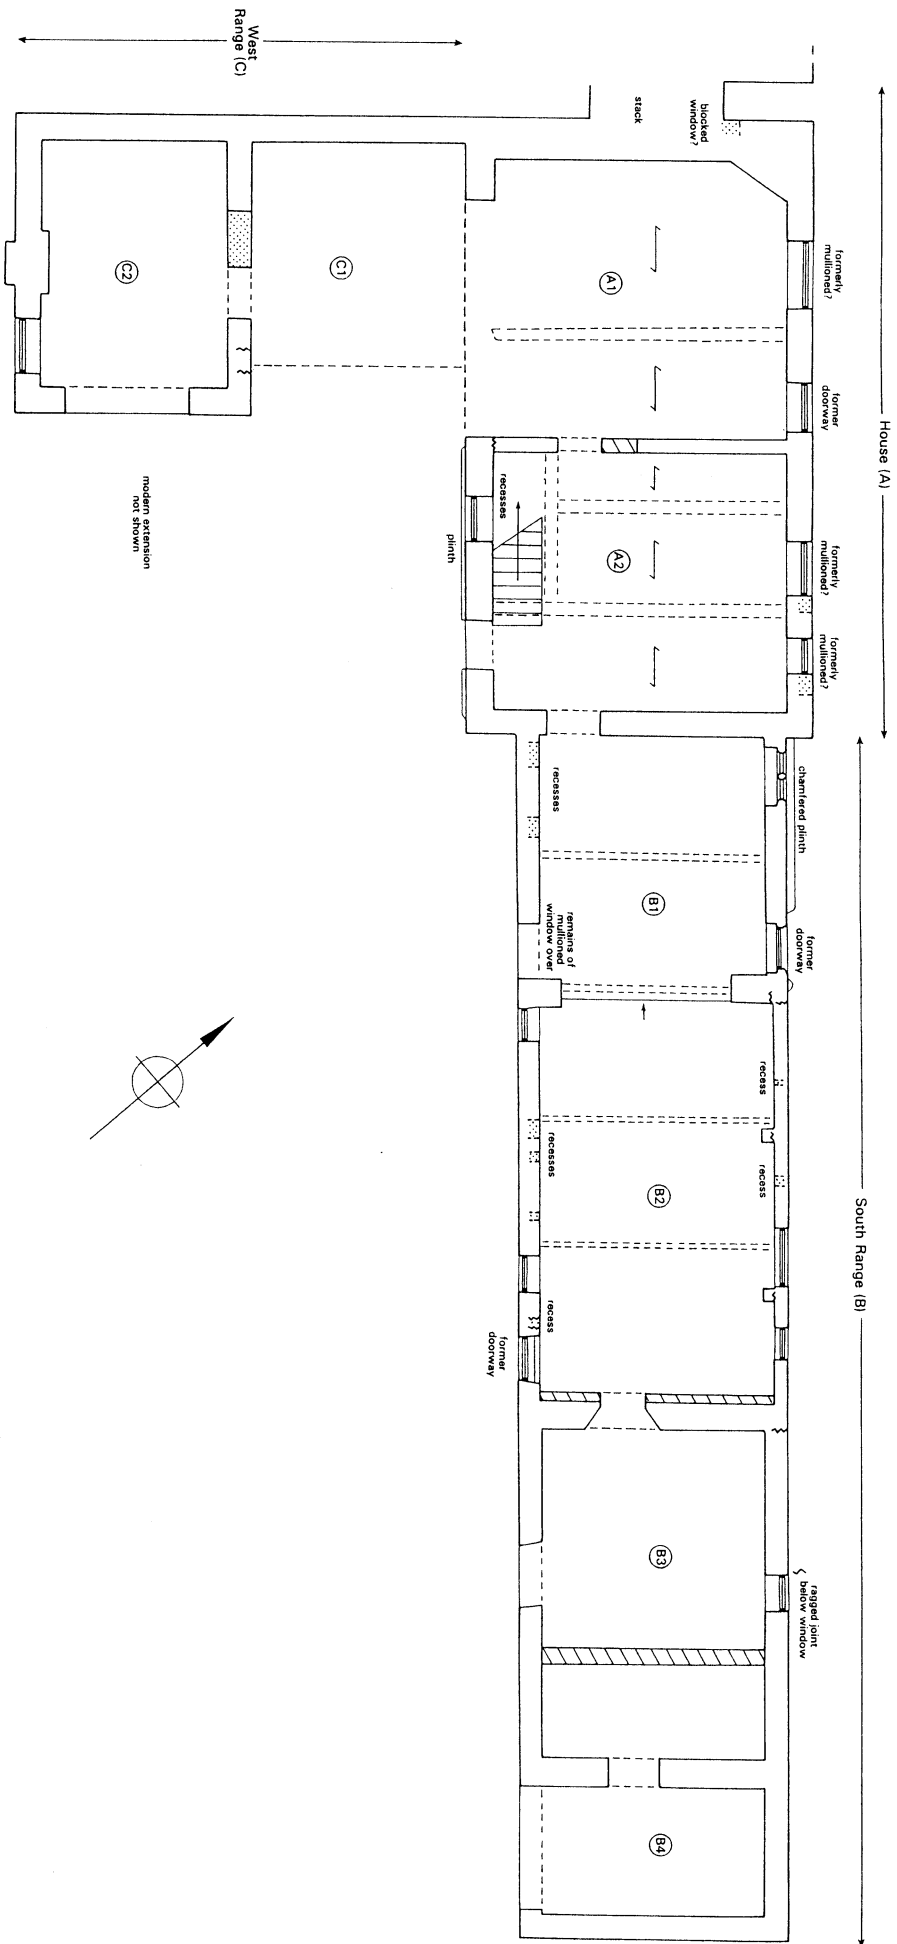
PRODUCT	MANOR FARMHOUSE, CARLTON	
TITLE	SCHEMATIC GROUND PLAN	
SCALE	AS SHOWN	DATE
		JUL 2006
EDAS	FIGURE	3

- 2.2 The farmhouse is represented by a range of linked buildings, having overall an L-shape in plan and aligned north-west/south-east, although for the purposes of description it is considered to be aligned north-south. The range has maximum dimensions of c.33.90m long (north-south) by c.15m wide (east-west) (see figure 3).

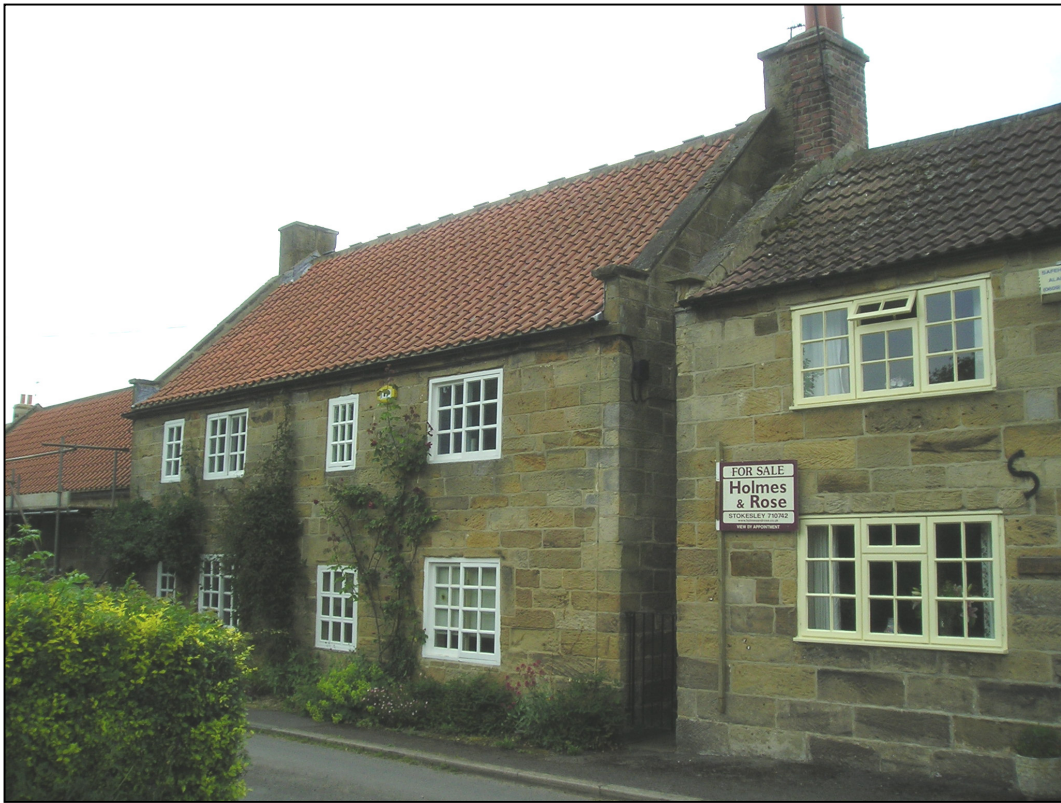
- 2.8 The main front of the house (A) faces east and is of 4 bays, extending slightly beyond the south range (see plate 1). Each bay has a single window to the ground and first floors, all fitted with replacement horizontal sliding sash or casement frames. The windows to the southernmost bay are notably narrower than the others, and the Listing Building description suggests that they may be enlarged fire windows (see Appendix 2). Blockings to the south side of the two southernmost ground floor windows, together with that to the north bay, indicate that these were once all of similar width to the existing openings, but much shallower and almost certainly mullioned. The ground floor window in the third bay from the south end was once a doorway and retains a flattened "Tudor" arched lintel with chamfered recess to the soffitt; comparison with other surviving examples suggests that it is of later 17th century date (RCHME 1987, 213). There may have been another former ground floor mullioned window, now blocked, at the east end of the north gable, apparently partly obscured by the large stepped stack here. Above, on the first floor, there is a small window with a chamfered surround which is evidently contemporary with the stack. The remainder of the north gable cannot be viewed.

Plate 1: East side of house (A1 and A2), looking south (photo 72).

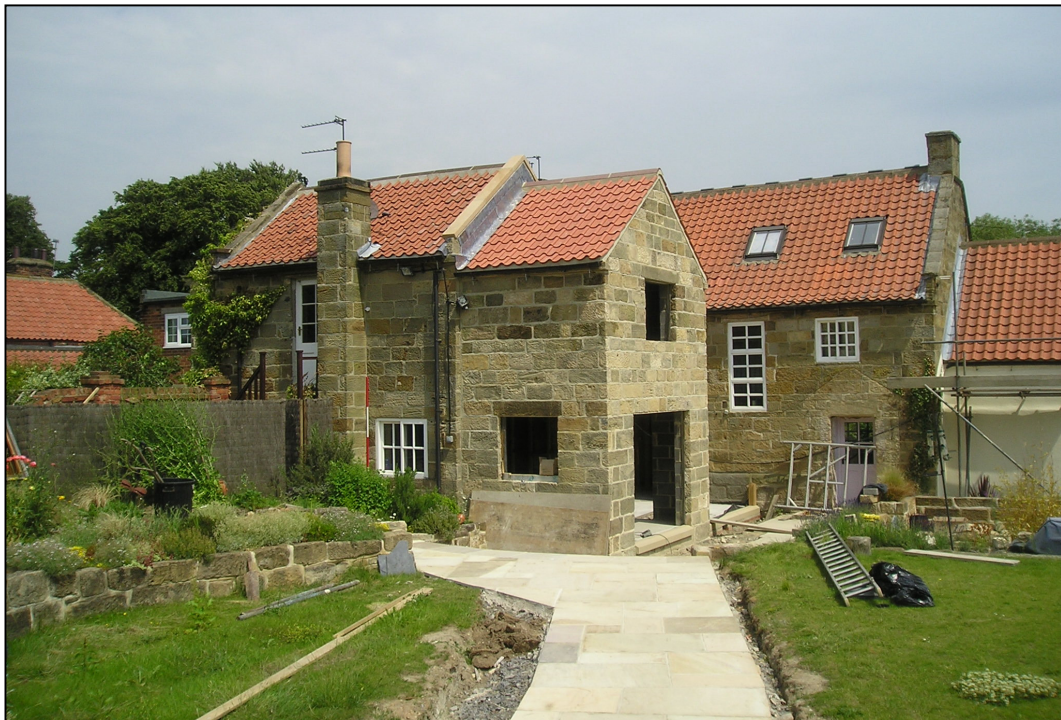
- 2.4 The house is of two storeys with an attic (see plate 1). The west range also rises to two storeys, but is slightly lower than the house (see plate 2). The south range is of a single storey but is divided into two parts; both are of a single storey, the northern half being slightly higher than the southern (see plate 4).

Plate 2: West side of west range and house (C2 and A2), looking east (photo 79).

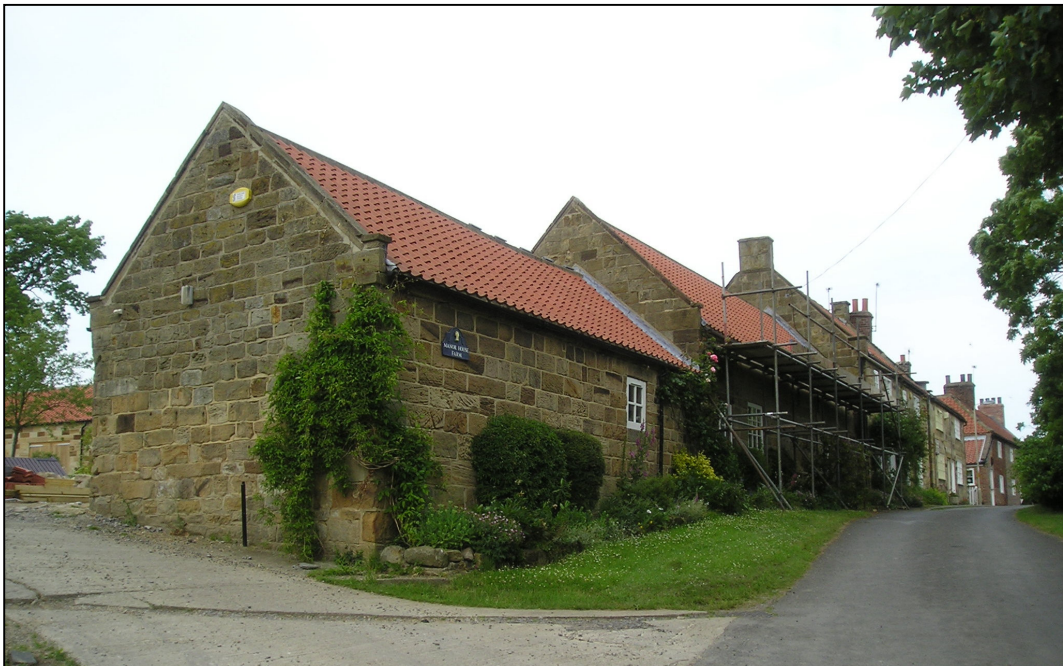
- 2.13 The southern half of the east elevation of the south range is largely blank, pierced only by a small four-pane casement window (see plate 4). There is a ragged joint beneath the north jamb of this window running down to ground level. To the south of the joint, the stone courses are deeper with some crude herring-bone tooling, whilst to the north they are generally shallower with less tooling. Further north, there is another ragged joint where the southern half of the south range appears to butt the slightly taller northern half. Beyond this joint, there is a small window and then a larger window, both with modern casement frames, and then another ragged joint which rises to first floor level. To the north of the joint, the masonry projects very slightly forward from that to the south, and originally rose from a well-built chamfered plinth. This plinth is clearly visible to the north of a blocked doorway, where it appears to pass beneath the house (A), but only fragments remain to the south. The blocked doorway has been converted into a window, but it retains chamfered jambs and a flattened "Tudor" arched lintel with a chamfered recess, again of probable later 17th century date. To the north, close to the junction of the south range and the house, there is a later 17th century two-light mullioned window, the central mullion splayed and flush to the frame (see plate 5).

Plate 4: South gable and east side of south range (B3 and B4), looking west (photo 67).

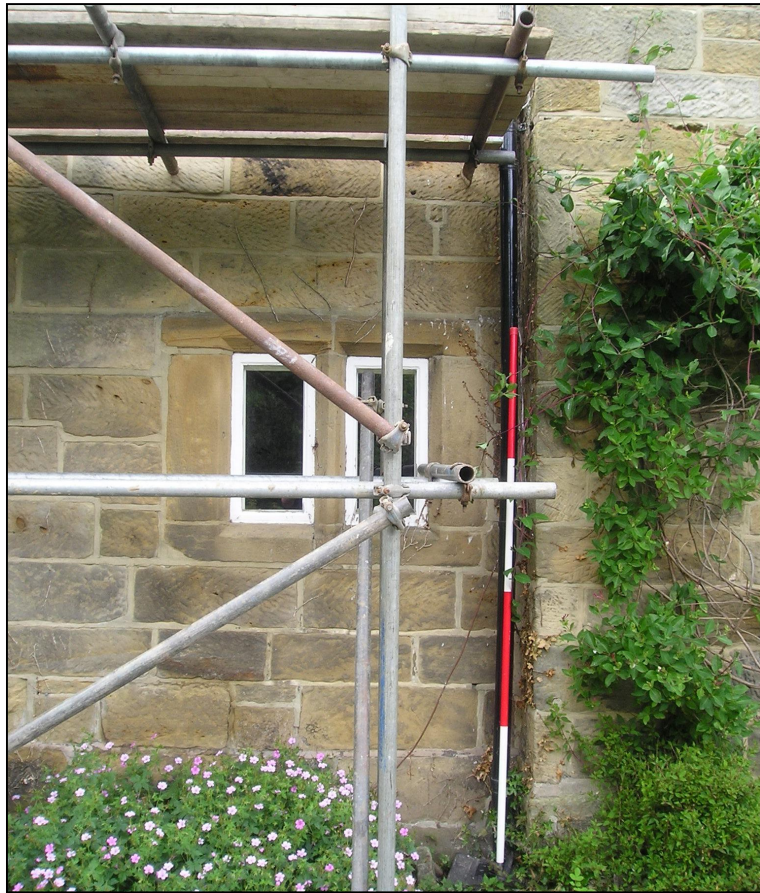
Plate 5: Later 17th century mullioned window at north end of east elevation of south range (B1) (photo 70).

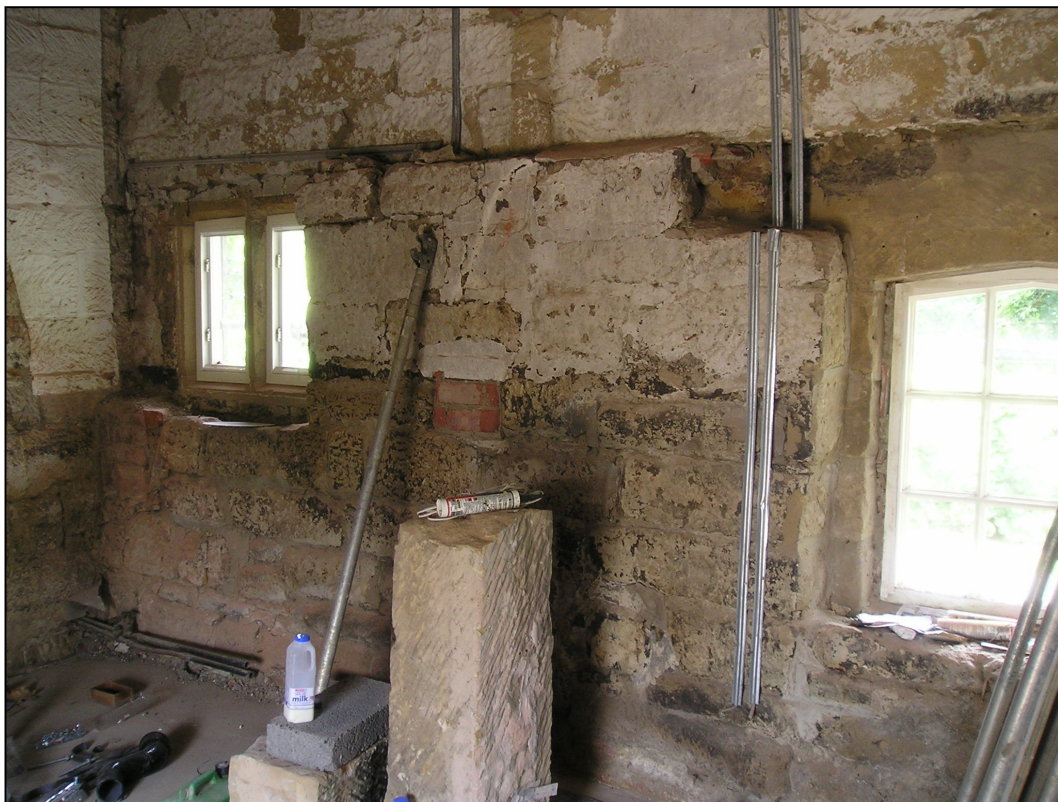
Plate 6: East internal elevation of north part of south range (B1), looking north (photo 103).

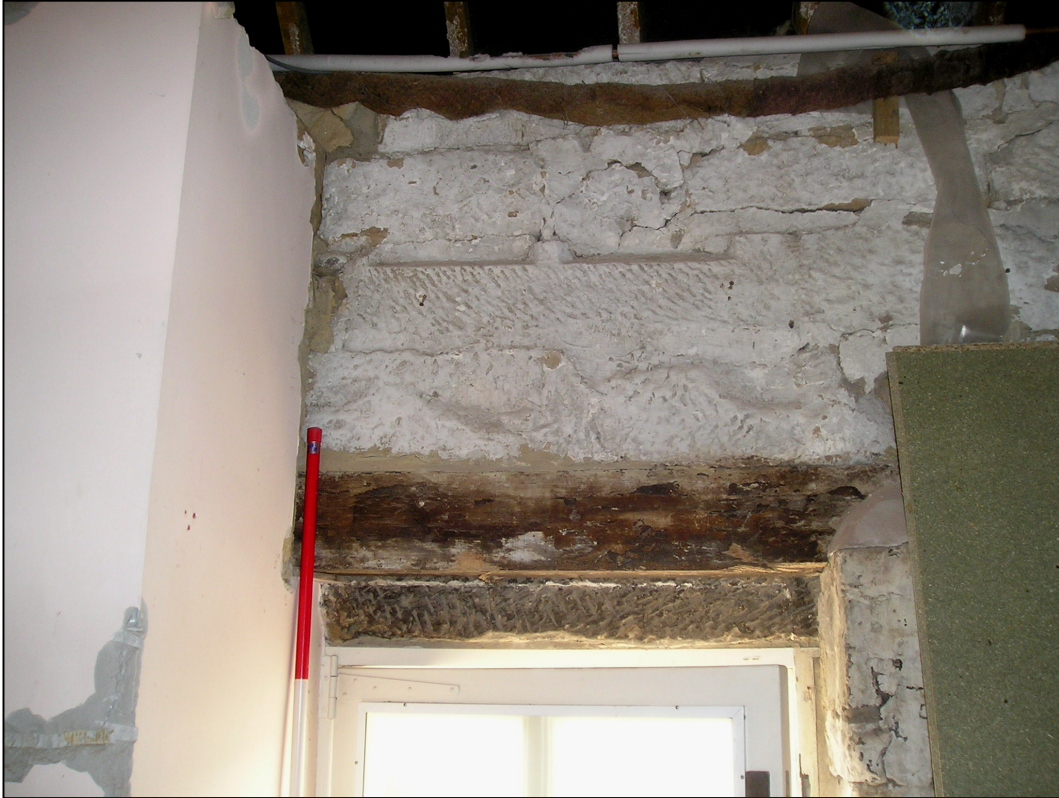
- 2.19 Both interior walls change markedly in character beyond the broad projecting wall stubs which define the division between the smaller space to the north (B1) from that to the south (B2). The stubs themselves are 0.50m wide and heavily plastered/limewashed, but they appear to be built of coursed squared stone. Beyond the stubs, the east and west walls of space B1 are both built of coursed squared stone, slightly worn or rounded in appearance and with a hammer-dressed surface. The blocked doorway in the east wall with the flattened "Tudor" arched lintel is definitely contemporary with the hammer-dressed stonework, whilst the mullioned window to the north probably is also (see plate 6). The doorway at the south end of the west wall may also be contemporary, but there are two later recesses, blocked with brick, inserted into the stonework to the north. The hammer-dressed stonework rises to c.2.10m above ground floor in both walls and then the wall faces steps back c.0.20m. Above the step, both walls are built of coursed squared stonework similar to that used in the east wall of space B2. Above the doorway in the west wall, this stonework incorporates the base of a two-light mullioned window (see plate 7). This is

probably reused here, although the fact that it is positioned above a doorway and set the right way up could indicate that it is *in situ*, perhaps suggesting that this part of the south range once had an upper floor which has since been removed.

Plate 7: Reused base of 2-light mullioned window over west door in south range (B1) (photo 57).

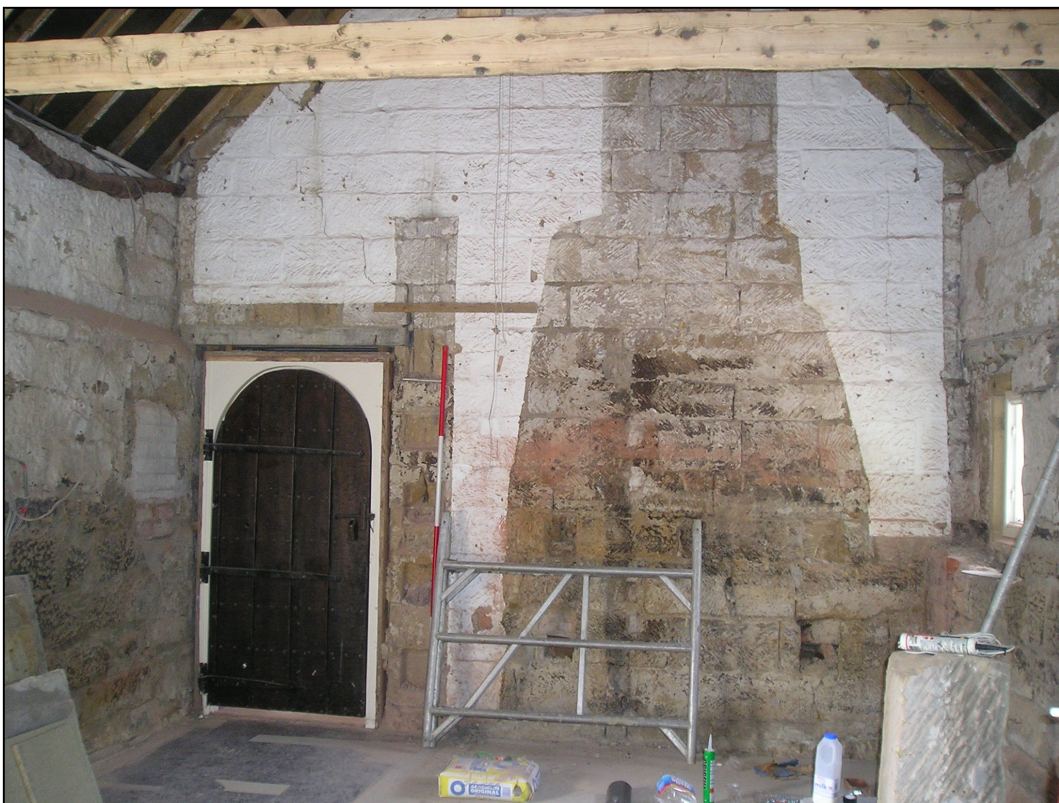
- 2.20 As stated above, the south gable of the house (A) is formed by neat coursed squared stone with fine herring-bone tooling. This appears to butt the upper parts of the east and west walls of the northern part of the south range (B1), but its relationship with the lower parts of the walls is unclear. Just below the existing roof line of space B1, an earlier and very slightly lower roof line is visible as a line of scarring, cut into the masonry of the gable. The doorway at the base of this gable has also been much altered, and its original form is now unclear. A modern timber frame has been inserted to house a round-headed board door of probable late 17th/early 18th century date, hung on substantial spearhead strap hinges (Alcock & Hall 1994, 14-15). A shadow running up the gable has been left by the removal of a modern flue rather than any historic feature such as a firehood (see plate 8).

Plate 8: North side of south range (B1) showing scarring of former flue and altered doorway (photo 83).
