FORMER PICTURE PLAYHOUSE AND SWIMMING  
POOL COMPLEX, SATURDAY MARKET,  
BEVERLEY, EAST YORKSHIRE

ARCHITECTURAL AND ARCHAEOLOGICAL  
OBSERVATION, INVESTIGATION AND RECORDING

Report no: 2006/298.R01  
Version: Final  
Date: November 2007  
Author: Ed Dennison & Shaun Richardson

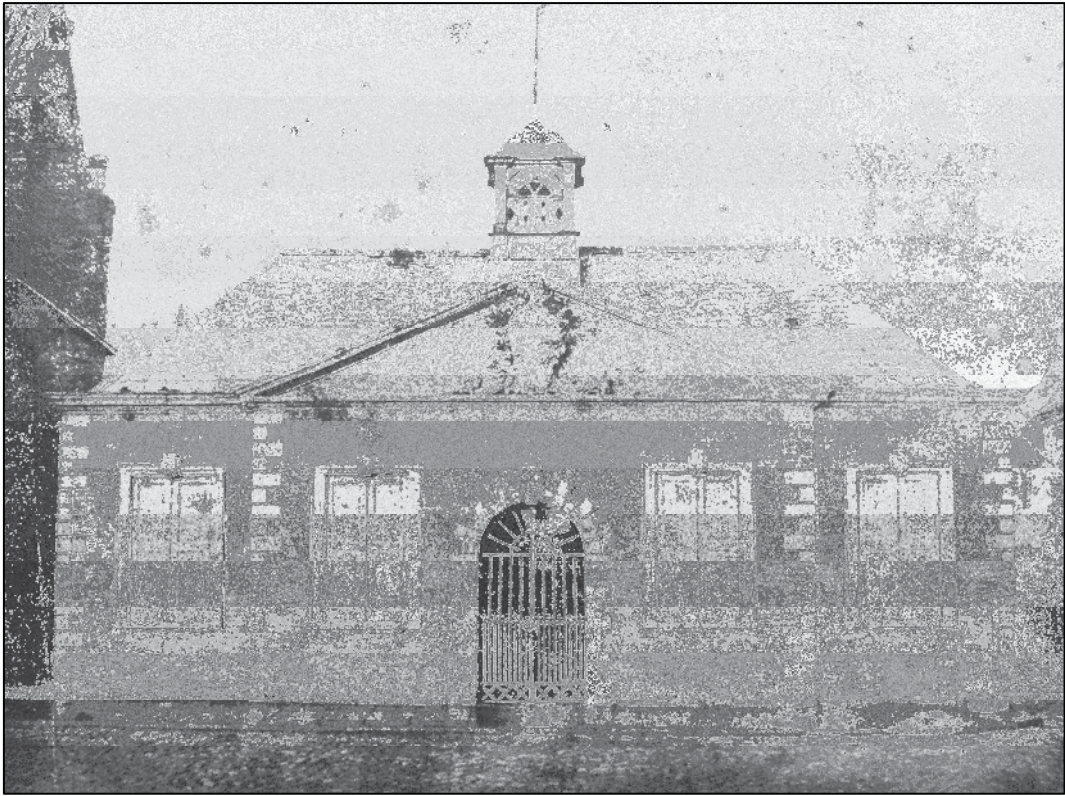
Plate 1: Corn Exchange, c.1880, built 1753 (Source: Brown 1983, 26).

- 4.10 The 1853 Ordnance Survey map depicts the market place in some detail (see figure 3). Smith's Corn Exchange faced onto Corn Hill while behind, to its north-west, lay the Butchers' Shambles and the Butter Market and, further north again, Middleton's octagonal-shaped Fish Shambles. These buildings were separated by a narrow lane from the row of shops and houses (the Dings) to the west, which still largely survive today. There are two c.1880 photographs of the Corn Exchange and Fish Shambles (Brown 1983, 26-27; see plates 1 and 2). The Corn Exchange is shown as having a symmetrical five-bay single storey frontage to the Market Place. It was of brick construction with rusticated quoins and triple keystones to

the flat-headed windows. The central three bays broke forward and were surmounted by a low pediment, bearing a cartouche, while the slated hipped roof was equipped with a central bell cupola. The Fish Shambles was also of brick with tall semi-circular headed openings to all sides, two on the two longer sides and one in each of the shorter sides. The interior had a flagstone floor and the openings were equipped with stone benches which served as serving counters. A lithograph produced by E H Buckler in c.1860 depicts this part of the market place, the Corn Exchange sitting rather incongruously adjacent to the larger two storey buildings (see plate 3).

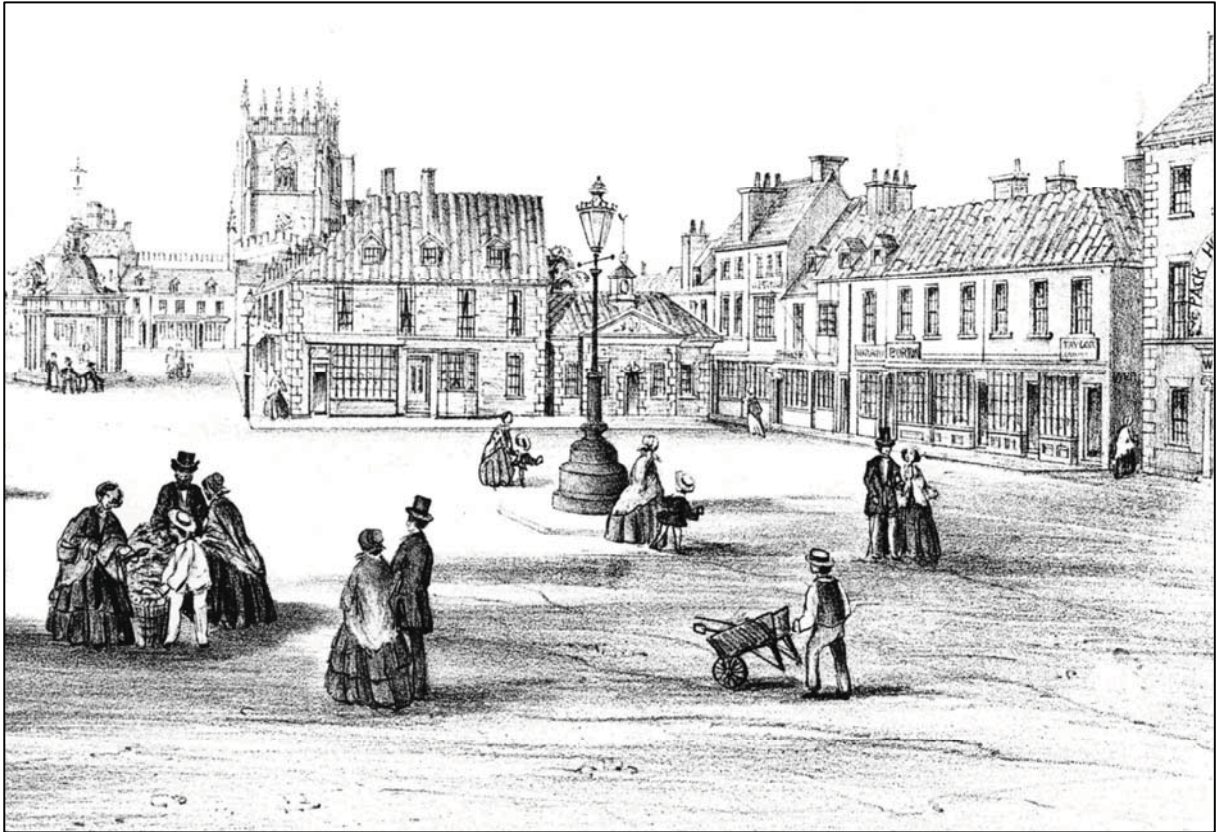
Plate 3: View of Saturday Market, c.1860, showing 1753 Corn Exchange in place  
(Source: Brown 1983, 26).

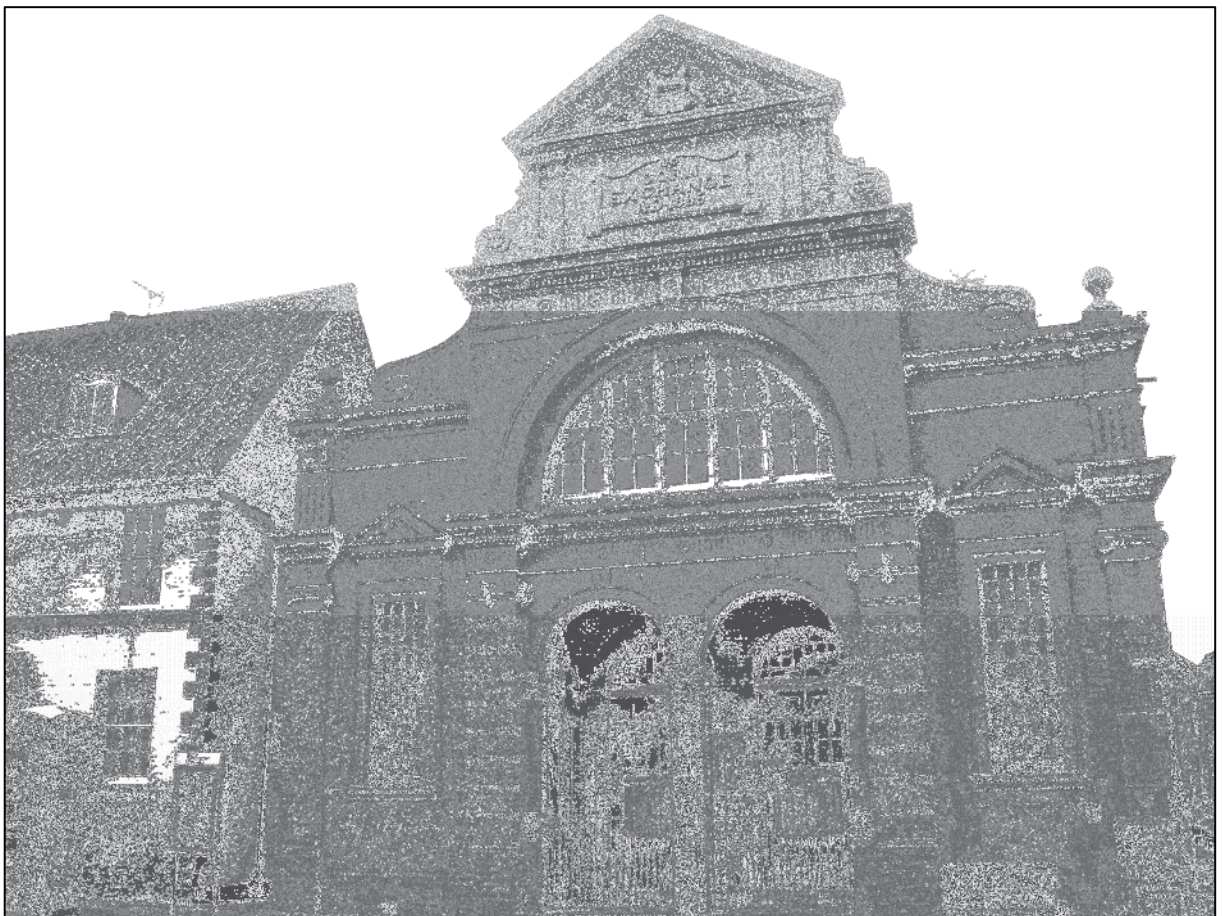
Plate 4: The present Corn Exchange, built 1886.

- 4.11 The Corn Exchange, Butchers' Shambles, Butter Market and Fish Shambles were all demolished in 1886, to be replaced by the present large red brick complex. It was built at a cost "not to exceed £2,000" and was designed by Samuel Musgrave of Hull, and is known for its elaborate Flemish Renaissance façade of red brick and terracotta decoration (see plate 4). The complex comprised a new Corn Exchange fronting onto Saturday Market, with a butter market and public baths behind, as well as an engine house and porters' accommodation (Robinson 1985, 13). There was no accommodation for butchers, who were said in 1889 to have abandoned Saturday Market in favour of shops. The Corn Exchange and butter market had to be arranged so as to form one large public room when required, and the principal entrance into the swimming baths was from Ladygate. In 1889 the new building was said to be little used, with the butter and poultry sellers having returned to the market cross, and part of it was temporarily used as an infant school between 1904 and 1906. However, corn continued to be traded in this area until 1947. The new buildings are depicted in detail on the Ordnance Survey 1890 map of the area (see figure 4). It is interesting to note that the northern extension of the alley which runs along the west side of the new buildings was called "Fish Shambles" at this date.

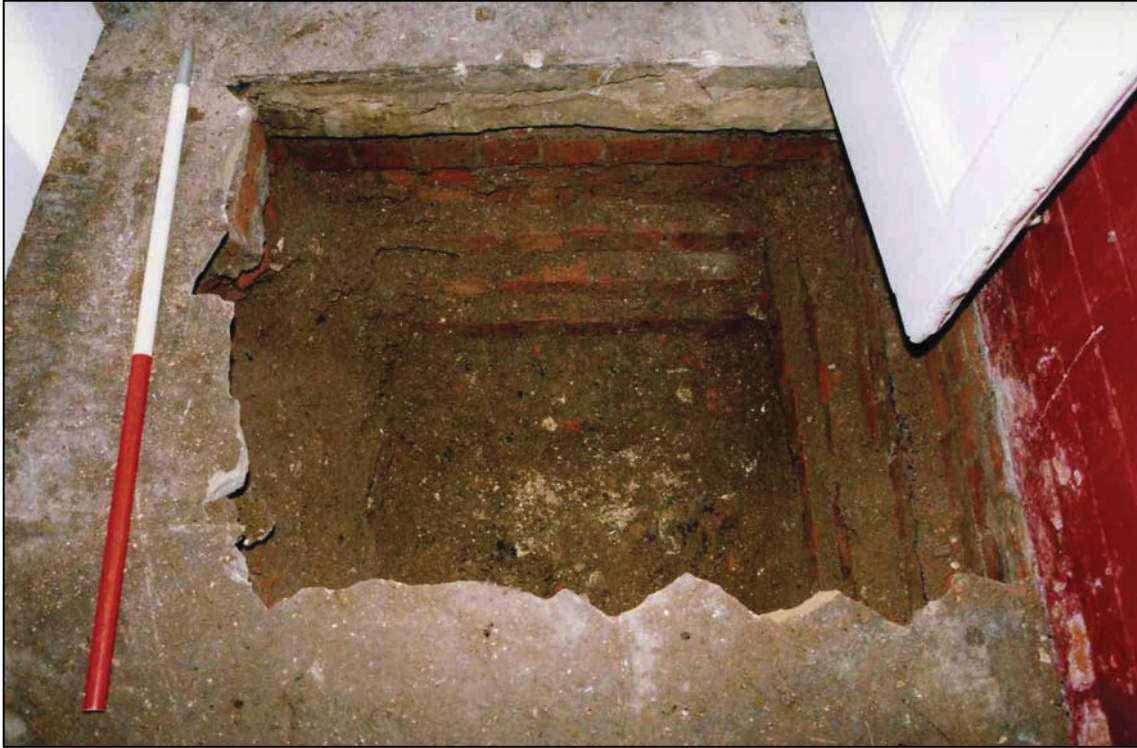
Plate 5: View of Test Pit 1, looking east.

- 5.1 Test Pit 1 was located inside the building, in a small lobby or hallway adjacent to the doorway which gave access to the Public Baths from Ladygate; prior to the excavation, the concrete floor of the lobby was set at 10.80m AOD. The test pit measured 1.10m long (north-south) by 0.90m wide (east-west), and was hand excavated to a maximum depth of 0.86m (9.94m AOD) (see plate 5).

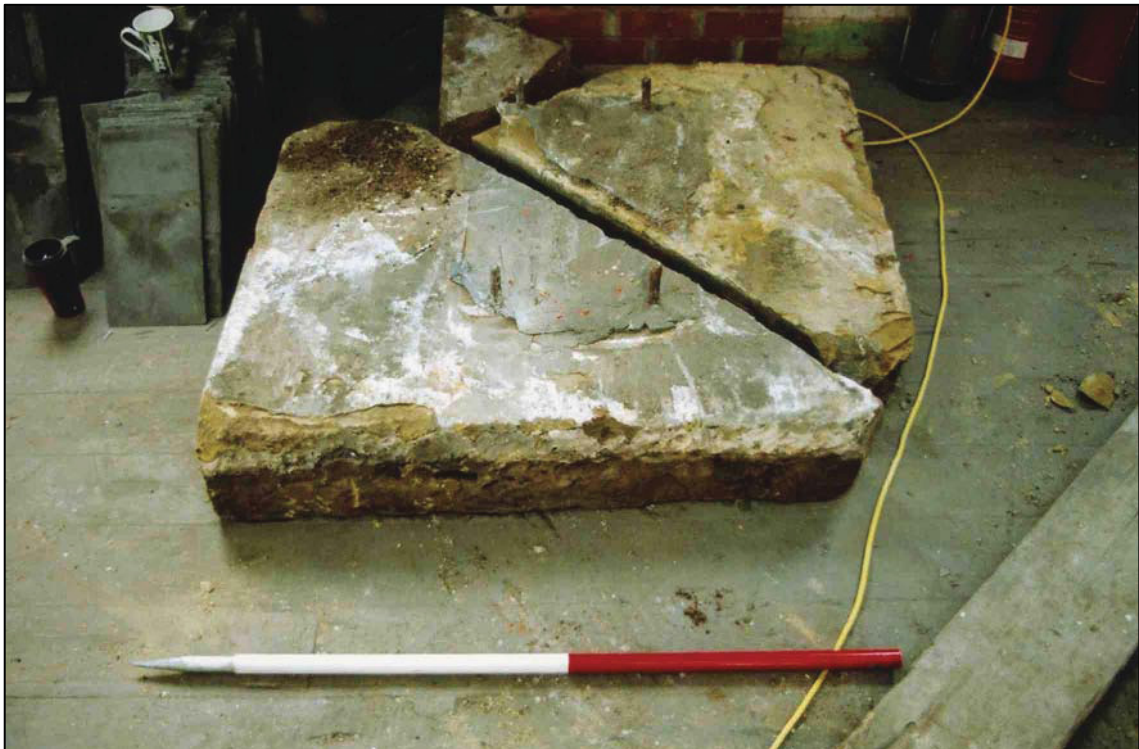
Plate 6: Test Pit 2 – stone base from plinth 003.

- 5.6 The asphalt/bitumen overlay a mixed but compacted 0.34m thick layer of mid brown sandy silt (006), which contained frequent inclusions of chalk rubble and red handmade brick fragments, some animal bone and some 19th century pottery. This layer appeared to be divided into two distinct deposits towards its western end, and it may have been contemporary with two very substantial brick and chalk rubble plinths, situated at either end of the test pit. The western plinth (003) was c.1.45m square and c.1.0m deep; its surface was formed from handmade red tiles and was set at 0.57m BGL. This plinth supported a large composite sandstone base which was made from two triangular pieces of stone which fitted together to make a base 1.16m square and 0.22m thick (see plate 6). The upper surface of this base contained a recessed area in the centre, 0.92m long by 0.65m wide, with

a threaded bolt projecting from each corner. The main body of the plinth appeared to have been made by cutting a pit and filling it with a mixture of brick rubble, chalk blocks and lime mortar. The eastern plinth (004), which was c.1.50m square and 0.50m deep, had a very similar form to that to the west, and was evidently constructed in the same manner. However, it did not have the tiled surface and the sandstone base above was slightly smaller, 0.95m square and 0.22m thick, although it had the same recessed area with corner bolts. It was not possible to remove the western plinth (003), as it extended beyond the west end of the test pit, and so this was left *in situ*, but the eastern plinth was taken out of the test pit, thus exposing the section behind.

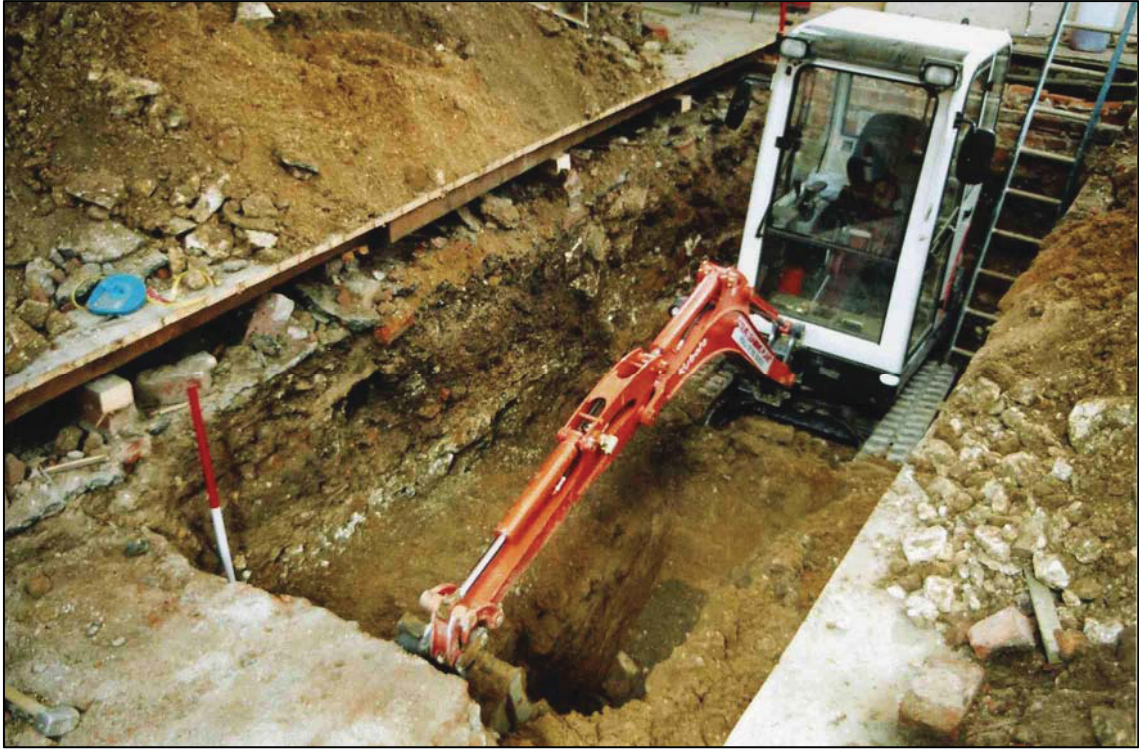
Plate 7: Test Pit 2, south facing section, looking north-east.

- 5.4 Test Pit 2 was located within the auditorium of the former cinema, slightly to the north of centre, adjacent to the opposed doorways in the east and west walls. Although an area of wooden flooring 8.80m long (east-west) by 2.20m wide (north-south) was taken up, the finished test pit measured 6.40m long (east-west) by 2.20m wide (north-south). The majority of the test pit was machine excavated to c.1.75m BGL (9.02m AOD) but a small section towards the west end was increased to 3.42m BGL (7.35m AOD) (see plate 7).

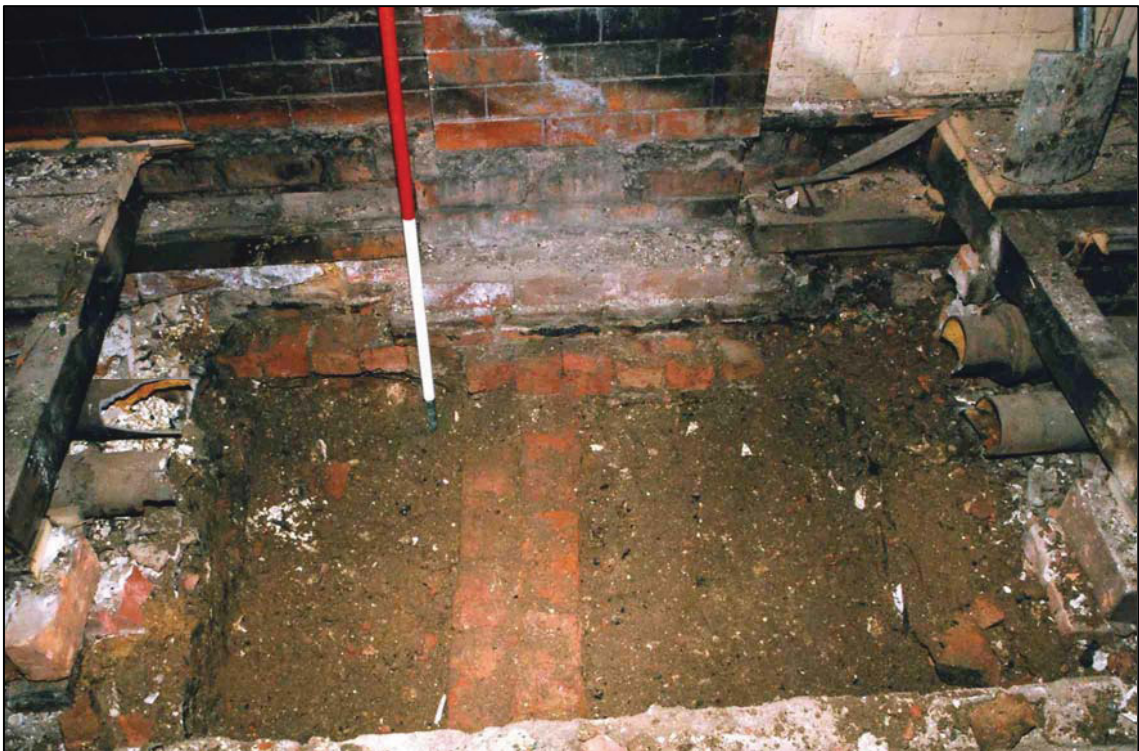
Plate 8: Test Pit 5 – brick wall (037) before removal, looking east.

- 6.1 As might be expected, the walls of the Playhouse Cinema have been repaired or altered over the last century, and this is reflected in the archaeological deposits uncovered in the test pits. In many places in the former cinema auditorium, the bottom of the wall piers had been repaired using very modern machine-made bricks; when the base of one such pier was investigated in Test Pit 6, it was found to be crudely underpinned by concrete (040), and it is likely that many other piers will have been treated in a similar manner. By contrast in Test Pit 5, the original late 19th

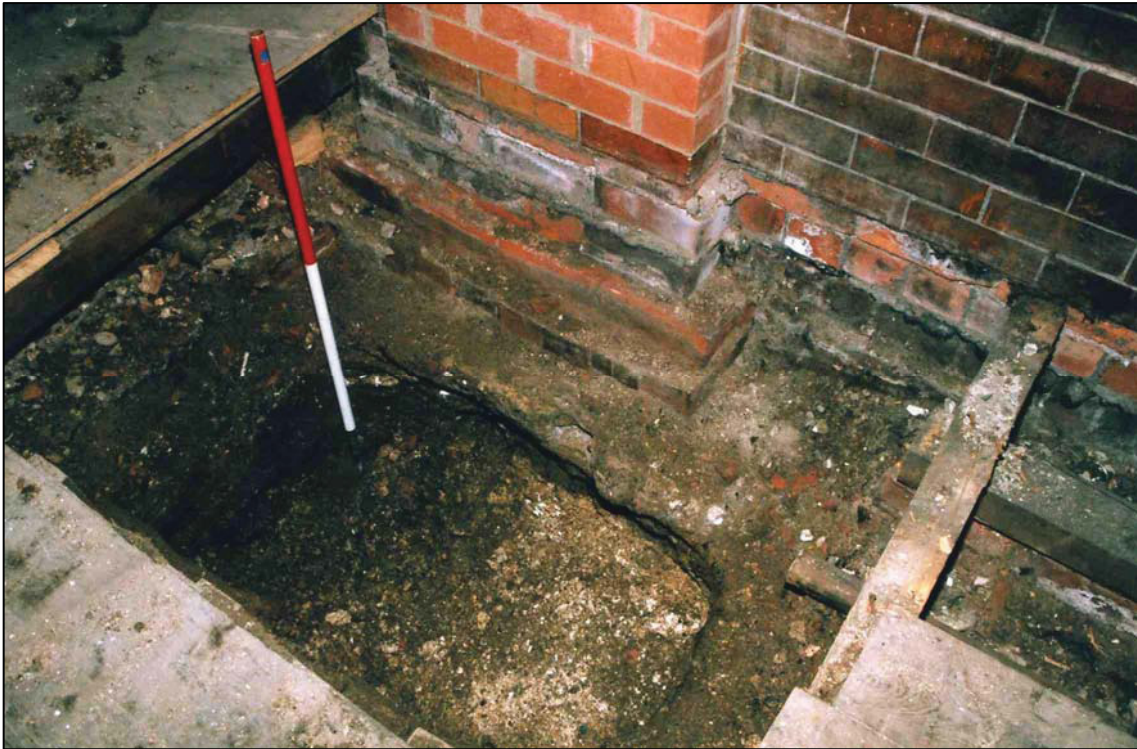
Plate 9: Test Pit 6, looking west.

- 5.23 The uppermost deposit exposed in the test pit was a dark brown sandy silt (039), 0.60m thick and containing frequent inclusions of red handmade brick rubble, angular chalk pieces and a small amount of 19th century pottery; it was directly comparable to deposit 036 seen in Test Pit 5. The sandy silt (039) had been cut by crude modern concrete underpinning (040) of the adjacent pillar, the base of which had been rebuilt in modern machine-made brick (see plate 9). At c.0.90m BGL (9.87m AOD), the sandy silt was replaced by a deposit of very hard-packed but unmortared angular chalk rubble (041), which extended below the base of the test pit.

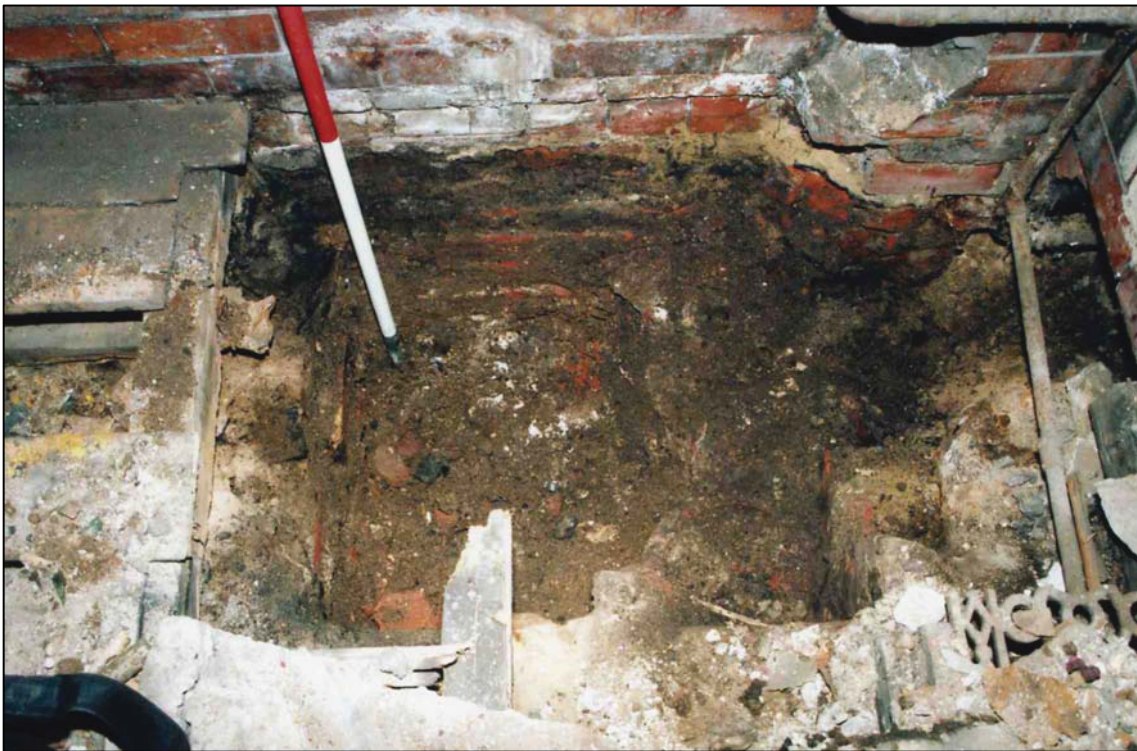
Plate 10: Test Pit 8, looking west.

- 5.25 The uppermost deposit exposed in the test pit was a dark brown sandy silt (042), containing frequent inclusions of red handmade brick rubble and angular chalk pieces; it was directly comparable to deposit 036 seen in Test Pit 5. The sandy silt enclosed a north-east/south-west aligned 0.20m diameter ceramic pipe; the surface of the pipe was set at 0.60m BGL and was apparently serving a toilet to the immediate north. The sandy silt (042) appeared to continue below the base of the test pit. The east wall of the cinema was observed to be supported by stepped brick footings, which ran to 0.78m BGL, at which point they were replaced by a crude mass of chalk rubble and brick, similar to deposit 041 in Test Pit 6. The stepped footings of the north wall appeared to continue below the base of the test pit.
