HALL FARM, KILHAM,
EAST YORKSHIRE

ARCHAEOLOGICAL OBSERVATION,
INVESTIGATION AND RECORDING

Report no: 2004/237.R01
Version: Final
Date: January 2007
Author: Ed Dennison & Shaun Richardson

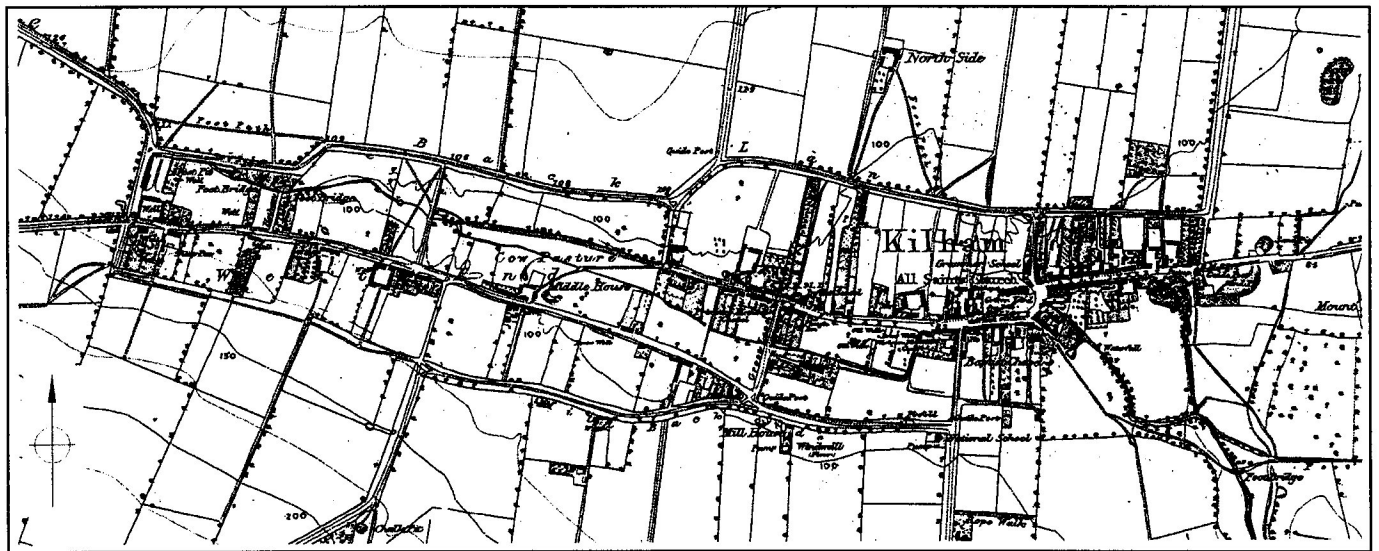
PROJECT		HALL FARM, KILHAM	
TITLE		HISTORIC MAPS	
SCALE	NTS	DATE	JAN 2007
EDAS		FIGURE	2

made in 1729 prior to modern development and expansion (reproduced in Purdy 1974, 248) (see figure 2). The documentary evidence for the development of the village is discussed at some length by Purdy and only a summary is given here (Purdy 1974, 247-251). At its most basic level, the main street of the village can be divided up into three parts. East Street, upon which the development site is located, may be the 'East Gate' mentioned in 1317. It is noticeable that in 1729 the crofts and garths on the north side of East Street are much longer than those on the south side (including the site), which back onto a large sub-rectangular area with lanes running around it. In 1420-21 the lord of the manor owned several shops in Kilham, including four, described as being newly built, in the east part of the village, perhaps along the current East Street.

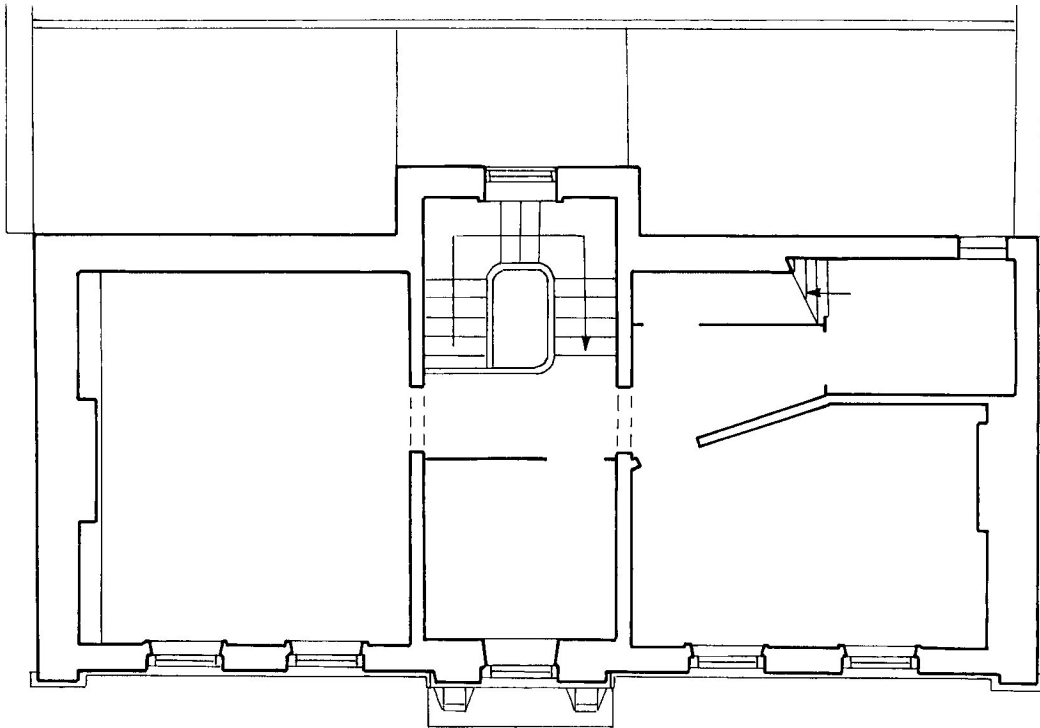
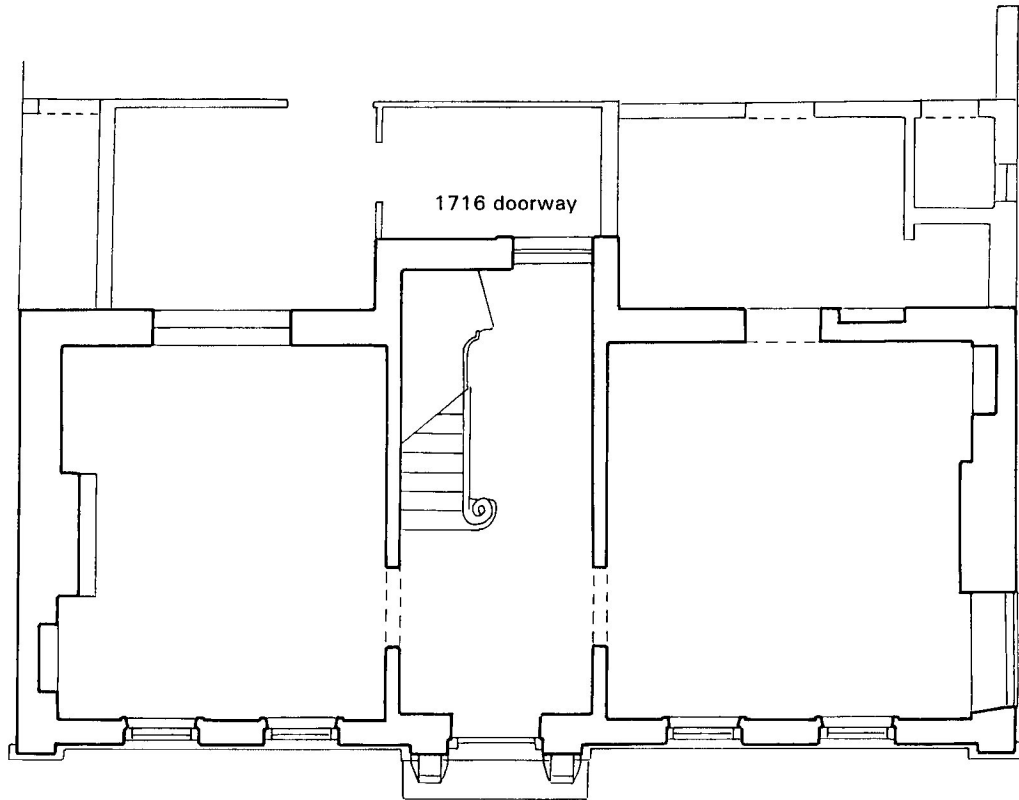
PROJECT		HALL FARM, KILHAM	
TITLE		FLOOR PLANS OF HOUSE	
SCALE	AS SHOWN	DATE	JAN 2007
	EDAS	FIGURE	4

the dated keyblock on the main elevation. Floor plans of the building are shown in figure 4.

- 4.11 Internally, the ground floor has a broadly symmetrical plan, with a central stair entrance hall flanked by sub-square rooms, that to the west being slightly longer than the east room (YVBSG 1993) (see figure 4). The dog leg stair rising up the

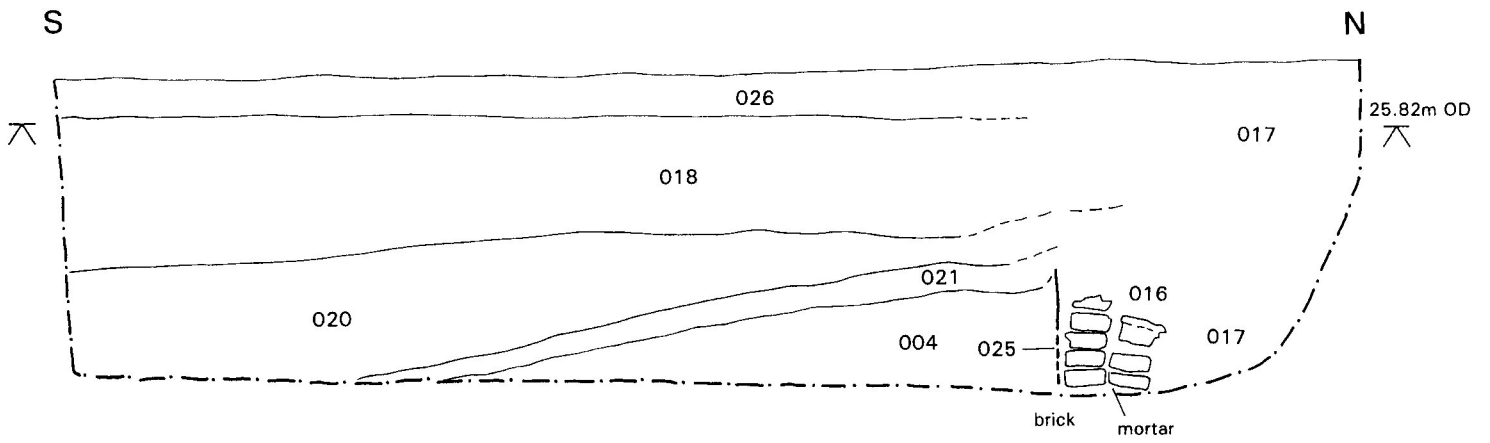
Section 3

- 5.9 The west arm of the foundation trench was dug from the south-west corner of the house. In the west section (see Section 3), five courses of an east-west aligned 0.27m wide brick wall footing (016) were exposed, set some 1.35m to the south of rear elevation of the house (see plate 3). The red handmade bricks (? x 128mm x 58mm) appeared to be bedded on a layer of soft mortar and positioned within a vertical cut (025) made into the yellow-brown natural chalk gravel (004); these footings were not visible further to the west in the stripped driveway. The position of the footings suggest that they form the truncated foundations of the single storey lean-to structure visible at the rear of the building on the c.1900 photograph.

- 5.10 The lowest visible deposit that the vertical foundation cut (025) disturbed was the yellow-brown chalk gravel (004) (see Section 3). To the south, this was overlain by a deposit of clean orange-brown sand (021), 0.08m thick and containing small lumps

of clay, possibly a construction layer associated with the former lean-to building, beneath a 0.38m thick layer of dirty yellowish fine chalk gravel (020), containing some chalk rubble. The latter might be upcast from the excavation of the cellars which formerly existed beneath the service building to the west of Hall Farm. These deposits were, in turn, overlain by a dark loamy soil (018) up to 0.45m thick containing brick rubble, tile, coal, coke and some cobbles and chalk rubble; above this was the compacted brown loam surface (026) of the modern driveway. To the north of the foundation cut (025) and footings (016), a loose mixed deposit (017) of predominantly brick rubble was assumed to have resulted from the infilling of the former cellars here. As noted above, this material was visible intermittently in the area of stripping undertaken to the west of the house on the existing driveway.

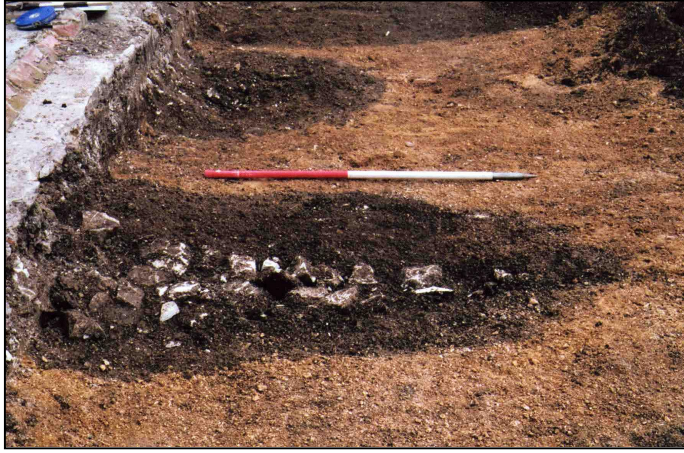
Plate 1: Possible wall foundation (011) in cut 010, looking E.

- 5.3 The linear cut (005) was only visible in the south side of the deeper foundation trench, and it did not appear to continue north towards the house. However, further stripping to the north did reveal the remains of a 0.55m wide chalk rubble wall (011) extending for 1.30m on a similar alignment; only one clear course remained *in situ*, the surface of which was set 0.24m below the level of the concrete floor of the demolished extension (26.02m AOD) (see plate 1). The chalk rubble wall (011) was set within a 1.1m wide linear trench or cut (010) of unknown depth, which was filled with a firm grey-brown loam (012) which also contained oyster shell and one sherd of green glazed post-medieval pottery. The linear cut (010) appeared to continue beneath the concrete floor of the demolished extension, but it could not be traced as far south as the adjacent foundation trench nor could it be seen to join with the similarly-aligned cut 005. However, it is likely that both linear cuts (005 and 010) are part of the same structure, and the gap between the two might possibly represent an entrance. Both cuts were dug into a firm yellow-brown gritty fine chalk gravel (004), which is probably a natural deposit although perhaps is imported levelling-up material.

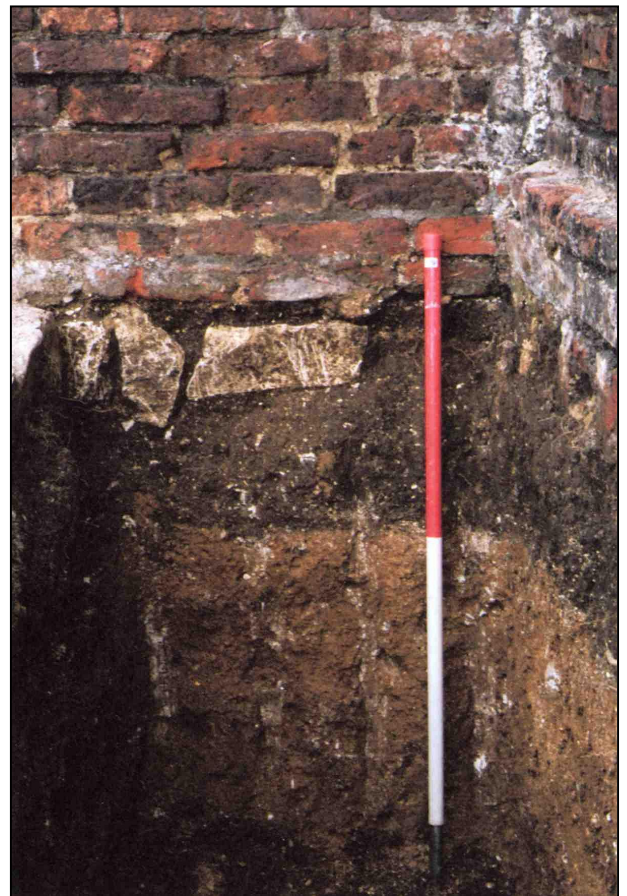
Plate 4: Chalk foundation (013) at SE corner of house, with plinth and foundation (024) of east garden wall to right, looking N.

- 5.8 The east arm of the foundation trench for the new extension was dug from the south-east corner of the house, and this showed that the rear wall of the house was built on a single course of insubstantial chalk rubble footings (013) (see Section 1 and plate 4). The footings were only a single course (0.26m) deep, and were set on and within a spread of brown loamy soil (007) (see Section 4) which was here generally 0.40m thick and which extended some distance to the south, thinning out and overlying the yellowish chalk gravel (004), and possibly associated with the east garden wall (see below).

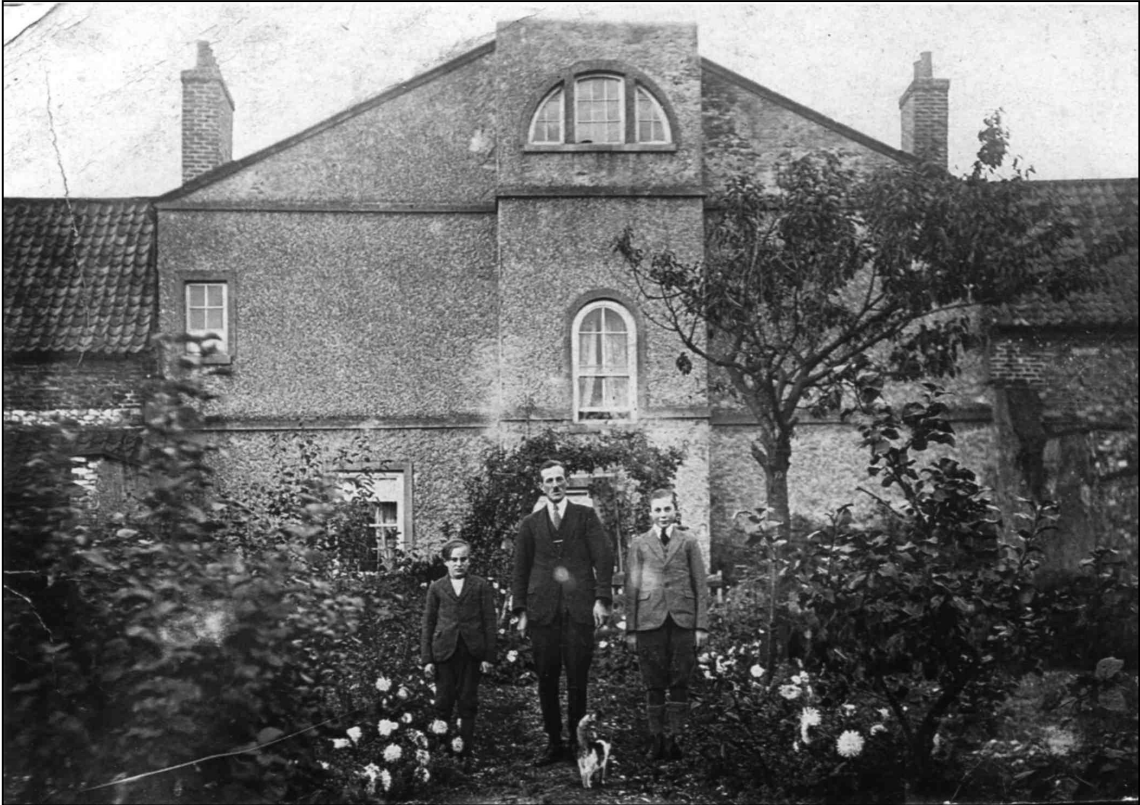
Plate 5: Early photograph (c.1900) showing south elevation of Hall Farm house.

- 4.13 Judging by the c.1900 photograph (see plate 5), the building standing immediately to the west of Hall Farm was of similar proportions and form to 'Five Pennies', with a pitched pantiled roof but a slightly lower eaves line. However, although its south elevation is largely obscured by a lean-to structure, the majority appears to be built of chalk, with only a narrow band of brickwork to the upper part, suggesting that it may have originated as a single storey chalk building. Purdy described the building as a "service wing ... recently demolished" in 1974 (Purdy 1974, 250), whilst local information suggested that it latterly served as a rat trapper's cottage (YVBSG 1993). Information from the project architect suggests that the building to the west (on the site of the present drive) was indeed a linked service wing which was demolished in c.1960 (Jonathan Hobson, *pers. comm.*). The 1854 1st edition 6" map (see figure 3), and subsequent editions of 1890 and 1910, shows a continuous range of buildings, of a similar width, along this part of East Street.

- 5.7 The demolition of the modern kitchen extension exposed part of the rear (south) elevation of the house that had previously been concealed. Part of a blocked window with a shallow arched-head (027), estimated to be 0.58m wide, was visible on the ground floor, close to the south-west corner, apparently vertically aligned with and of a similar size to that visible on the first floor in the c.1900 photograph. Traces of a similar blocked window (but without an arch) in a corresponding position were also noted at the south-east corner, formerly hidden from view by the coal shed; this latter area of the elevation appeared to have been subject to much alteration. Finally, the remnants of a flat-headed concrete window surround (028) were exposed on the ground floor, 2.62m east from the south-west corner; again, this window is shown on the c.1900 photograph (see plate 5).
