## ERECTION OF A WIND TURBINE, SKEFFLING VILLAGE HALL, HUMBER LANE, SKEFFLING, EAST YORKSHIRE

## ARCHAEOLOGICAL OBSERVATION, INVESTIGATION AND RECORDING

Report no: 2006/297.R01

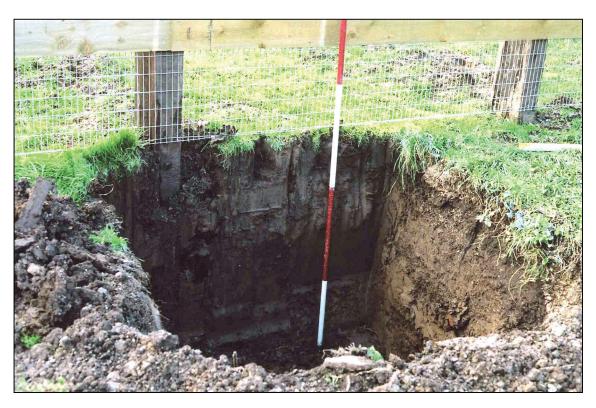
Plate 1: South and west sides of Trench 1, looking SSW.

5.1 Trench 1 revealed only a part of the former fence line on the south side of the site, and part of the infill of the former drainage ditch (006) which crossed this area, a friable dark brown loam containing 19th /20th century pottery and metal debris. This was overlain by a friable mid-brown gritty loam (007), c.0.22m thick, above which was a rough firm black-brown loam containing gravel, hardcore and tarmac fragments (001) forming the car park surface (see plate 1).
