ALL SAINTS CHURCH, HESSLE,  
EAST YORKSHIRE

ARCHAEOLOGICAL OBSERVATION,  
INVESTIGATION AND RECORDING

Report no: 2006/290.R01  
Version: Final  
Date: January 2007  
Author: Ed Dennison

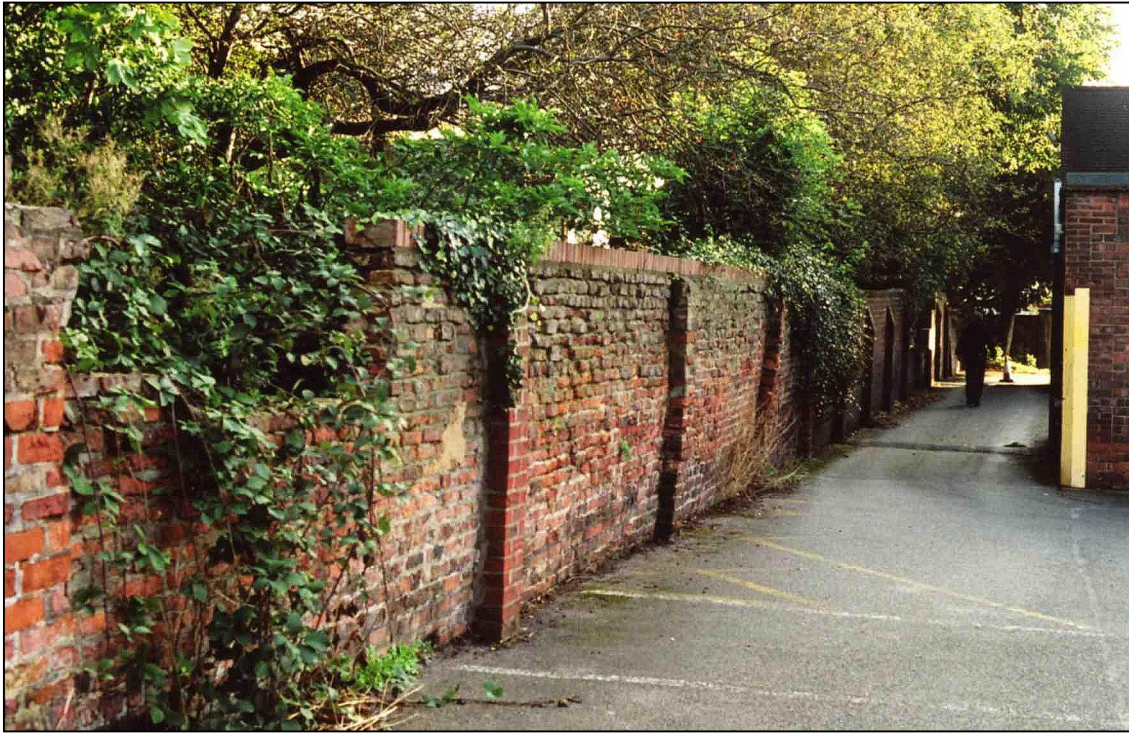
Plate 1: General view of wall 012 prior to demolition, from car park looking north-east.

- 5.1 As noted above, the c.16m length of bowed churchyard wall which was required to be rebuilt lay in the south-west corner of the graveyard (see figure 2). The 2m high wall (012) showed evidence of several phases of repair and had been strengthened with numerous shallow buttresses along its length (see plate 1). The wall formed a revetment to the churchyard to the north, the ground surface of the latter lying c.0.70m above the level of the car park to the south.
- 5.2 A thick covering of ivy was removed by hand from the churchyard side of the wall and from nine *ex situ* gravestones, which had been re-sited alongside the wall. Six of the nine grave stones were removed, some with the aid of the mini-excavator, and

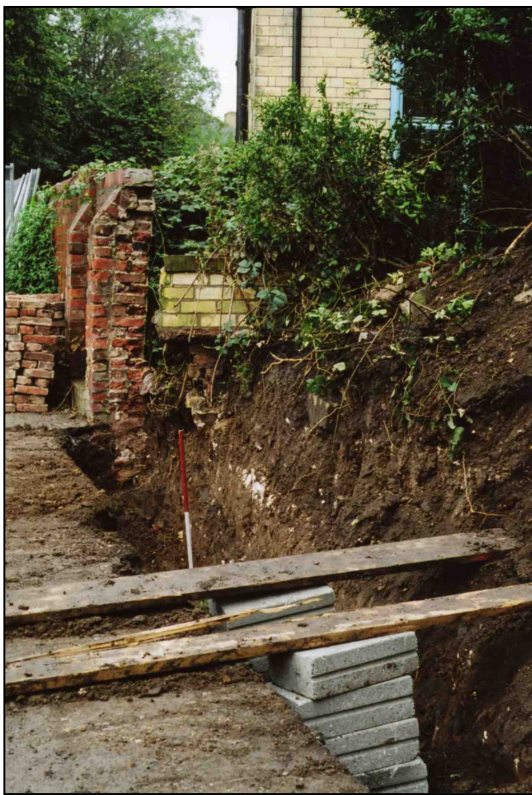
Plate 2: Work in progress, looking west.

- 3.3 The c.16m length of bowed churchyard wall which was required to be rebuilt formed a revetment to the churchyard to the north, the ground surface of the latter lying c.0.70m above the level of the car park to the south. This meant that, following the demolition of the wall, the exposed bank of loose soil required a slight battering back, extending to c.0.5m into the churchyard, before a foundation trench for the new section of wall could be dug. This trench was c.1.0m wide and 0.4m deep on the car park side (see plates 2 and 3).
