EXTERNAL DRAINAGE WORKS,
BURTON CONSTABLE HALL,
NEAR SPROATLEY, EAST YORKSHIRE

ARCHAEOLOGICAL OBSERVATION,
INVESTIGATION AND RECORDING

Report no: 2021/652.R01
Version: Final
Date: November 2021
Author: Shaun Richardson & Ed Dennison

Burton Constable Foundation
Burton Constable Hall
Skirlaugh
Hull
HU11 4LN

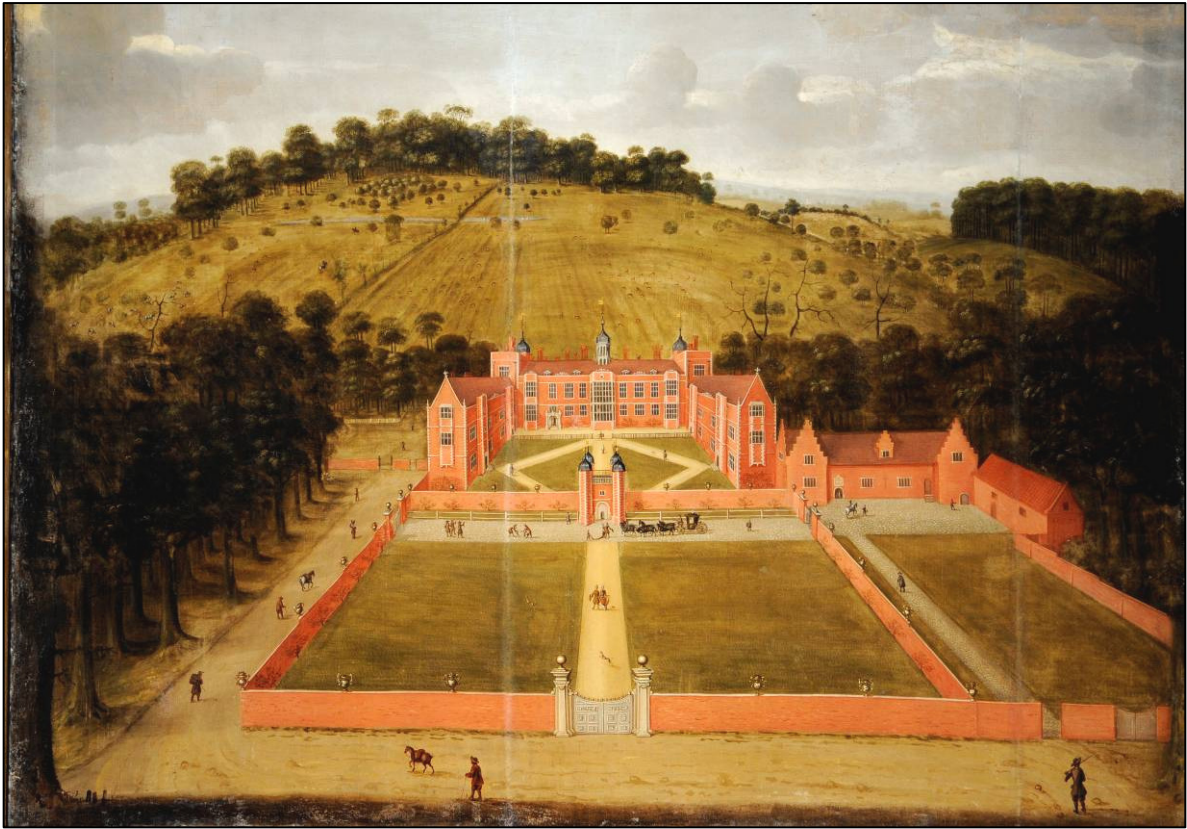
Prospect of Burton Constable Hall and Deer Park from the East, Anon, c.1690
 (source: Burton Constable Foundation).

- 2.7 An anonymous c.1690 view of Burton Constable (BCF) provides some interesting detail to enhance the bare lines of the 1621 survey (see figure 4 top). The square enclosure shown to the east of the house enclosure in 1621 (marked '1.30') forms a walled forecourt. The surrounding high brick walls are surmounted by urns at regular intervals and on the outer east side, there is a gateway, flanked by tall stone piers; a wide road runs along the outside of the wall which is assumed to be the route to Sproatley, in the position of the moat depicted in 1621. The road then turns west to run along the south side of the walled forecourt.

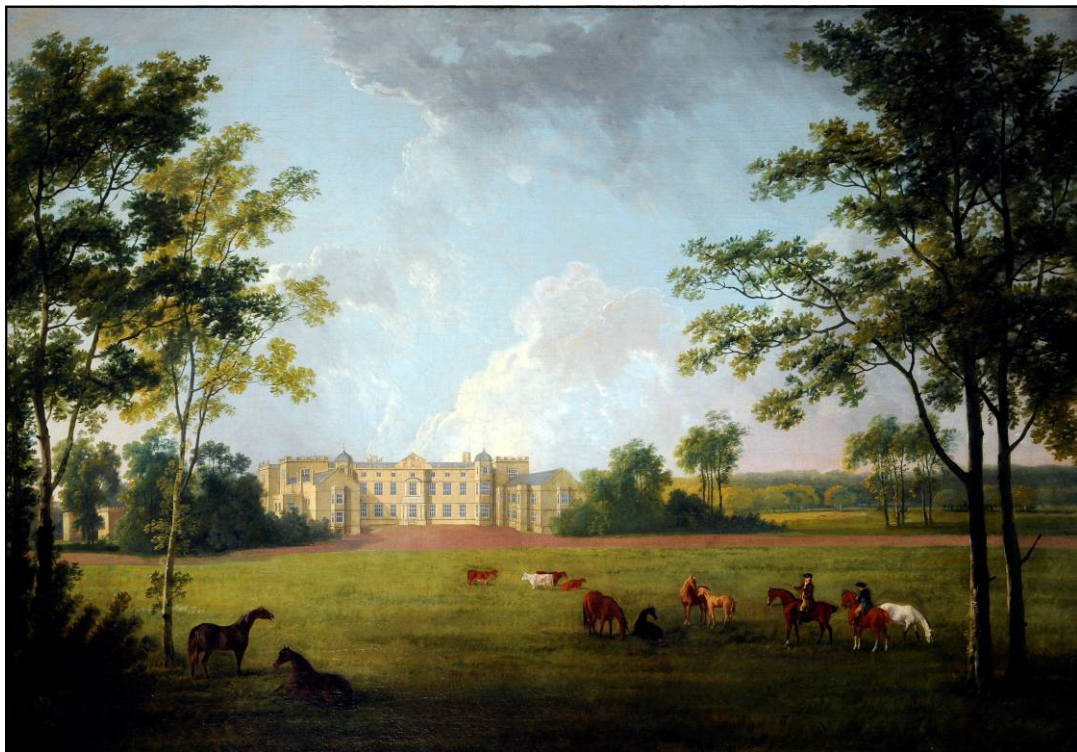
PROJECT		BURTON CONSTABLE DRAINAGE	
TITLE			
HISTORIC PAINTINGS			
SCALE	NTS	DATE	NOV 2021
EDAS		FIGURE	4

The East Front of Burton Constable Hall, G Barrett, 1776
 (source: Burton Constable Foundation).

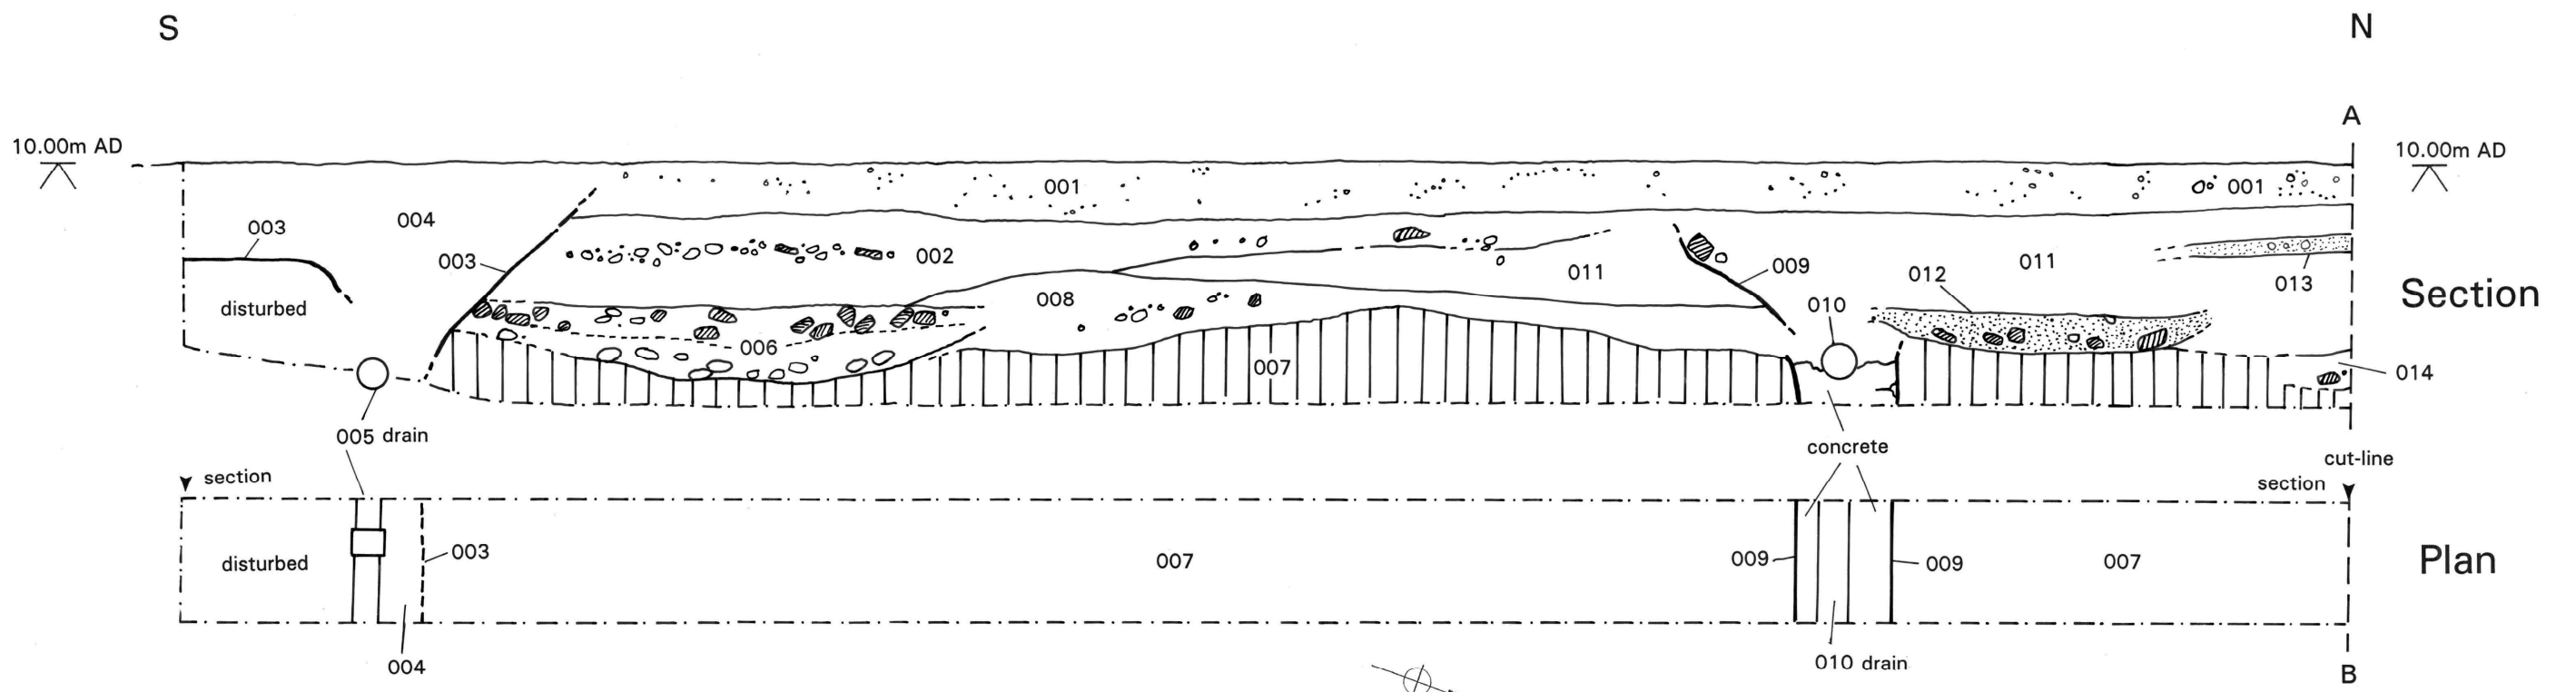
PROJECT BURTON CONSTABLE DRAINAGE	
TITLE WATCHING BRIEF RESULTS	
SCALE AS SHOWN	DATE NOV 2021
EDAS	FIGURE 7

5 RESULTS OF THE WATCHING BRIEF (see figure 7)

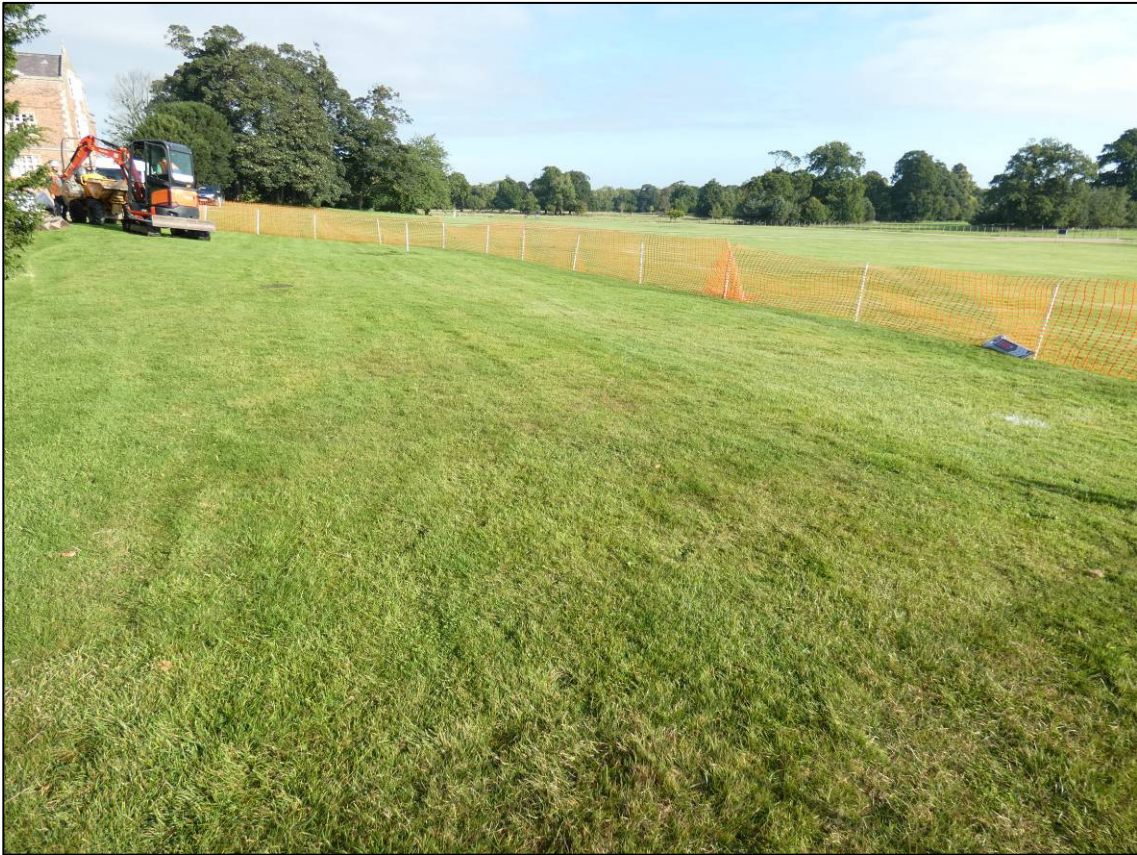
Plate 1: General view of area of excavation, looking NE.

- 5.1 A description of the results of the watching brief is given below, based on the records made in the field. In the following text, 'modern' is used to denote features or phasing dating to after c.1945.
- 5.2 Prior to the start of the excavations, the area of the proposed drain lay within an area of mown grass, forming part of the east lawn in front of the hall. As noted above, the ground surface was almost level across the area, with a slight, curvilinear, east-facing scarp to the west, marking the former extent of the small belt of tree planting here (see plate 1). As noted above, the trench measured 18.10m long, with an average width of 0.50m, and it was excavated to an average depth of 1.00m below ground level (BGL), increasing to 1.20m BGL at the northern end (see plate 2). The east-facing section of the trench is described below, but the west-facing section was very similar.

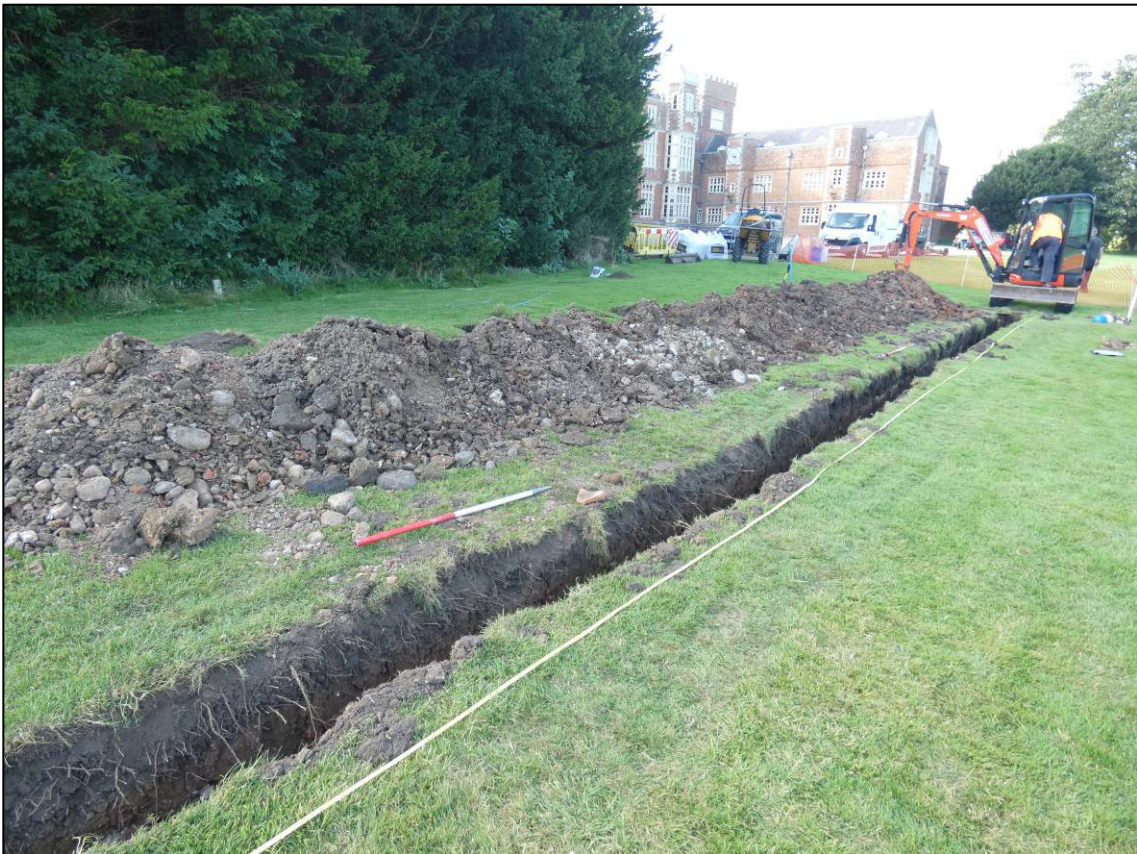
Plate 2: General view of excavations in progress, looking NW.

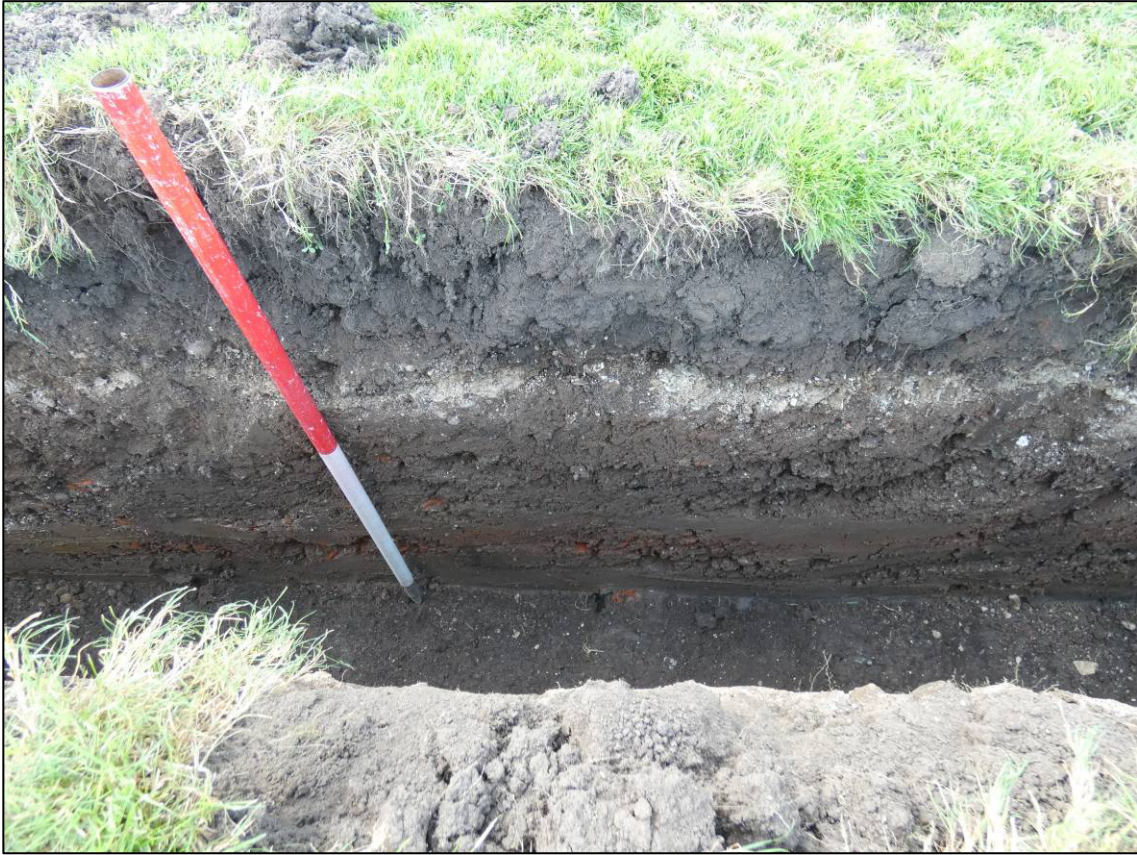
Plate 3: Shallow band of friable lime/lime mortar (013), below the topsoil (001) and a black sandy silt (011), seen in the central part of the west side of the trench, looking W.

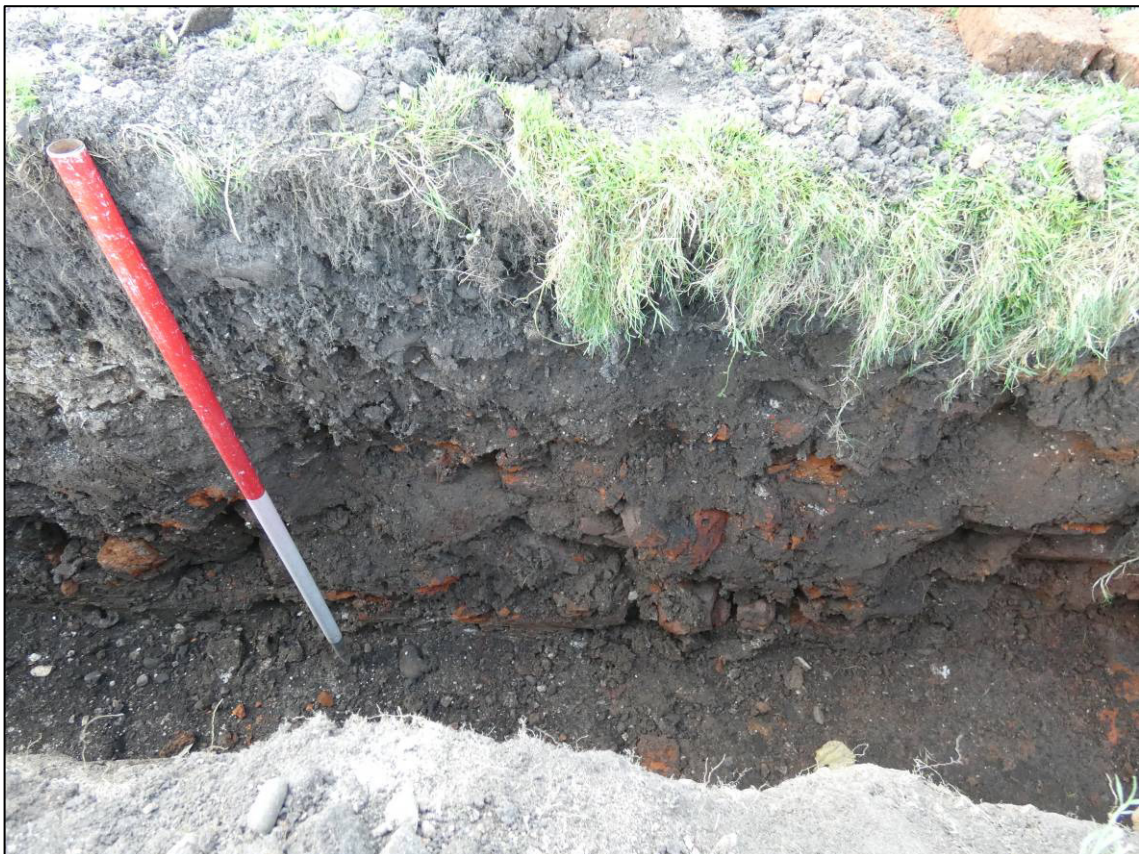
Plate 4: Hard packed compacted brick rubble (018) seen at the north end of the west side of the trench, looking W.

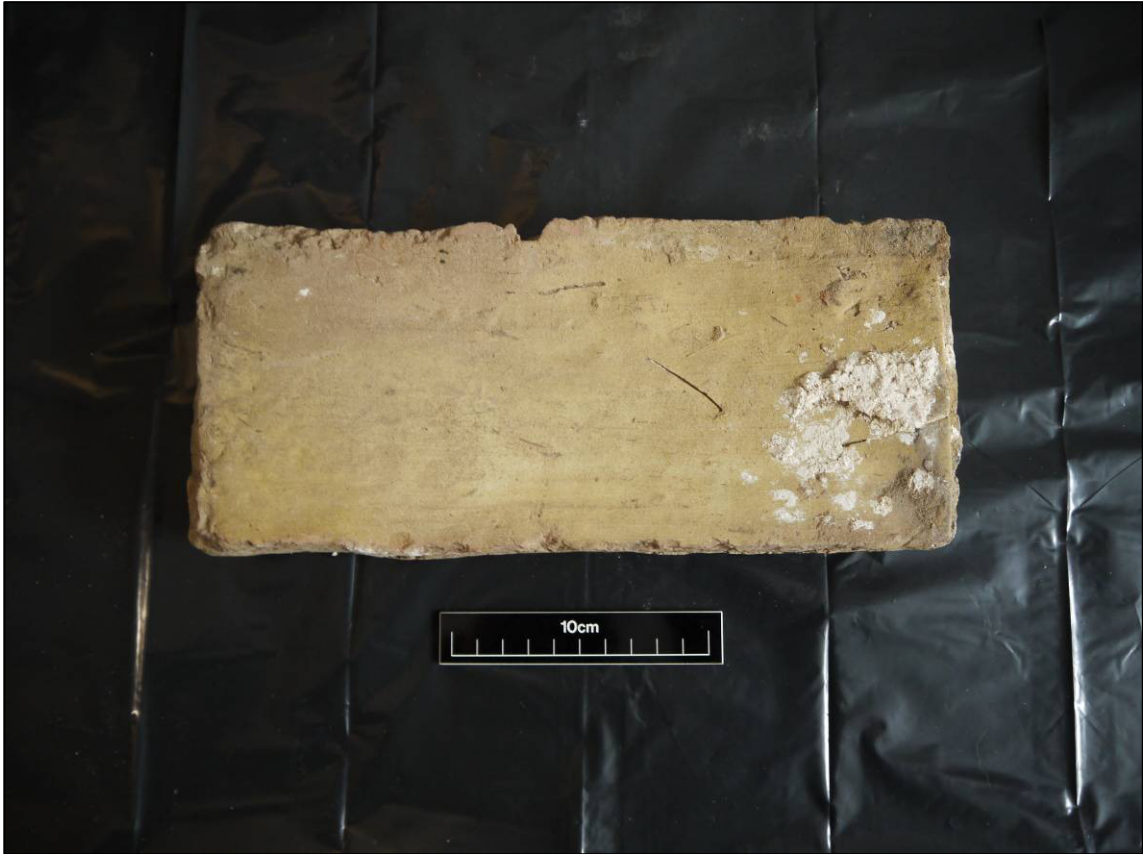
Plate 5: One example of a 14th-early 15th century complete brick recovered from the compacted brick rubble deposit (018).

Of the four bricks submitted, three are of 14th/early 15th century date - erring to the former - with dimensions between 260-280mm x 118-120mm x 46-50mm (10³/₄"-11" x 4³/₄" x 1³/₄"-2") (see plates). One example was over-fired causing slight warping but is not considered to be a lower quality 'second'. Patches of Very Pale Brown (10YR/8/2-3), fine-grained, lime-based mortar were noted on one stretcher and both bed surfaces of 2 bricks, probably from original use. Two bricks displayed a Pale Yellow (2.5Y/7/3) - firing slip.

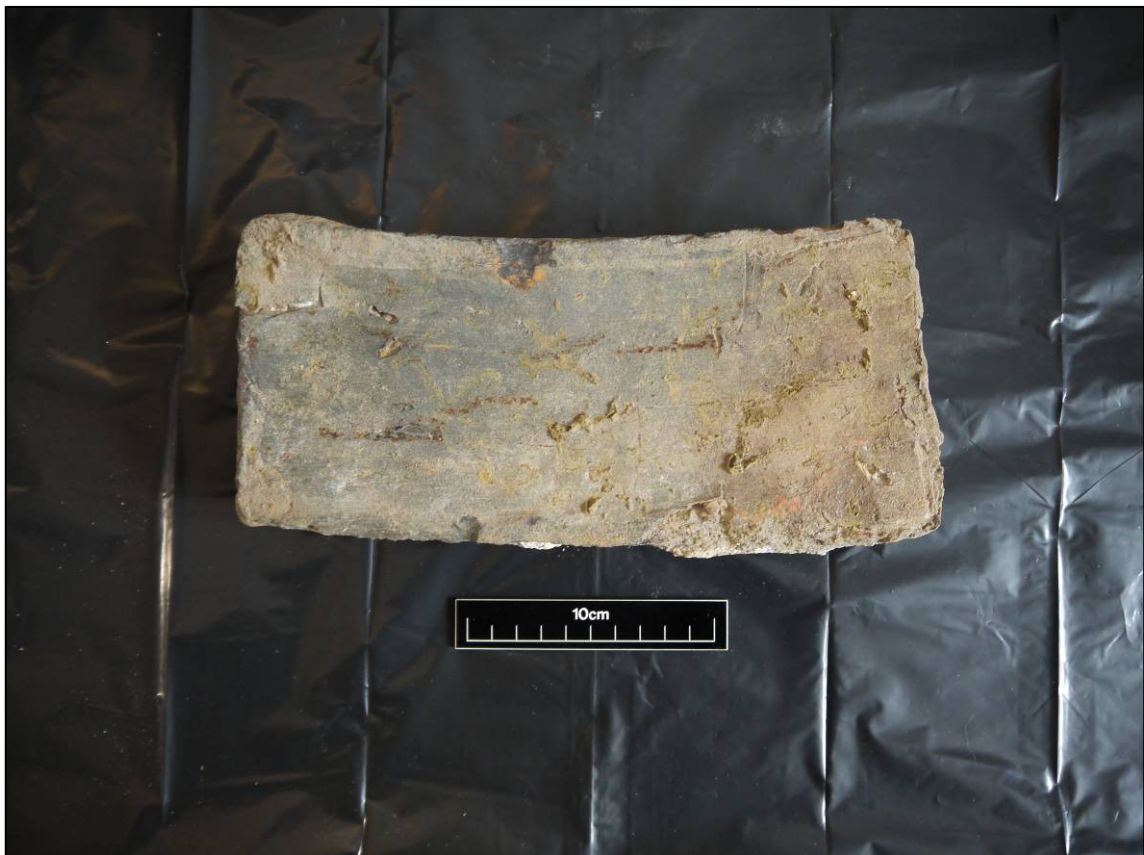
Plate 6: Second example of a 14th-early 15th century complete brick recovered from the compacted brick rubble deposit (018).

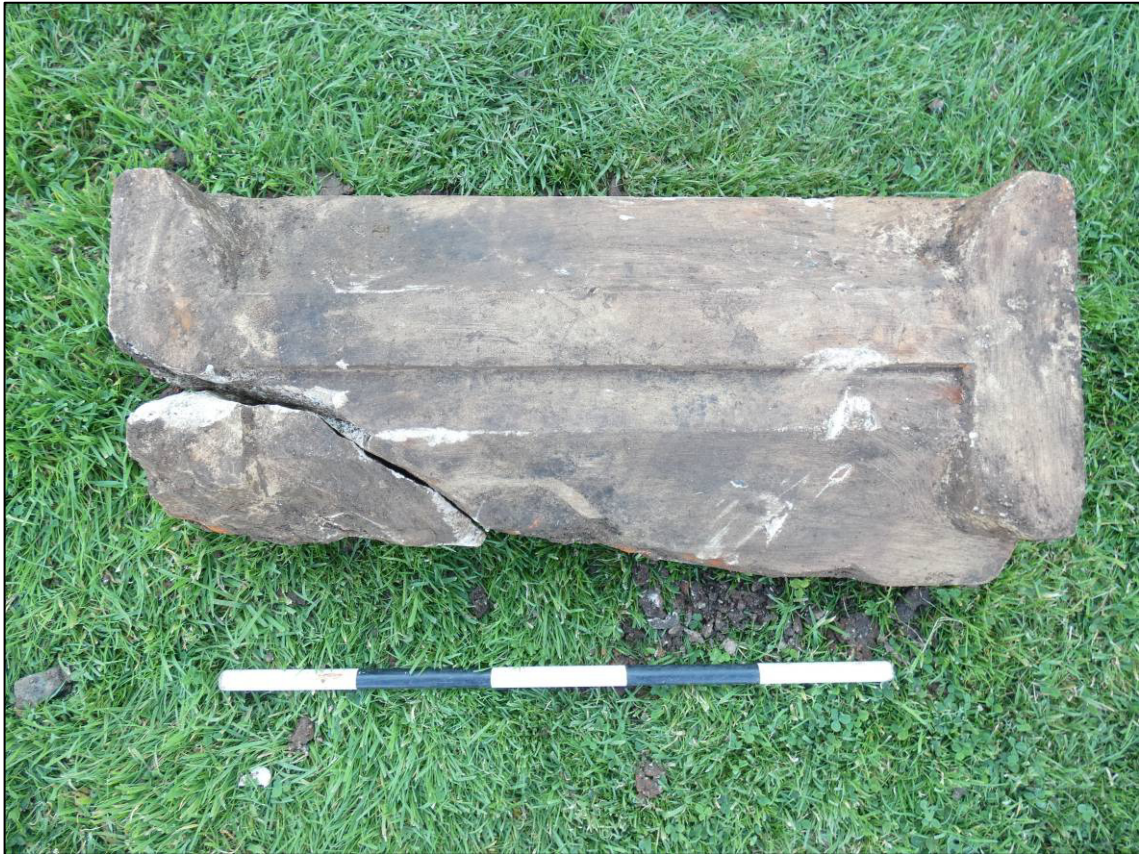
Plate 7: Dressed limestone window lintel or sill, recovered from compacted brick rubble deposit (018), possibly 16th century.

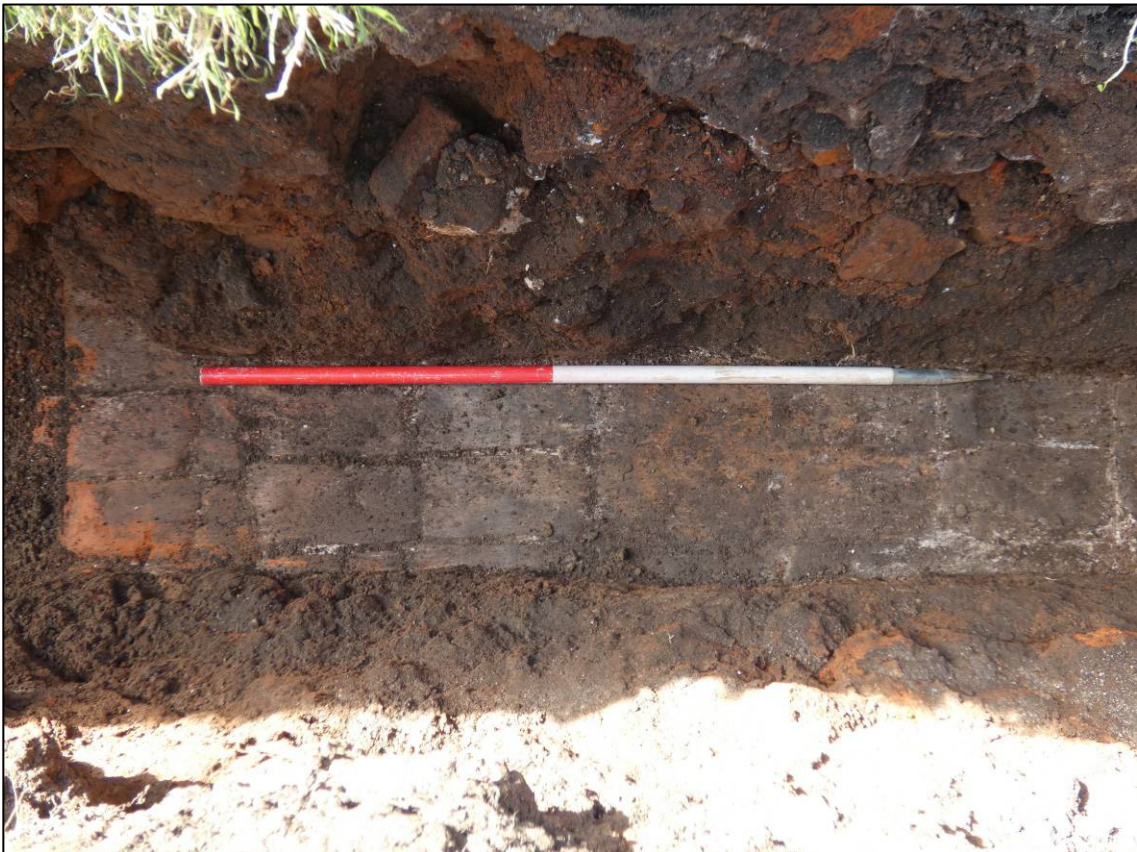
- 5.10 The compacted brick rubble (018) partly overlay the only *in situ* structure exposed within the trench, a brick surface (019), which was evident in the very bottom of the excavation (see plate 8). The surface had a level top, and was set 1.12m BGL. It was at least 2.0m long, and continued beyond the northern end of the trench, although it had been partly disturbed here by the construction of an inspection chamber. The surface was only a single brick deep, and was composed of yellowish-red handmade bricks, with average dimensions 260mm by 120mm by 550mm. There was a narrow band of wear along the very southern edge of the surface, and a second 0.25m wide band of wear to the north of this - the latter wider band had a gently concave profile and ran parallel to the southern edge of the surface; both bands of wear ran virtually east-west on the same alignment across the trench.

Plate 8: Brick surface (019) below the compacted brick rubble deposit (018), seen in the bottom of the north end of the trench.

- 6.2 It is tempting to see the *in situ* brick surface (019) exposed in the bottom of the very northern end of the trench as being associated with the former road to Sproatley, shown running along the south side of the walled forecourt in the c.1690 painting (see figure 3 bottom). It is in approximately the right position, and the shallow linear depressions in the surface could be interpreted as the pattern of wear caused by carts or other wheeled traffic passing over the bricks; in this case, there would presumably be another similar band of wear set to the north just beyond the end of the drainage trench.
