ALL SAINTS' CHURCH, BISHOP BURTON,
EAST YORKSHIRE

ARCHAEOLOGICAL OBSERVATION,
INVESTIGATION AND RECORDING

Report no: 2019/595.R02
Version: Final
Date: July 2021
Author: Ed Dennison & Richard Coates

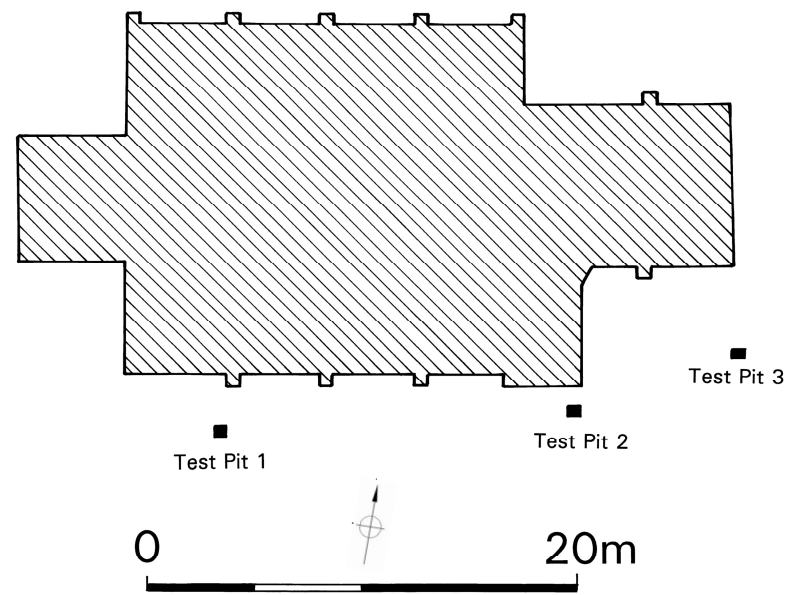
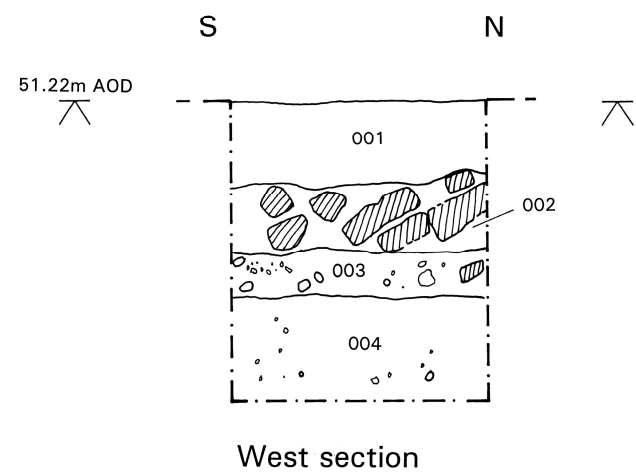
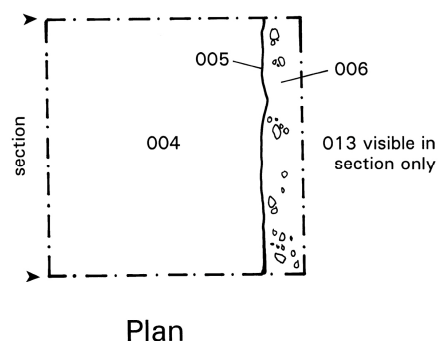
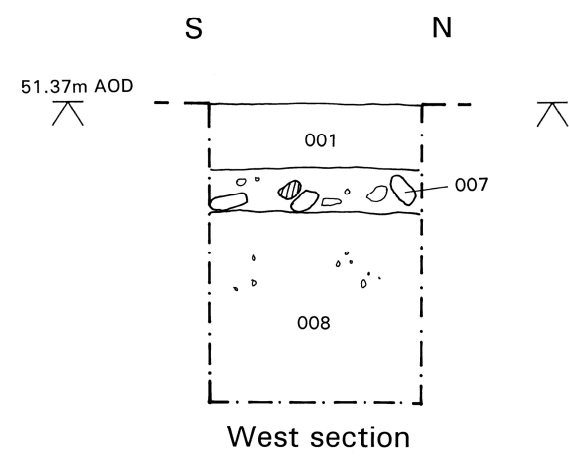
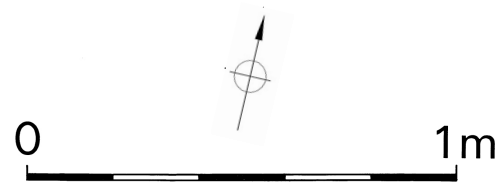
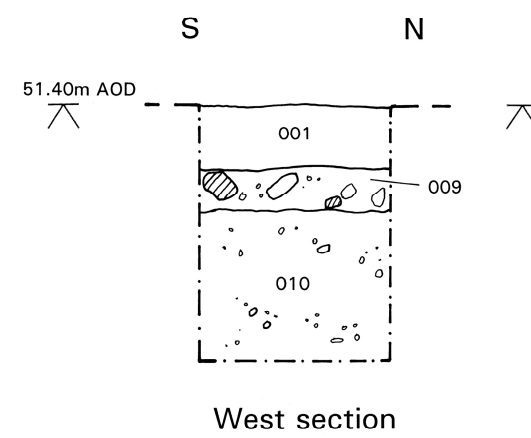
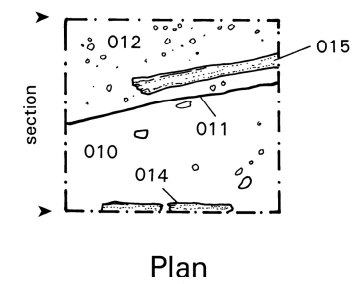
PROJECT		BISHOP BURTON CHURCH	
TITLE		2019 TEST PITS	
SCALE	AS SHOWN	DATE	JUL 2021
EDAS		FIGURE	4

- 4.5 As noted above, three small test pits were excavated on the south side of the church in April 2019 to assist with the design of a proposed Trench Arch drainage system (see figure 4). All three pits exposed a gravel pathway laid over a base of brick and/or chalk rubble hardcore. However, beneath this, the western-most pit (Pit 1) contained one side of a brick structure of probable 19th or 20th century date, almost certainly part of a burial vault. The central pit (Pit 2) produced quantities of disarticulated human bone from the brick/chalk rubble layer, which overlay a natural sandy clay deposit. Pit 3 to the east produced disarticulated human bone from the lowest deposit, as well as the partial remains of two articulated burials at a depth of 0.50m below existing ground level (Richardson & Dennison 2019). In the event, the proposed Trench Arch system was abandoned in favour of more traditional drainage runs, the monitoring of which is the subject of this report.

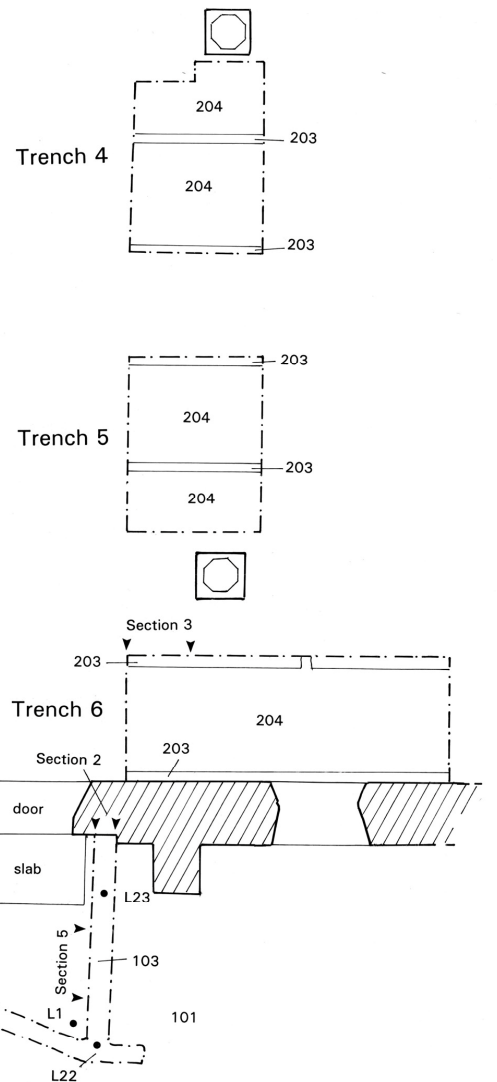
PROJECT		BISHOP BURTON CHURCH	
TITLE			
WATCHING BRIEF RESULTS: PLAN			
SCALE	AS SHOWN	DATE	JUL 2021
EDAS		FIGURE	5

The External Works (see figures 5 and 6)

- 5.2 Prior to the start of the watching brief, the area to the immediate south of the church was gravelled, and had an average height of 51.30m AOD. There are also narrower gravelled strips, edged by concrete, around the tower, which are assumed to be French drains (see plate 1).
- 5.3 As noted above, the enclosed area to the north of the church is marked as a 'Grave Yard' from 1855 onwards, with terraces stepping down to the north shown from 1890 onwards (see figure 3 and plate 2). The ground slopes downwards from south to north across the terraces; to the west of the tower, the ground surface was set at 49.18m AOD, falling away to 45.24m AOD adjacent to the north boundary wall. There are a number of grave stones and other grave markers within the area which have been cleared and laid flat on the terraces, and it is assumed that the whole area has been used for burials in the past.

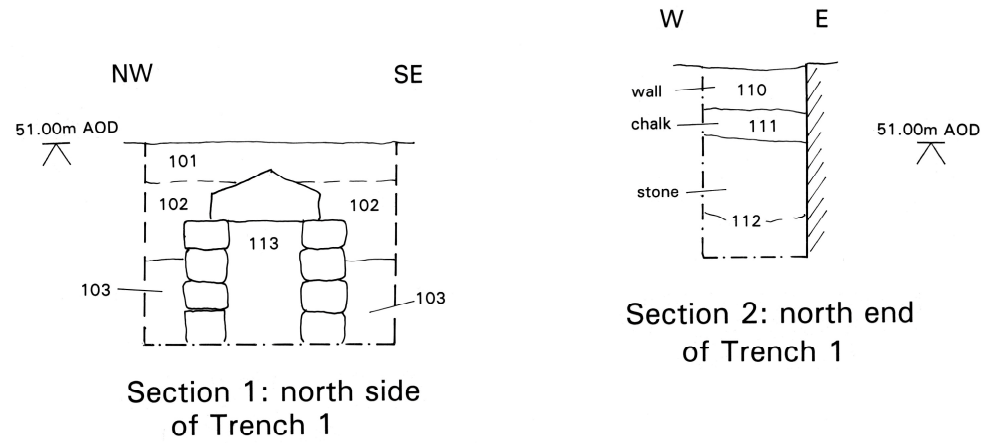
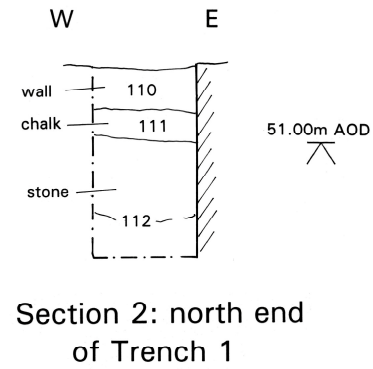
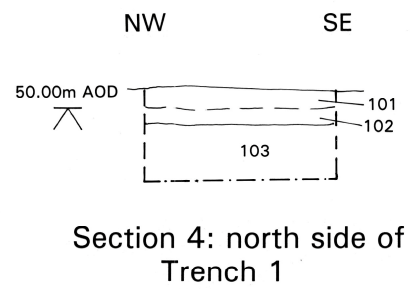
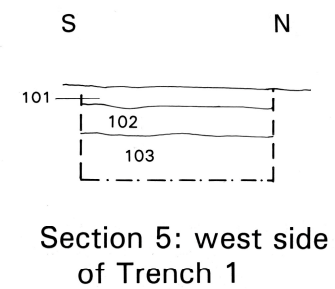
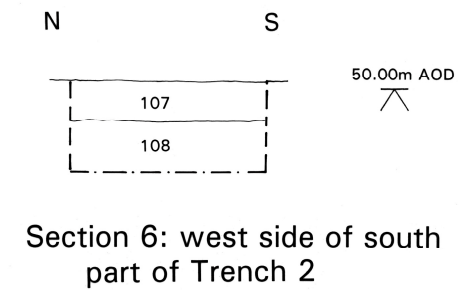
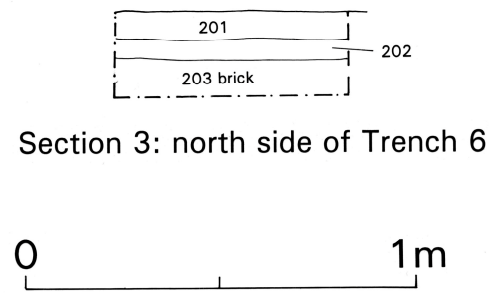
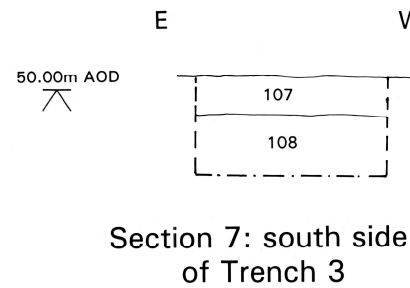
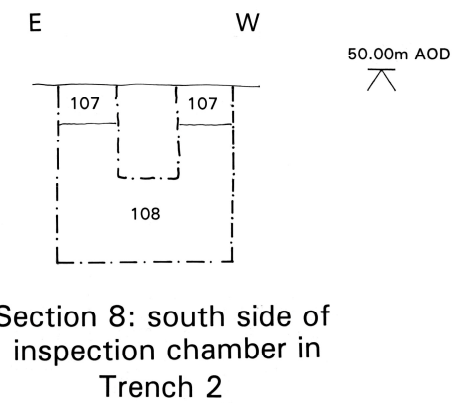
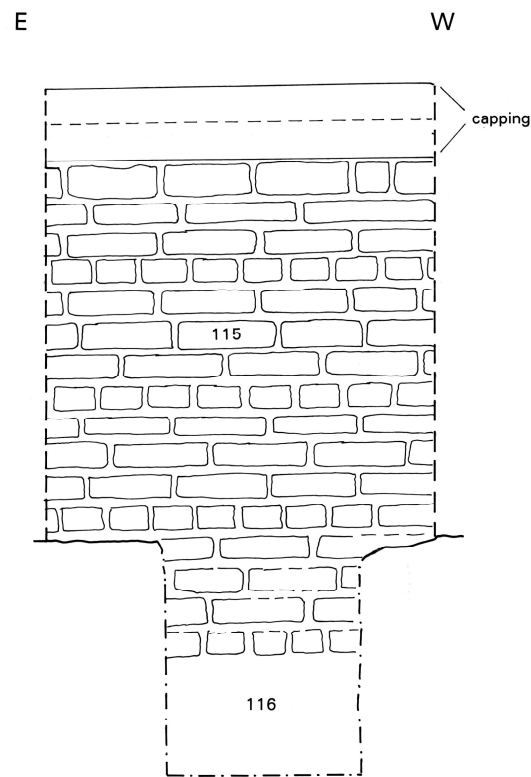
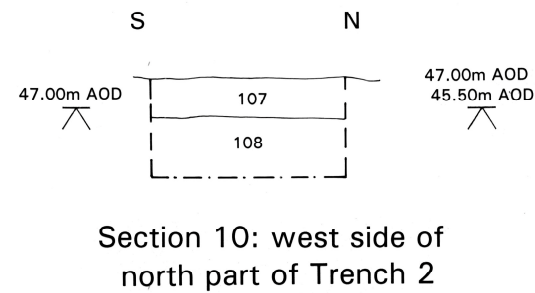
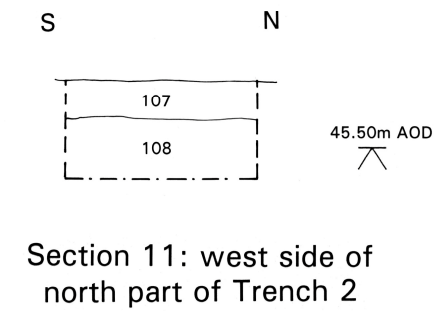
PROJECT		BISHOP BURTON CHURCH	
TITLE			
WATCHING BRIEF RESULTS: SECTIONS			
SCALE	AS SHOWN	DATE	JUL 2021
EDAS		FIGURE	6

extended below the base of the trench; it was probably the local 'natural' deposit (see sections 4 and 5 on figure 6).

- 5.8 In the same area, a modern yellow gas main pipe (106) cut and crossed the clean mid-brown clayey sand deposit (103) in the base of the trench (0.56m below ground level), to re-immerge at the north-western end of the trench, close to the south-west corner of the tower. The north end of the short north-south section of the trench met the south wall of the south aisle (110) and its associated stone and chalk foundations (111 and 112) which extended for the full depth of the trench (0.50m) and below (see section 2 on figure 6 and plate 6).

- 5.19 In all three trenches, a similar sequence of deposits was exposed (see section 3 on figure 6). The 0.07m thick flooring material (201), comprising wooden floorboards in Trenches 4 and 5 and the eastern half of Trench 6 to support the pews were laid on brick sleeper walls (203); the western half of Trench 6 had stone paving slabs on the sleeper walls to support the font (see plate 18). Below the flooring material (201) was a c.0.05-0.08m thick mixed, loose rubble and sand levelling deposit (202) which was lain on the top of brick sleeper walls. These walls (203) were built from red handmade bricks (average dimensions 230mm by 105mm by 50mm) and were at least two courses high; additional courses may have lain beneath but these were not exposed by the works. The majority ran east-west, but in several places additional support was provided by shorter cross walls running north-south. Beneath and between the walls, and forming the top of a shallow void beneath the flooring material (201), was a light to mid yellow-brown consolidated deposit of crushed sand and mortar (204). In the western half of Trench 6, the base of the font (205) below the stone floor (201), was set on an additional brick rubble and cement foundation (206), 0.30m thick, with a brick sump beneath. At the eastern end of this trench, a 0.20m diameter salt-glazed ceramic pipe (207) was also exposed running through this foundation (206), providing a vent from the void beneath the floor surface (201) and the consolidated surface (204) (see plate 19).

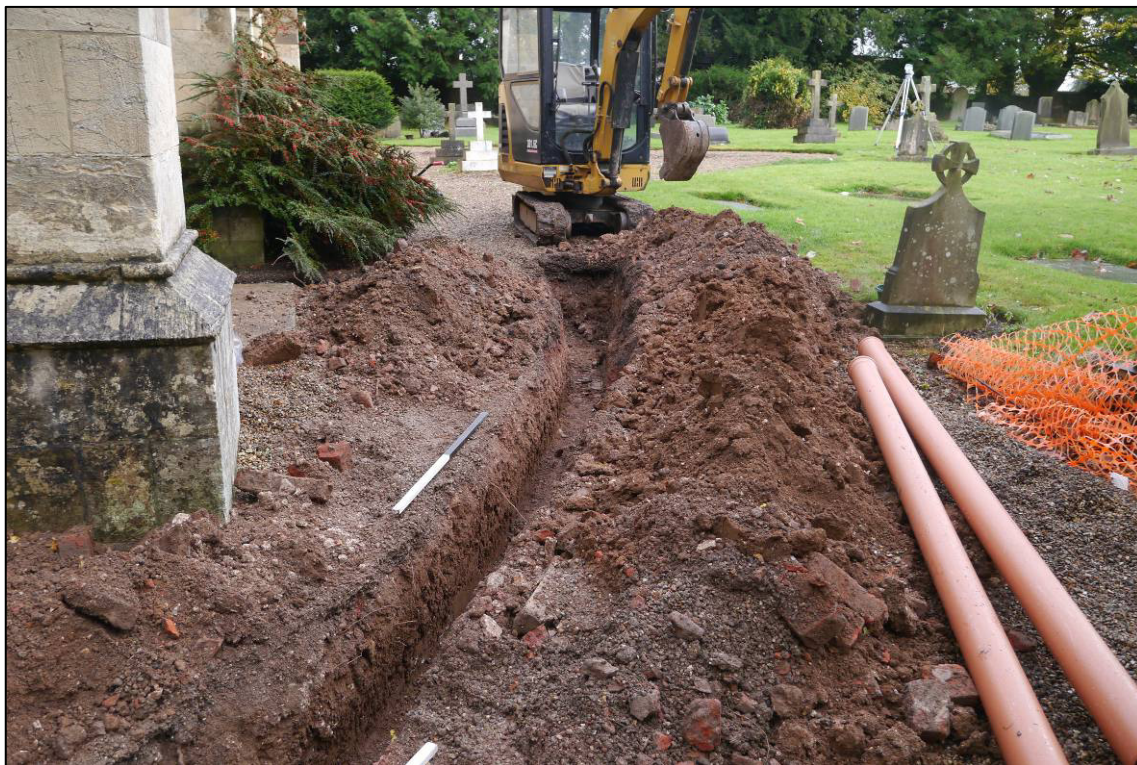
- 5.4 Trench 1 commenced at the south-west corner of the church tower, running c.13.30m to the south-east before angling sharply to the north for c.3m to meet the wall of the south aisle just to the east of the south doorway (see figure 5). Adjacent to the tower, the trench was up to 0.75m wide, with an average width of 0.35m. The trench was excavated in a number of different, discontinuous stages, using a combination of machine and hand excavation, to a maximum depth of 0.56m below ground level (BGL) (c.50.26m AOD) (see plate 3).

Plate 3: Trench 1 around south-west corner of tower under excavation, looking SE.

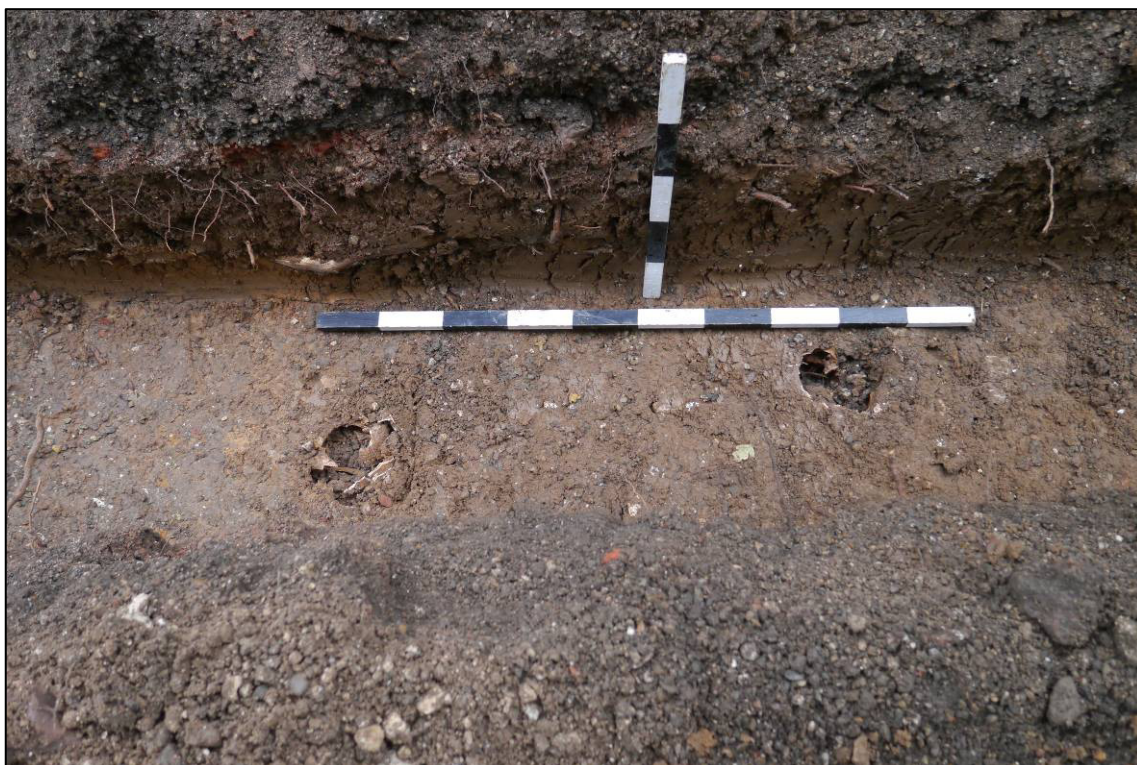
- 5.6 During the excavation, two human skulls were encountered in the base of the trench. The first (104) was located c.2m to the south-east of the south-west corner of the tower, and the second (105) c.3m to the south-east of the same point, both at a depth of 0.56m below ground level (50.51m AOD) (see plate 4). The tops of both skulls were damaged by the mechanical excavator. The area was carefully hand cleaned, but there was no discernable evidence of an associated grave cut to either skull within the clean mid-brown clayey sand (103). It was determined that the trench did not need to be excavated any deeper, and so both skulls were covered and left *in situ*. Another possible skull fragment was discovered in the base of the trench c.5m to the south-east of tower, whilst a human long bone (117) was encountered in the base of the eastern end of the trench, some 1.00m to the south of the foundations of the south aisle.

Plate 4: Exposed skulls (104 and 105), in base of Trench 1, looking NE.

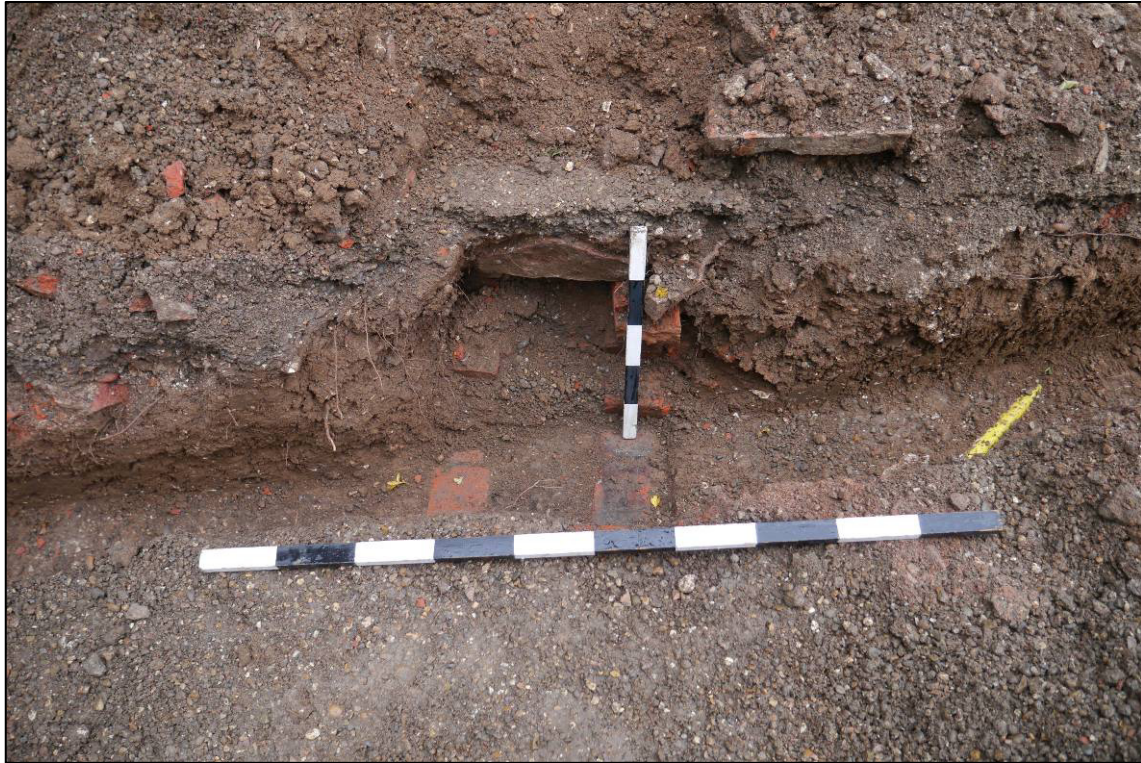
- 5.7 Approximately 7m to the south-east of the church tower, the trench was crossed by a north-east/south-west aligned brick culvert (113), 0.40m wide and defined by single-skin un-mortared brick walls either side of a central void 0.19m wide; the top of the cut was 0.06m below the ground surface (at 51.00m AOD) (see plate 5). The culvert had been cut through the sandy deposits (102) and (103) (see section 1 on figure 5). It was interpreted as an air vent emerging from the west side of the south aisle.

Plate 5: Brick culvert (113) in central section of Trench 1, looking NE.

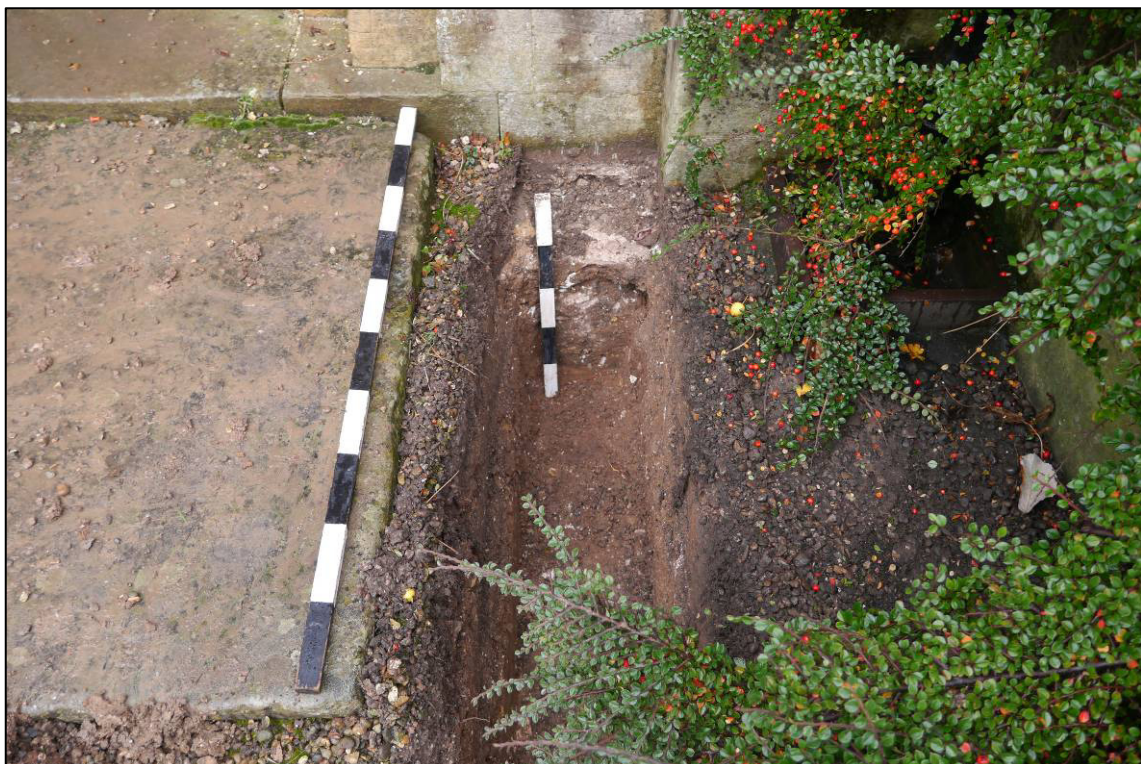
Plate 6: Foundations to south aisle wall (110, 111 and 112) at north end of Trench 1, looking N.

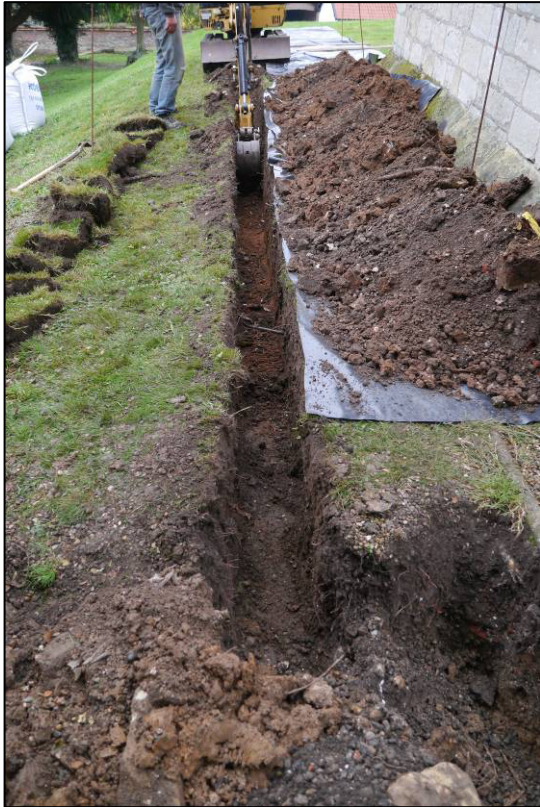
Plate 7: South part of trench 2, west side of tower, under excavation, looking N.

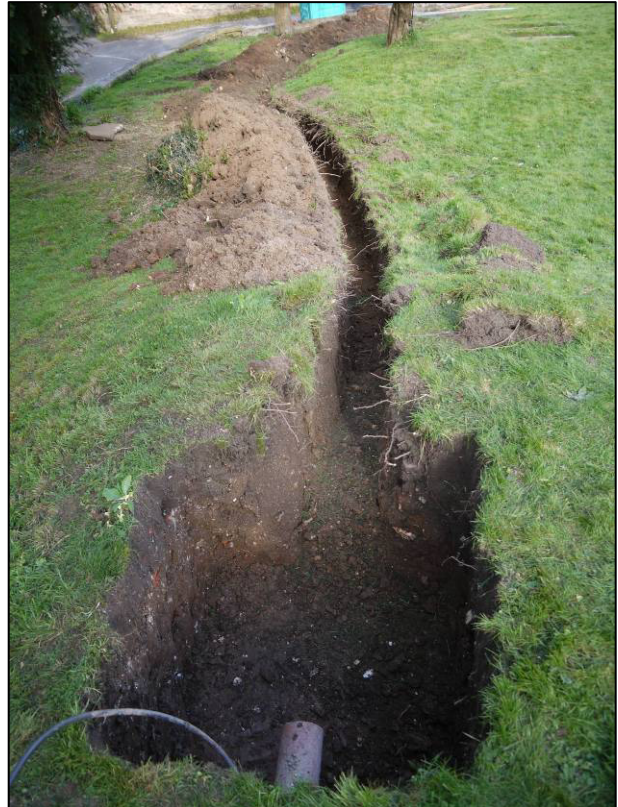
Plate 8: North part of Trench 2, showing curving alignment from central inspection chamber, looking N.

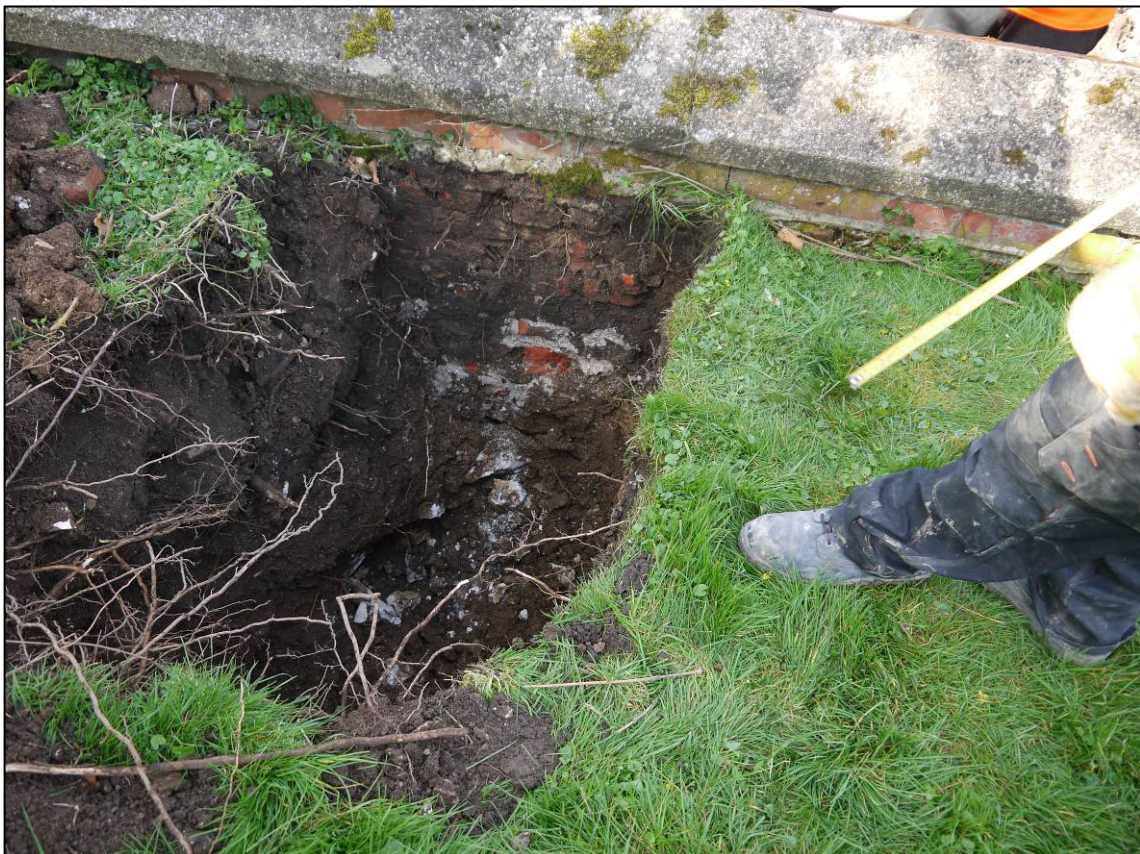
- 5.13 Within the inspection chamber adjacent the north boundary wall (115), at between 0.20m to 0.30m BGL (c.45.04m to 44.94m AOD), a loose mixed deposit of brick, stone and mid to dark brown clayey sand was observed (116), abutting the south side of the wall and extending below it; the depth of the chamber meant that detailed measurements could not be taken. The churchyard wall was topped with a 0.40m wide angled concrete capping which overhung the wall face below. The wall effectively acted as a revetment for the churchyard, with only one course of brick below the capping visible on the south side (0.30m high). On the north side, in this particular section, the wall (115) measured 1.25m high and was built of handmade brick (typical dimensions 220mm long by 50-80mm thick) in English Garden Wall bond (one course of headers for every three courses of stretcher), with a mixture of lime mortar and more modern cement mortar repairs; the upper course of bricks, below the capping, were larger more modern replacements (see section 9 on figure 6) (see plate 11). A new pipe was run under the boundary wall through the underlying revetment deposit (116) to join up with an existing drain in Church Lane.

Plate 9: Northern end of Trench 2, inspection chamber against north churchyard boundary wall (115), looking NW.

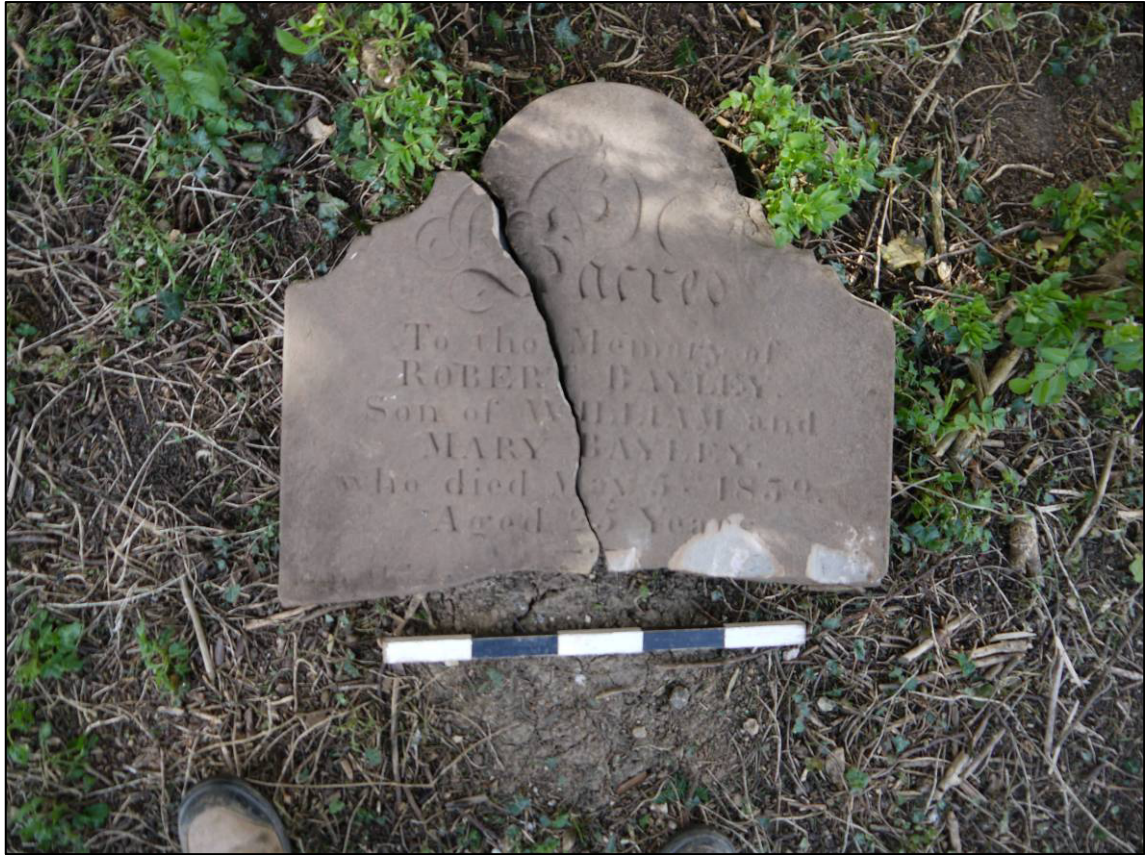
Plate 10: North part of Trench 2, ex situ broken headstone.

118	Part of an ex situ 19th century broken headstone, inscribed "Sacred / to the memory of / ROBERT BAILEY, / son of WILLIAM and / MARY BAILEY, / who died May 5th 1839 / Aged 25 years".	T2
119	Modern copper water pipe, adjacent to the north door of the tower.	T3
120	Modern electricity cable run.	T3
Internal trenches		
201	Stone paving slabs and floorboards forming internal floor surface below pews and font, typically 0.07m thick.	T4, T5 & T6
202	Mixed, loose light-mid yellow brown rubble and sand, c.0.05-0.08m thick, with small stones and brick fragments - levelling deposit between 201 and 203.	T4, T5 & T6
203	Brick sleeper walls supporting 201, aligned E-W, red handmade bricks (average dimensions 230mm x 105mm x 50mm), at least two courses high.	T4, T5 & T6
204	Consolidated light-mid yellow brown forming top of shallow void under 201.	T4, T5 & T6
205	Stone font and plinth.	T6
206	Brick rubble and cement foundation, 0.30m thick, below font 205.	T6

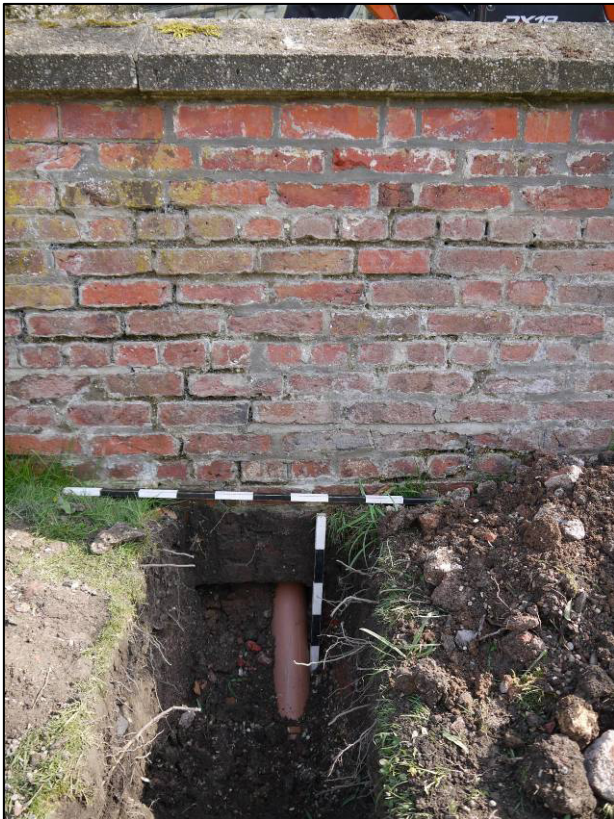
Plate 11: Drainage pipe emerging through north churchyard wall (115), looking S.

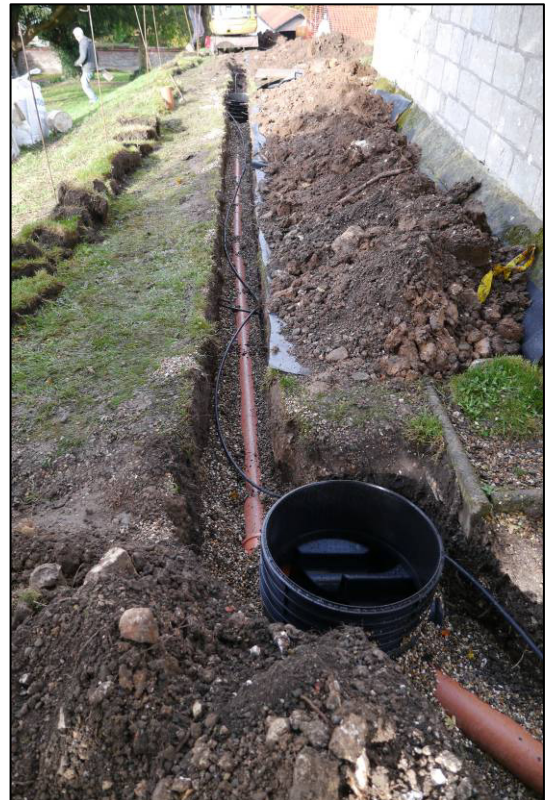
Plate 12: South end of Trench 2, prior to backfilling, looking N.

- 5.14 Once the necessary drains and other pipes had been inserted, the trench was backfilled and the turf reinstated (see plates 12 and 13).

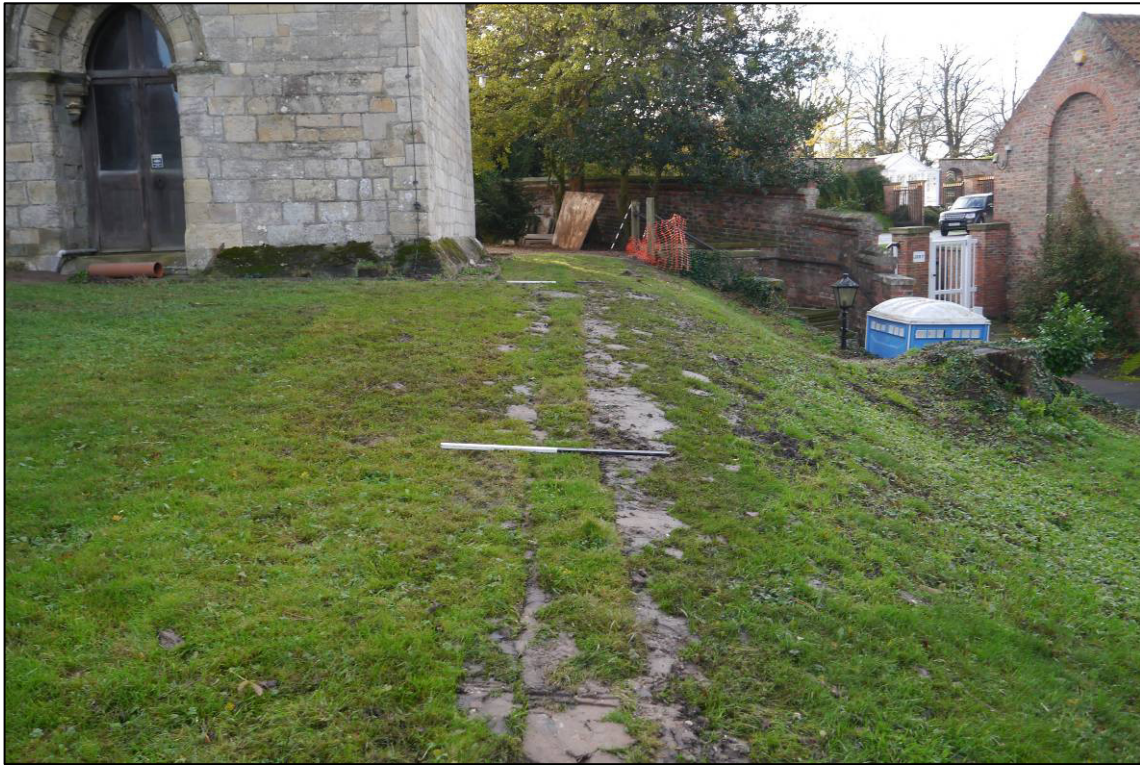
Plate 13: South end of Trench 2 after re-instatement, looking S.

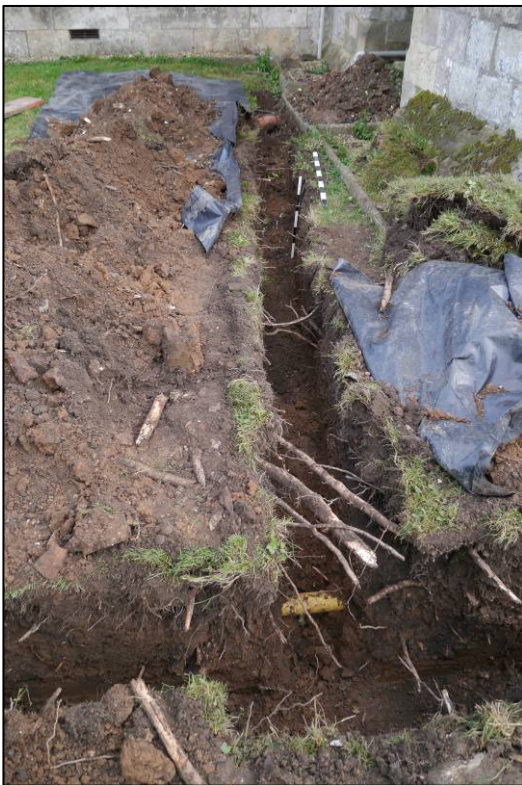
- 5.15 Trench 3 was aligned broadly east-west, measuring c.5m long, and running at a slight angle to the north side of the church tower; it ran from the east side of the doorway to the east side of Trench 2. The trench had an average width of 0.30m, and was dug by a combination of machine and hand excavation to a maximum depth of 0.30m BGL (c.50.46m) (see plate 14).

Plate 14: Trench 3 under excavation, looking E.

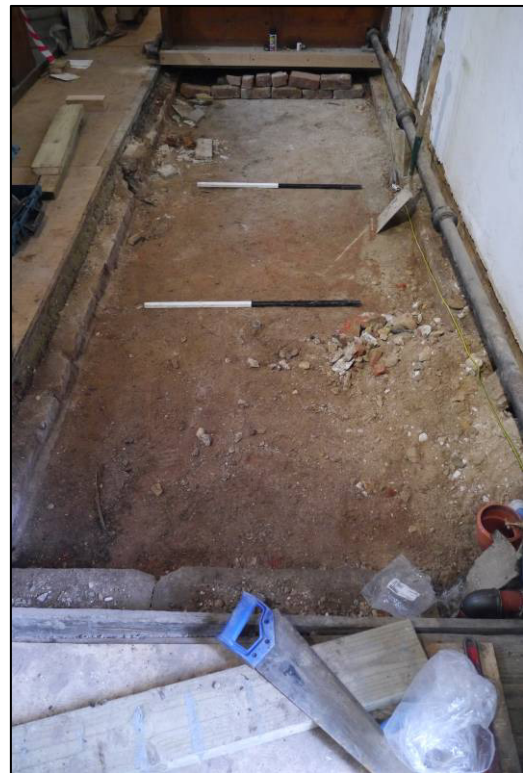
- 5.18 Trench 4 was located at the west end of the nave, on the south side of the westernmost pier of the north arcade. It was aligned north-south, with maximum measurements of 2.74m by 1.80m, and was excavated to a maximum depth of 0.25m BGL (see plate 16). Trench 5 was also located at the west end of the nave, to the south of Trench 4 and to the north of the westernmost pier of the south arcade. It was aligned north-south, with maximum measurements of 2.63m north-south by 1.81m east-west, and was excavated to a maximum depth of 0.28m BGL (see plate 17). Trench 6 was positioned to the south of Trench 5, at the west end of the south aisle, to the immediate east of the south doorway and against the south wall. It was aligned east-west, measuring 4.75m east-west by 1.80m north-south, and was excavated to a maximum depth of 0.22m (see plate 15).

Plate 15: Trench 6, showing floor deposit (204) and sleeper walls (203), looking E

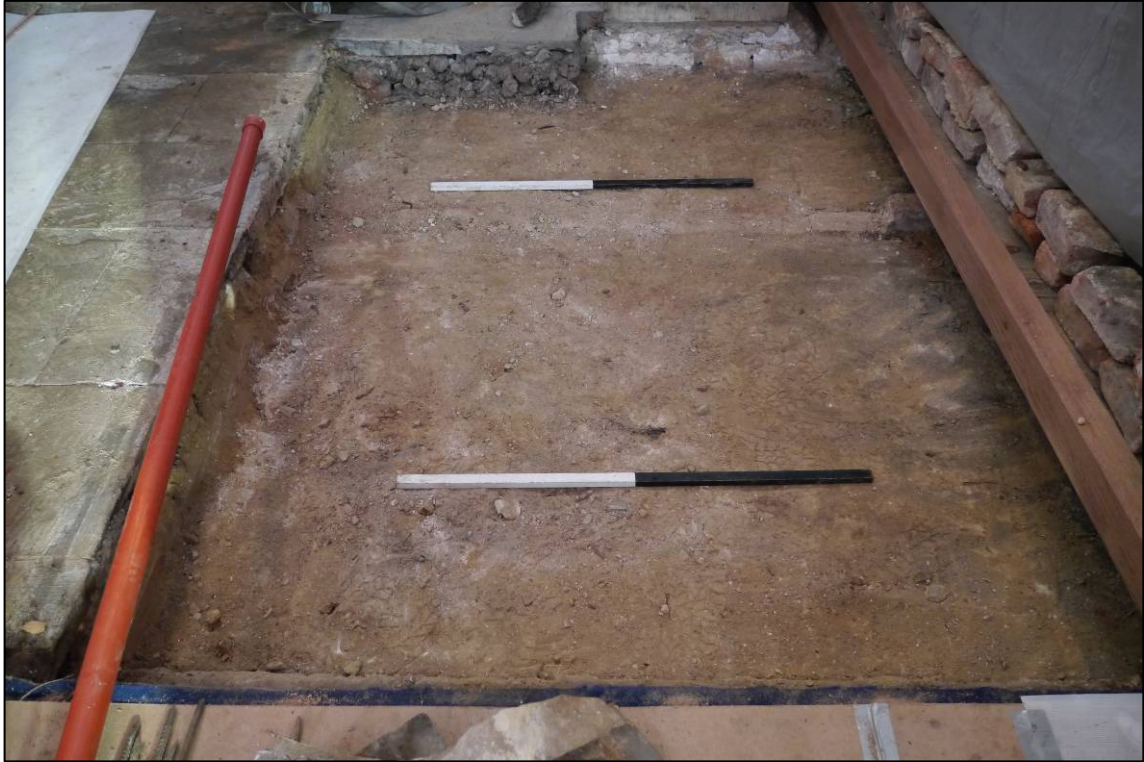
Plate 16: Trench 4, showing floor deposit (204), looking N.

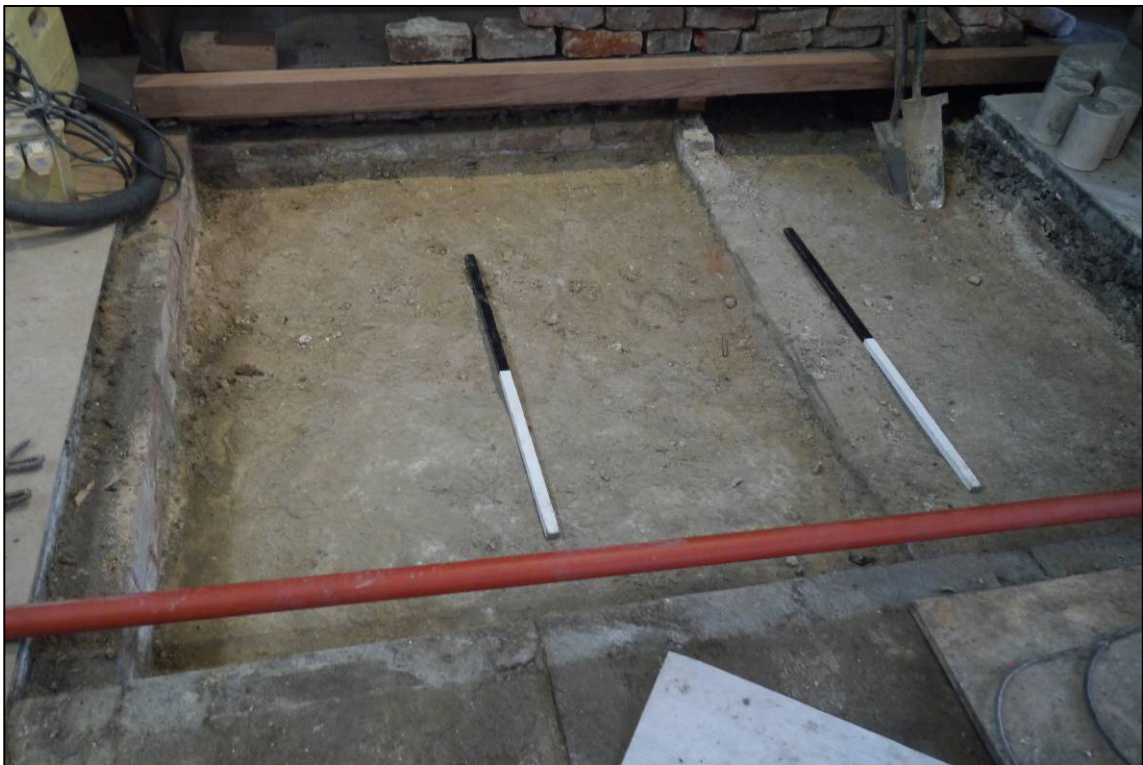
Plate 17: Trench 5, showing floor deposit (204 and sleeper walls (203), looking E.

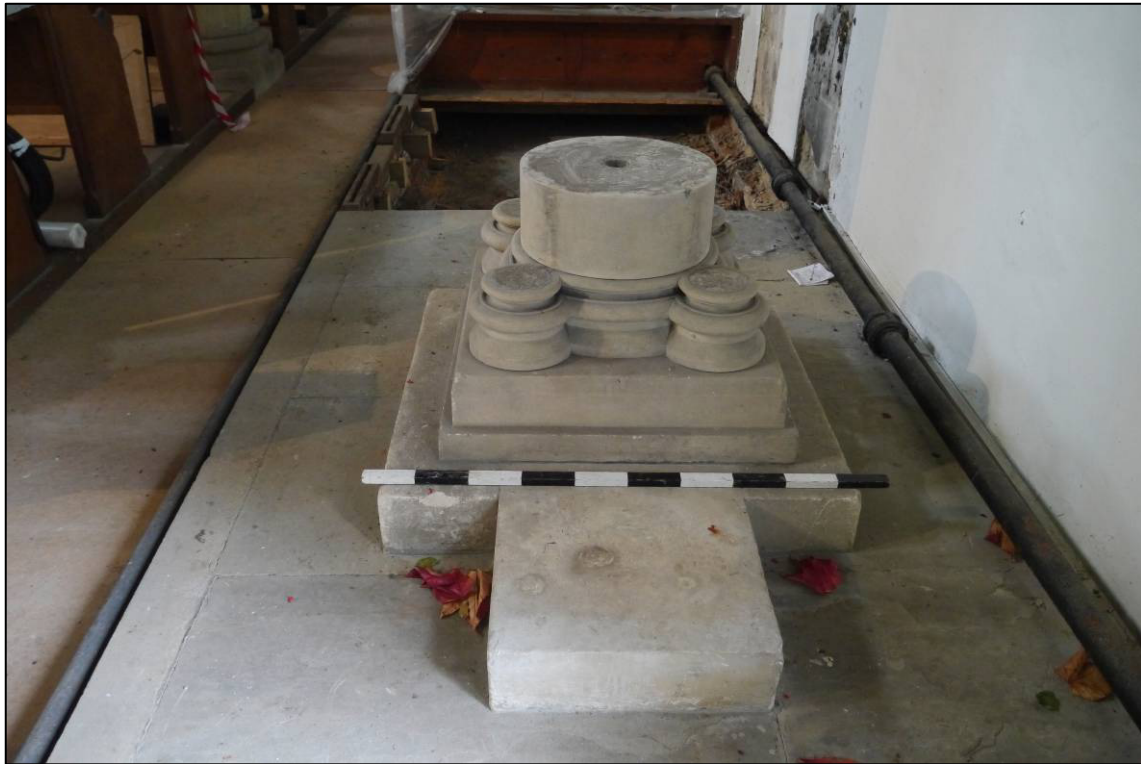
Plate 18: West end of Trench 6, prior to removal of font base, looking E.

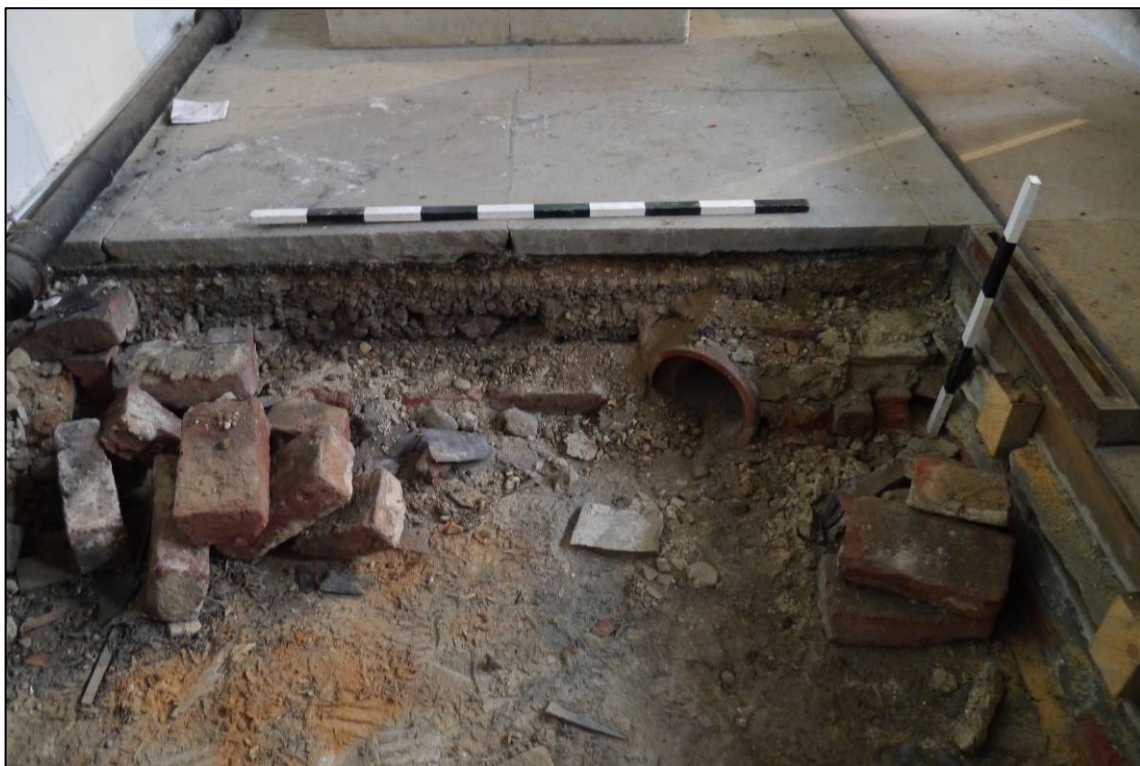
Plate 19: Trench 6, after removal of floorboards (201), showing vent (207) within foundation (206), looking W.

207	Salt-glazed ceramic pipe, 0.20m diameter, running through 206, venting the void beneath 201.	T6
