ERECTION OF INTERPRETATION BOARDS,
DEEP GROVE QUARRY, FOSS CASTLE
AND OLD MULGRAVE CASTLE,
LYTHE, NORTH YORKSHIRE

ARCHAEOLOGICAL OBSERVATION,
INVESTIGATION AND RECORDING

Report no: 2020/615.R01
Version: Final
Date: December 2021
Author: Ed Dennison

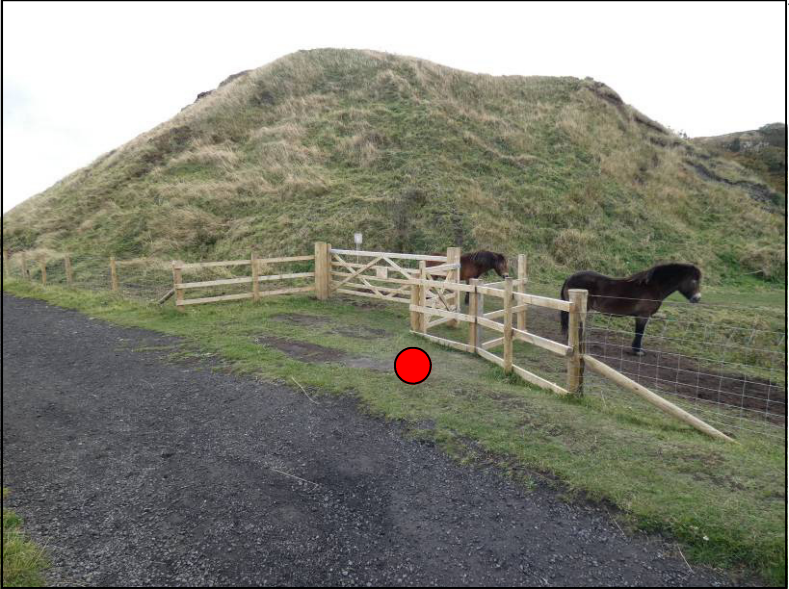
PROJECT MULGRAVE ESTATE INTERPRETATION	
TITLE FOSS CASTLE BOARD LOCATION	
SCALE 1:1250	DATE DEC 2021
EDAS	FIGURE 3

- 2.6 The Foss Castle interpretation board lies adjacent to the entrance into the site, on the east side of a public footpath which runs south from High Leas farm to cross the Barney Beck (at NGR NZ 83120 11752) (see figure 3); the site was first scheduled on 11th March 1974 (SM 20536; NHLE 1018286). The board uses text, photographs, a LIDAR (light detection and ranging) survey image, l'Anson's 1913 archaeological survey and a reconstruction drawing of a similar site at Driffield (East Yorkshire) to explain the function and likely layout of the motte and bailey castle.

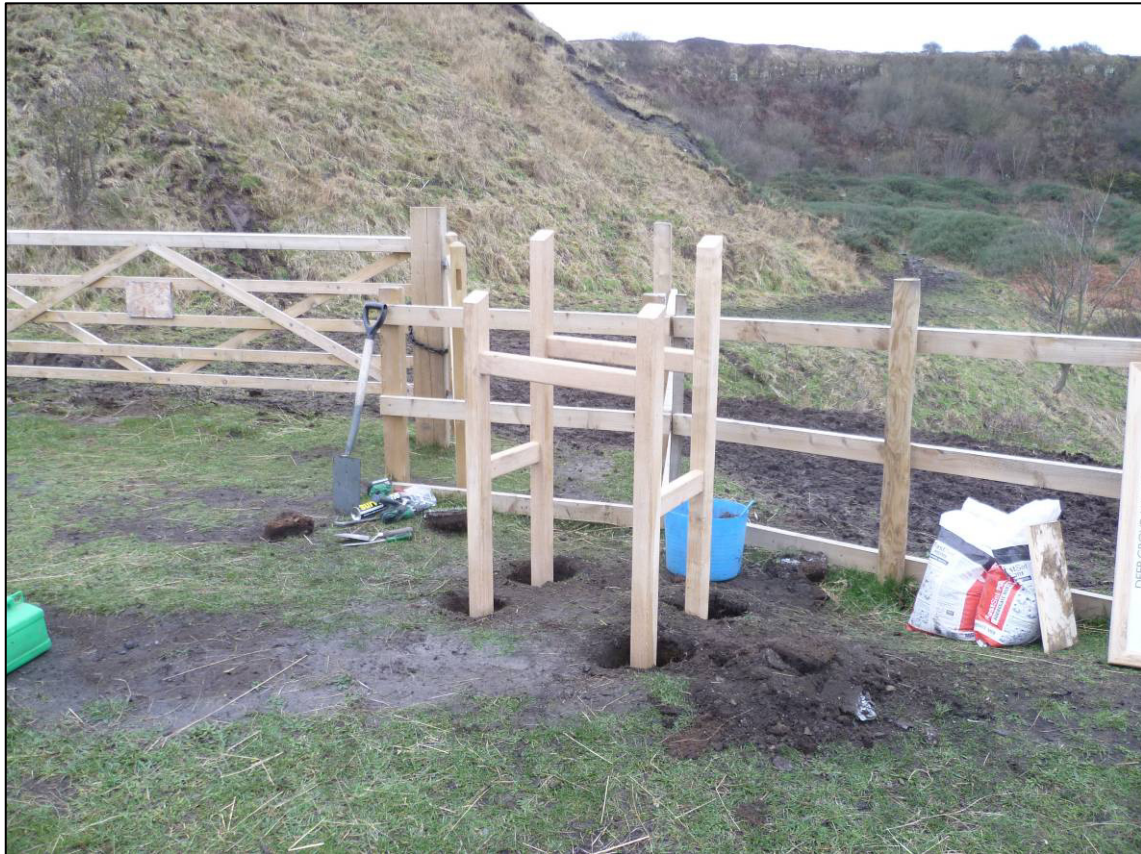
Plate 1: Installation of Deep Grove quarry interpretation board, looking SW.

- 5.1 As noted above, four small holes were excavated for the leg supports of this board, on the south-west side of the former Whitby to Middlesborough railway track, adjacent to recently installed fencing and gates, towards the south-east corner of the former quarry (at NGR NZ 85764 13863) (see plate 1). The four holes lay at the corners of a rectangle measuring 730mm by 430mm, on a north-west/south-east alignment, and all the holes measured 300mm square by 250mm deep (see plate 2 and figure 5 top).

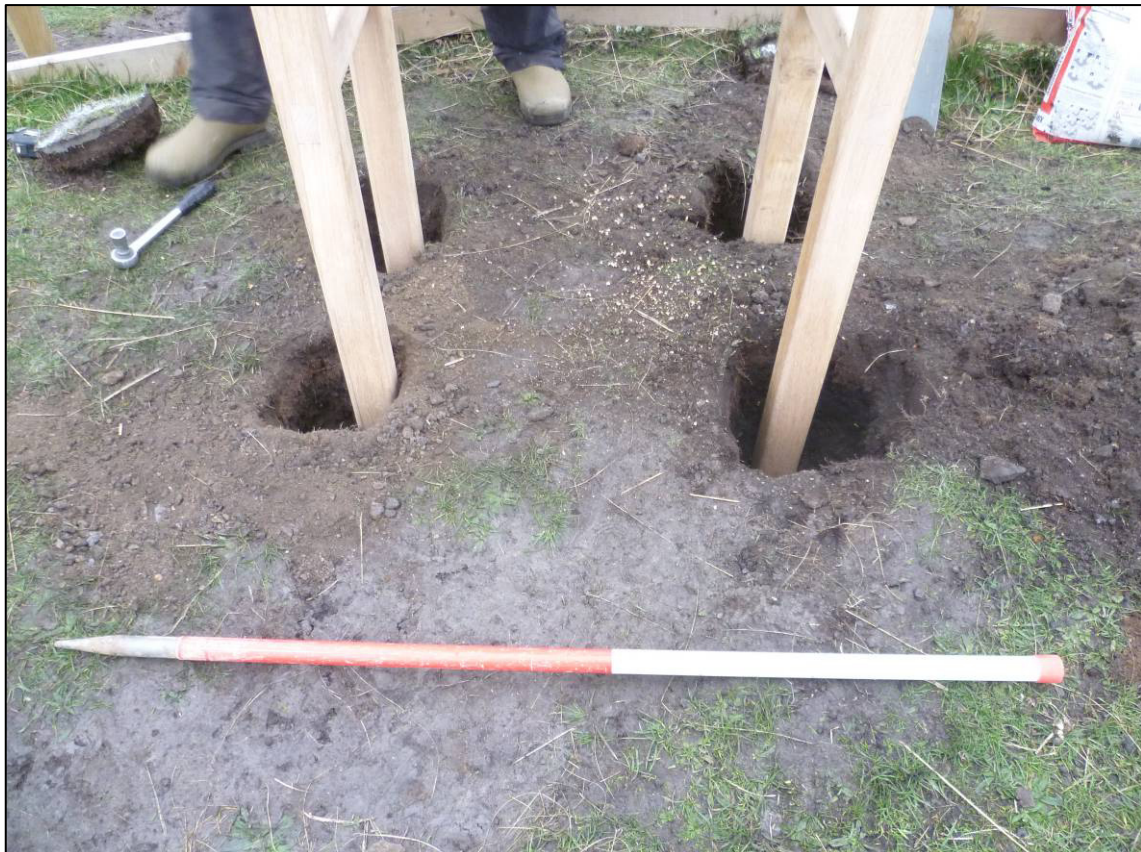
Plate 2: Excavated holes for leg supports, Deep Grove quarry interpretation board, looking W.

- 5.2 The deposits in all four holes at this location were the same. A 20mm thick layer of loose dark brown-black turf and topsoil (101) overlay a loose friable brown-black clay soil containing some small stones and clay lenses (102) which extended beyond the bottom of the hole; this deposit represented the eroded top layer of the former railway track. Towards the base of the south-east hole, a small rusted and corroded iron fragment, c.160mm long by c.0.55m diameter, was uncovered and removed from the hole (see plate 3) - this almost certainly represents the remains of a railway spike, which would have been used to secure a rail base plate to one of the wooden railway sleepers. It was not retained.

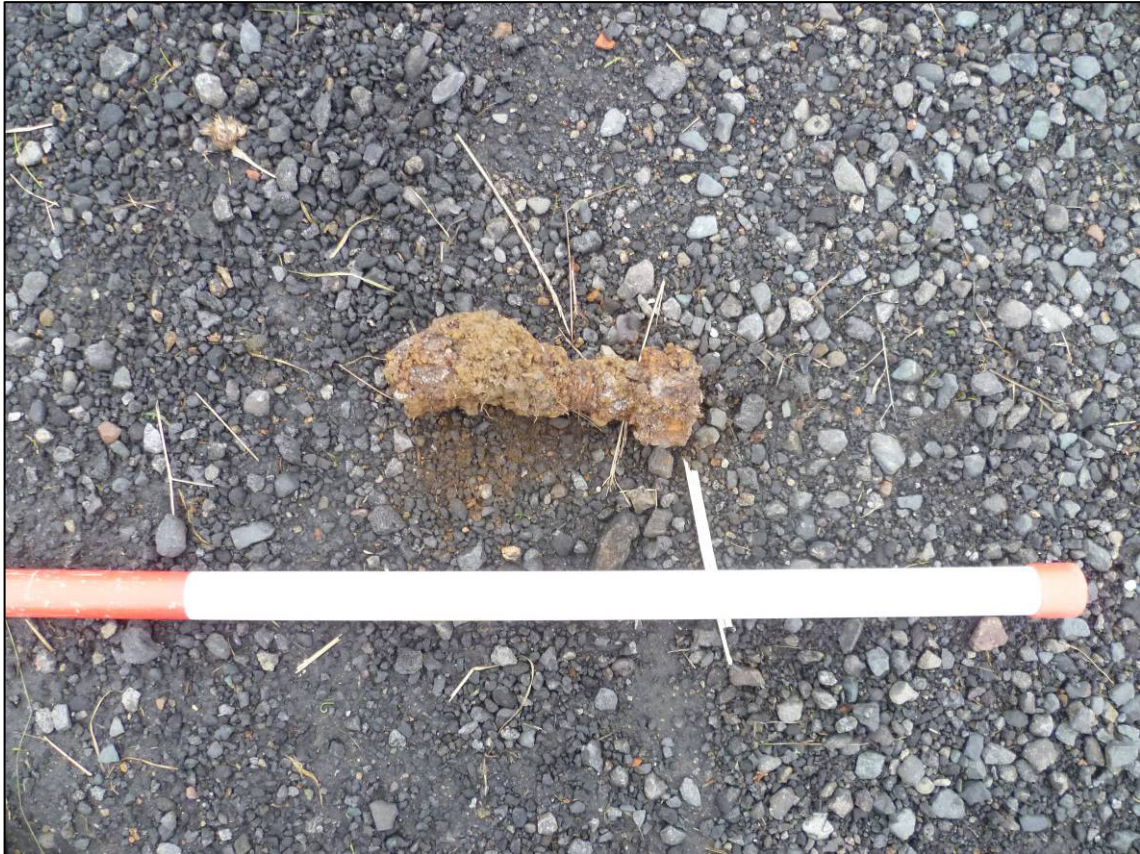
Plate 3: Corroded iron railway spike recovered from Deep Grove quarry interpretation board excavations.

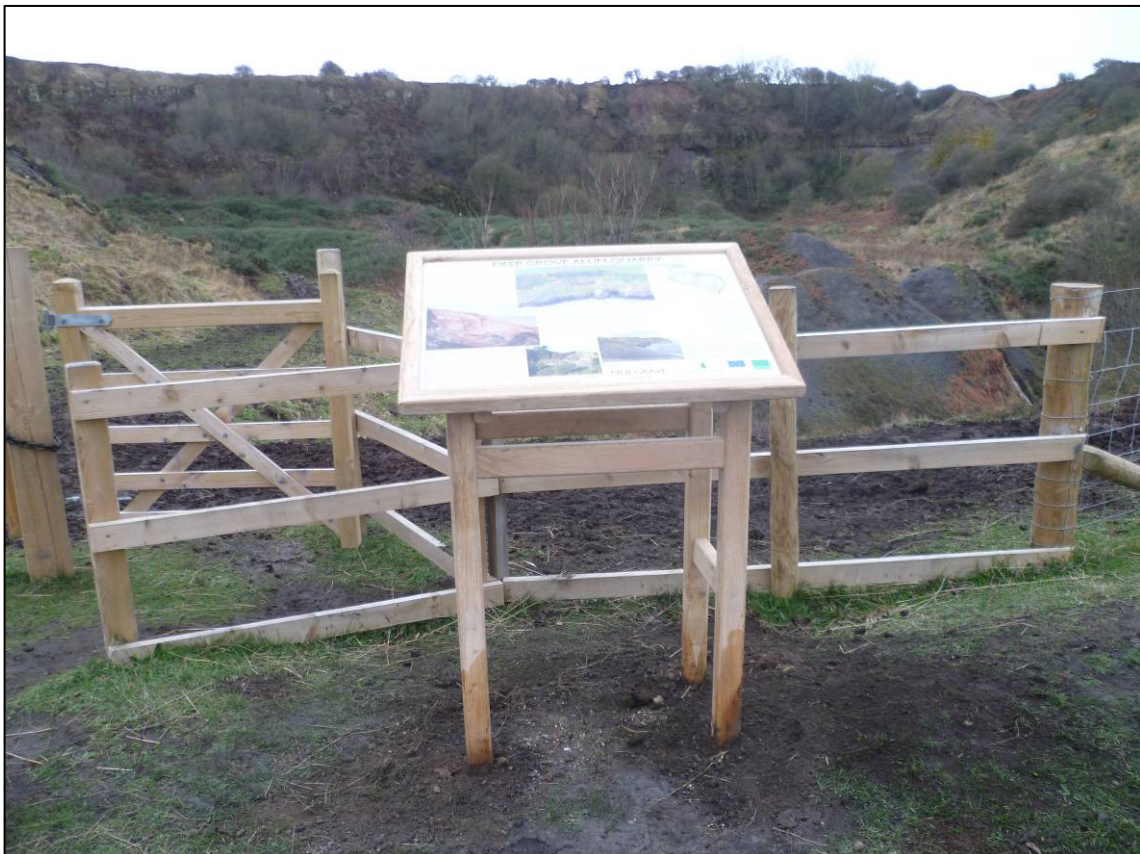
Plate 4: Installed Deep Grove quarry interpretation board, looking W.

- 5.3 Once the leg supports were in place, the sloping stand containing the information board, which was printed directly onto di-bond for durability and backed by a

marine ply backing sheet, was screwed into place. The whole structure was then levelled, and the leg supports were concreted into the ground; the top 20mm-30mm of each hole was filled with excavated soil to avoid any unsightly concrete etc (see plate 4).

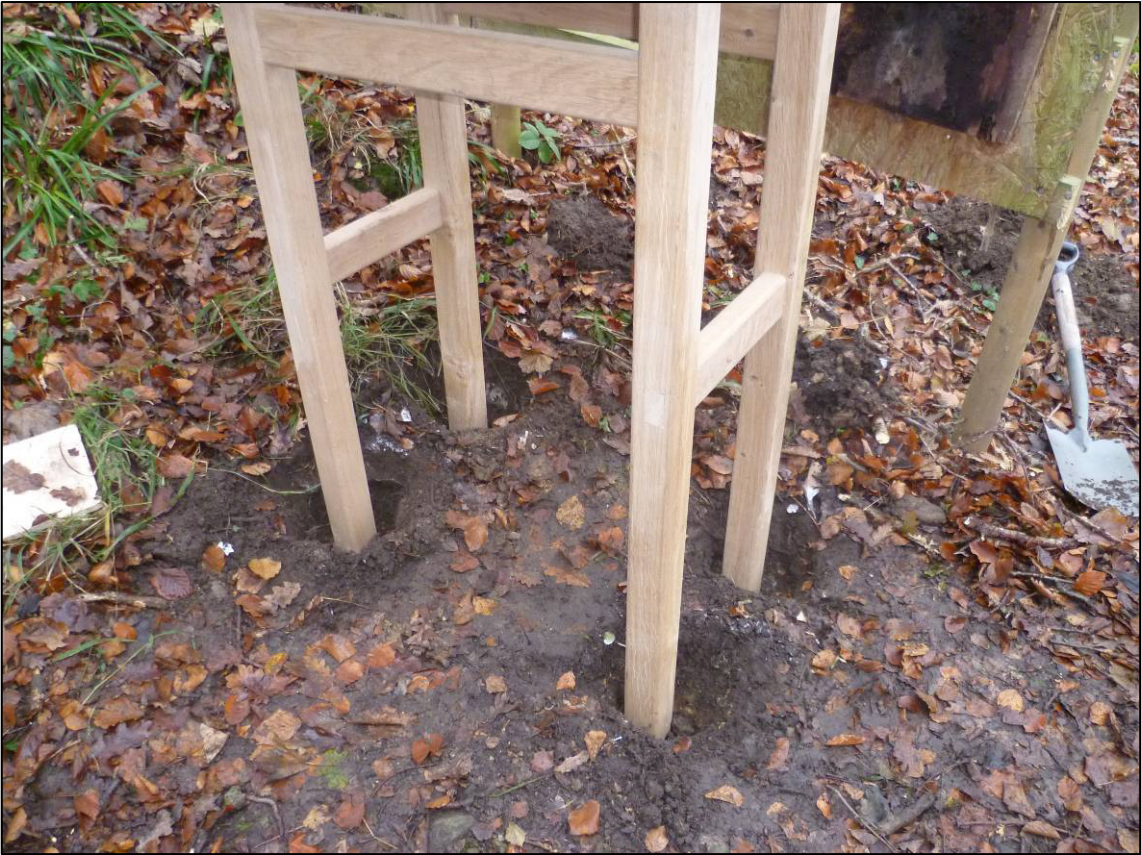
Plate 5: Excavated holes for leg supports, Foss Castle interpretation board, looking NE.

- 5.4 Once again, four small holes were excavated for the 65mm square leg supports of this board, on the east side of the public footpath which passes along the west side of the castle, adjacent to the entrance to the site (at NGR NZ 83120 11752). The four holes lay at the corners of a rectangle measuring 0.73m by 0.43m, with a north-west/south-east alignment, and all the holes measured 250mm square; the northern holes were excavated to a depth of 300mm to take account of the sloping ground while the southern holes were 250mm deep (see plate 5).

- 5.5 Only one deposit was recorded in all the holes, a relatively hard packed dark brown clay soil containing frequent small stones and pebbles as well some larger stones (201). This deposit extended below the base of the holes. No finds or other datable material was recovered.

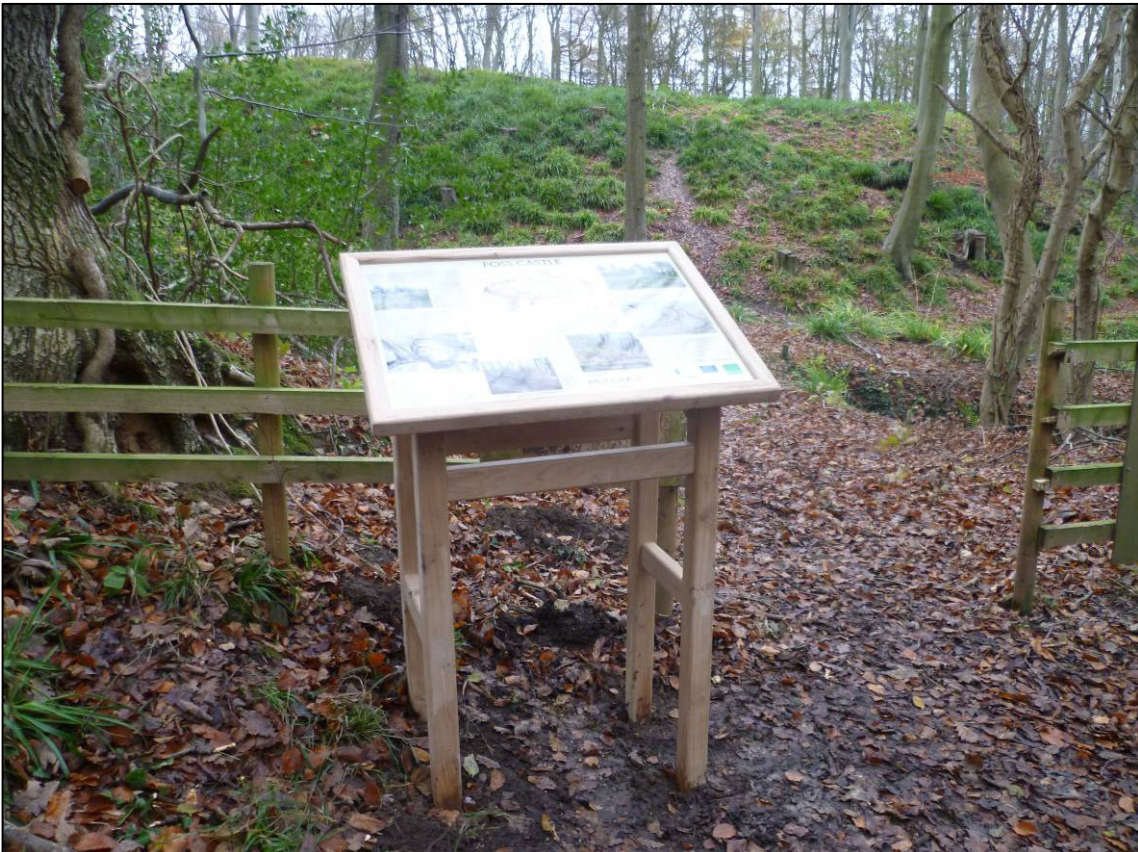
Plate 6: Installed Foss Castle interpretation board, looking E.

- 5.6 As with the previous panel, the sloping stand was screwed onto the base, the structure was levelled, and the leg supports were concreted into the ground; the top 20mm-30mm of each hole was filled with excavated soil to avoid any unsightly concrete etc (see plate 6).

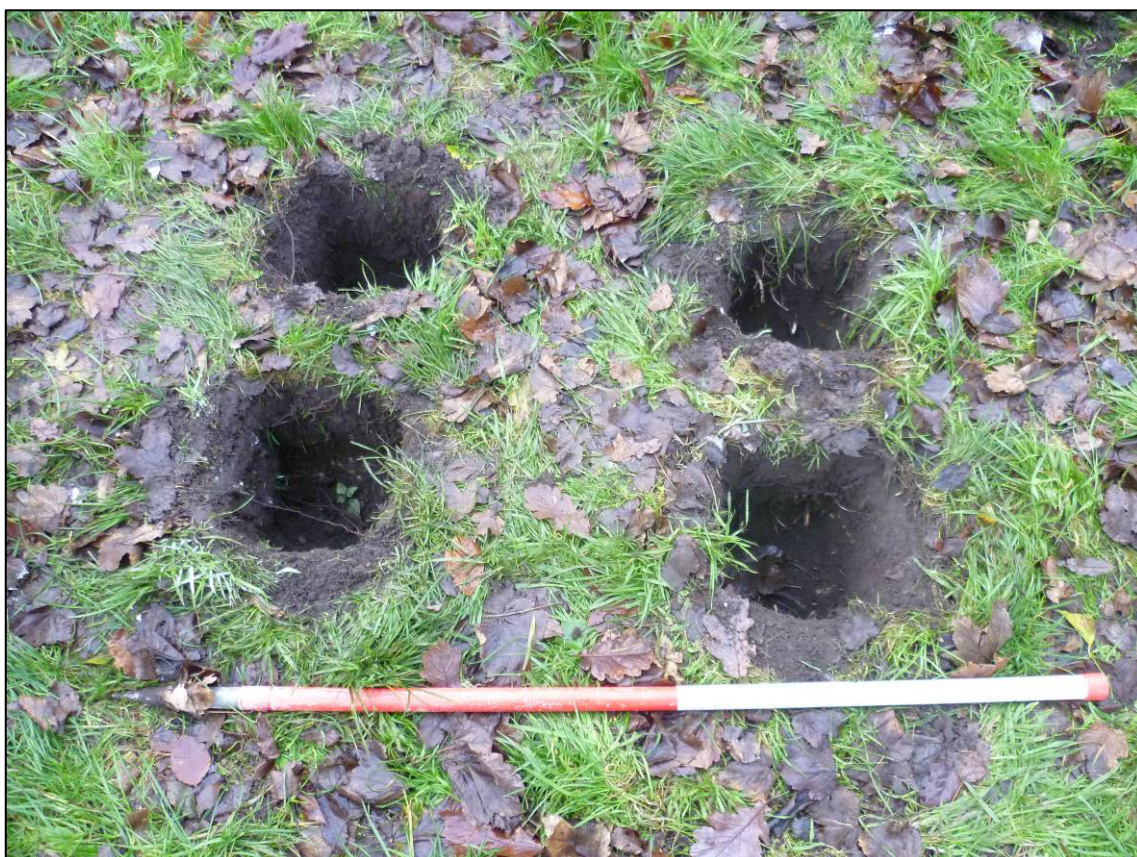
Plate 7: Excavated holes for leg supports, Old Mulgrave Castle interpretation board, looking E.

- 5.7 This interpretation board was placed within the castle enclosure, a short distance to the north-east of the surviving well structure and on the 'desire line' between the castle entrance and the ruined tower (at NGR NZ 83918 11681). The four holes lay at the corners of a rectangle measuring 730mm by 430mm, with a north-north-east/south-south-west alignment, and all the holes for the 65mm square leg supports measured 250mm square and were excavated to a maximum depth of 250mm (see plate 7 and figure 6 bottom).

- 5.8 Only one deposit was recorded in all the holes, a loose dark brown clay topsoil containing occasional small stones and roots from an adjacent tree (301); this deposit extended below the base of the holes. This deposit is likely to represent material resulting from the landscaping of the interior following the 1995-2000 repair and consolidation work.

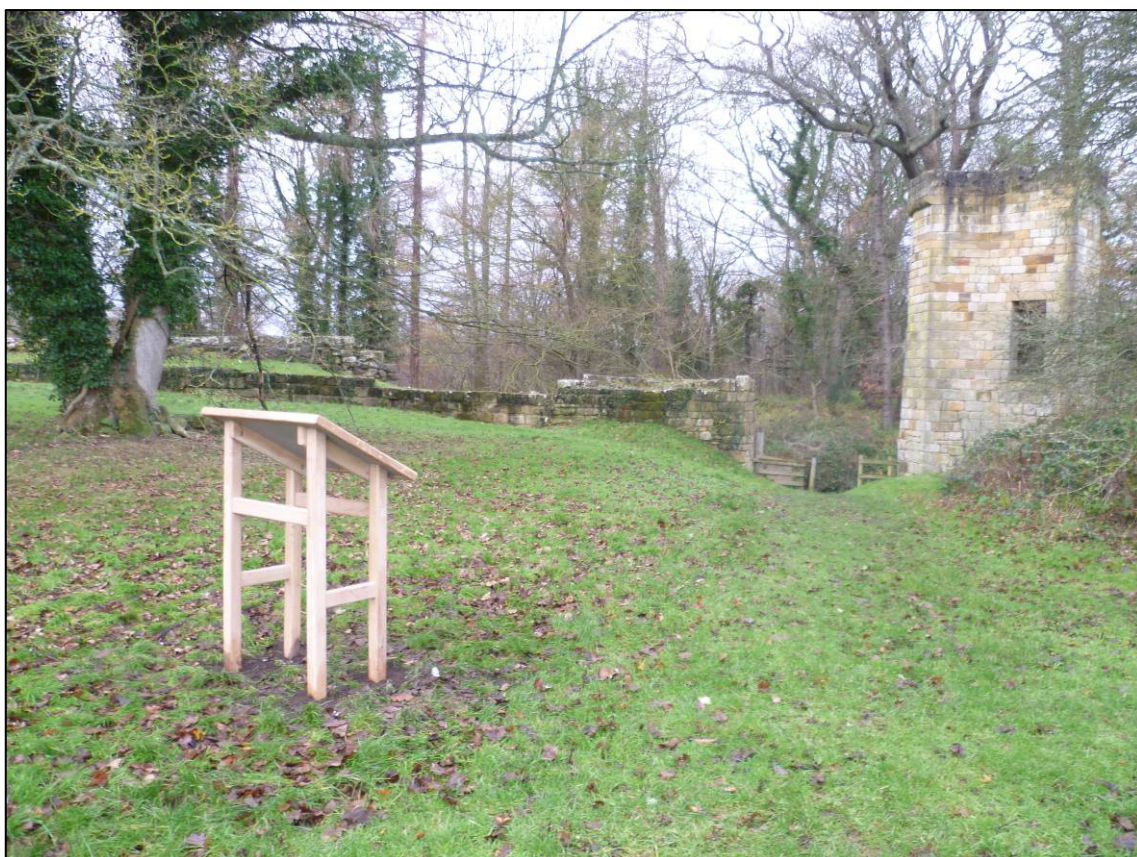
Plate 8: Installed Old Mulgrave Castle interpretation board, looking W.

- 5.9 As before, the sloping stand was screwed onto the base, the structure was levelled, and the leg supports were concreted into the ground; the top 20mm-30mm of each hole was filled with excavated soil to avoid any unsightly concrete etc (see plates 8 and 9).

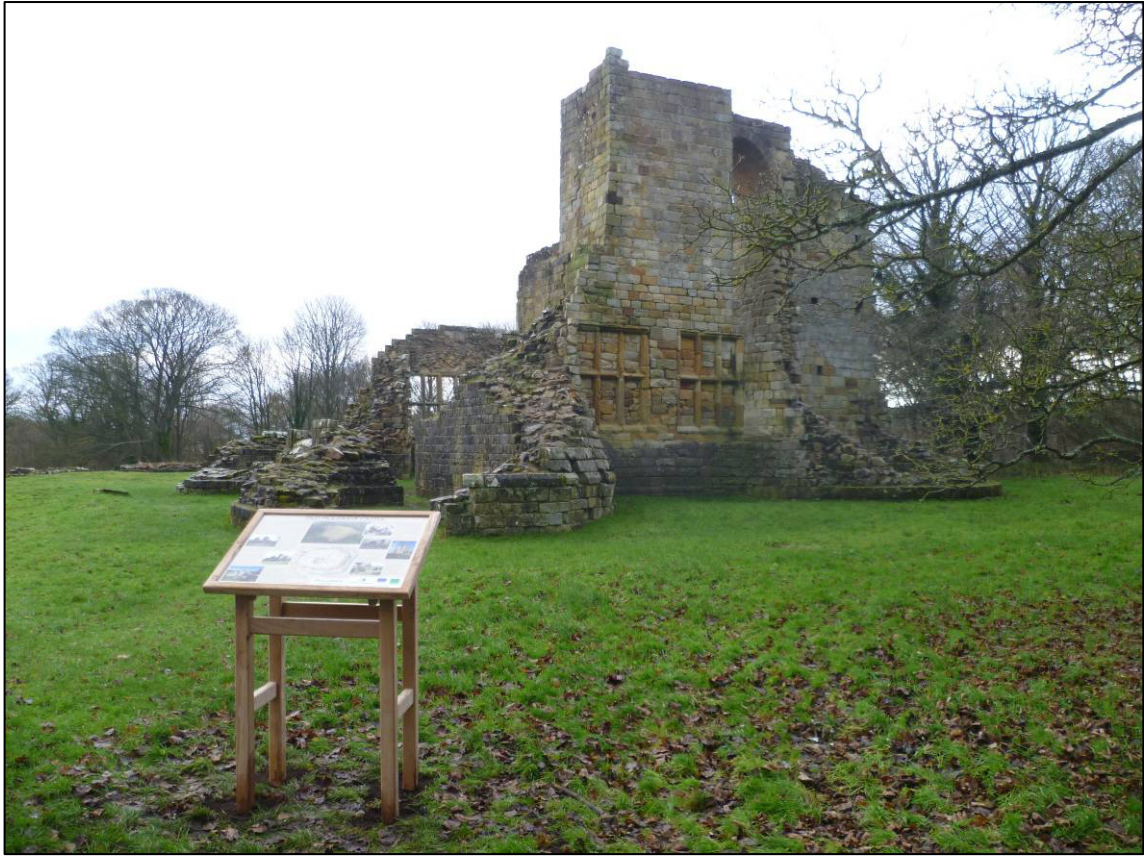
Plate 9: Installed Old Mulgrave Castle interpretation board, looking E.
