INSTALLATION OF A PAINTED MURAL,
NO. 47 FLOWERGATE,
WHITBY, NORTH YORKSHIRE YO21 3BB

DESIGN, ACCESS AND HERITAGE STATEMENT

Report no: 2021/646.R01
Version: Final
Date: August 2021
Author: Ed Dennison & Shaun Richardson

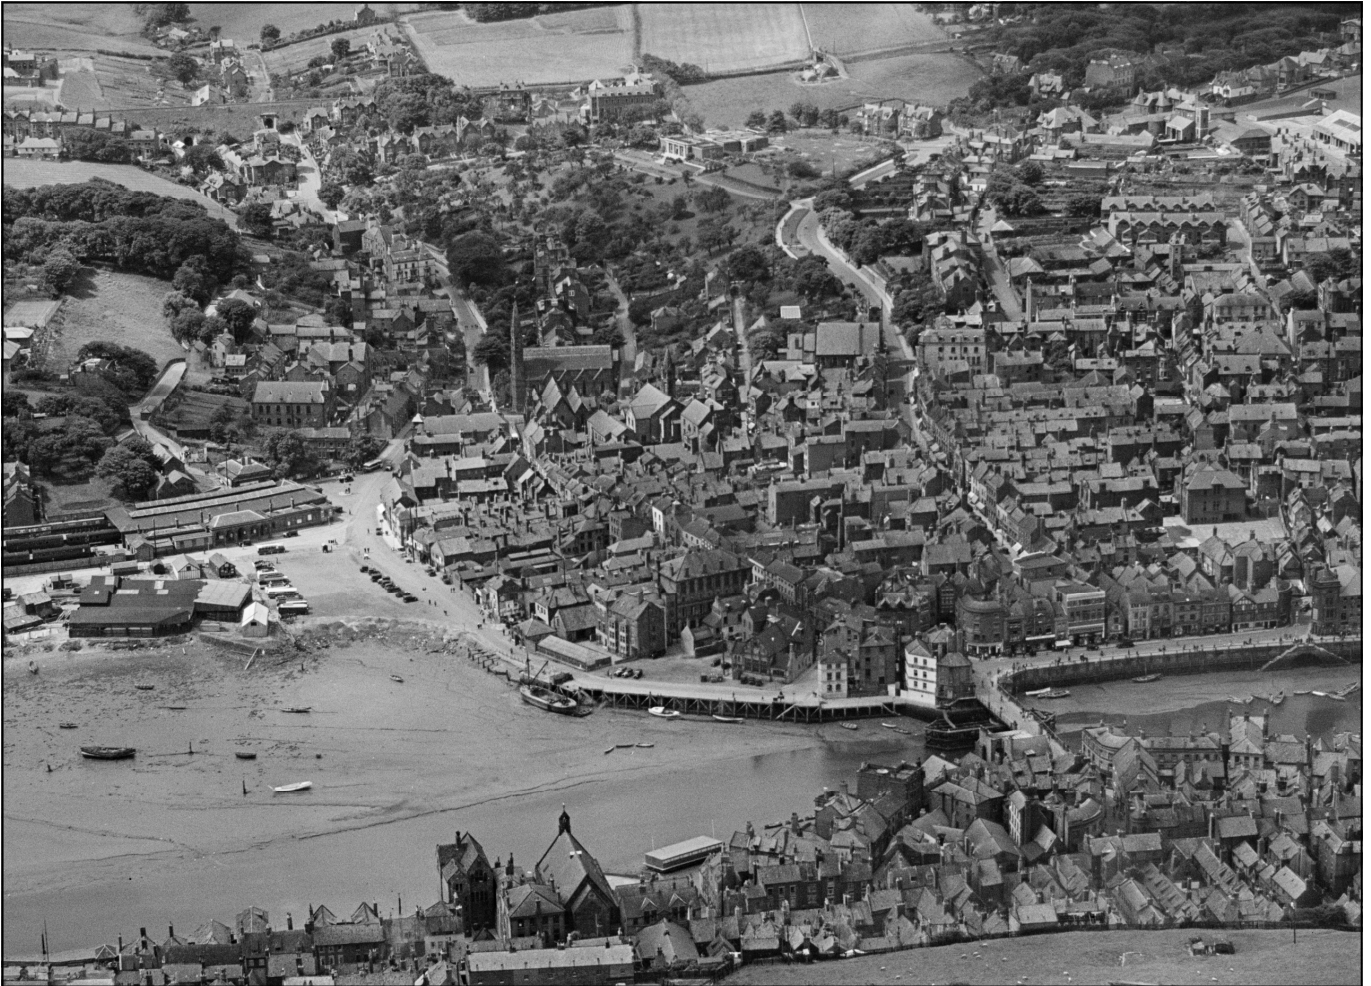
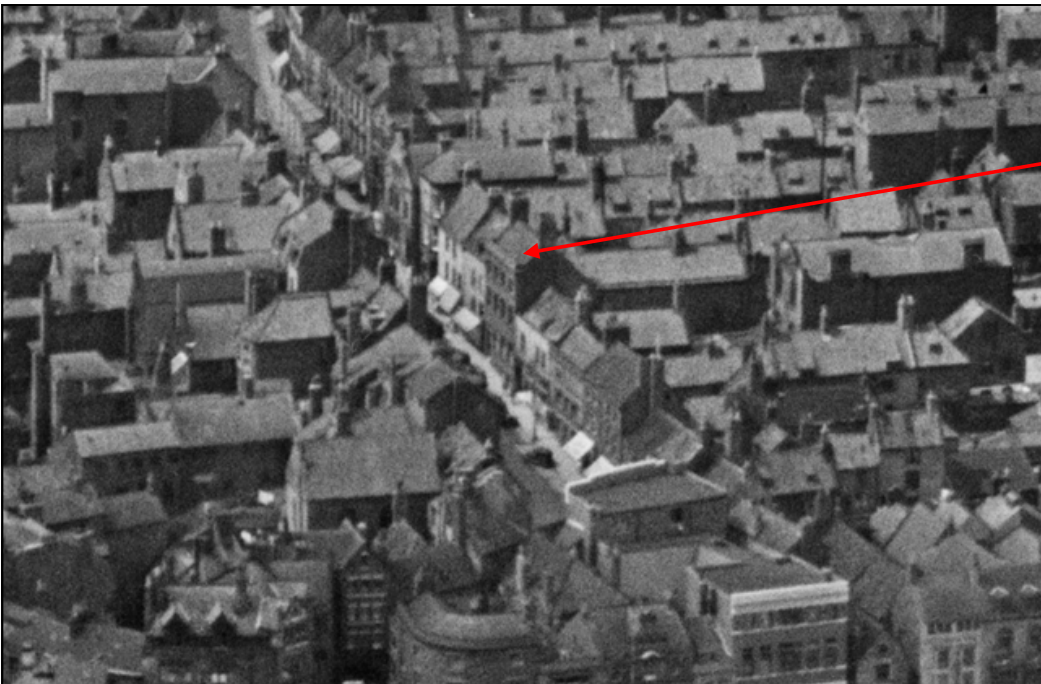
PROJECT		47 FLOWERGATE, WHITBY	
TITLE		1932 AERIAL PHOTOGRAPH	
SCALE	NTS	DATE	AUG 2021
EDAS		FIGURE	7

No. 47 Flowergate is the three storey dark coloured building with two end stacks.

Oblique black and white aerial photograph showing New Quay and the town, Whitby, taken July 1932.

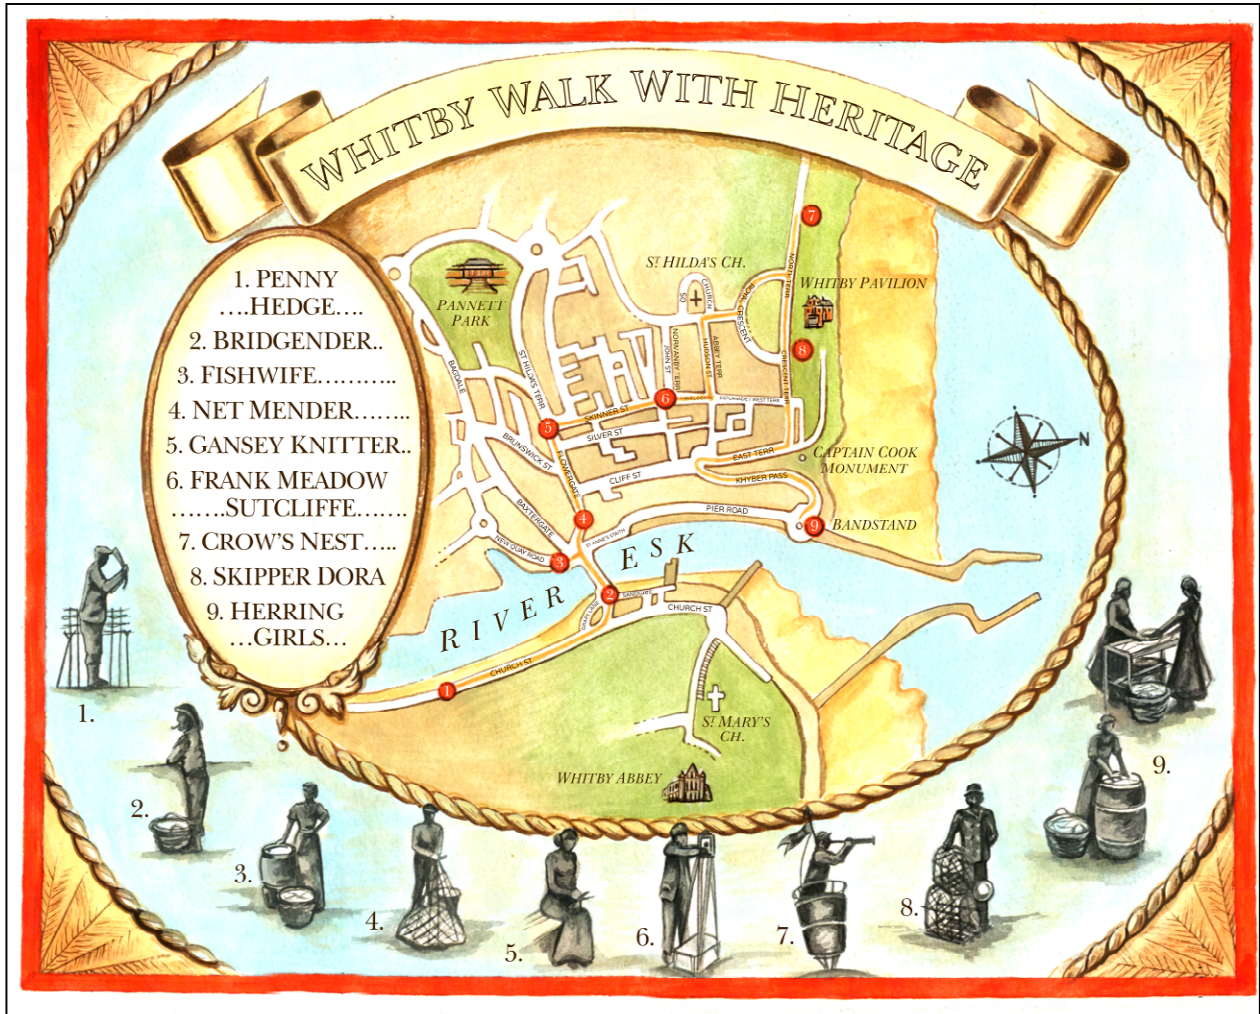
PROJECT		47 FLOWERGATE, WHITBY	
TITLE		PROPOSED MURAL	
SCALE	NTS	DATE	AUG 2021
EDAS		FIGURE	8

Mural measures 4.2m wide by 3.2m high.

- 7.3 The mural will measure 4.20m wide by 3.20m in height, and has been created as four separate wooden panels which are designed to join together to create a single image (see figure 8). A method statement for the installation of the mural has been produced by the Council's contractors (see Appendix 4). Rather than fixing the mural directly to the gable, tanalised wooden battens outlining its shape will be fixed to the wall face using stainless steel wall bolts; it is envisaged that some 28 bolts will be needed. The mural will then be mounted on the wooden framework so that it protrudes c. 60mm from the wall face. A mock-up of the position of the mural on the gable has been provided by Scarborough BC (see figure 9).

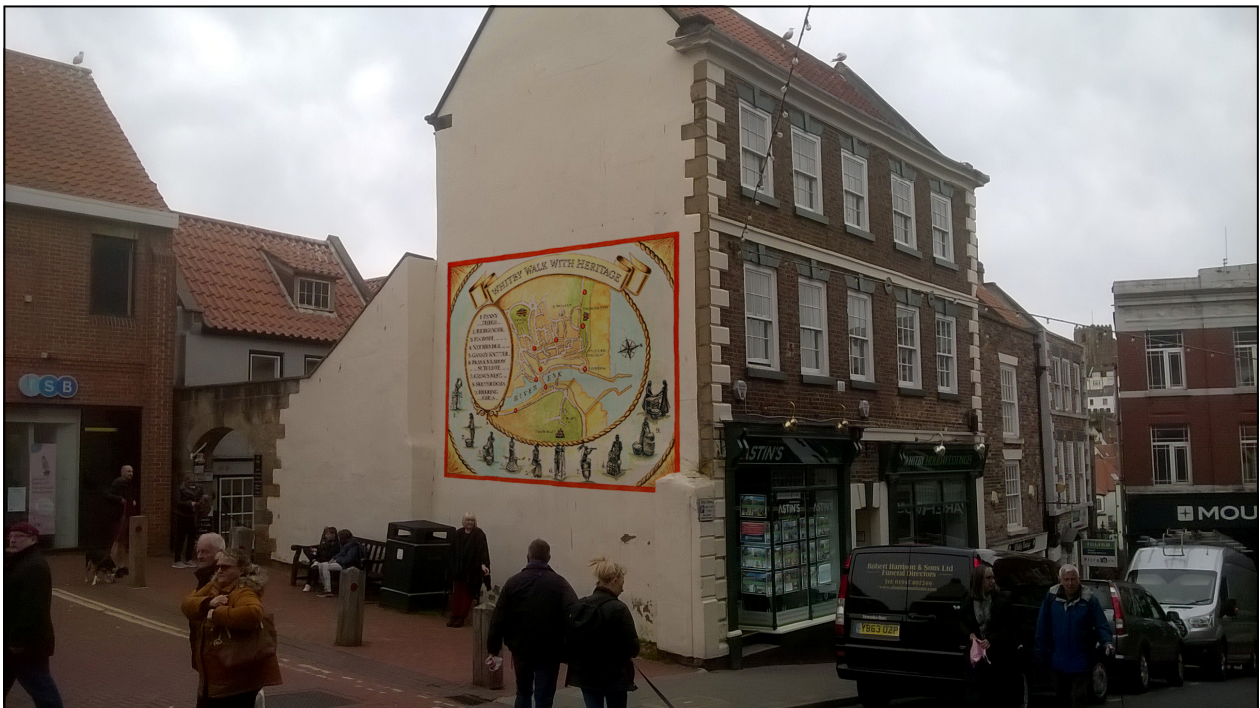
PROJECT		47 FLOWERGATE, WHITBY	
TITLE			
		PROPOSED MURAL MOCK-UP	
SCALE	DATE		
NTS	AUG 2021		
EDAS		FIGURE	9

West gable of no. 47 Flowergate with indicative position of mural (re-located Astin's advertising hoarding not shown).

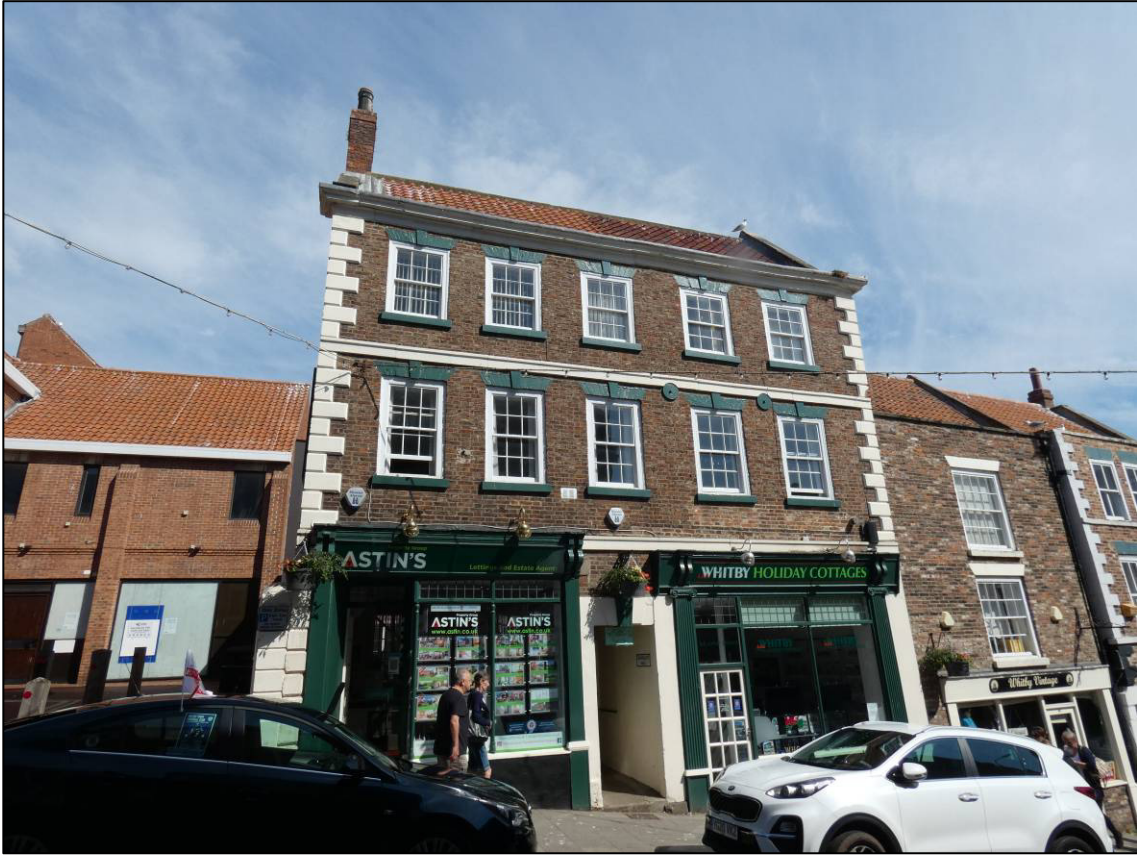
Plate 1: No. 47 Flowergate, south elevation, looking N.

- 6.4 The principal elevation faces south onto Flowergate and is of five bays (see plate 1). To the ground floor, the central bay is occupied by a passage leading through to a small rear court; the passage has a rusticated arch with triple keystone. To the east of the passage, no. 48 has a modern shop front incorporating the remains of 19th century pilasters. To the west of the passage, no. 47 has a 19th century shop front. A painted stone band is visible above the shop front of no. 48 which extends across the full elevation. There are five windows to the first floor, one to each bay, each having a painted brick arch with keystone and fitted with double-hung 12-pane (6 over 6) sashes set flush to the elevation face. Above the first floor windows, another painted stone band crosses the elevation, and then there are five similar but slightly lower windows to the second floor, with a moulded eaves cornice over.

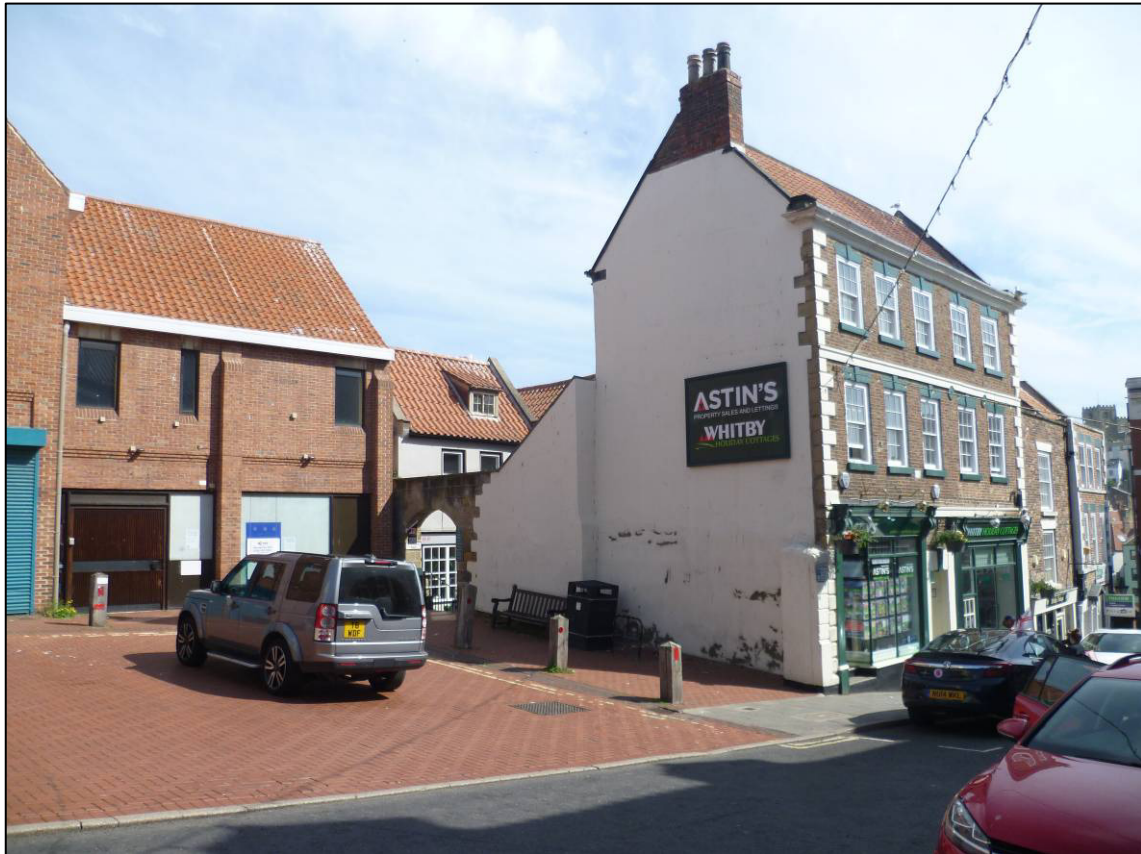
Plate 3: No. 47 Flowergate, showing car parking area and street furniture at base of west gable, looking NE.

- 7.21 In order to mitigate the impact of the proposed installation of the mural, a number of measures could be considered.
- 7.22 As noted above, it is recommended that the gable of no. 47 should be repaired and repainted prior to the installation of the mural - this will serve to enhance and maintain the listed structure. Future maintenance of the wall face behind the mural will be impossible once it has been erected. In addition, in order to improve and enhance the visual appearance and appreciation of the mural, it is recommended that the immediate setting of the gable is improved. This can be achieved by swapping the positions of the bicycle rack and litter bin at the base of the gable

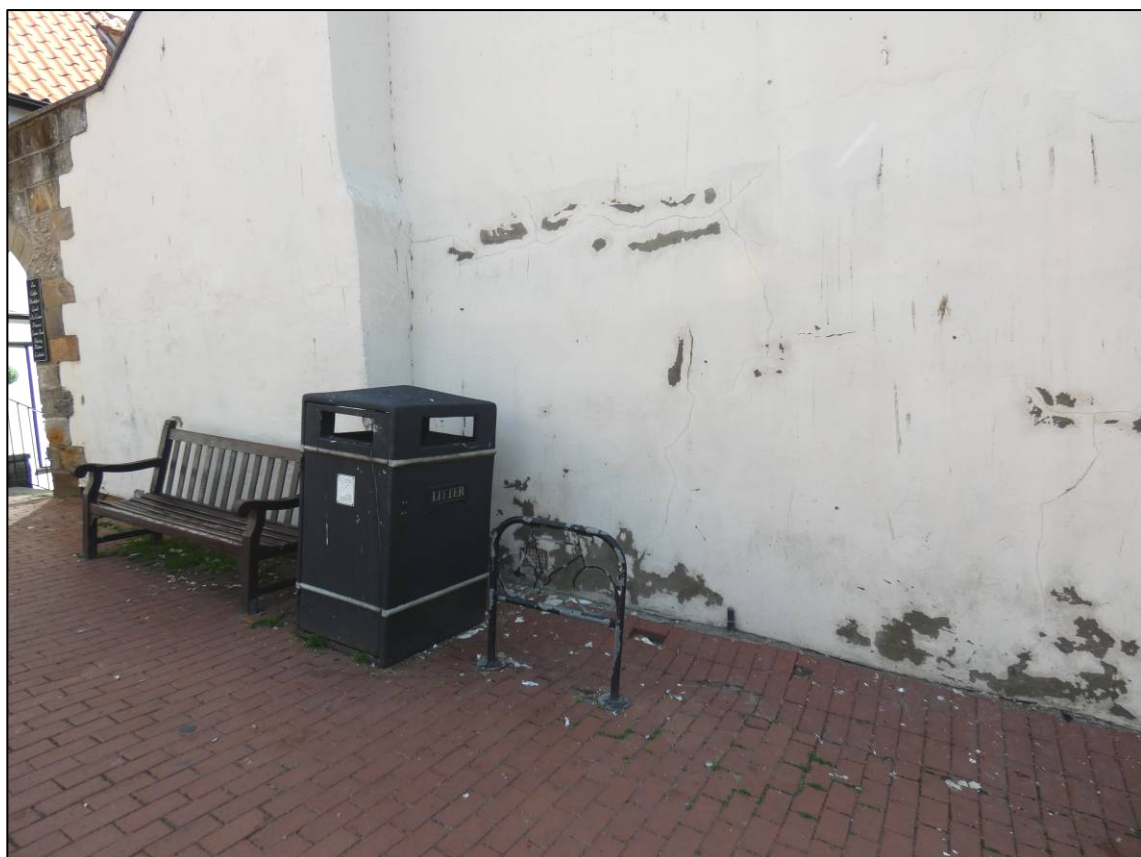
Plate 4: No. 47 Flowergate, street furniture at base of west gable, looking NE.

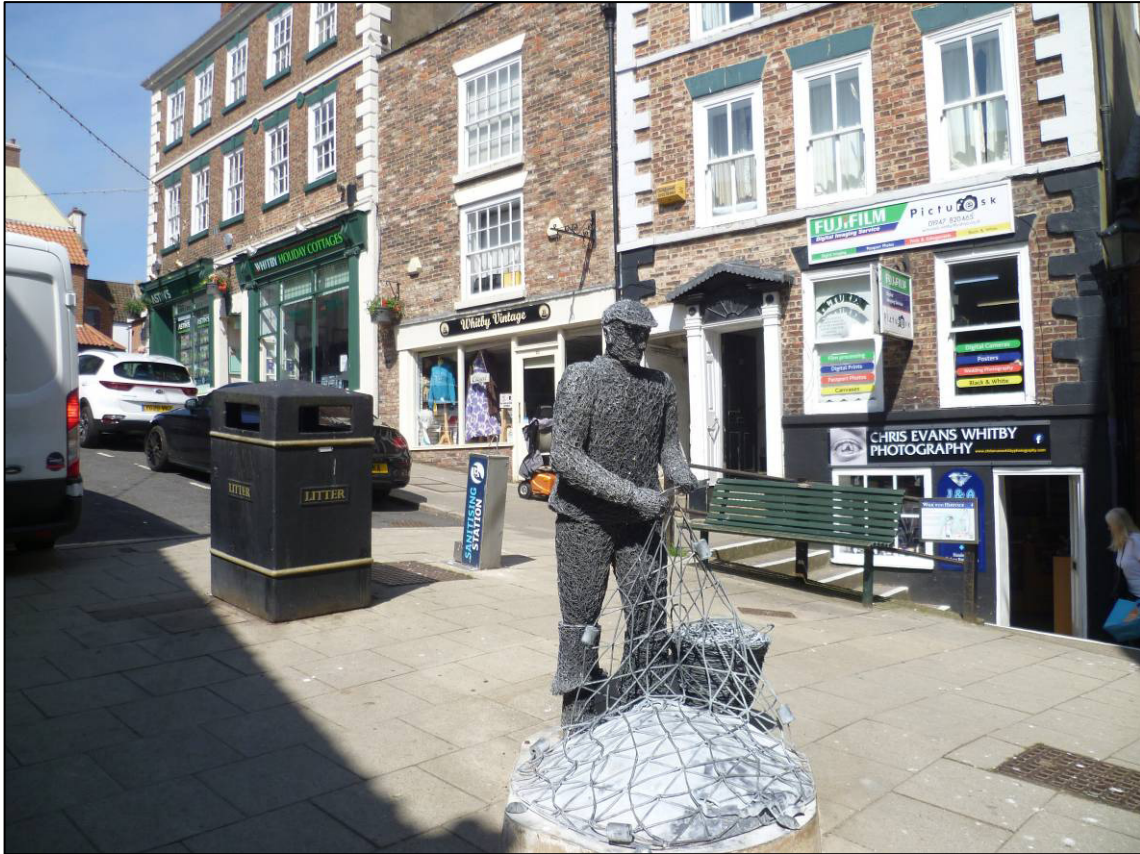
Plate 7: The setting of the 'Walk with Heritage' sculpture (No. 4 The Net Mender), at the east end of Flowergate, looking NW.

7.24 Although not technically part of the remit of this Heritage Statement, it would be worth considering the setting of the nearest 'Walk with Heritage' sculpture (No. 4 The Net Mender), which is placed in the cul-de-sac of Flowergate, some 23m to the east of the study building. At present, a large litter bin (only slightly lower in height than the sculpture itself) is placed to the immediate west of the sculpture, effectively blocking it from view from one of the major sight lines and pedestrian routes along Flowergate, and even from the position of the mural itself (see plate 7). Even when viewed from the east, the bin appears in the immediate background to the sculpture, and the associated information board is rather tucked away and not especially prominent. It is suggested that the litter bin is re-located, so as to improve the visual link between the mural and the sculpture, and to make the latter more prominent to visitors walking up and down Flowergate; one possible location for the bin would be adjacent or closer to the Mountain Warehouse building to the east. Furthermore, the area around the sculpture would benefit from more regular street cleaning as, at the time of the site inspection in June 2021, there was much bird excrement and numerous old cigarette ends lying adjacent to the Mountain Warehouse building, which itself has prominent and very discordant advertising in its windows.

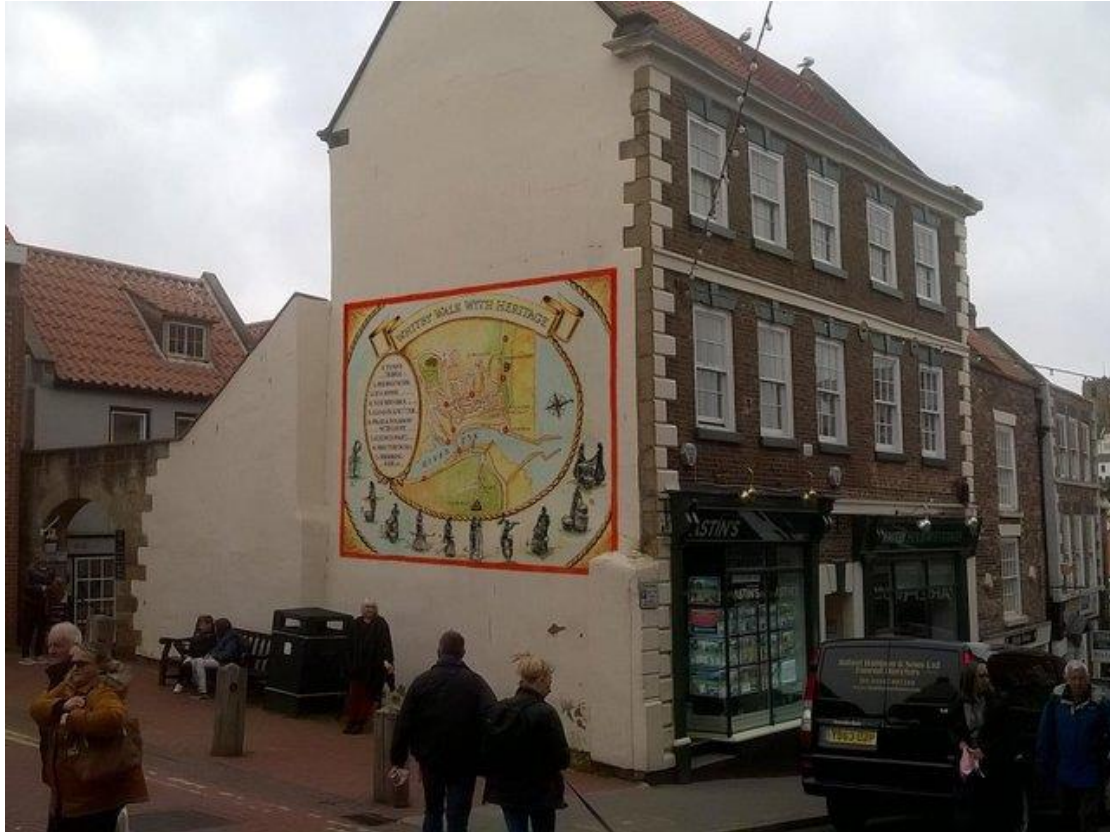
An artist's impression of how the mural would look on the wall of Astin's estate agents in Whitby
