ST CATHERINE'S CHURCH, LECONFIELD,
EAST YORKSHIRE

ARCHAEOLOGICAL OBSERVATION,
INVESTIGATION AND RECORDING

Report no: 2007/314.R01
Version: Final
Date: July 2008
Author: Ed Dennison & Shaun Richardson

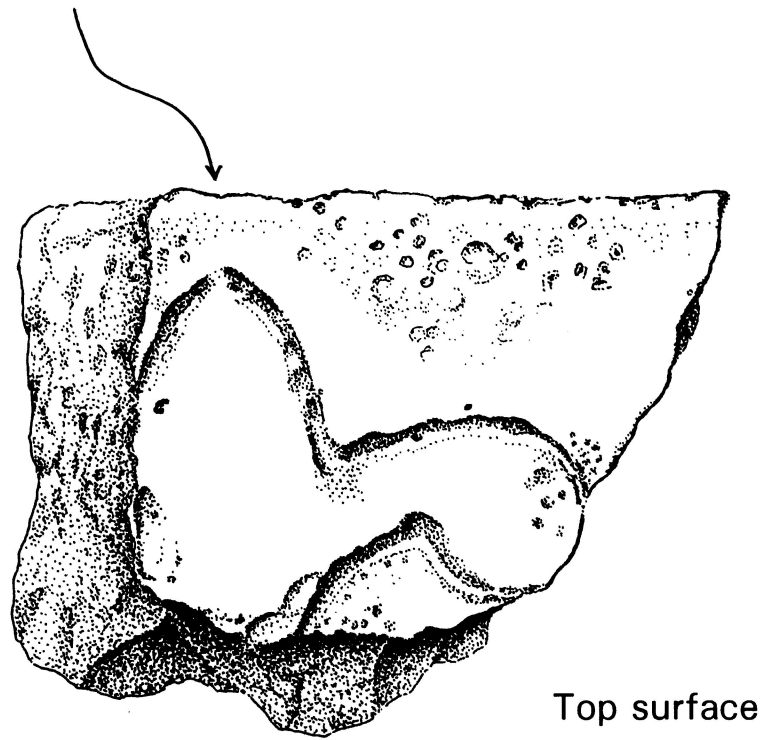
PROJECT	LECONFIELD CHURCH	
TITLE	CARVED STONE FROM TRENCH 6	
SCALE	AS SHOWN	DATE JULY 2008
	EDAS	FIGURE 5

- 5.28 Beneath a 0.28m depth of turf and topsoil (003), a firm greyish-brown loam subsoil (020) was exposed, extending beyond the base of the trench. In the east section, the subsoil was noted to be disturbed by a shallow (0.10m deep) oblique cut (019), 1.40m long, sub-circular in plan and filled with a yellowish cream fine sand (018); both features may be associated with the construction of the path to the south porch. No *in situ* burials were exposed and only a small amount of *ex situ* human bone fragments recovered and placed back into the trench. To the west of the south porch, a small piece of carved stone was recovered from the trench; although it is difficult to be certain and the stone was broken, it may have had a stubby fleur-de-lys design on one side (see figure 5).

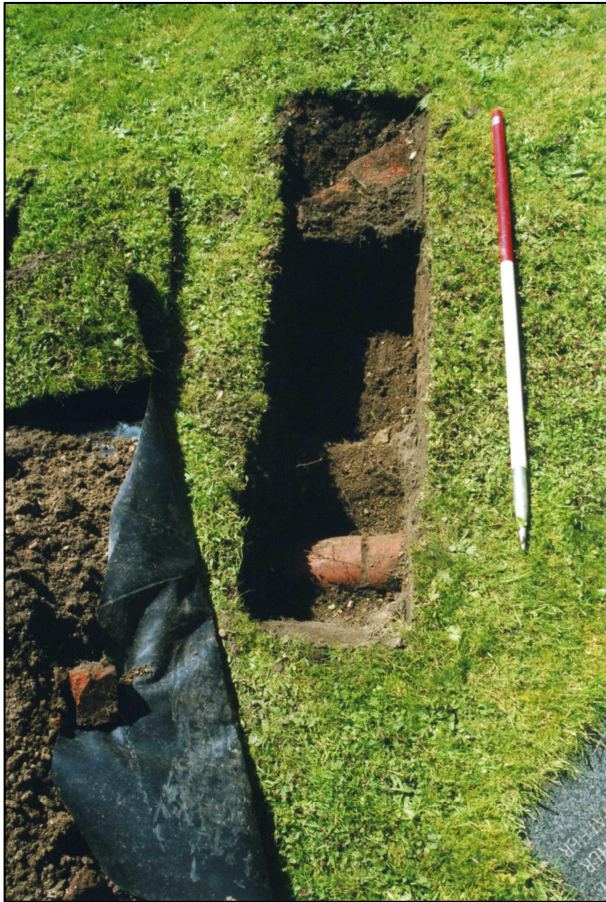
- 5.3 Test Pit 2 was located off the south-east corner of the south aisle. The pit was aligned north-east/south-west, a maximum of 1.42m long by 0.40m wide, and was excavated to a maximum depth of 0.30m BGL (10.75m AOD) (see plate 2). Beneath the 0.12m thick turf and topsoil (003) was a compacted mid-brown sandy silt (004), up to 0.45m thick and containing frequent small inclusions of stone and

brick fragments. At the northern end of the trench, the sandy silt was cut by a modern 0.15m diameter clay drainpipe serving the downpipe set against the east wall of the south aisle. At the southern end of the trench, a line of east-west aligned bricks (006) was set within the sandy silt. The bricks were red and handmade (average dimensions 240mm by 110mm by 70mm), and are probably either the remains of a path edging or the top of a burial vault. The sandy silt (004) continued below the base of the pit.

Plate 2: Test Pit 2, looking east.

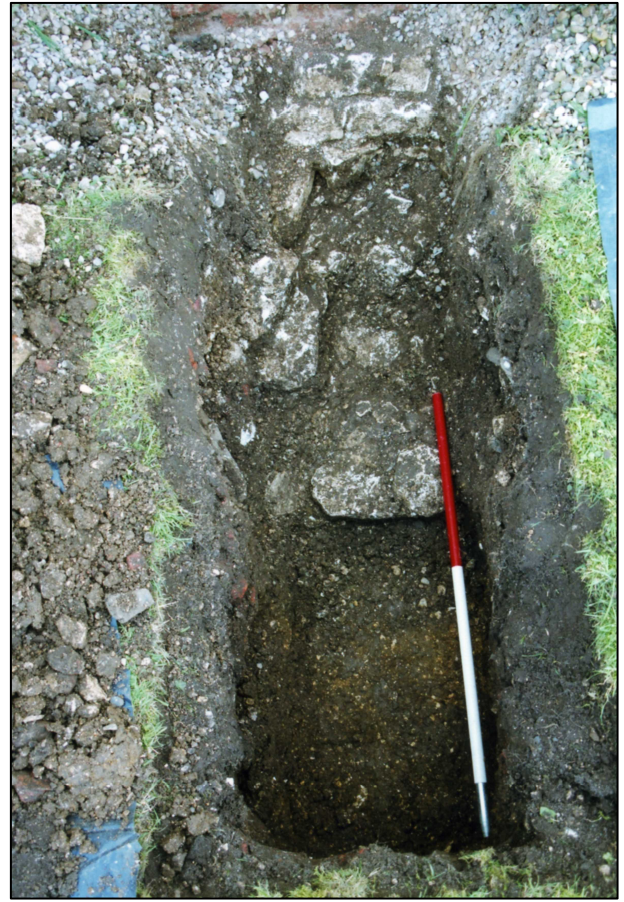
- 5.8 Test pit 7 was located against the north wall of the north aisle, close to the east side of a buttresses (B). The pit was aligned north-south, measured a maximum of

2.07m long and 0.67m wide, and was excavated to a maximum depth of 0.80m BGL at the north end (10.25m AOD). The existing gravel and French drain (001) cut through the turf and topsoil (003) here, which was c.01.5m thick. When the turf and topsoil were removed, a grave cut (005) and a second possible cut (012) were exposed. The grave cut (005) was visible only in the east side of the pit, and even then only the south side could be clearly seen (see Section 2 on figure 3). It appeared to be aligned north-west/south-east and the south side sloped steeply downwards at an angle of more than 45 degrees; within the trench it measured 0.50m long, c.0.60m wide and c.0.35m deep. The cut was filled with a mid-brown sandy silt (007), the same as deposit 004, but containing a few fragments of red handmade brick which overlay the human burial (013). The burial was only partly exposed but it appeared to be an adult, aligned north-west/south-east, with the tibia projecting from the pit section; a very few *ex situ* vertebrae were also recovered from this general area. There was no evidence for a coffin or shroud, and the burial was quite shallow, only 0.55m BGL (10.50m AOD). The second possible cut (012) was located between the burial and the French drain (001). It appeared to be aligned east-west and had a roughly semi-circular profile, being 0.40m wide at the top and 0.30m deep. It contained large angular pieces of chalk, probably from the overlying deposit 008, and it may have been a crude drain or soakaway.

- 5.9 Both the grave cut (005) and the possible drain (012) were cut into the same mid-brown sandy silt (004) noted in all but one of the other test pits. The sandy silt overlay substantial chalk wall footings (008) projecting some 1.17m from the face of the chamfered plinth of the church above and set at a slightly different angle than the existing north wall of the north aisle (see plate 3 and figure 3). At the base of the chamfered plinth, there were two courses of stepped squared chalk blocks but the main body of the footings was more crudely constructed, apart from the north edge, which was properly faced. The possible east-west aligned construction cut (009) for the footings was visible to their immediate north, apparently backfilled with re-deposited sandy silt (010). This possible construction cut disturbed a level layer of compacted gritty (almost gravelly) silty sand (011) containing very frequent small inclusions of flint and chalk. This deposit continued below the base of the pit.

Plate 3: Test Pit 7, looking south.

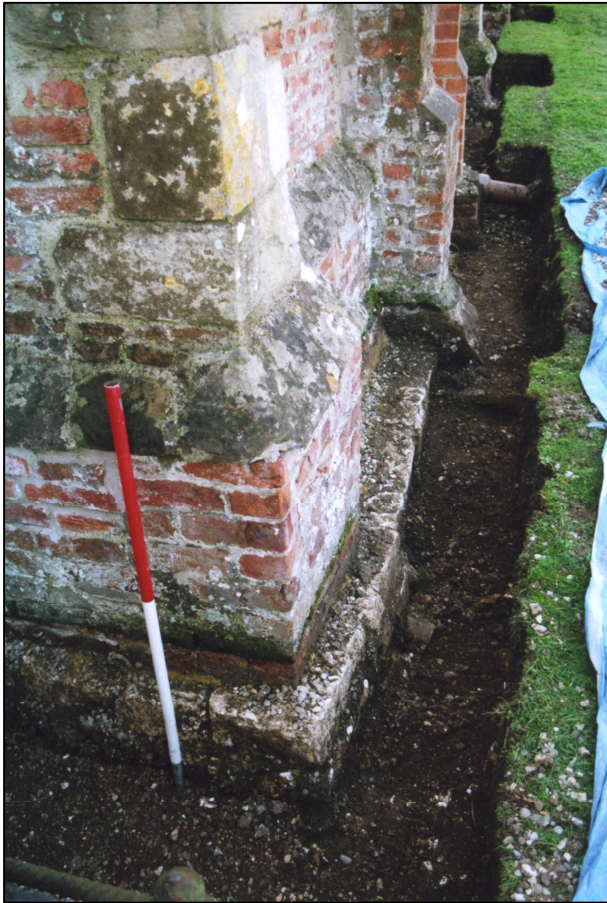
Plate 4: Footings around butress F, looking west.

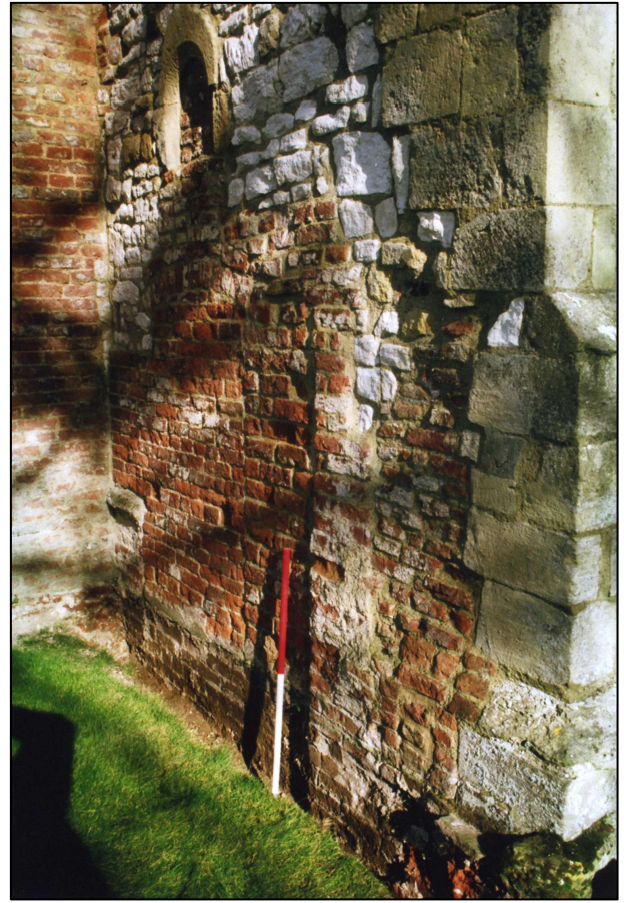
Plate 5: Blocked features and stub wall in west end of south aisle, looking north-east.

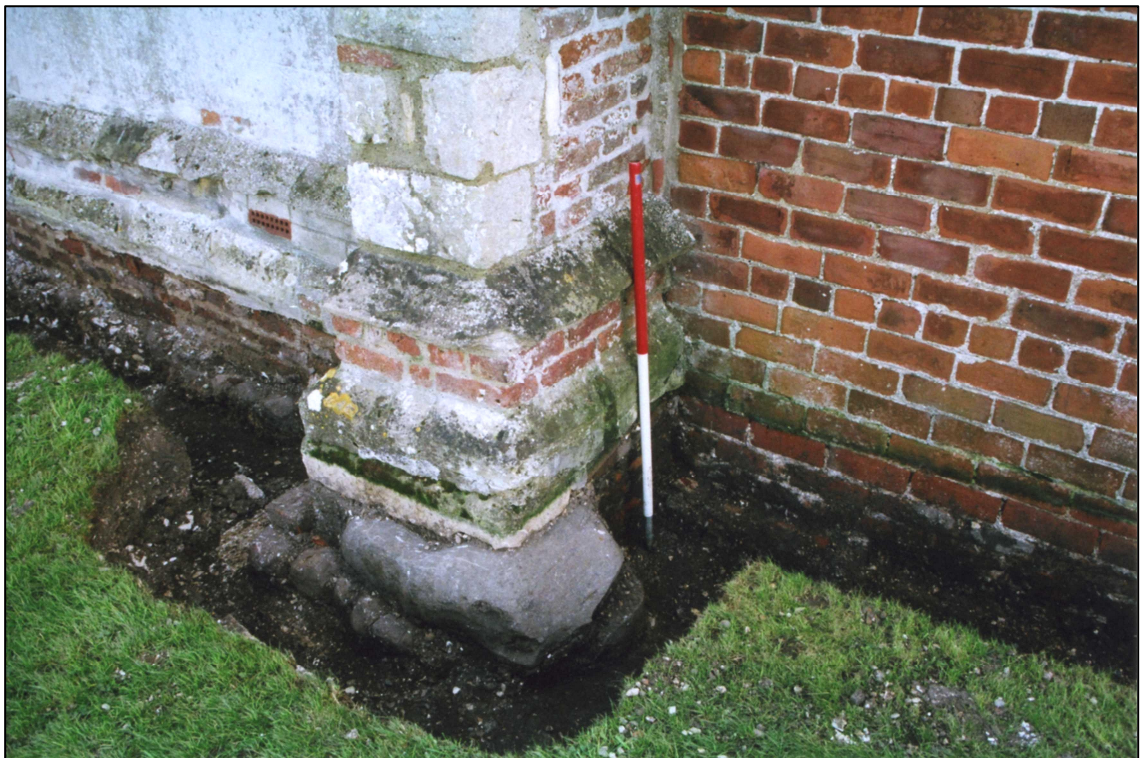
- 5.16 At the west end of the north aisle, the westernmost buttress (A) rests upon a large smooth stone, the surface of which was set 0.05m BGL (10.95m AOD) (see plate 6). The stone was c.0.60m long (east-west) and at least 0.30m deep. It is butted to the east by mixed brick fragment/cobble footings; the top of these was set 0.30m BGL (10.70m AOD) and they projected c.0.18m from the chamfered plinth above. These footings continued along the east side of the buttress, disappearing beneath the north wall of the north aisle. There is then a short gap before the footings resume, running east towards buttress B, although they are not on exactly the same alignment as the chamfered plinth above. Here, the footings comprise roughly squared chalk blocks, up to 0.40m long and 0.20m deep. The lowest part

Plate 6: Footings to butress A on north aisle, looking south-east.

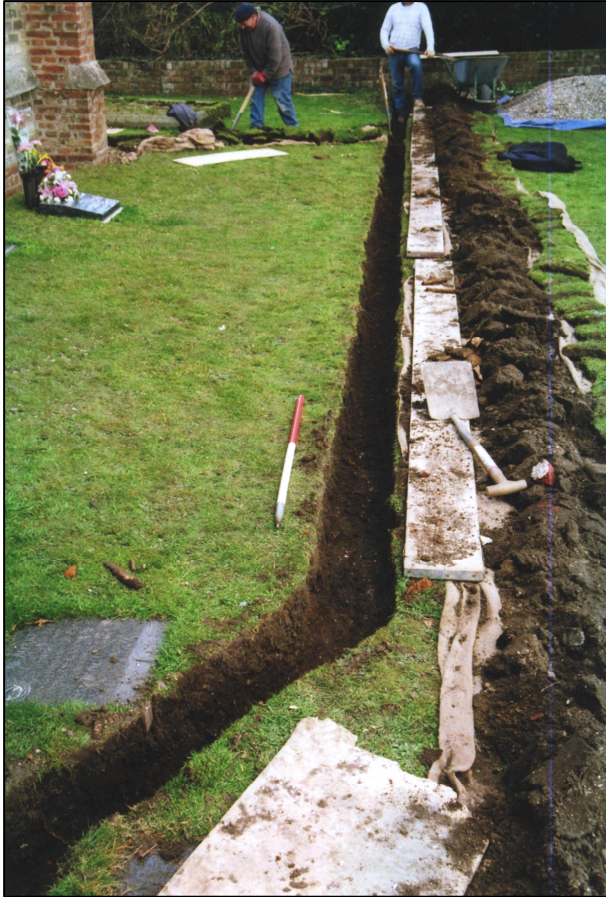
- 5.24 The new drainage trenches to the north and south of the church were 0.30m wide and 0.40m deep (c.10.65m to 10.35m AOD) (Trenches 2, 3 and 4 on figure 4) (see plates 7 and 8). However, in order to pass beneath the north boundary wall of the churchyard, and to accommodate the c.1m drop in height of the ground surface to the north of this, the trench (Trench 5) along the east boundary wall was gradually increased in depth from south to north. By the time that it reached the north boundary wall, it was c.1.25m deep (9.96m AOD); it was also increased to 0.90m wide immediately adjacent to the wall. After passing beneath the wall, the trench resumed its average width and depth of 0.40m across the burial ground extension. The ground surface within the burial ground extension slopes gently downwards from south to north, so at the south end the trench was excavated to 9.76m AOD and at the north end to 9.48m AOD.

Plate 7: General view of Trench 2 under excavation, looking east.

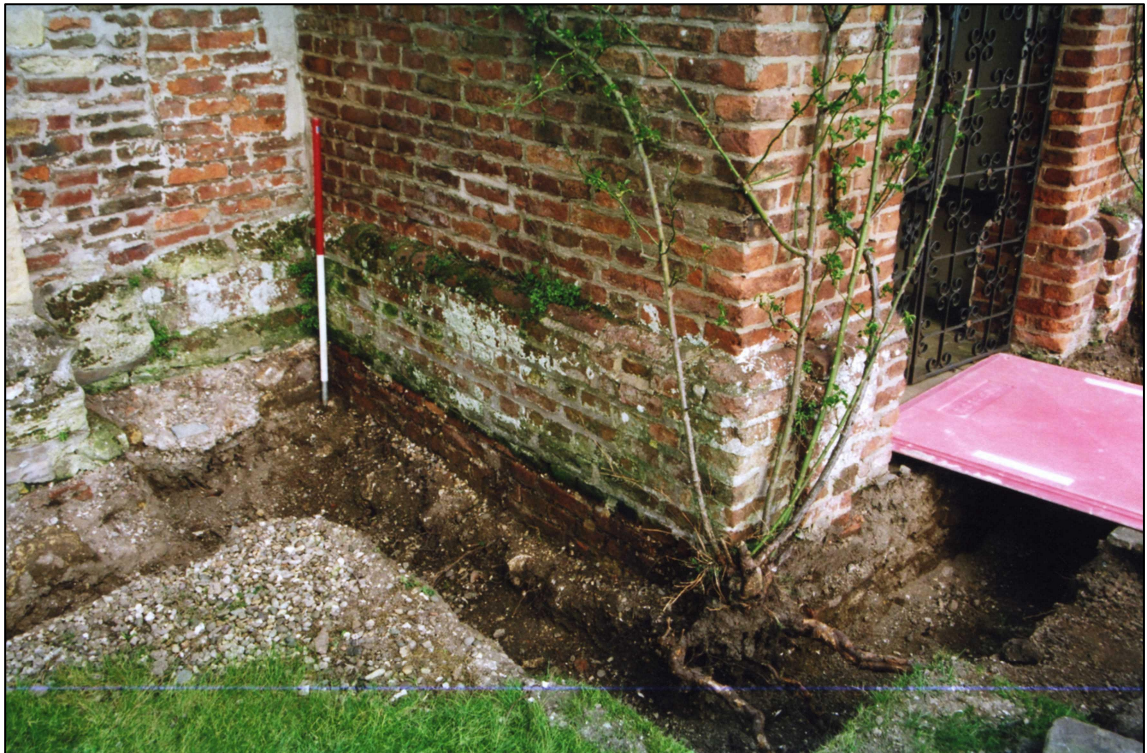
- 5.22 The footings of the south porch were reasonably uniform. They were built of pinkish red handmade bricks (average dimensions 225mm by 120mm by 50mm) laid in English Garden Wall bond (alternate header/stretcher courses) and set with a buff lime mortar (see plate 9). On the west side, the brickwork is replaced by chalk rubble at 0.20m BGL (10.80m AOD), while at the very base of trench around the south wall, projecting chalk rubble can also be seen. To the west of the south porch, the footings of buttresses L and M to the south aisle wall comprised a very ragged mixture of sandstone, stone cobbles and red handmade brick fragments. The chamfered plinth of the south aisle does not continue around to the west gable, but rather terminates at buttress L. The west gable retains evidence for several phases of alteration. In addition to the truncated structure (014) described above, there is the chamfered brick south jamb of what appears to be a former doorway opening (see plate 5). The bricks forming the jamb are red and handmade (average dimensions 230mm by 100-110mm by 60mm) and set with a lime mortar. At a later date, the chamfered doorway appears to have been truncated or replaced by a slightly wider doorway opening with a shallow arched head, which was itself subsequently blocked. Both the jambs of the opening and the blocking are formed from handmade red bricks (average dimensions 230mm by 120mm by 65-70mm); to the blocking, they are laid in a variation of English Garden Wall bond (three to five stretcher courses to each header course).

Plate 9: Footings of south porch, looking north-east.
