ST HELEN'S CHURCH,  
TREETON, SOUTH YORKSHIRE

ARCHAEOLOGICAL WATCHING BRIEF

Report no: 2008/340.R01  
Version: Final  
Date: November 2008  
Author: Ed Dennison

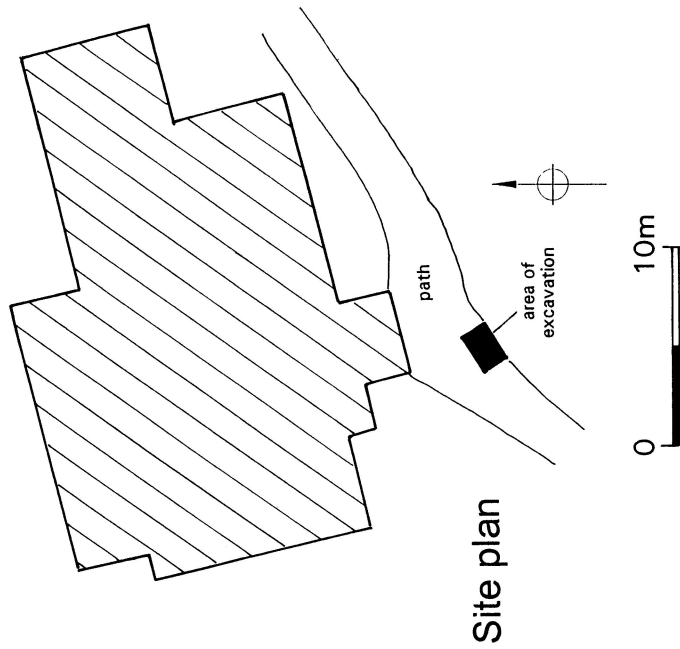
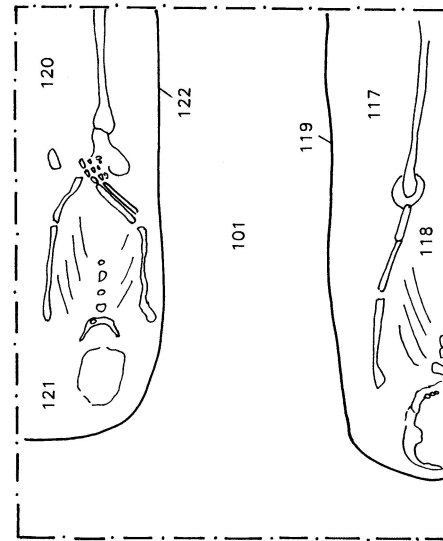
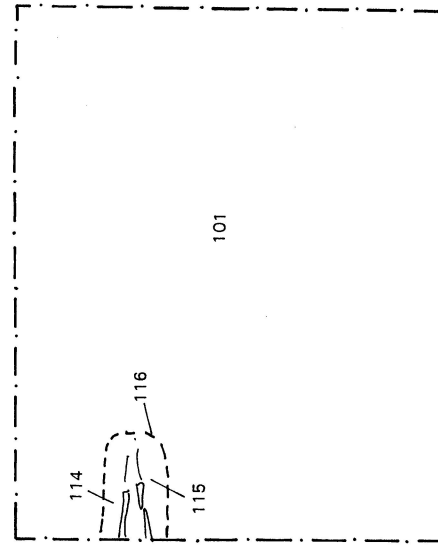
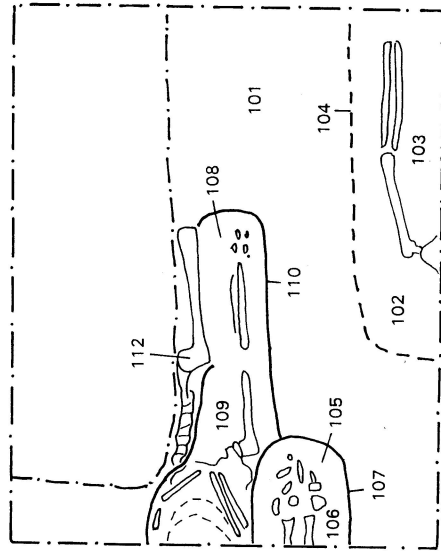
PROJECT	ST HELEN'S CHURCH, TREETON		
TITLE	WATCHING BRIEF RESULTS		
SCALE	AS SHOWN	DATE	NOV 2008
	EDAS	FIGURE	4

Lowest level burials (c.0.95m BGL)

Mid level burials (0.86m BGL)

Highest level burials (c.0.7m BGL)

- 5.1 The upper deposits within the soakaway pit comprised the existing concrete and the kerbing (100) of the path, totalling 0.34m in depth. Below this was a layer of mid reddish-brown sandy loam (101), interpreted as graveyard soil. This deposit extended through the depth of the pit, as far as the natural (123) which was a friable reddish brown sandy clay located at c.1.20m below the existing ground level.
- 5.2 Within the graveyard soil (101), a total of seven *in situ* partial articulated supine inhumations were uncovered and recorded. At the base of the pit, at a depth of 0.95m below existing ground level, were two articulated east-west aligned adult

- 5.3 Above these burials, at a depth of 0.86m below the existing ground level, was a further partial inhumation (115) which extended mostly beyond the limits of the excavation to the west. The fragile remains consisted of the partially preserved lower limbs of a toddler or infant. The grave fill (114) was also a reddish-brown silty sand defined by a well defined cut (116) 0.40m long by 0.22m wide within the pit.

- 5.4 Above this at an average depth of 0.70m below existing ground level were the remains of three inter-cutting graves and an isolated grave to the south. These remains were much better preserved. The grave (104) to the south contained the left arm of an adult (103) but the remainder of the skeleton lay beyond the edges of the pit; this skeleton was left *in situ*. The fill (102) of the grave consisted of reddish brown sandy loamy silt, with occasional small pebbles and occasional disarticulated bone, and there was no evidence for any coffin.

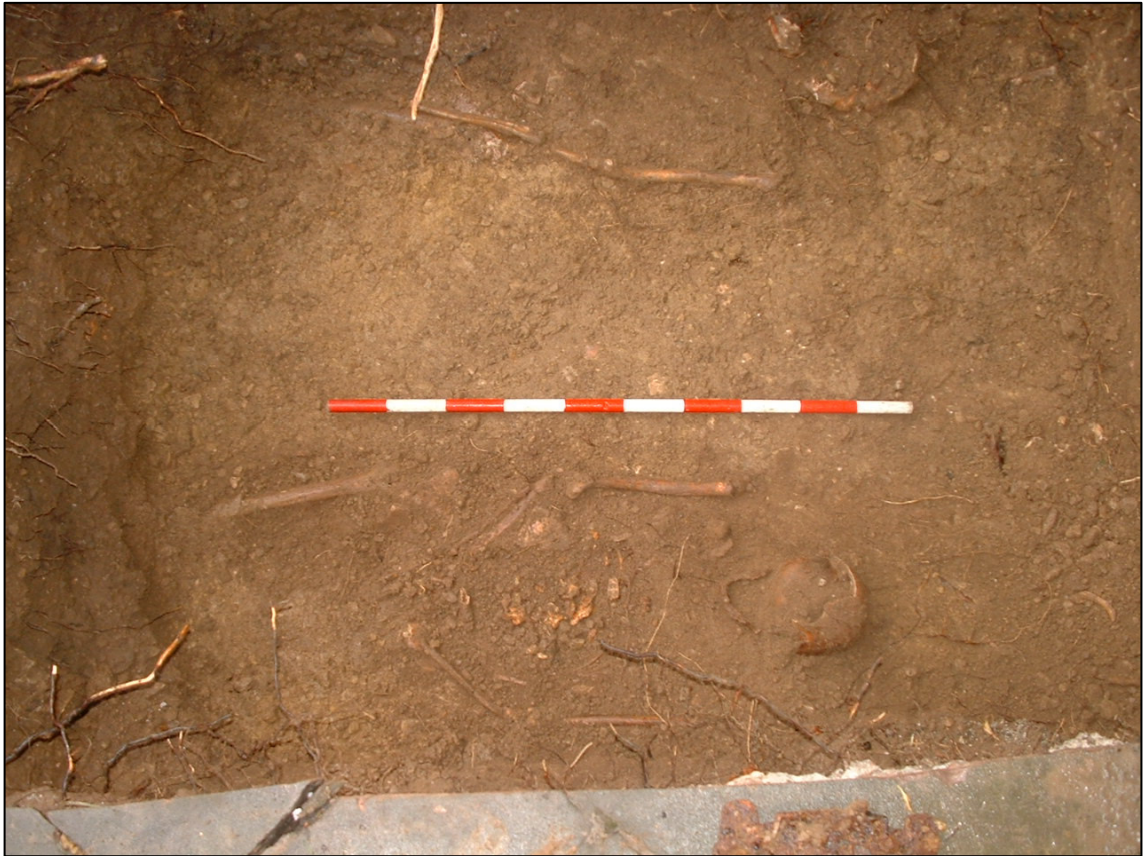
Plate 1: Skeletons 118 and 121 in base of excavated pit (east to left).

skeletons (118) and (121) (see plate 1). Skeleton 118 to the south consisted of a supine inhumation which extended beyond the southern and eastern edges of the pit; the left arm was present and was seen to be laying flat to the side. Skeleton 121 to the north also extended beyond the northern and eastern limits of the pit, and its right arm was flexed with the hand placed over the pelvis. The grave fills (117 and 120 respectively) were composed of mid reddish-brown silty sand with occasional small pebbles and frequent disarticulated bone. Both skeletons lay in definable grave cuts (119 - 1.80m long by 0.42m wide, and 122 - 1.60m long by 0.42m wide respectively), and were probably originally placed in coffins which had since degraded. At this depth, the moisture content was high and the bones were severely softened, and so had to be removed with their soil matrix for reburial. In accordance with best practice, the burials were not "chased" beyond the limits of the excavation (EH/CoE 2005, 33).

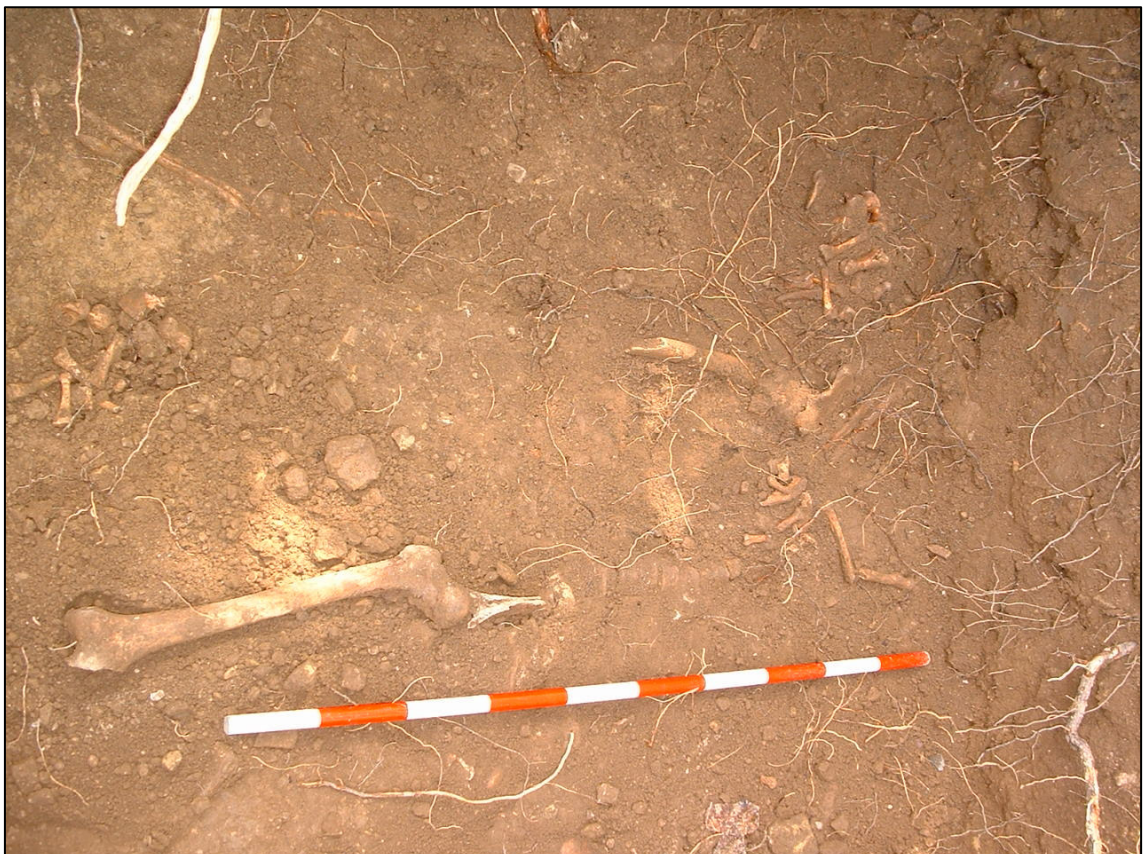
Plate 2: Intercutting skeletons 109, 106 and 112 (east to left).

- 5.5 Of the three inter-cut graves (see plate 2), the earliest example was an adult skeleton (112), which had been truncated by later graves and comprised largely of spinal remains, the sacrum and elements of the right femur and pelvis within the excavated area. The grave fill (111) was a reddish-brown silty sand contained within a cut (113) measuring 1.20m long by 0.12m wide. This grave had then been cut by another grave (110), 1.26m long and 0.40m wide, which contained the chest, pelvis, and elements of the right leg and foot of an adult skeleton (109) and a fill of reddish-brown silty sand (108). Finally, the most recent grave disturbed by the soakaway pit was 0.70m below existing ground level. This grave (107) extended largely beyond the trench to the west and the exposed remains consisted only of a pair of feet (106) in a reddish-brown silty sand (105).
