ST MARY'S PRIORY CHURCH,
OLD MALTON, NORTH YORKSHIRE

ARCHAEOLOGICAL DESK-TOP ASSESSMENT
OF PROPOSED WC EXTENSION

Report no: 2008/324.R01
Version: Final
Date: May 2008
Author: Ed Dennison

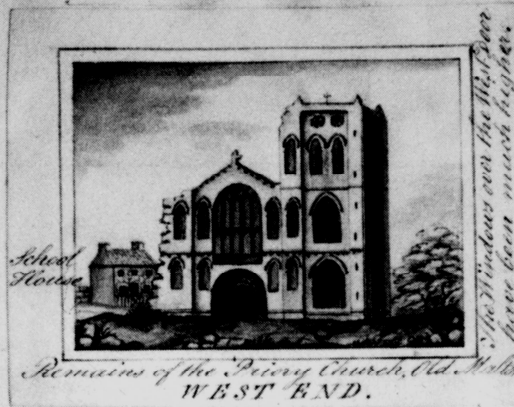
Malton Old Priory.

*The dark, shaded Walls remain in 1810.
The light shaded found
aligns were laid open by
the late George Watson, Esq.
Within the Enclosure is
the present Parish Church.
The Groined Arches of the
Crypt yet remain A.D. 1810.
The side Isles have had
Groined Arches.*

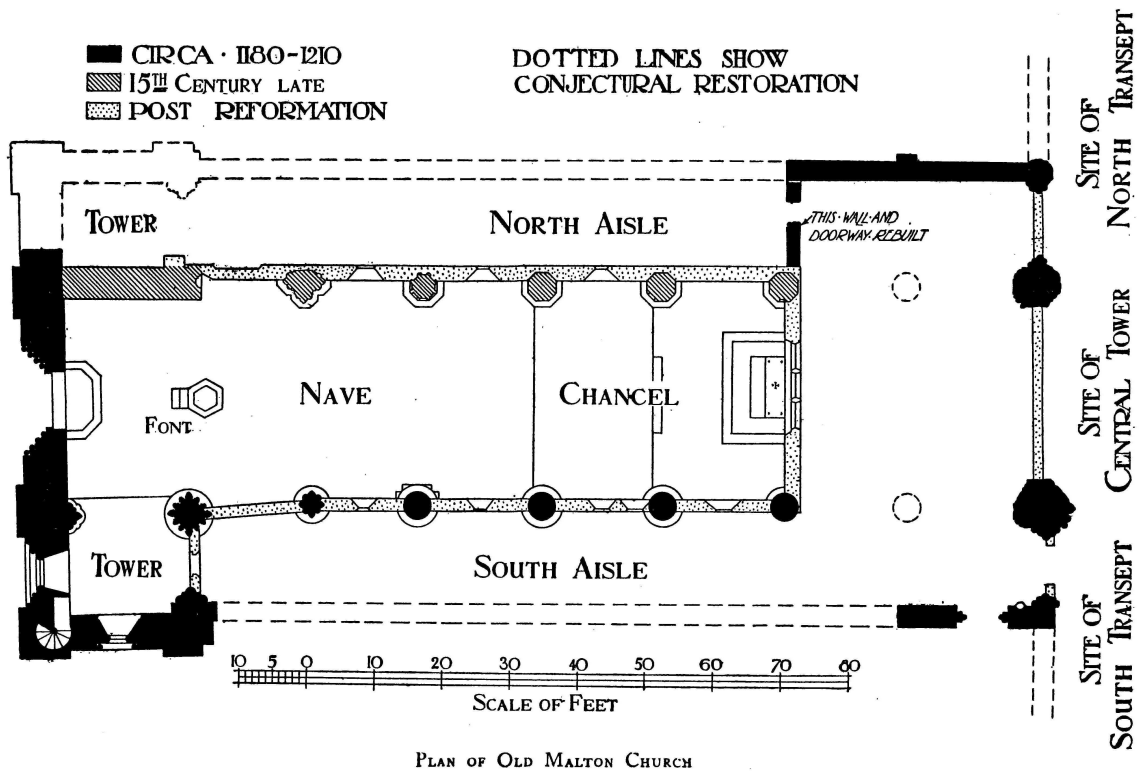
PROJECT	
ST MARY'S CHURCH, OLD MALTON	
TITLE	
PLAN OF CHURCH	
SCALE	DATE
NTS	MAY 2008
EDAS	FIGURE
	3

Source: Russell 1914, 539.

- 5.2 The existing church consists of a chancel and nave in one range, formed from the six western bays of the priory church's nave (see figure 3). The present three stage tower lies at the south-west corner of the nave, representing one of the two towers formerly positioned either end of the west front, with a central tower further east (see plate 1). The ground floor of the south-west tower is currently used as the vestry. The church is built of Hildenley limestone, with substantial parts of the standing fabric dating to the 12th and 13th centuries, although much was later robbed to build other houses in the town (Senior 1990, 160). Construction of the church commenced in c.1150 at the east end and progressed slowly westwards, the nave and claustral complex being complete by c.1190; the west front is considered to date from c.1200-1210 (Jennings 1999, 150).

- 7.1 The new WC building lies inside the former extent of the priory church (see figure 3), in the north-west corner of the former south aisle. While the shallow c.0.2m reduction of existing ground level inside the new building is unlikely to be archaeologically significant, it is quite possible that the excavations for the new foundations, which will extend for a depth of 0.8m, will encounter the floor or below-floor deposits of the former south aisle. It is also possible that

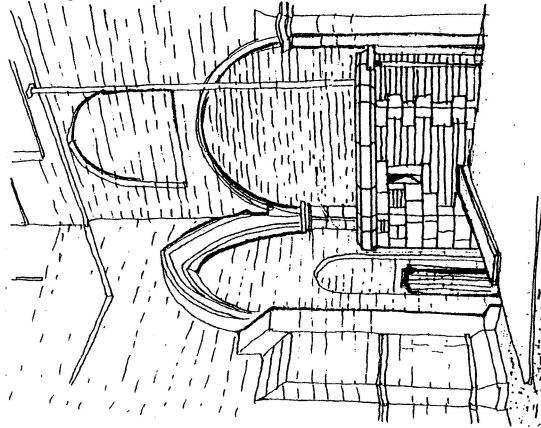
PROJECT	ST MARY'S CHURCH, OLD MALTON
TITLE	PROPOSED EXTENSION
SCALE	AS SHOWN
DATE	MAY 2008
FIGURE	4

CONNECT TO ADJACENT FOUL DRAIN TO SEWER
SKETCH PERSPECTIVE AS PROPOSED

- 6.1 In summary, the proposed works involve the construction of a small WC on the outside of the church, in the angle of the south-west tower and south side of the nave (see figures 4 and 5).

- 6.2 Externally, the new structure measures a maximum of 3.7m east-west by 1.9m north-south, with the south-west corner angled to the north to allow for continued access through the east side of the tower via the existing door and steps (see plate 3). The structure will be constructed on traditional strip foundations, which will extend to a maximum of 0.8m below the present ground surface - it should be noted that the ground surface in the area of the new building has already been reduced by c.0.5m compared to the adjacent ground level, presumably as part of the works to reduce the internal floor of the church in 1899 when the destroyed pillar bases of the south aisle were exposed and restored (see plate 3). There will also be a slight lowering of the existing ground surface inside the new building, by c.0.2m to allow the new floor to be constructed. Externally, the new structure will have Magnesian limestone ashlar and rubble walls to match the existing south wall of the nave, and it will be roofed in lead. Access into the new WC will be from the nave, via a new doorway 1.10m wide cut through the centre of the adjacent blocked bay of the south aisle (see plate 2). Inside the church, the early 20th century oak panelling by Temple Moore which runs along the south side of the nave will need modifying to create the new access; the new door will be of a similar oak panelling, to match the existing.

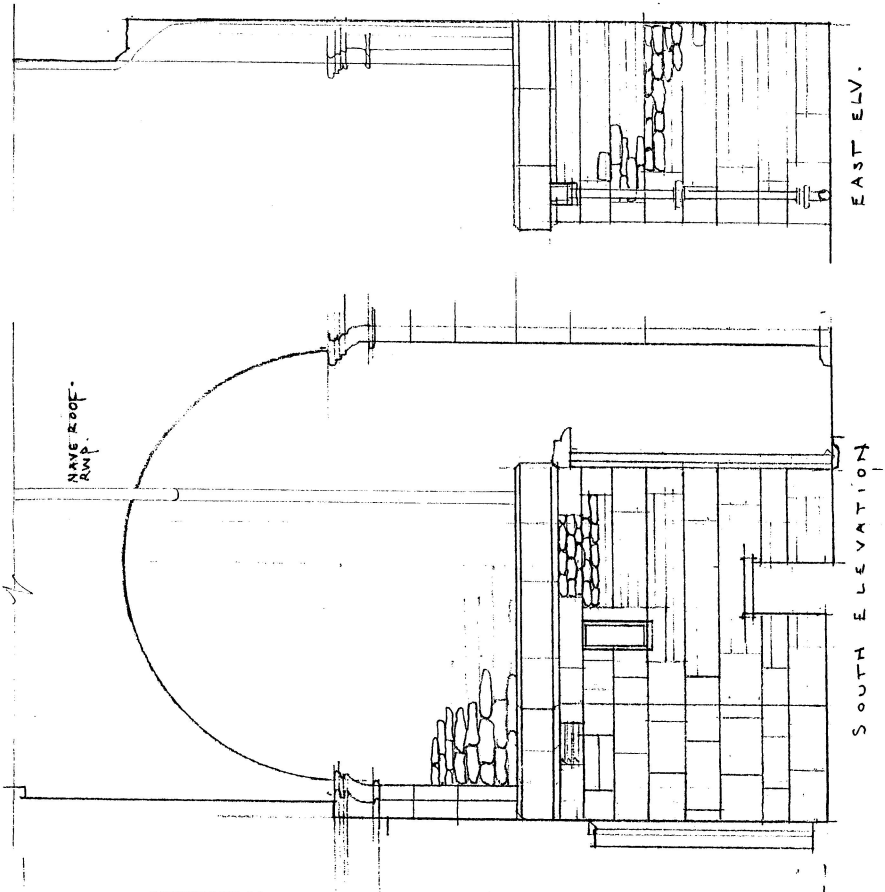
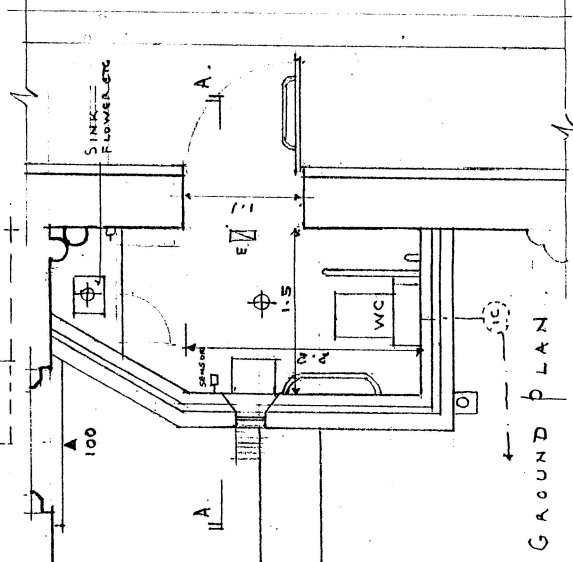
PROJECT	ST MARY'S CHURCH, OLD MALTON		
TITLE	DETAILED PROPOSALS		
SCALE	AS SHOWN	DATE	MAY 2008
FIGURE	EDAS	5

NAVE DASH PANELLING - ASBUILT
FOR NEW DOORWAY TO WC
IN CORNER MATCH

ACCESSIBLE WC

WALLS - MAGNESIAN LIMESTONE ASHLAR AND COURSED ASBLES AS ADJACENT WALL - SOUTH NAVE

ROOF - CODE 8 LEAD SHEET & ROLL JOINTS

INTERIOR WALL WITH PLASTER CEILING - TILED FLOOR

TWYFORDS 'DOC PLUS' PACK-FITTINGS

- 6.3 It is possible that there will need to be additional services associated with the new WC facilities, although it may be possible to break into an existing drain. If required, a surface water drain will run south-east from the south-east corner of the new building for a distance of c.10m towards a new soakaway pit which will measure c.1.0m square and 1.5m deep. A new inspection chamber will be constructed against the east wall of the new building and a new foul water drain will run south from here for a distance of c.15m to a new manhole, placed on the south side of the present churchyard wall, and then east for c.5m to connect with an existing manhole adjacent to Abbey House; this drain will be c.0.4m wide and up to 1.5m deep.

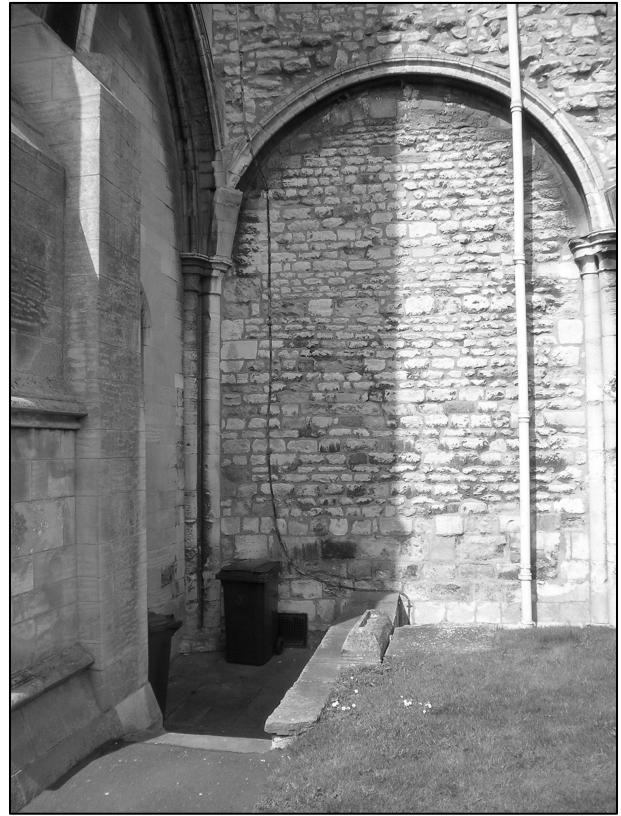
Plate 2: Location of proposed new extension, showing blocked bay of south aisle.

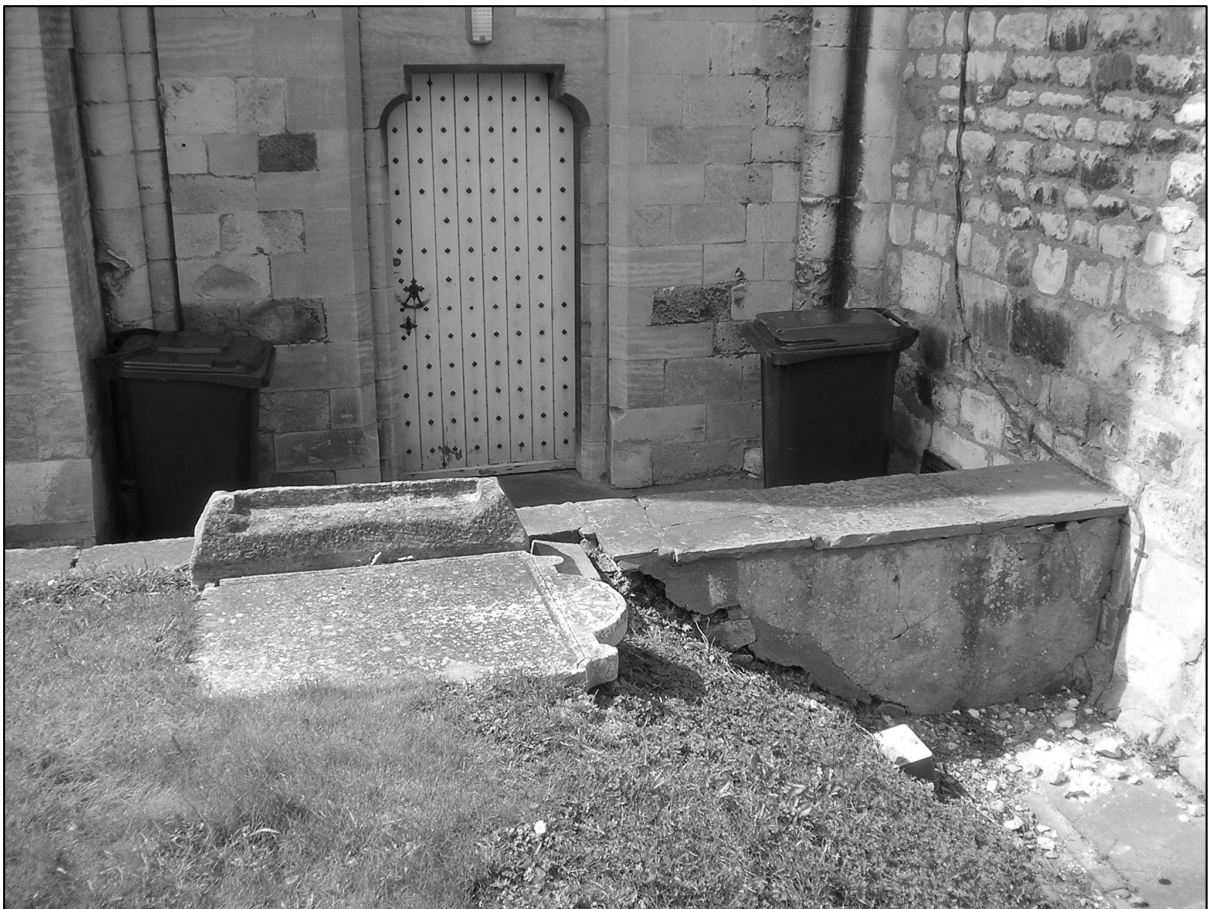
Plate 3: Location of proposed new extension, showing difference in ground levels and existing door into south-west tower.
