FAIR ACRE COTTAGE, KEARTON,
SWALEDALE, NORTH YORKSHIRE

ARCHAEOLOGICAL AND
ARCHITECTURAL SURVEY

Report no: 2007/302.R01
Version: Final
Date: May 2009
Author: Shaun Richardson & Ed Dennison

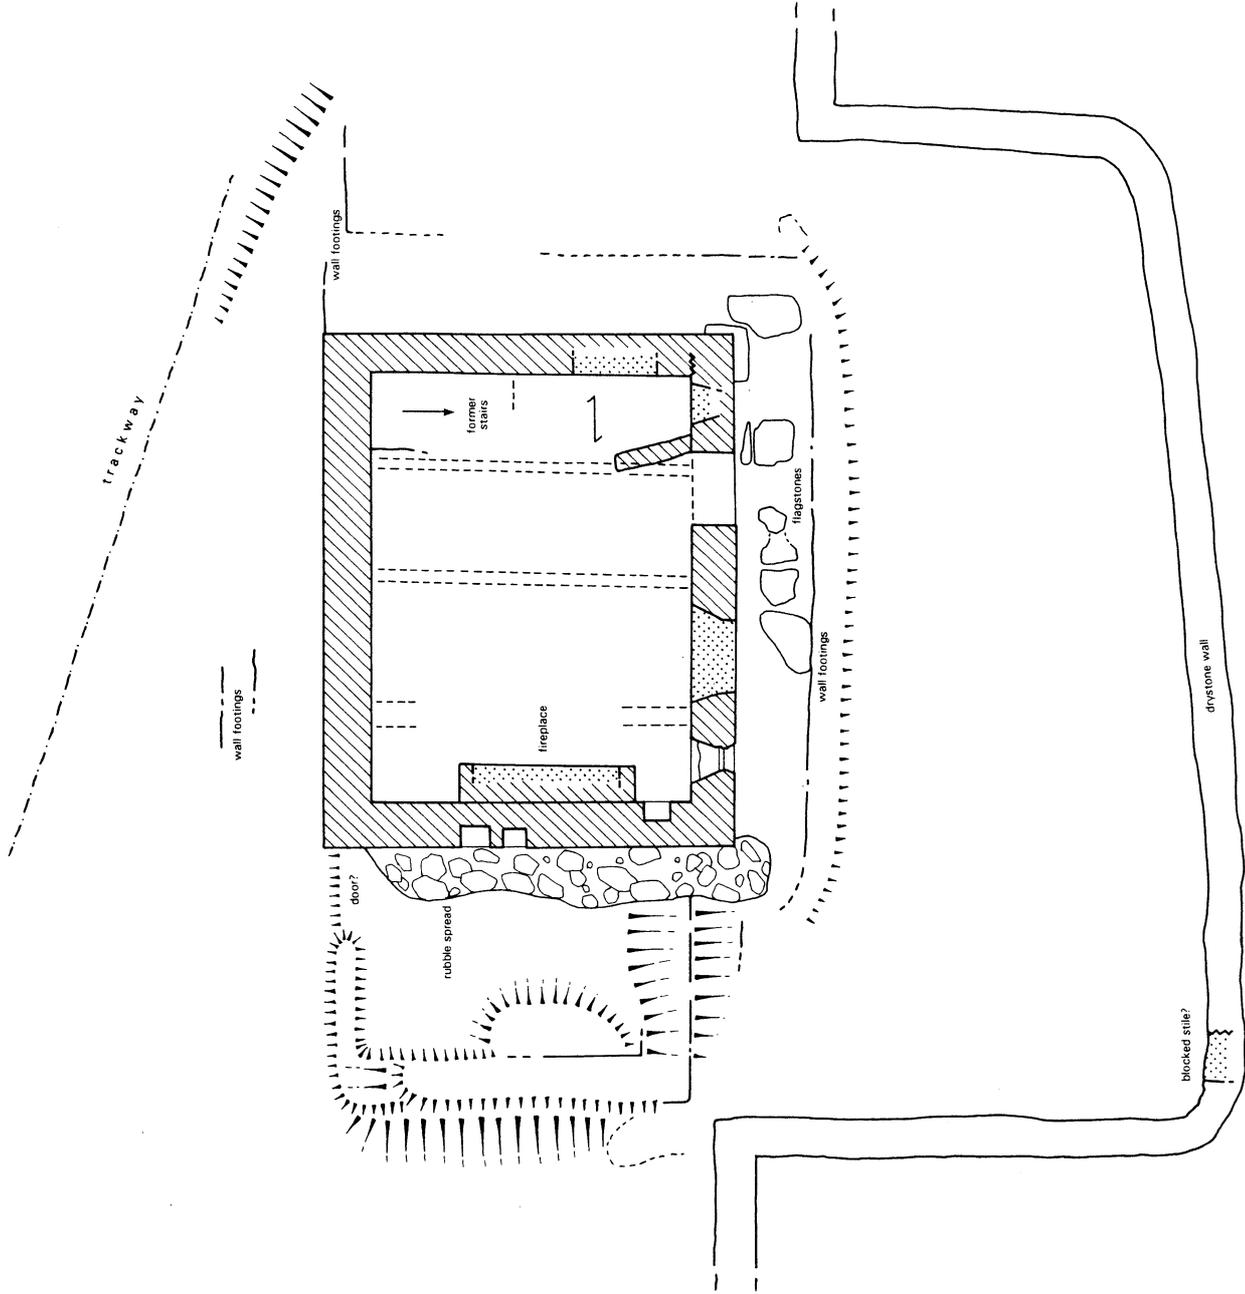
PROJECT	FAIR ACRE COTTAGE, KEARTON		
TITLE	PLAN		
SCALE	AS SHOWN	DATE	MAY 2009
	EDAS	FIGURE	3

- 3.2 The cottage stands on the south side of the unclassified track leading to the core of Kearton hamlet, set slightly above the level of the trackway itself (see plate 1). To the south, there is a small area of ground enclosed by a drystone wall, beyond which the ground slopes downwards very steeply into the valley (**1/3**, **1/4** and **3/5** to **3/8**). The ground also slopes away steeply to the east, although to the west, it rises gently towards an adjacent occupied house.
- 3.3 The cottage itself is rectangular in plan, of a single cell direct-entry form, with maximum external dimensions of 6.90m long (east-west) by 5.40m wide (north-south); the walls are on average 0.55m in width, although the north and west walls are slightly thicker at 0.65m (see figure 3). There was originally a single room to each floor.

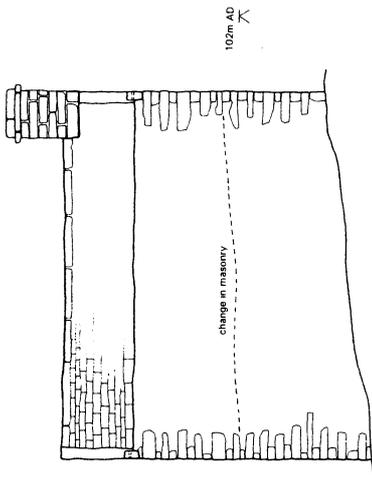
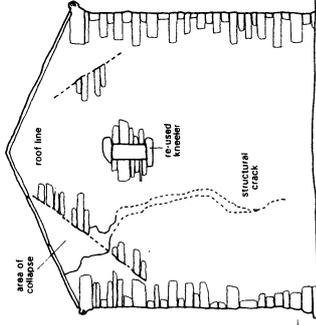
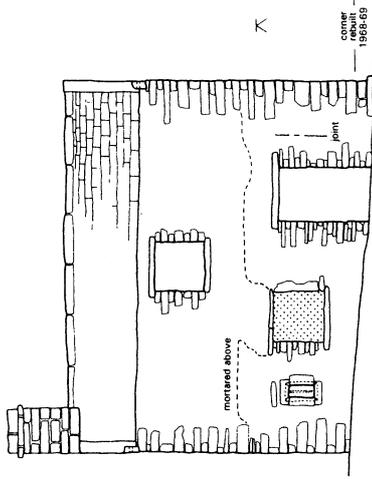
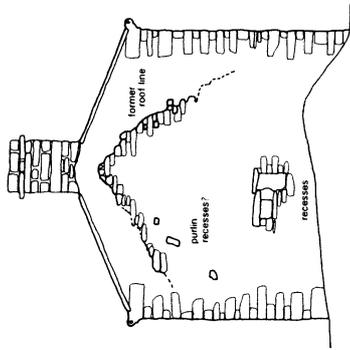
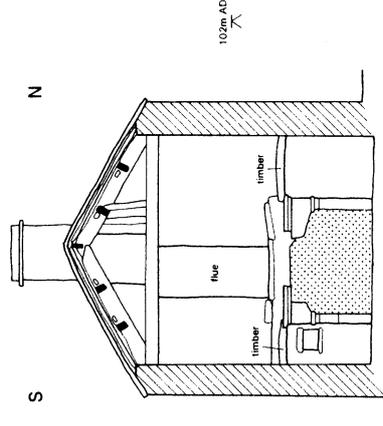
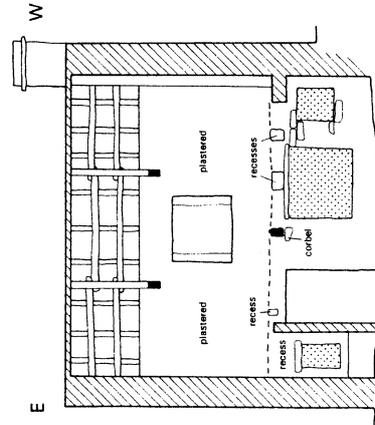
PROJECT	FAIR ACRE COTTAGE, KEARTON		
TITLE	ELEVATIONS AND SECTIONS		
SCALE	AS SHOWN	DATE	MAY 2009
	EDAS	FIGURE	4

- 3.6 The main (south) elevation of the cottage faces into a small adjacent enclosed area, and provides the only existing access to the interior, through a plain doorway

at the east end of the elevation (1/2, 3/1 and 3/2). The doorway is flanked to the east by a straight joint relating to a blocked window visible from the interior, and to the west by a larger sub-square blocked window with a stone slate dripstone above (see plate 2). At the west end of the ground floor, there is a recessed and chamfered single-light fire-window with seatings for a central bar to sill and lintel (1/6). The stonework of the ground floor is dry, whilst that the first floor has been mortar pointed. There is a single central sub-square window to the first floor.

- 3.7 The base of the west gable (2/14 and 2/15) is partly obscured by the collapsed remains of a small attached structure, now visible largely in plan only (see below). There are two shallow recesses to the centre of the ground floor (1/7), together with a number of smaller recesses at a higher level probably relating to the former roof of the attached structure. Above these, the line of a steeply pitched gable can be made out, although it is not as apparent nor of the same profile as that seen on the east gable (see below) (1/8 and 1/11; see plate 3). The north elevation is blank, with no openings (1/49); the principal feature of interest is the change from dry to mortar pointed stonework at first floor level, as noted on the south elevation. The east gable preserves the line of the original steeply pitched thatched roof, pierced by a single narrow opening which has a re-used kneeler as a sill (1/1, 1/5, 3/3 and 3/4).

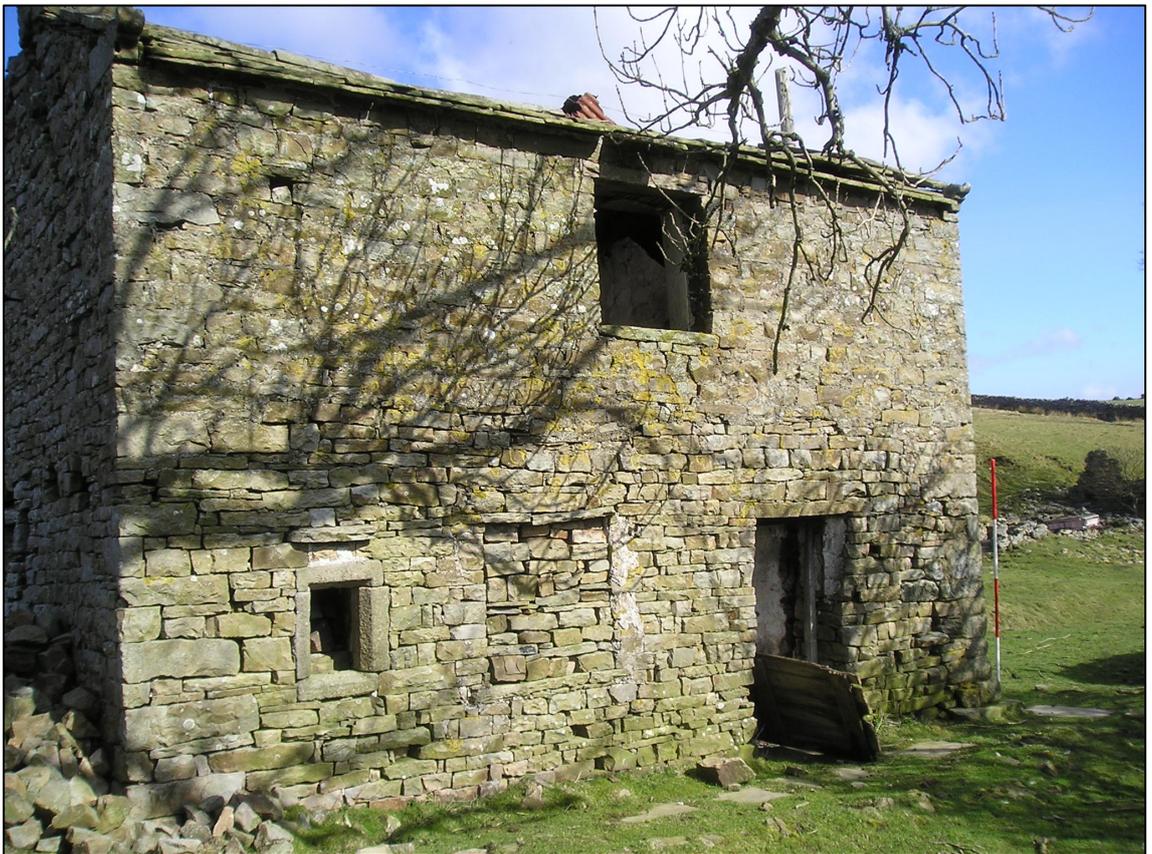
Plate 2: South elevation, looking NE (photo 1/2).

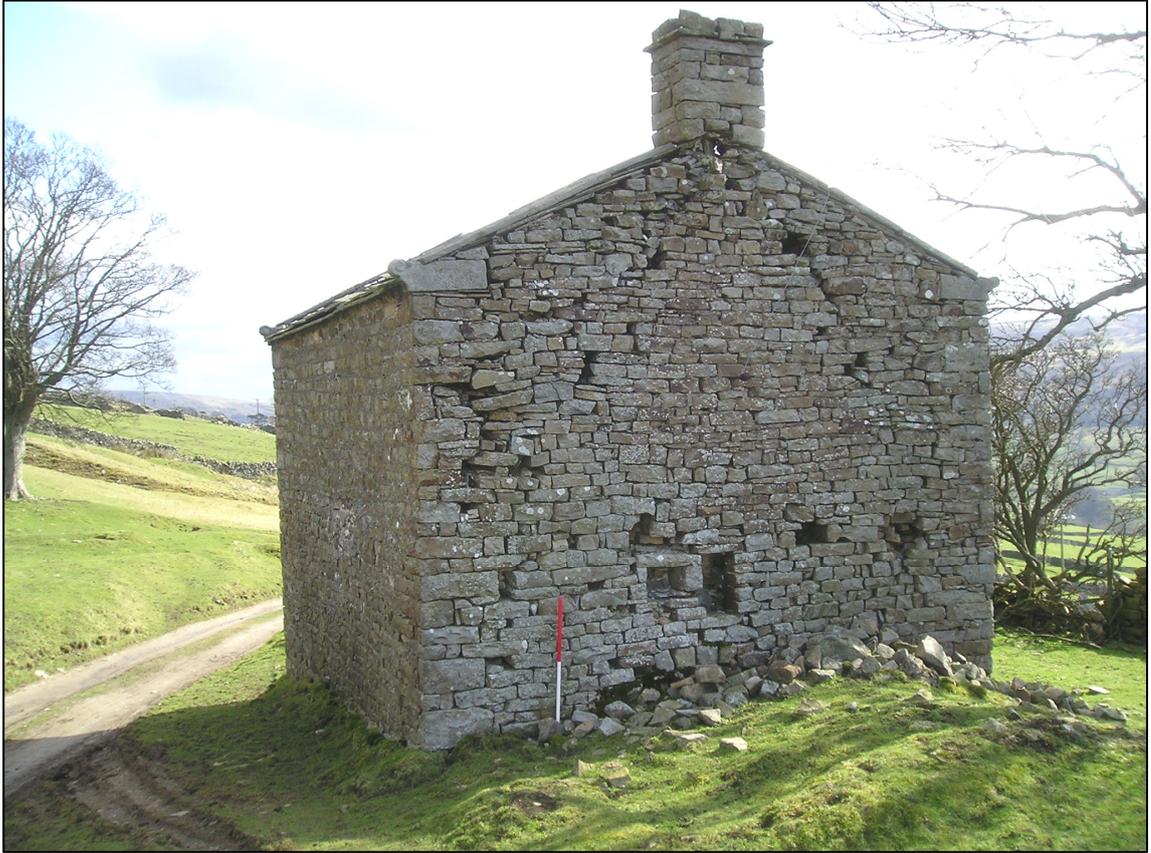
Plate 3: West gable, looking E (photo 1/11).

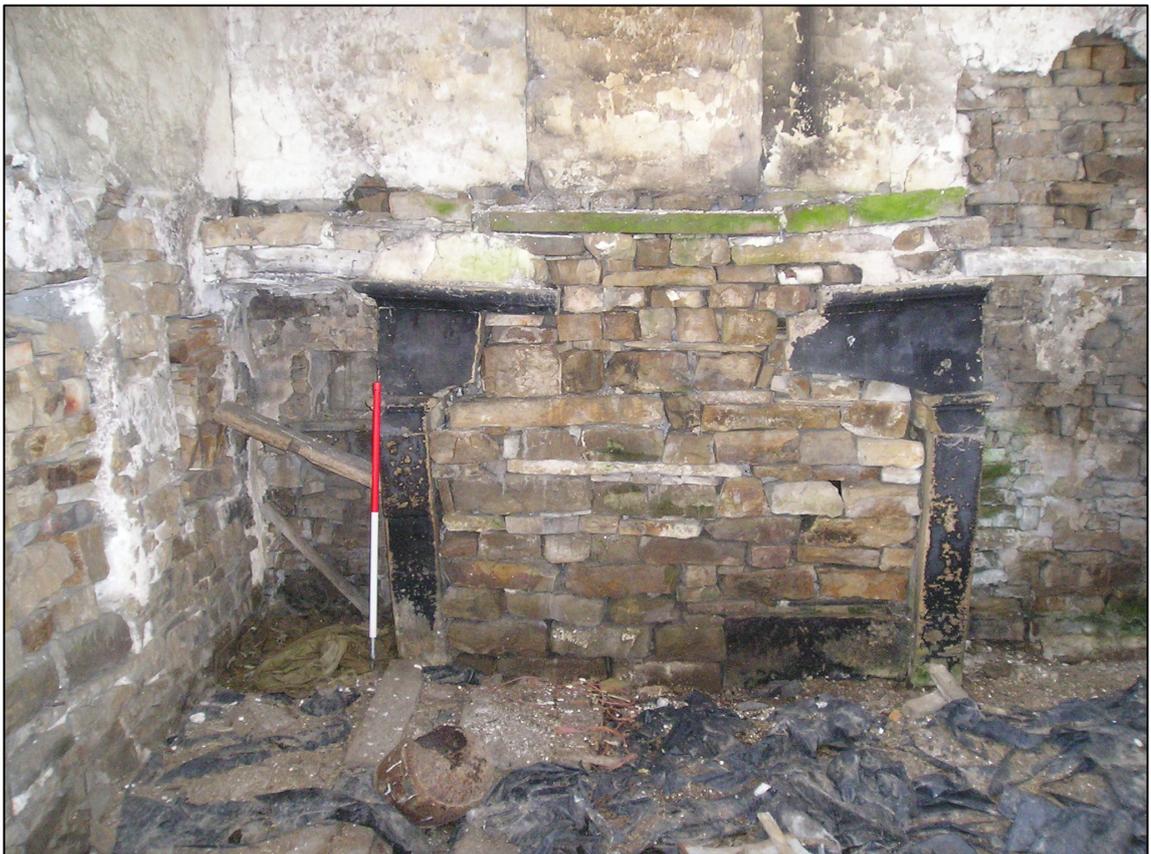
- 3.9 The cottage had a single room to the ground floor. The principal feature of interest is the large, now blocked, mid-18th century fireplace to the west wall (see plate 4). This fireplace has monolithic jambs, surmounted by simple moulded corbels, supporting the broad arched head and moulded mantelshelf over; all are painted black (1/15, 1/27, 1/32 and 3/9 to 3/13). The fireplace was once flanked by recessed areas to either side, which both retain curved wooden lintels. The southern area has a second small square recess set into the rear (west wall) (1/40, 1/47, 1/48 and 3/16); an adjacent hole is partly blocked using a silk parachute, which was found blowing around on the moorland above Kearton during the Second World War (George Tiplady, *pers. comm.*).

- 3.10 In the 1988 survey (Potter *et al* 1988), it was noted that there were suggestions that a bake-oven had once existed here, but that no trace of it could be found. The fireplace was suggested to have replaced a firehood, the former position of which was marked by approximately opposed recesses in the north and south walls (1/35). There are further opposed recesses to the east, marking the former position of the first floor north-south aligned beams, together with a single recess immediately above the largest window in the south wall which is not mirrored to the north (3/14). A short angled wall projects into the ground floor on one side of the doorway (3/15), screening the area to the east. This was formerly lit by a now blocked splayed window in the south wall, whilst there is a tall blocked feature adjacent in the east wall (3/20). This is of similar dimensions to a doorway but cannot be seen externally, and so may be a shallow recess rather than an opening.

Plate 4: Blocked fireplace, internal west wall, looking W (photo 1/15).

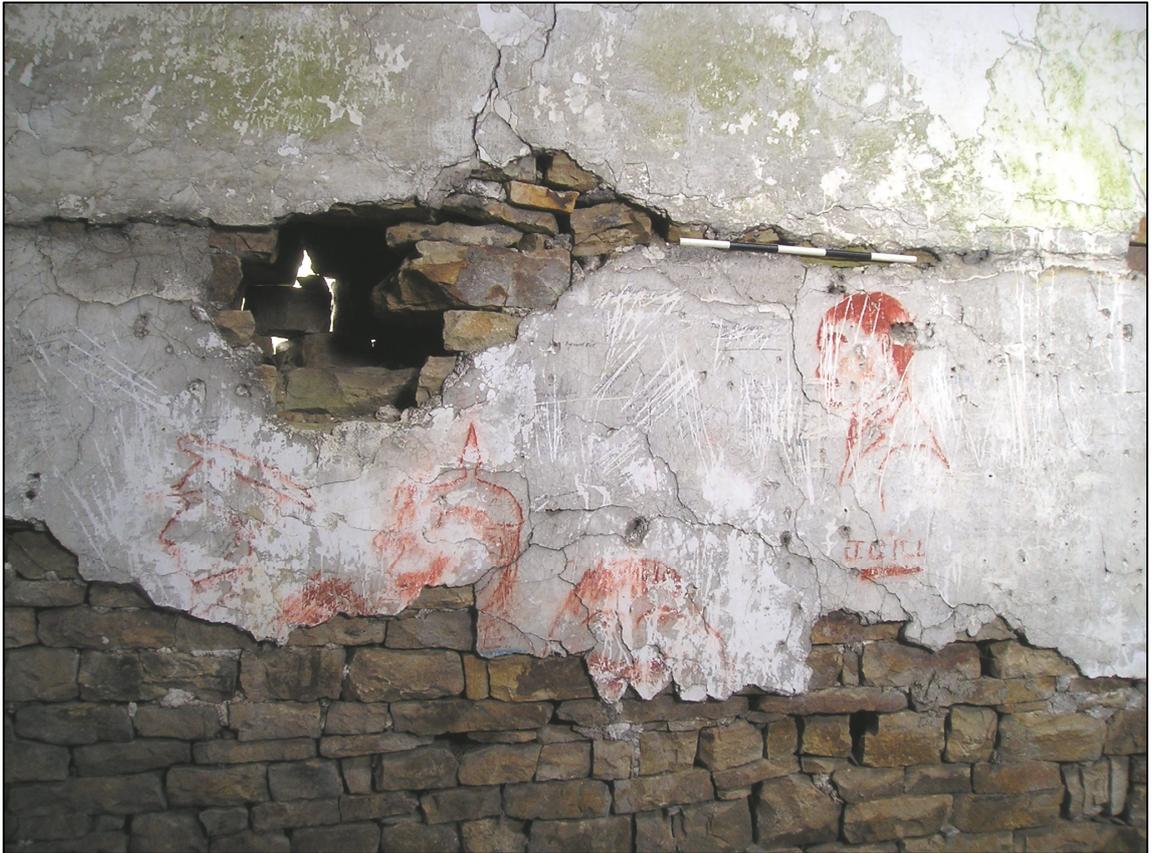
- 3.13 The principal items of interest are four paintings on the north wall (**1/17**, **1/18**, **1/25**, **2/17** and **2/18**; see plate 5). All are done in a red paint or dye, possibly sheep raddle (Robert White, *pers. comm.*), and, like the rest of the graffiti, they are quite badly scratched; in addition, only one is complete, the lower half of the other three having been lost when the plaster fell away. The paint or dye used for the complete painting is slightly darker than that for the other three, and the complete painting is arguably better drawn than the others, but there is no convincing reason to believe that they were done at different times. The owner of the barn and local farmer, George Tiplady, believes that the paintings have been there for all of his life and possibly since his family bought the farm in the early to mid 1920s (George Tiplady, *pers. comm.*). Although it was previously thought that the paintings might have been drawn by First World War prisoners of war held in the Richmond area, who could have been out-working on Swaledale farms, it is now thought that they were done by one of the younger male members of the Spensley family, of Langhorne House in Kearton, some of whom were known to be good artists (Raymond Alderson, *pers. comm.*).

Plate 5: Painted portraits, north internal wall (photo 1/18).

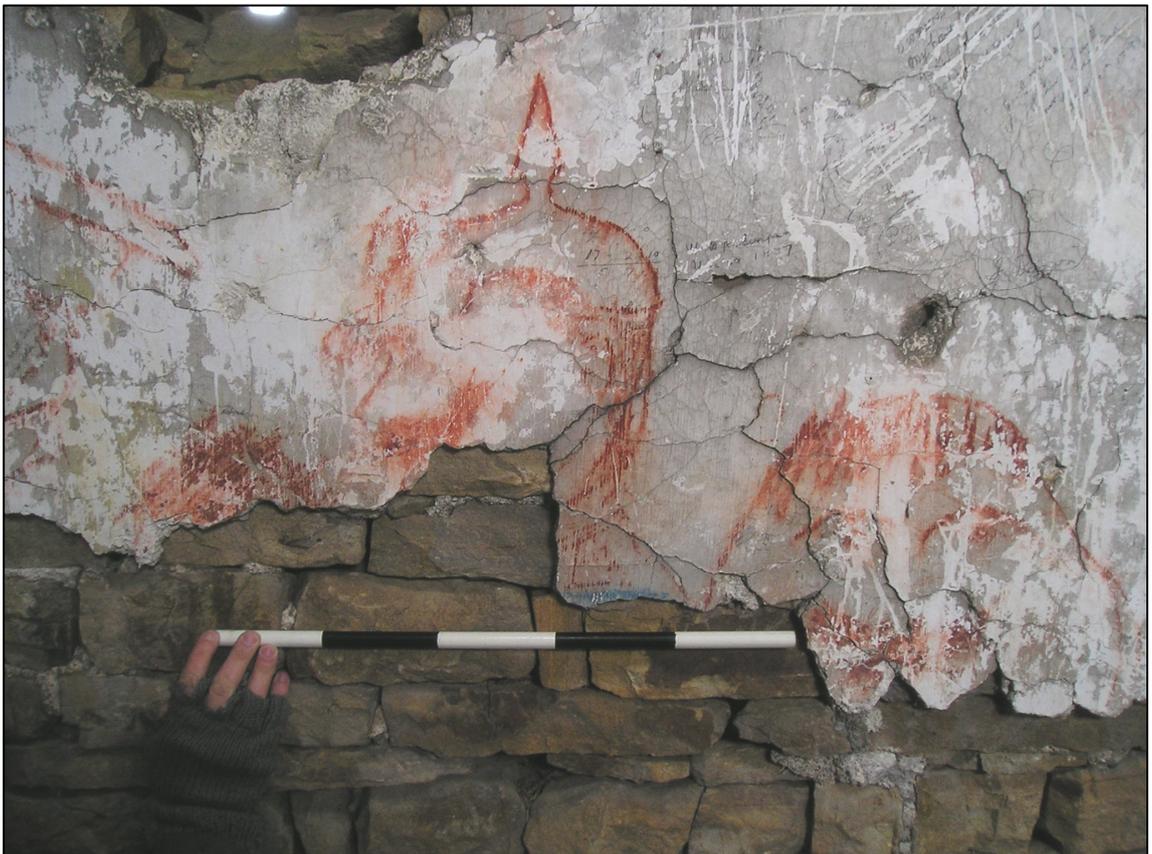
- 3.15 Below and to the left of Gill are the other three paintings (**1/17** and **1/18**). The far left painting shows the head and shoulders of a man in profile wearing a British Army soft cap; a patch of red to one side might obscure another name (**1/23** and **1/59**; see plate 7). The central painting is a similar profile of a German soldier wearing a spiked First World War *Pickelhaube* helmet; the prominent *Schnurbarr* moustache suggests that he may be intended to represent Kaiser Wilhelm II (**1/19**, **1/20**, **1/24** and **1/60**; see plate 6). The painting to the right shows part of the full face of another man, again with a prominent moustache (**1/19** and **1/20**), perhaps

bearing a passing resemblance to the famous recruitment poster of Lord Kitchener (see plate 6).

Plate 6: Kaiser and Kitchener portraits?, north internal wall (photo 1/20).

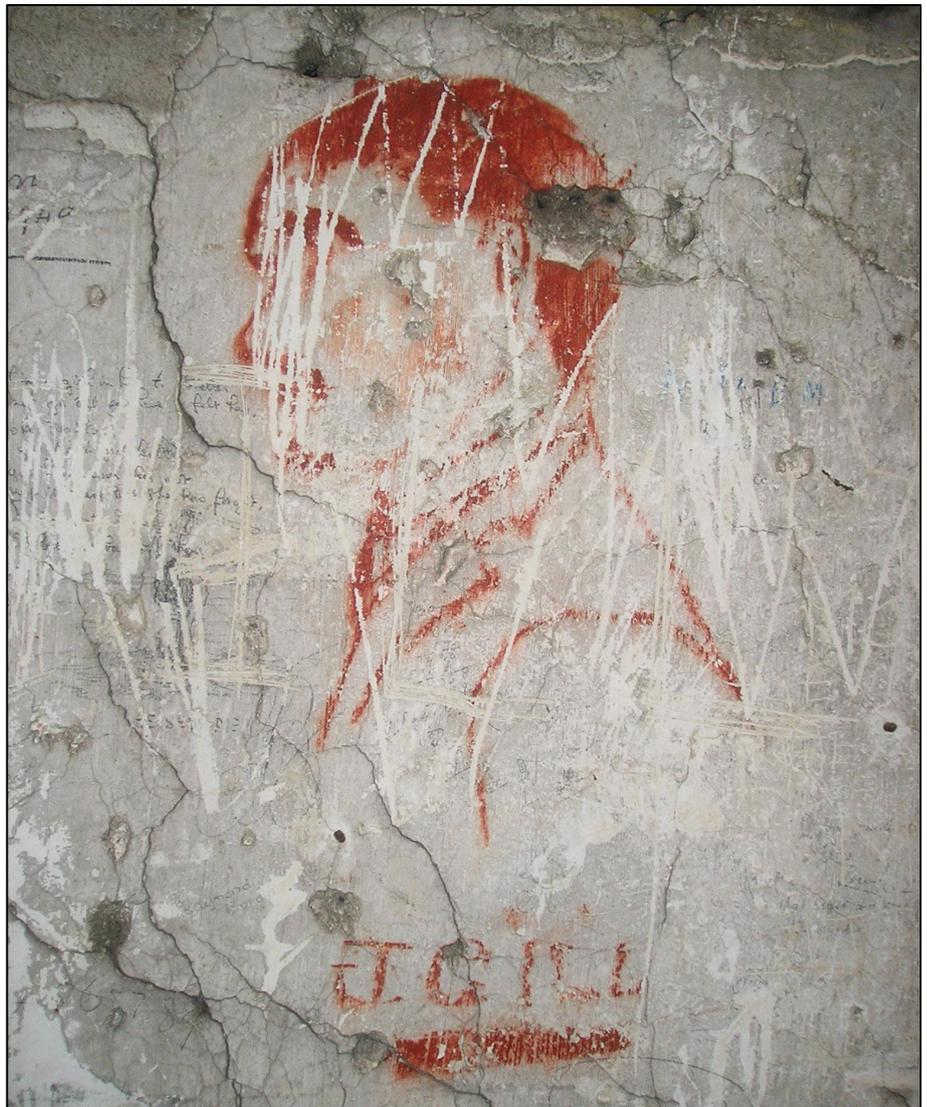
- 3.14 The complete painting on the north wall shows the head and shoulders of a man in profile (**1/21** and **1/56**; see plate 8). He has neat (slicked back?) hair, prominent eyebrows and a moustache, and is wearing a collar and tie. Beneath the portrait is the name "J. GILL", believed to refer to the identity of the portrait (James or Jim Gill of Low Row), not the painter (Raymond Alderson, *pers. comm.*). Beneath this, there is a smudgy red line. Initially, this was thought to be some underlining of the name, but it apparently obscures the word "Murphy". Murphy was Gill's nickname, because his moustache made him resemble an Irishman who came to Swaledale once a year with a travelling fair; Gill's grandson didn't like the comparison, and so must have crossed it out (Raymond Alderson, *pers. comm.*). Consultations undertaken by Lawrence Barker with members of the Gill family still living in Swaledale have failed to reveal any further information relating to the portrait (Lawrence Barker, *pers. comm.*).

Plate 8: J Gill portrait, north internal wall (photo 1/56).

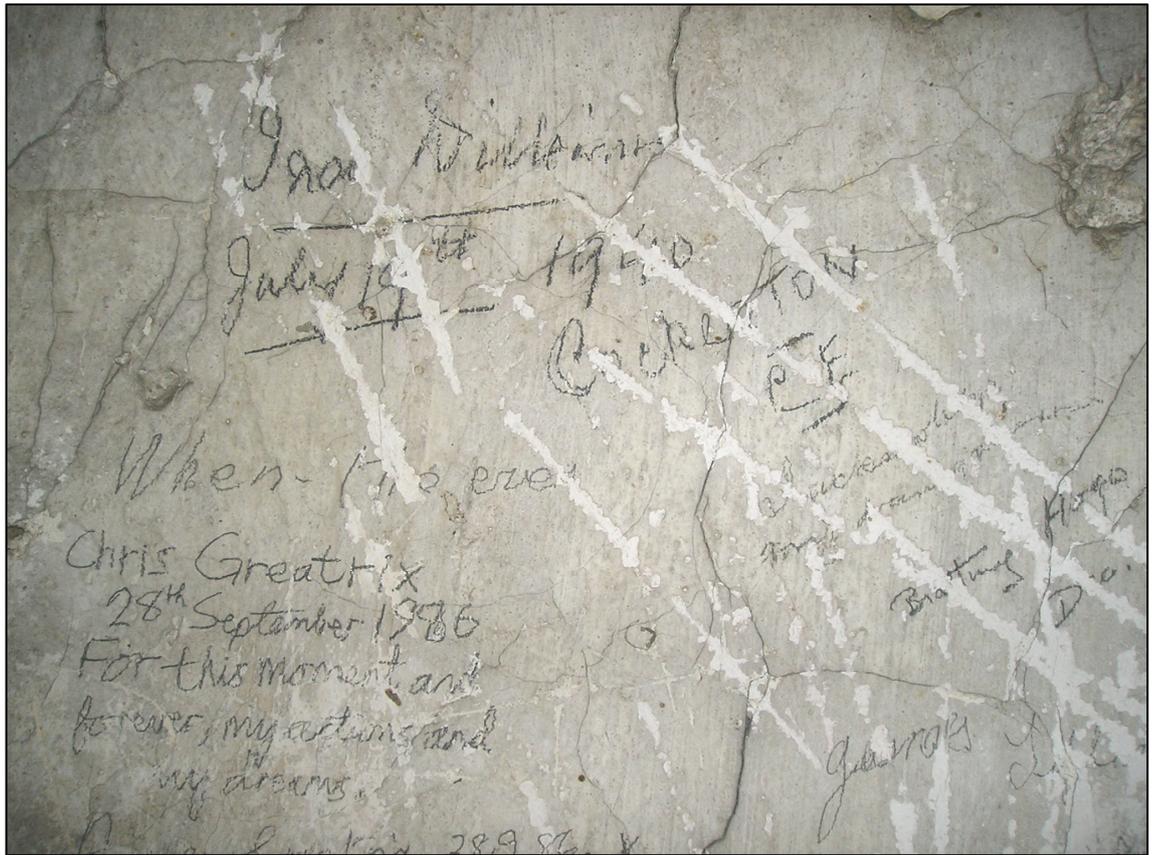
(?) Wilkinson July 19th 1940 COCKERTON CE (1/22 and 1/57)

Plate 9: Graffiti, north internal wall (photo 1/57).

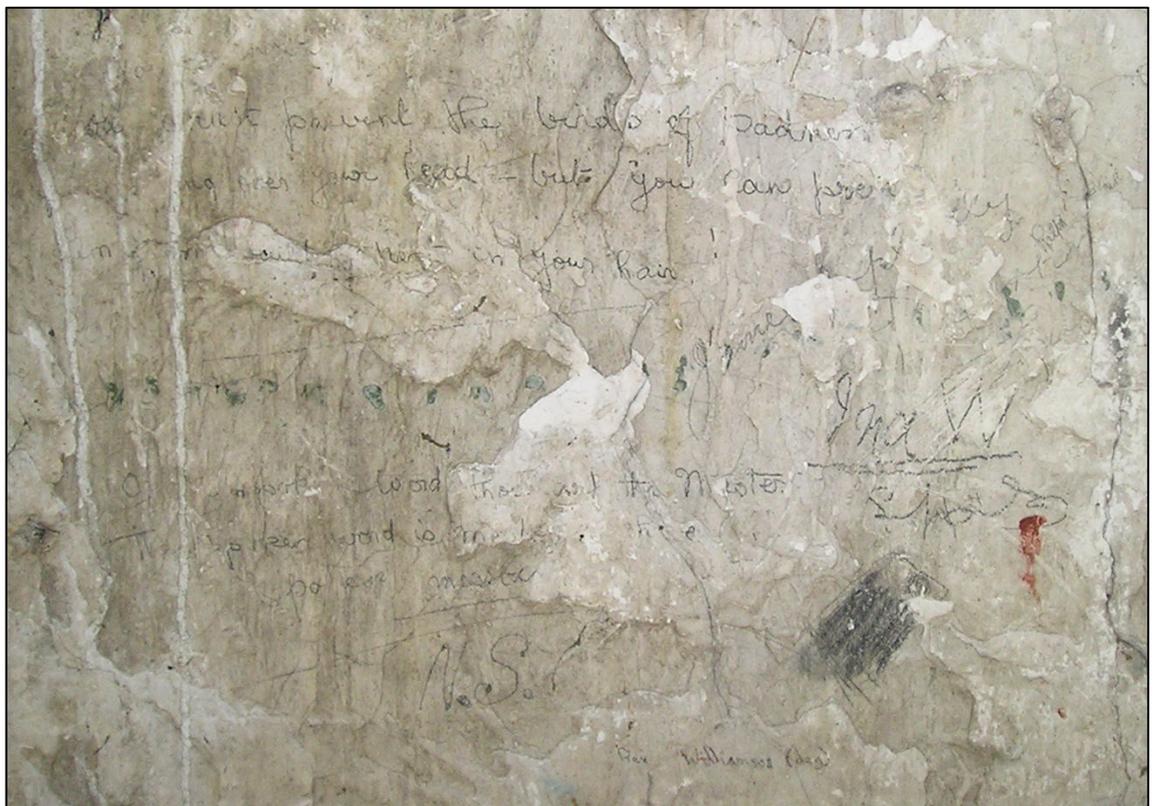
(*In same hand*) You cannot prevent the birds of sadness from flying over your head, but you can prevent them from settling in your hair! (1/28, 1/29 and 1/42)

Plate 10: Graffiti, north internal wall (photo 1/29).

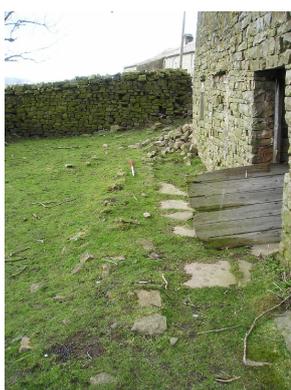
1-12.JPG

- 3.18 The cottage once had a narrow pathway, c.1.1m wide, running along its east and south sides (1/12). On the south side, the pathway retains flagstone paving and was once enclosed by a wall running parallel to it, although only the footings for this now remain. The drystone wall enclosing the area to the south of the cottage is of roughly coursed rubble, with vertical coping but few throughstones. It stands up to 1.4m high and has a slightly battered profile, being c.0.60m wide at the base. The wall may have a blocked stile towards its south-west corner and an old bedstead, possibly taken from the cottage, is leant against its central section.

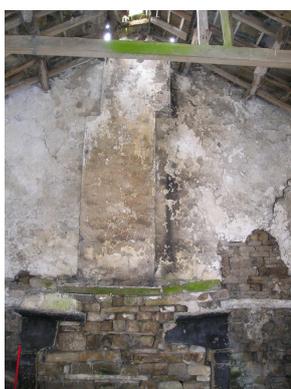
1-16.JPG

3/17). Like the ground floor, the first floor also comprised only a single room. It was unheated (**1/16**), lit by a single central window in the south wall and a smaller opening in the east wall (**1/37** and **1/41**); some of the first floor walls retain expanses of whitewashed plaster.

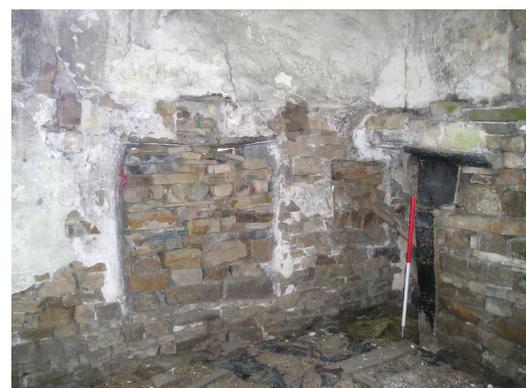
1-35.JPG

Film	Frame	Subject	Scale
1	34	Blocked fireplace, west internal wall, looking SW	1m
1	35	South-west internal corner, looking SW	1m
1	36	North-east internal corner showing stair stain, looking E	1m
1	37	East internal wall, upper part, looking E	-
1	38	Roof trusses, looking W	-
1	39	East roof truss, looking E	-
1	40	Possible earth closet, south-east internal corner, looking S	1m
1	41	East internal wall, upper part, looking E	-
1	42	Detail of graffiti, south internal wall, looking S	-
1	44	Ruined house, north-east of site, looking NE	-
1	45	Separate structure to south-west of ruined house, NE of site, looking NE	-
1	46	Ruined house, north-east of site, looking NE	-
1	47	Recess to south of fireplace, west internal wall, looking W	-
1	48	Recess to south of fireplace, west internal wall, looking W	-
1	49	North elevation, looking SE	-
1	50	Ruined house, north-east of site, looking NE	-
1	51	Detail of graffiti, north internal wall, looking N	-

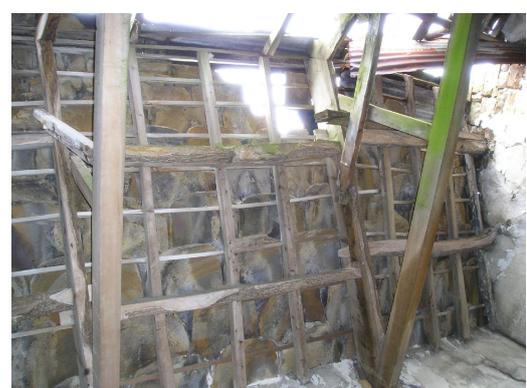
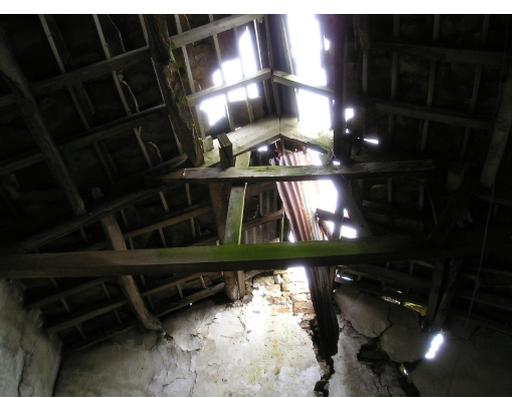
- 3.5 The roof structure of the cottage comprises two roof trusses. In 1988, the roof was described as being supported by modern king-post trusses (Potter *et al* 1988). However, this appears to have been erroneous for at the time of the present survey, the trusses were both of tie-beam, principal rafter and collar form, each formed from a mixture of modern softwood and earlier hardwood (**1/33**, **1/38**, **1/39**, **3/18** and **3/19**). Vertical softwood struts have been added at a later date. Each principal carries a pair of staggered butt purlins with common rafters over (**1/38** and **1/39**).

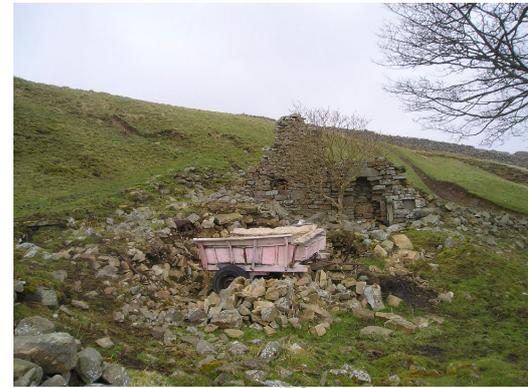
1-46.JPG

- 3.19 The ruined remains of another house/cottage can be seen on the north side of the track running past the cottage (1/44, 1/46, 1/50 and 3/21 to 3/25). It is almost completely ruinous, the only portion standing to any height being the eastern gable which contains the remains of a fireplace similar to that noted within Fair Acre Cottage. However, unlike Fair Acre, there is no indication in the ruined building of an earlier gable incorporated into the existing one. The main body of the house appears to have comprised two cells; the southern contained the remains of a small 19th century cart or wagon converted into a wheeled trailer at the time of the survey. This building, unnamed but roofed and intact, is shown on the Ordnance Survey 1st edition 6" map (sheet 52) (see figure 2). There is a further ruinous structure to the south of the house.
