FOXHOUSE FARM, DREWTON LANE,
SOUTH CAVE, EAST YORKSHIRE

ARCHAEOLOGICAL OBSERVATION,
INVESTIGATION AND RECORDING

Report no: 2008/318.R01
Version: Final
Date: April 2009
Author: Ed Dennison

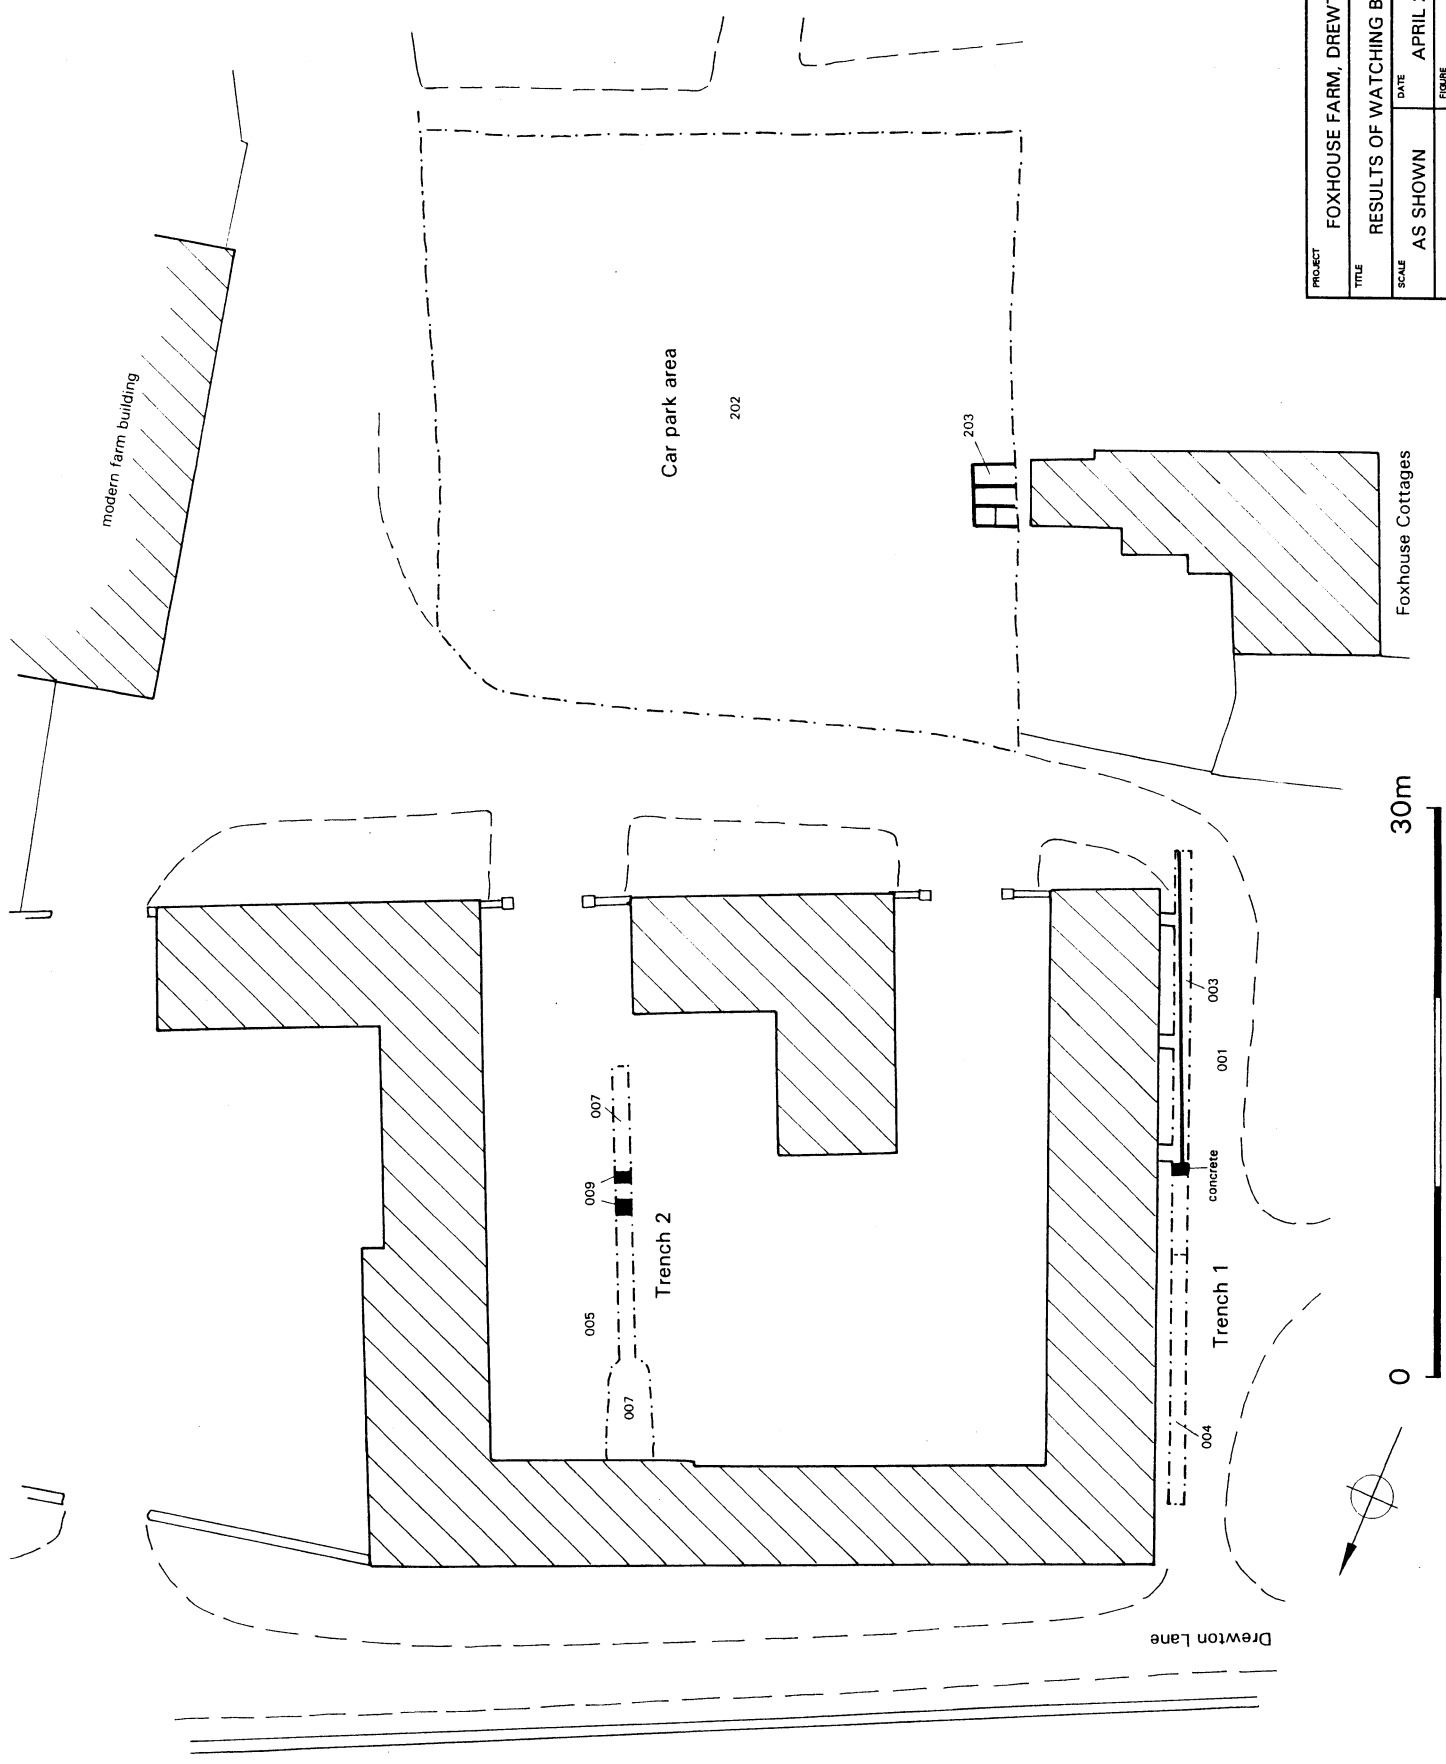
PROJECT	FOXHOUSE FARM, DREWTON
TITLE	RESULTS OF WATCHING BRIEF
SCALE	AS SHOWN
DATE	APRIL 2009
FIGURE	4

5 RESULTS FROM THE WATCHING BRIEF (see figure 4)

- 5.1 The watching brief associated with the excavation of the external drainage was undertaken in several separate operations. On the 18th March 2008, the main section of the drainage trench was excavated along the south-west side of the farm complex, along the line of an access track. This trench ran parallel to the west wall of the west range of the complex but was set some 0.85m out from it, with a number of small arms running between the main trench and the farm range. The main trench started at a point 1.90m to the south of the south-west corner of the west range, and continued to a point 3.20m to the south of the north-west corner, giving a total length of 34.50m. The trench had an average width of between 0.80m to 0.90m, and an average depth of 0.50m below ground level (BGL) (99.28m AD) at the southern end, increasing in depth to 0.90m BGL (98.26m AD) at the northern end.

- 5.4 At the time of the initial watching brief visit on the 18th March 2008, a second excavated drainage trench was still open in the east yard of the farm complex (see plate 2). This trench was aligned north-west/south-east, measured c.20.70m in length and had an average width of 0.95m, although the sides had been crudely widened beyond the main excavation for the northernmost 5.0m. The trench was excavated to an average depth of 0.70m; the ground surface within the yard sloped very slightly downwards from south to north, with the base of the trench similarly sloping downwards from 99.00m AD to 98.90m AD in the same direction.

- 5.9 Towards the centre of the west side of the stripped area, the remains of a small structure (203) were revealed, in line with the gable of the adjacent Foxhouse Cottages. This structure had already been demolished at some time prior to the stripping operation. It was brick-built, and measured 3.0m long (north-south) by 2.0m wide (east-west); only the bases of the walls were visible, represented by two courses of machine-made brick. The structure was divided into three cells, the northern cell being further subdivided into two bays by a single brick skin wall. These two bays were filled with a thin layer of ash, the central cell was clean, and the southern cell had a brick floor. There was some modern pottery and pantiles scattered about in the general vicinity. The building, which appeared to be of late 19th century date, had probably served as a coal house or ash house. The fact that the west side of the structure was not seen in the stripped area might suggest that it formerly extended further to the west, and it may well have originally been attached to the end of Foxhouse Cottages, which represent the former farmhouse. A small structure appears to be shown on the Ordnance Survey 1855 map (see figure 3) in this area, although it is not known whether this is actually the building revealed by the topsoil stripping. The main part of the stripped area is shown as an orchard on the 1855 map.

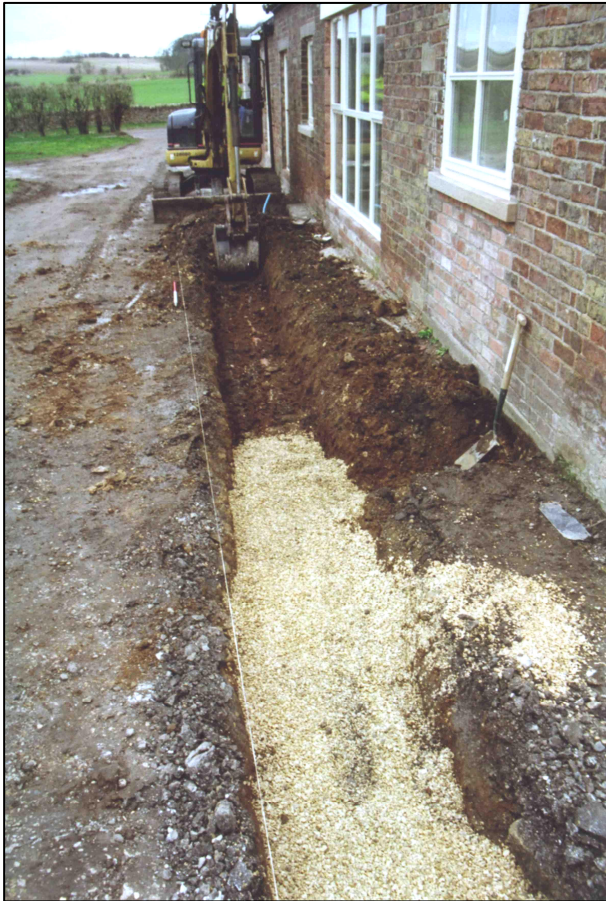
- 5.2 Following the removal of 0.10m deep layer of modern tarmac (001), a bed of angular limestone pieces (002), up to 0.10m across, was exposed. This formed a bedding layer for the tarmac and had an average depth of 0.10m. The limestone (002) overlay a richly coloured mid-brown sandy silt clay (003), quite firm and clean with few inclusions, which was up to 0.70m thick. In the southern half of the trench, a 0.12m diameter ceramic pipe ran along the base of the trench, parallel to the east section (0.50m BGL to 0.70m BGL; 99.28m AD to 99.25m AD) (see plate 1). There was no clear cut for the pipe, and it gradually angled across the line of the trench, eventually disappearing near the centre of the trench, where it was crossed by a north-east/south-west aligned concrete capping. The top of the concrete capping was set at 0.30m BGL (99.65m AD) and it concealed a ceramic pipe.

- 5.3 At the southern end of the main trench, the sandy silt clay (003) continued beneath the base of the trench (0.50m BGL or 99.28 AD). As the trench deepened towards the north, the sandy silt clay (003) continued to be the lowest visible deposit. However, at a point c.20m to the north-west of the south end of the trench, where the excavation had reached c.0.70m in depth (99.25m AD), the sandy silt clay became shallower and faded out. It was seen to overlie a deposit of hard-packed angular chalk rubble (004), with a small amount of sandy silt clay (003) mixed in. The chalk rubble was only visible in the east section of the trench, not the west; a dividing line between the rubble and the sandy silt clay (003) may have been visible in the base of the trench, but it was not clear cut. Towards the northern end of the trench, the chalk rubble (004) was set at between 0.60m to 0.80m BGL (98.40m to 98.20m AD), and it continued beneath the base of the trench.

Plate 1: Trench 1 under excavation, looking north-west.

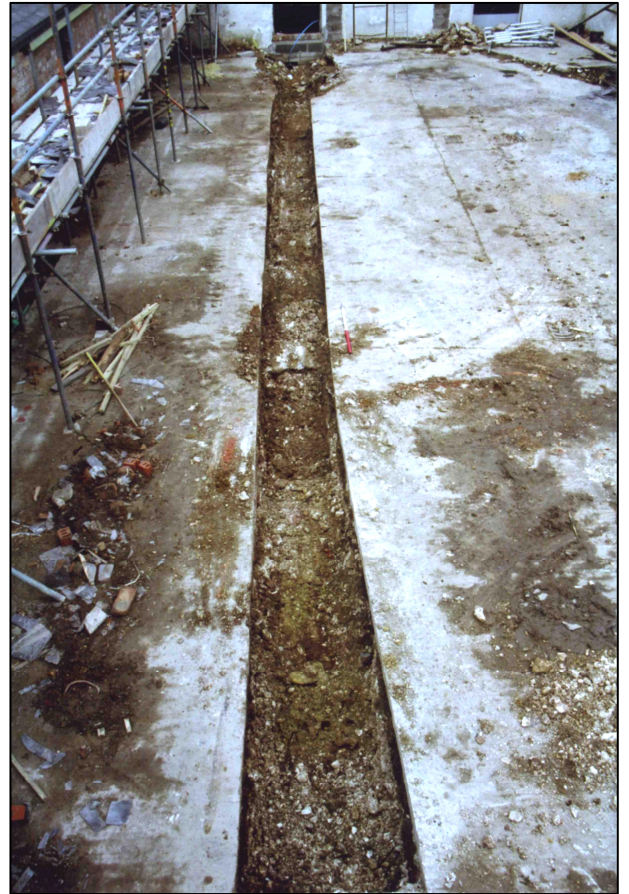
- 5.5 Following the removal of the 0.10m thick layer of concrete yard surface (005), a gritty black/dark brown silt (006) was exposed, set at between 0.10m to 0.34m BGL, although it varied in depth and in some places was as shallow as 0.10m deep. The silt (006) contained frequent inclusions of red handmade brick (average dimensions ? by ? by 0.07m). It overlay a 0.36m deep deposit of hard-packed angular chalk rubble (007), made up of pieces up to 0.10m across, and extending below the base of the trench for the majority of its length. However, in a few places where the trench went slightly deeper, the chalk rubble was seen to overlie a mid-brown sandy silt clay (008), relatively clean but containing occasional small fragments of pantile and red handmade brick.

- 5.6 No earlier structure pre-dating the existing farm complex was exposed in this second drainage trench. The only structures uncovered by the excavation were a pair of parallel concrete footings (009), predating the existing concrete yard surface (005) but overlying the chalk rubble (007). The top of the concrete footings was set immediately below the yard surface (0.10m BGL) and the surface of the narrower southern footing was slightly rounded in profile; they are unlikely to be any earlier than the mid 20th century.

Plate 2: Trench 2, looking north-west.

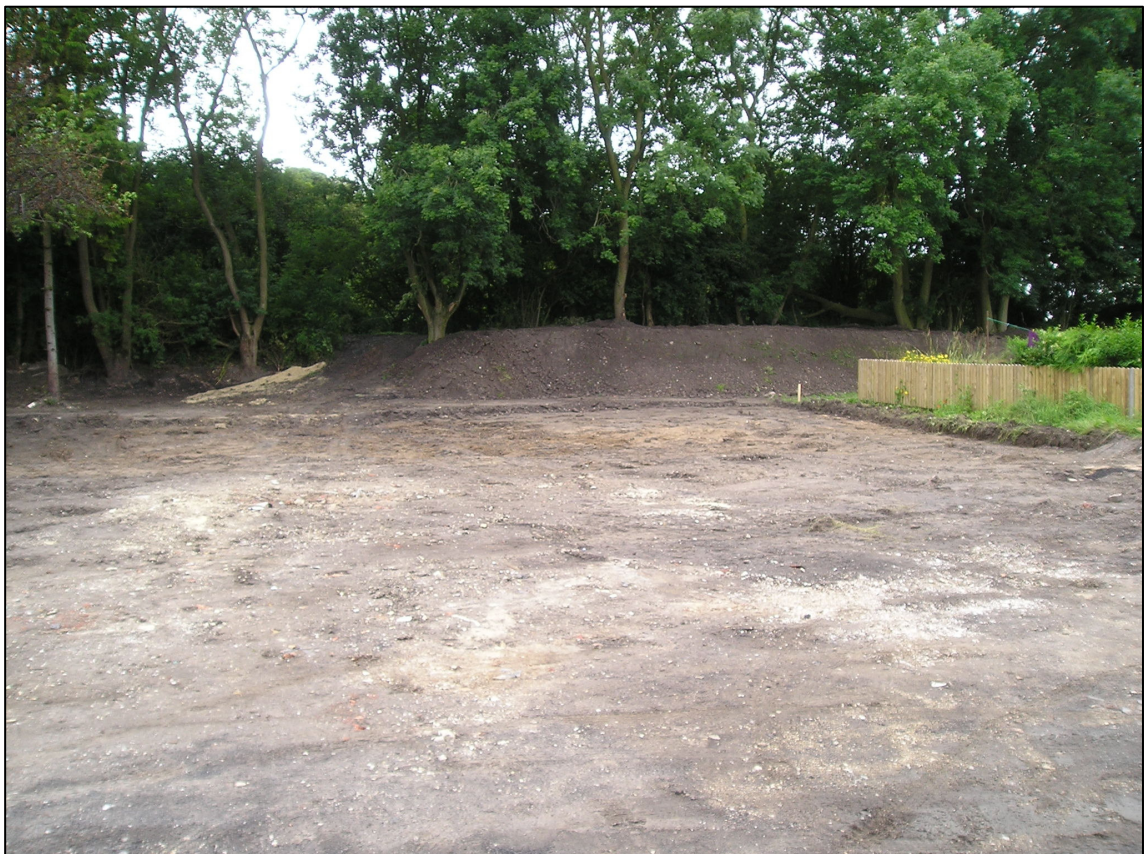
- 5.7 The topsoil stripping for the area of the new car park had already been completed when the monitoring visit was made, on 22nd July 2008. A large area had been stripped, totalling some 30m square, extending south from a track along the south side of the farm complex (see plate 3). Within the stripped area, the ground surface had originally sloped gently from north to south, and the area had previously been used as a dumping ground for agricultural and building material.
- 5.8 The stripping only took off the topsoil, which was between 0.20m-0.30m deep, to expose the subsoil. The topsoil (201) was a firm mid-brown sandy silt clay, which contained occasional scatters of chalk, modern intrusions (including a c.2m diameter

circular dump of modern rubbish towards the south end of the site), modern machine-made bricks and some animal bone. The underlying subsoil (202) was a mottled firm light brown silty clay with frequent chalk inclusions. No evidence for any cut archaeological features was noted within the stripped area.

Plate 3: Car park area following topsoil stripping, looking south-east.
