HAREWOOD CASTLE, HAREWOOD,
WEST YORKSHIRE

ARCHAEOLOGICAL AND ARCHITECTURAL
CONDITION SURVEY

VOLUME 3: APPENDICES

Report no: 1999/97.R01
Version: Final
Date: November 2008
Authors: Ed Dennison & Shaun Richardson

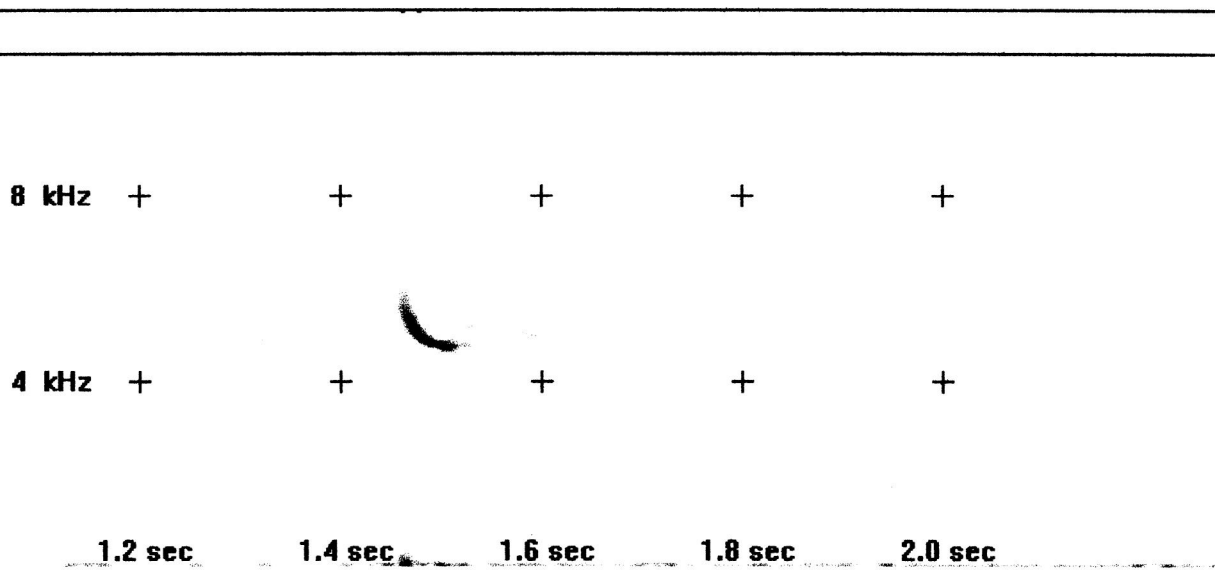
Figure 2 Sonogram of an echolocation call by the FM/CF bats *Pipistrellus pipistrellus* (Common Pipistrelle)

Habitat: Harewood Castle (Sample No. 1, May 25th 2000)
Duration: 5.6ms; Start frequency 59.2kHz; End frequency 46.7kHz.

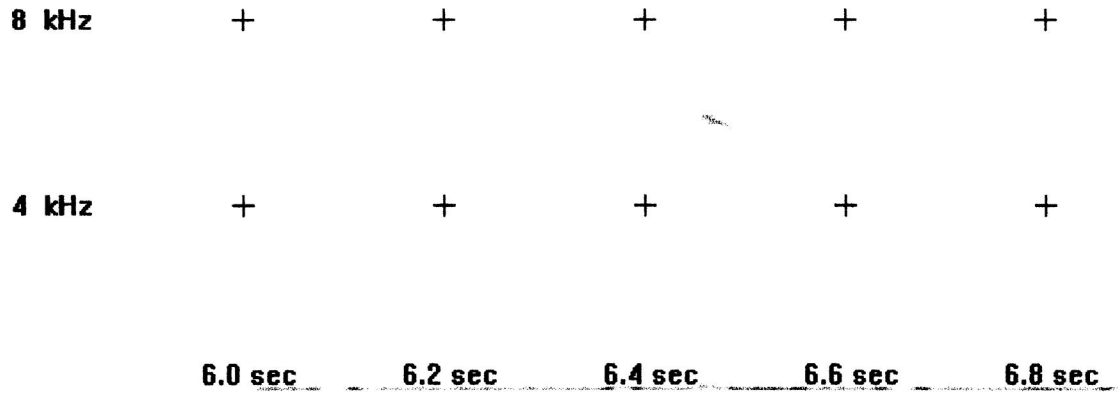
Figure 3 Sonogram of an echolocation call by the FM/CF bats *pipistrellus pygmaeus* (Soprano Pipistrelle)

Habitat: Edge of ancient, old sweet chestnut (Sample No. 6, May 25th 2000)
Duration: 3.0ms; Start frequency 59.2kHz; End frequency 56.6kHz.

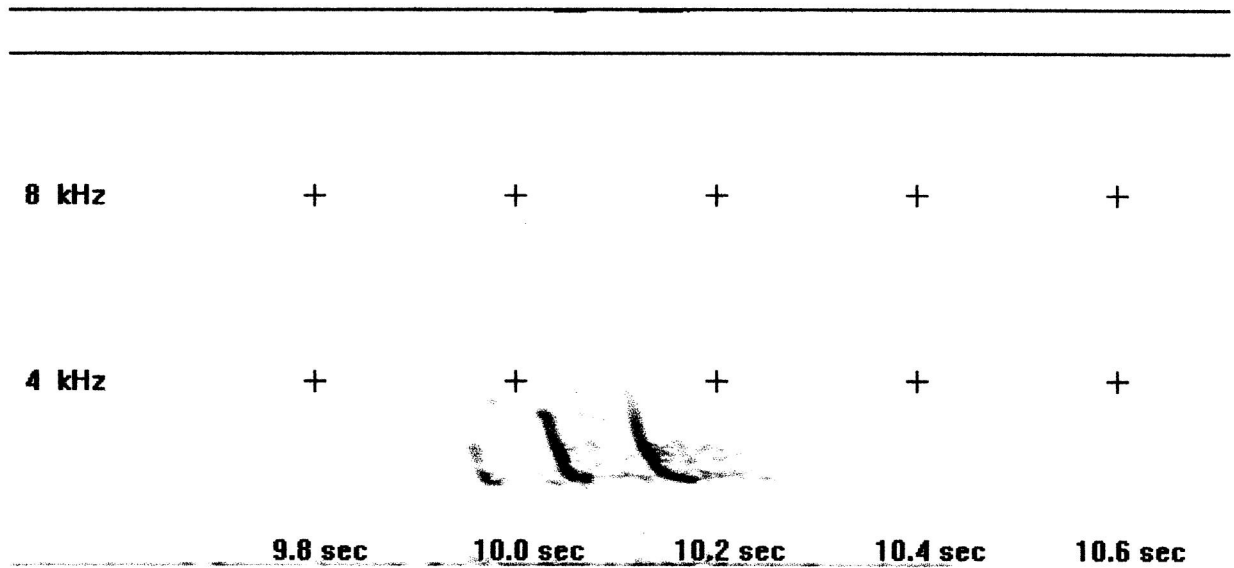
Figure 6 Sonogram of echolocation calls by the FM/CF bats *Nyctalus noctula* (Noctule)

Habitat: Ash and sycamore plantation with bluebell, dog's mercury and Lords- and-Ladies in field layer (Sample 7, June 7th 2000)

1st bat call
 Duration: 3.0ms
 Start frequency: 26.9kHz
 End frequency: 17.9kHz

3rd bat call
 Duration: 7.2ms
 Start frequency: 37.3kHz
 End frequency: 18.3kHz
 Interpulse interval: 8.6ms

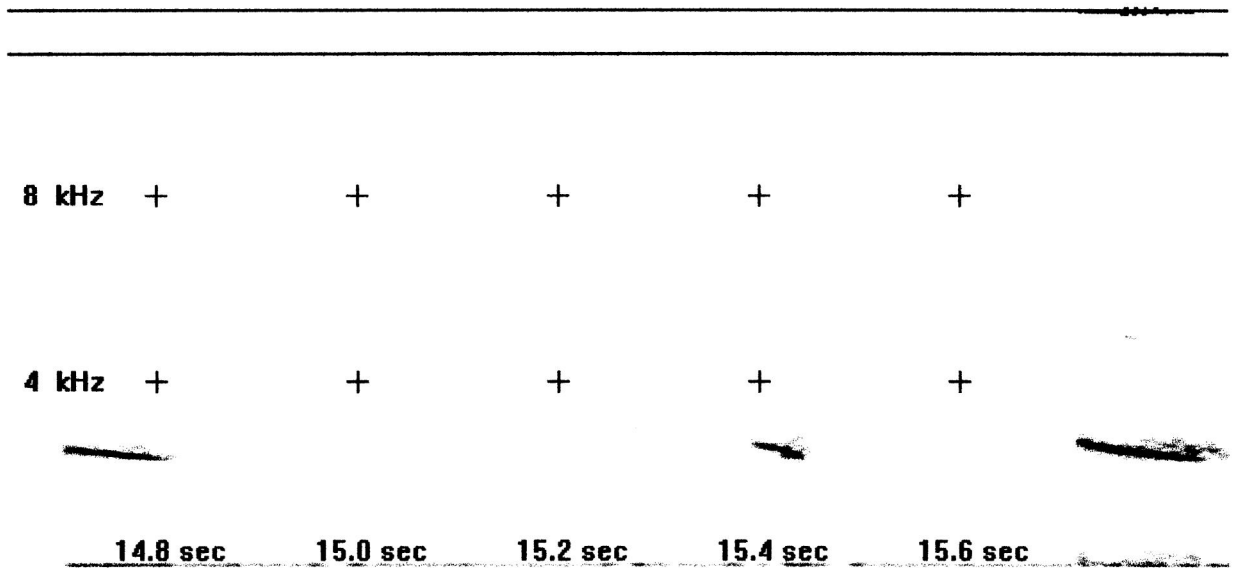
Figure 7 Sonogram of echolocation calls by the FM/CF bats *Nyctalus lesleri?* (Leisler's bat?)

Habitat: Edge of mixed beech and Scot's pine plantation (Sample 8, June 7th 2000)

1st bat call
 Duration: 10.6ms
 Start frequency: 25.2kHz
 End frequency: 23.0kHz

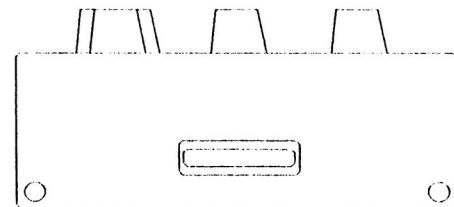
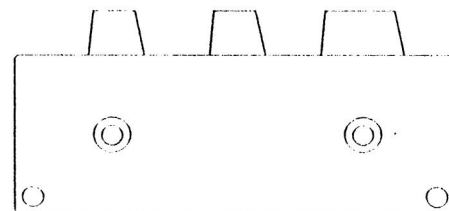
Controls on the Tranquility II

The Tranquility II is a new second-generation bat detector/recorder. It combines a heterodyne type detector, tuneable over the range 12kHz to 120kHz, and a time expansion detector, that can record up to 1.28 seconds of bat calls. The digital display is only illuminated when a **tune** position is selected, and indicates the tuned frequency. It also indicates a bat present situation when the tens digit decimal point flashes.

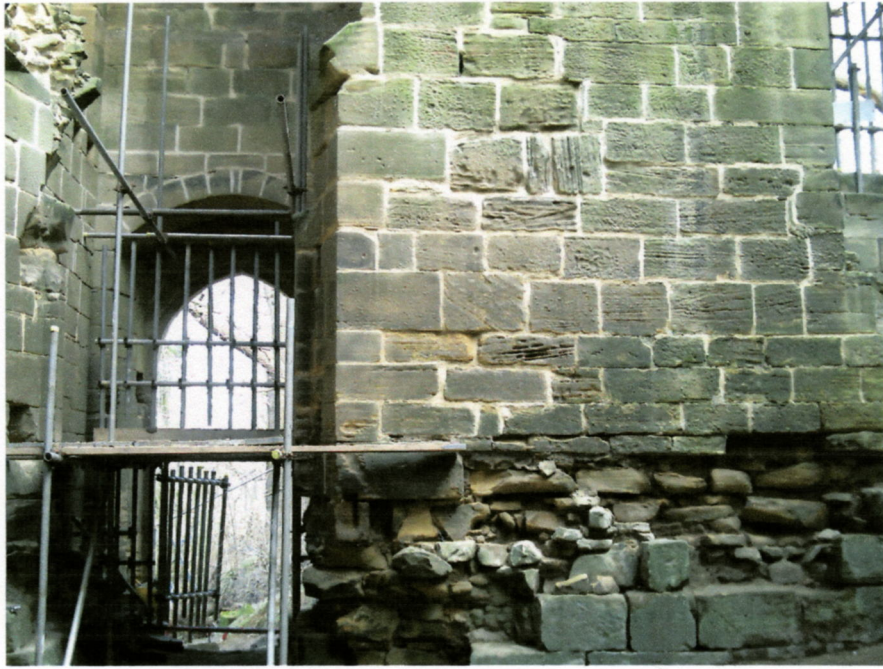
Figure 1. View towards main gate from central space. The use of plane bedded blocks on the corner contrasts with the blocks showing cross-bedding used in the rest of the wall.

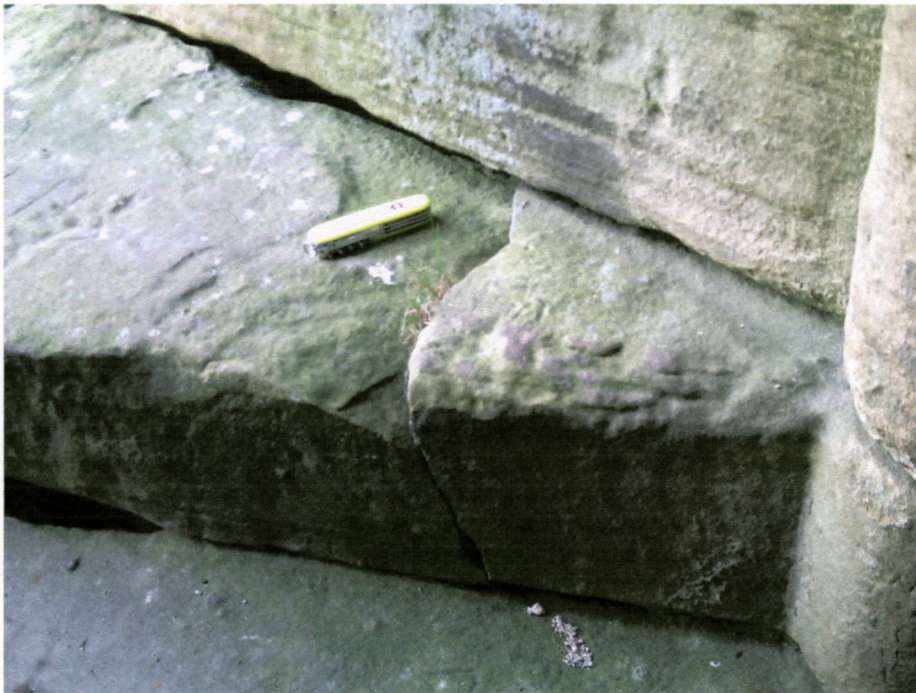
Figure 2. Failure of a slab forming a step in the north east spiral staircase.

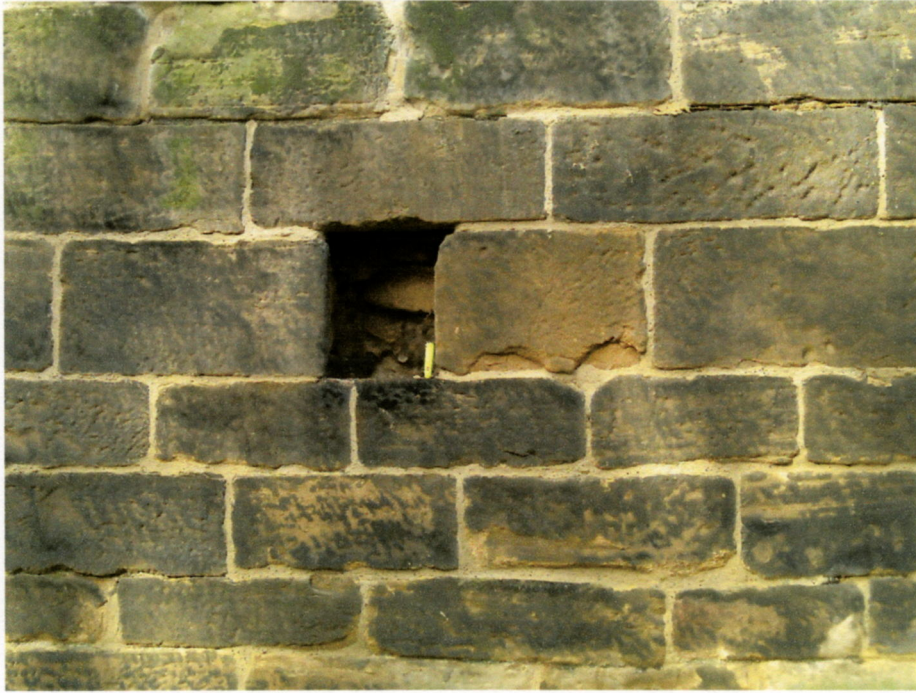
Figure 3. The single block on the exterior walls placed face-bedded. The block is spalling badly.

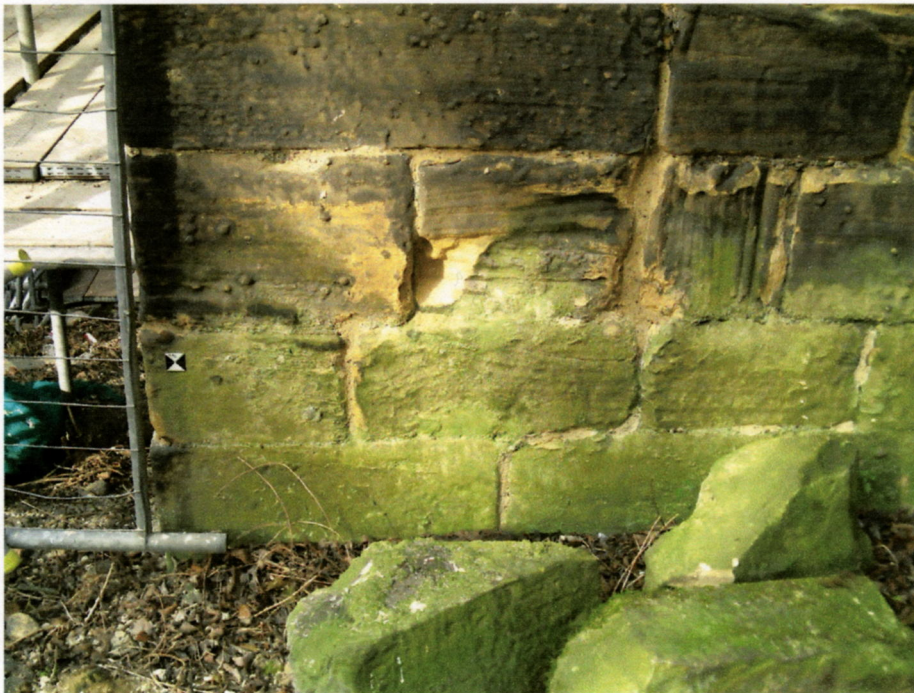
Figure 4. Heavy algal growth in the porous outer layer of the lower two courses has resulted in a green appearance. The 'nobby' texture in the upper two courses is a result of different degrees of cementation of the sandstone being picked out by erosion.

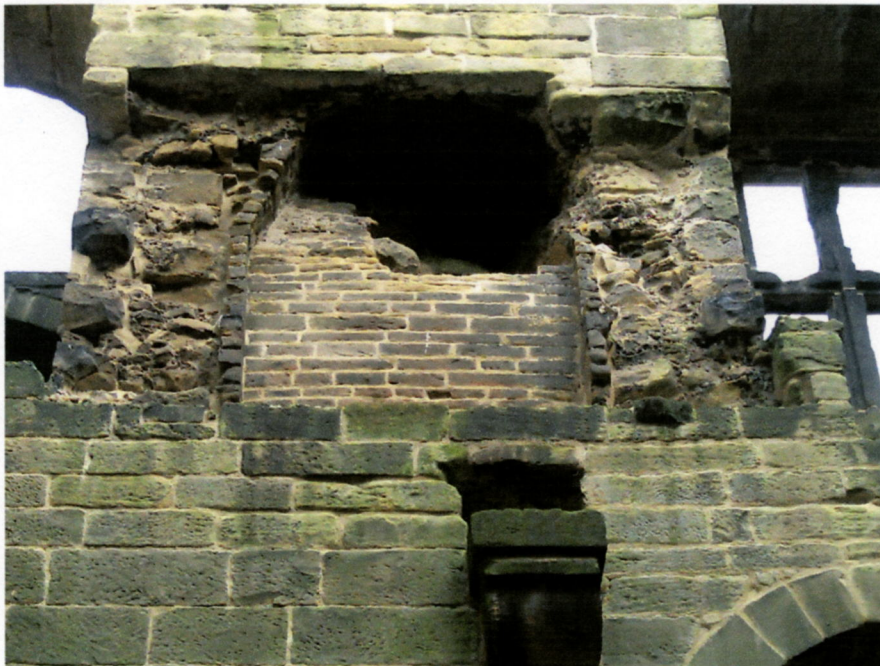
Figure 8. The much thinner bedded and finer grained stone used in this fire place on the east wall contrasts with the large blocks sourced from the Millstone Grit used in the rest of the picture.
