WATERFALL GILL POND,
SCAWTON, NORTH YORKSHIRE

ARCHAEOLOGICAL INVESTIGATION
AND RECORDING

Report no: 2008/338.R01
Version: Final
Date: May 2009
Author: Shaun Richardson & Ed Dennison

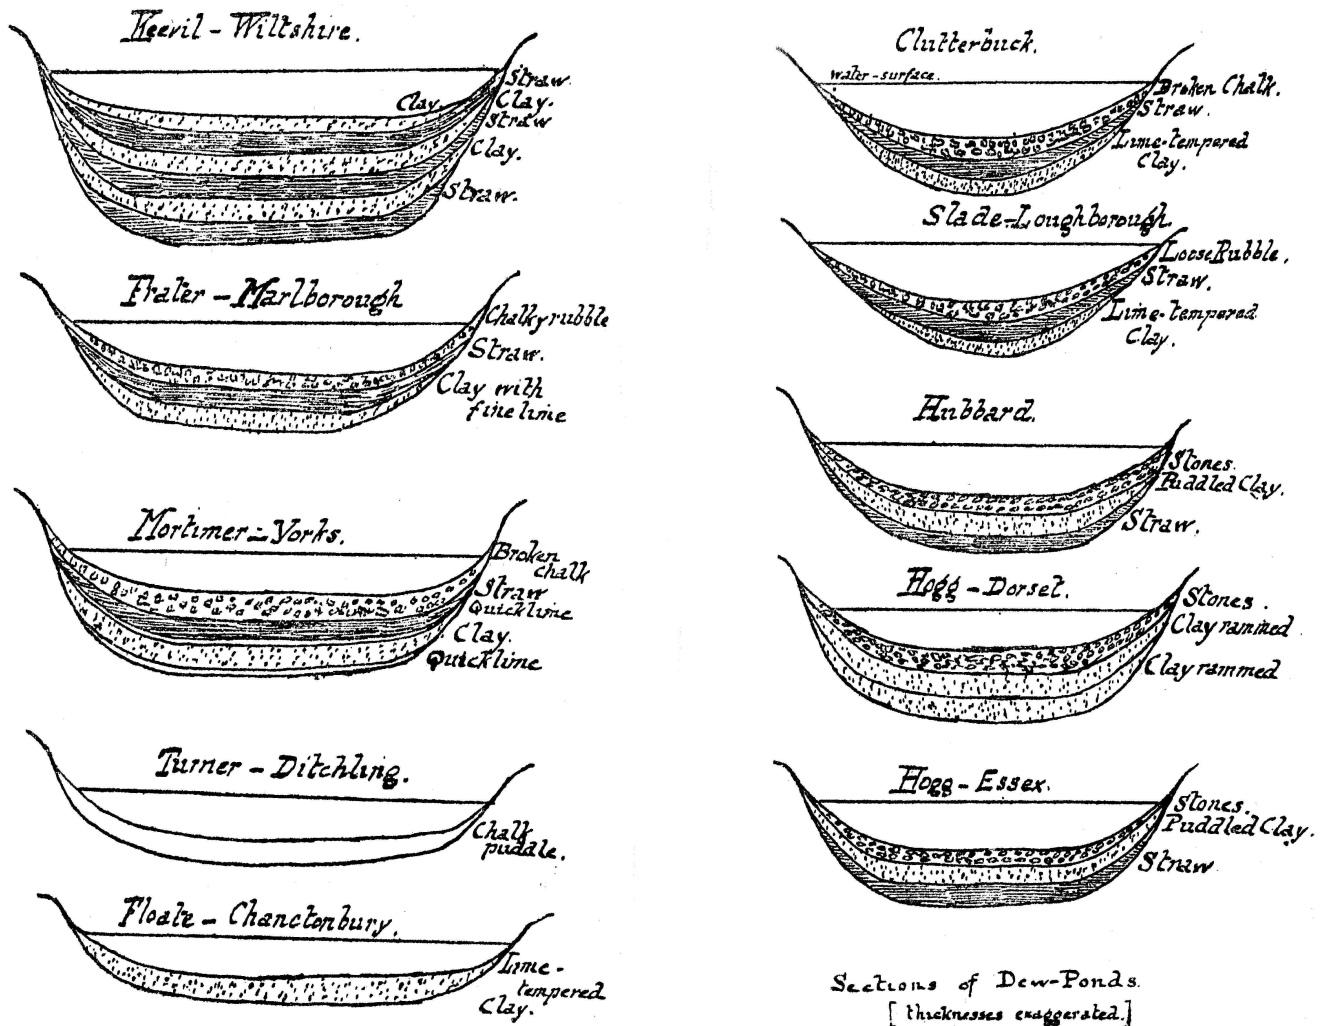
PROJECT	
WATERFALL GILL POND, SCAWTON	
TITLE	
SECTIONS THROUGH DEW PONDS	
SCALE	DATE
NTS	MAY 2009
EDAS	FIGURE
	3

Source: Martin 1910, 106-107.

- 2.13 Martin was also scathing of the belief that the introduction of straw into a pond lining created a non-conducting layer which allowed the clay to become chilled and attract dew (Ashford 1913, 37), believing that straw was laid over the clay either to stop it cracking or to prevent the chalk rubble lining of the pond being pushed into the clay (Martin 1910, 84, 95-98; Martin 1930, 349-50). Through his conversations with pond makers, Martin learnt that some would choose a site where “runnels made their appearance in rainy weather”, that the ideal depth for a pond was less than 4 feet (and in practice often less than 2 feet), and that there was some importance attached to a wide water-collecting margin (Martin 1910, 89, 114-118 & 136-138). Finally, he quote the late 18th century naturalist Gilbert White, who noted that a pond 30 feet in diameter and never more than 3 feet deep in the middle afforded water for 300 to 400 sheep and 20 head of large cattle (Martin 1910, 37). Martin also provided an illustration of schematic sections through ten dew ponds, including a Yorkshire example (Martin 1910, 106-107) (see figure 3).

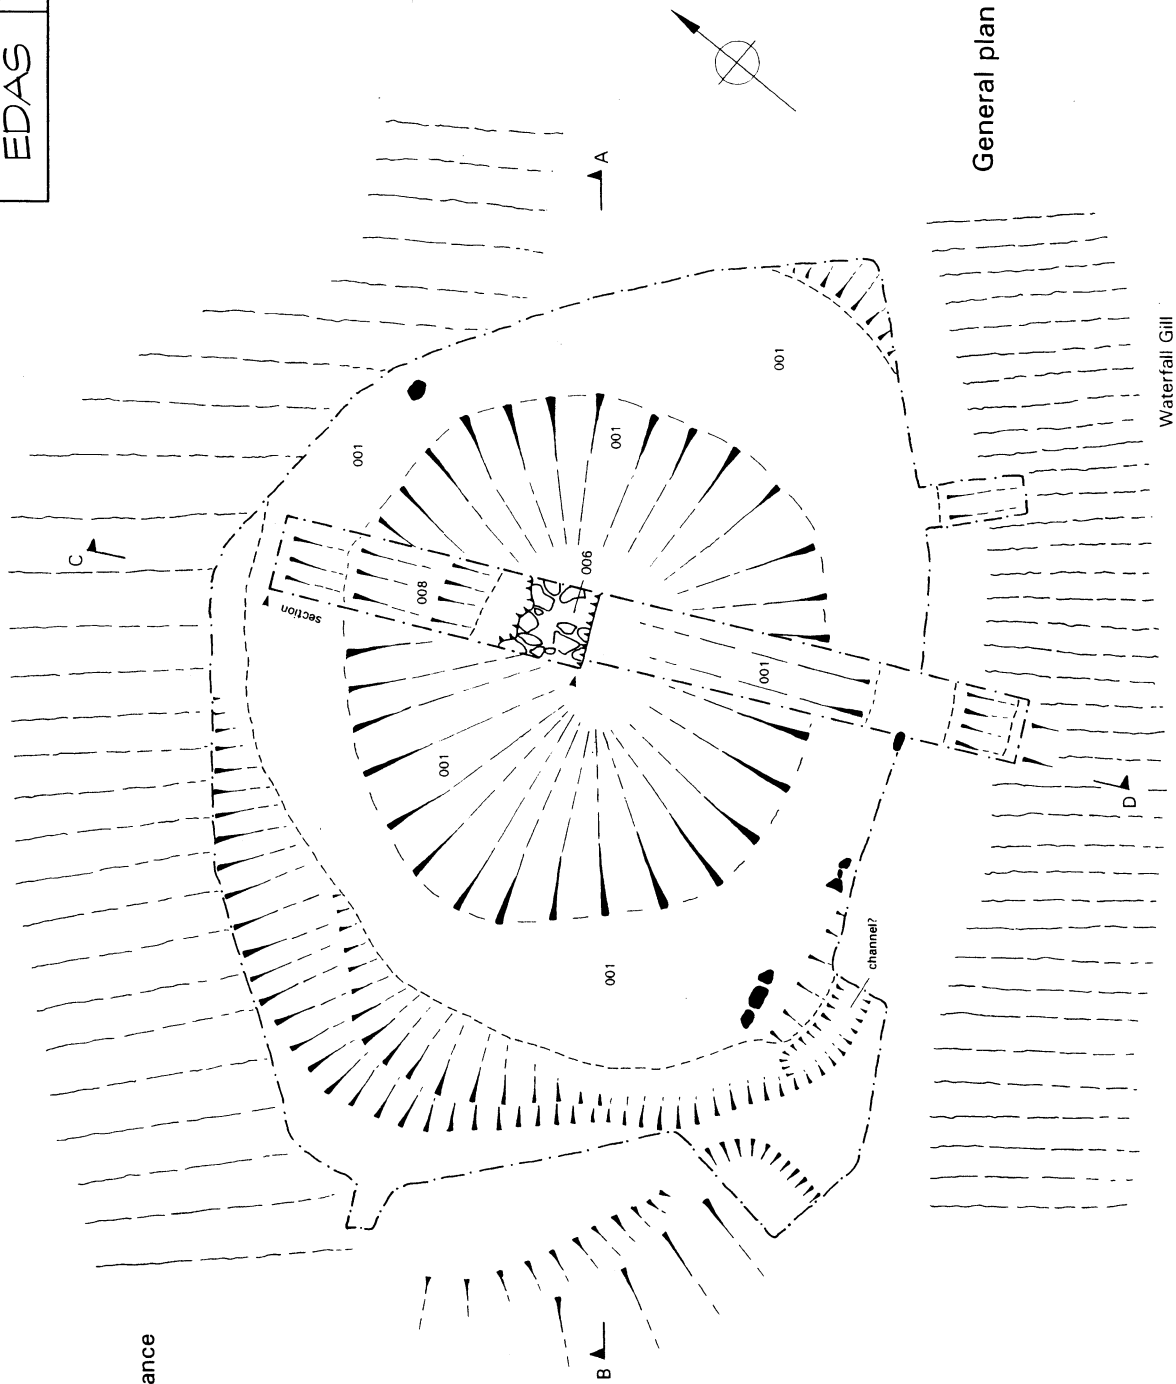
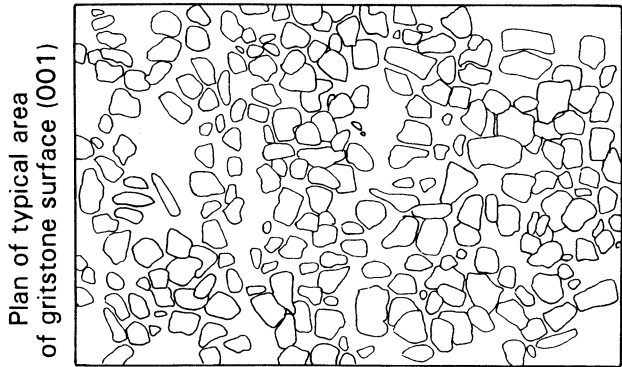
PROJECT	WATERFALL GILL POND, SCAWTON		
TITLE	PLANS		
SCALE	AS SHOWN	DATE	MAY 2009
	EDAS	FIGURE	4

General plan

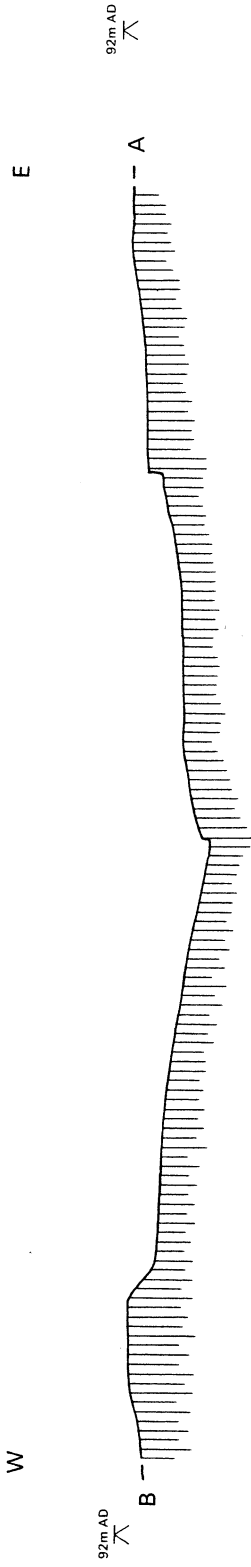
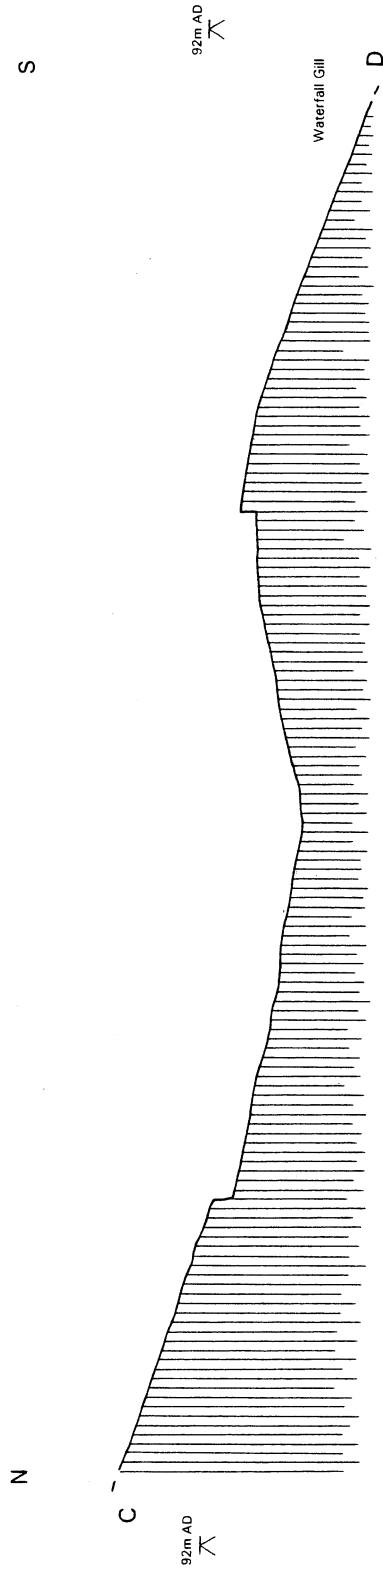
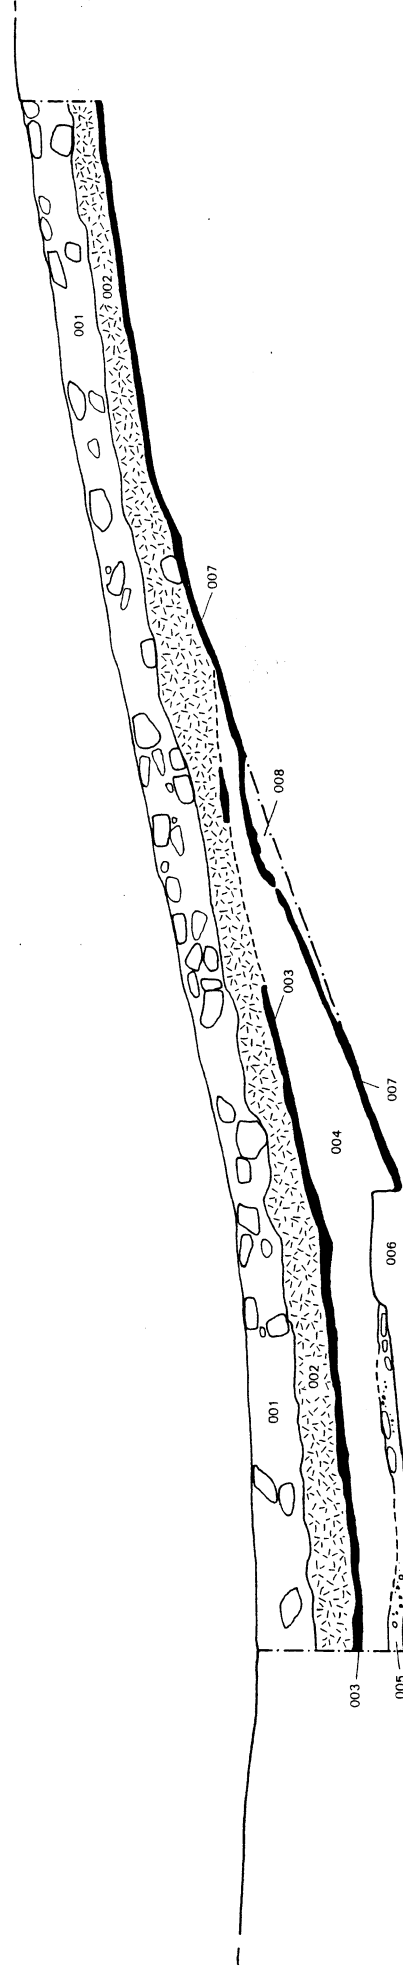
PROJECT	WATERFALL GILL POND, SCAWTON		
TITLE	EXCAVATED SECTION		
SCALE	AS SHOWN	DATE	MAY 2009
	EDAS	FIGURE	6

East-west section

North-south section

South side of trench

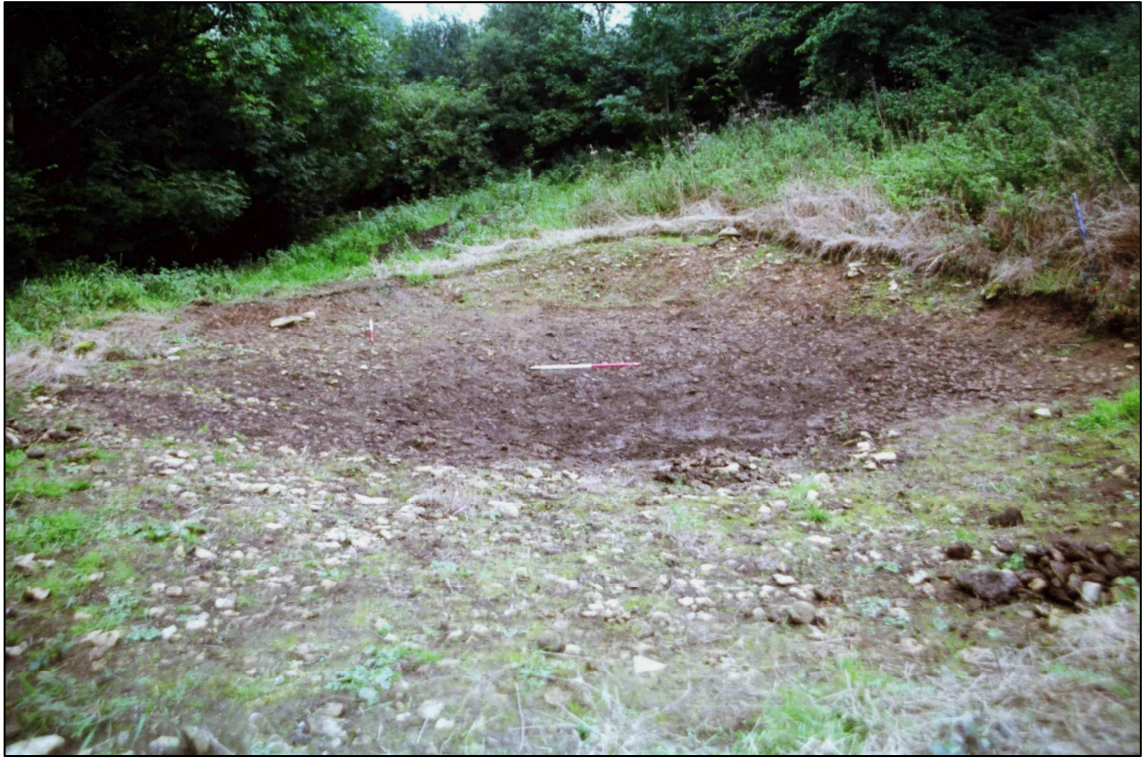
Plate 1: Pond after first phase of archaeological work, looking SW.

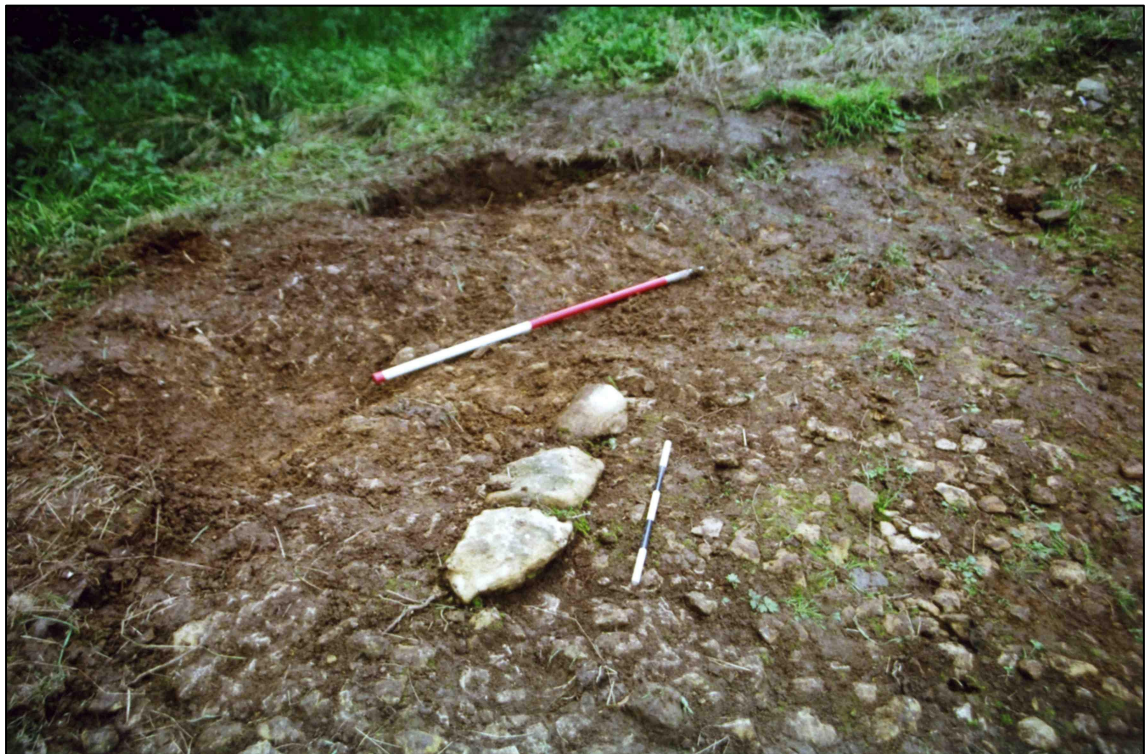
Plate 2: Possible kerbstones on south side of pond, looking SW.

authorities, but the 0.7m central depth is close to the two feet depth most commonly recorded by Martin. The possible kerbstone perimeter seen at the Waterfall Gill pond appears to be an unusual feature, but it may just be that insufficient examples of ponds have been recorded regionally, and that others with the same edging might be found elsewhere. Similarly, the possible run-off channel recorded around the southern edge of the pond is not mentioned in any of the historic pond construction sources consulted during the research for this survey. However, a note of caution must be sounded in regard to the latter. An excavated dew pond at Langcliffe Scar in the Yorkshire Dales had a shallow hemispherical hollow running around the eastern side, which appeared to be a channel. This was thought likely to be the result of settlement around the edge of the stone paving, and it was stated that the same effect had been seen at another unexcavated dew pond in the area (Wilson 1995, 8).

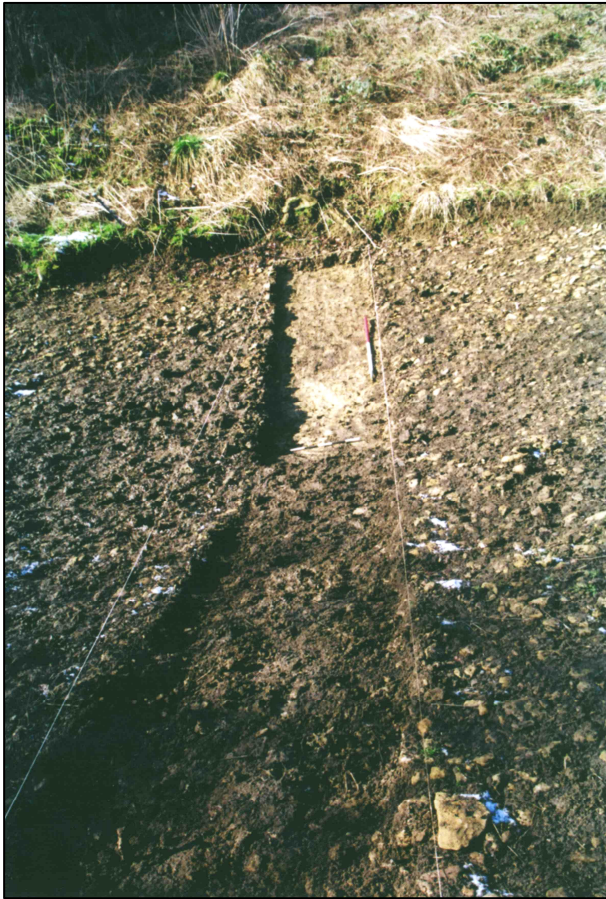
Plate 3: Trench after removal of gritstone surface (001), showing clay (002) beneath, looking NW.

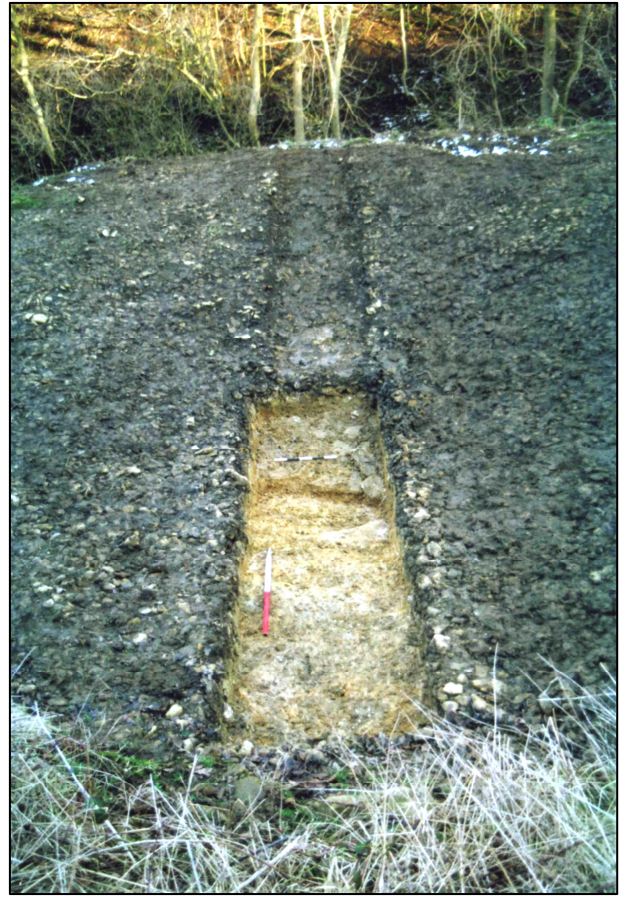
Plate 4: Completed trench, showing orange sand (008) overlying oolitic limestone, looking SE.

- 4.2 Although no clear construction cut was visible, the hard-packed clean orange sand (008) may have been used to even out the surface of the oolitic limestone beneath, to provide a smooth base for the pond lining, as recommended by William Marshall in 1788. The two layers of crushed lime mortar, ash and charcoal (003 and 007) are also reminiscent of Marshall's recommendations (and Mortimer's in the early 20th century), although he had them placed above and below a clay layer, whereas at Waterfall Gill they were separated by a clayey sand (004) with the clay layer (002) above. There was no evidence of any straw between the clay (002) and the gritstone lining (001), but a dew pond at Towthorpe excavated in 1985 also showed no trace of straw, although this was ascribed to it having decayed since the pond was built (Hayfield & Brough 1986/87, 84).

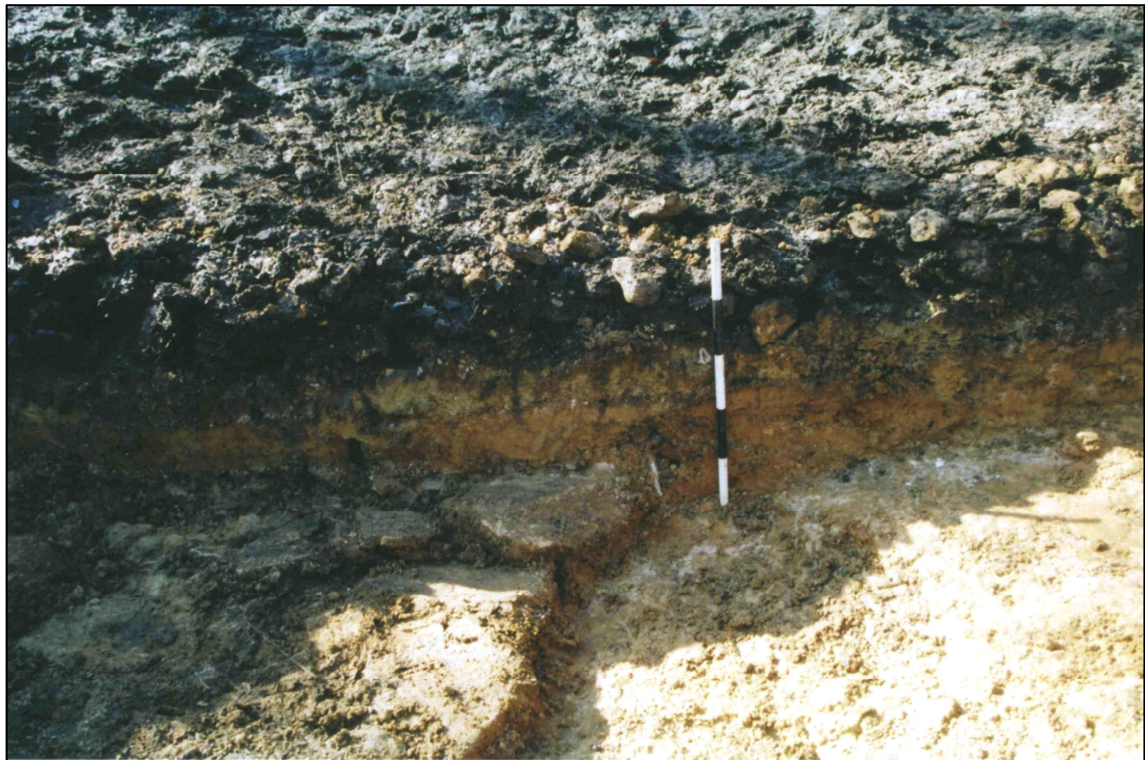
Plate 5: Completed trench, showing limestone rubble (006) and east-facing section, looking W.
