*Archaeological Monitoring at*

**English Bicknor Primary School  
English Bicknor  
Gloucestershire**

**For Gloucestershire County Council**

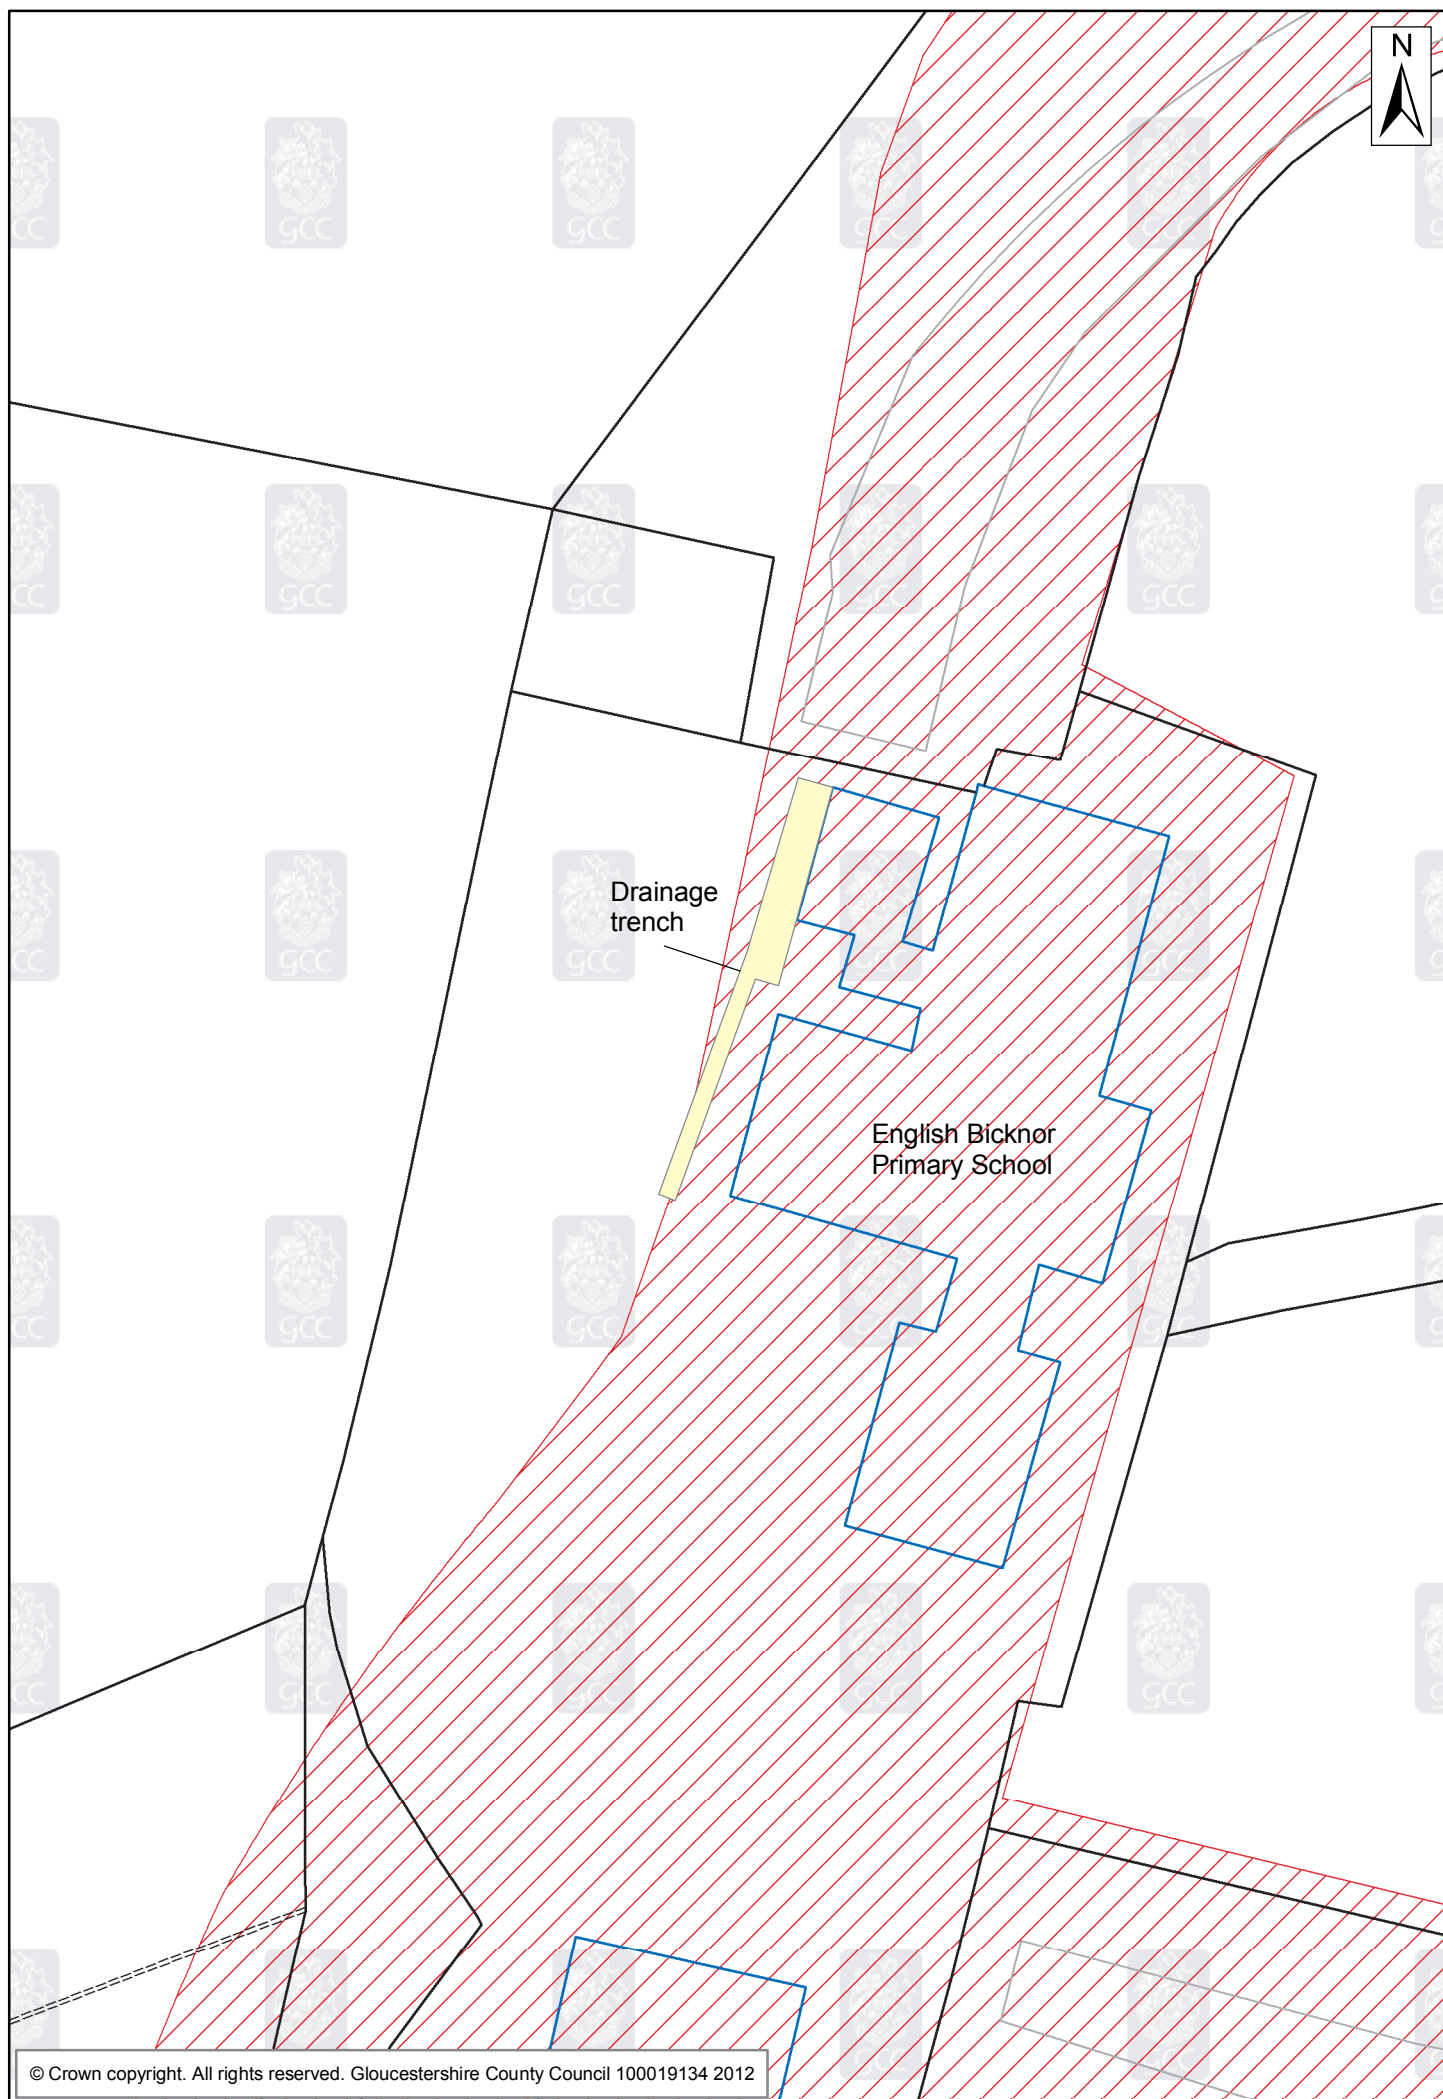
Figure 2: Location of the drainage trench (yellow) and the area of the Scheduled Monument (red) (Scale 1:250 @ A4)

**5.1** In total approximately 15m of drain was excavated and replaced. The drain was orientated roughly north-east to south-west, located immediately west of the main school buildings and was excavated in two sections (Figure 2).

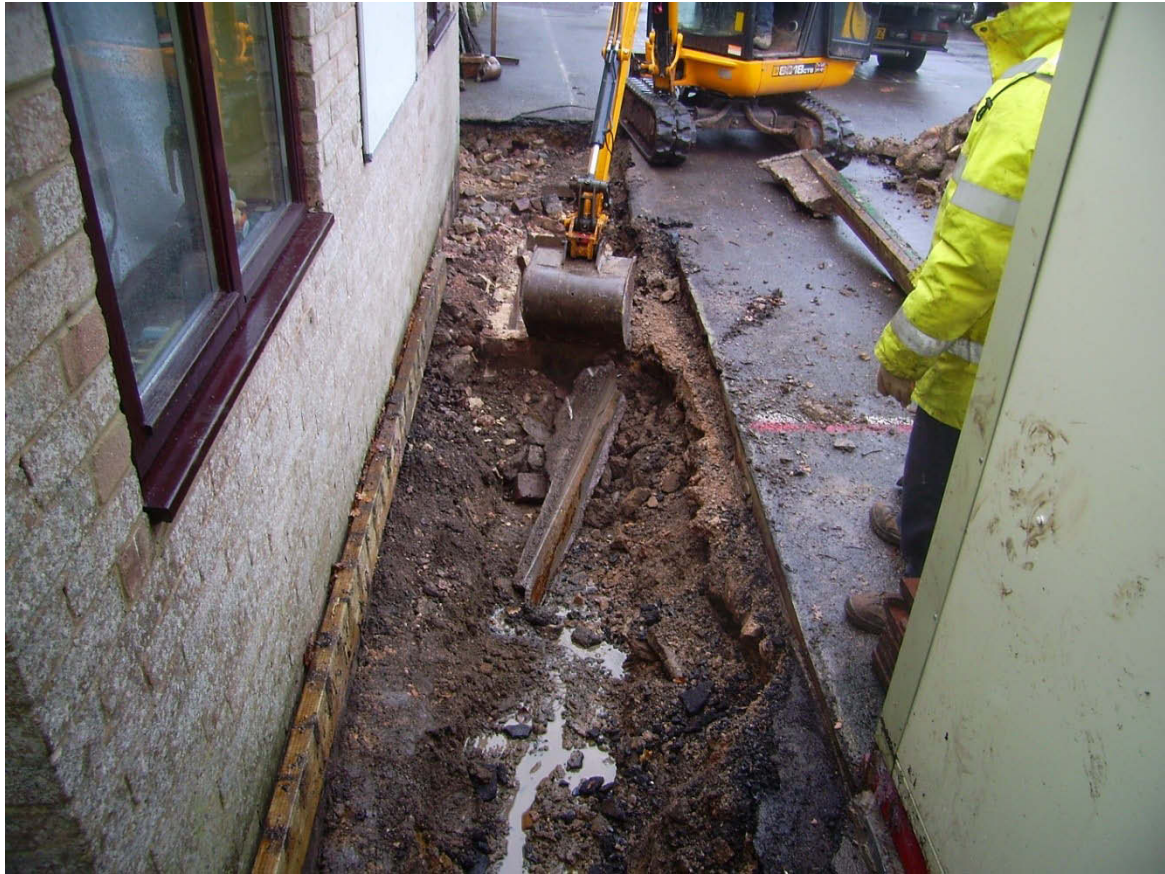
Plate 1: Excavation of the northern section of the drain, looking south

**5.2** The northern section of the drain (c. 7m in length) was located below a concrete slab which was removed, and a 1.2m wide trench was excavated to a maximum of 0.75m in depth (Plate 1). To the south the remaining section of drain was located below asphalt. Here a 0.6m wide trench was excavated to 0.8m in depth (Plate 2). The only deposits exposed were modern backfill and hardcore layers (Plate 3). No archaeological features, finds or deposits were identified during the course of the archaeological monitoring.

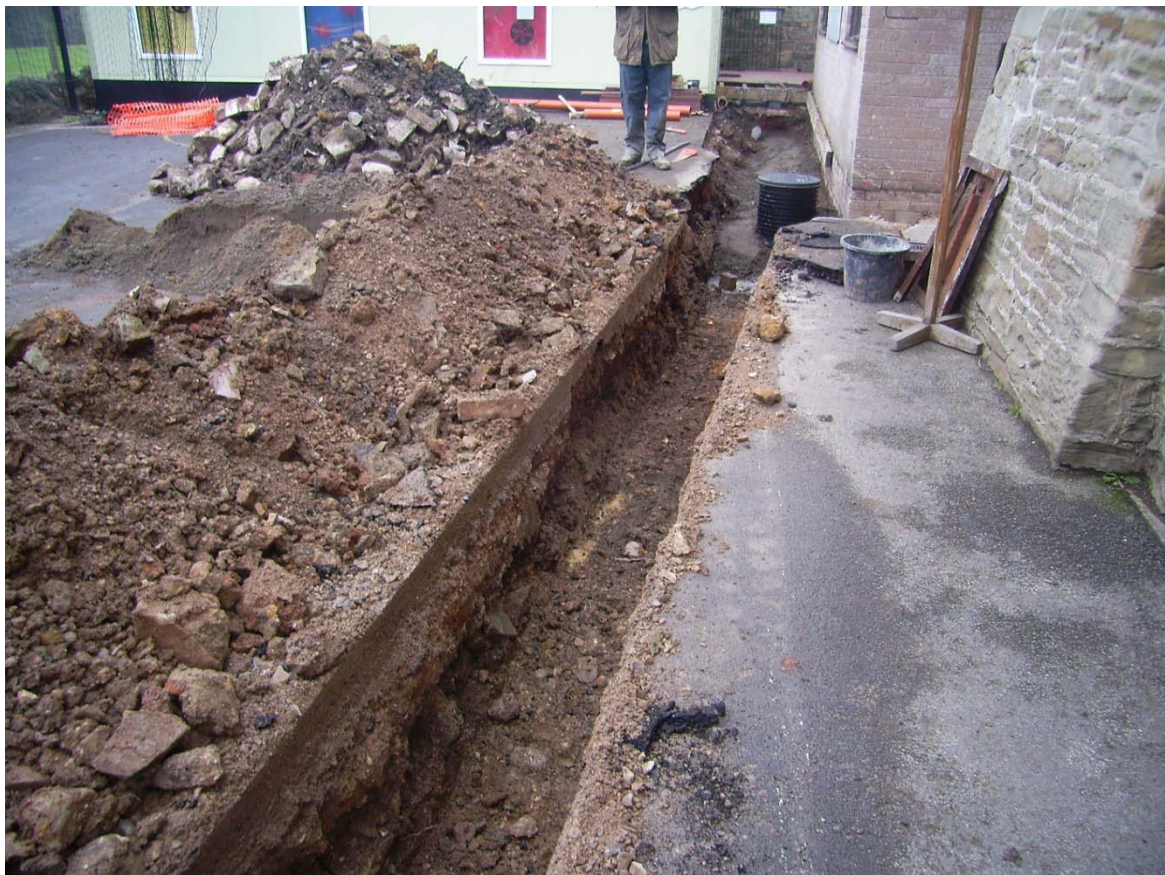
Plate 2: The southern section of the drain has been removed and the northern section has been reinstated. Photo looking north

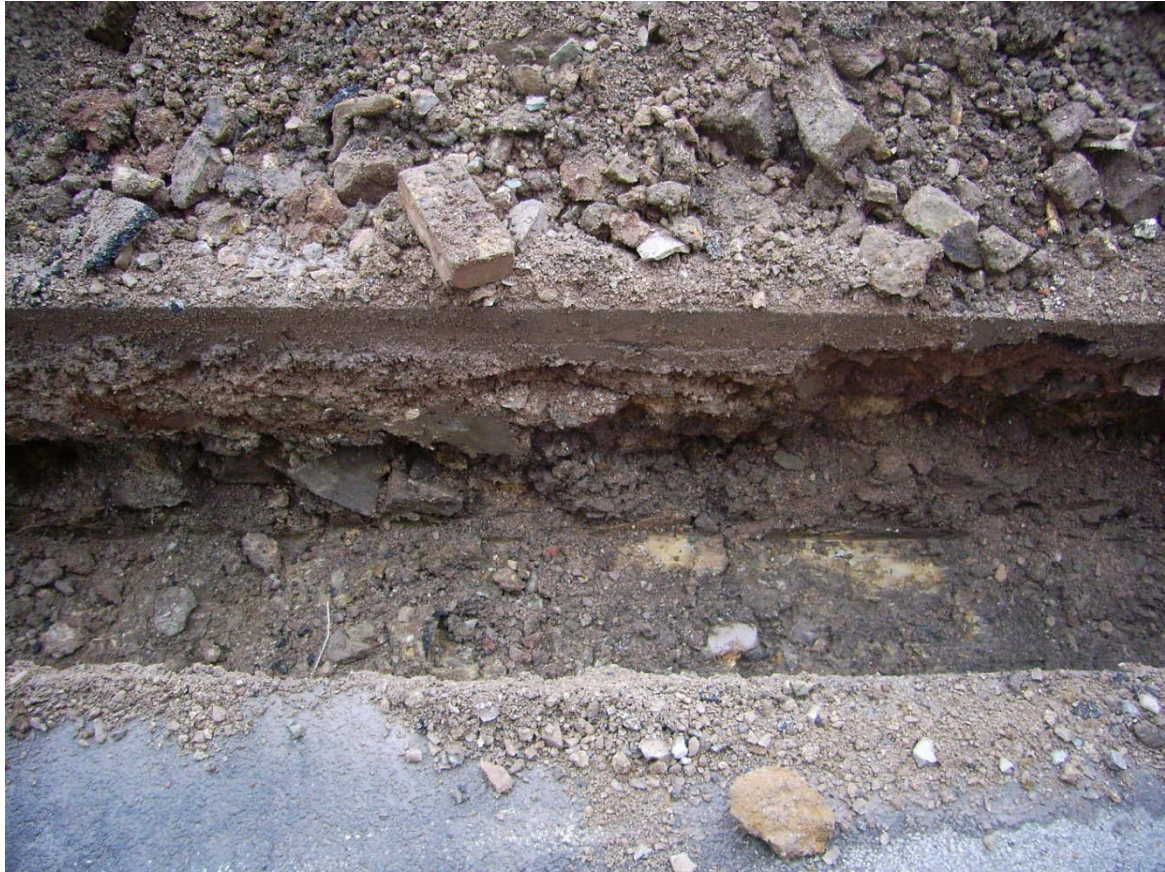
Plate 3: No archaeological features, deposits or finds were identified during the works. Photo looking north-west

Archaeological monitoring undertaken during the replacement of a defective drain revealed an absence of any archaeological features, deposits or finds. This is probably due to truncation when the original drain was laid and, given its proximity to the school buildings, may also be partially due to disturbance dating from the construction of the school. However no natural deposits were identified and significant archaeological remains may survive below the levels exposed during these works.
