*An Archaeological Desk-based Assessment and
Historic Building Appraisal at*

**The Old Chapel
Horton Road
Gloucester**

For M. E. Wynn and Co. Ltd.

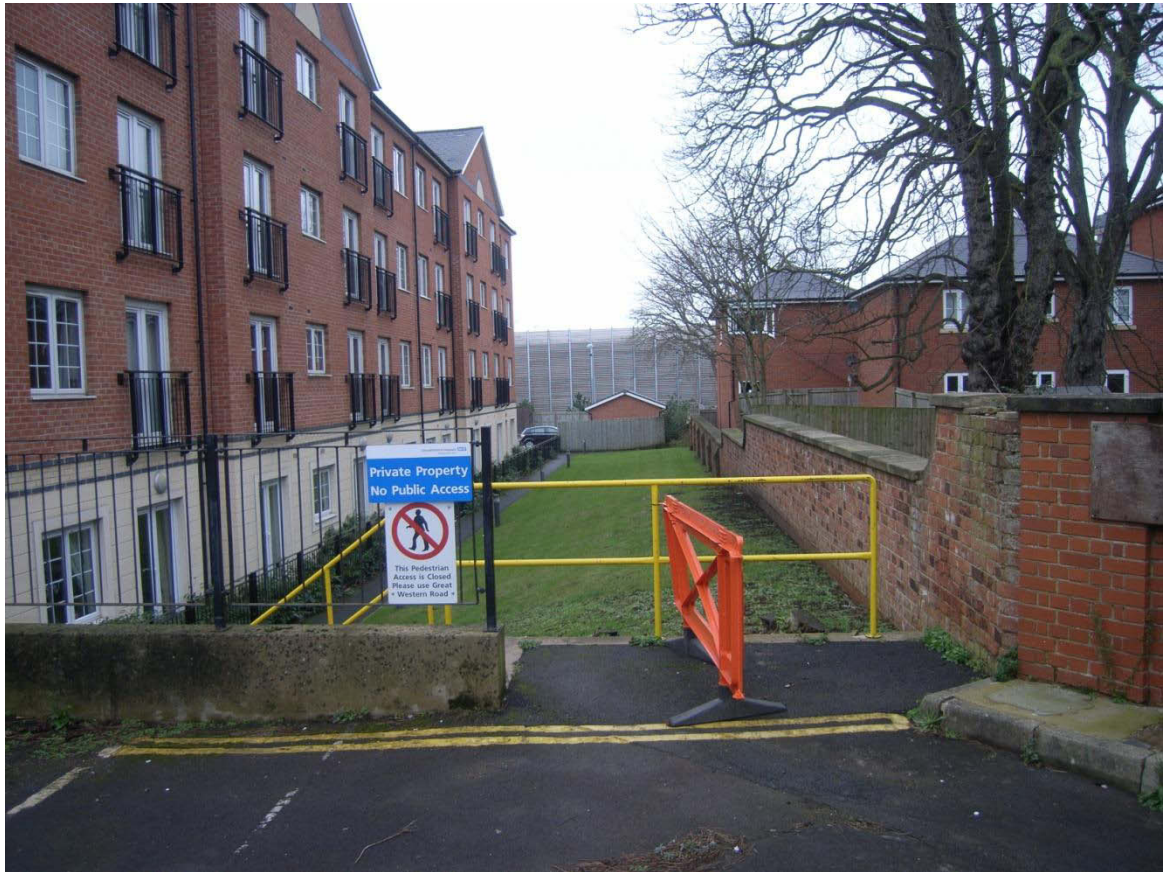
Plate 1 : Southwest strip of land looking northwest

5.1 The proposed development area was visited on the 9th February 2012. The Old Chapel is located in an irregular plot of land, including a strip of land at the southwest that was formerly a footpath to the Gloucester Royal Infirmary. This strip of land borders residential flats to the southwest and northeast and is mostly under grass with a modern brick wall to the northeast (Plate 1). The presence of a slope falling off to the southwest is indicative of landscaping works associated with the Horton Road Hospital and the terracing depicted in the historic mapping (see below).

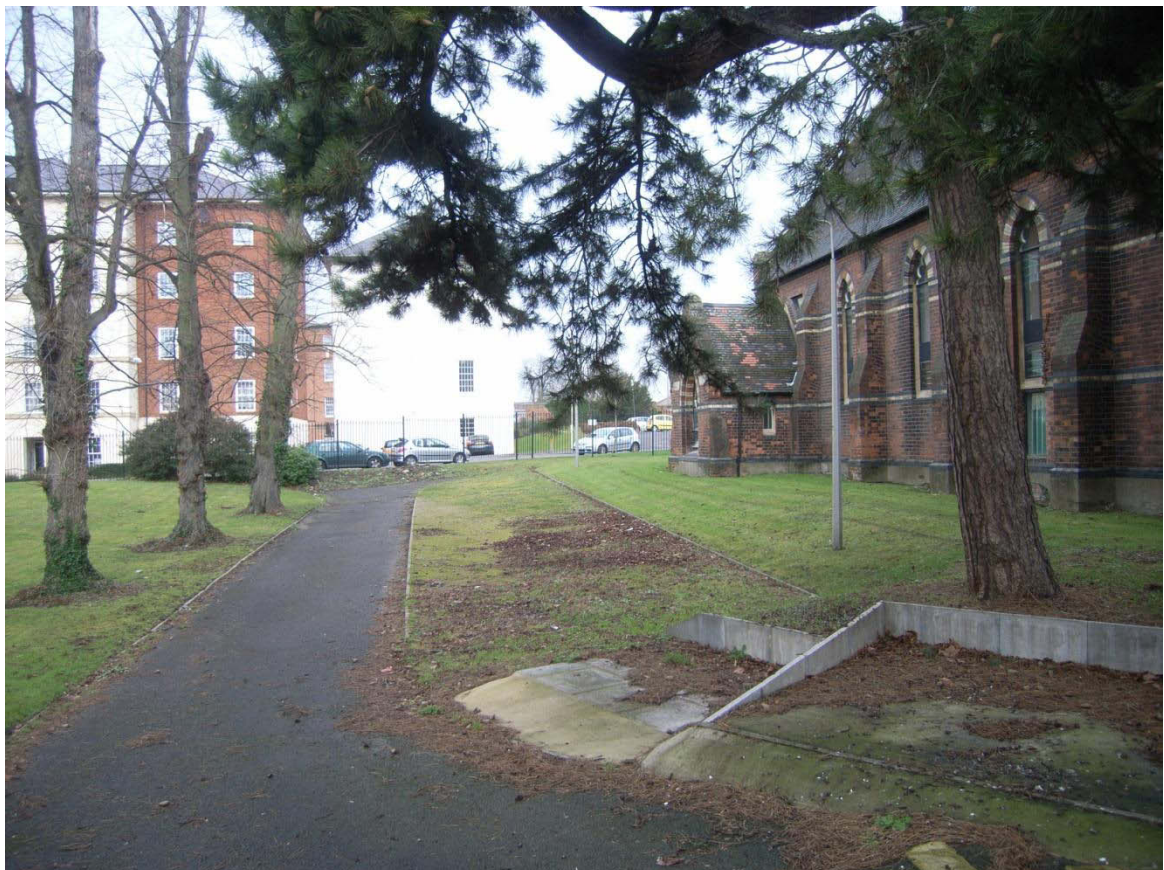
Plate 2 : Driveway and car park looking north

5.2 At the northwest of the chapel is the former car park. The car park includes a macadam driveway across the centre of the area with gravel parking bays to the east and a grassed area with trees to the west (Plate 2). The car park appears to have been terraced, with a distinct drop in level evident from the original ground level present immediately adjacent to the west of the chapel. In the northwest of the area a large undulation in the ground level is present and may represent spoil derived from the terracing process (Plate 3). Various modern and contemporary service runs are present across the area. This area is separated from the modern residential housing to the west by a brick built wall.

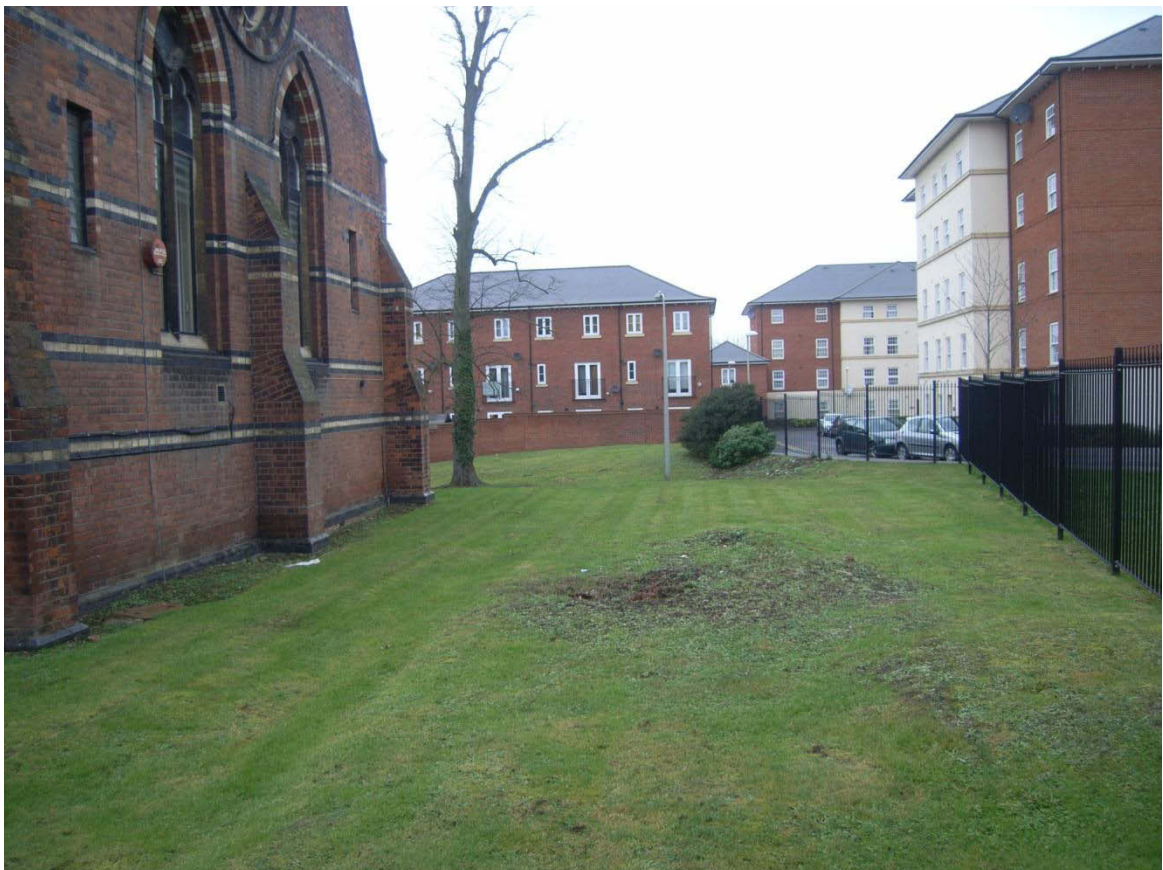
Plate 4 : Northern portion of the development area looking west

5.3 North of the chapel is a grassed area abutting Harescombe Drive and currently partitioned by an iron fence. The level of this area of ground appears on a level with the original chapel terrace (Plate 4).

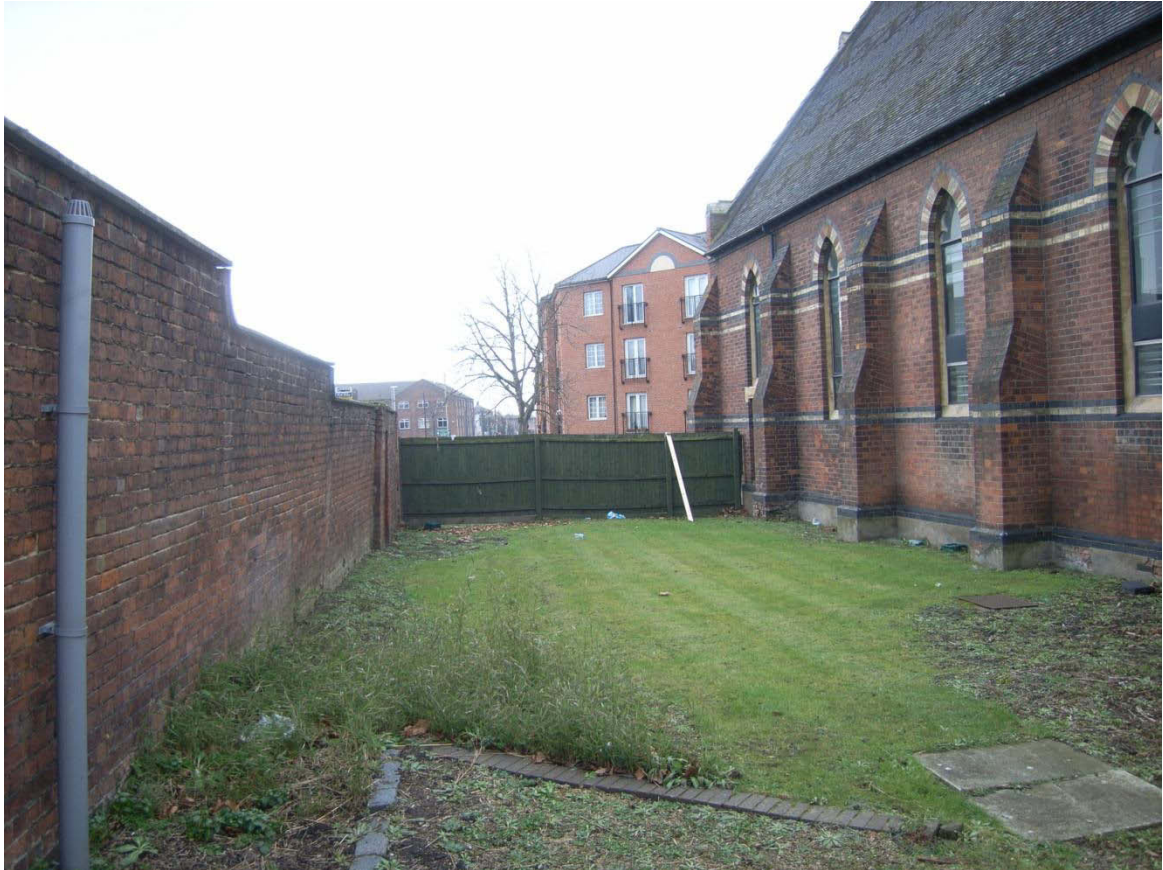
Plate 5 : Eastern strip of land within the development area looking south

The area of land between the wall and the chapel is again mostly under grass and extant drainage runs across the area are evident. In addition, a large area of disturbance was noted adjacent to the porch on this side of the chapel. This is likely to be associated with a former entranceway into the chapel and connected to Horton Road through a now bricked up gateway, as shown in the historic mapping (Plate 5).

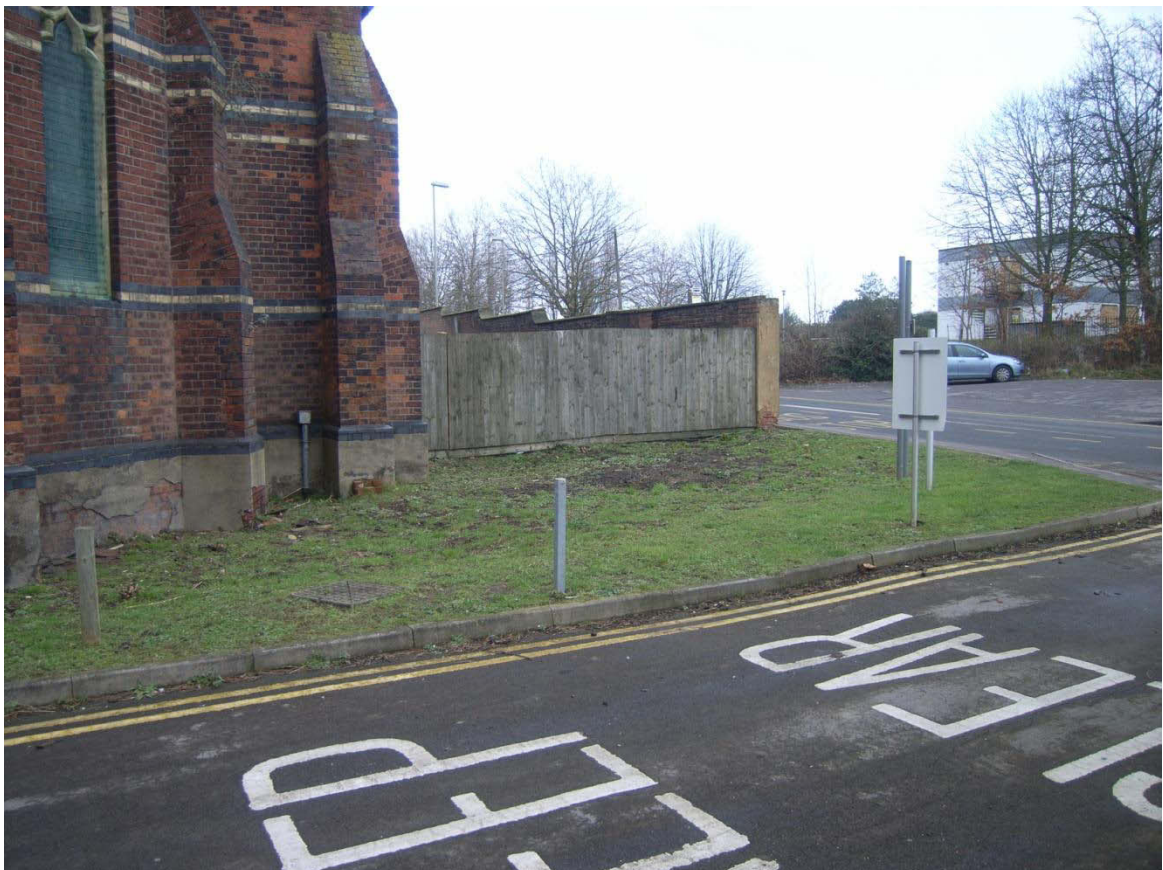
Plate 6 : Southern end of boundary wall and chapel with grassed area looming north

5.5 The southern area of the proposed development area immediately adjacent to the apse south of the chapel is composed of a macadam driveway from Horton Road and a small grassed area. This area is separated from the eastern side of the chapel by a wooden fence. The modern addition of a doorway and associated steps on the western side of the apse is also present. Modern service runs were also noted within this area. This area is separated from the car park area by a brick wall and gateway (Plate 6).

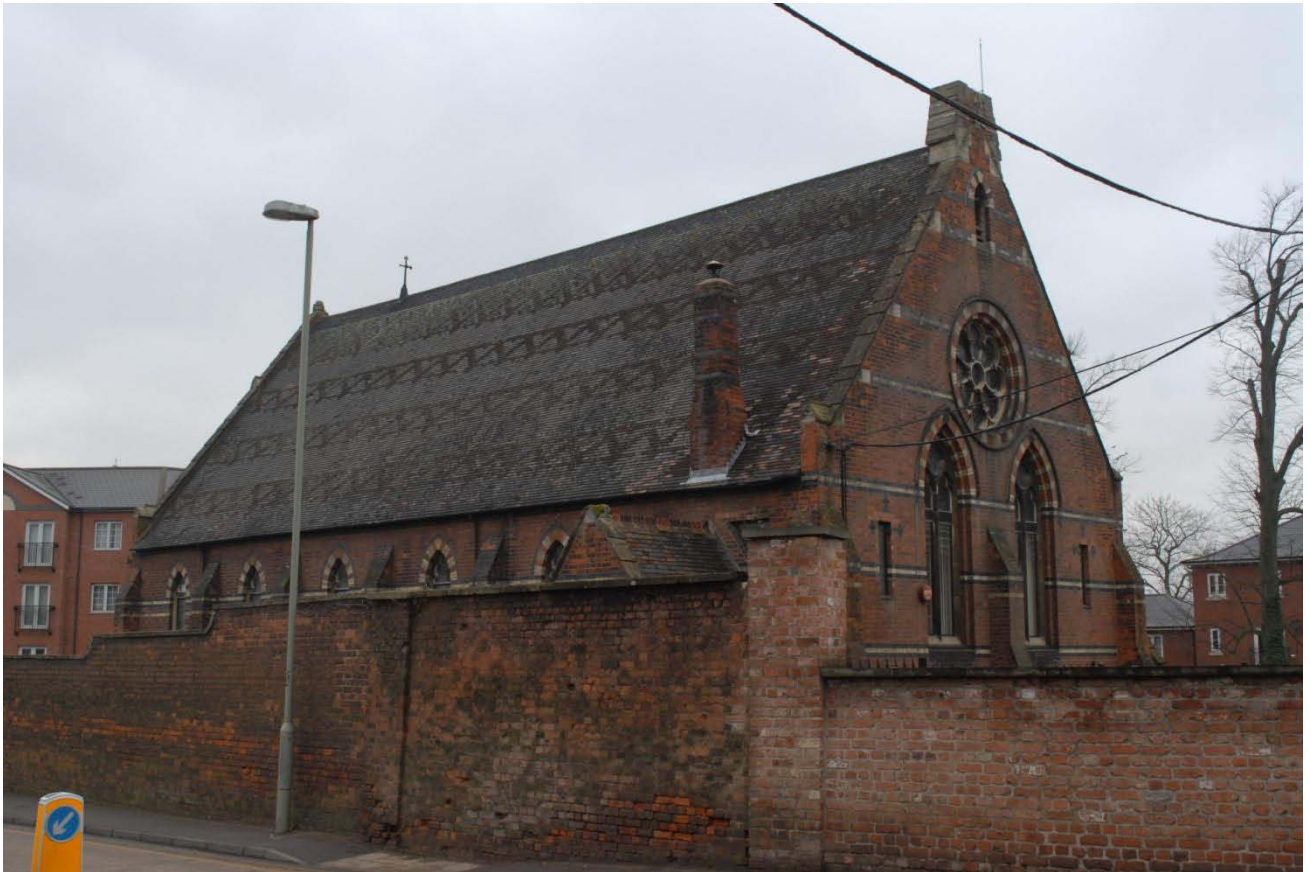
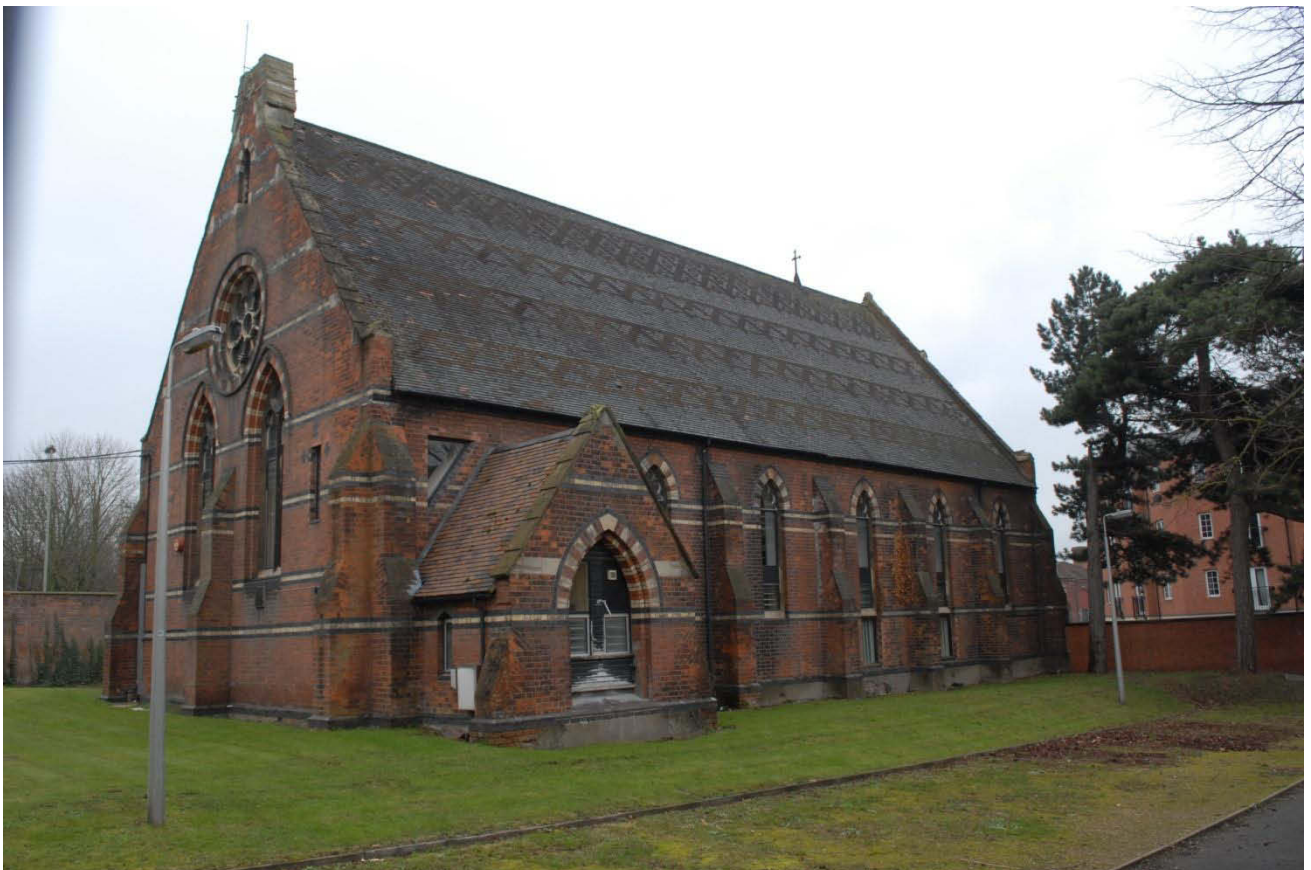
Plate 7 : The Old Chapel from the northeast

Plate 8: The Old Chapel from the northwest

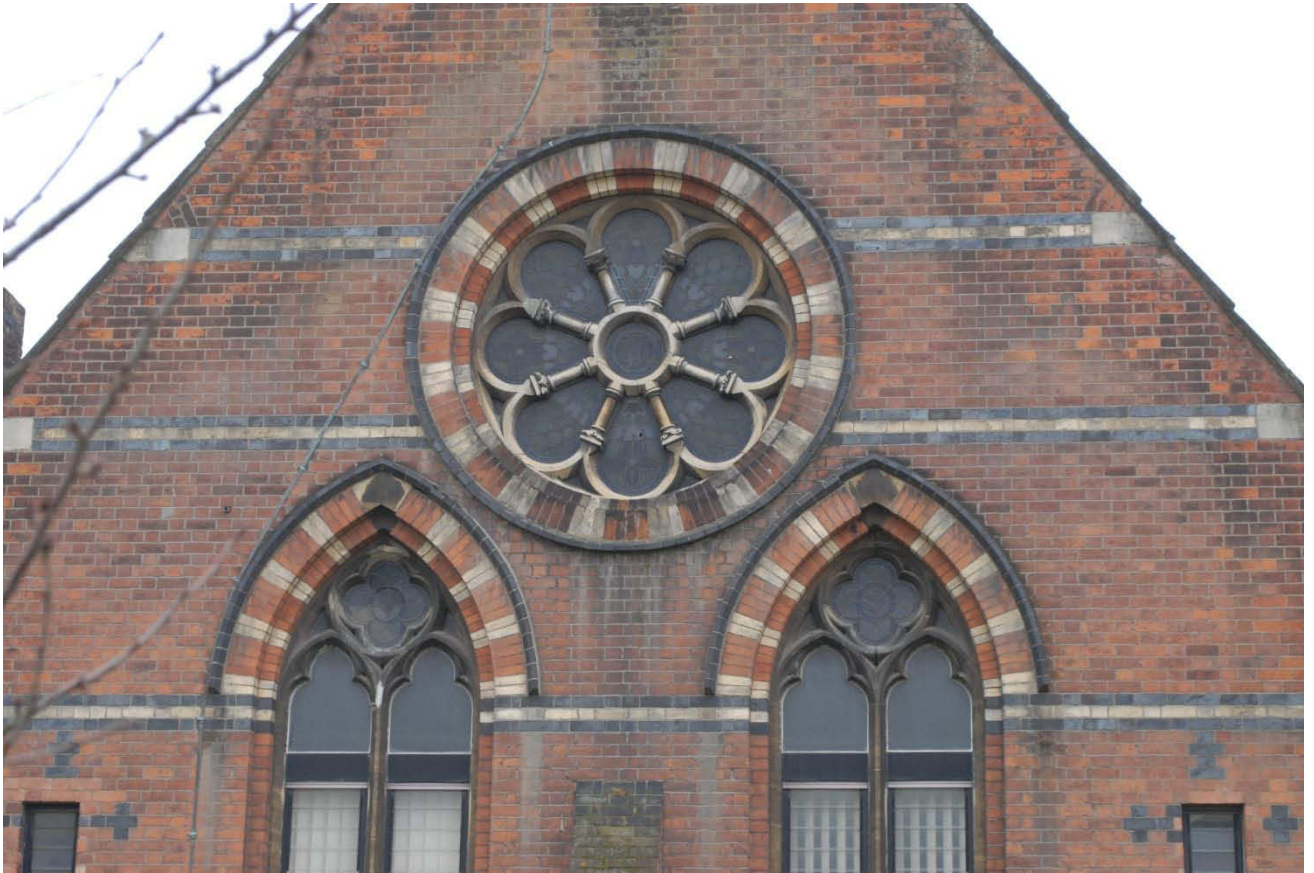
The detailing of the rose window in the gable is similar to that of the windows below, with eight 'spokes' radiating from a central circle. The detailing is Early English, each of the spokes being miniature columns with octagonal bases and floral capitals – a motif picked up internally at the liturgical east end of the chapel. The framing of the rose window is a modified version of the heads of the windows below it, and the stained glass glazing could be original.

It is unclear how much stained glass there originally was in the chapel's windows. It is possible that the glass in the rose window – with the 'IHS' monogram in the boss and red radial trefoils – could be original, but little is indicated on the architect's plans. Instead the windows in the plans are shown as plain glass with diamond-patterned quarries (Plate 11).

Plate 11 : Detail of rose window in north gable

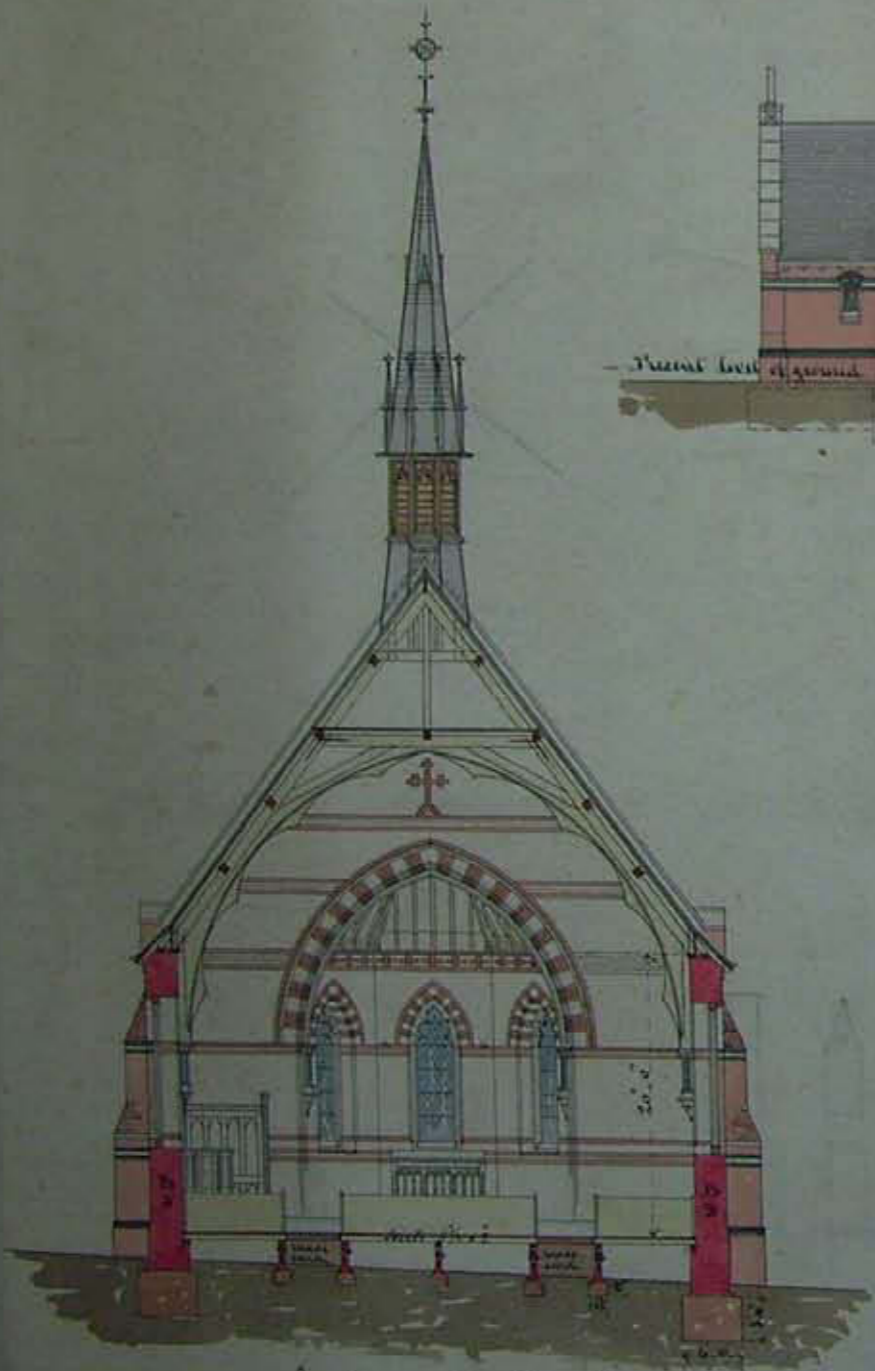
Section on line "A-B"

North-East elevation

Longitudinal section

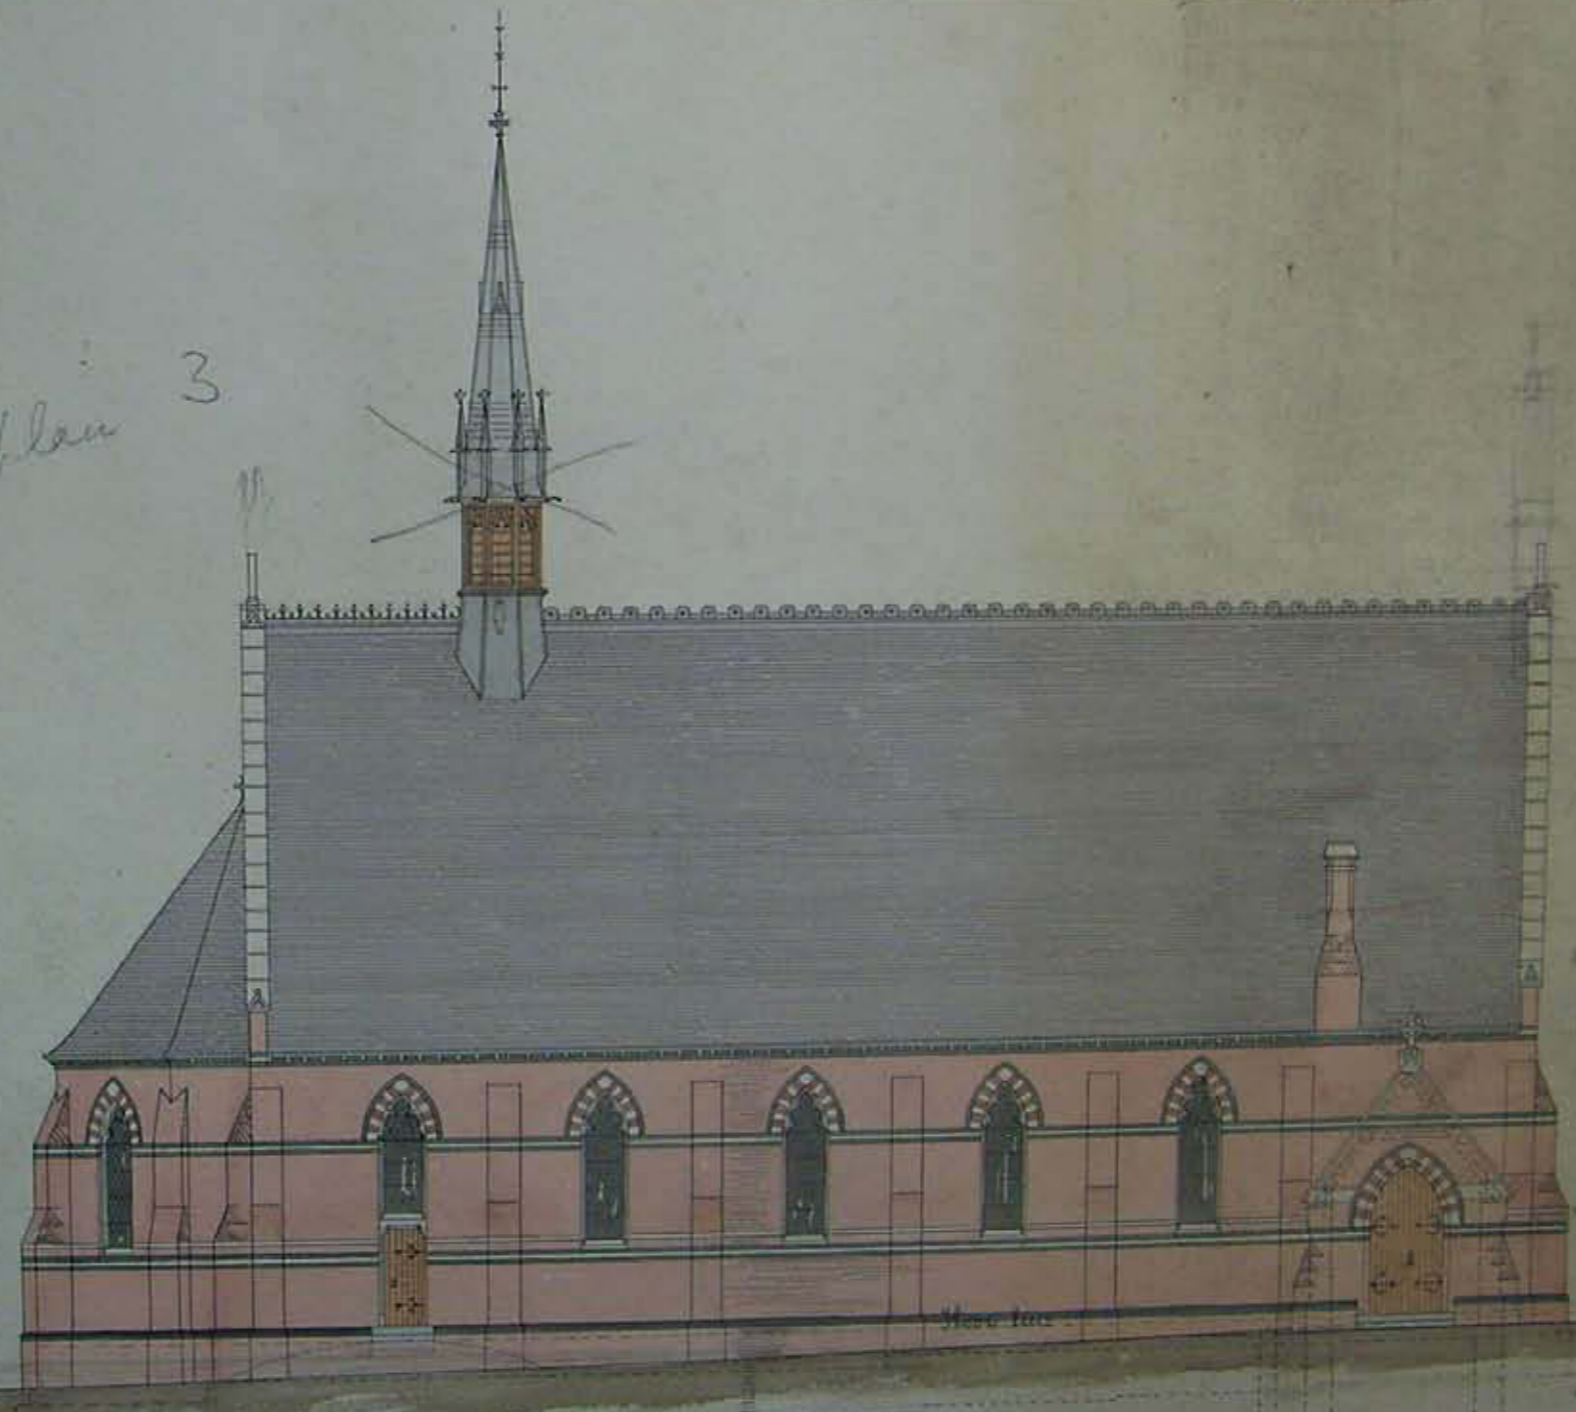
South west elevation.

South-east elevation

Figure 6 : Elevations of the chapel 1871. Reproduced by kind permission of Gloucestershire Record Office (GRO Q/AL/25a/3-5)
