*An Archaeological Watching Brief
at*

***Gloucestershire Royal Hospital
Gloucester
Gloucestershire***

G.L Hearn Ltd
For
Gloucestershire Hospitals NHS Foundation Trust

*Nick Witchell
Archaeology Service
Environment Directorate*

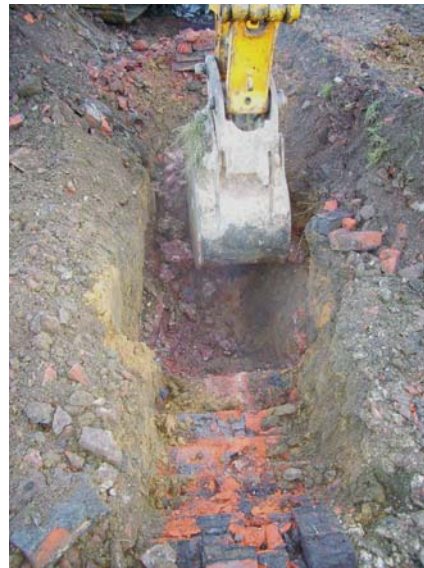
Plate 2

Removal of Infirmary foundations under archaeological supervision.
