**CAWSEY MEETHE MILL,  
KING'S NYMPTON, DEVON**

**HISTORIC BUILDING RECORDING**

**April 2014**

Project CMM60/2014

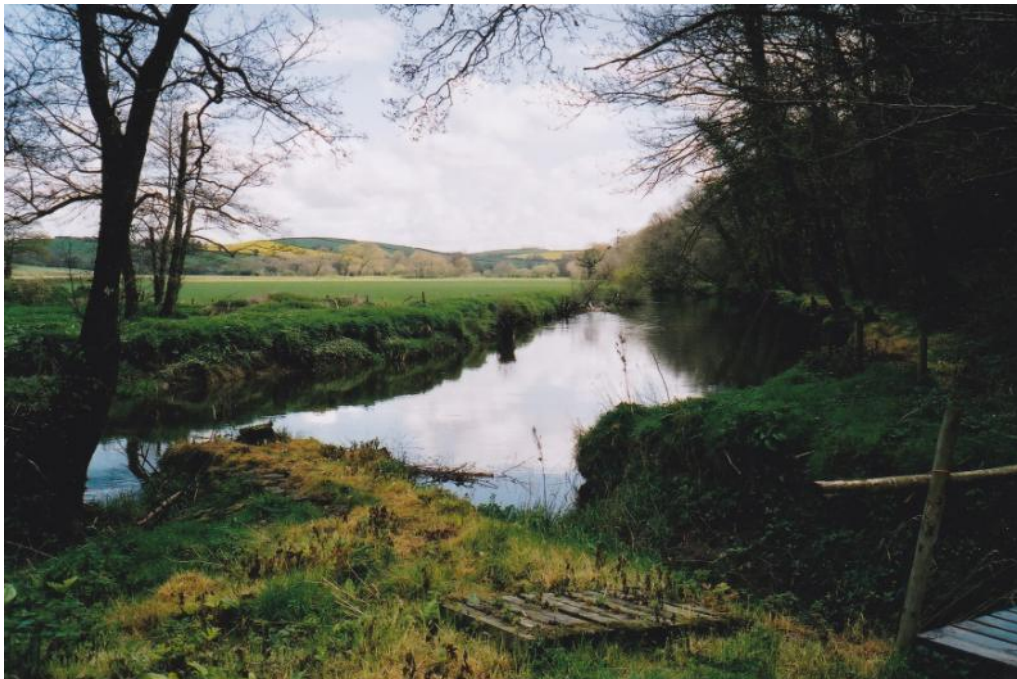
The mill was fed by a leat, an artificial channel taken from the west end of a weir built across the river Mole (Figure 5). The weir no longer stands. The leat channel can still be traced, however, although it is silted up and largely dry except in times of flood or high rainfall. Immediately upstream of the mill the leat is revetted with stone walls, the walling extending about 12m to the east on the north side. Stone footings about 0.86m thick survive on the south side, where the wall appears to have been broken down, allowing flood water to divert into the spillway channel around the south end of the mill. There is some standing water in this channel. The south mill effectively stands on an island between the spillway and the wheel chamber.

Site of weir across river Mole, with leat entrance bottom right, looking upstream (south-east)

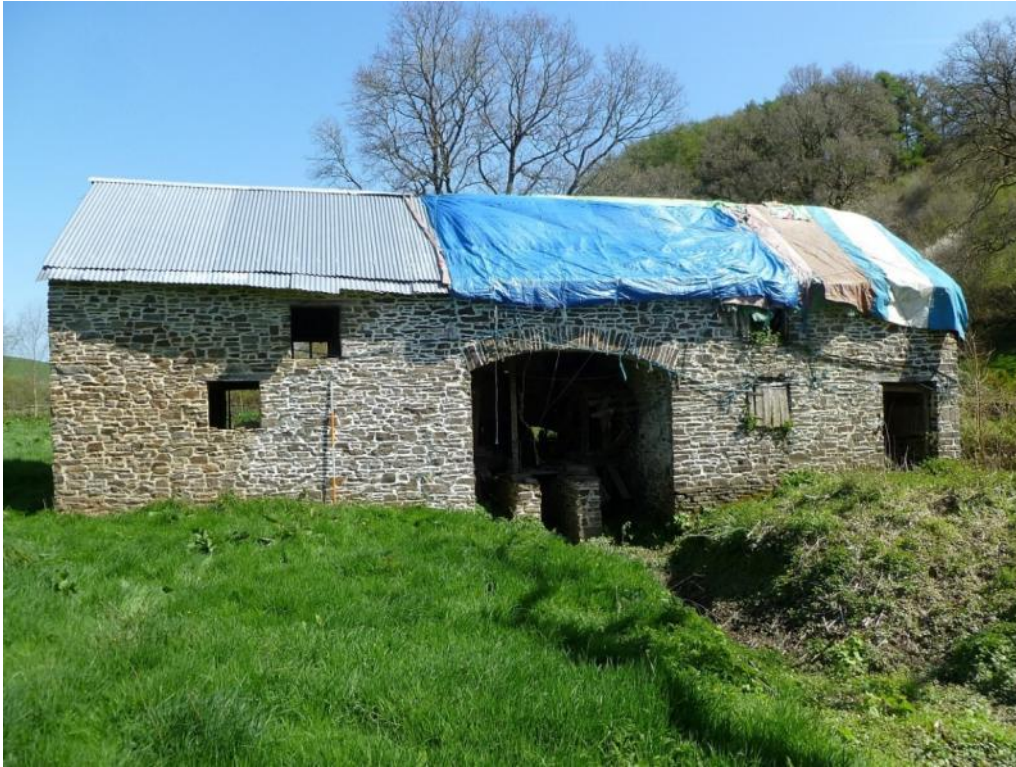
West elevation

The west side is the principal downstream elevation which faces the road. There is a projecting base course along lower wall of south mill at about floor level. The doorway to the south mill has a pegged oak frame which has rotted and dropped and the lower leaf of the stable-type door has now gone. The top leaf is ledged and braced with six vertical boards and has a wooden latch lifter and flame-ended blacksmith-made hinges. The ground floor window to south mill has a softwood frame and an outward-opening shutter which is hung on modern T hinges on the left side. The shutter is ledged and braced with five vertical boards. The first floor window above is similar, with a decayed outward-opening shutter in a softwood frame and the remains of a stone cill.

In the centre of the west elevation is the opening of the wheel chamber, which has a segmental arch over with stone voussoirs. In the return walls on both sides of wheel chamber is a single beam recess for a 16cm deep by 13cm wide timber which would have spanned the full width of the opening at about the level of the waterwheel shafts. There are three further beam recesses higher in the wall behind the north waterwheel position.

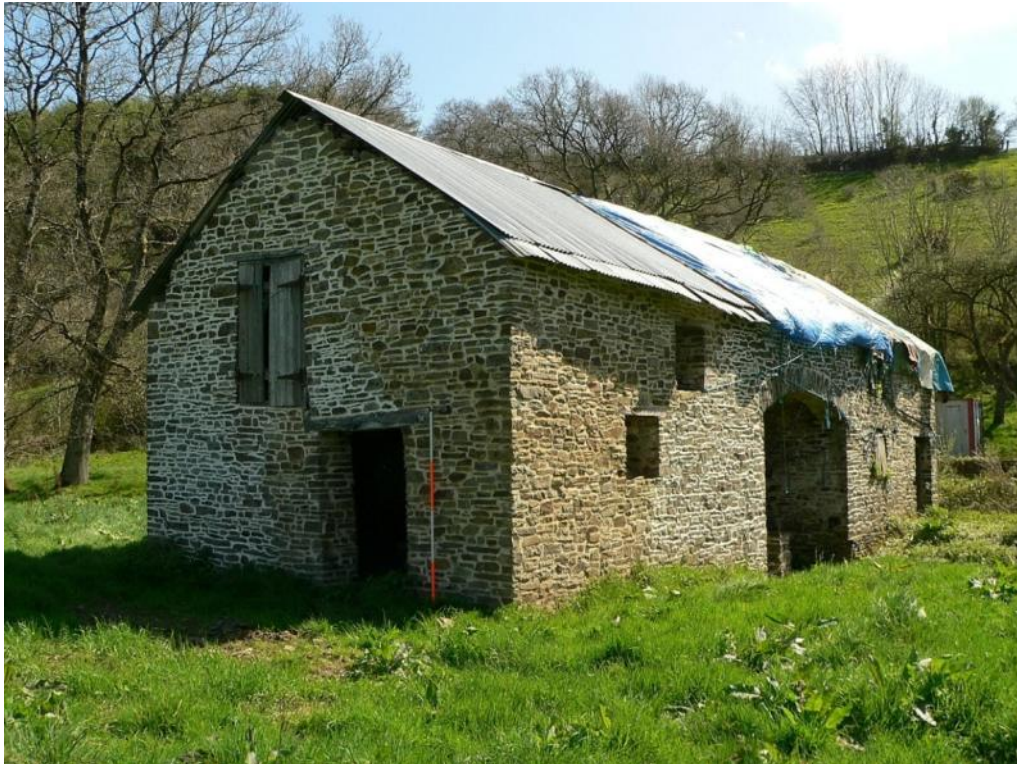
North gable and west elevation, from the north west

The first floor window opening to the north mill has new oak lintels and some brickwork in the return on its south side. Some rebuilding of the stonework is apparent around both this and the ground floor opening slightly to the north. Both of these openings formerly had timber frames and shutters similar to those on the south mill.

The north gable end has a ground floor doorway into the north mill, now without a frame or door. The first floor doorway has a pair of outward-opening doors, which are ledged and braced with vertical boards hung on modern T hinges in a timber frame.

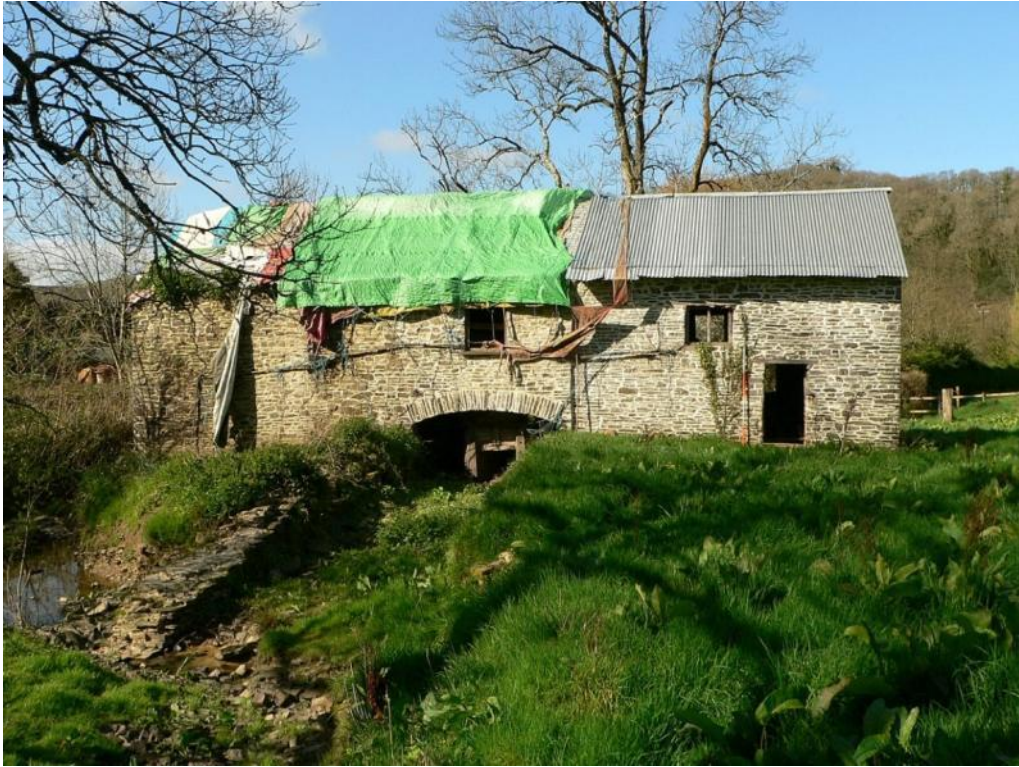
East elevation, with stone revetted leat and spillway to left

The upstream (east) elevation has a doorway into north mill with a slightly raised stone threshold. Marks in the mortar indicate that there was formerly a frame set in from the outer face of the wall. This opening appears to have acted as an outlet or exhaust from a machine formerly positioned inside, rather than being a doorway for access (see below). To the south of this opening is a first floor window with a timber frame for two fixed glazed lights; the mullions have notches in them for three horizontal bars. The frame appears to have been painted brown. There is a clear building break to the north side of the wheel chamber opening. This has been repaired recently, but formerly read as a full height crack in the wall. The opening for the wheel chamber, which is 2.95m wide, has a low arched head with stone voussoirs, similar but set lower than that on the downstream side. Above the centre of the arch is a window with a thick cut slate cill and a pegged timber frame for an outward-opening shutter which is hung on the south side. No further openings or features are visible in the east wall of the south mill.

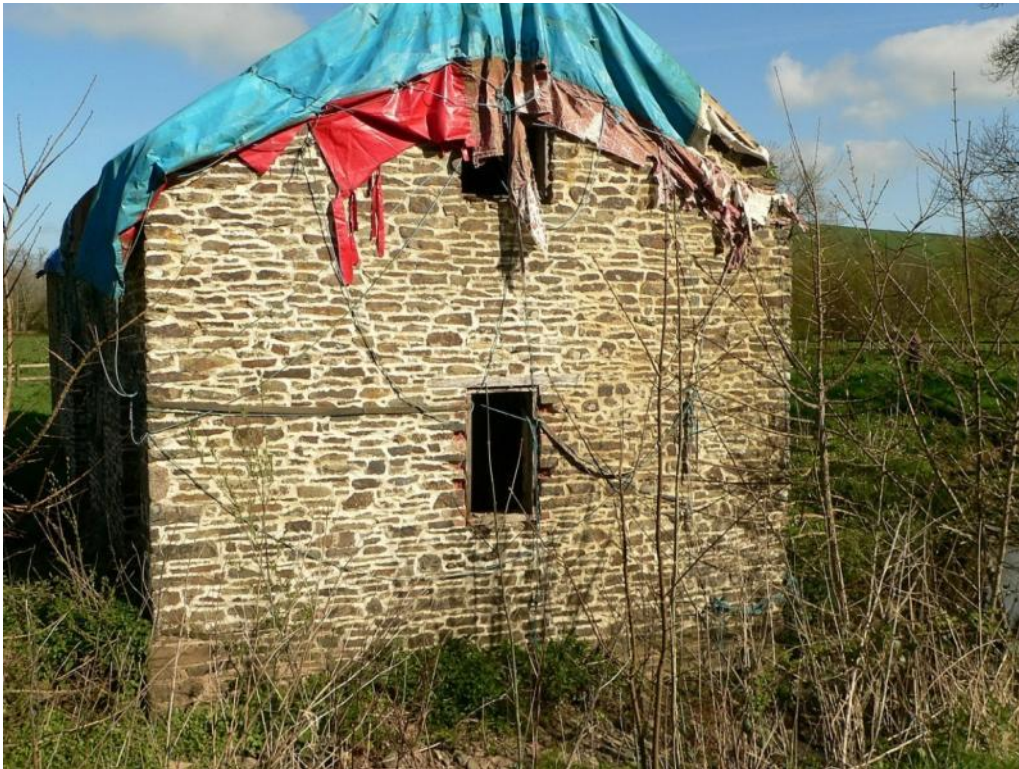
South gable

The south gable end has a ground floor window opening with some brick quoins and two timber needles through wall beneath the cill, although no external cill survives. The opening retains a pegged softwood timber frame. There are remains of the timber frame in the first floor window opening above.

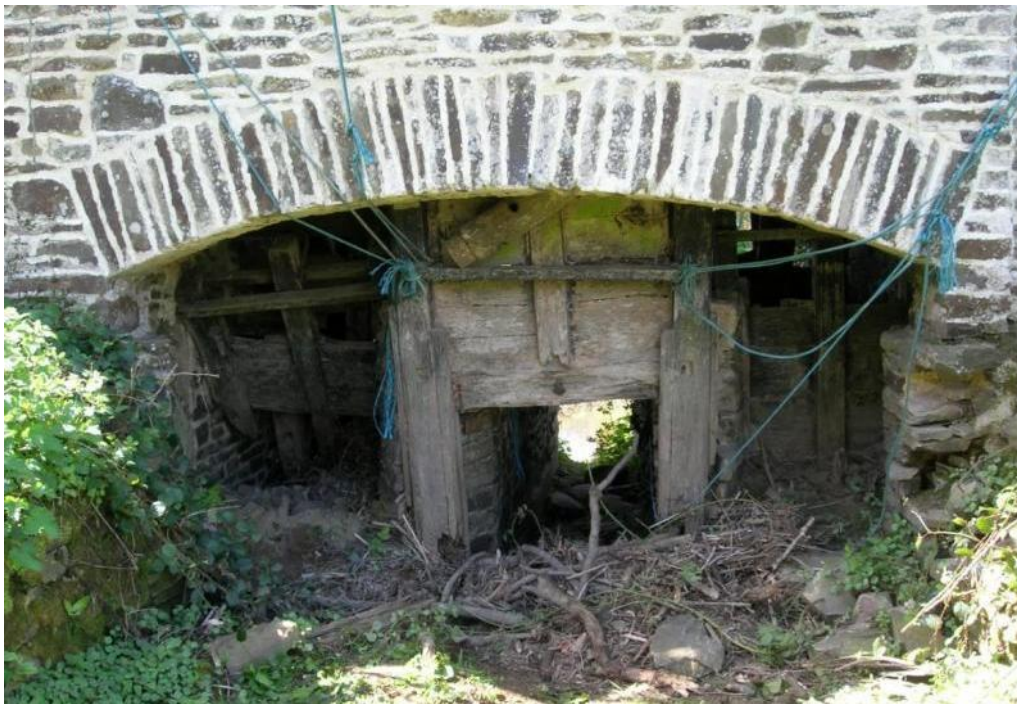
Wheel chamber: The central chamber is divided into three channels by two rubble stone walls capped with timber boards. The south and north channels contain the waterwheels, while the central channel was a spillway. Water flow through all three channels was controlled by vertical timber sluice gates at the upstream end. All three channels are now heavily silted. The spillway channel appears to have had a sloping flagged floor, some broken remains of which are visible at its upstream end. The lower part of the wall on the south side of this channel has some *in situ* concrete repair and the wall to the north wheelpit has partly collapsed towards the upstream end. The south wheelpit has curved stone breastwork which starts just downstream of the vertical sluice or penstock that controlled the water flow onto the wheel. This sluice has become displaced and although relatively complete, is now inclined at an angle towards the wheel. The north wheelpit was noted as having some concrete breastwork at its upstream end on a previous visit, but this is now covered with silt and debris. The vertical timber penstock to the north wheelpit is still *in situ*. Both of the penstocks are positioned downstream of the central spillway gate. All three sluice gates are of horizontal timber boards with a single central post, located in channels formed by battens fixed to the faces of vertical posts which are built into the stonework. The gates were raised by a chain and timber windlass arrangement. Both the spillway and south wheel gates were operated from the small timber framed and clad compartment built over the central race inside the east wall, by turning timber bollards which wound up the chain. The bollard for the spillway gate has fallen out of its half-

round timber housings. The penstock for the north wheel was operated from the platform at the east end of the hurst, the inner end of the bollard having a ratchet and pawl and provision for a metal handle.

Headrace entrance, with penstocks to waterwheels each side of the central spillway

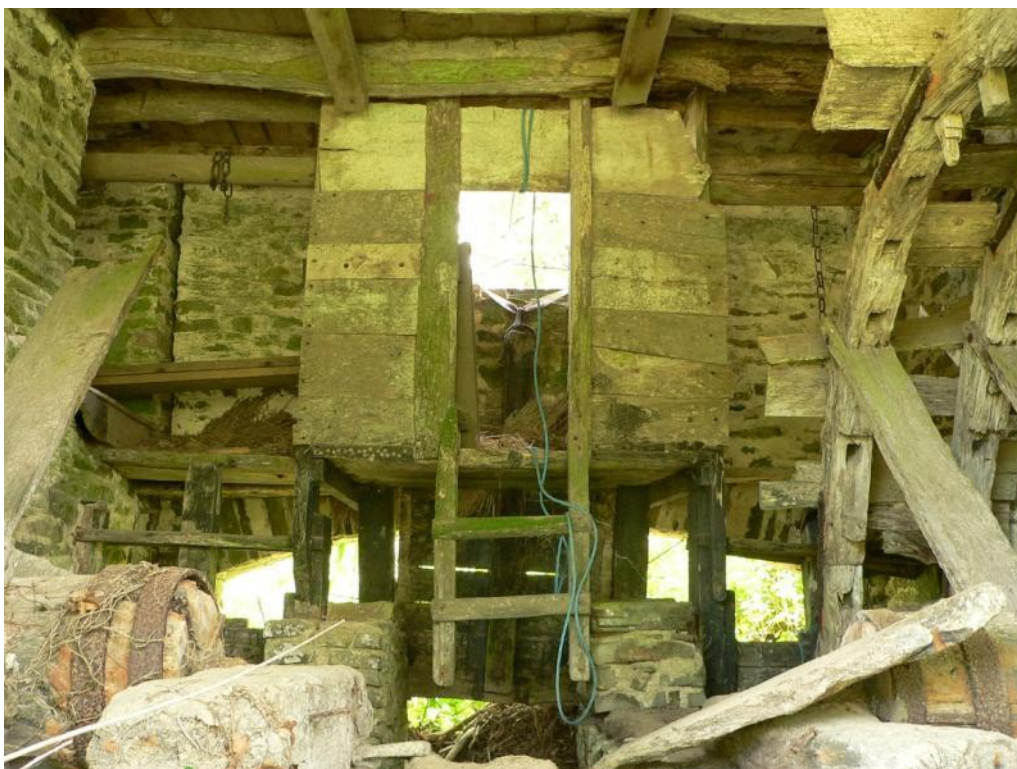
Wheel chamber with north wheel to left and south wheel to right, with central spillway. The short ladder down from the small timber boarded compartment over the spillway entrance was in place in 2012 but has now gone. There appears formerly to have been boards spanning over the spillway channel, to allow access to the outer wheelshaft bearings

for lubrication. Above the tops of the waterwheels the wheel chamber is joisted and boarded over at a raised first floor level (see section drawing).

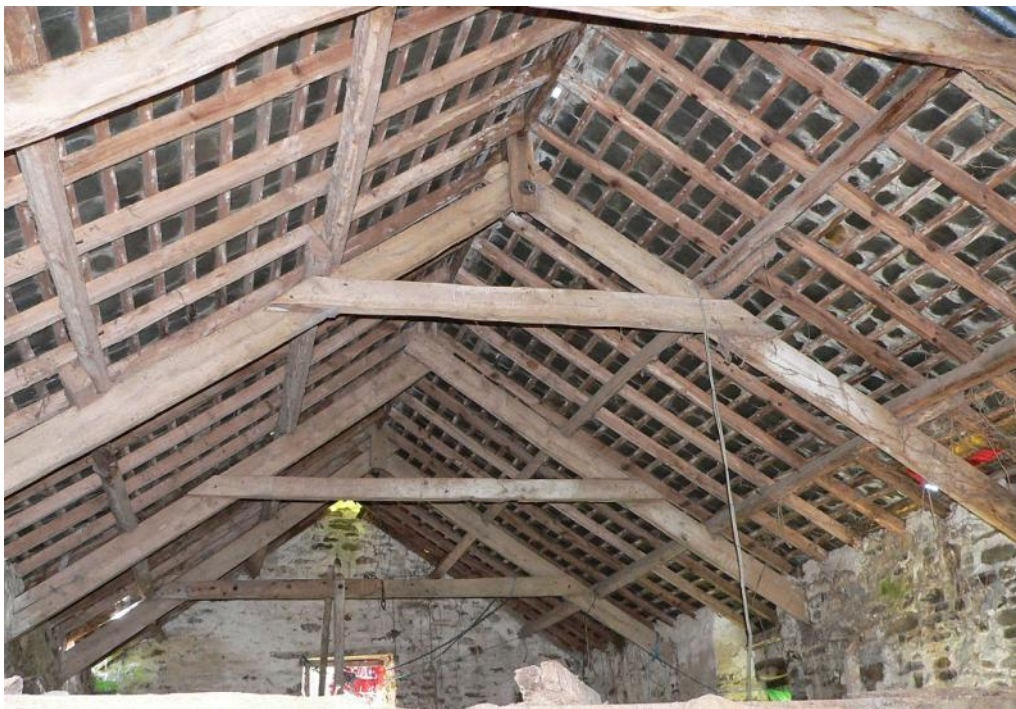
The roof is a seven bay structure with six A-frame collar trusses. The feet of the principals are built into the wall heads on both sides. The wall heads on the west and east sides above the wheel chamber and the south mill are built up to a higher level than those of the north mill. The roof trusses are of pit-sawn timber, with softwood collars and, although visually similar, there is some variation between them. The collars are set at different heights and not all are fixed on the same faces of the principals; those to T5 and 6 (in the north mill) are on the south sides and are pegged as well as nailed. The remainder, over the wheel chamber and south mill, are nailed. The principals are lapped and crosses at their apexes, although not all in the same direction, and they have vertical boards nailed over them to support the ridge purlin. The truss timbers are generally sparingly converted and rustic, with some plain chamfers. There are two rows of softwood purlins to each slope, which pass over the backs of principals. Between T3 and T4 the purlins are short and set slightly higher than elsewhere. There are two vertical pieces of wood fixed towards the east end of the collar of T5, apparently to act as a guide for a rope or chain. The bays between the principals are quite regularly laid out with softwood common rafters and battens for slates.

Roof, general view showing construction, looking to north

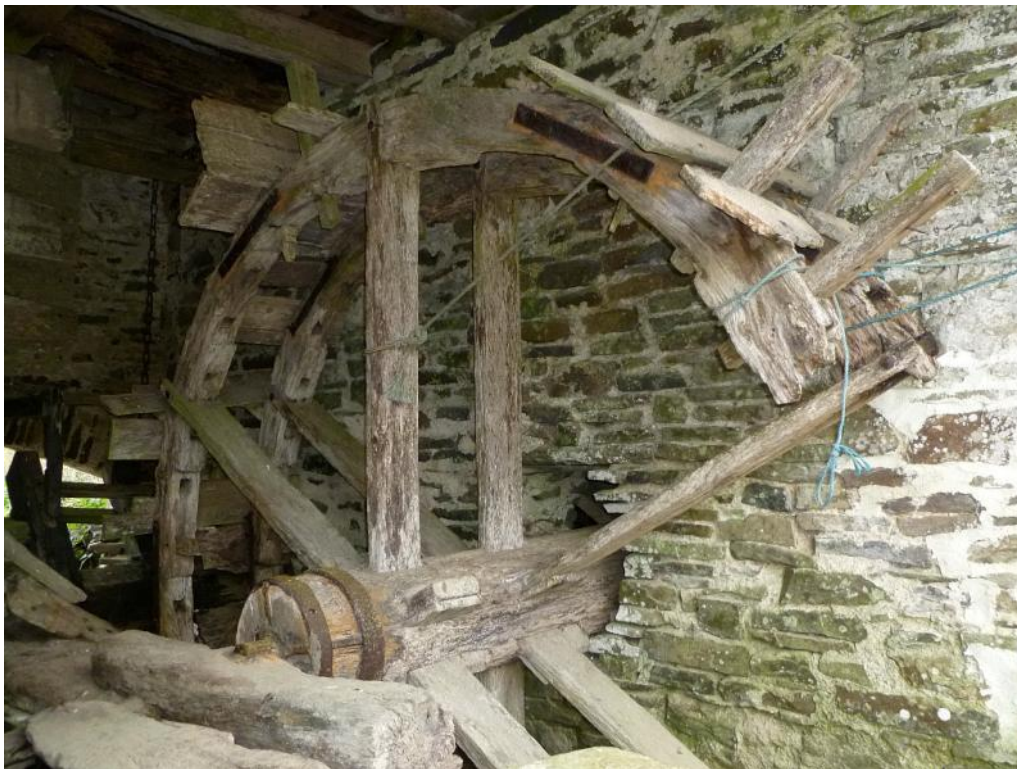
The southern mill wheelpit is about 1m wide and contains the remains of a low-breast waterwheel. Water entry is estimated to have been about 0.8m below the shaft centreline. The waterwheel is of timber construction, with two sets of three pairs of compass arms mortised radially through the wheelshaft. One arm has been deliberately sawn off on the north side. The arms carry timber felloes, curved sections which are joined midway between the arms and mortised for the shafts, the short radial timbers which project beyond the rings to which the floats or paddles are fixed. There were 36 floats, with sole boards fixed across the rings. The overall diameter of the south wheel is about 3.8m and the width over the floats 0.89m. The timber wheelshaft is circular in section, about 0.36m diameter, with iron cross-tail gudgeons forming the bearings and two iron gudgeon rings binding the shaft at both ends. The outer bearing is a simple brass or bronze half bearing let into a timber pillow block which is carried on two timber bearers on top of the stone wall which divides the wheel pit from the spillway.

South waterwheel. Note the sawn off arm on the outer side

Waterwheel: timber, low breast, water entry about 0.8m below shaft centreline. About 3.8m overall diameter x 0.89m wide. Timber shaft, circular (turned?); cross tail gudgeons let in, with two gudgeon rings, both ends. Two sets of three compass arms, 16 x 5cm section, long dimension parallel with shaft, mortised through shaft and wedged. One outer arm has been deliberately sawn off on downstream side of wheel. Double tenon at end of each arm, clasping and mortised into rings/felloes. Rings 15cm x 12cm section, thickening to 20 x 12cm where arms tenoned and bolted to them. Six ring sections each side, joined end to end midway between arm ends with iron plates and bolts. Approx diameter over rings 2.97m. Starts 9.5 x 6cm, overall length 60cm, project 36cm beyond rings. Float boards about 89cm wide, varying thicknesses (2 - 3.5cm measured), pegged with faceted tapering dowels to starts. Sole boards fixed to rings are 24cm wide x 2.5cm thick; only a few remain.

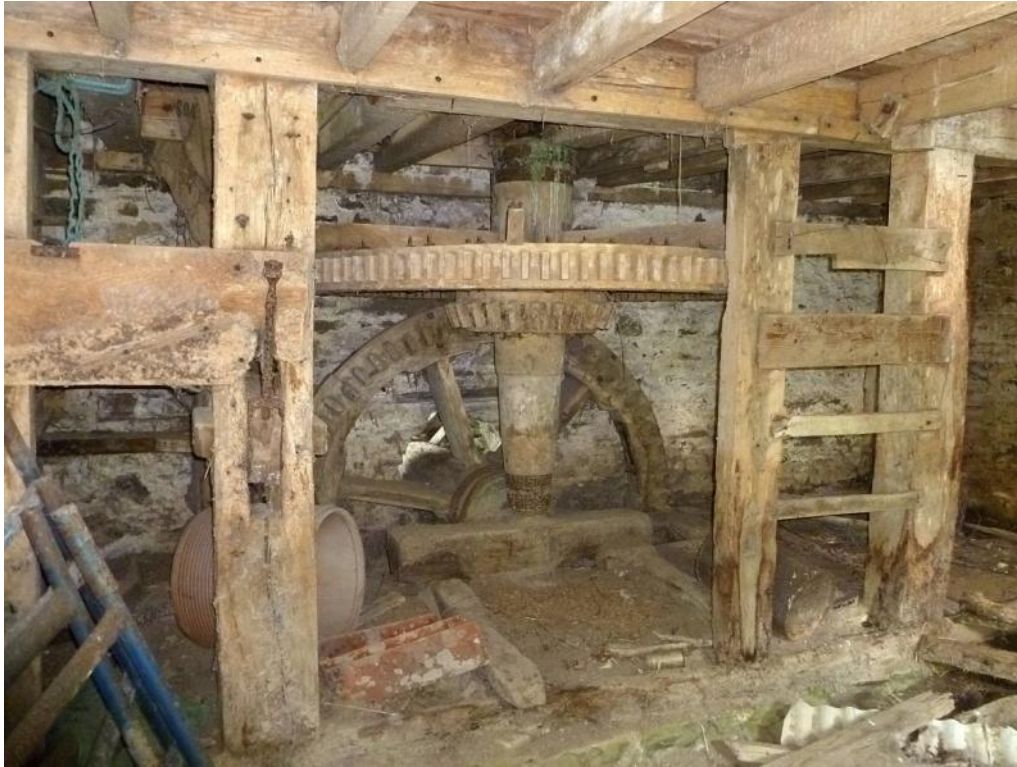
On the inner end of the wheelshaft is the pitwheel, a fine all timber gear with a bevelled face which carries about 66 cogs. The pit in which this gear rotated is neatly built with a timber surround at the top. The pitwheel meshes with the wallower, a solid-planked timber gear with 24 cogs which is fixed to the upright shaft. The upright shaft is elegantly turned, tapering to head and foot. Its foot bearing is carried in a cast-iron bridging box on a timber bearer, which also supports the inner wheelshaft bearing. Close above the wallower is the spurwheel, also of timber, which has three pairs of compass arms carrying the cants and felloes which make up the cog ring. This gear has about 102 cogs. The gearing in the south mill is well made and still in fair condition, although the spurwheel is slightly warped.

There was formerly a single pair of millstones, the drive being taken off the downstream side of the spurwheel, but the drive spindle and stone nut are missing. A single millstone survives at first floor level, leaning against the east wall. This is a worn French burr stone, 1.19m in diameter. The stone beams and circular emplacement which carried and located the bedstone survive in the floor on the downstream side of the hurst, with the remains of skirting boards for an octagonal tun (millstone case). No millstone furniture or other fittings survive.

South mill hurst and primary machinery, with bridge post and tentering adjuster on left

The hurst, the timber frame that encloses the driving gears and supports the millstones, has a 20cm x 20cm oak bressummer at first floor level, which runs the full width of the mill. The first floor joists bear on a timber nailed to the face of this beam. The front cill beam is in poor condition. It supports four posts, including the bridge post through which the front end of the bridge tree, the horizontal timber that carries the foot bearing of the stone drive, is tenoned. The elevation of the bridge tree can be altered by the tentering screw, which raises and lowers the upper millstone whilst working, so controlling the texture of the ground product. The inner ends of the beams that supported the lower millstone bear on a timber plate built into the pit wall.

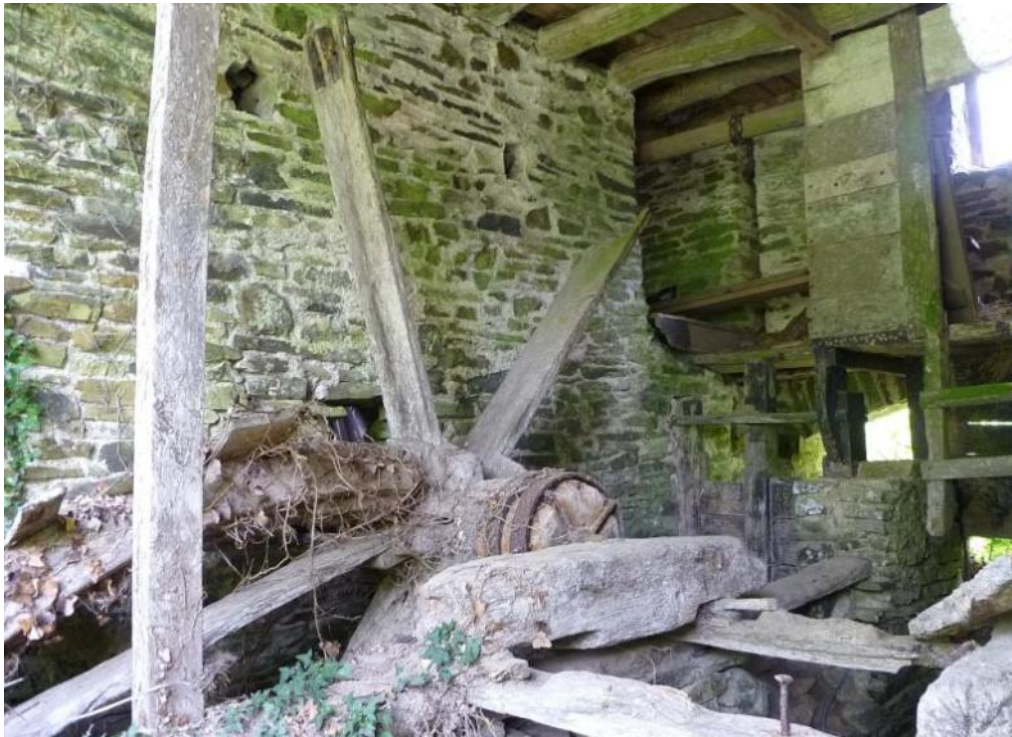
The northern wheelpit and the waterwheel that drove the machinery in the north mill are narrower than those of the south mill and the wheel is of slightly larger diameter, up to 3.9m, its wheelshaft centre being set higher. The working head and water feed arrangements were similar for both wheels. When first recorded by the writer in 1989 more of this wheel, including some of the floats, was in place. Part of one of the ring sections still survived in 2005, although this appears to have gone and what remains is generally in

a poor and fragmented condition. The north wheel is an unusual survival in having only a single set of three sturdy compass arms. As with the south wheel, these carried timber felloes which made up a circular ring from which V-shaped timber starts projected. These carried flat timber floats which were 0.7m wide. It was calculated that there were 36 floats and also sole boards which were fixed to ring. The timber wheelshaft is now very eroded, but was circular in section, about 36cm diameter and 2.2m in length. It has cross-tail gudgeons fitted in both ends, the outer journal running in a bronze half bearing let into a timber bearer, similar to the south wheel. On the north side of the waterwheel arms an iron or steel clamp has been fitted around the shaft, presumably an historic repair as the timber is split from this point. Close inside the pit wall, behind the present pitwheel, there are mortises through the shaft through into the timber arms of the original pitwheel were fixed. The wheelshaft appears to have broken within the pitwheel centre.

Remains of north waterwheel

Waterwheel: low breast wheel with water entry and control as south wheel. Slightly larger diameter, about 3.92m, as shaft centre set about 7.5cm higher than south wheel. Circular section shaft only about 2.2m long by about 36cm diameter inside outer gudgeon rings, in poor condition, with long split from where compass arms are mortised through towards pitwheel. Single set of three compass arms, 22 x 5cm section, with double tenon at outer ends to clasp rings, to which they were held with a single bolt. No ring/felloe sections visible (2014) but when measured before they were 15cm square, increasing to 15cm thick x 17.5cm deep where they met the arms. Rings were mortised for starts, two in V-shaped arrangement for single float board, pegged to starts. Estimated to have had 36 floats, flat radial boards 0.71m long x 30cm wide, with sole boards fixed to rings. Mortises 30 x 10cm for compass-arm gear behind present pitwheel.

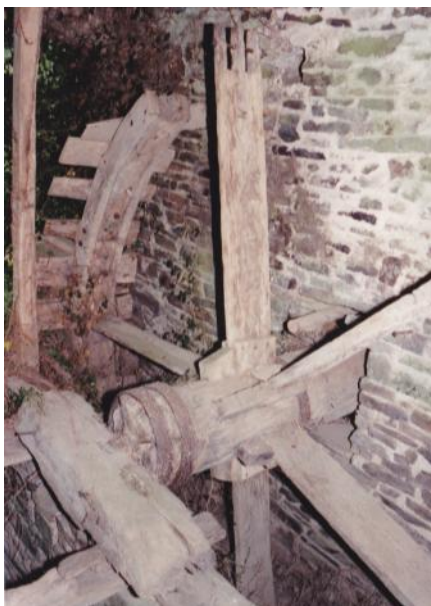
Remains of north waterwheel and detail of V-shaped start and float, July 1989

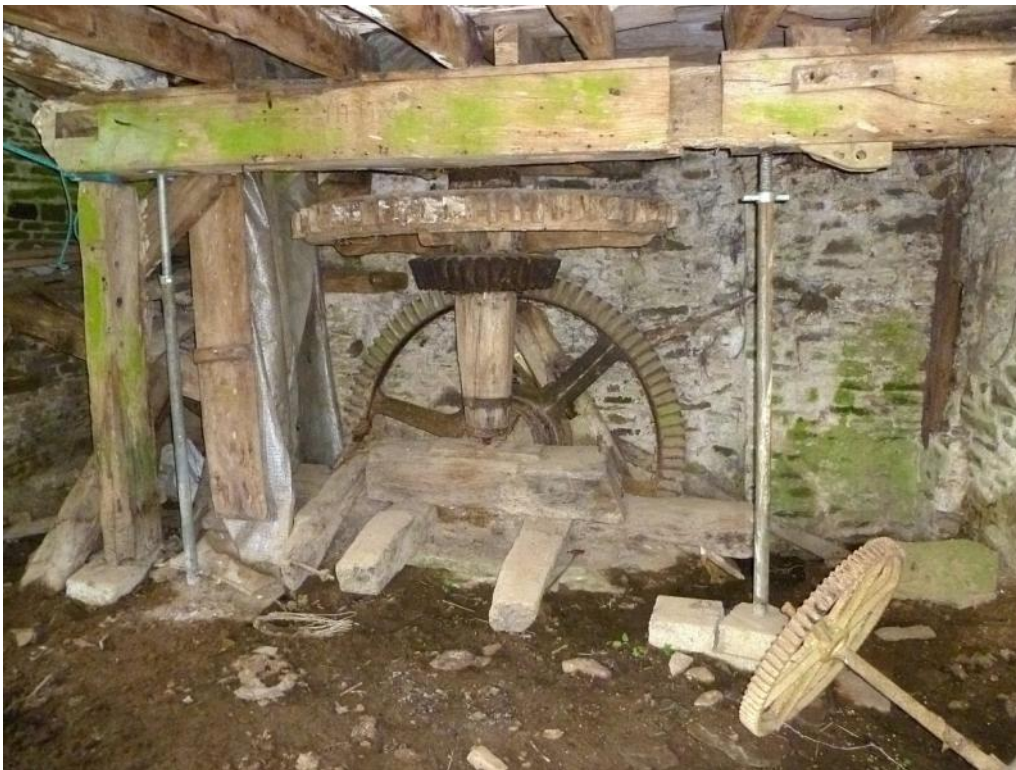
The present pitwheel is a split-cast iron bevel gear with approximately 96 oak cogs. It formerly meshed with the wallower, a cast-iron bevel gear with 34 teeth, which is mounted on a short oak upright shaft. The foot bearing of the upright shaft is carried on a timber block along the edge of the cog pit, which is filled with silt and debris. Above the wallower is the spurwheel, a timber gear with two pairs of compass arms which carry a cog ring with about 64 cogs mortised into it. As in the south mill the millstone drive and millstones are long gone, but there was a single pair of stones of about 1.2m diameter on the downstream side. The stone beams and circular opening in the floor on the top of the hurst remain. The bridging timbers that supported the millstone drive were displaced but were still in the mill in 2012, although they now appear to be missing. Their positions and dimensions have been recorded, however.

North mill: remains of hurst and primary machinery

The oak bressummer of the hurst has rotted at its downstream end where it was built into the wall, but has been propped and retains one original post at its upstream end. There must originally have been a cill beam on the floor directly below this beam, for the feet of the posts to bear on, and the floor area will require careful clearance to determine its exact position and dimensions. The bressummer has \* I H \* 1796 \* chisel-cut into its vertical face and has a curiously moulded upstream end (see discussion below). There was a raised platform about 1.2m over the ground floor at the east end of the hurst, which gave access to the penstock and spillway sluice controls, then a further two steps up to the millstone level. No millstone furniture or other fittings appear to have survived.

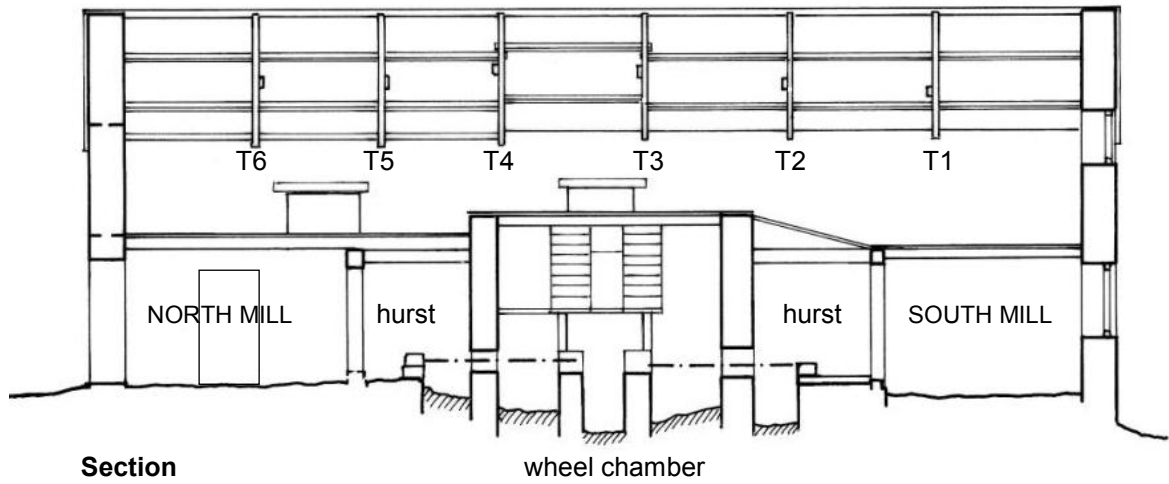
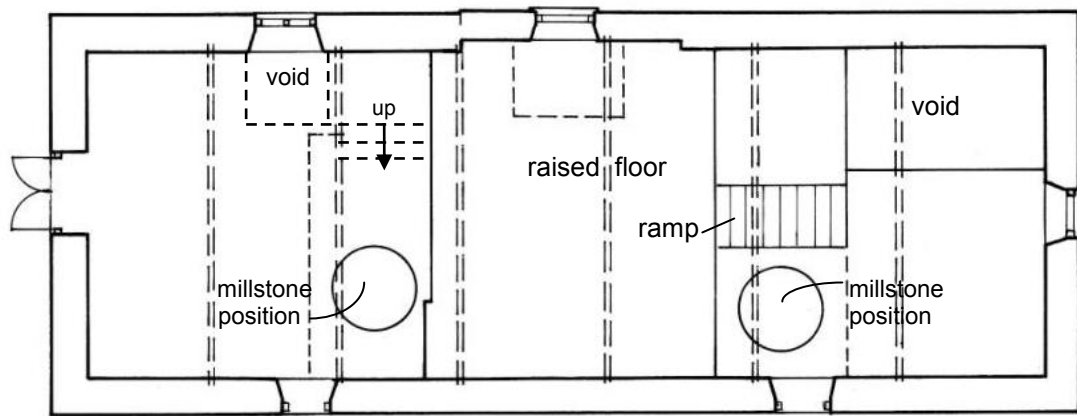
Figure 7: Cawsey Meethe Mill. First floor plan and north-south section

positions of roof trusses indicated by broken lines

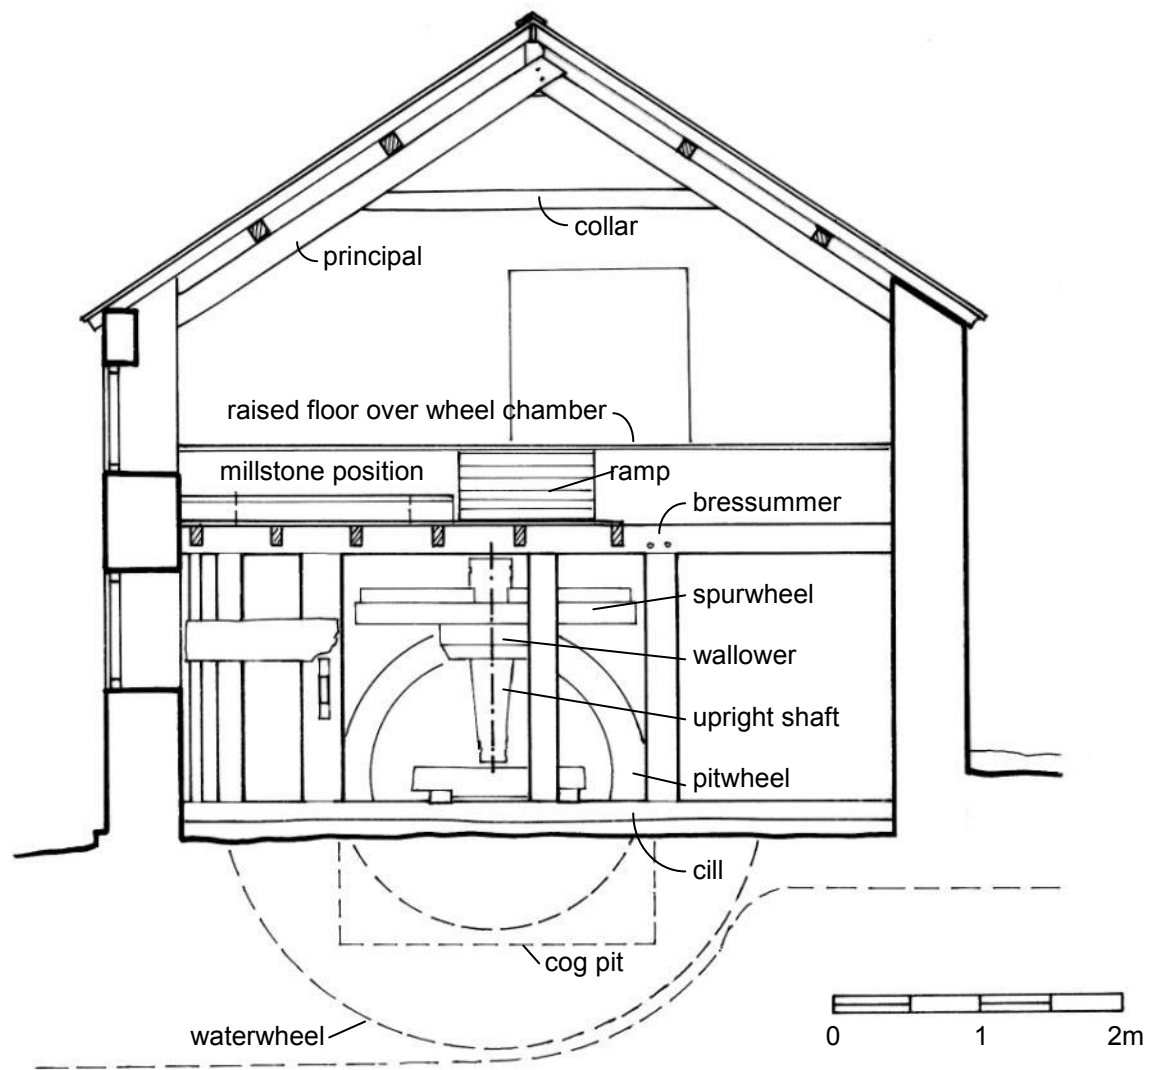
Figure 8: West – east section through south mill,  
 looking at hurst face with machinery shown in outline

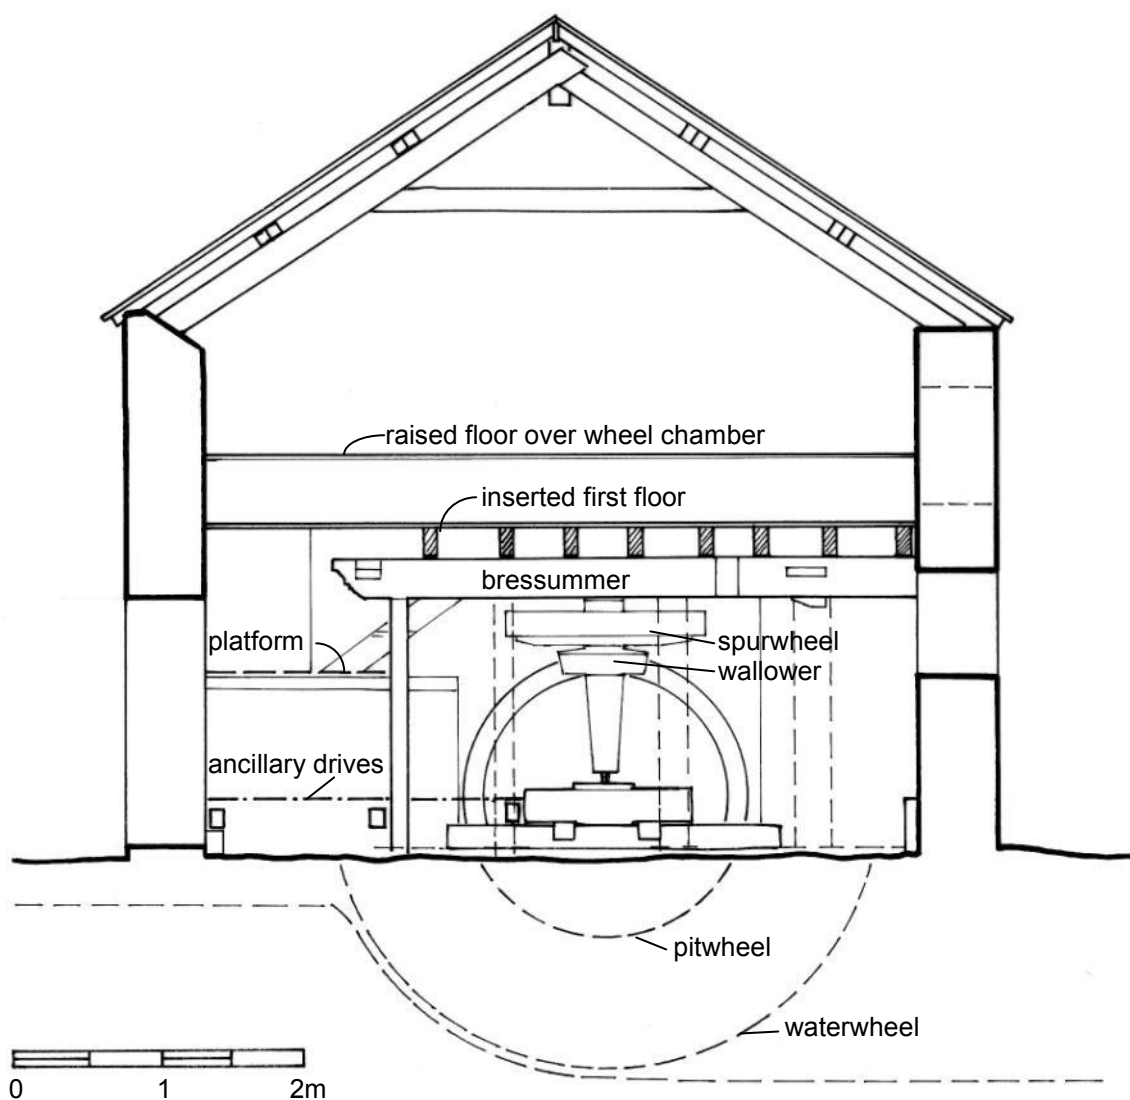
Figure 9: East – west section through north mill,  
 looking at hurst face with machinery shown in outline.  
 Position of missing bridge posts indicated by broken lines

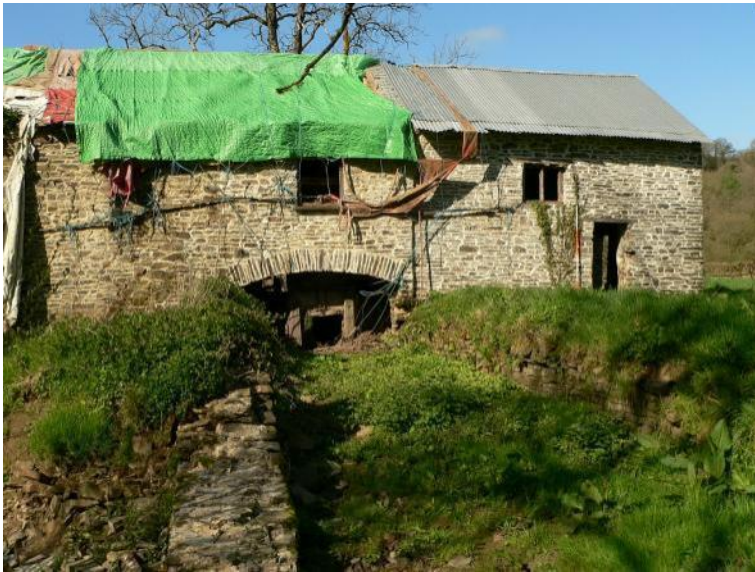
Headrace with wall to spillway on right

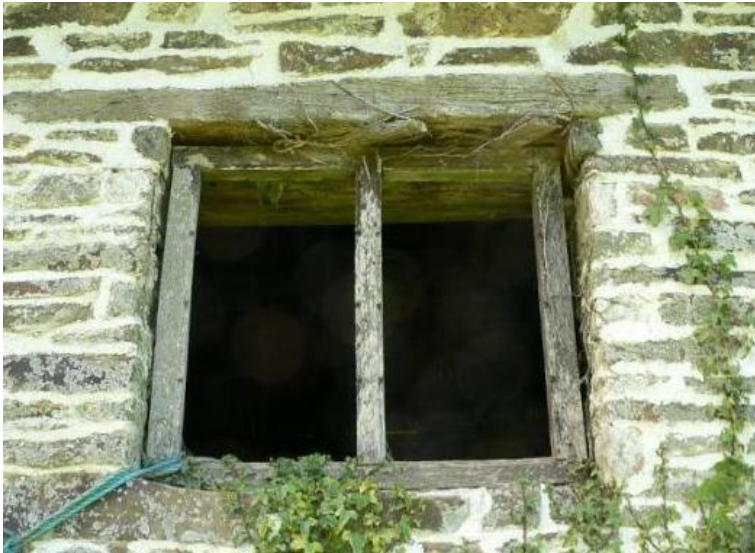
Timber-framed two light window, east elevation of north mill

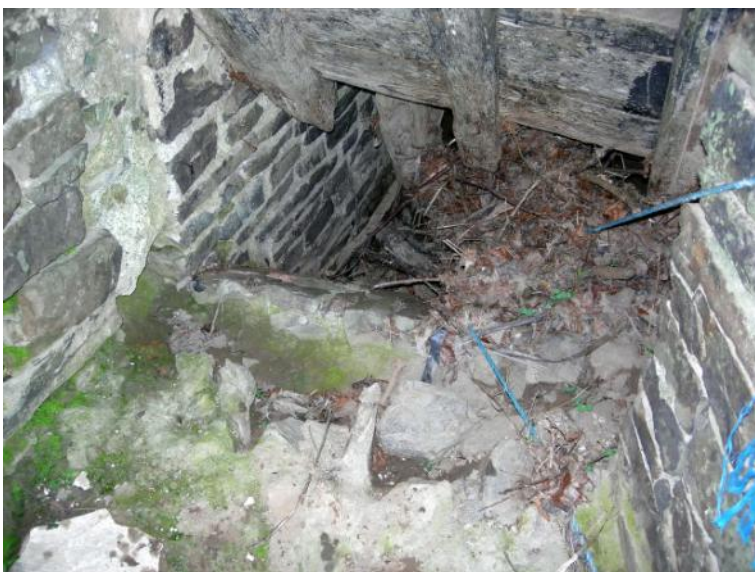
Displaced penstock to south waterwheel, showing edge of curved stone breastwork

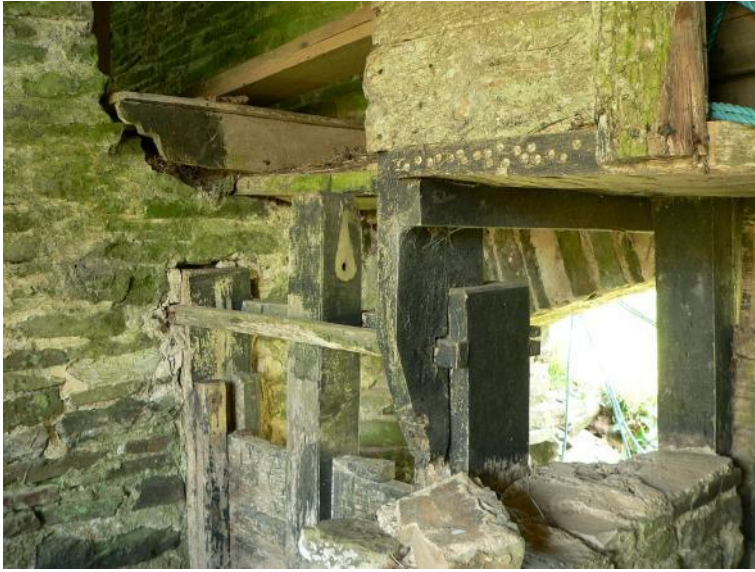
Top of penstock to north waterwheel, with timber supports for compartment over spillway

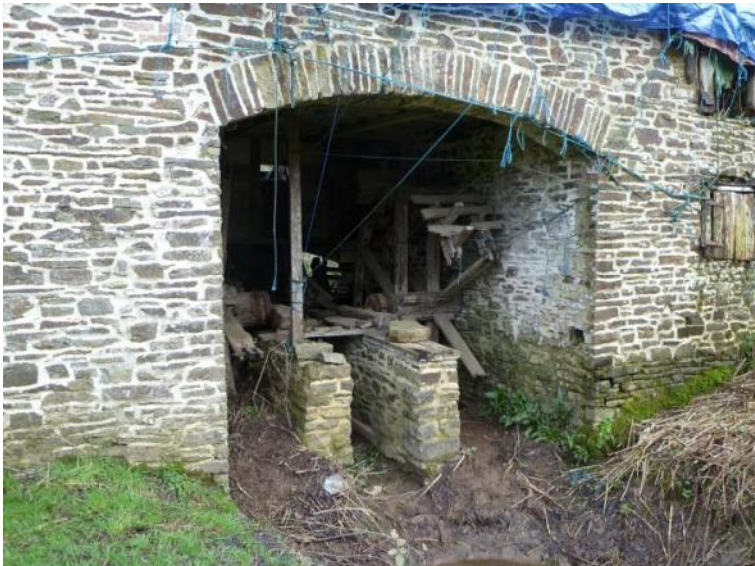
West end of wheel chamber and tailrace channel

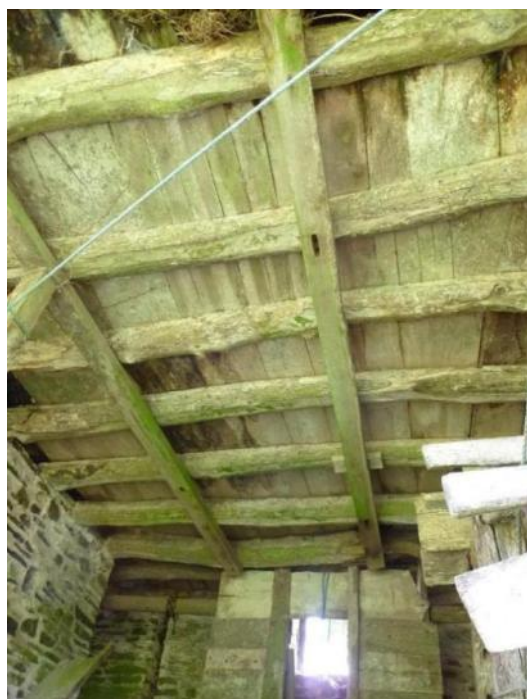
Floor support structure over central wheel chamber, looking east

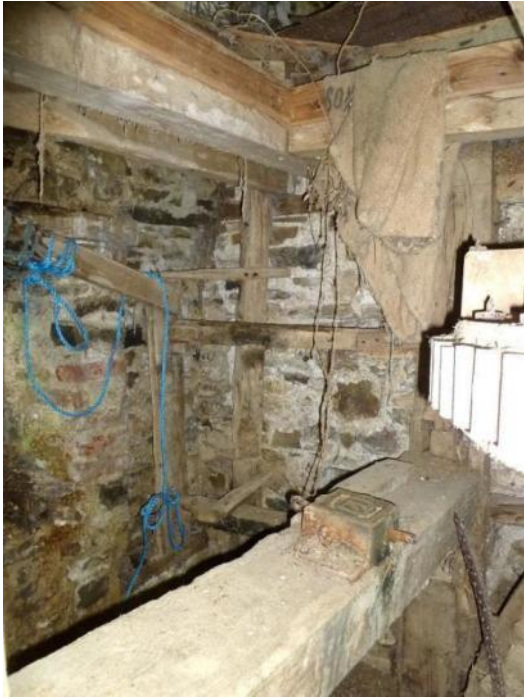
< Bridge tree and north-west corner under hurst in south mill

Lower sprattle beam carrying footstep bridging box is 1.22m long x 24 x 23cm; upper beam is 19 x 13cm section, with bearing on downstream face.

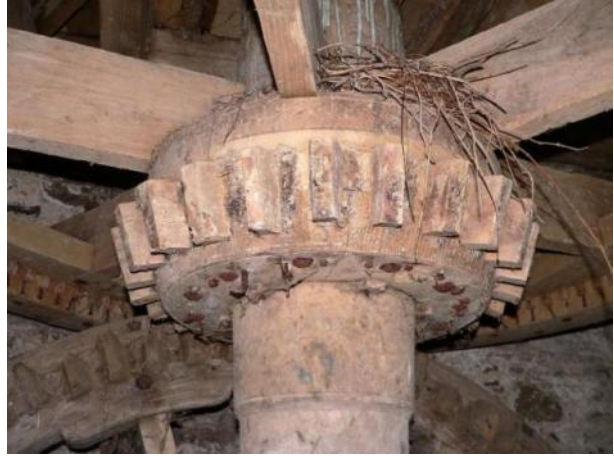
Detail of wallower, south mill

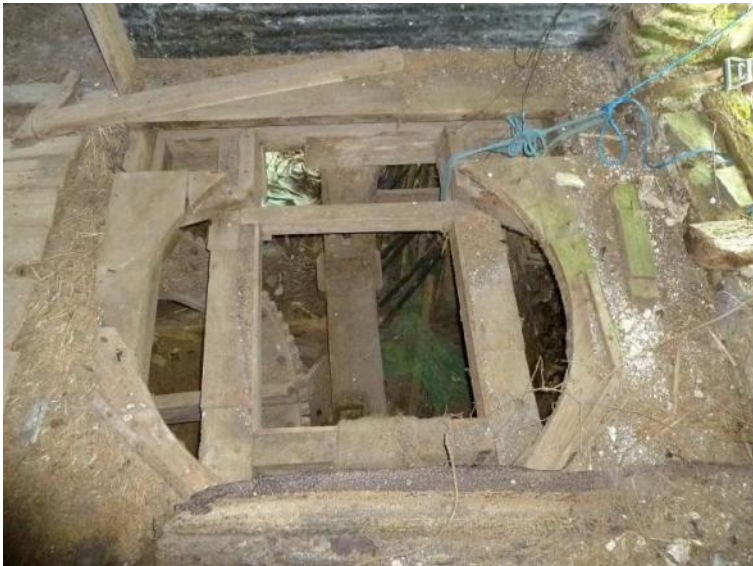
Millstone emplacement in hurst floor, south mill

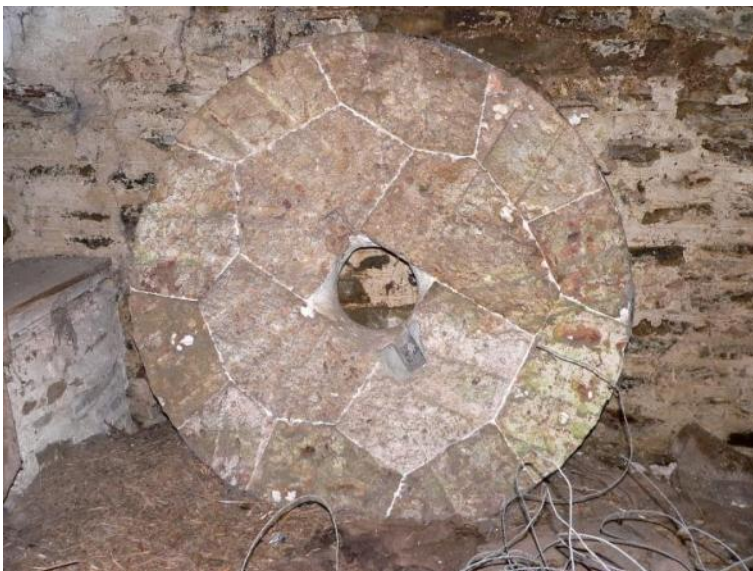
Displaced French burr millstone in south mill

Single displaced French burr runner leaning against east wall at first floor level. Very worn 1.19m diameter French burr, 18cm thick, 22cm diam eye, but was formerly square, so possibly a re-used bedstone. 40cm span bridge chases. Anti-clockwise dress, very coarse pitched furrows. Possibly re-backed as plaster in good condition; no maker's name or other marks visible.

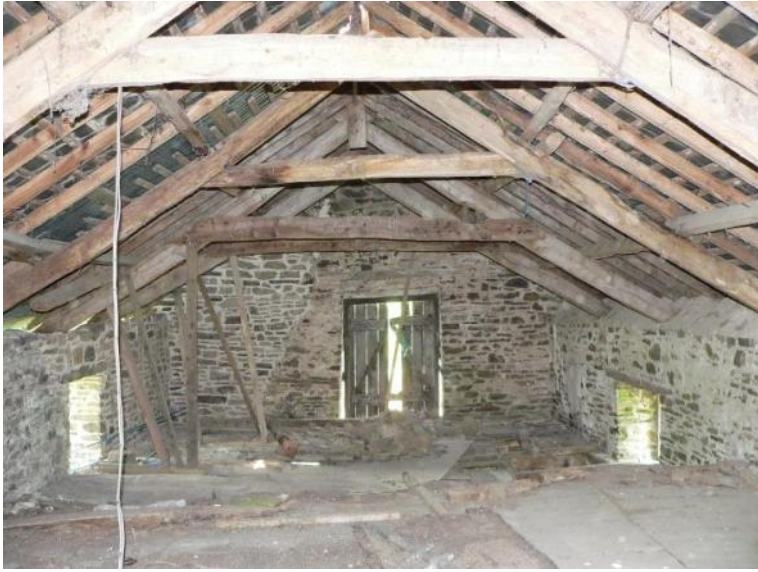
Roof structure, looking north
