**CAWSEY MEETHE MILL,  
KING'S NYMPTON, DEVON**

**HISTORIC BUILDING RECORDING**

**April 2014**

Project CMM60/2014

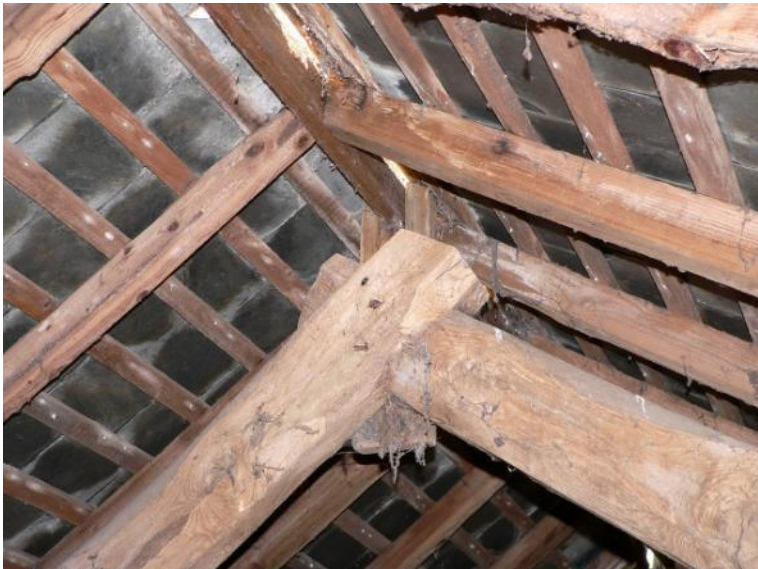
Detail of truss apex

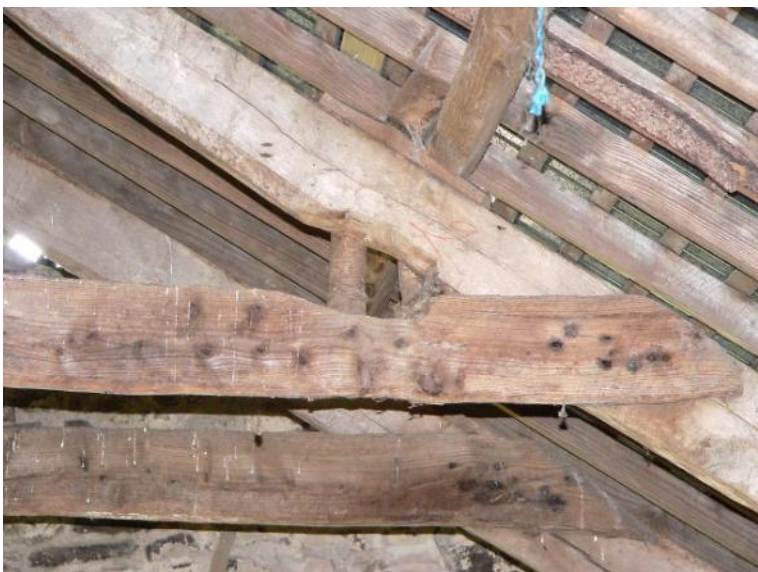
Detail of collar/principal joint, T5, with roundwood uprights for rope guide?

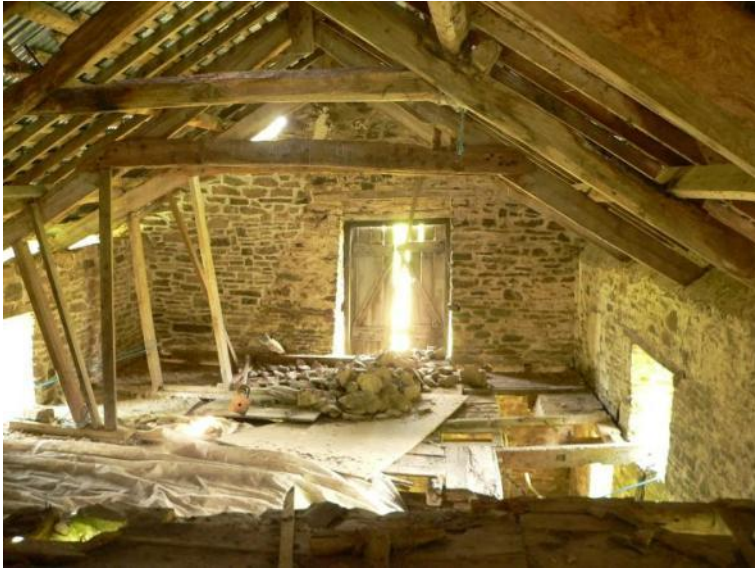
Roof structure and first floor of north mill

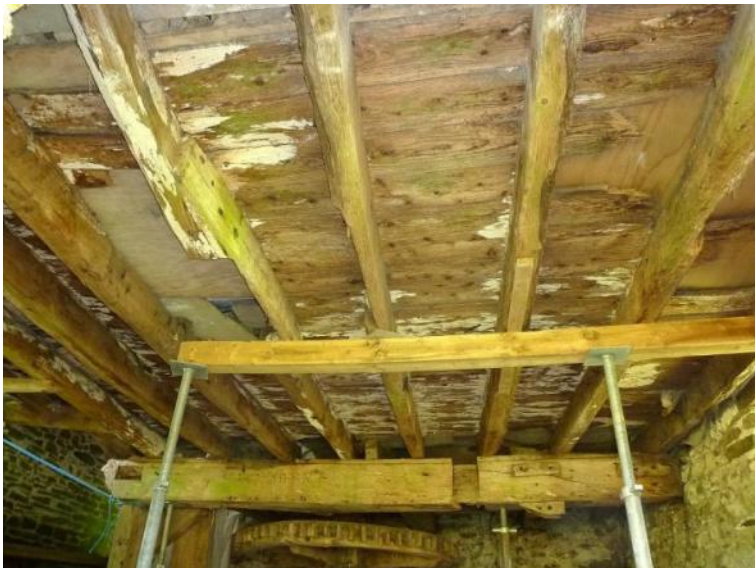
First floor joists, north mill, looking south to hurst frame

The full first floor of the north mill also appears to be a later insertion, as the joists sit on top of the hurst bressummer rather than being notched into it. This floor also cuts across the upper level window in the east elevation of the north mill, which is the only opening to retain a frame for fixed lights rather than a shutter. This could lend support to an interpretation that the north mill was originally a single cell mill, with the millstones set on a hurst which was accessed by steps up at the east end from ground floor level, vestiges of which remain. The documentary evidence for the existence of a mill here earlier in the 18th century might therefore suggest that the north mill was rebuilt in 1796, perhaps after flood damage or simply wear and decay through the passage of time.

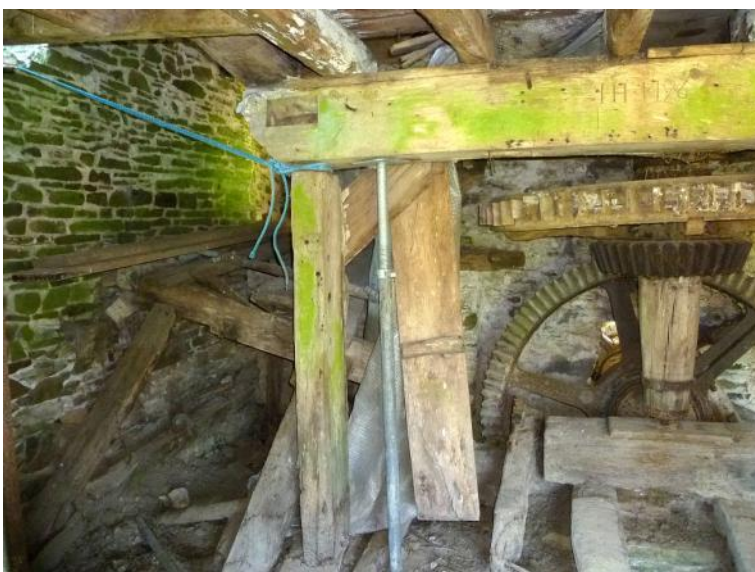
Position of raised platform at east end of hurst, north mill

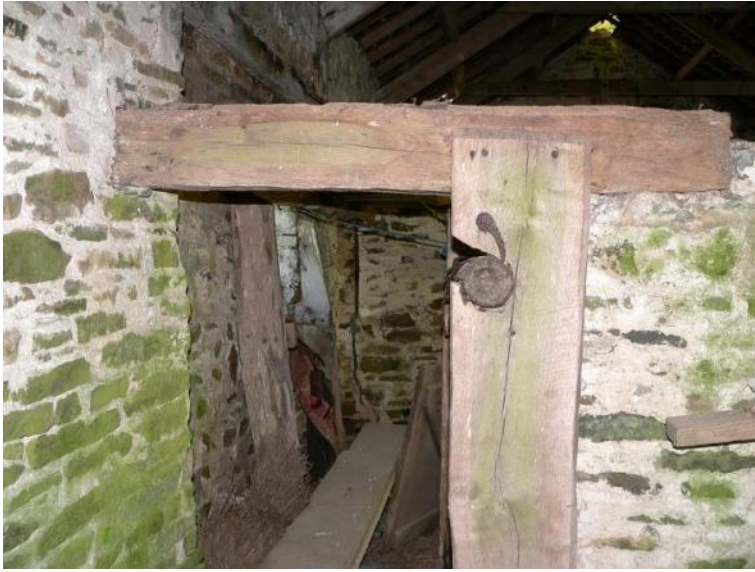
Ratchet on inner end of penstock control, north mill

round timber housings. The penstock for the north wheel was operated from the platform at the east end of the hurst, the inner end of the bollard having a ratchet and pawl and provision for a metal handle.

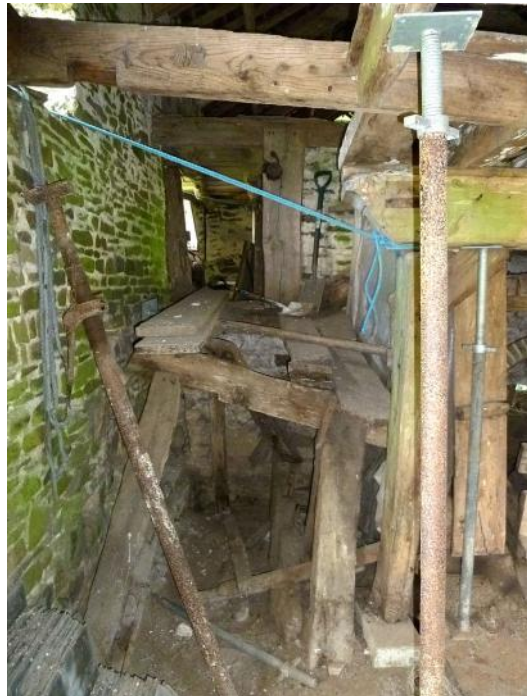
Remains of platform at east end of hurst, with ancillary drive support timbers beneath

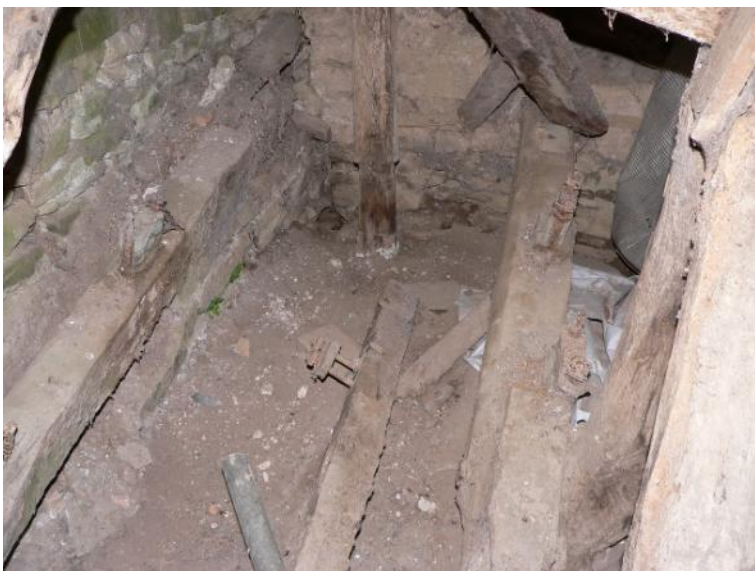
Ancillary drive support timbers with bearing against east wall

There was a secondary drive train taken off the upstream side of the pitwheel. There are three horizontal timbers with bearings attached, which formerly supported two iron shafts with gears and pulleys attached, from which ancillary drives were taken. The latter are now displaced, but are still in the mill.

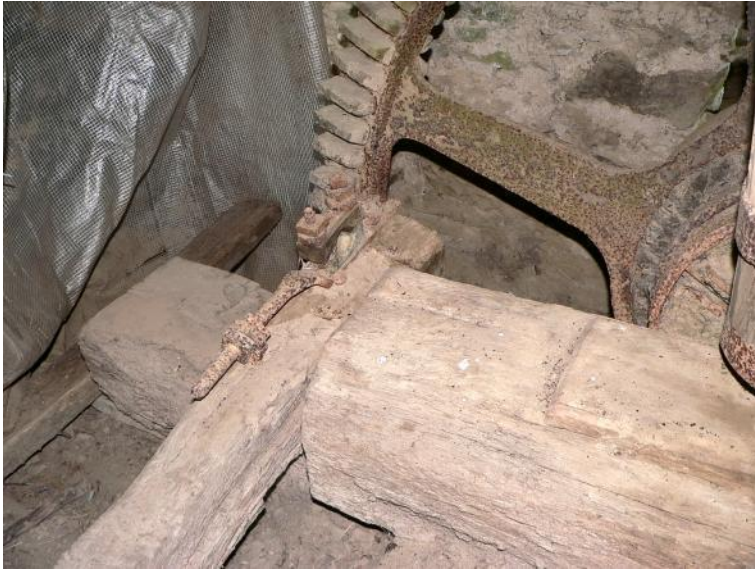
Ancillary drive shaft support timber with bearing at upstream side of pitwheel

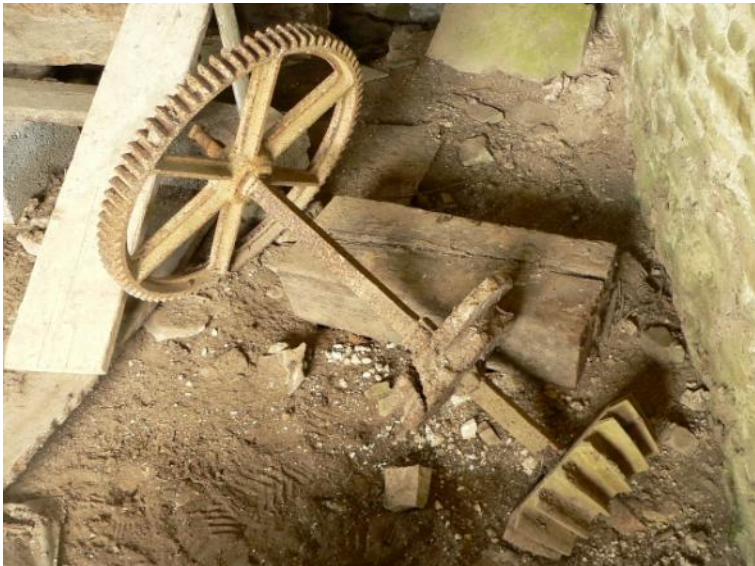
Displaced drive shaft (1). The iron bevel gear meshed with the pitwheel and the spur gear with the pinion on drive shaft (2)

Layshaft 1: 4cm square iron, about 1.2m long overall, journal at each end. CI bevel gear on one end which meshed with pitwheel, 36cm max diam, about 20 teeth, worn to quite thin section; 40cm diam x 8cm wide solid timber pulley, decayed, with groove for rope drive; 66cm diam x 5cm face CI spur gear, 6 + section arms, 80 teeth at outer end.

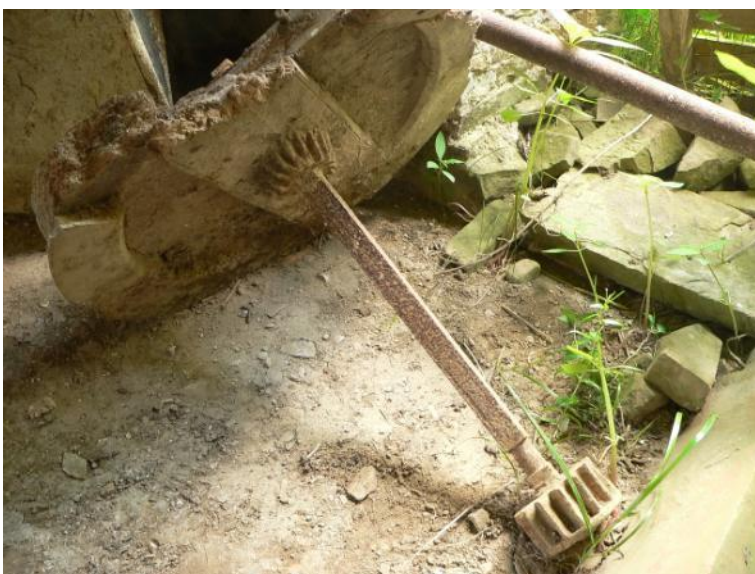
Displaced drive shaft (2), with cast-iron pinion and remains of timber pulley for belt drive to ancillary machine

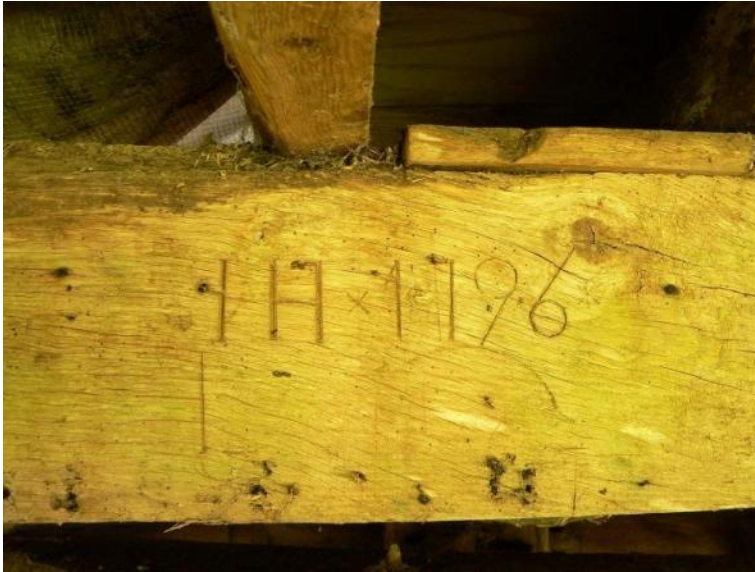
Inscription on hurst  
bressummer, north mill

The only positive dating evidence in the mill is the initials and date cut into the face of the hurst bressummer beam in the north mill.<sup>2</sup> Taken with other mechanical features, it is considered that this may represent a primary construction date for some of the surviving gearing at the north end. The upright shaft and spurwheel appear contemporary with each other and both may date from 1796, the laid-in gudgeon in the foot of the upright shaft and the coarse pitch of the spurwheel teeth being consistent with a late 18th date (see Watts 1994; Stoyel 1997). However, the machinery of the north mill was 'modernised', probably about the middle of the 19th century, with a cast-iron pitwheel and wallower being introduced to replace earlier timber ones. The mortises through the wheelshaft behind the present pitwheel indicate the position of the arms of the earlier gear.

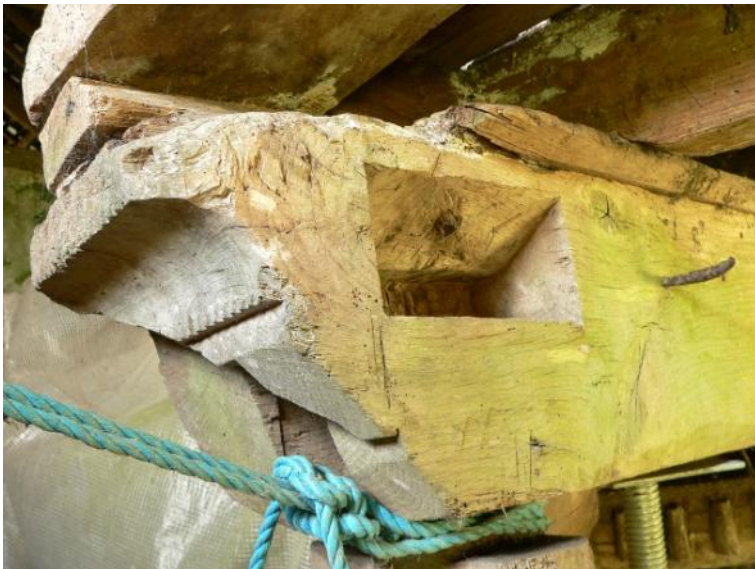
Moulded upstream end of  
hurst bressummer

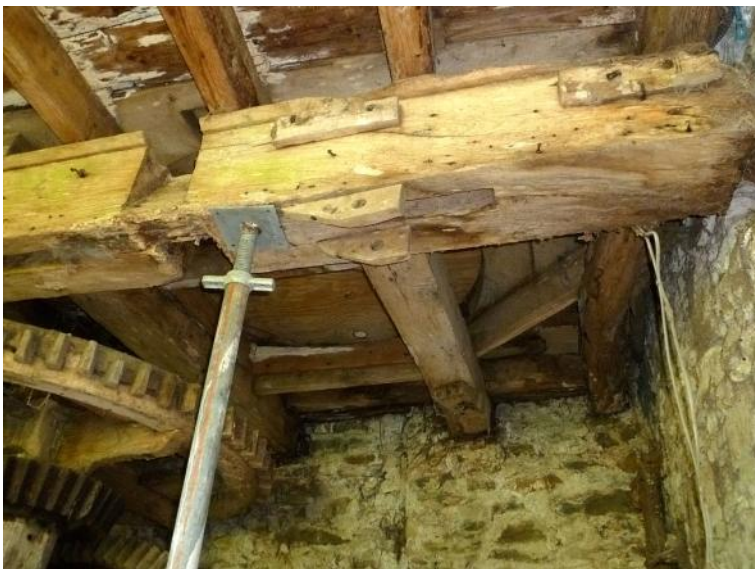
Downstream end of hurst  
bressummer, north mill, with  
cut out (left of prop) for  
meal spout from millstones

The oak bressummer of the hurst has rotted at its downstream end where it was built into the wall, but has been propped and retains one original post at its upstream end. There must originally have been a cill beam on the floor directly below this beam, for the feet of the posts to bear on, and the floor area will require careful clearance to determine its exact position and dimensions. The bressummer has \* I H \* 1796 \* chisel-cut into its vertical face and has a curiously moulded upstream end (see discussion below). There was a raised platform about 1.2m over the ground floor at the east end of the hurst, which gave access to the penstock and spillway sluice controls, then a further two steps up to the millstone level. No millstone furniture or other fittings appear to have survived.

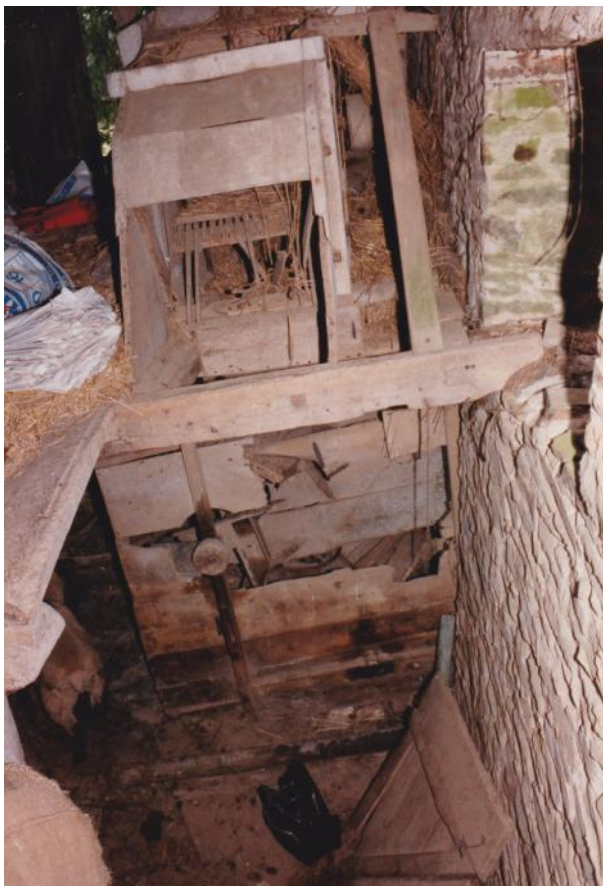
Remains of small threshing machine in north mill, looking north along the east wall. 29 July 1989

The ancillary drive was to a wooden framed machine with a winnowing fan in it, probably a small purpose-built thresher rather a reed comber (as in Thorpe 1989, 38), from the remains seen by MW in 1989 and with Peter Child in 1990. The woodwork of this machine was in poor condition and with the exception of some iron parts, now displaced, has been subsequently lost.
